Geology and Soils Evaluation Report

Proposed Skye Vista Subdivision

16850 Stepler Road

VIVID Project No.: D24-2-807

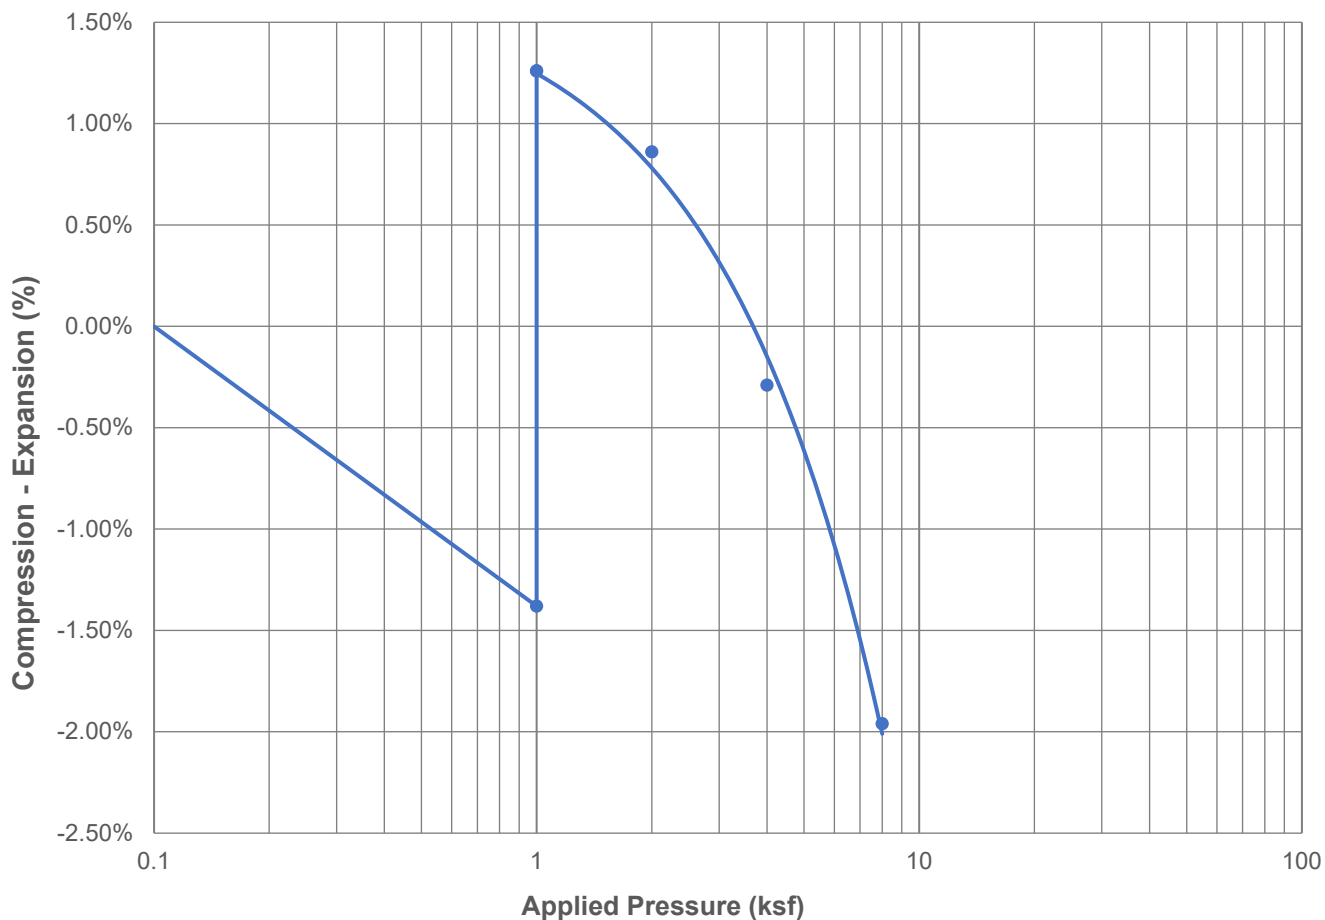
Borehole: TH-1
 Sample Depth: 4 Ft
 Classification: SC

Applied Load (lbs)	Displacement (in)
0	0.0000
1,000	-0.0138
Add Water	0.0126
2,000	0.0086
4,000	-0.0029
8,000	-0.0196

Based on lab testing performed by A Better Soil Solution, swells of the onsite soils ranged from 0.1 to 2.6 percent when wetted under 1,000 psf surcharge load and compression from 0.1 to 0.6 percent. It should be noted that expansive clay or clayey sandstone is not uncommon within the Dawson Formation. This condition, if it exists, should be evaluated at the time of final geotechnical investigations for each specific residence. Expansive soils can be mitigated through typical engineering approaches including removal of expansive layers, over-excavation and treatment or replacement, or use of deep foundations.
