(d)OWTS Report. (i)General Requirements.

example report

The proposed project includes the development of a 35-acre parcel into a residential subdivision. Thirteen lots are planned that will be approximately 2.5 acres in size. A home is currently on the property with horse stables and a small barn. The development will include construction of access roadways and utilities. Residential lots will require individual water well and septic systems. A preliminary site layout is shown on Figure 3, attached to this report.

Preliminary Soils Report and Investigation by A Better Soil Solution

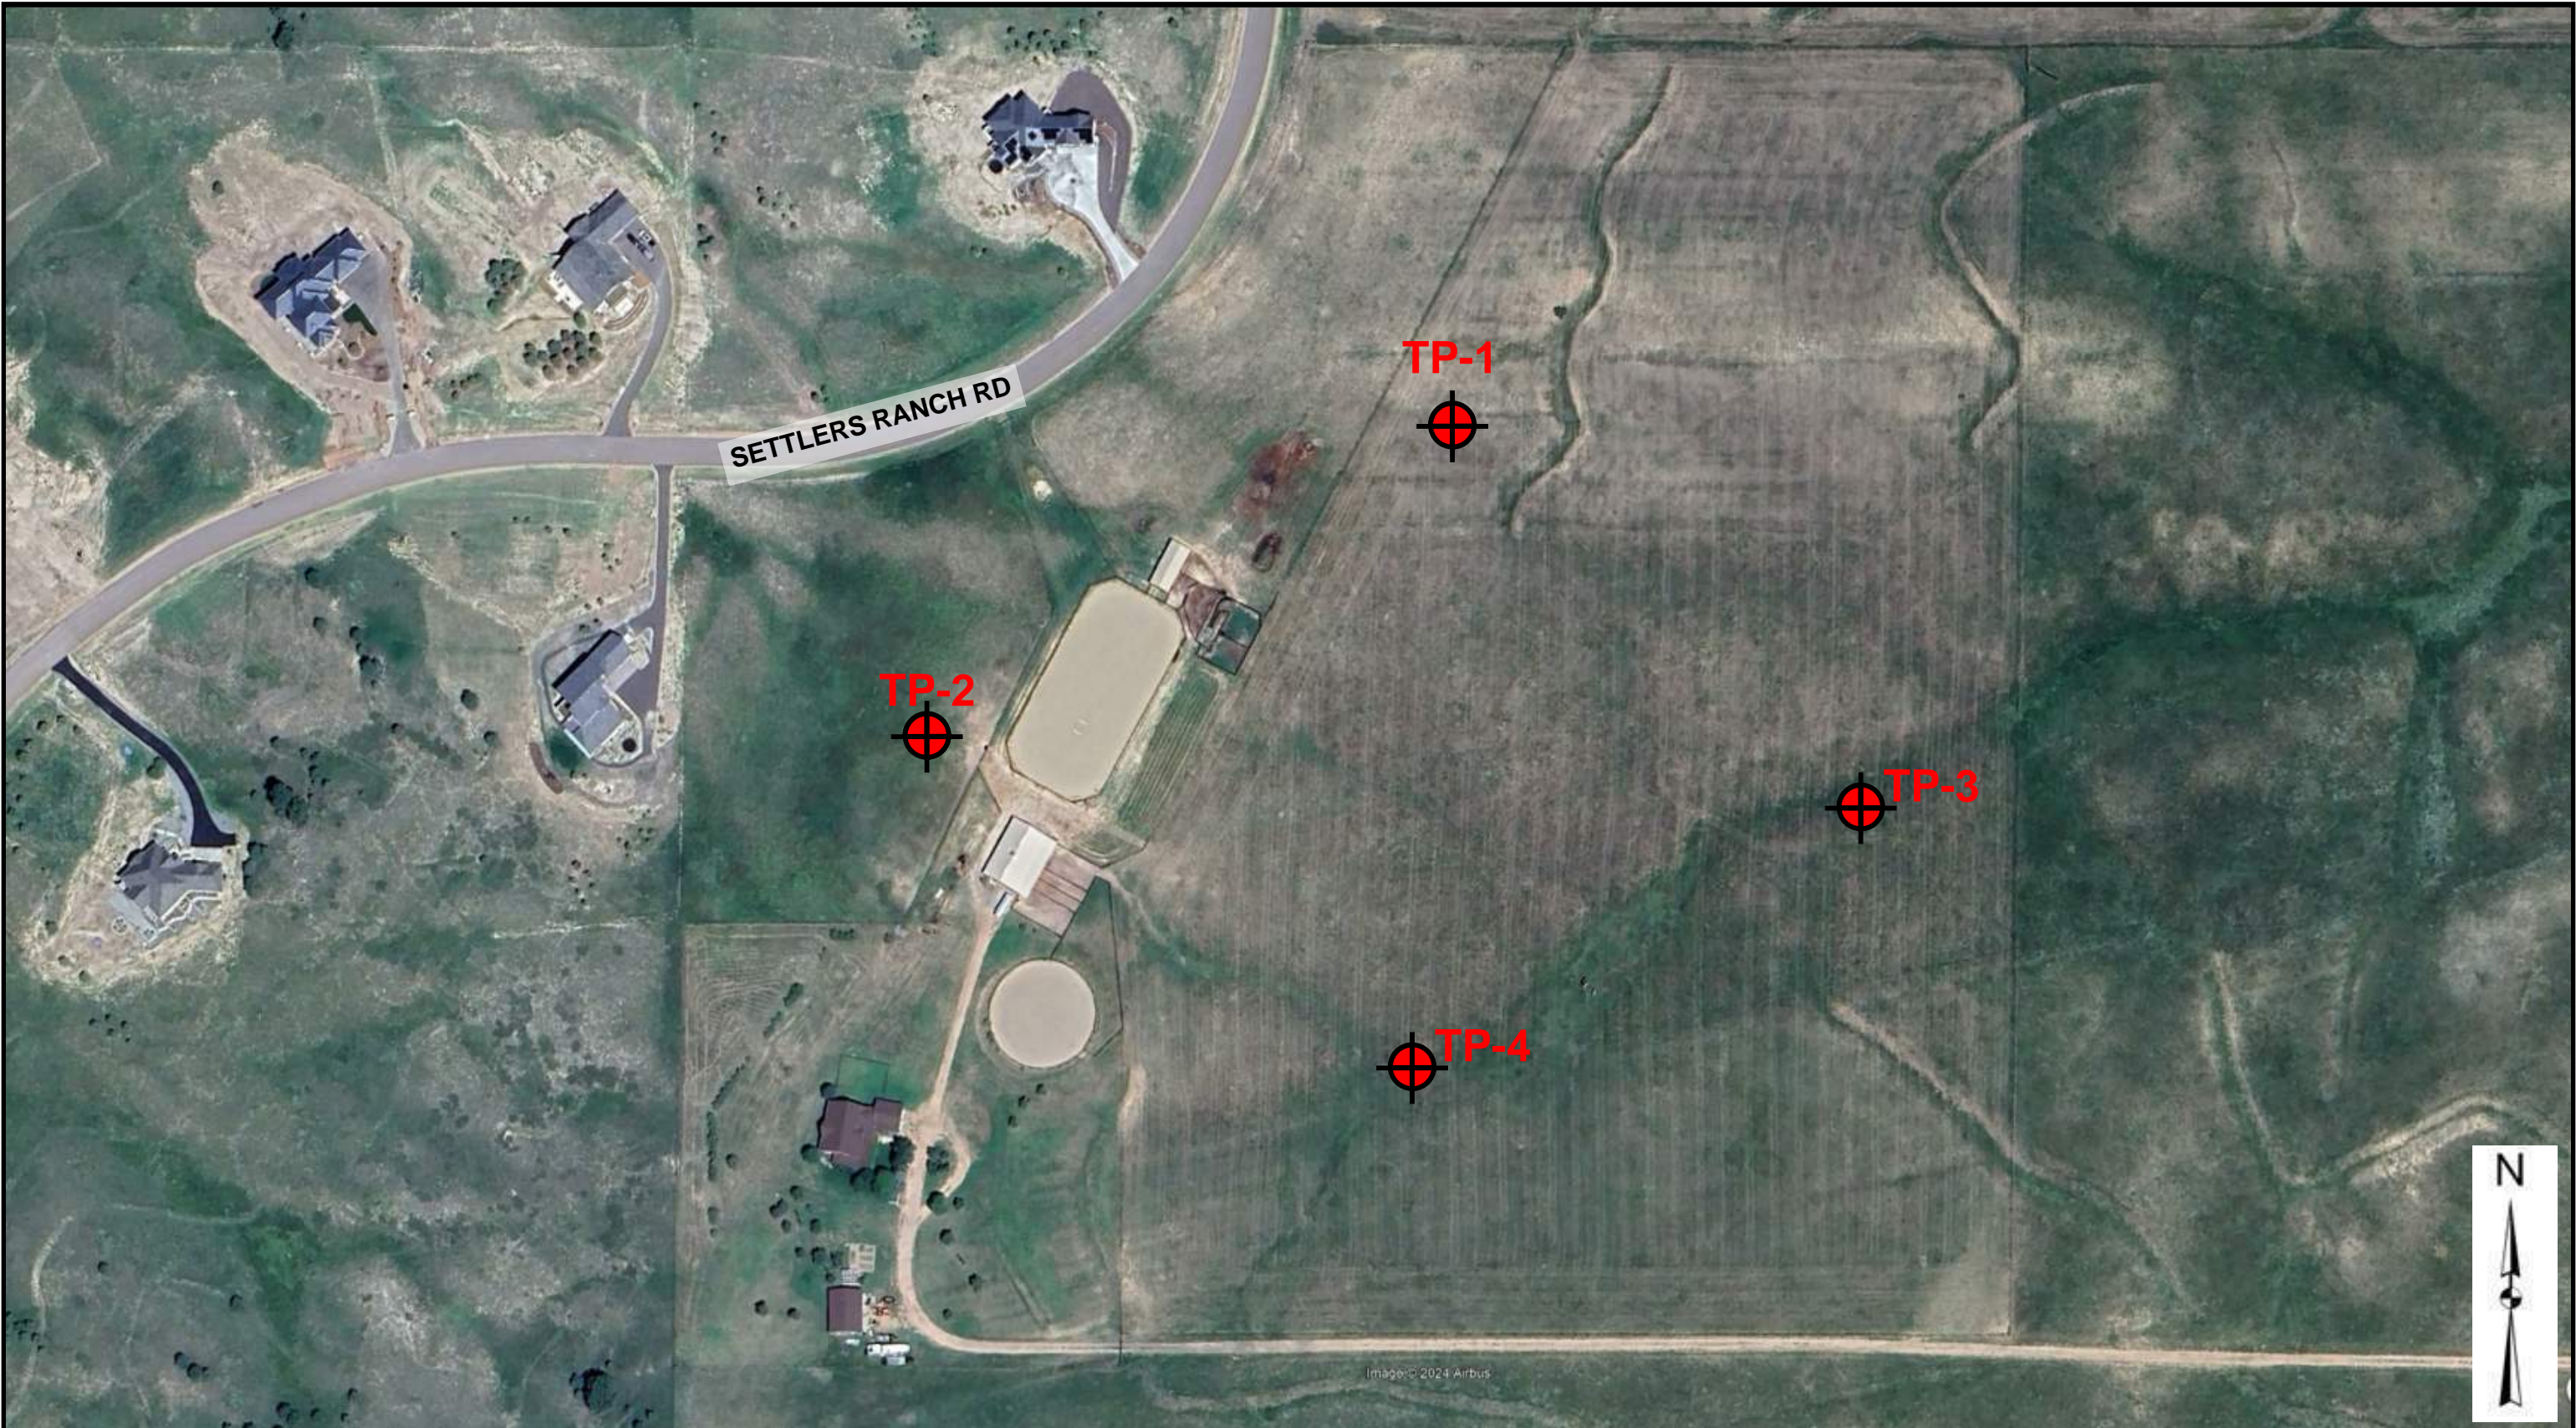
2

Figure 1:	VICINITY MAP
Figure 2:	FIELD EXPLORATION PLAN (AERIAL)
Figure 3:	FIELD EXPLORATION PLAN (CONCEPTUAL)
Figure 4:	FLOOD HAZARD MAP
Figure 5:	GEOLOGIC MAP
Figure 6:	NRCS SOIL SURVEY MAP

- A visual reconnaissance to observe surface and geologic conditions at the project site and locating the test pit sites;
- The review boring logs from the previous Preliminary Soils Report and Investigation performed by A Better Soil Solution (Job #24-0181) dated June 23, 2024;
- The excavation and logging of four test pits for tactile evaluation of the soils;
- Laboratory testing of selected samples obtained during the test pit exploration to evaluate relevant physical, geologic, and engineering properties of the soil; and
- Preparation of this report, which includes a description of the proposed project, a description of the surface and subsurface site conditions based on review of previous reports, and conditions found during our investigation, and an evaluation of the feasibility of the use of OWTS for this development.

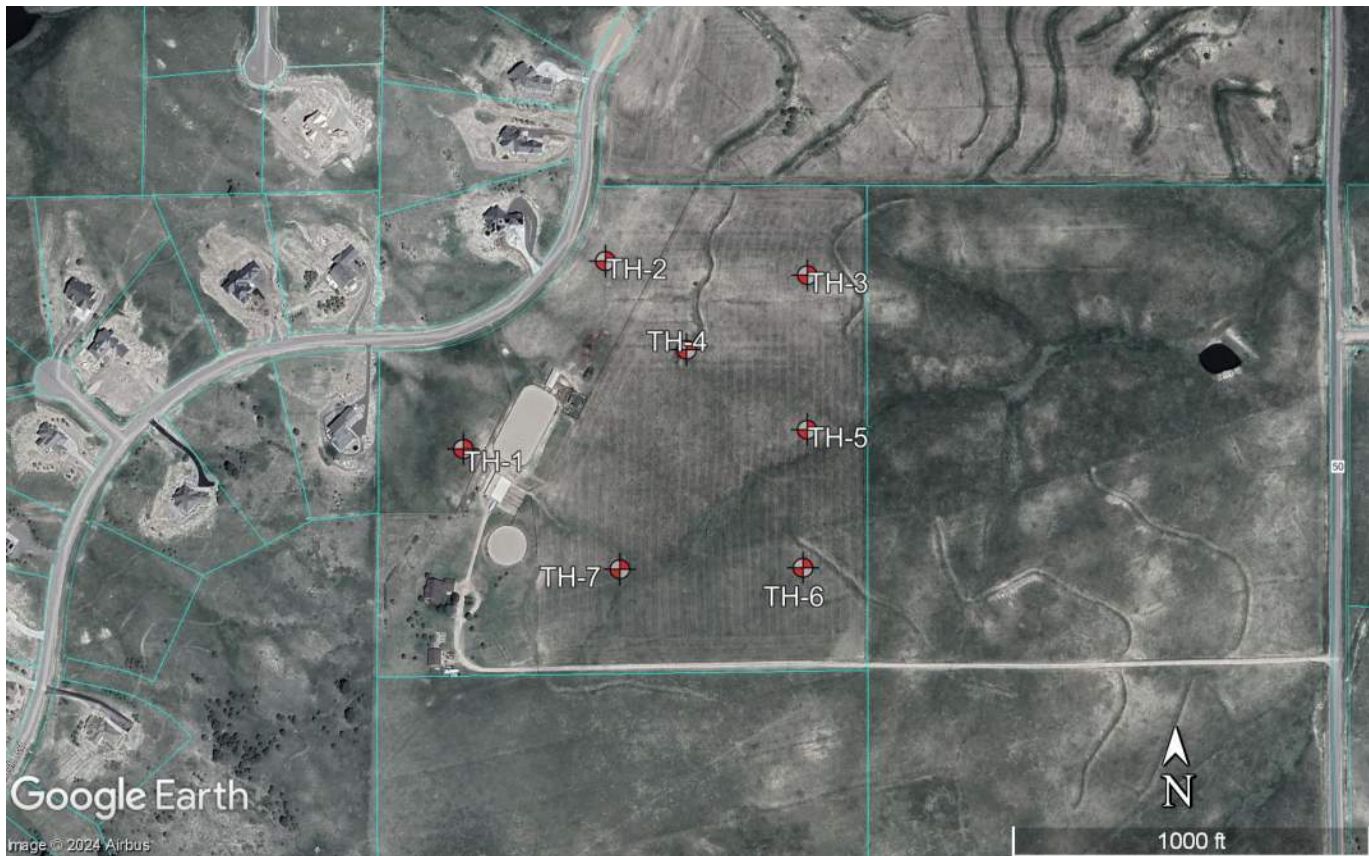
Coordinates

Bore Hole	Latitude	Longitude
TH-1	39.076165	-104.742139
TH-2	39.077563	-104.740765
TH-3	39.077471	-104.738812
TH-4	39.076908	-104.739986
TH-5	39.076309	-104.738808
TH-6	39.075274	-104.738857
TH-7	39.075265	-104.740630

Seven (7) exploratory holes were drilled on May 22, 2024, at the locations shown on the enclosed site map. The location of these test holes was determined by Herebic Homes. The test holes were drilled with a 6-inch diameter hollow stem auger to a depth of 20 feet below the existing ground surface. At intervals anticipated to be the foundation depths, and as determined by the soils conditions, the drill tools were removed, and samples were taken by the use of a 2.5-inch split barrel sampler connected to a 140-pound drop-hammer. This hammer is dropped 30 inches to drive the penetration sampler into the soil (ASTM D-1586). The depths and descriptions of the materials encountered in each test boring at which the samples were taken are shown on the enclosed log sheets.
