**GEOLOGY AND SOILS REPORT  
and Wastewater Study with  
Detention Storage Criteria**

**Redtail Ranch Subdivision, Filing No. 1  
Parcel No's: 5209002006, 5209002008, 5209000129 and 5209000128  
El Paso County, Colorado**

**JOB NO. 162652  
May 18, 2018  
Revised November 9, 2018  
Revised January 2, 2019  
Final January 18, 2018**

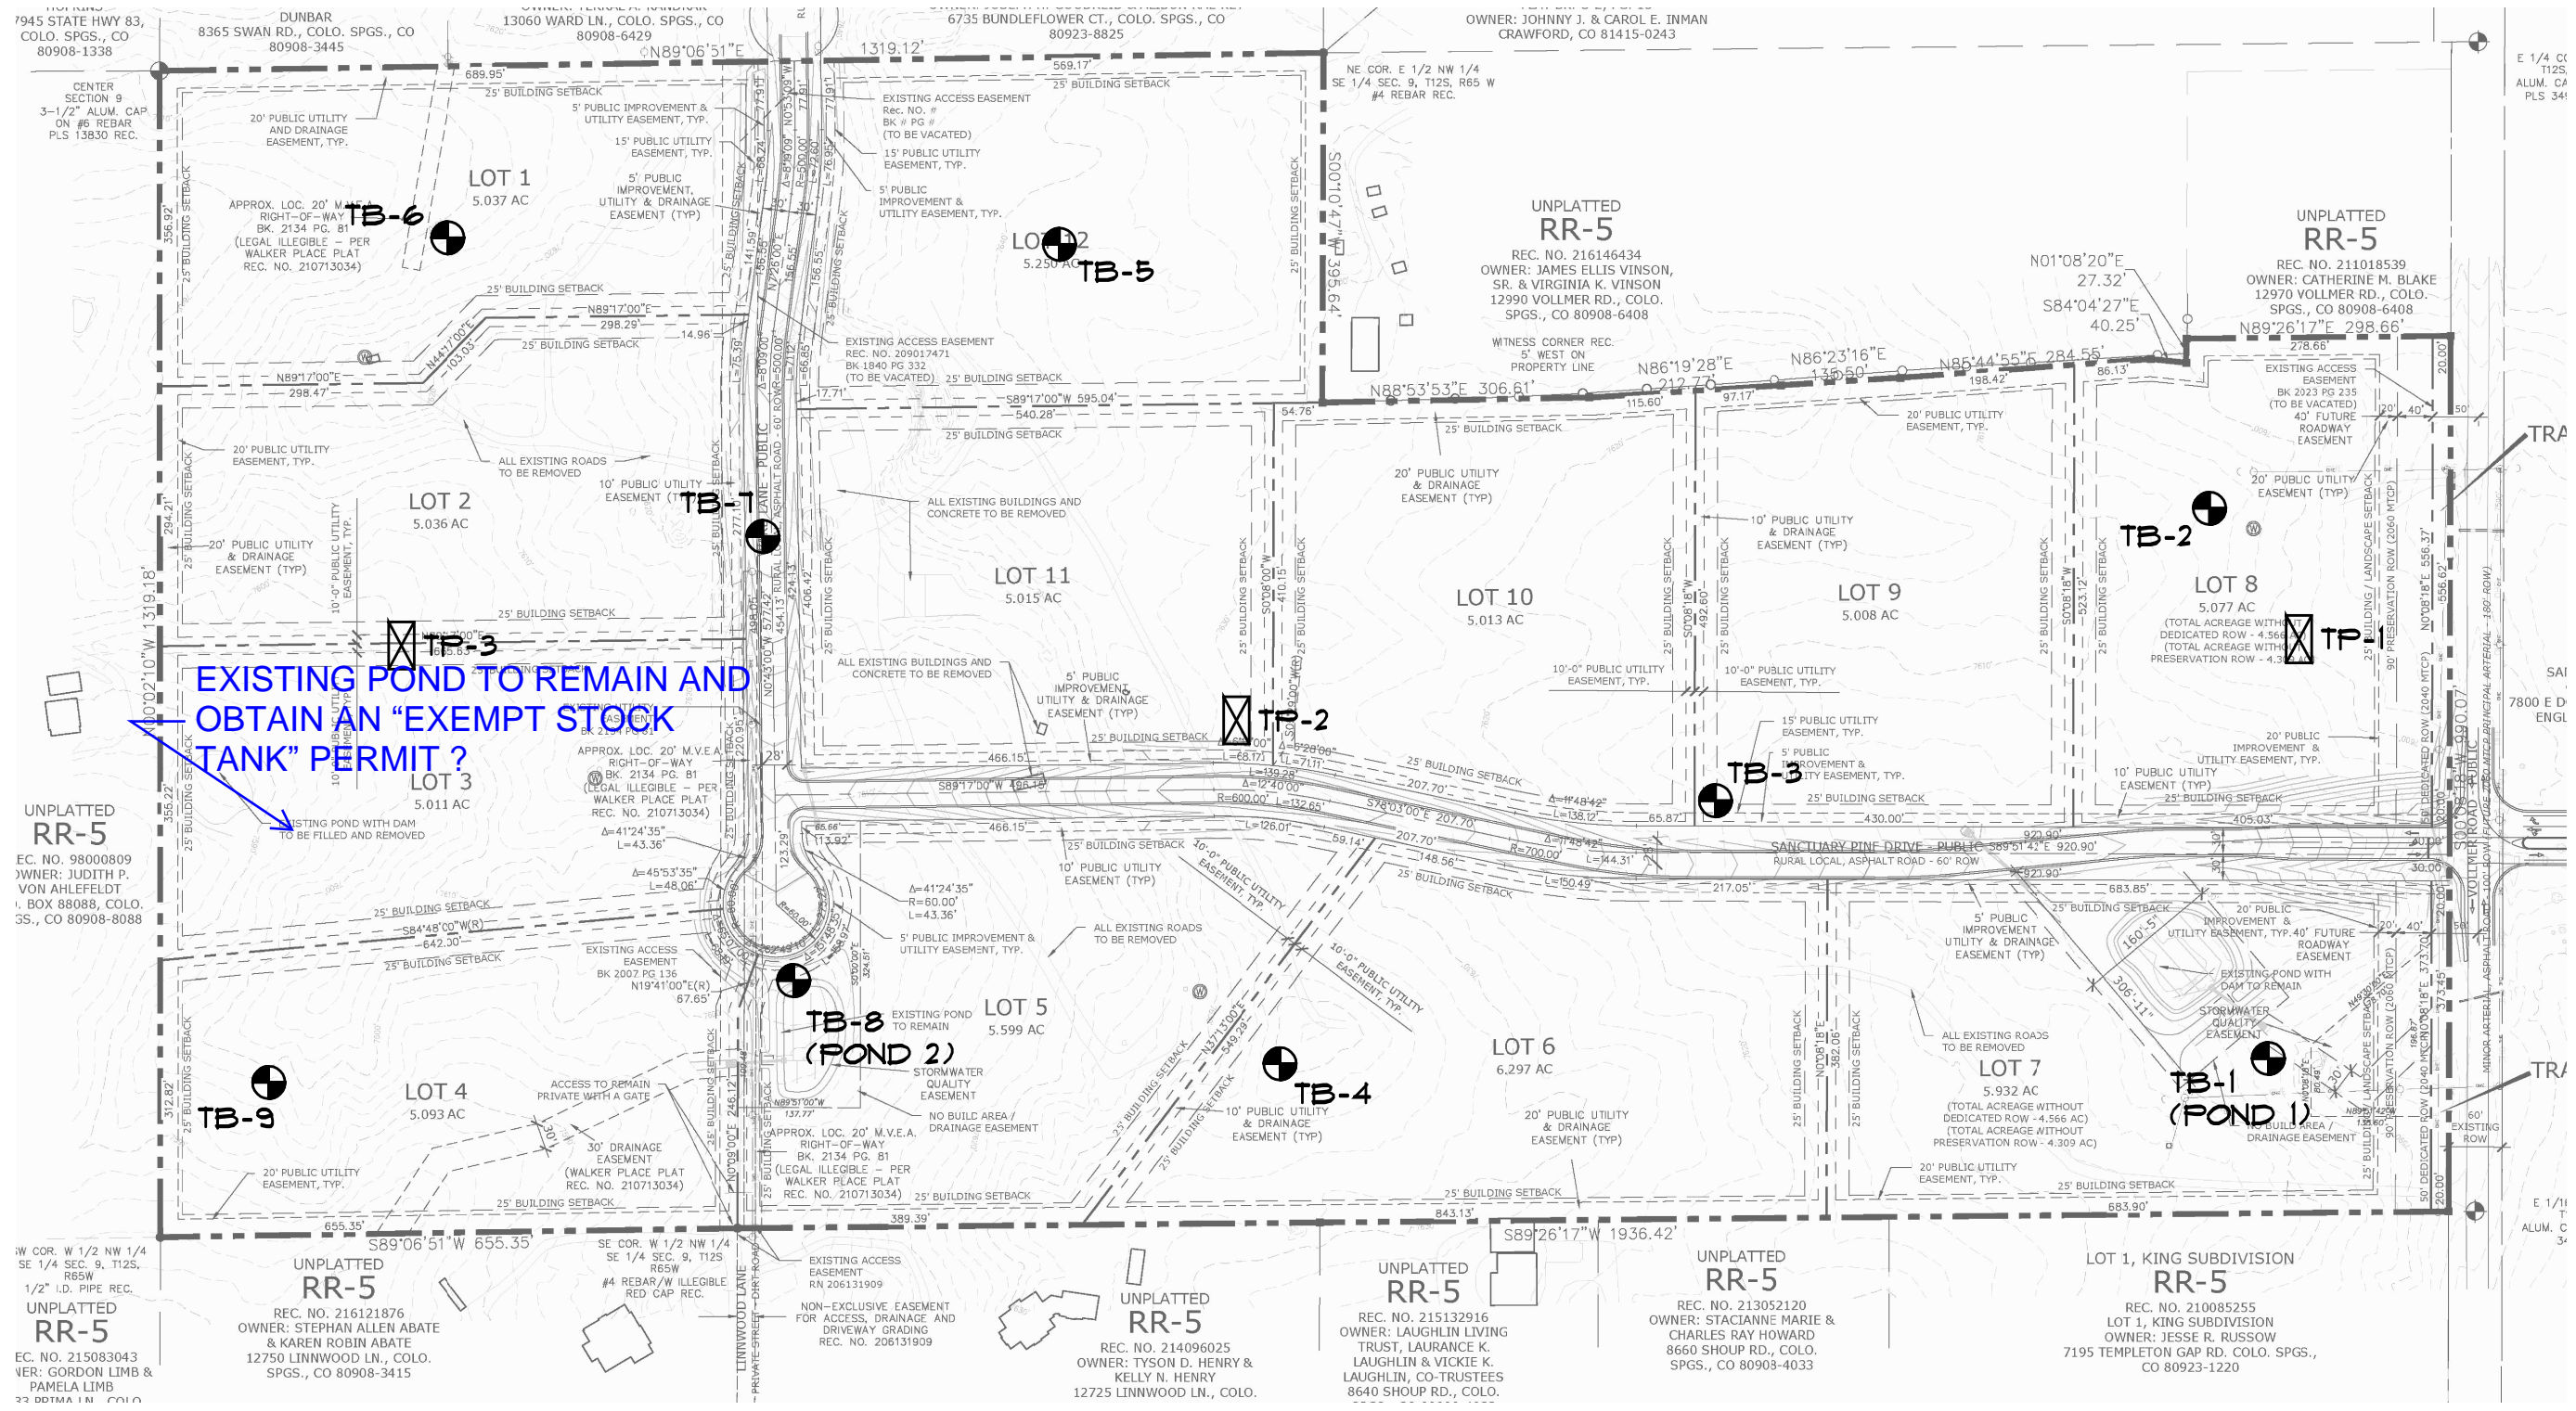
⊕ DENOTES APPROXIMATE LOCATION OF TEST BORINGS

The subsurface conditions within the property were explored by drilling nine exploratory borings on March 14, 2018 extending to depths of approximately 20 feet below the existing ground surface. The test borings were performed to explore the subsurface soils underlying the proposed site. The number of borings is in excess of the minimum one test boring per 10 acres of development up to 100 acres and one additional boring for every 25 acres of development above 100 acres as required by the ECM, Section C.3.3.

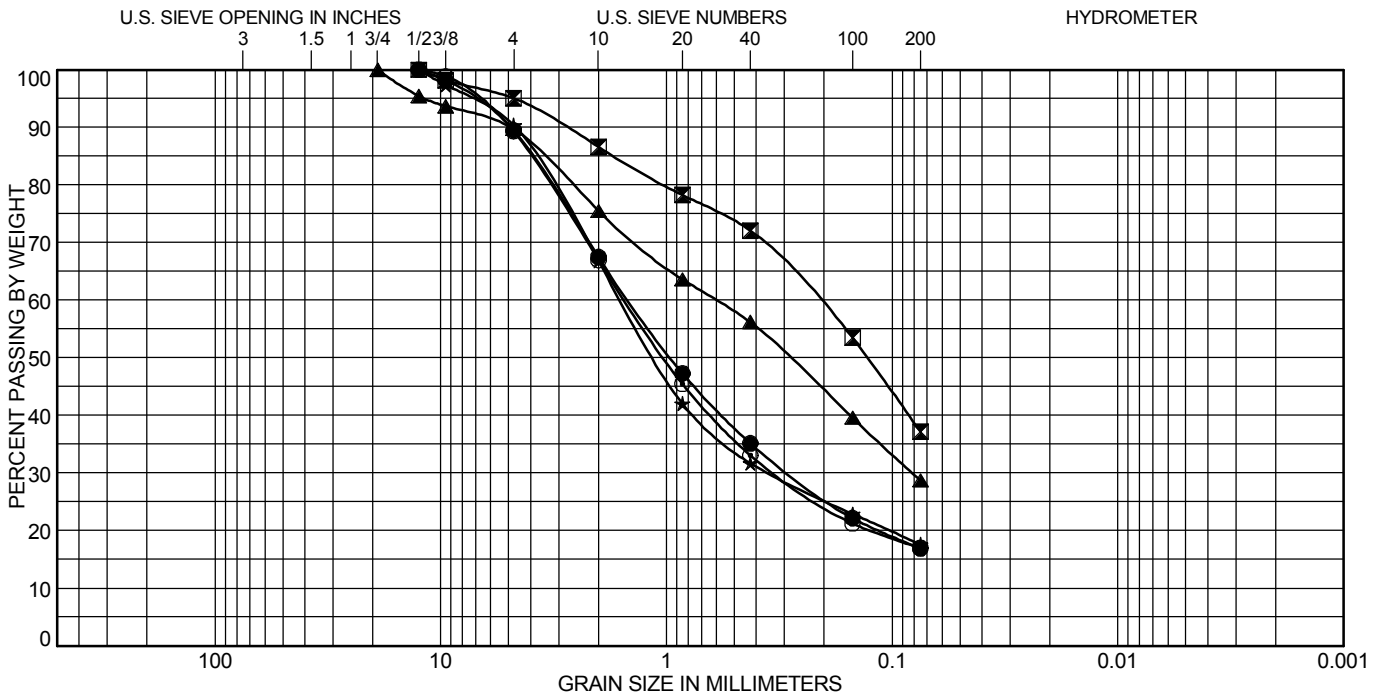
FIGURE No. 14

Test Boring	Depth (ft)	Classification	LL	PL	PI	Cc	Cu
● 1	4.0	CLAYEY SAND(SC)	33	14	19		
☒ 1	9.0	SILTY SAND(SM)	NP	NP	NP		
▲ 1	14.0	SILTY SAND(SM)	NP	NP	NP		
★ 2	9.0	SILTY SAND(SM)	NP	NP	NP		
⊙ 3	19.0	CLAYEY SAND(SC)	34	15	19

Test Boring	Depth (ft)	%Gravel	%Sand	%Silt	%Clay
● 1	4.0	10.5	72.6	16.9	
☒ 1	9.0	4.9	57.9	37.2	
▲ 1	14.0	10.3	61.0	28.7	
★ 2	9.0	9.6	72.8	17.6	
⊙ 3	19.0	10.7	72.3	17.0

## SOIL CLASSIFICATION DATA

Soil laboratory testing was performed as part of this investigation. The laboratory tests included moisture content, dry density, grain-size analyses and Atterberg Limits. Swell/Consolidation tests were not performed on the onsite non-expansive silty sand and sandstone. A Summary of Laboratory Test Results is presented in Figure 13. Soils Classification Data is presented in Figures 14 and 15.

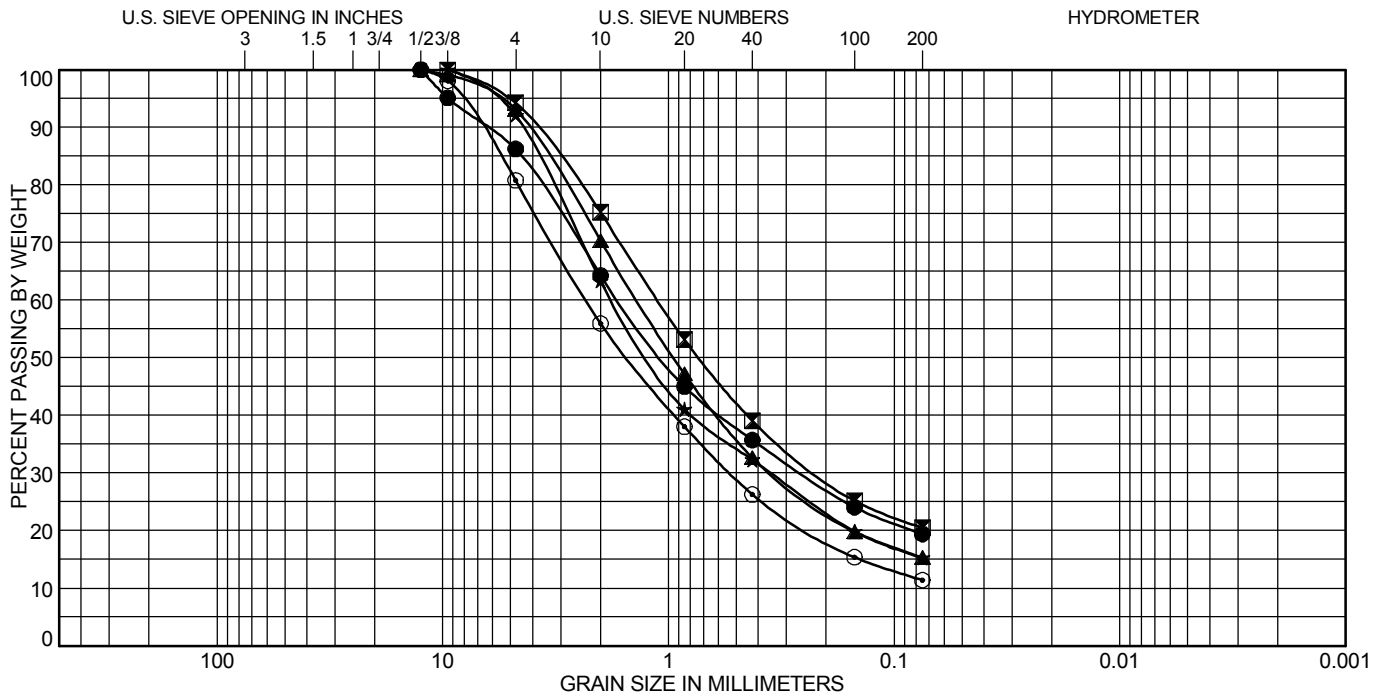
FIGURE No. 15

Test Boring	Depth (ft)	Classification	LL	PL	PI	Cc	Cu
● 6	4.0	CLAYEY SAND(SC)	36	20	16		
⊠ 7	9.0	CLAYEY SAND(SC)	33	14	19		
▲ 8	9.0	CLAYEY SAND(SC)	34	15	19		
★ 8	14.0	CLAYEY SAND(SC)	37	18	19		
⊙ 9	9.0	WELL-GRADED SAND with CLAY and GRAVEL(SW-SC)	34	16	18	2.1	39.2

Test Boring	Depth (ft)	%Gravel	%Sand	%Silt	%Clay
● 6	4.0	13.7	66.9	19.4	
⊠ 7	9.0	5.8	73.8	20.5	
▲ 8	9.0	6.9	77.8	15.3	
★ 8	14.0	7.9	76.8	15.3	
⊙ 9	9.0	19.2	69.4	11.4

## SOIL CLASSIFICATION DATA

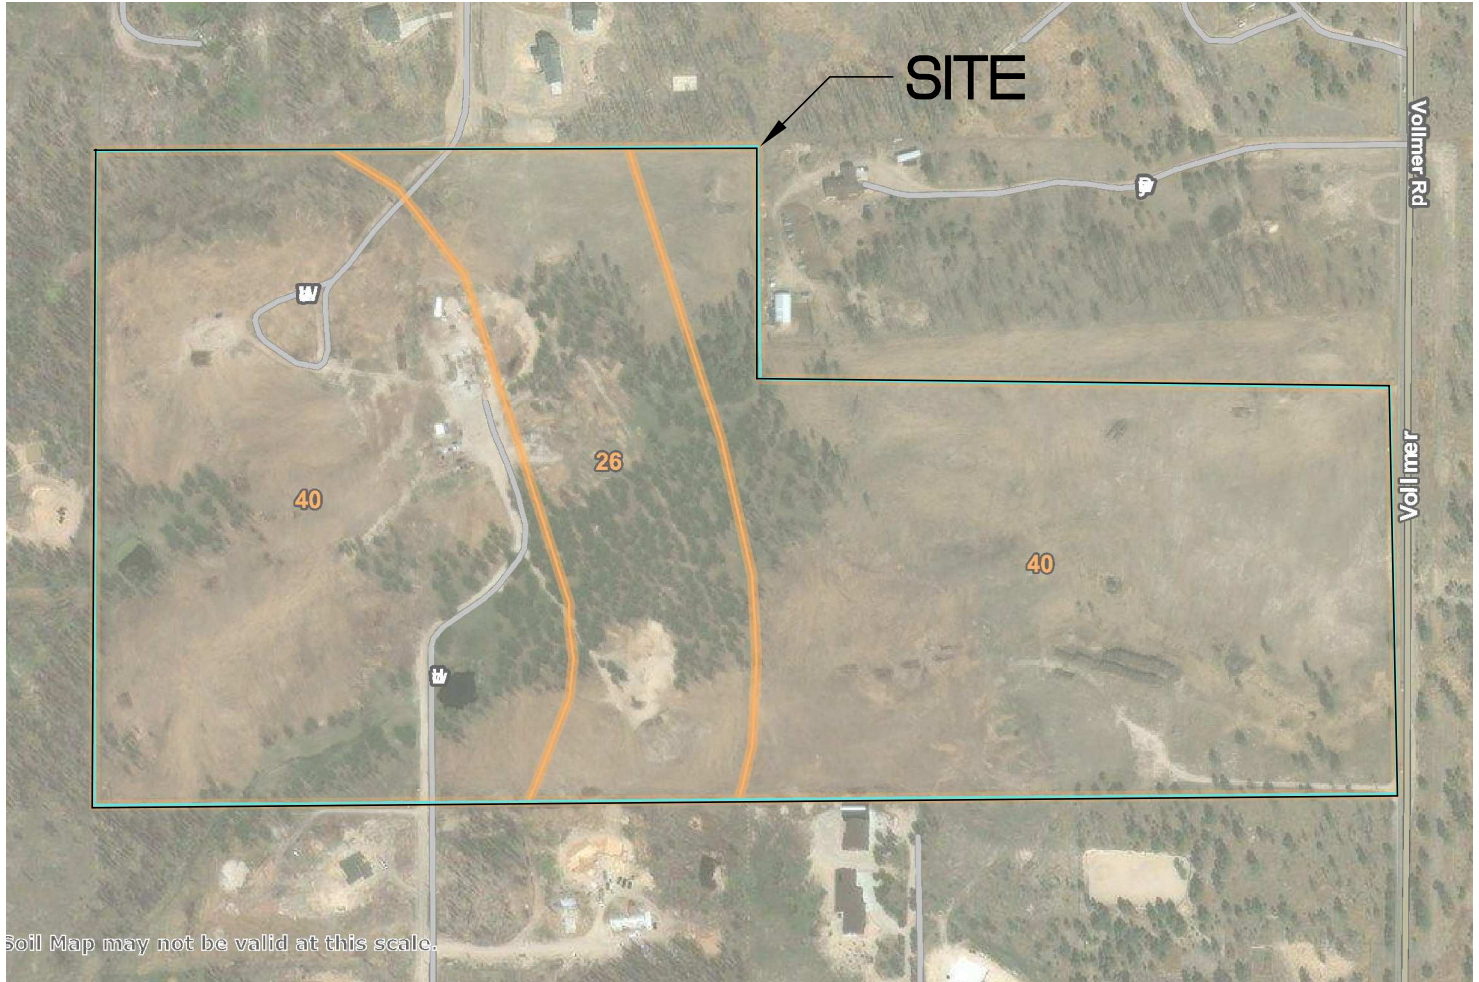
FIG No. 16

26 - ELBETH SANDY LOAM  
 40 - KETTLE GRAVELLY LOAMY SAND

*The USDA Soil Survey Map is presented in Figure 16.*

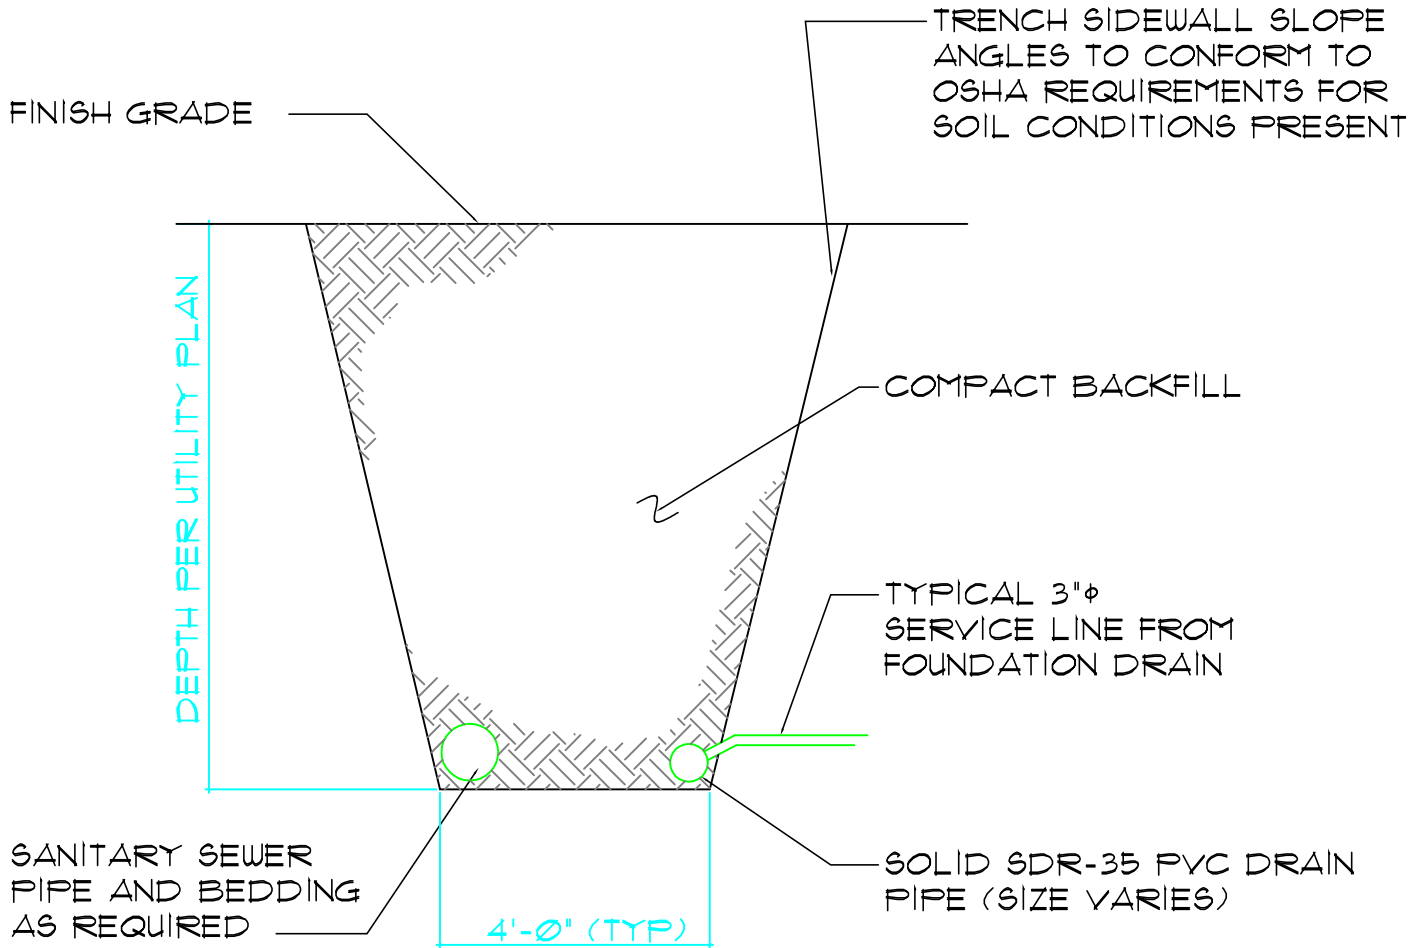
**NOTE:** TO BE USED WHERE NO SHALLOW GROUNDWATER IS KNOWN TO EXIST

## PASSIVE DRAIN IN SANITARY SEWER TRENCH
