# GEOLOGY AND SOILS REPORT and Wastewater Study with Detention Storage Criteria

**Redtail Ranch Subdivision**  
**Parcel No's: 5209002006, 5209002008, 5209000129 and 5209000128**  
**El Paso County, Colorado**

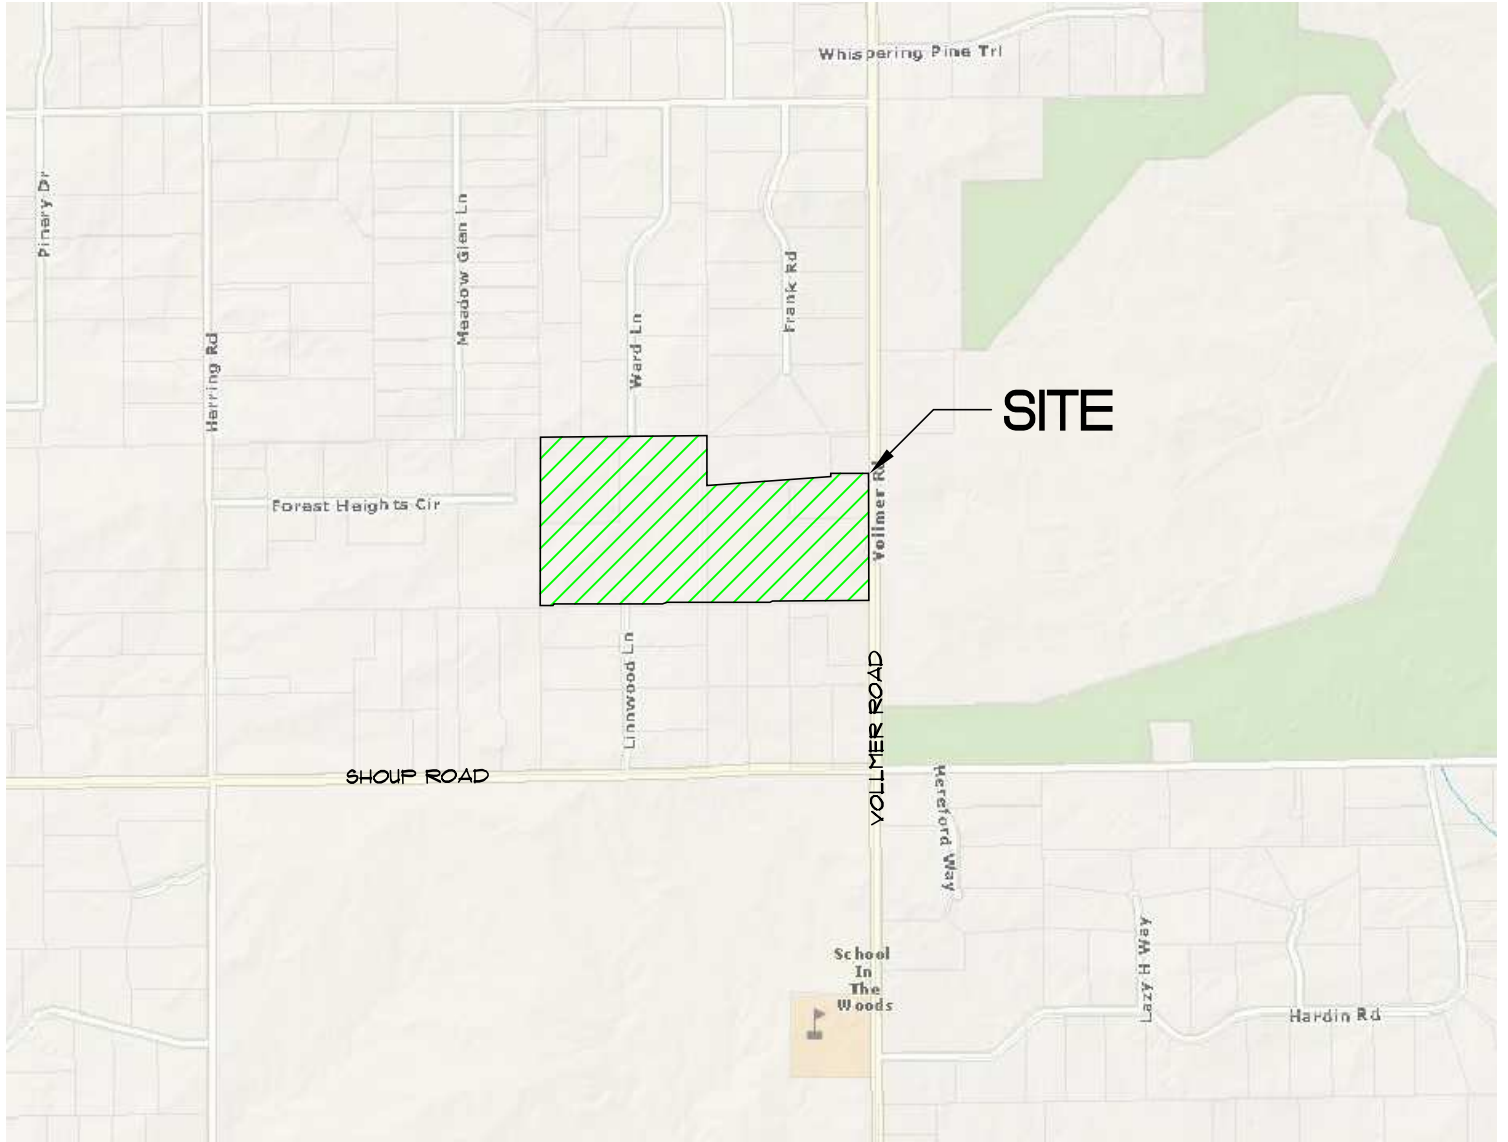
FIG No. 1

The project lies in the northeast portion of Section 9, Township 12 South, Range 66 West of the 6<sup>th</sup> Principal Meridian in El Paso County, Colorado. The approximate location of the site is shown on the Site Vicinity Map, Figure 1.

The site is generally located north and west of the intersection of Vollmer Road and Shoup Road, Colorado Springs, El Paso County. The site includes four parcels and has a combined total acreage of approximately 67.9 acres, on which there has been multiple non-permanent structures placed along with parked heavy equipment in a "yard" located north of Linwood Lane. Figure 1 presents the general boundaries of our investigation.
