ROCKY MOUNTAIN GROUP  
EMPLOYEE OWNED

Job No. 162652

Re: Response to El Paso County Review Comments  
Redtail Ranch Subdivision  
Sanctuary Pines Dr  
Parcel No's: 5209002006, 5209002008, 5209000129 and 5209000128  
El Paso County, Colorado

RMG – Rocky Mountain Group (RMG) prepared a Geology and Soils report (RMG Job No. 162652, last dated March 4, 2019) for the proposed residential development project comprising 12 single-family residential lots located at the parcel no.'s referenced above. The report was reviewed by personnel of the El Paso County Planning & Community Development in September 2018 and again in February 2019. The majority of the original comments were addressed in the revised Geology and Soils Report.

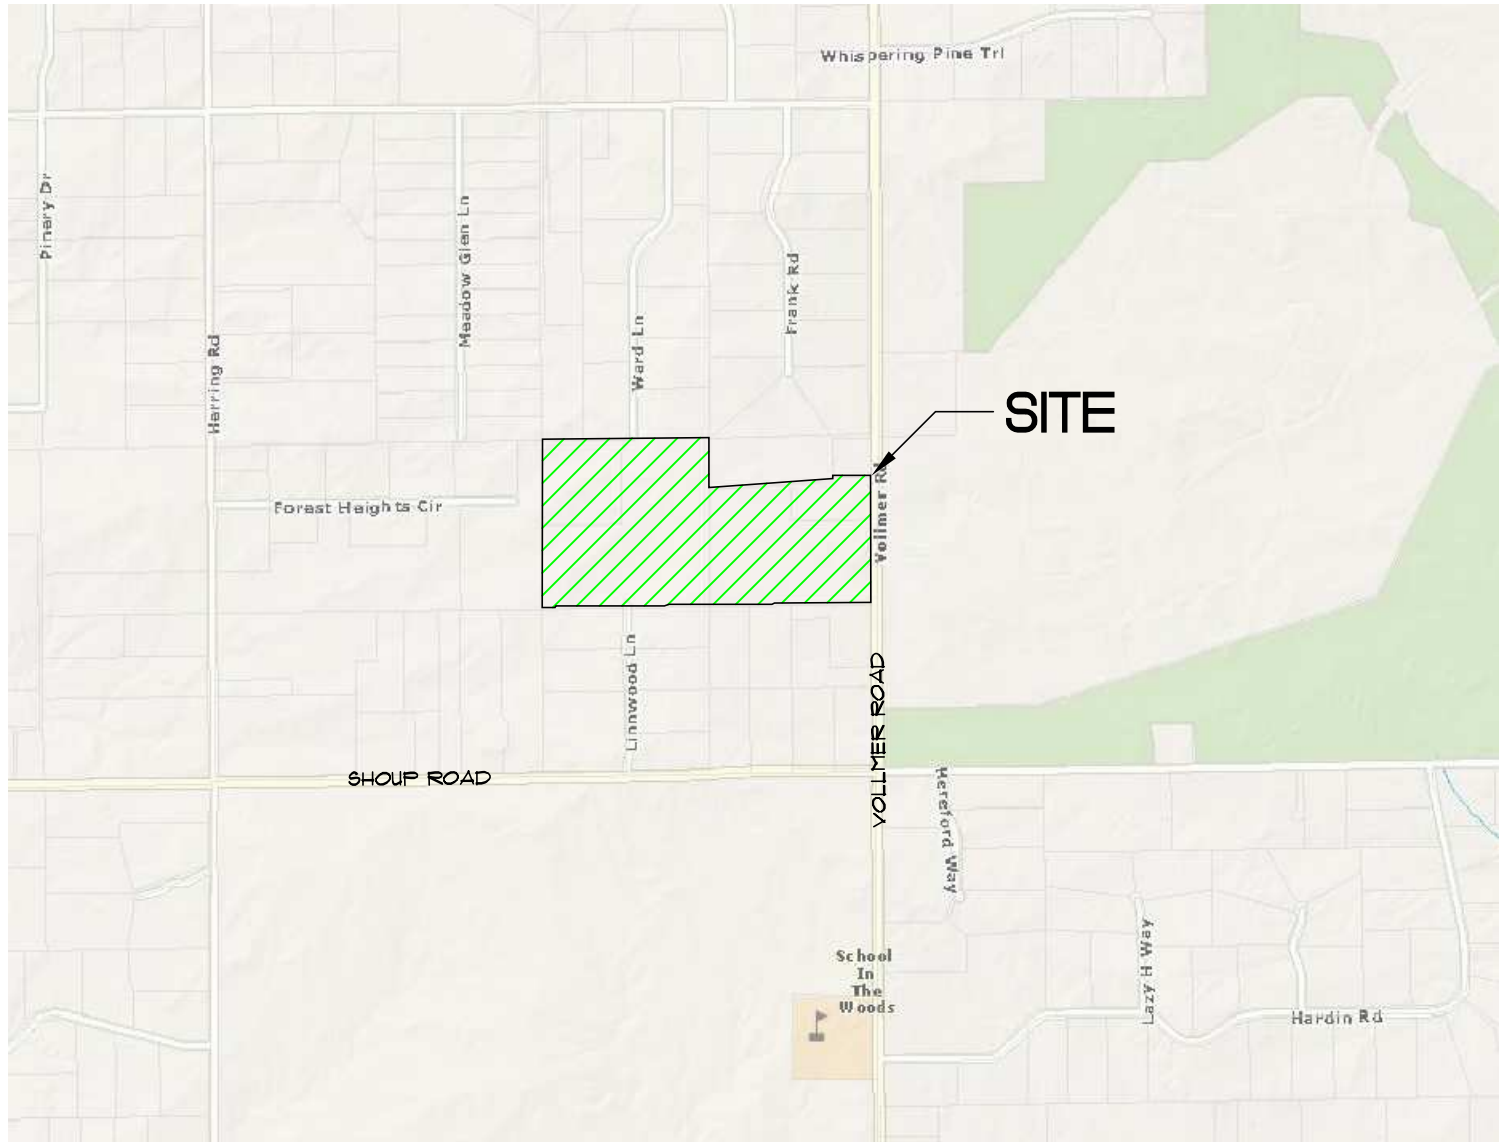
FIG No. 1

REFERENCE  
NOT TO SCALE

The project lies in the northeast portion of Section 9, Township 12 South, Range 65 West of the 6<sup>th</sup> Principal Meridian in El Paso County, Colorado. The approximate location of the site is shown on the Site Vicinity Map, Figure 1.

The site is generally located north and west of the intersection of Vollmer Road and Shoup Road, Colorado Springs, El Paso County. The site includes four parcels and has a combined total acreage of approximately 67.9 acres, on which there has been multiple non-permanent structures placed along with parked heavy equipment in a "yard" located north of Linwood Lane. Figure 1 presents the general boundaries of our investigation.

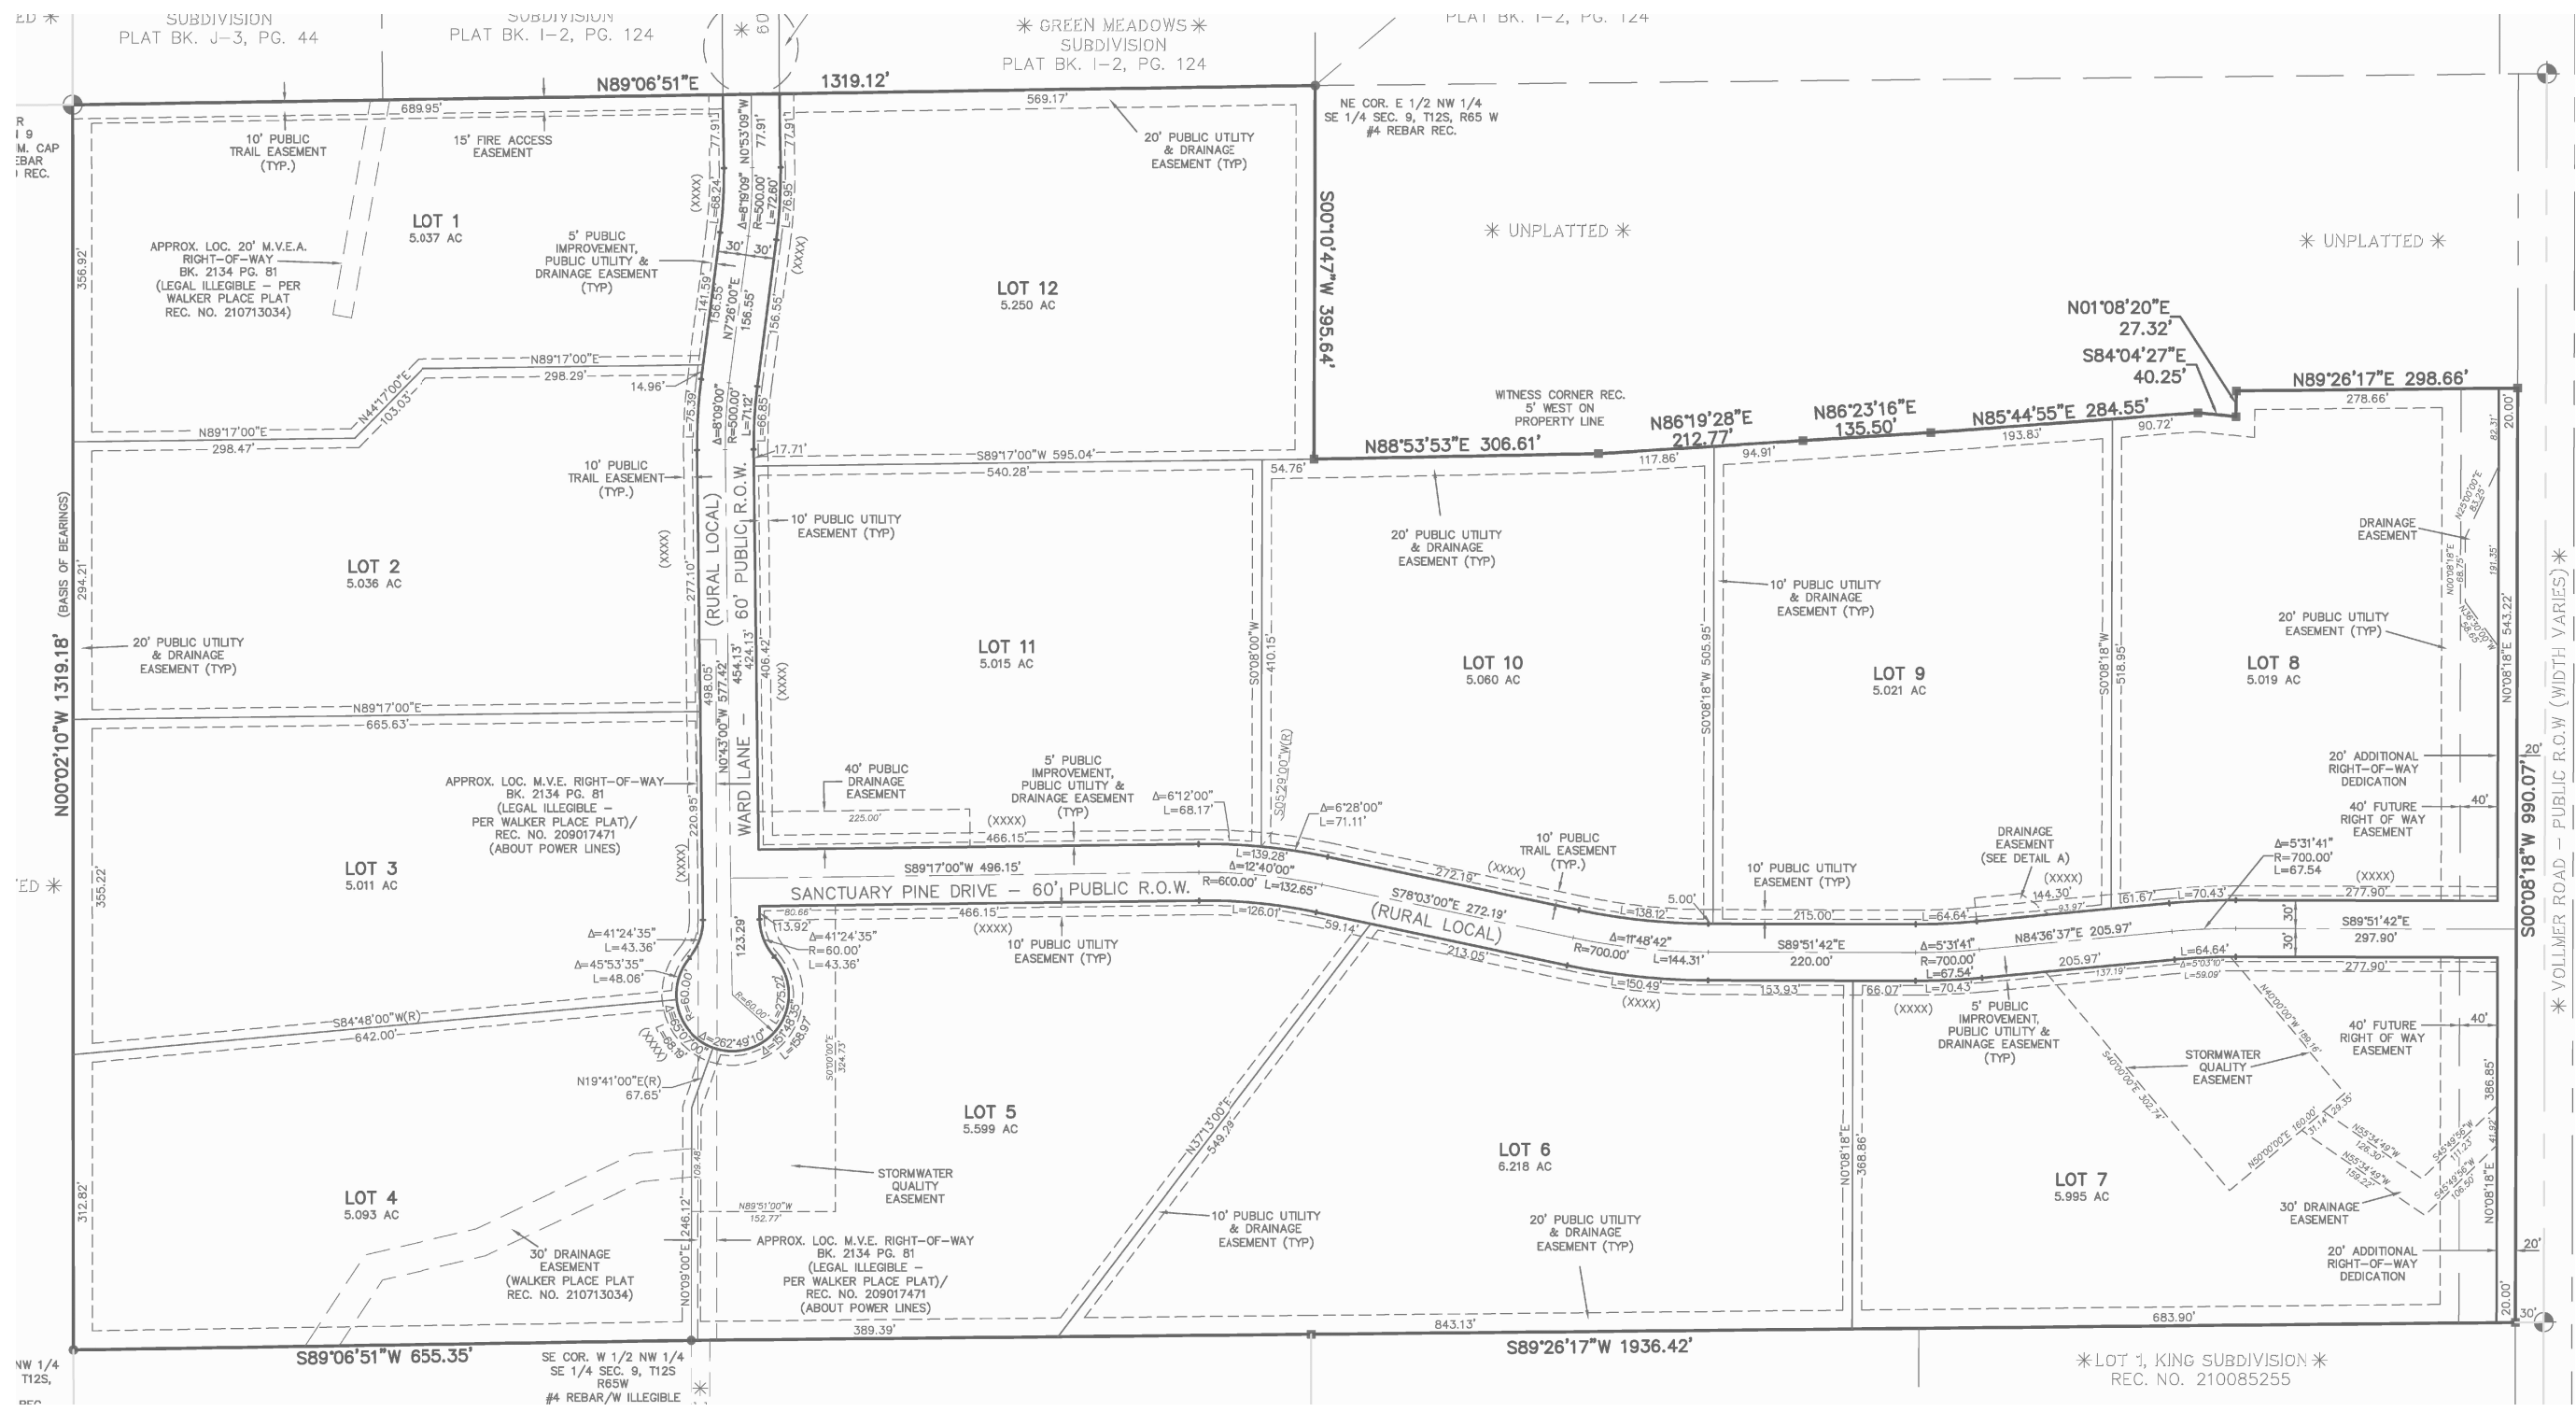
SHEET No.  
FIG-3

NOT TO SCALE  
BASE MAP PROVIDED BY: NES, INC.

CONCEPT  
PLAN

- **EPC County Comment:** *"Existing pond to remain and obtain "Exempt Stock Tank" permit?" as denoted on RMG's Figure 3, Concept Plan and Figure 4, Concept Plan with Test Boring and Test Pit Location Plan.*

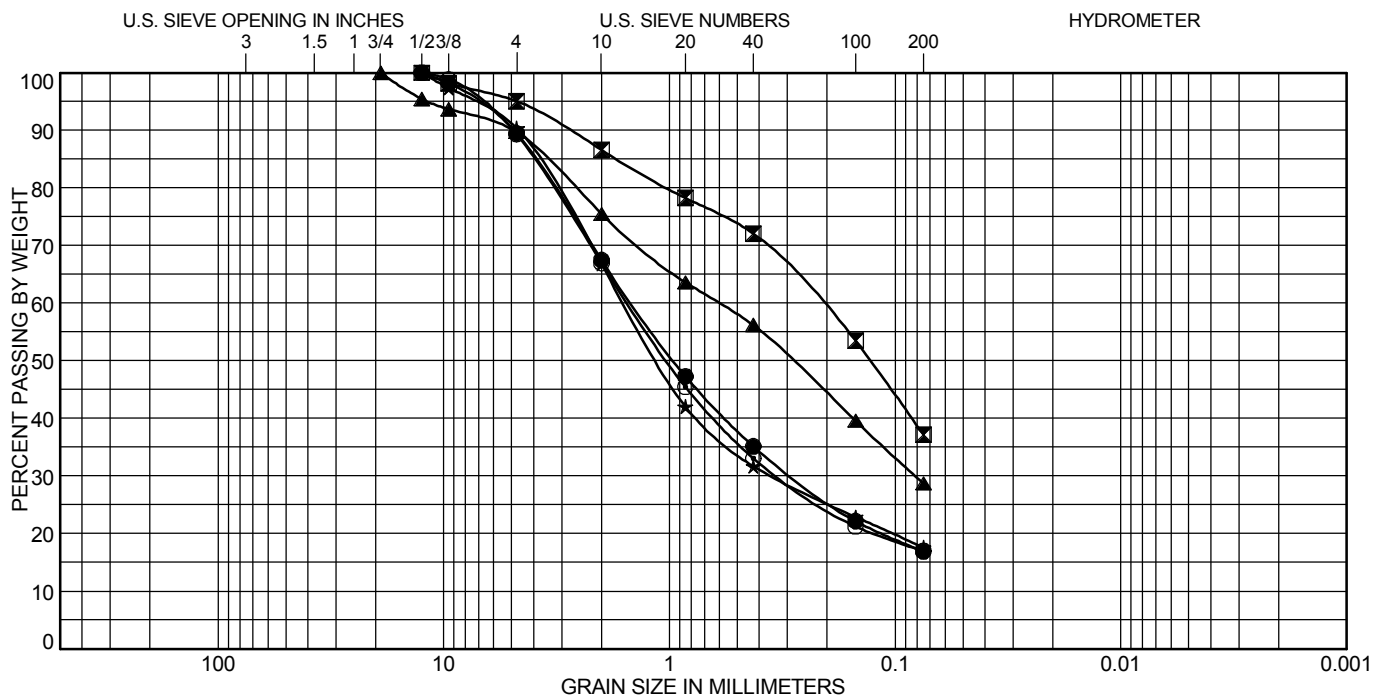
FIGURE No. 14

Test Boring	Depth (ft)	Classification	LL	PL	PI	Cc	Cu
● 1	4.0	CLAYEY SAND(SC)	33	14	19		
☒ 1	9.0	SILTY SAND(SM)	NP	NP	NP		
▲ 1	14.0	SILTY SAND(SM)	NP	NP	NP		
★ 2	9.0	SILTY SAND(SM)	NP	NP	NP		
⊙ 3	19.0	CLAYEY SAND(SC)	34	15	19

Test Boring	Depth (ft)	%Gravel	%Sand	%Silt	%Clay
● 1	4.0	10.5	72.6	16.9	
☒ 1	9.0	4.9	57.9	37.2	
▲ 1	14.0	10.3	61.0	28.7	
★ 2	9.0	9.6	72.8	17.6	
⊙ 3	19.0	10.7	72.3	17.0

## SOIL CLASSIFICATION DATA

Soil laboratory testing was performed as part of this investigation. The laboratory tests included moisture content, dry density, grain-size analyses and Atterberg Limits. Swell/Consolidation tests were not performed on the onsite non-expansive silty sand and sandstone. A Summary of Laboratory Test Results is presented in Figure 13. Soils Classification Data is presented in Figures 14 and 15.

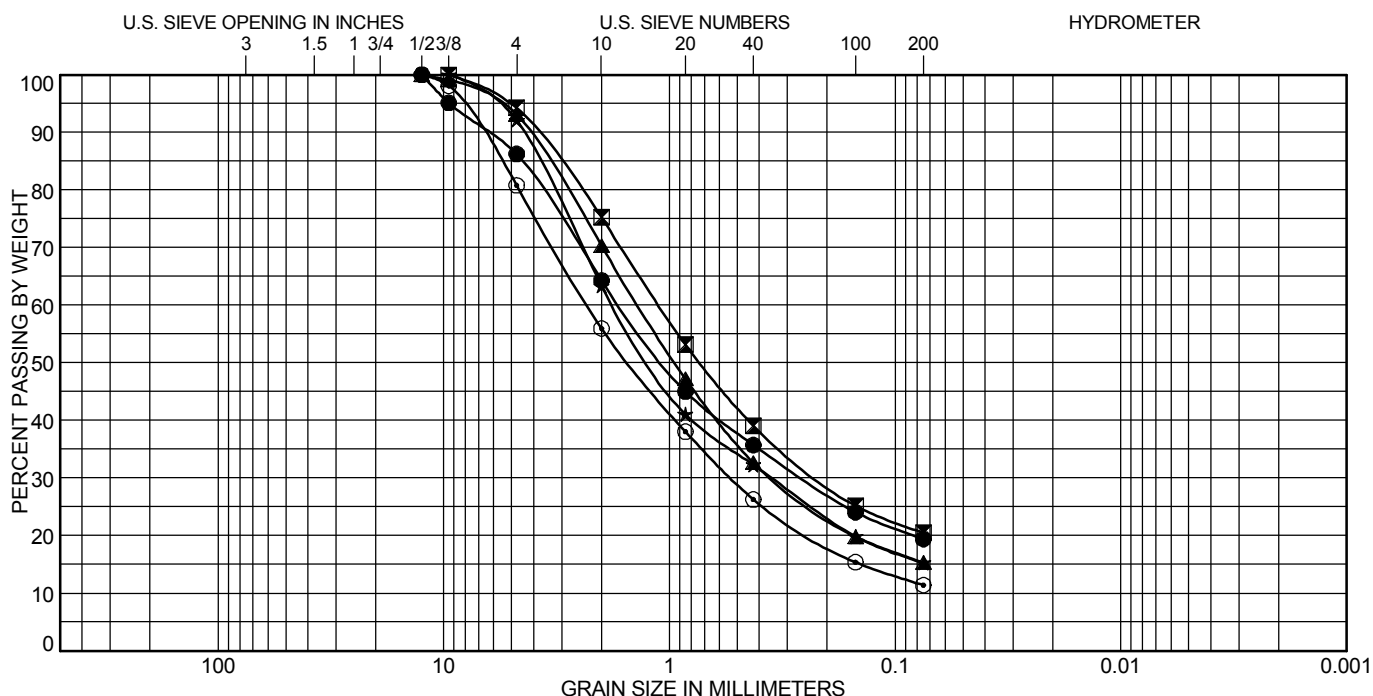
FIGURE No. 15

Test Boring	Depth (ft)	Classification	LL	PL	PI	Cc	Cu
● 6	4.0	CLAYEY SAND(SC)	36	20	16		
⊠ 7	9.0	CLAYEY SAND(SC)	33	14	19		
▲ 8	9.0	CLAYEY SAND(SC)	34	15	19		
★ 8	14.0	CLAYEY SAND(SC)	37	18	19		
⊙ 9	9.0	WELL-GRADED SAND with CLAY and GRAVEL(SW-SC)	34	16	18	2.1	39.2

Test Boring	Depth (ft)	%Gravel	%Sand	%Silt	%Clay
● 6	4.0	13.7	66.9	19.4	
⊠ 7	9.0	5.8	73.8	20.5	
▲ 8	9.0	6.9	77.8	15.3	
★ 8	14.0	7.9	76.8	15.3	
⊙ 9	9.0	19.2	69.4	11.4

## SOIL CLASSIFICATION DATA

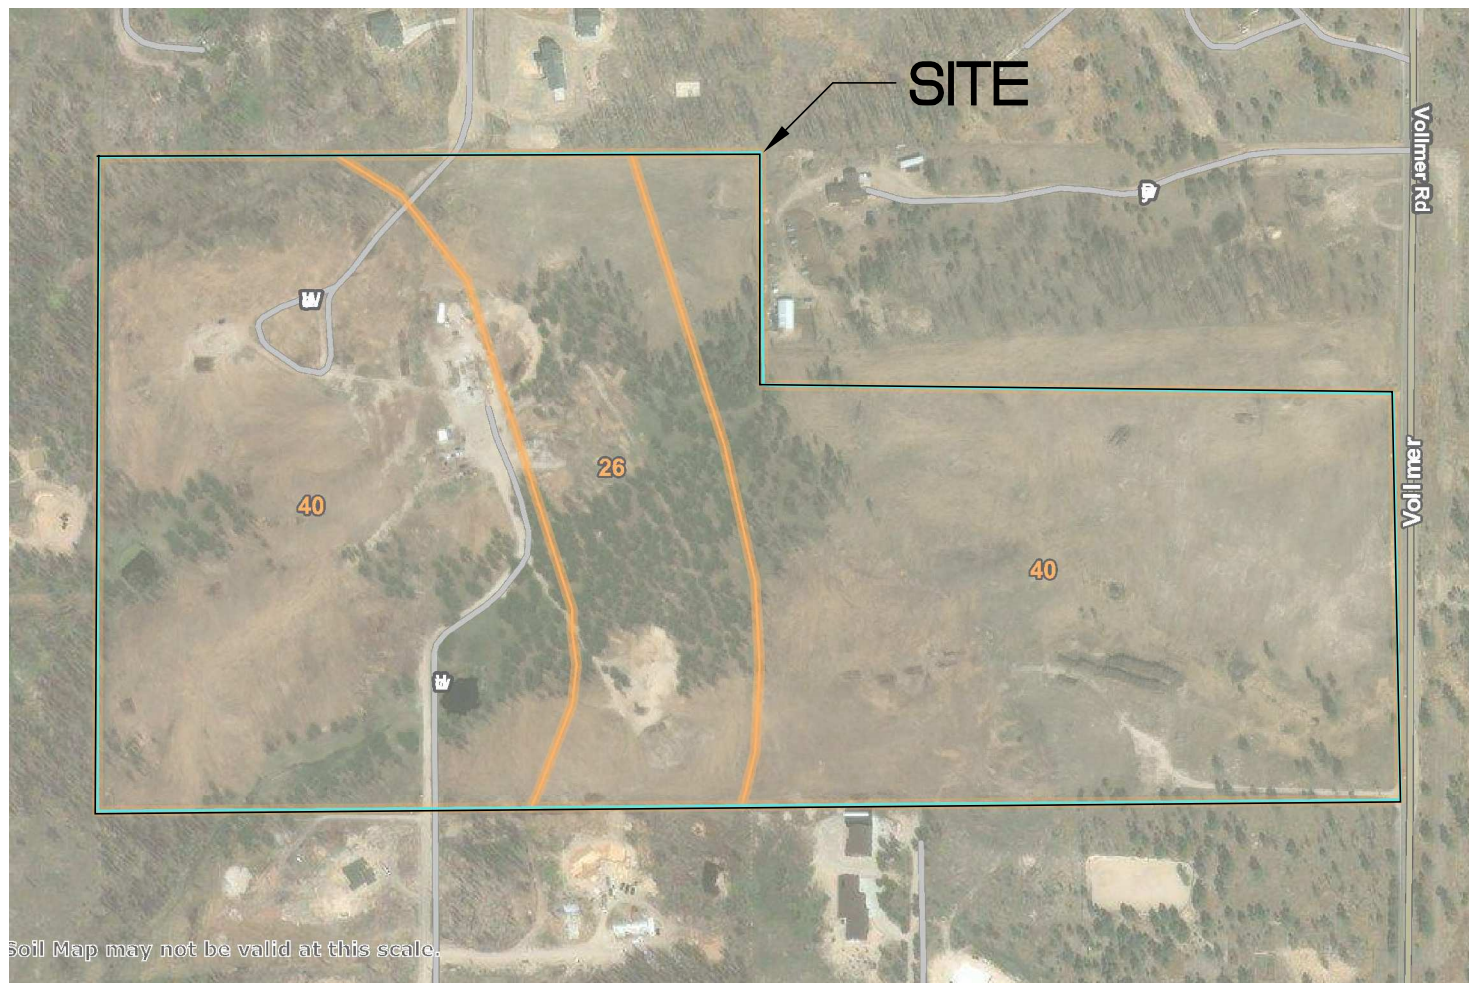
FIG No. 16

26 - ELBETH SANDY LOAM

40 - KETTLE GRAVELLY LOAMY SAND

*The USDA Soil Survey Map is presented in Figure 16.*
