**GEOLOGY AND SOILS REPORT
and Wastewater Study with
Detention Storage Criteria**

**Redtail Ranch Subdivision
Parcel No's: 5209002006, 5209002008, 5209000129 and 5209000128
El Paso County, Colorado**

JOB NO. 162652

**May 18, 2018
Revised November 9, 2018**

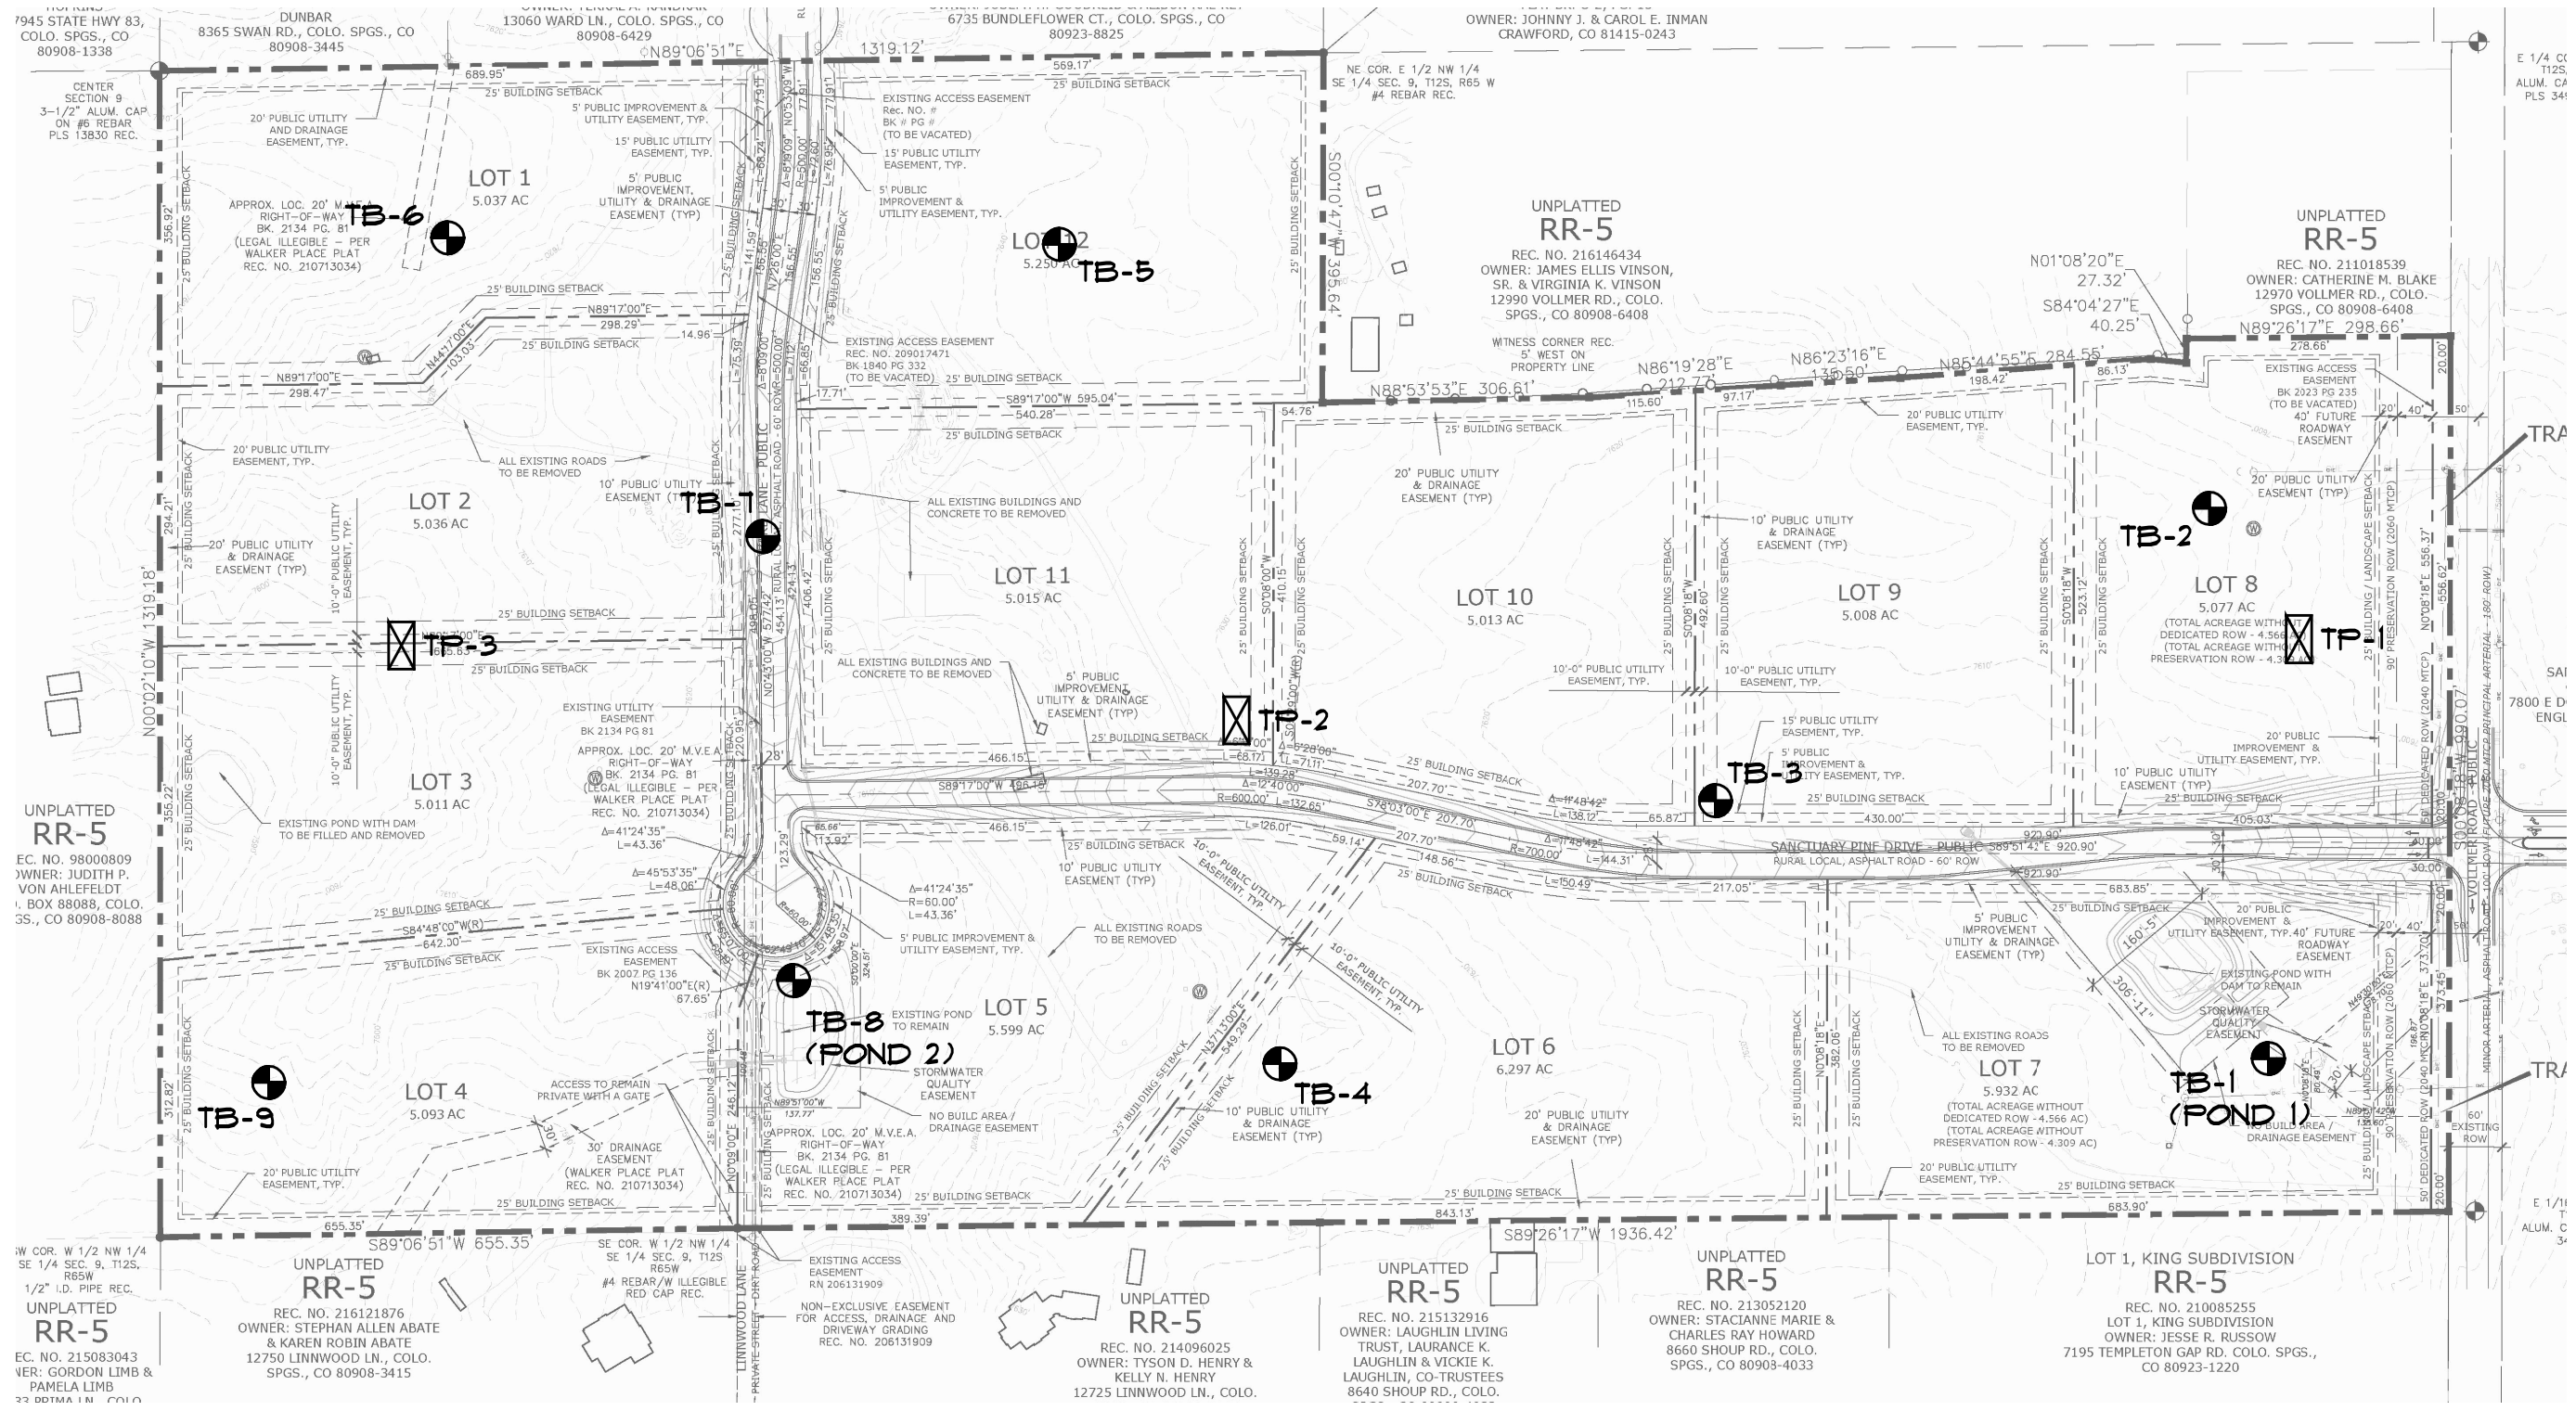
⊕ DENOTES APPROXIMATE LOCATION OF TEST BORINGS

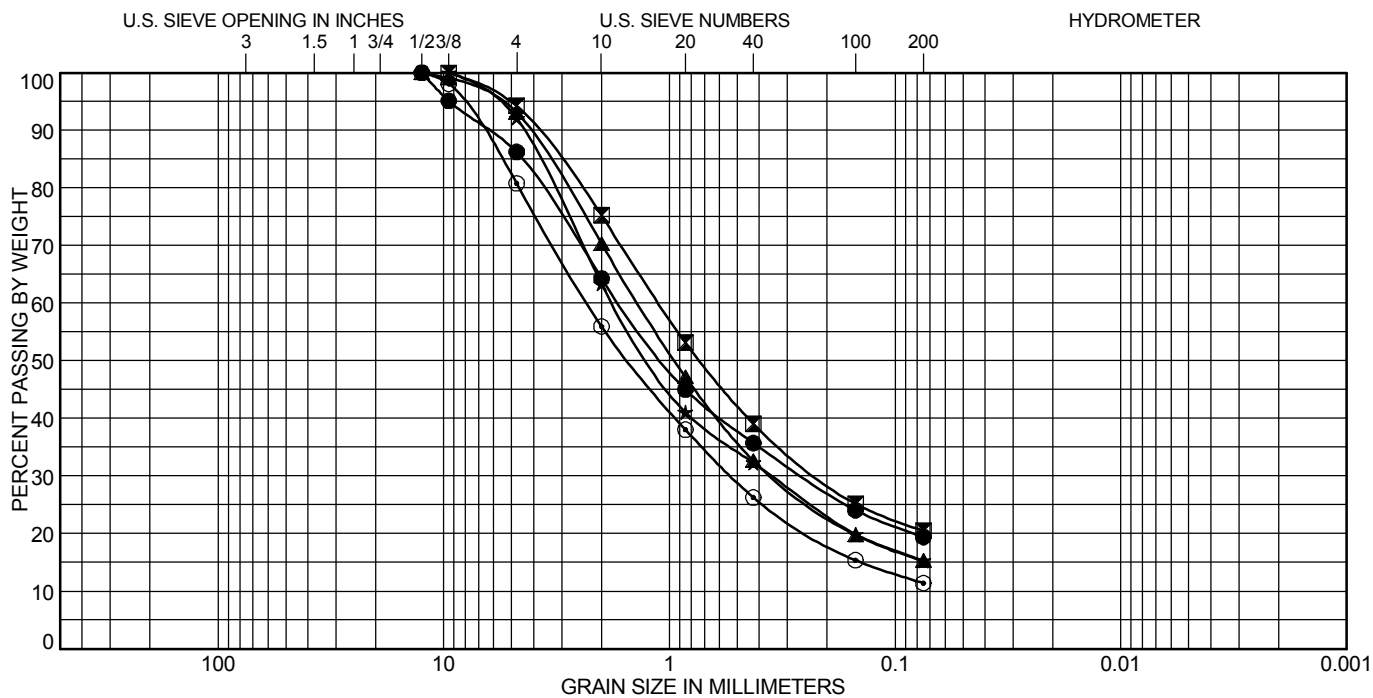
FIGURE No. 15

Test Boring	Depth (ft)	Classification	LL	PL	PI	Cc	Cu
● 6	4.0	CLAYEY SAND(SC)	36	20	16		
■ 7	9.0	CLAYEY SAND(SC)	33	14	19		
▲ 8	9.0	CLAYEY SAND(SC)	34	15	19		
★ 8	14.0	CLAYEY SAND(SC)	37	18	19		
○ 9	9.0	WELL-GRADED SAND with CLAY and GRAVEL(SW-SC)	34	16	18	2.1	39.2

Test Boring	Depth (ft)	%Gravel	%Sand	%Silt	%Clay
● 6	4.0	13.7	66.9	19.4	
■ 7	9.0	5.8	73.8	20.5	
▲ 8	9.0	6.9	77.8	15.3	
★ 8	14.0	7.9	76.8	15.3	
○ 9	9.0	19.2	69.4	11.4

SOIL CLASSIFICATION DATA

Soil laboratory testing was performed as part of this investigation. The laboratory tests included moisture content, dry density, grain-size analyses and Atterberg Limits. Swell/Consolidation tests were not performed on the onsite non-expansive silty sand and sandstone. A Summary of Laboratory Test Results is presented in Figure 13. Soils Classification Data is presented in Figures 14 and 15.

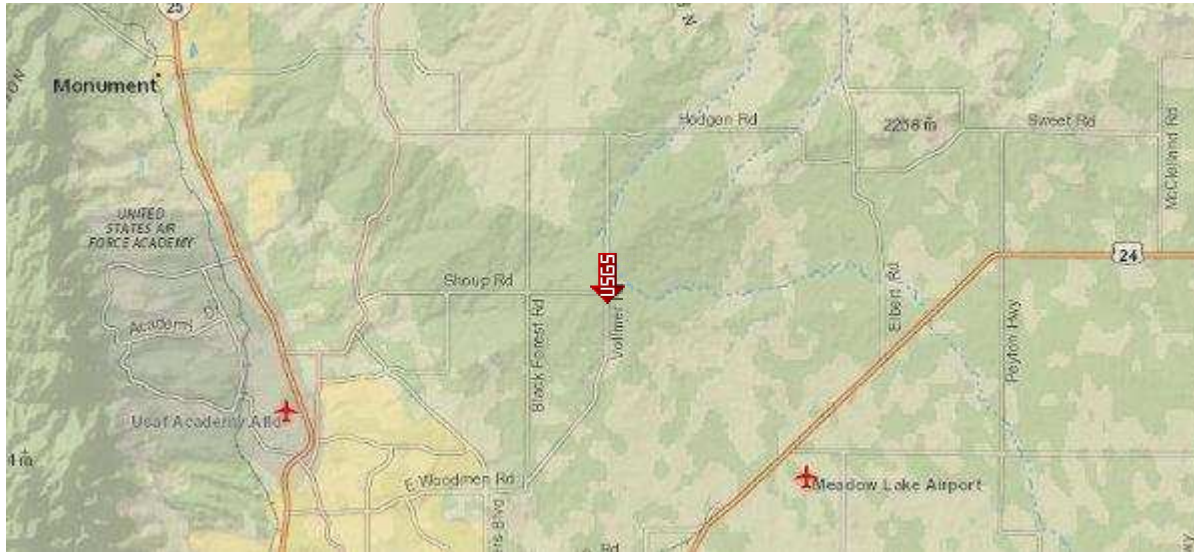
USGS-Provided Output

$S_S = 0.174 \text{ g}$	$S_{MS} = 0.208 \text{ g}$	$S_{DS} = 0.139 \text{ g}$
$S_1 = 0.058 \text{ g}$	$S_{M1} = 0.099 \text{ g}$	$S_{D1} = 0.066 \text{ g}$
