## SOIL AND GEOLOGY STUDY

**6001 E. Platte Road  
Platte Self-Storage  
El Paso County, Colorado**

**JOB NO. 195706**

**May 9, 2024**

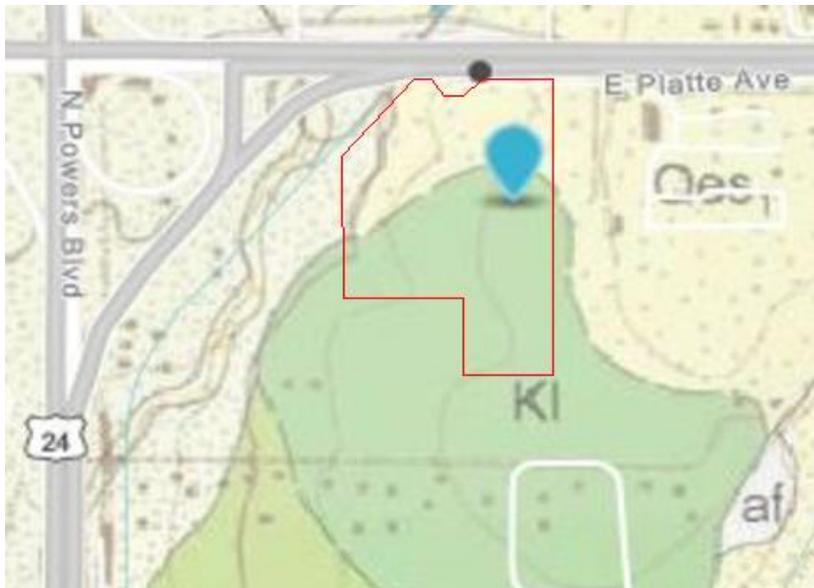
Based on our PSSI field exploration and observations, as well as the Geologic Map of the Elsmere 7.5 Minute Quadrangle (depicted in the image below), we created an interpreted map of geologic conditions affecting the development, significant surficial deposits, and surface features for the site. The interpreted map is presented on the Engineering and Geology Map, Figure 3.

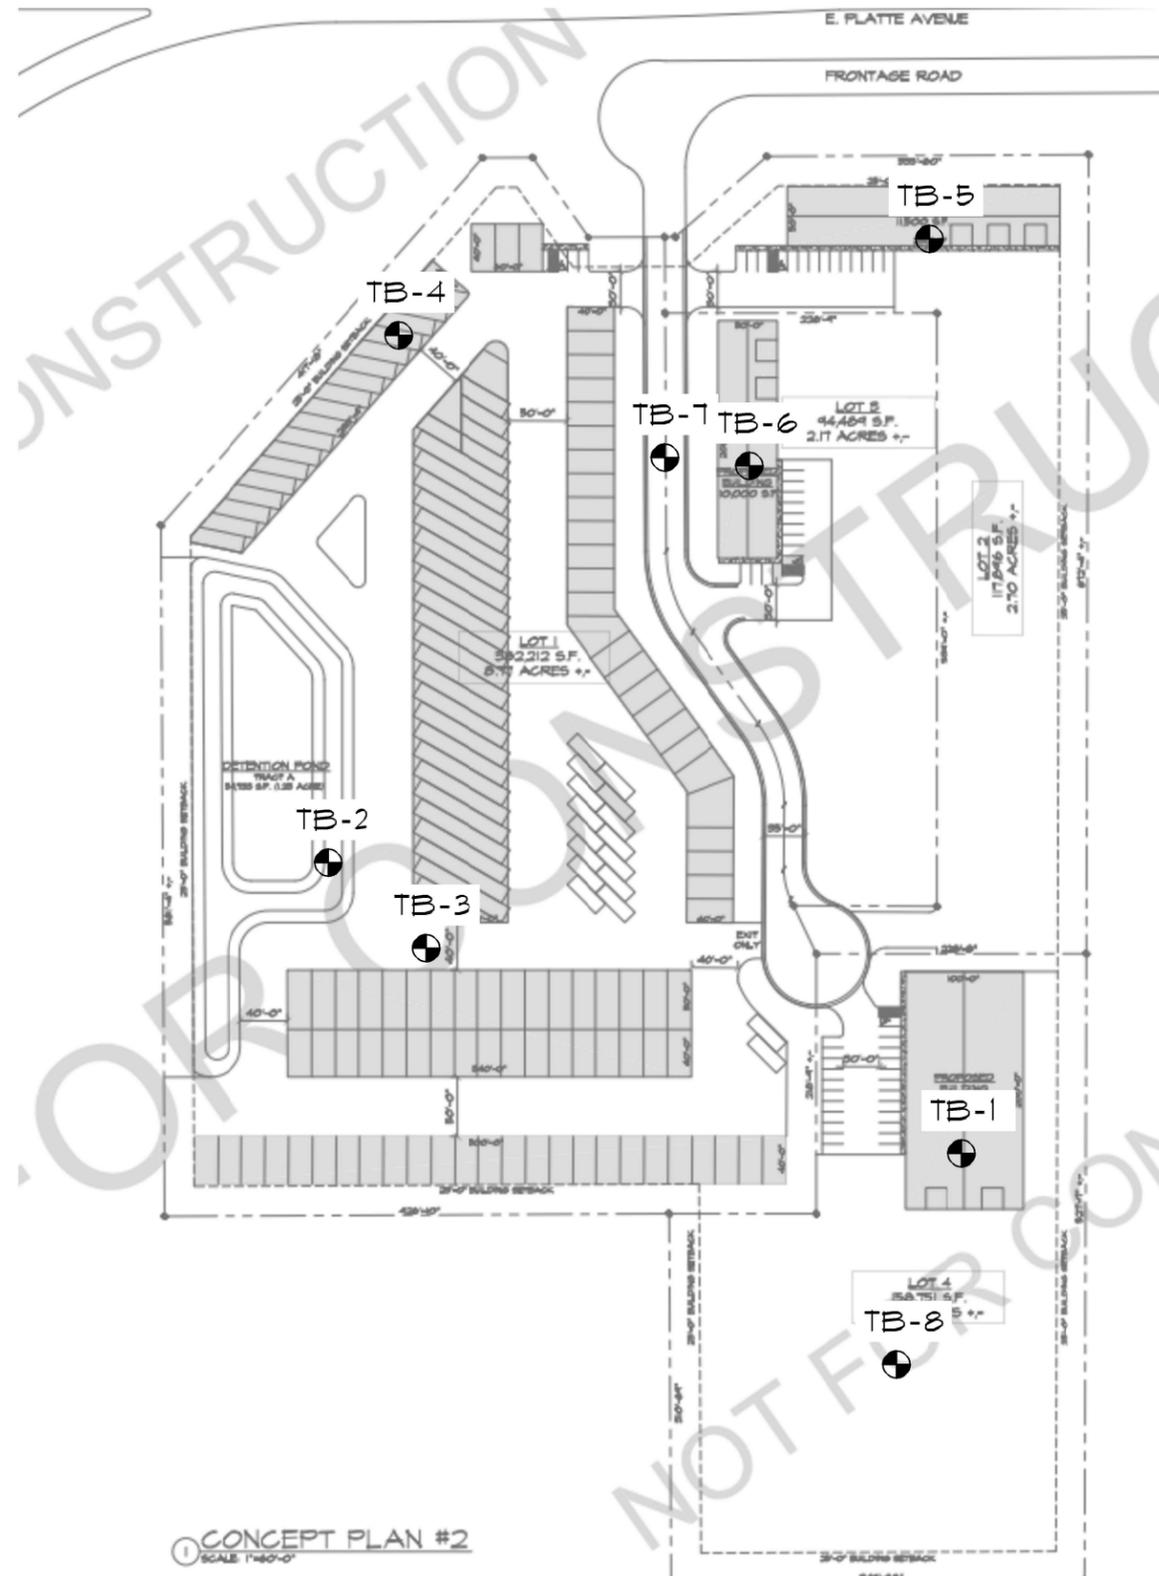
1 CONCEPT PLAN #2  
SCALE 1"=40'-0"

⊕ DENOTES APPROXIMATE  
LOCATION OF TEST BORINGS

Based on a concept plan prepared by RMG, we understand the Platte Storage Facility development is to consist of single-story storage unit structures along the eastern half of the property. The storage units are to be atop slab-on-grade foundations. The Proposed Development Plan is included in Figure 2.

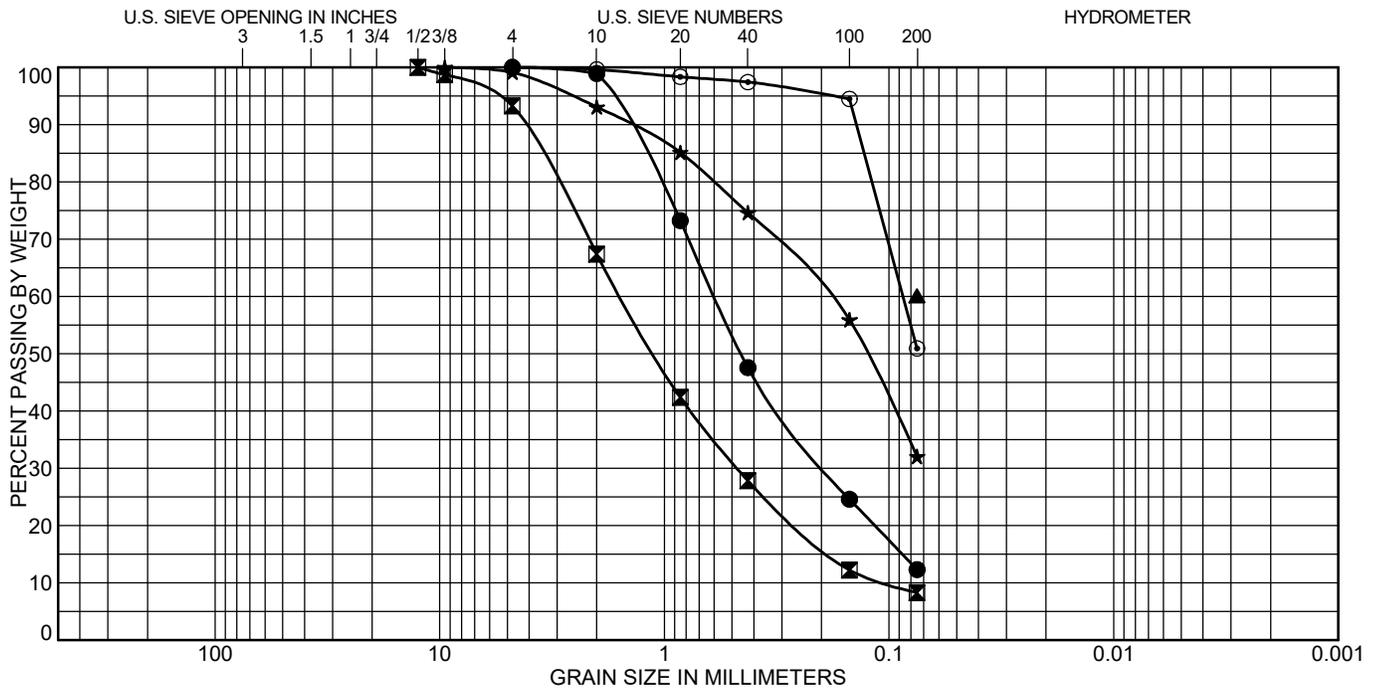
FIGURE No. 9

COBBLES	GRAVEL		SAND			SILT OR CLAY
	coarse	fine	coarse	medium	fine

Test Boring	Depth (ft)	Classification	LL	PL	PI
● 1	4.0	SILTY SAND(SM)	NP	NP	NP
☒ 1	14.0				
▲ 1	29.0	SANDY SILT(ML)	NP	NP	NP
★ 2	7.0	SILTY SAND(SM)	NP	NP	NP
⊙ 3	9.0	SANDY SILT(ML)	NP	NP	NP

The moisture content for the recovered samples was obtained in the laboratory. Grain-size analysis, Atterberg Limits, and Denver Swell/Consolidation tests were performed on selected samples for purposes of classification and to develop pertinent engineering properties. A Summary of Laboratory Test Results is presented in Figure 8. Soils Classification Data are presented in Figures 9 through 11 Swell/Consolidation Test Results are presented in Figure 12.

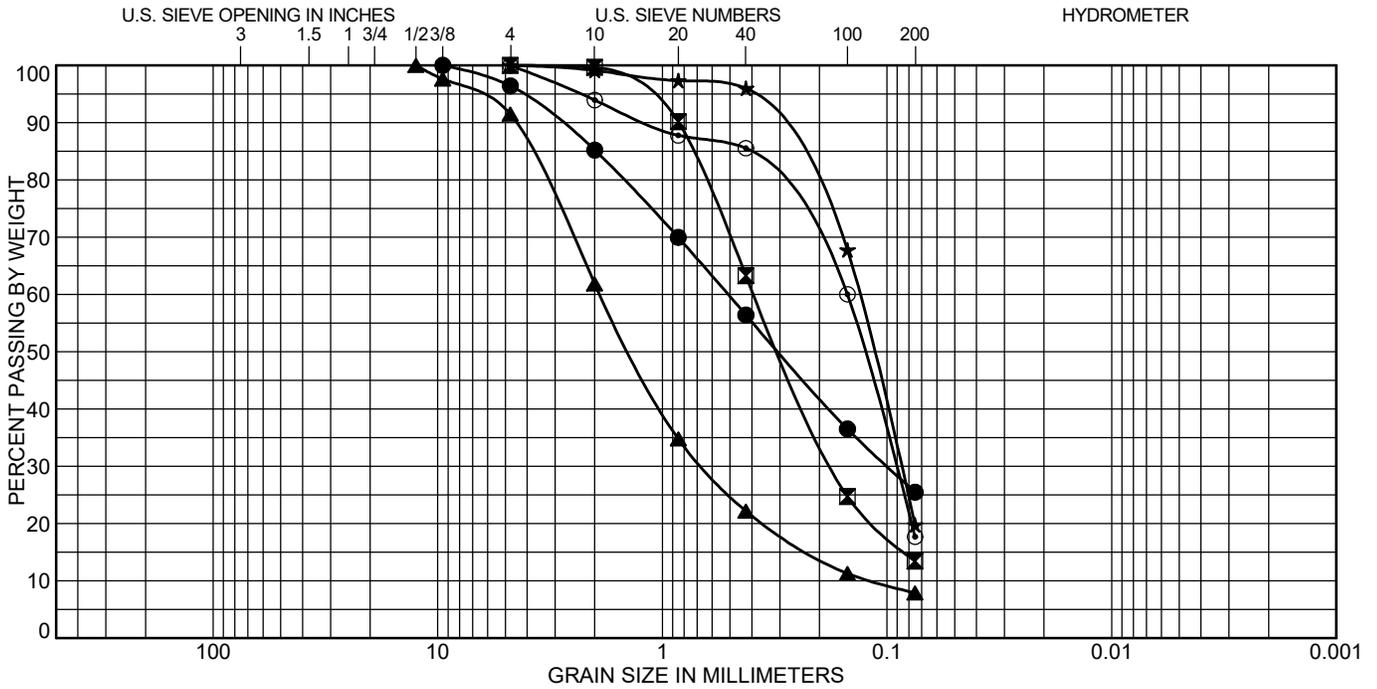
FIGURE No. 10

COBBLES	GRAVEL		SAND			SILT OR CLAY
	coarse	fine	coarse	medium	fine

Test Boring	Depth (ft)	Classification	LL	PL	PI
● 4	14.0	CLAYEY SAND(SC)	27	16	11
⊠ 5	9.0	SILTY SAND(SM)	NP	NP	NP
▲ 6	7.0	WELL-GRADED SAND with SILT(SW-SM)	NP	NP	NP
★ 7	4.0	SILTY SAND(SM)	NP	NP	NP
⊙ 7	9.0

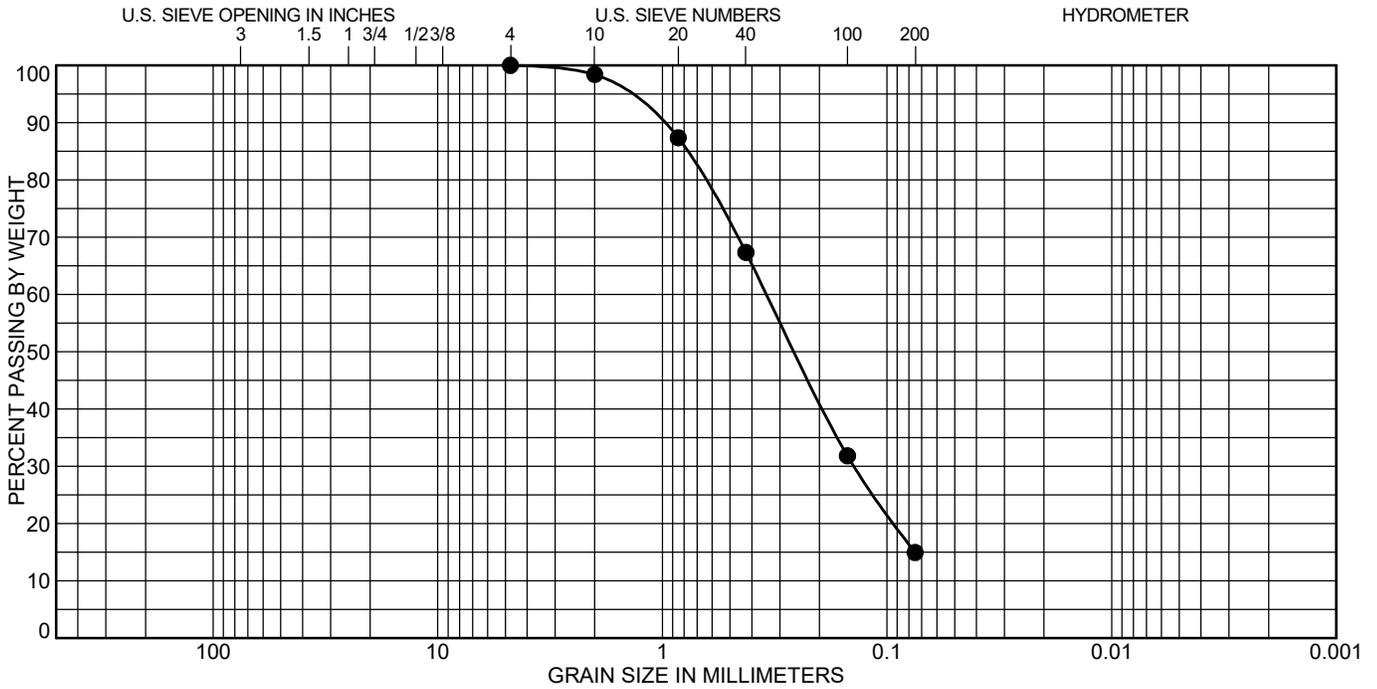
FIGURE No. 11

COBBLES	GRAVEL		SAND			SILT OR CLAY
	coarse	fine	coarse	medium	fine

Test Boring	Depth (ft)	Classification	LL	PL	PI
● 8	7.0

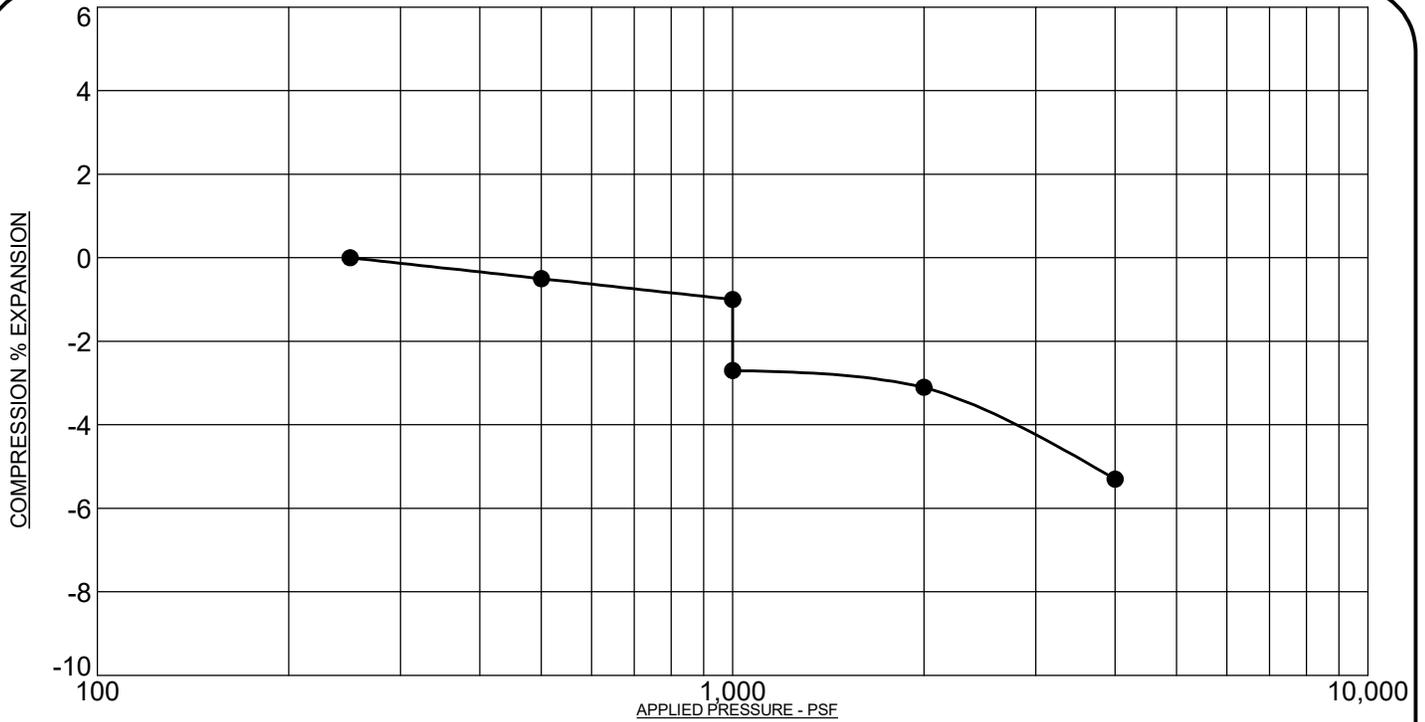
PROJECT: 6001 E Platte Ave, Colorado Springs, Colorado  
 SAMPLE DESCRIPTION: SANDSTONE, SILTY  
 NOTE: SAMPLE WAS INUNDATED WITH WATER AT 1,000 PSF

SAMPLE LOCATION: 1 @ 29 FT  
 NATURAL DRY UNIT WEIGHT: 98.6 PCF  
 NATURAL MOISTURE CONTENT: 16.8%  
 PERCENT SWELL/COMPRESSION: - 1.7

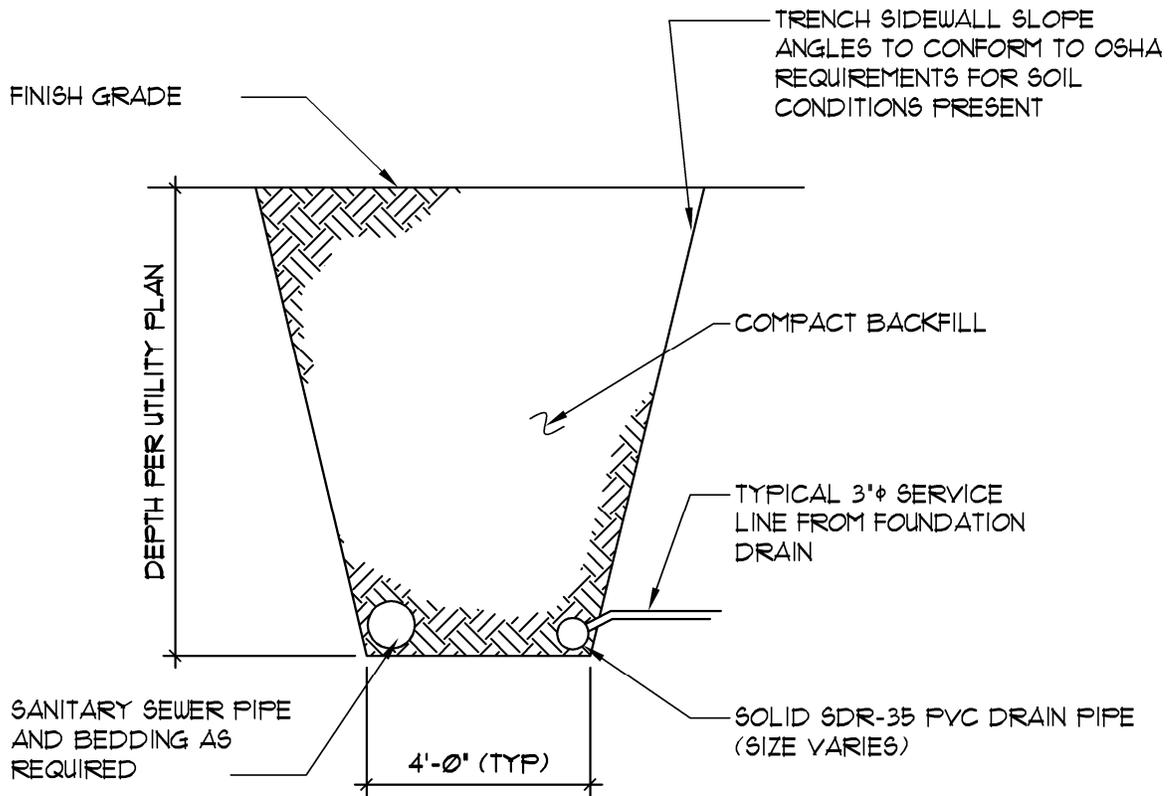
**FIG No. 13**

NOTE: TO BE USED WHERE NO SHALLOW  
GROUNDWATER IS KNOWN TO EXIST

It is a common local practice for underdrains to be placed at the bottom of sanitary sewer trenched within drive lanes. Underdrains placed in the sanitary sewer trenches in areas where groundwater is anticipated will likely be the "active" type, which uses a perforated drain pipe. In areas where groundwater is not anticipated, “passive” type underdrains may be used. The outfall for the sanitary sewer trench underdrain was not known at the time of this investigation because the development plan and grading plan were not available for our review. Typical underdrain details are presented in Figures 13 and 14.

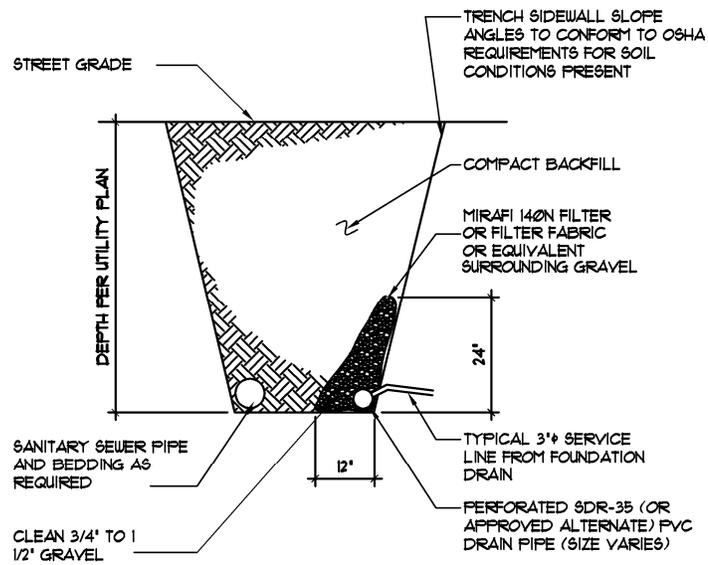
NOTE: TO BE USED IN CASES WHERE GROUNDWATER IS FOUND DURING TRENCHING OR WHERE SHALLOW GROUNDWATER IS KNOWN TO EXIST
