SOIL AND GEOLOGY STUDY

6001 E. Platte Road Platte Self-Storage El Paso County, Colorado

JOB NO. 195706

May 9, 2024

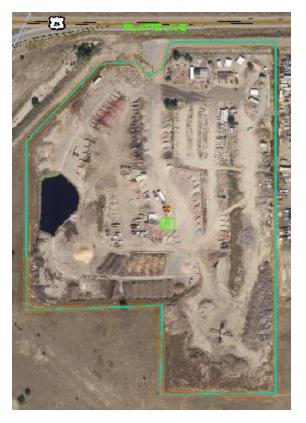
The U.S. Soil Conservation Service along with United States Department of Agriculture (USDA) identifies the site soils as:

• 8 – Blakeland loamy sand, 1 to 9 percent slopes. The Blakeland loamy sand was mapped by the USDA to encompass the majority of the property. Properties of the loamy sand include, somewhat excessively drained soils, depth of the water table is anticipated to be greater than 6.5 feet, runoff is anticipated to be low, frequency of flooding and ponding is low, and landforms include depressions.

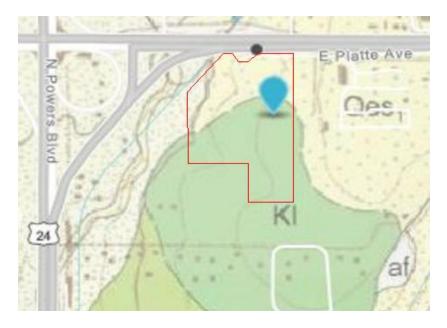
Based on our PSSI field exploration and observations, as well as the Geologic Map of the Elsmere 7.5 Minute Quadrangle (depicted in the image below), we created an interpreted map of geologic conditions affecting the development, significant surficial deposits, and surface features for the site. The interpreted map is presented on the Engineering and Geology Map, Figure 3.

The site generally consists of eolian deposits overlying sandstone bedrock. The geologic units mapped at the site were:

- *Qes*₁ *Younger eolian sand (middle and early Holocene and late? Pleistocene)* The unit is overall very coarse sand that appears to have been deposited as sand sheets (low relief sand dune). Unit thickness is estimated to be deeper on the eastern portion of the site and thickness could range between 3 to 20 feet.

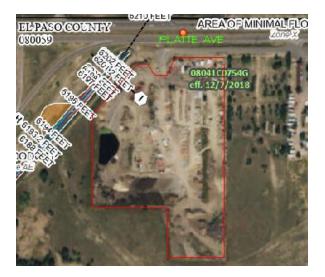
Based on our review of the Federal Emergency Management Agency (FEMA) Community Panel No. 08041C0754G and the online ArcGIS El Paso County Risk Map, the site does not lie within a 100-year floodplain. The site is within the boundaries of Zone X.

Zone X is defined by FEMA as an area of minimal flood hazard that is determined to be outside the Special Flood Hazard Area and higher than the elevation of the 0.2-percent-annual-chance (or 500-year) flood. Additional information is included in **7.6 Floodplains.**
