Revised: April 8, 2021  
December 21, 2020

**ENTECH**  
ENGINEERING, INC.

Re: OWTS – Wastewater Study  
Johnson Subdivision No. 1  
Parcel No. 61000-00-157  
14502 Highway 83  
El Paso County, Colorado

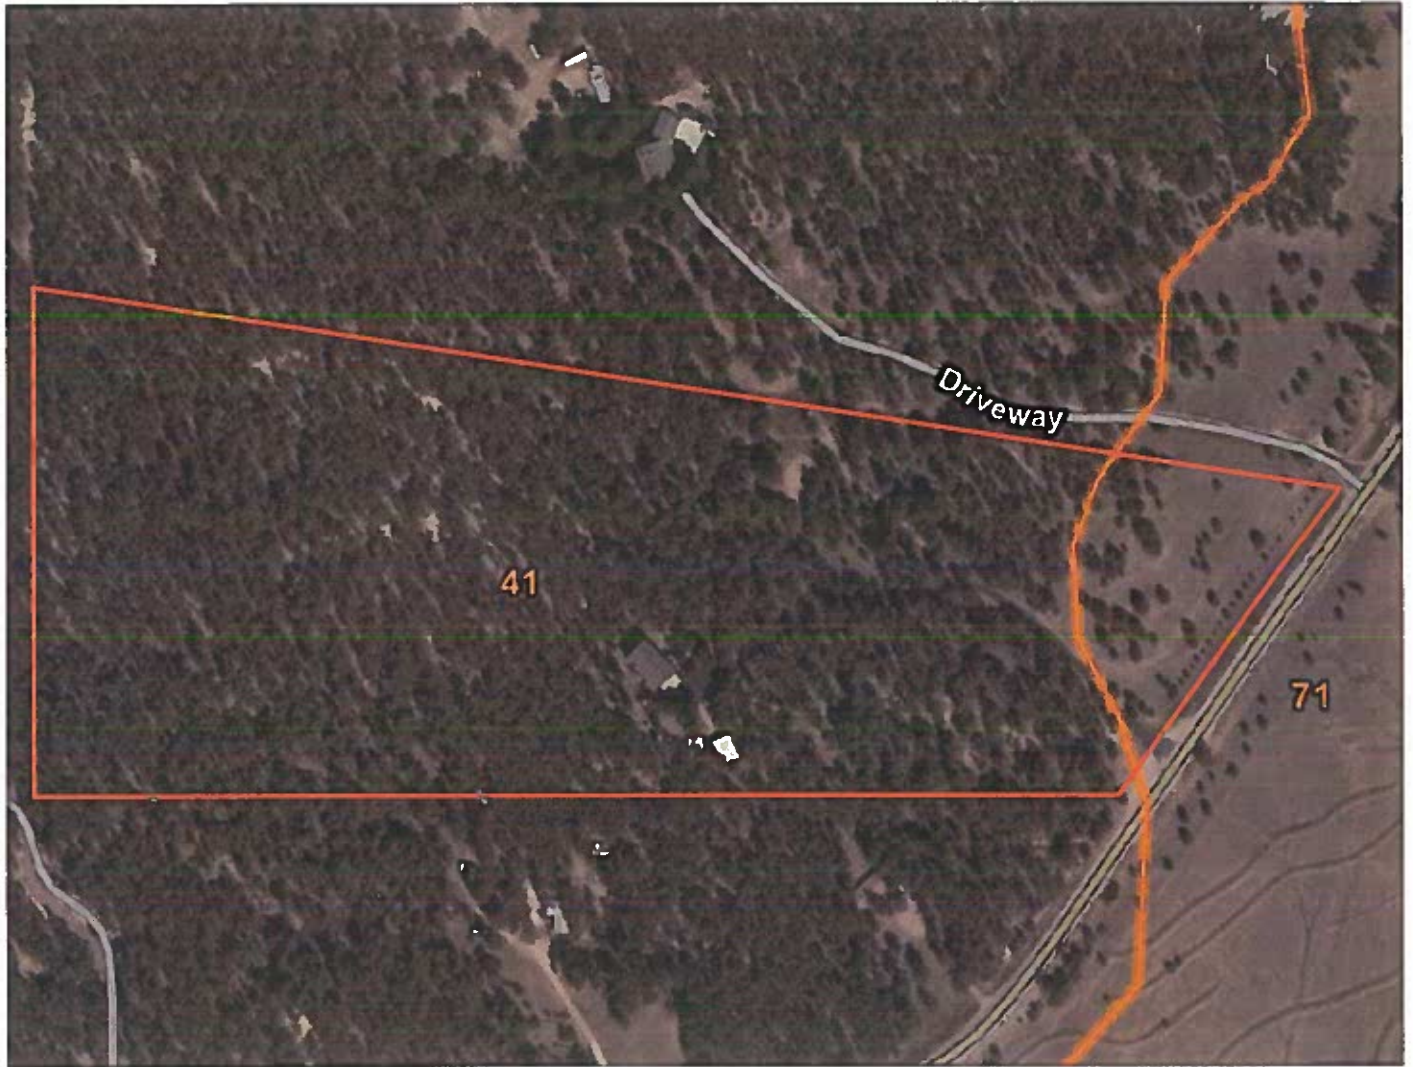
FIG NO.:  
 4

SOIL SURVEY MAP  
 JOHNSON SUBDIVISION NO. 1  
 14502 HIGHWAY 83  
 EL PASO COUNTY, CO.  
 FOR: DELROY JOHNSON

The soils have been described to have moderate to rapid permeabilities. The soils are described as well suited for use as homesites. Possible hazards with soils erosion are present on the site. The erosion potential can be controlled with vegetation. The soils have been described to have moderate erosion hazards (Reference 2).

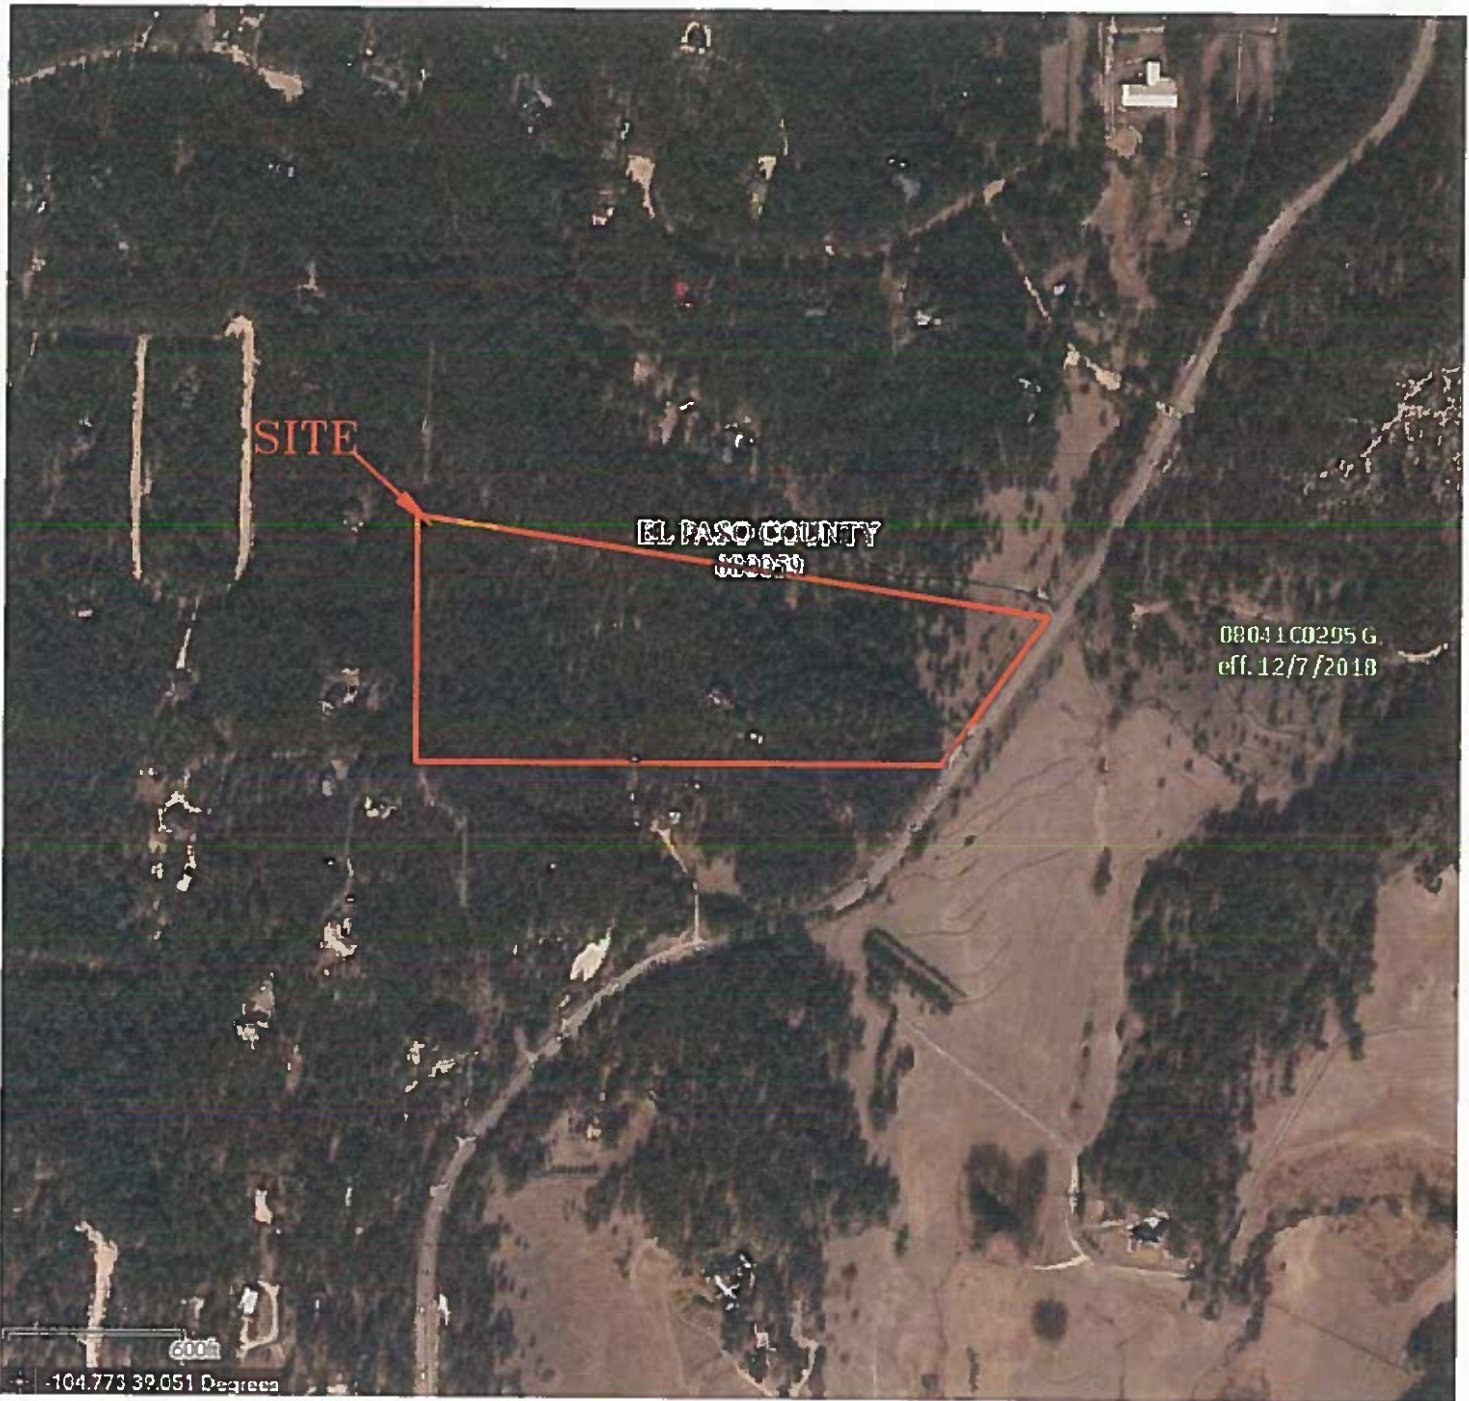
FIG NO.:  
**7**

FEMA FLOODPLAIN MAP  
 JOHNSON SUBDIVISION NO. 1  
 14502 HIGHWAY 83  
 EL PASO COUNTY, CO.  
 FOR: DELROY JOHNSON

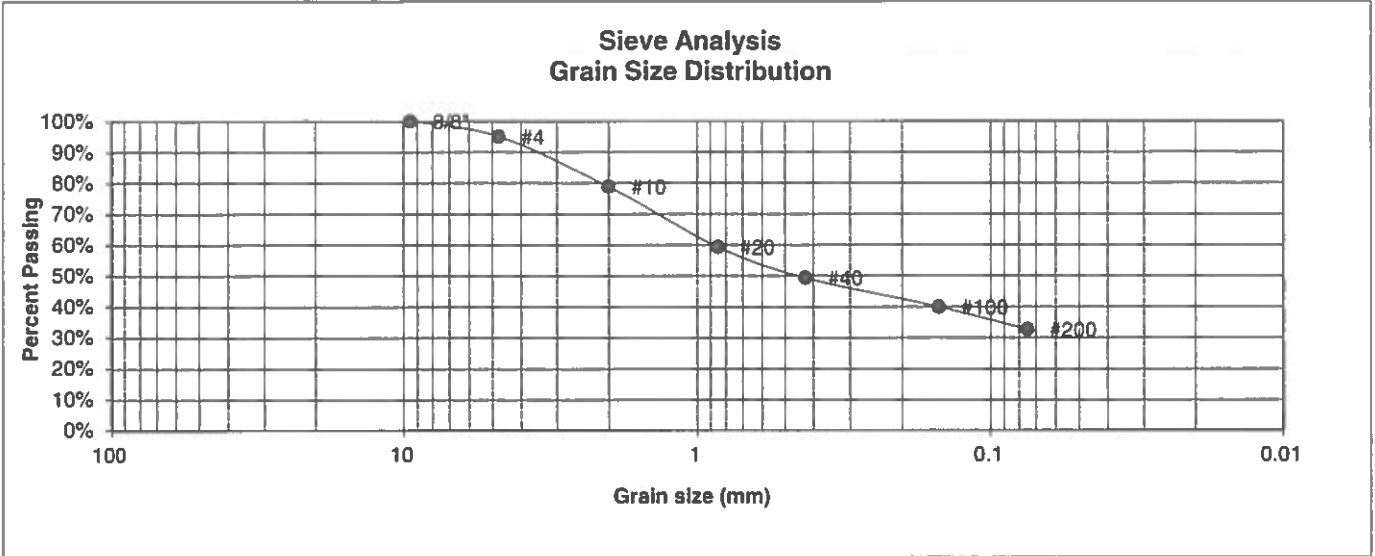
FIG NO.:  
B-1

BORING NO.	TP-1	UNIFIED CLASSIFICATION	SM	TEST BY	BL
DEPTH(ft)	2-3	AASHTO CLASSIFICATION		JOB NO.	202746
CLIENT	DELROY JOHNSON				
PROJECT	14502 HIGHWAY 83

U.S. Sieve #	Percent Finer
3"	
1 1/2"	
3/4"	
1/2"	
3/8"	100.0%
4	95.1%
10	78.8%
20	59.3%
40	49.3%
100	40.0%
200	32.7%

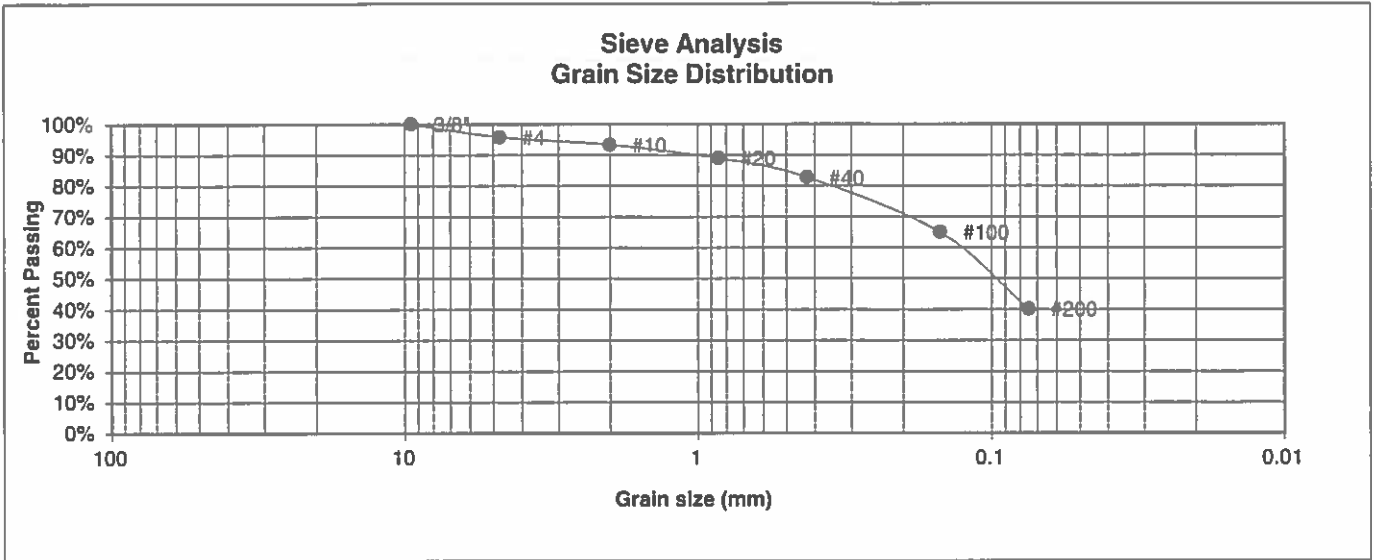
FIG NO.:  
6-2

BORING NO.	TP-2	UNIFIED CLASSIFICATION	SM	TEST BY	BL
DEPTH(ft)	3-4	AASHTO CLASSIFICATION		JOB NO.	202746
CLIENT	DELROY JOHNSON				
PROJECT	14502 HIGHWAY 83

U.S. Sieve #	Percent Finer
3"	
1 1/2"	
3/4"	
1/2"	
3/8"	100.0%
4	95.8%
10	93.3%
20	89.0%
40	82.7%
100	65.0%
200	40.1%

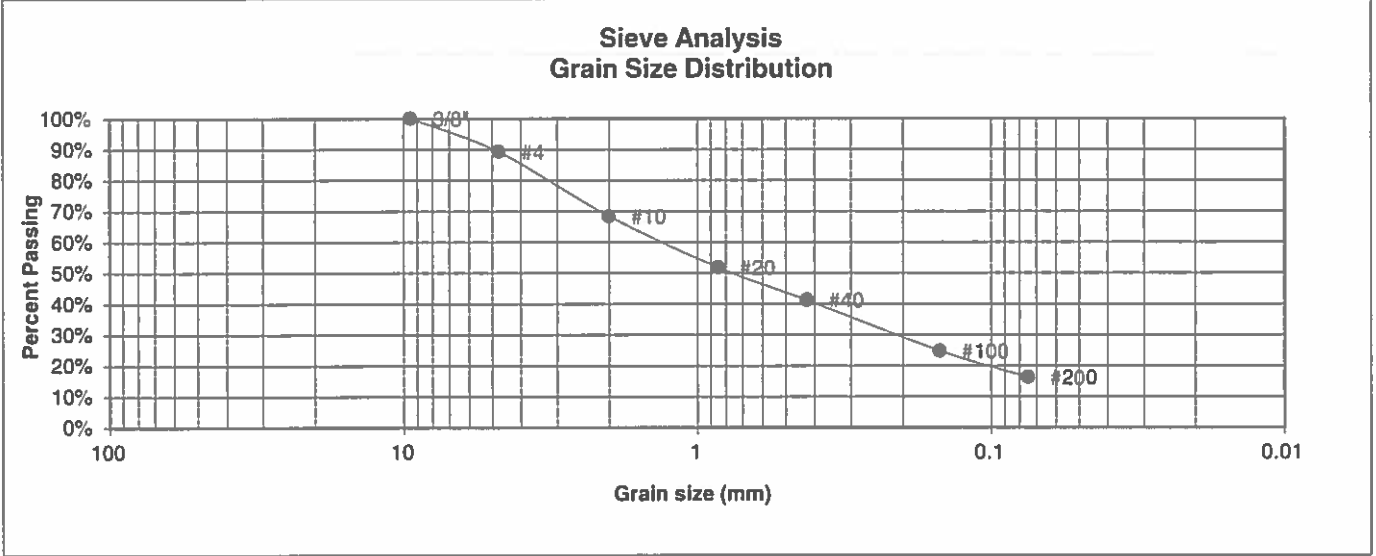
FIG NO.:  
B-3

BORING NO.	TP-3	UNIFIED CLASSIFICATION	SM	TEST BY	BL
DEPTH(ft)	5-6	AASHTO CLASSIFICATION		JOB NO.	202746
CLIENT	DELOY JOHNSON				
PROJECT	14502 HIGHWAY 83

U.S. Sieve #	Percent Finer
3"	
1 1/2"	
3/4"	
1/2"	
3/8"	100.0%
4	89.3%
10	68.4%
20	51.8%
40	41.2%
100	24.8%
200	16.2%

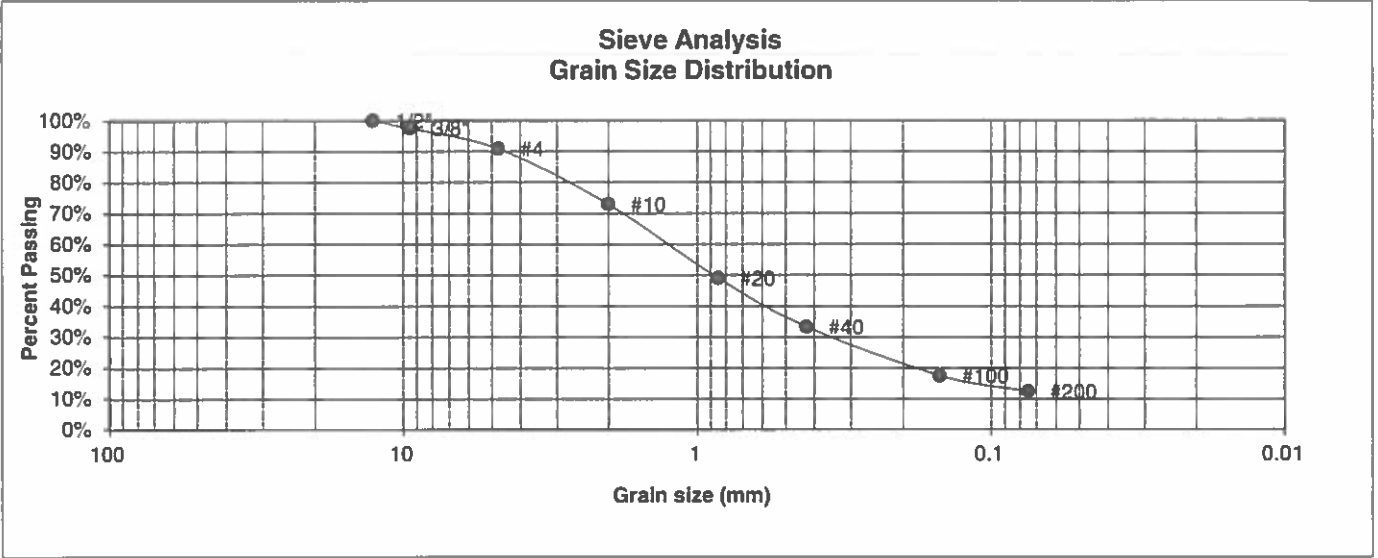
JOB NO.:  
202746  
 FIG NO.:  
B-4

BORING NO.	TP-4	UNIFIED CLASSIFICATION	SM	TEST BY	BL
DEPTH(ft)	2-3	AASHTO CLASSIFICATION		JOB NO.	202746
CLIENT	DELROY JOHNSON				
PROJECT	14502 HIGHWAY 83

U.S. Sieve #	Percent Finer
3"	
1 1/2"	
3/4"	
1/2"	100.0%
3/8"	97.5%
4	90.9%
10	72.9%
20	49.1%
40	33.3%
100	17.5%
200	12.5%

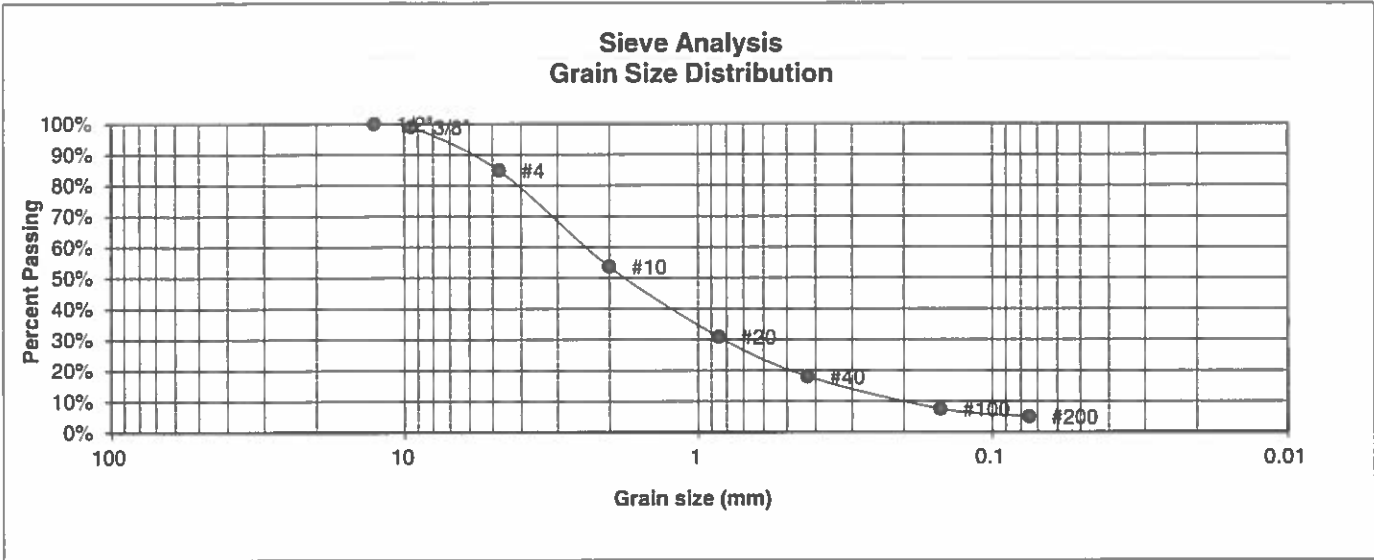
FIG NO.:  
B-5

BORING NO.	TP-5	UNIFIED CLASSIFICATION	SM-SW	TEST BY	BL
DEPTH(ft)	2-3	AASHTO CLASSIFICATION		JOB NO.	202746
CLIENT	DELROY JOHNSON				
PROJECT	14502 HIGHWAY 83

U.S. Sieve #	Percent Finer
3"	
1 1/2"	
3/4"	
1/2"	100.0%
3/8"	99.0%
4	84.8%
10	53.6%
20	30.9%
40	18.0%
100	7.5%
200	5.0%

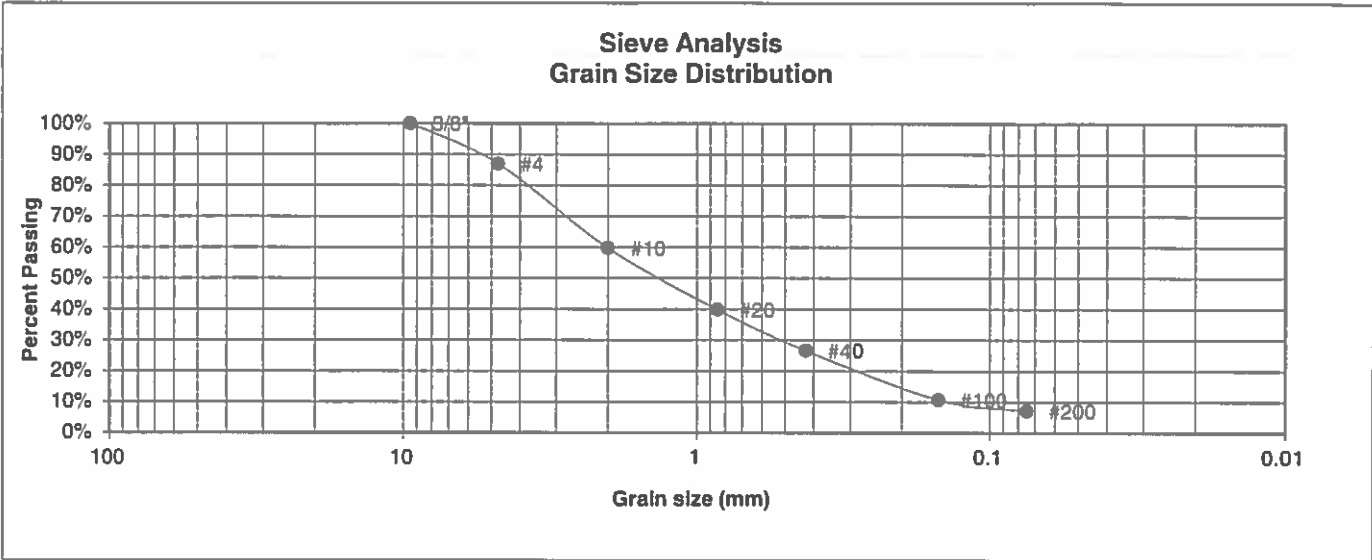
BORING NO.	TP-6	UNIFIED CLASSIFICATION	SM-SW	TEST BY	BL
DEPTH(ft)	5-6	AASHTO CLASSIFICATION		JOB NO.	202746
CLIENT	DELROY JOHNSON				
PROJECT	14502 HIGHWAY 83

U.S. Sieve #	Percent Finer
3"	
1 1/2"	
3/4"	
1/2"	
3/8"	100.0%
4	87.0%
10	59.7%
20	39.8%
40	26.6%
100	10.7%
200	7.2%
