**SOILS AND GEOLOGY STUDY
STERLING RANCH EAST – FILING NO. 5
PRELIMINARY PLAN NO. 2
COLORADO SPRINGS, COLORADO**

Prepared for:
Classic SRJ
2138 Flying Horse Club Drive
Colorado Springs, CO 80921

June 27, 2023

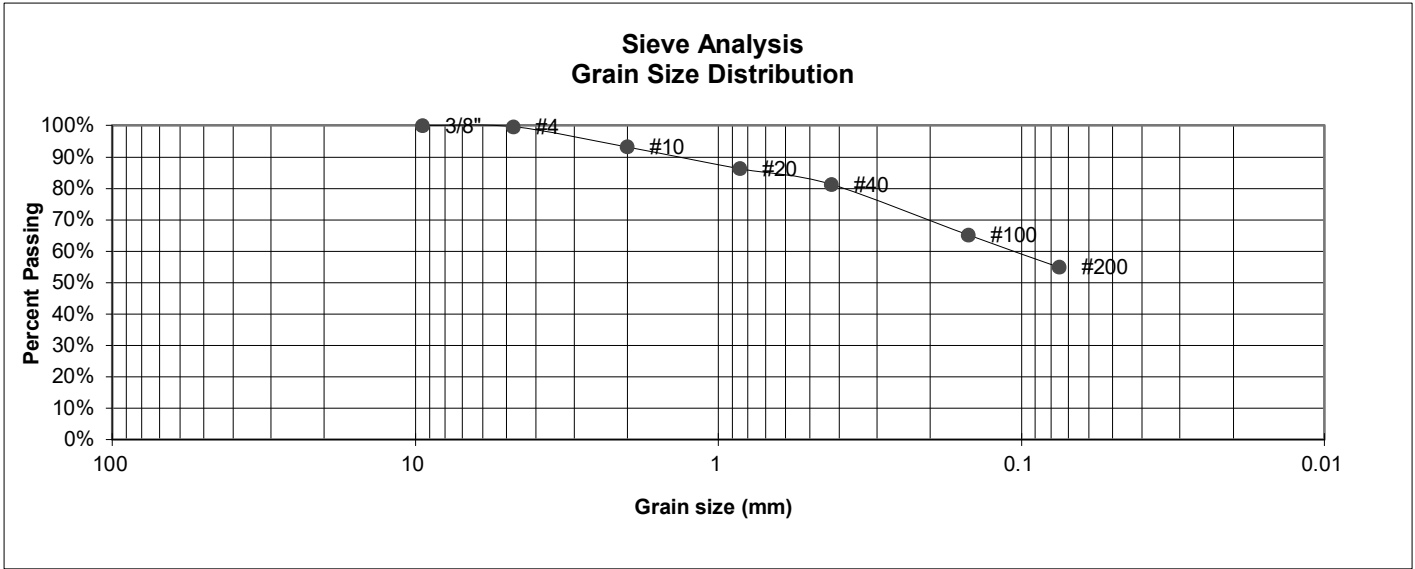
<u>UNIFIED CLASSIFICATION</u>	CL	<u>CLIENT</u>	CLASSIC SRJ
<u>SOIL TYPE #</u>	3	<u>PROJECT</u>	STERLING RANCH EAST, F-5
<u>TEST BORING #</u>	7	<u>JOB NO.</u>	230544
<u>DEPTH (FT)</u>	10	<u>TEST BY</u>	BL

U.S. Sieve #	Percent Finer
3"	
1 1/2"	
3/4"	
1/2"	
3/8"	100.0%
4	99.6%
10	93.2%
20	86.3%
40	81.3%
100	65.1%
200	54.8%
