ENTECH
ENGINEERING, INC.

**SOILS AND GEOLOGY STUDY
WATERVIEW EAST COMMERCIAL
PARCEL NO. 55092-00-002
SOUTH POWERS BOULEVARD AND BRADLEY ROAD
EL PASO COUNTY, COLORADO**

February 17, 2023

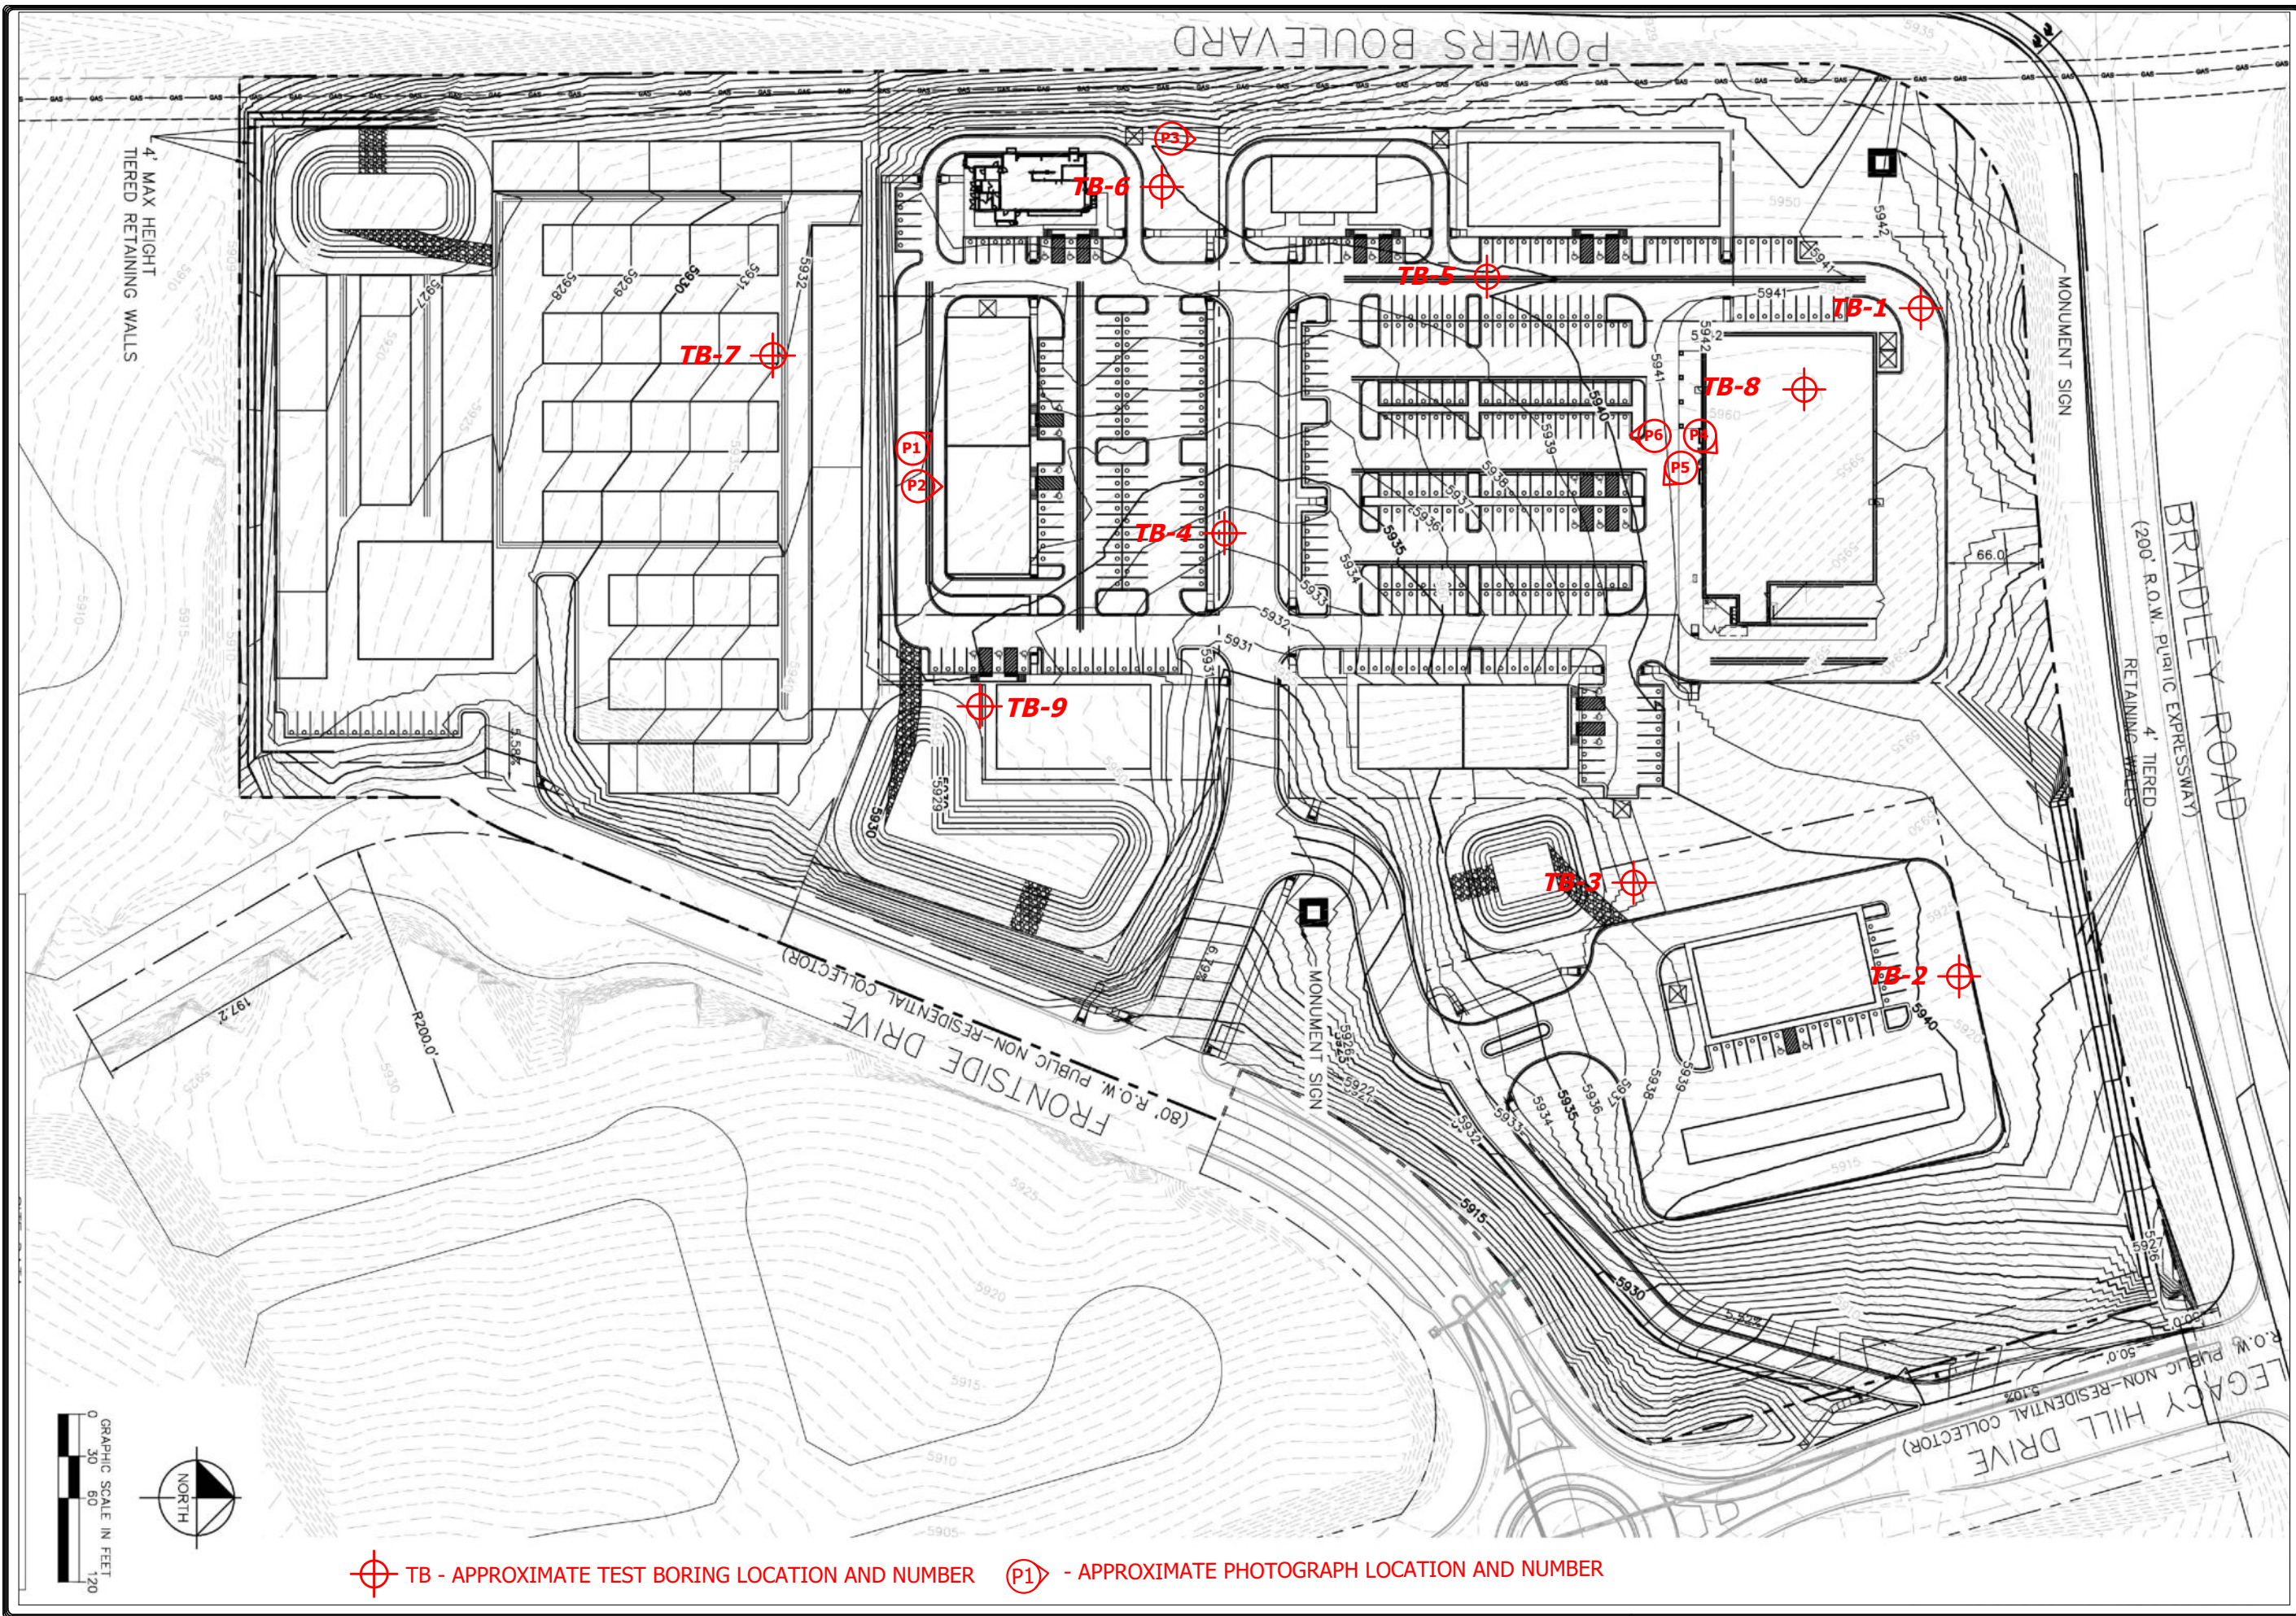
DRAWN L.L.
CHECKED
DATE 2/8/23
SCALE AS SHOWN
JOB NO. 220689
FIGURE No. 3

⊕ TB - APPROXIMATE TEST BORING LOCATION AND NUMBER (P1) - APPROXIMATE PHOTOGRAPH LOCATION AND NUMBER

SITE PLAN/TEST BORING LOCATION MAP
WATERVIEW EAST COMMERCIAL
POWERS BOULEVARD AND BRADLEY ROAD
EL PASO COUNTY, CO.
FOR: WATERVIEW EAST COMMERCIAL INVESTORS, LLC

Total acreage involved in the proposed development is approximately 22.1 acres. The proposed site development consists commercial development and associated site improvements. Three retail buildings, an office building, grocery store, three restaurants, a gas station, and storage facility are proposed. Three detention ponds are proposed in the northeastern, eastern, and southwestern portions of the site. Tiered retaining walls are proposed in the northeastern and southwestern portions of the site. Significant grading will be performed to develop the site. Cuts of up to 20 feet, and fills up to 35 feet are proposed. Reportedly the preliminary grading plan is a balanced site. Nine (9) Test Borings were drilled across the site to determine general soil and bedrock characteristics. The locations of the test borings are indicated on the Site Plan/Test Boring Location Map, Figure 3.

Nine (9) Test Borings were performed on the site to determine general soil and bedrock characteristics. The locations of the test borings are indicated on the Site Plan/Test Boring Location Map, Figure 3. The Test Boring Logs are presented in Appendix B. Results of this testing will be discussed later in this report.

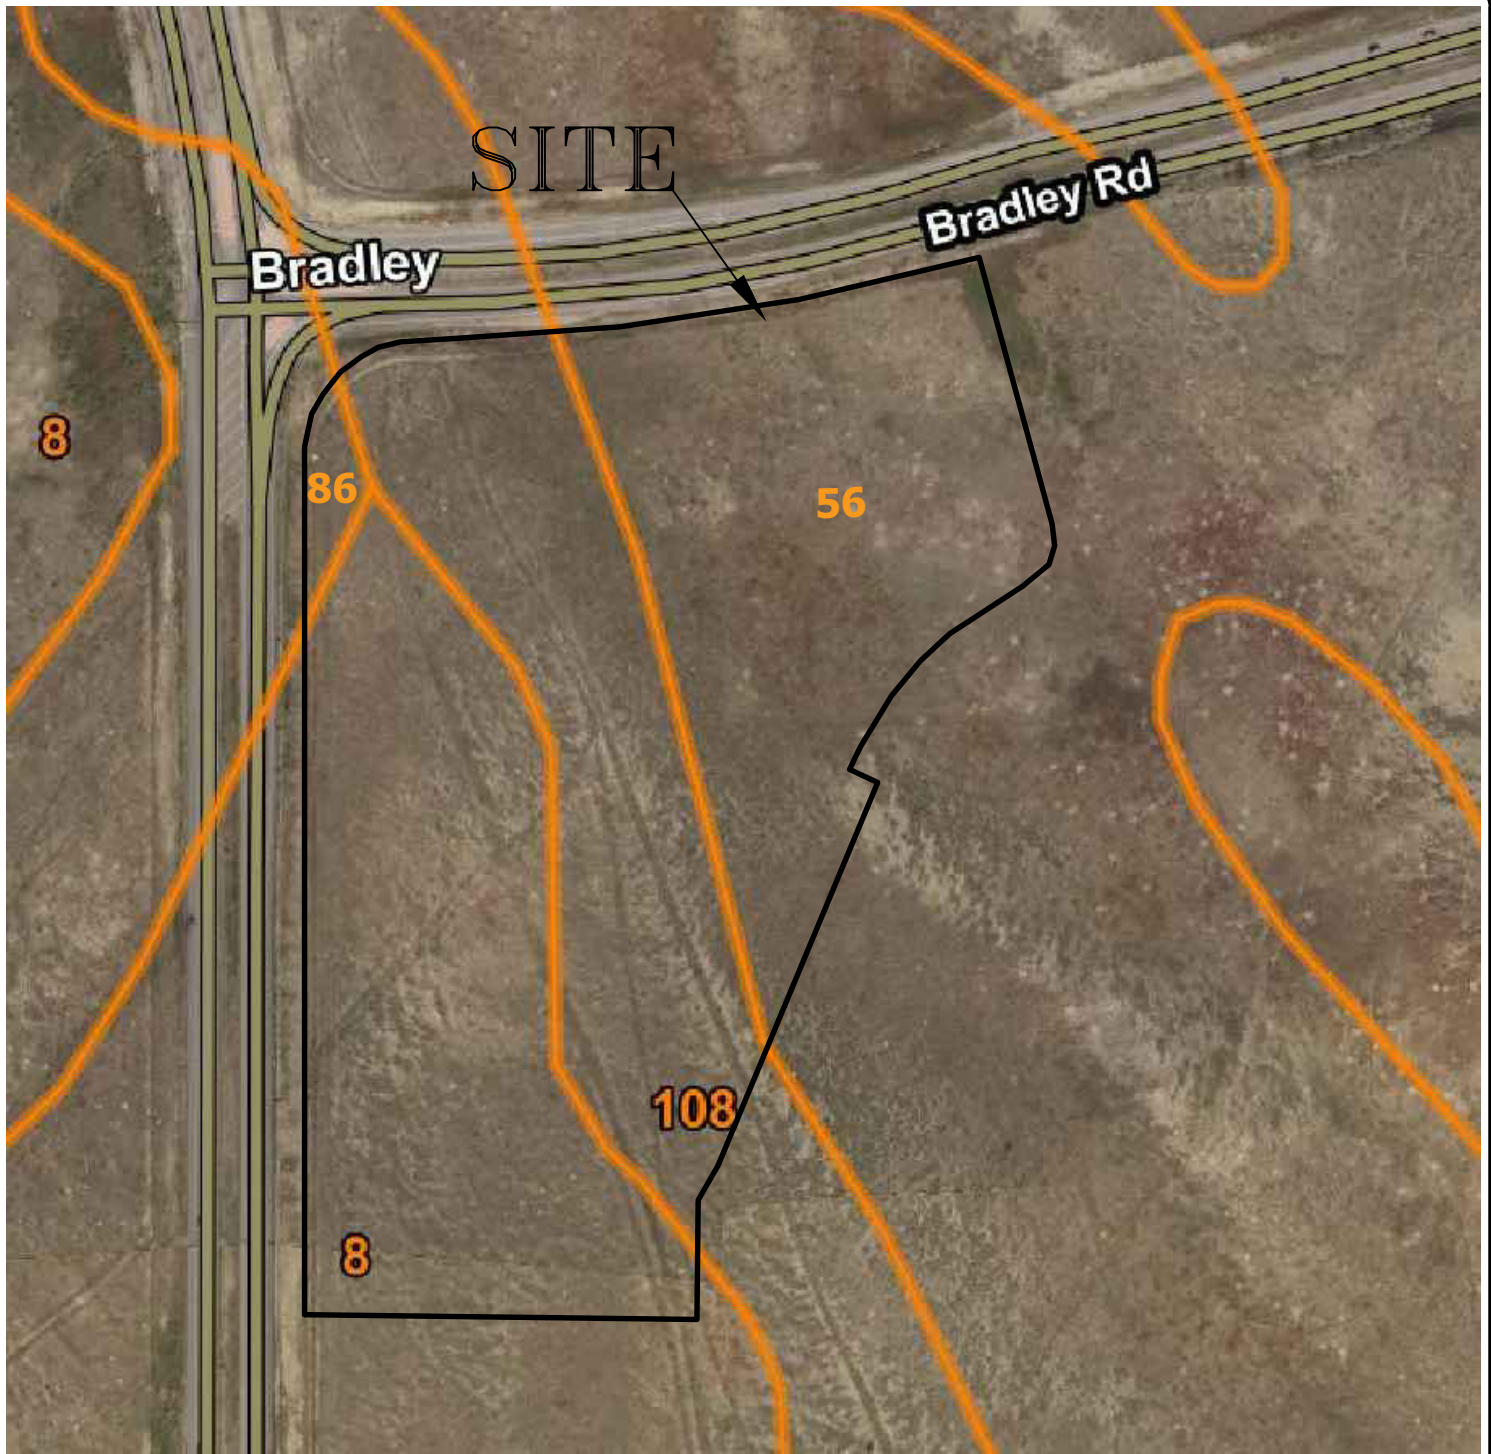
FIG NO.:
 4

SOIL SURVEY MAP
 WATERVIEW EAST COMMERCIAL
 POWERS BOULEVARD AND BRADLEY ROAD
 EL PASO COUNTY, CO.
 FOR: WATERVIEW EAST COMMERCIAL INVESTORS, LLC

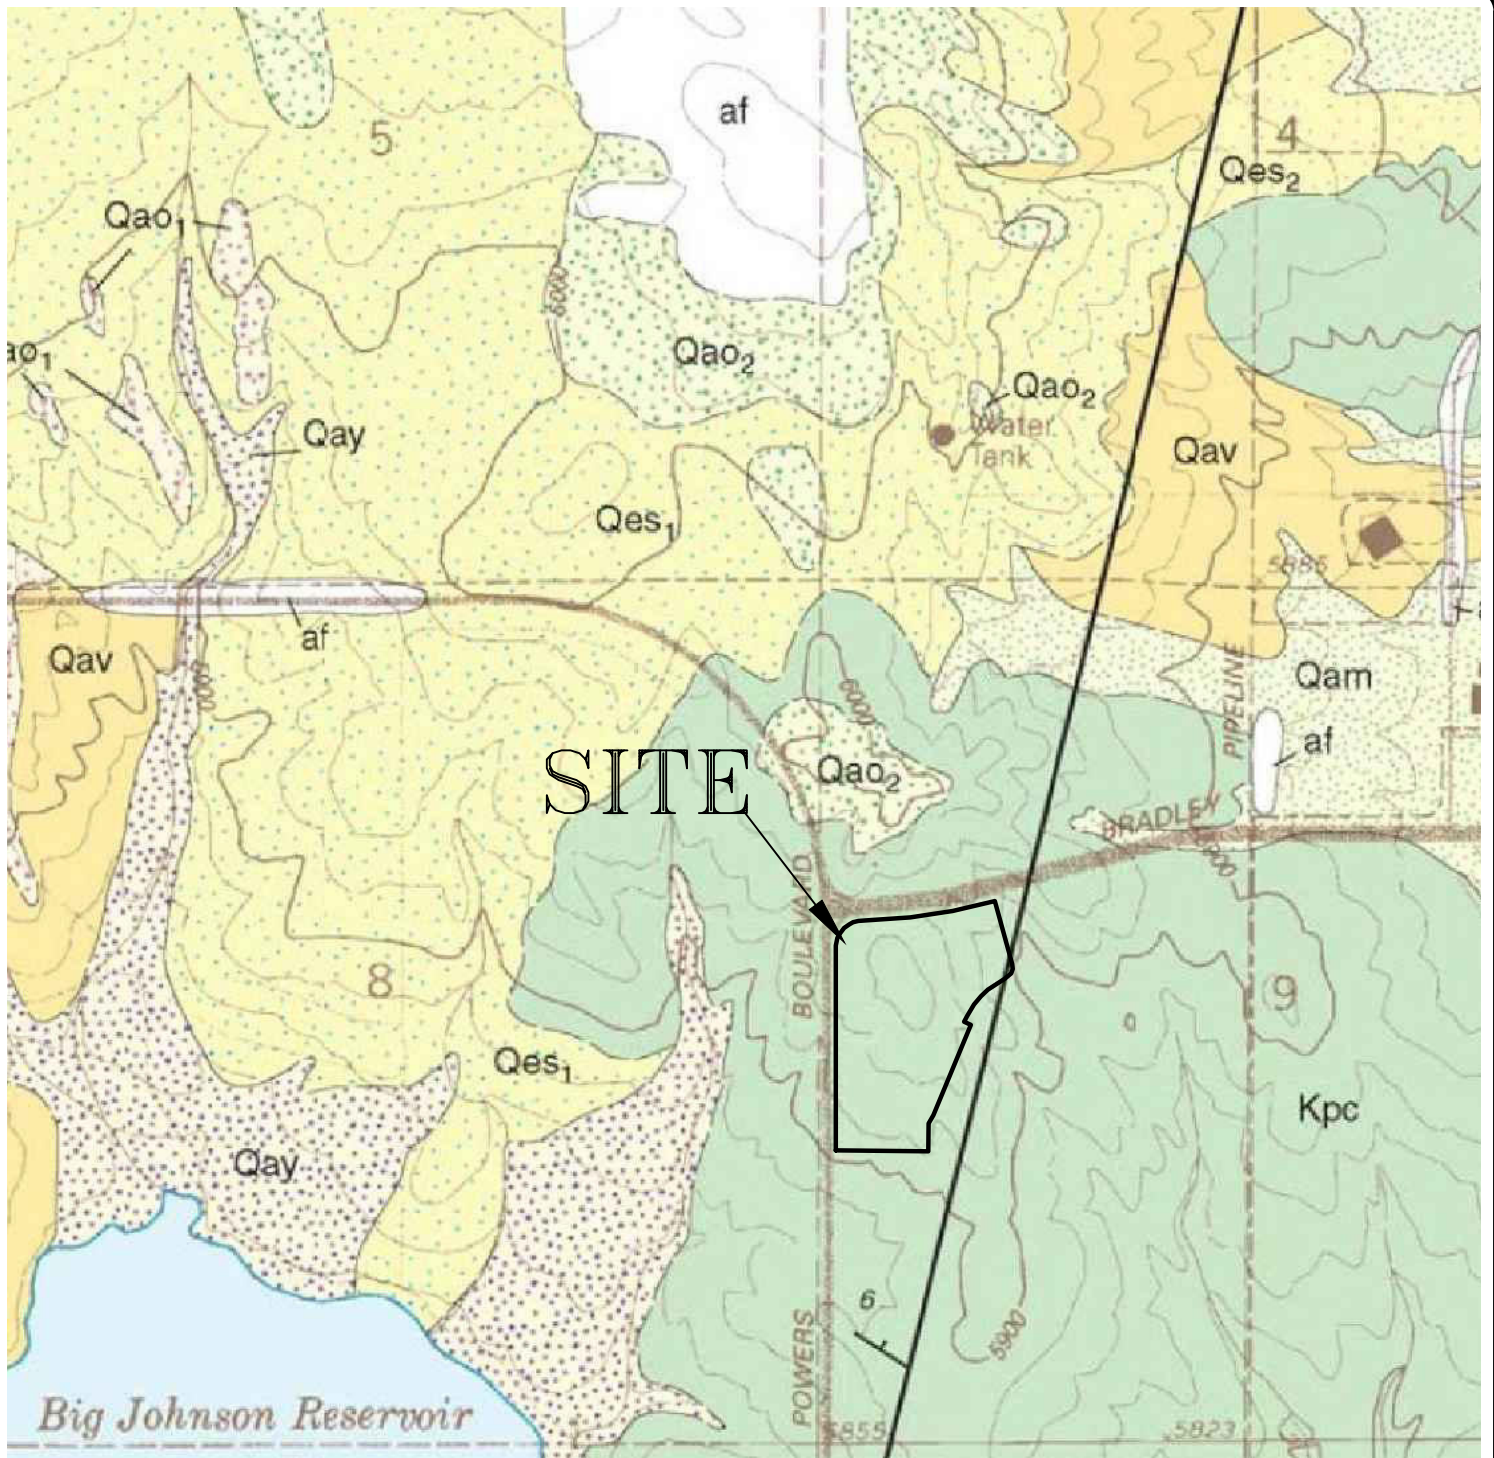
FIG NO.:
 5

ELSMERE QUADRANGLE GEOLOGY MAP
 WATERVIEW EAST COMMERCIAL
 POWERS BOULEVARD AND BRADLEY ROAD
 EL PASO COUNTY, CO.
 FOR: WATERVIEW EAST COMMERCIAL INVESTORS, LLC

The Elsmere Quadrangle Geology Map showing the site is presented in (Figure 5, Reference 4). The Geology/Engineering Geology Map prepared for the site is presented in Figure 6. Three mappable units were identified on this site which are described as follows:

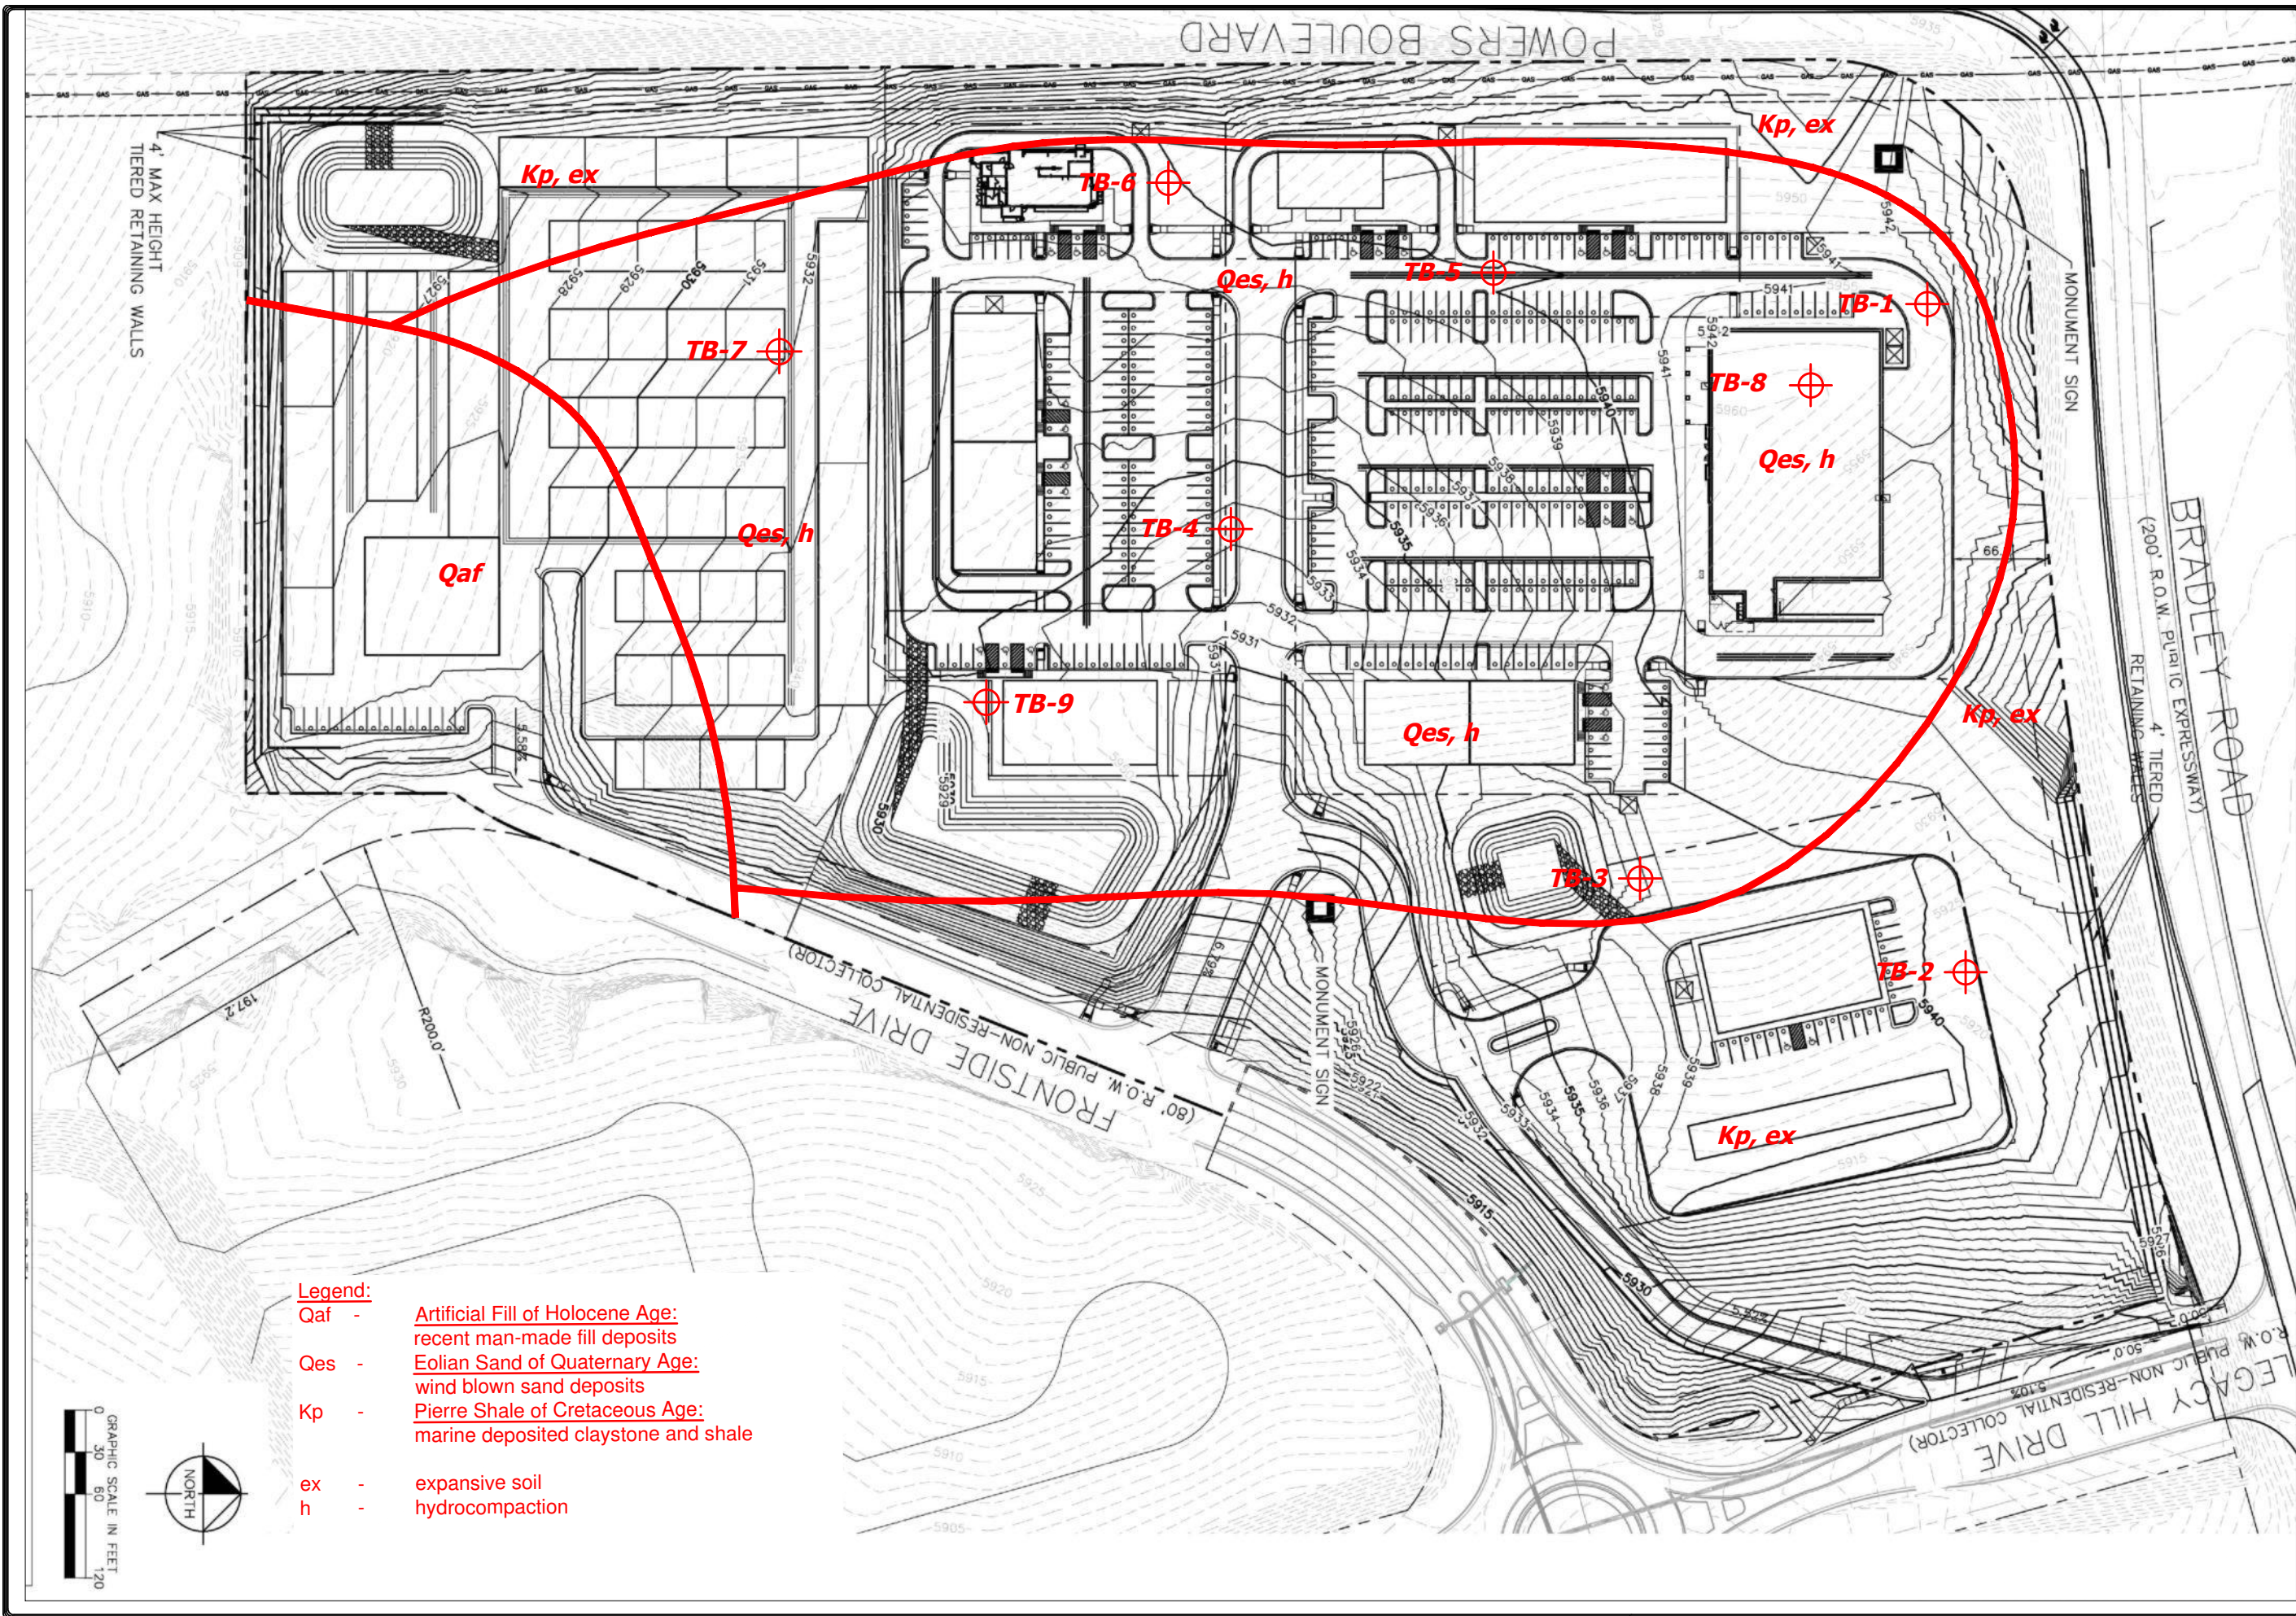
DRAWN L.L.
CHECKED
DATE 2/8/23
SCALE AS SHOWN
JOB NO. 220689
FIGURE No. 6

- Legend:**
- Qaf - Artificial Fill of Holocene Age: recent man-made fill deposits
 - Qes - Eolian Sand of Quaternary Age: wind blown sand deposits
 - Kp - Pierre Shale of Cretaceous Age: marine deposited claystone and shale
 - ex - expansive soil
 - h - hydrocompaction

GEOLOGY/ENGINEERING GEOLOGY MAP
WATERVIEW EAST COMMERCIAL
POWERS BOULEVARD AND BRADLEY ROAD
EL PASO COUNTY, CO.
FOR: WATERVIEW EAST COMMERCIAL INVESTORS, LLC.

The soils listed above were mapped from site-specific mapping, the *Geologic Map of the Elsmere Quadrangle* distributed by the Colorado Geological Survey in 2002 (Reference 4), the *Geologic Map of the Colorado Springs-Castle Rock Area*, distributed by the US Geological Survey in 1979 (Reference 5), and the *Geologic Map of the Pueblo 1^o x 2^o Quadrangle*, distributed by the US Geological Survey in 1978 (Reference 6). The Test Borings were also used in evaluating the site and are included in Appendix B. The Geology Map prepared for the site is presented in Figure 6.

Detailed mapping has been performed on this site to produce an Engineering Geology Map Figure 6. This map shows the location of various geologic conditions of which the developers should be cognizant during the planning, design and construction stages of the project. Hazards include areas of artificial fill, expansive soils, and hydrocompaction. These hazards and the recommended mitigation techniques are as follows:

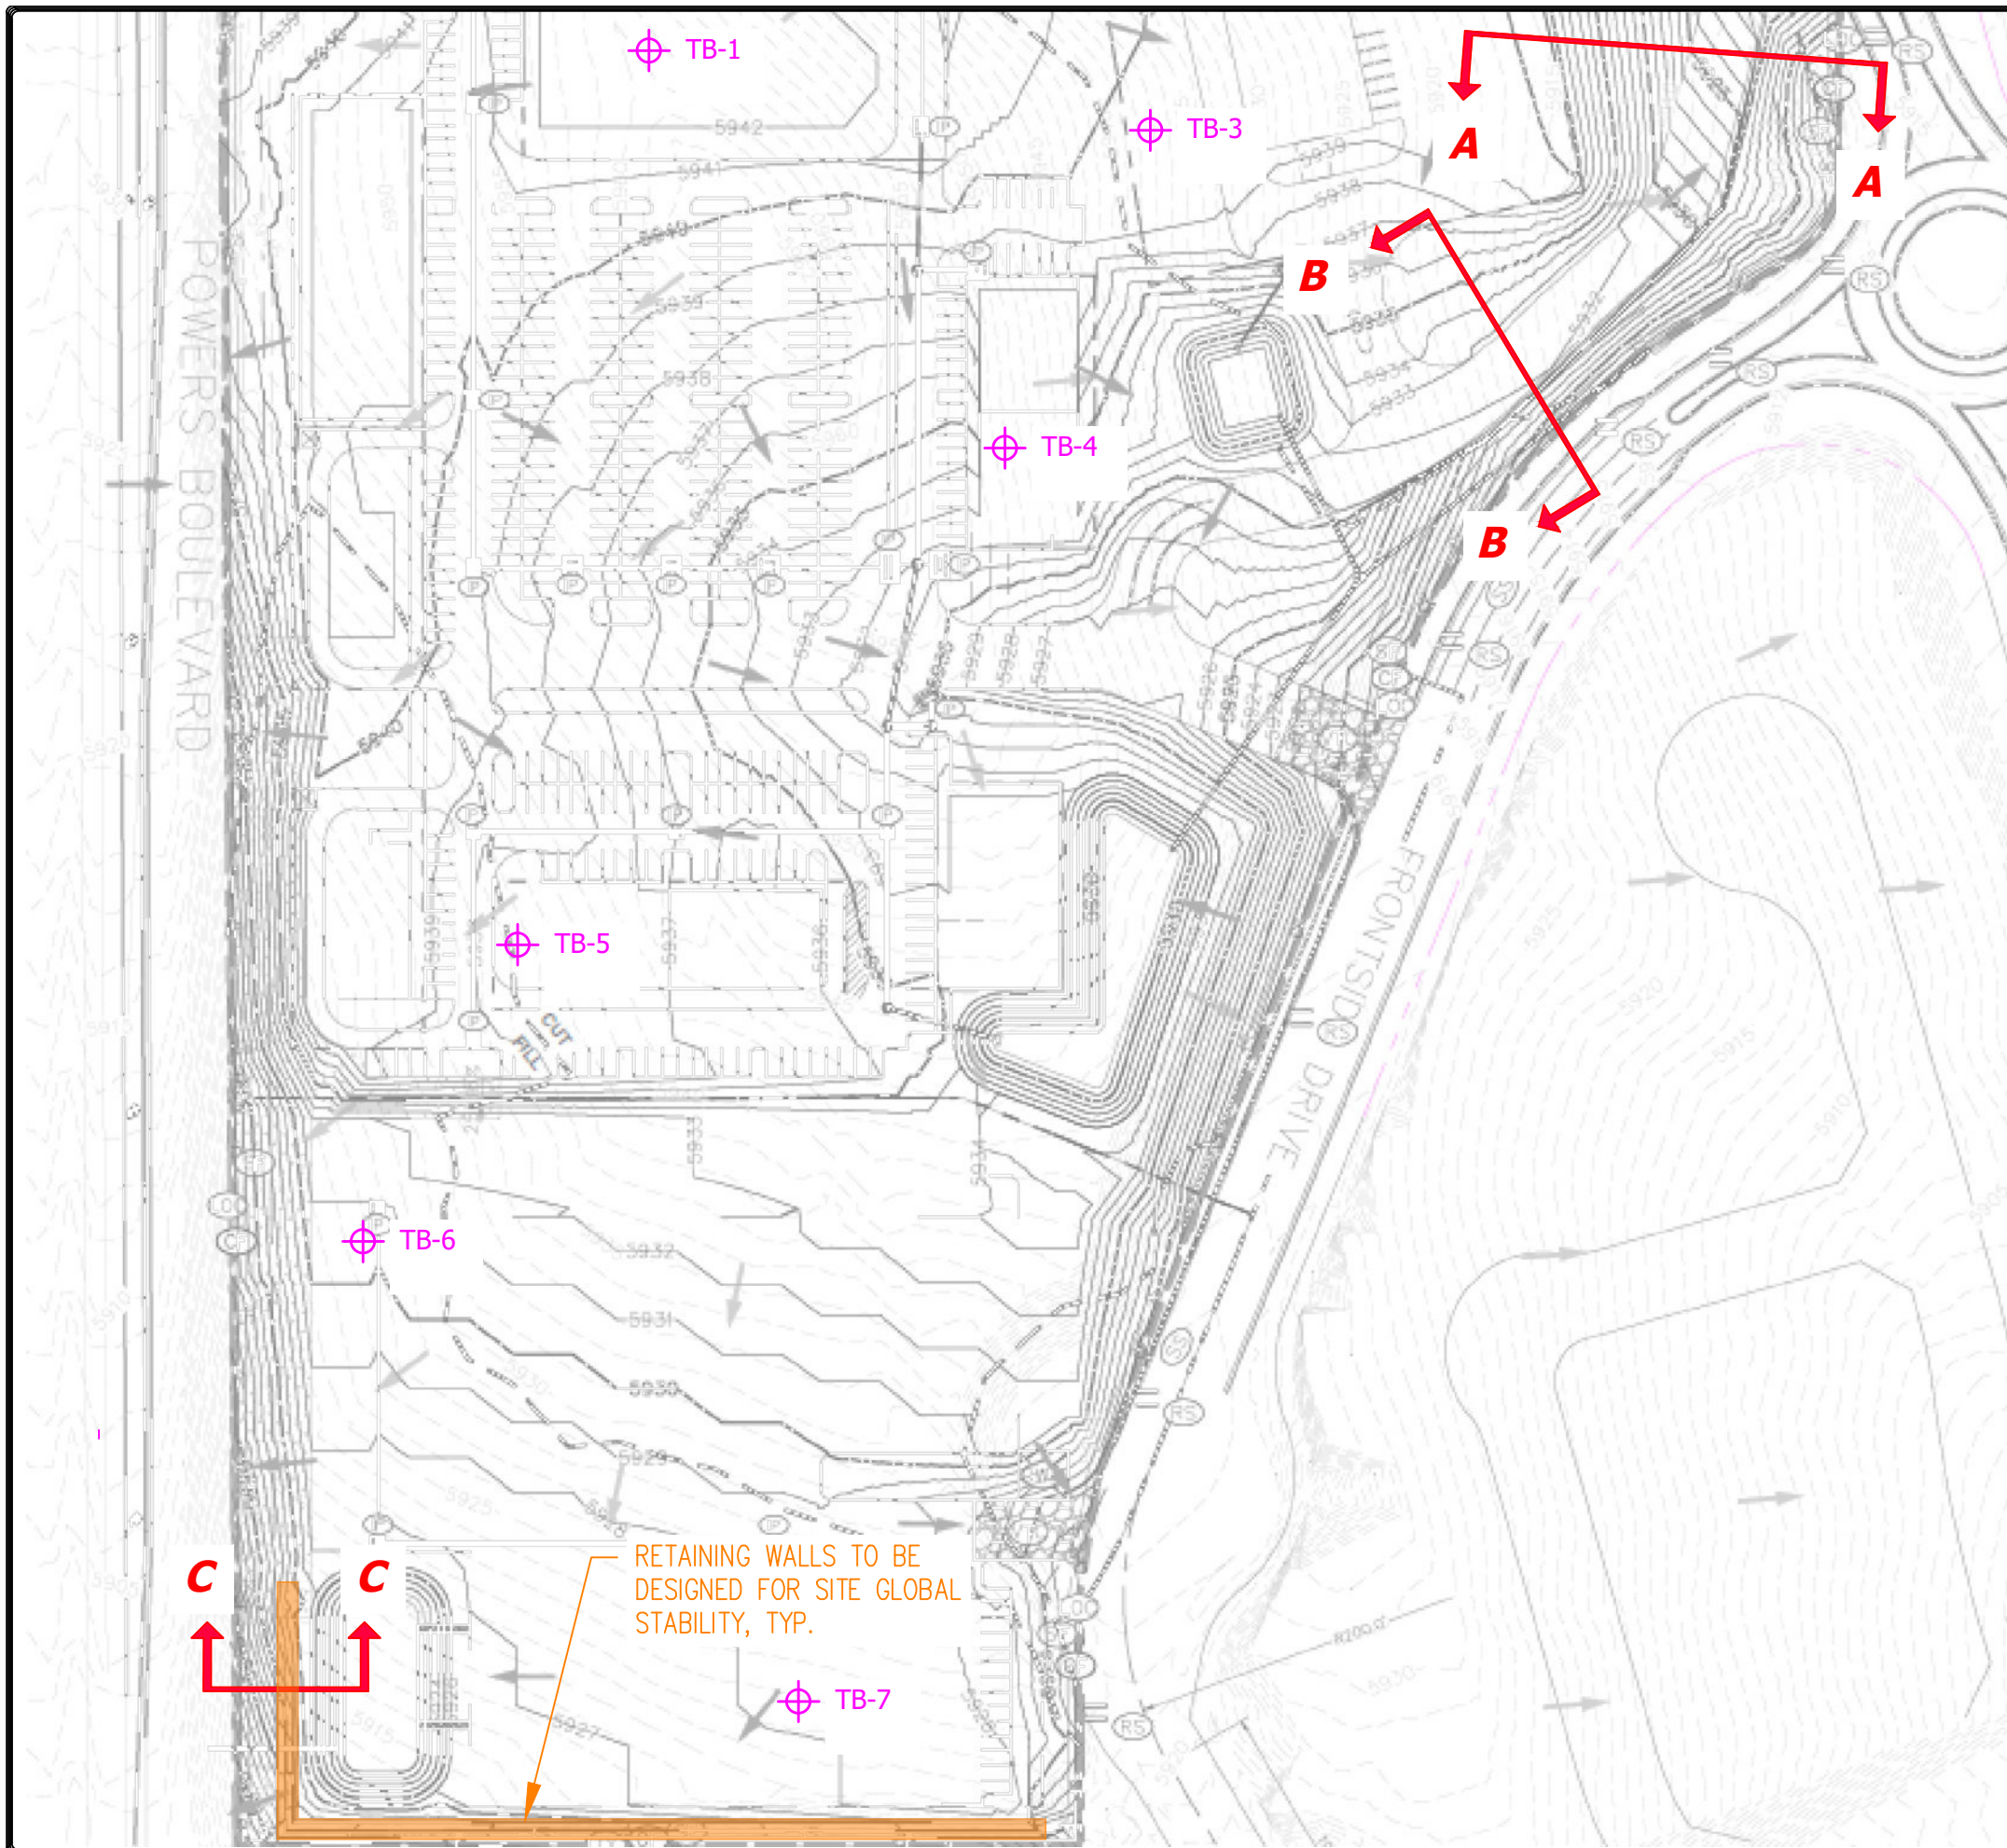
DRAWN	AMN
CHECKED	AMN
DATE	02/14/23
SCALE	AS SHOWN
JOB NO.	220689
FIGURE NO.	7

SLOPE STABILITY SECTION

SLOPE SECTION MAP
 WATERVIEW EAST DEVELOPMENT
 COLORADO SPRINGS, CO.
 FOR: WATERVIEW COMMERCIAL INVESTORS, LLC

Slope Stability Analyses were conducted utilizing the GSTABL7 computer program. The sections analyzed are shown on the Slope Stability Analysis Map, Figure 7. The sections were analyzed with the proposed grading. Results of the Slope Stability Analysis are included in Appendix D.

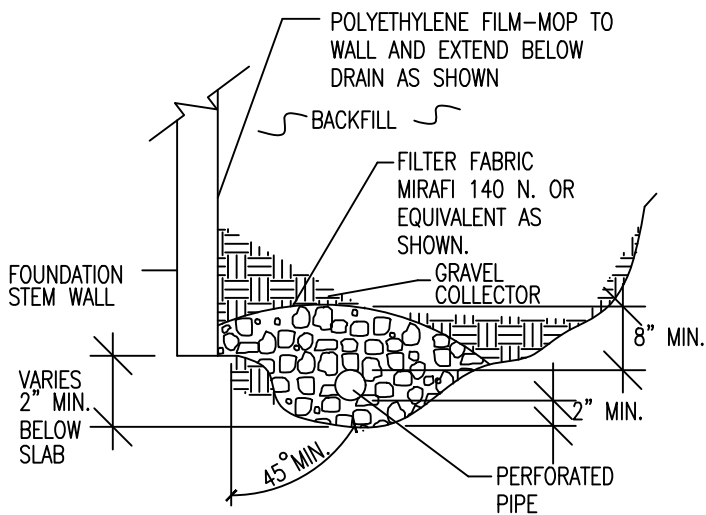
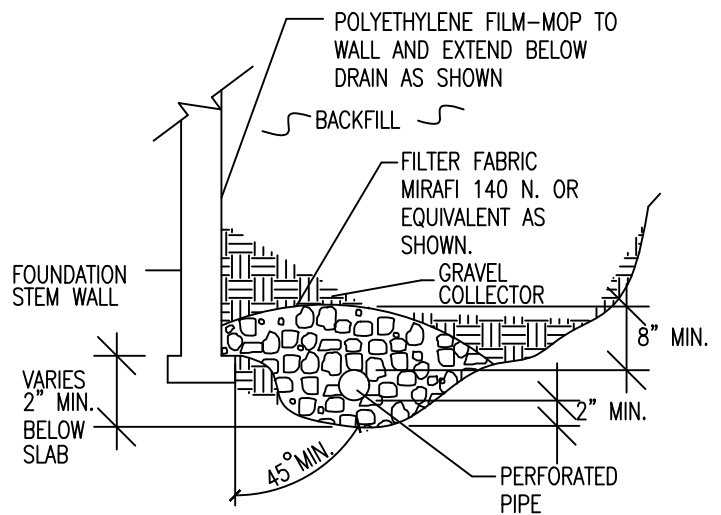
-GRAVEL SIZE IS RELATED TO DIAMETER OF PIPE PERFORATIONS-85% GRAVEL GREATER THAN 2x PERFORATION DIAMETER.

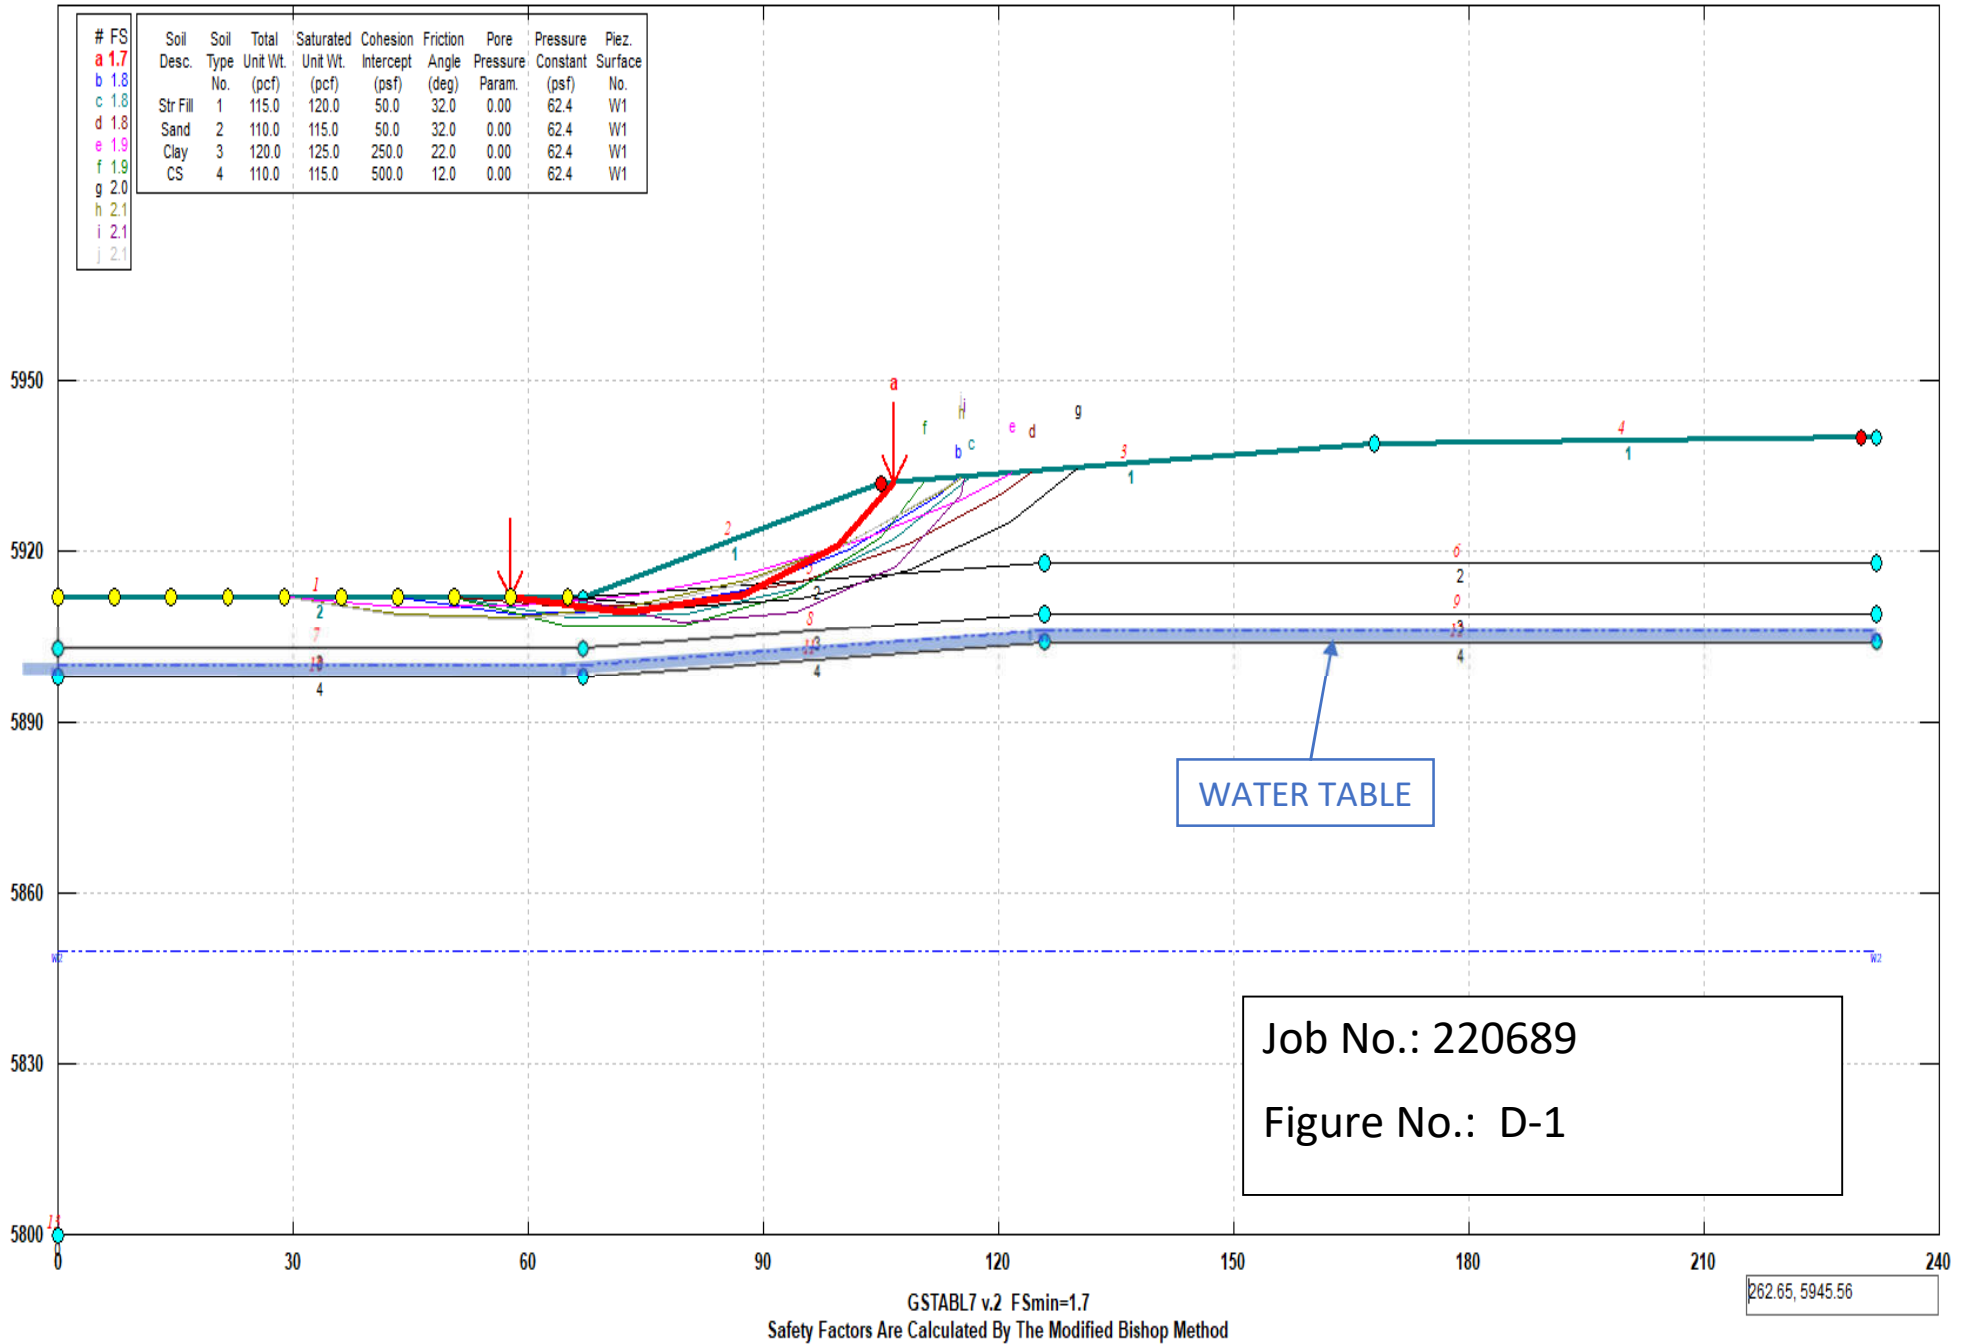
WATERVIEW COMMERCIAL – WATERVIEW EAST – A-A PROPOSED

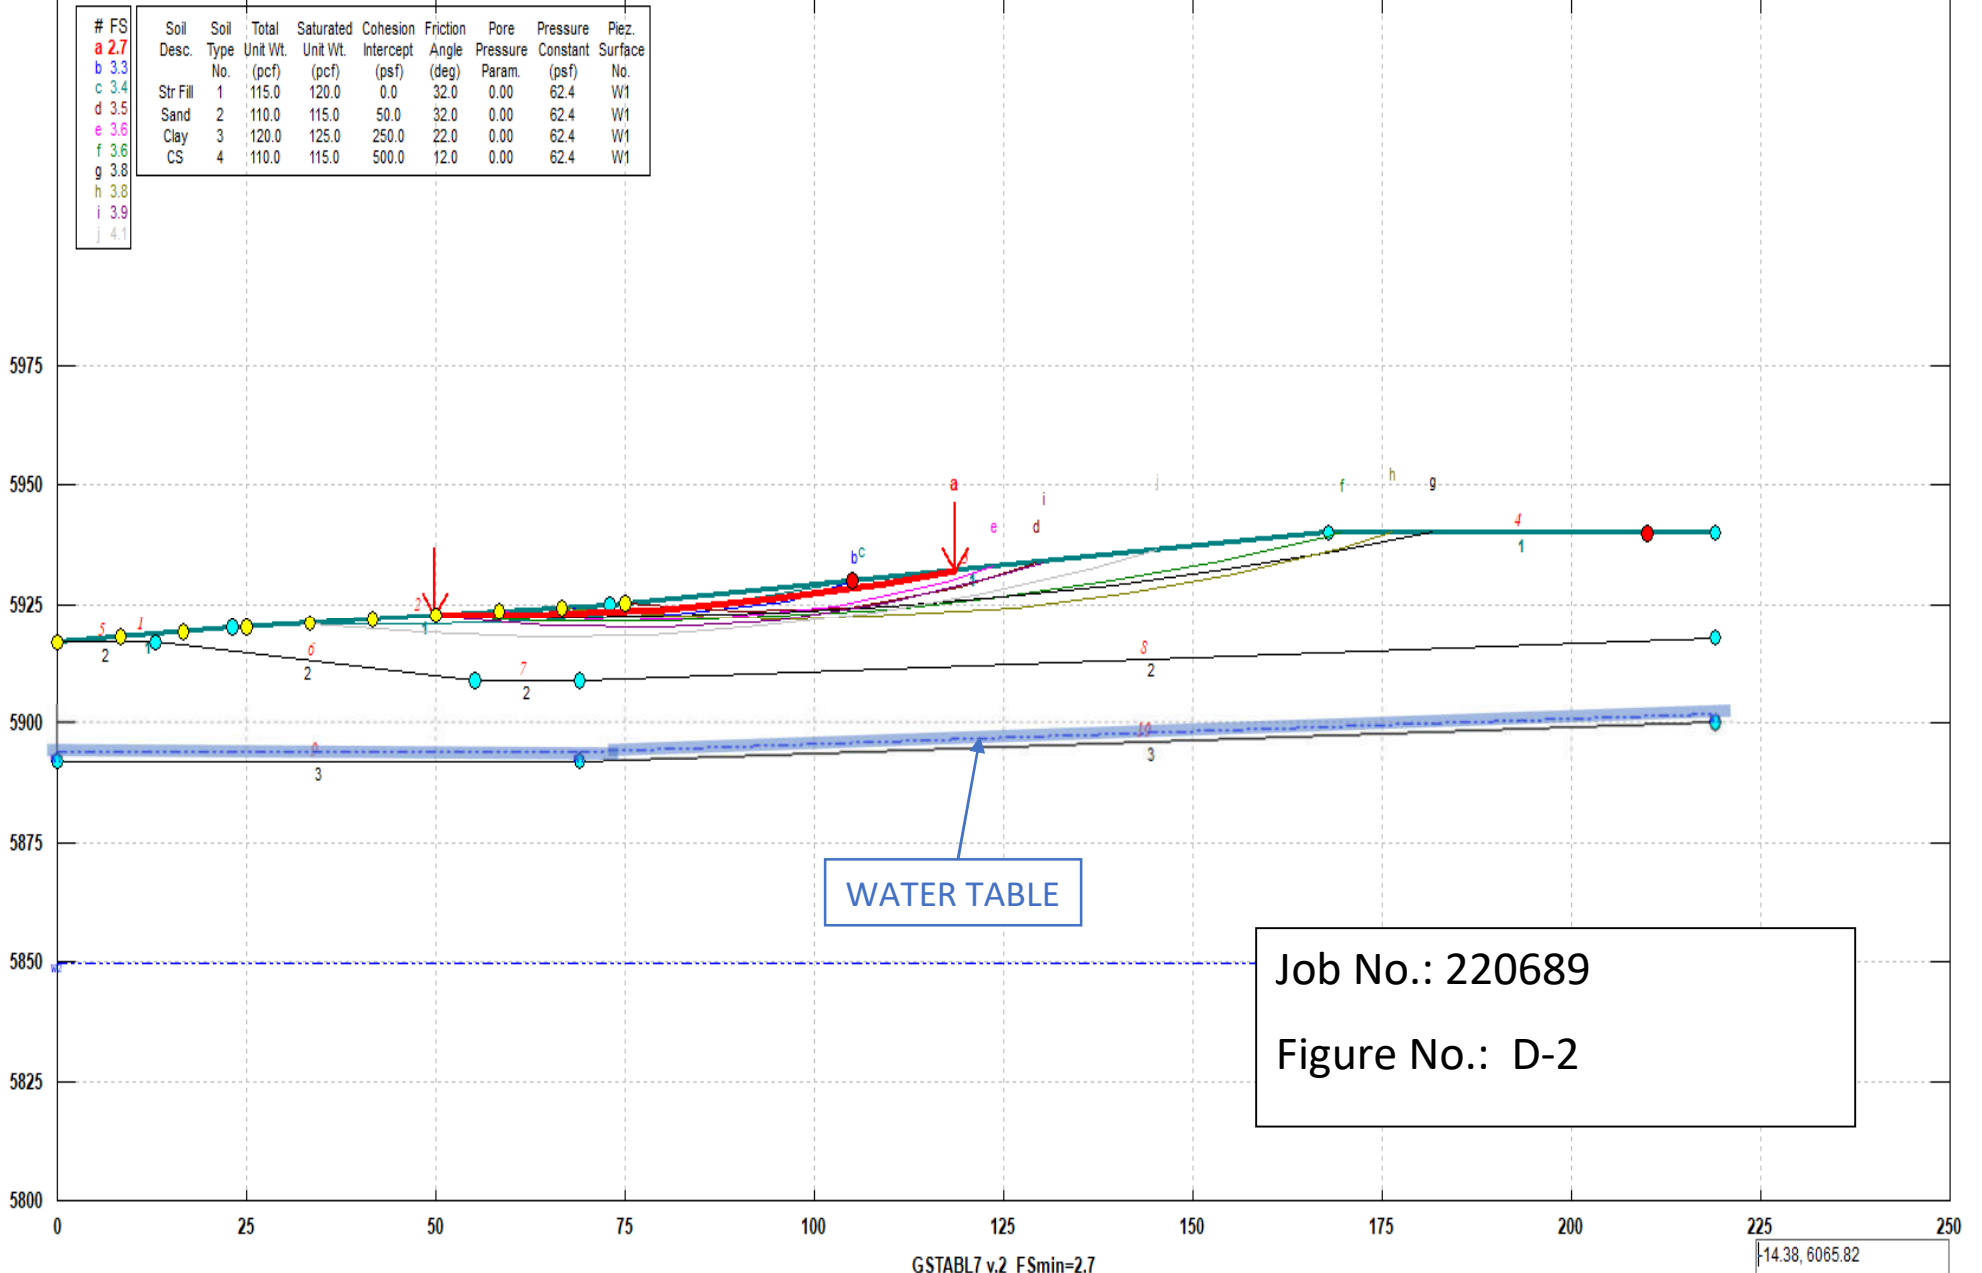
WATERVIEW COMMERCIAL – WATERVIEW EAST – B-B PROPOSED

#	FS	Soil Desc.	Soil Type	Total Unit Wt. (pcf)	Saturated Unit Wt. (pcf)	Cohesion Intercept (psf)	Friction Angle (deg)	Pore Pressure Param. (psf)	Pressure Constant (psf)	Piez. Surface No.
a	2.7									
b	3.3									
c	3.4	Str Fill	1	115.0	120.0	0.0	32.0	0.00	62.4	W1
d	3.5	Sand	2	110.0	115.0	50.0	32.0	0.00	62.4	W1
e	3.6	Clay	3	120.0	125.0	250.0	22.0	0.00	62.4	W1
f	3.6	CS	4	110.0	115.0	500.0	12.0	0.00	62.4	W1
g	3.8									
h	3.8									
i	3.9									
j	4.1

GSTABL7 v.2 FSmin=2.7
Safety Factors Are Calculated By The Modified Bishop Method
