ENTECH
ENGINEERING, INC.

**SOILS AND GEOLOGY STUDY
WATERVIEW EAST COMMERCIAL
PARCEL NO. 55092-00-002
SOUTH POWERS BOULEVARD AND BRADLEY ROAD
EL PASO COUNTY, COLORADO**

February 17, 2023

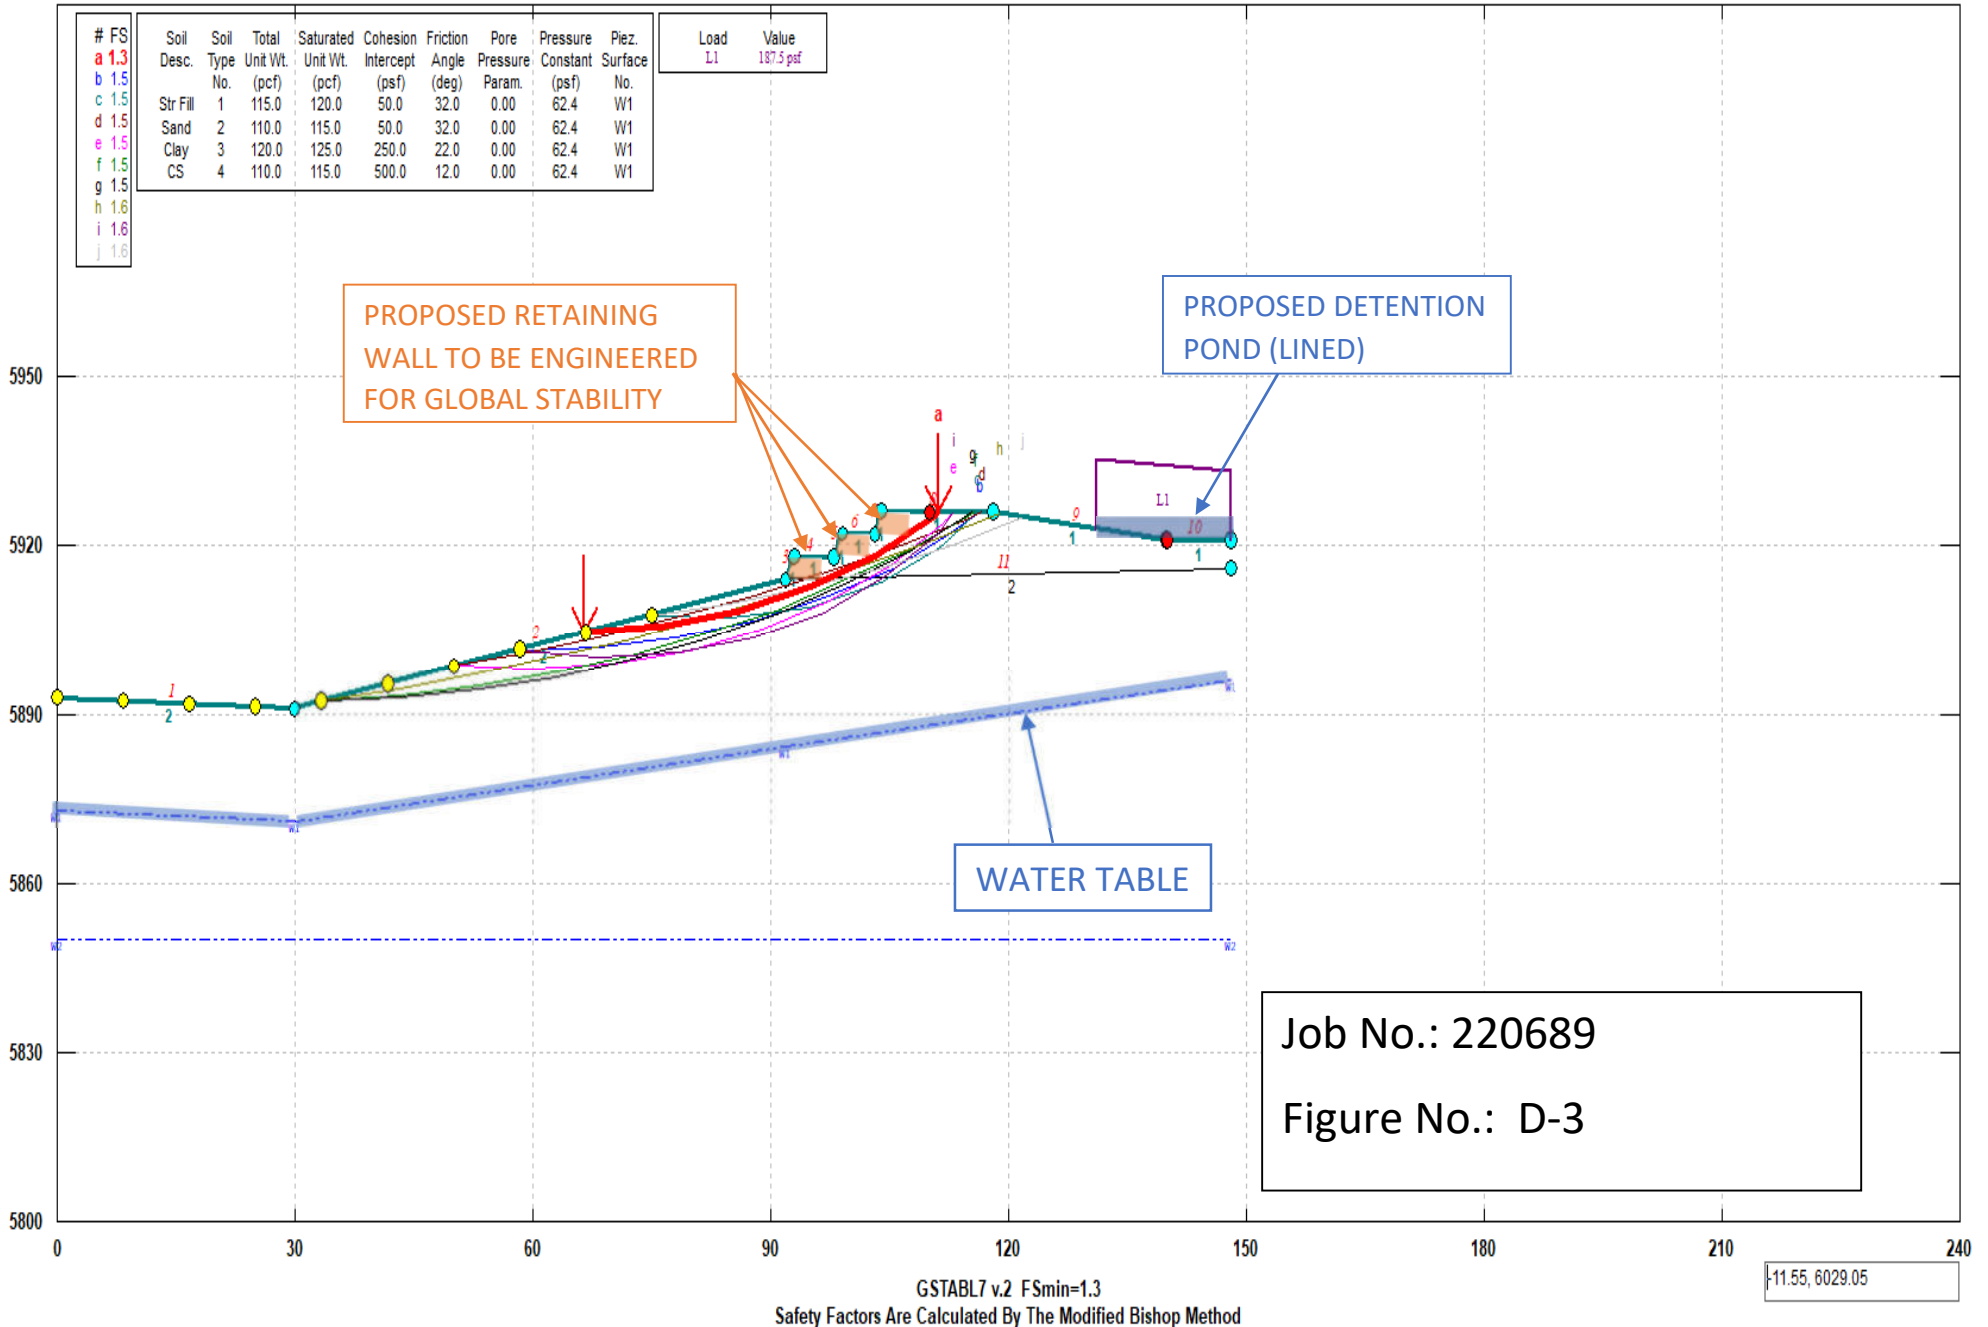
WATERVIEW COMMERCIAL – WATERVIEW EAST – C-C PROPOSED

Slope Stability Analyses were conducted utilizing the GSTABL7 computer program. The sections analyzed are shown on the Slope Stability Analysis Map, Figure 7. The sections were analyzed with the proposed grading. Results of the Slope Stability Analysis are included in Appendix D.

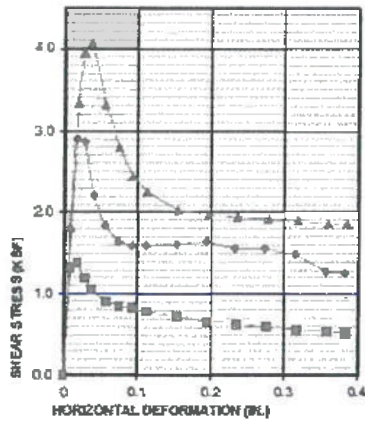
Sample No.	Boring No.	Depth (FT)	Moisture Content (%)		Dry Density (PCF)
			Before	After	
1	TH-11	9'8 1/4'	19.2	26.9	109.7
2	TH-11	9'8 1/4'	19.2	24.3	110.5
3	TH-11	9'6 1/4'	19.2	22.4	108.3

LL: 48 P: 31 -200: 96 Clay Content: % 44
 Thickness (in): 1.0 Diameter (in): 1.935
 Shearing Rate (in/min): 0.0018

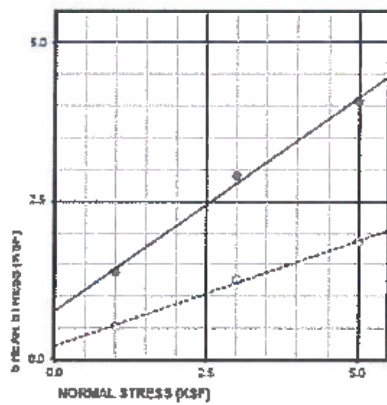
Sample No.	Normal Stress (KSF)	Peak Shear Stress (KSF)	Large Displacement	
			Shear Stress (KSF)	Displacement (IN.)
1	1	1.38	0.52	0.38
2	3	2.9	1.20	0.38
3	5	4.07	1.85	0.39

Peak ϕ (DEG): 34
 Large Displacement ϕ (DEG): 18
 Peak C (PSF): 770
 Large Displacement C (PSF): 220

Sample Description: Interbedded Claystone/Sandstone, Hard, M. Moist, Brown, L. Brown, Rust
 Sample Type: California
 Remarks: _____
