**SOILS AND GEOLOGY STUDY
WATERVIEW EAST COMMERCIAL
PARCEL NO. 55092-00-002
SOUTH POWERS BOULEVARD AND BRADLEY ROAD
EL PASO COUNTY, COLORADO**

February 17, 2023

Entech Job No. 220689
AAprojects/2022/220689 sgs

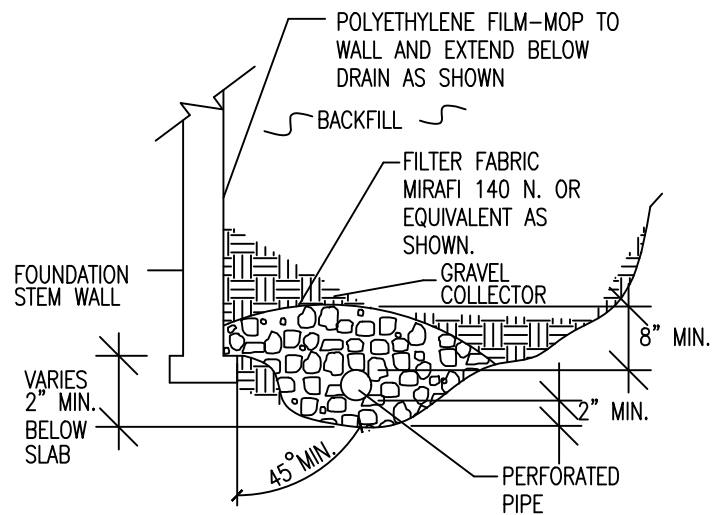
9

-GRAVEL SIZE IS RELATED TO DIAMETER OF PIPE PERFORATIONS-85% GRAVEL GREATER THAN 2x PERFORATION DIAMETER.

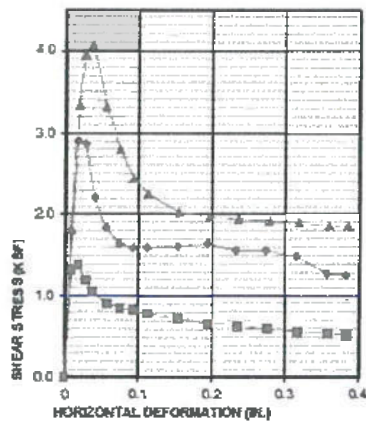
Sample No.	Boring No.	Depth (FT)	Moisture Content (%)		Dry Density (PCF)
			Before	After	
1	TH-11	9'8 1/4'	19.2	26.9	109.7
2	TH-11	9'8 1/4'	19.2	24.3	110.5
3	TH-11	9'8 1/4'	19.2	22.4	108.3

LL: 48 PI: 31 -200: 96 Clay Content: % 44
 Thickness (in): 1.0 Diameter (in): 1.935
 Shearing Rate (in/min): 0.0018

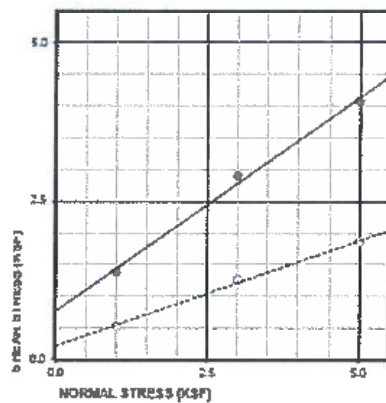
Sample No.	Normal Stress (KSF)	Peak Shear Stress (KSF)	Large Displacement	
			Shear Stress (KSF)	Displacement (IN.)
1	1	1.38	0.52	0.38
2	3	2.9	1.20	0.38
3	5	4.07	1.85	0.39

Peak ϕ (DEG): 34
 Large Displacement ϕ (DEG): 18
 Peak C (PSF): 770
 Large Displacement C (PSF): 220

Sample Description: Interbedded Claystone/Sandstone, Hard, M. Moist, Brown, L. Brown, Rust
 Sample Type: California
 Remarks:
