SOILS AND GEOLOGY STUDY

**Jeanette Mose Subdivision
Halleluiah Trail
EPC Schedule No. 4208000013
El Paso County, Colorado**

JOB NO. 177316

July 24, 2020

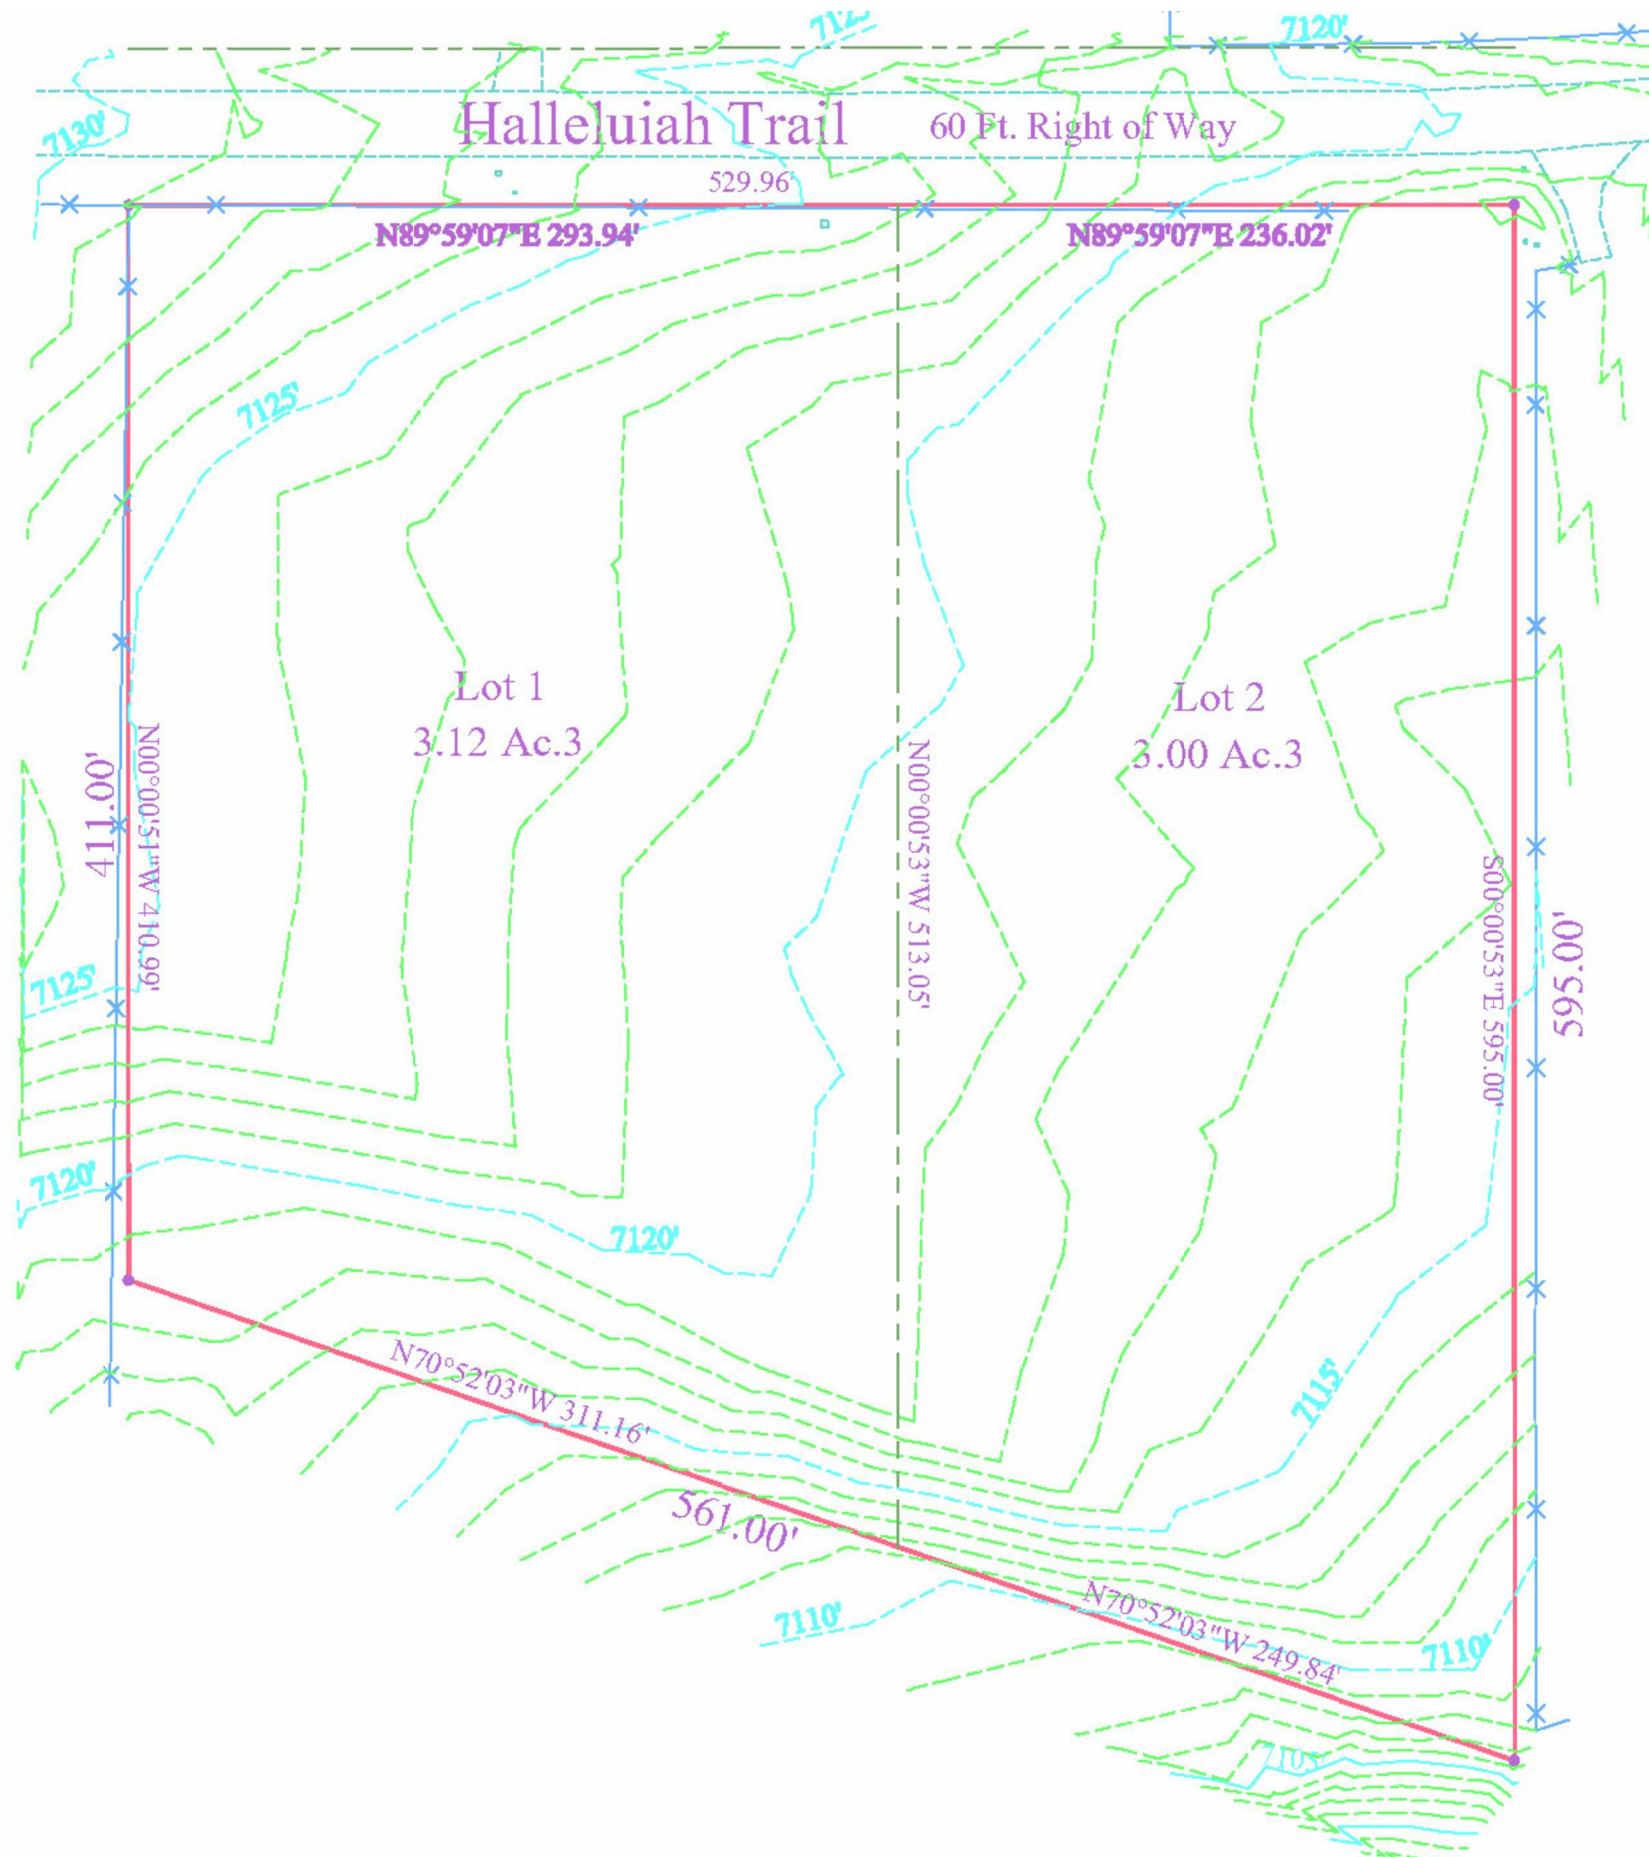
FIG-2

BASE MAP PROVIDED BY ALESSI AND ASSOCIATES, INC.

It is our understanding the parcel is to be subdivided into two lots. Lot 1 is to consist of 3.12 acres and Lot 2 is to consist of 3.00 acres. Each lot is to contain a new single family residence, well and on-site wastewater treatment system (OWTS). The Proposed Lot Layout is presented in Figure 2.

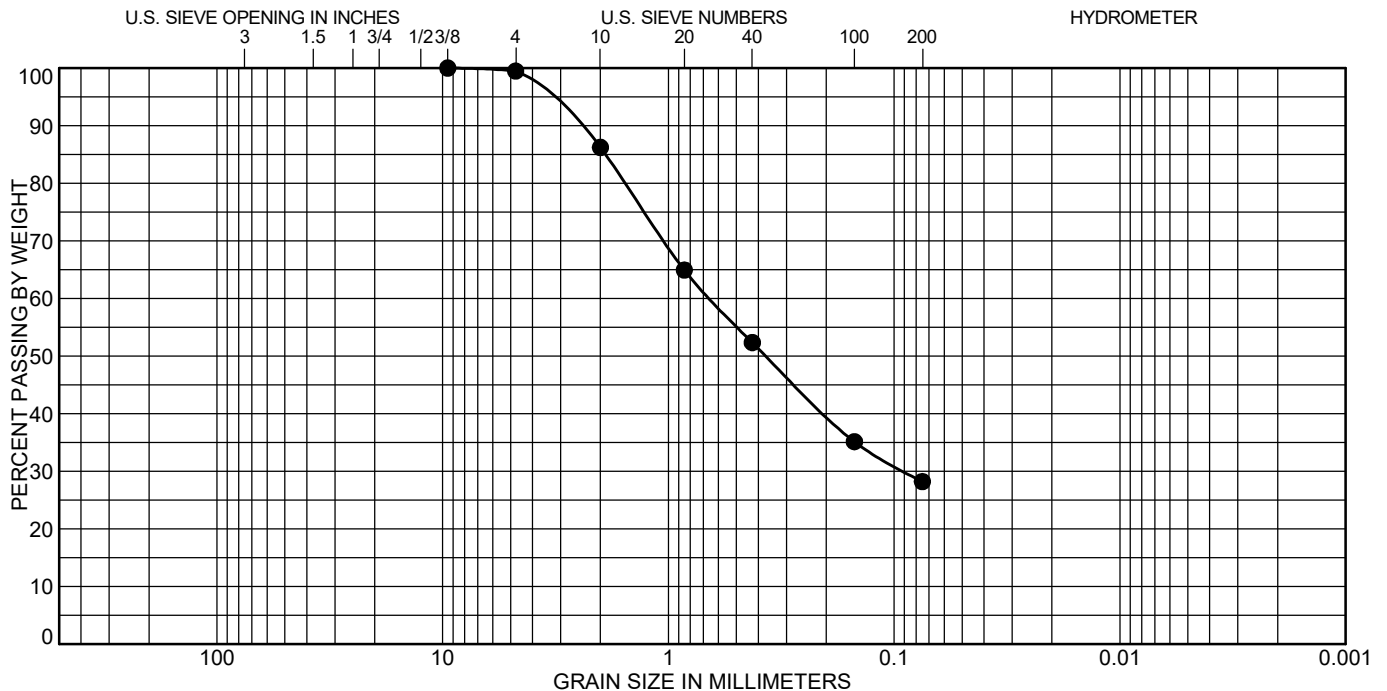
COBBLES	GRAVEL		SAND			SILT OR CLAY
	coarse	fine	coarse	medium	fine

Test Boring	Depth (ft)	Classification	LL	PL	PI
● 1	4.0	SILTY SAND(SM)	NP	NP	NP

The moisture content for the recovered samples was obtained in the RMG laboratory. RMG performed grain-size analysis and Atterberg Limits tests on selected samples for purposes of classification and to develop pertinent engineering properties. A Summary of Laboratory Test Results is presented in Figure 5. Soil Classification Data are presented in Figure 6.

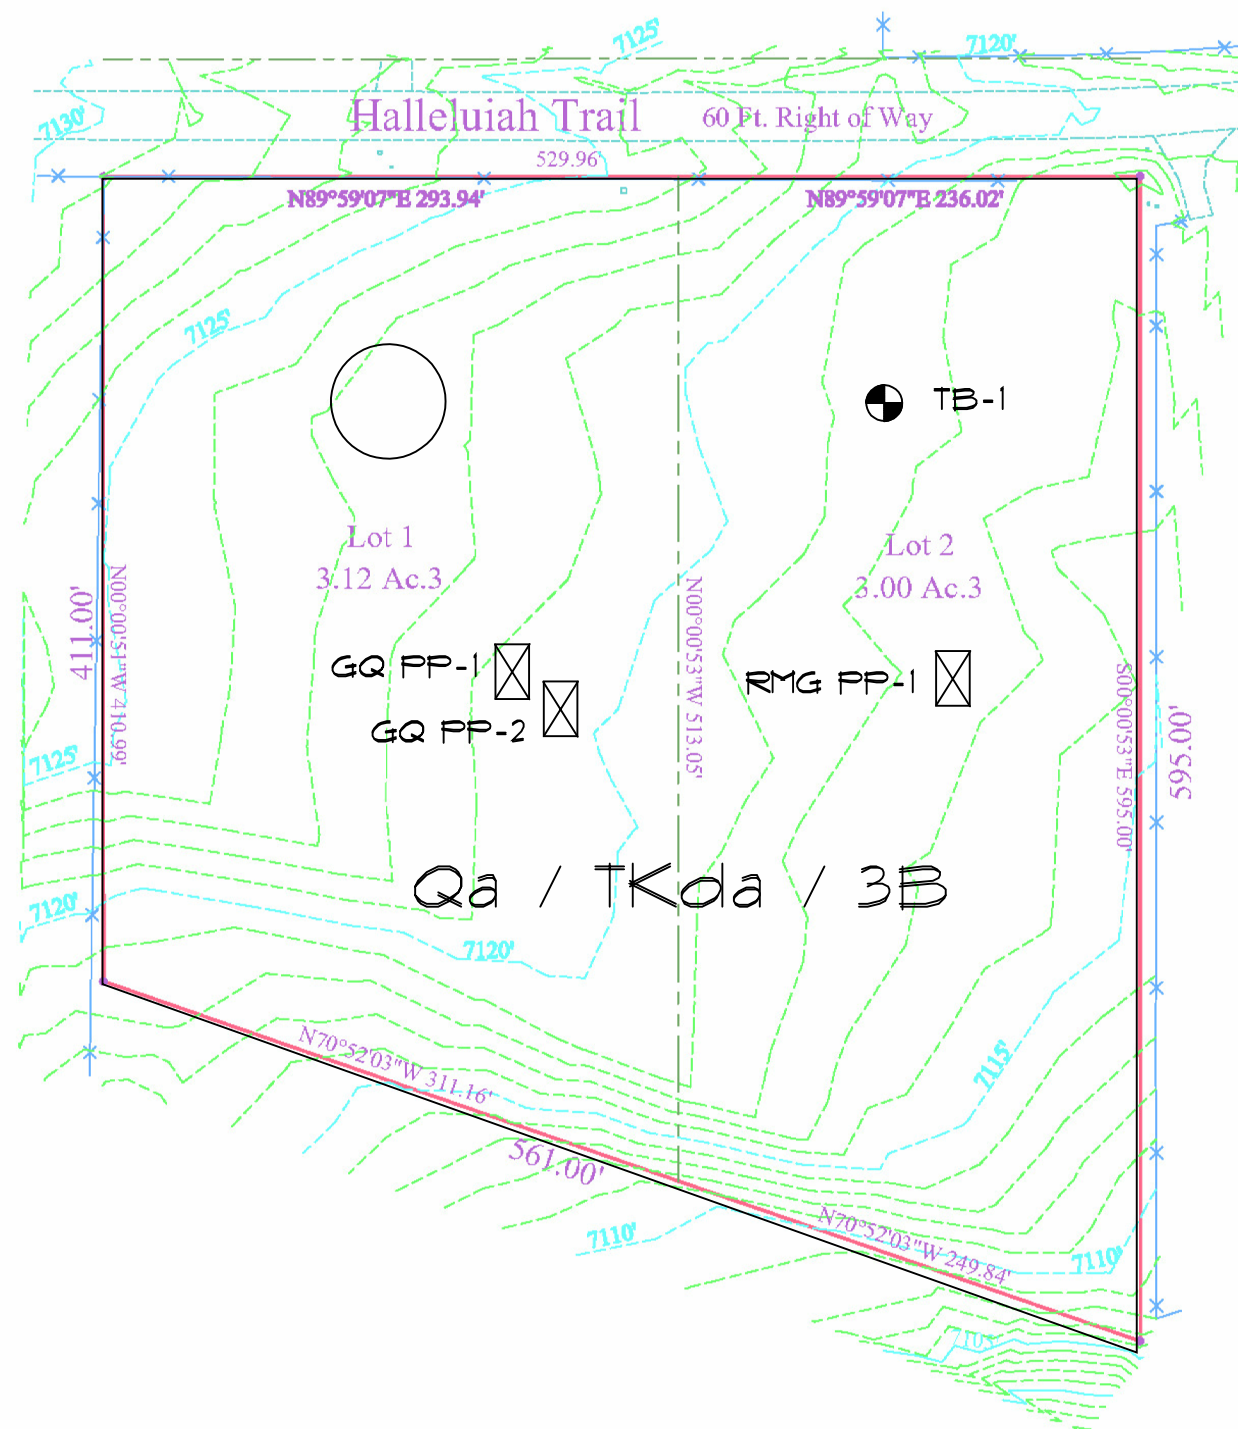
FIG-8

- *Qa* - Alluvium, undivided - (early Holocene and late Pleistocene) - generally poorly sorted sand, silty and clayey sand with beds of very fine to medium pebble-gravel. The alluvium was encountered in the test borings performed by RMG and Geoquest LLC to depths ranging between 4 to 7 feet.
- *TKda* - Dawson Formation - The Dawson Formation underlies the entire site. *Tkda* typically is light gray to tan and typically consists of arkose, arkosic conglomerate, sandstone and interbedded gray claystone seams. The residual soils overlying this formation were derived from the in-situ weathering of the bedrock materials on-site and typically weather to brown or reddish brown.

The subsurface conditions below Lot 1 were investigated by Geoquest, LLC on May 12, 2020 as part of the site specific *Soil Report* referenced above. RMG performed one test boring on Lot 2 on June 24, 2020. The locations of Geoquest, LLC's and RMG's test borings and profile pits are presented on the Engineering and Geology Map, Figure 8.

Two profile pits were observed on Lot 1 by Geoquest, LLC. According to the *Profile Pit Evaluation* report (referenced above), the profile pits were excavated to approximately 8 feet. One additional profile pit was located on Lot 2 by RMG. The profile pit was excavated to approximately 8 feet below the existing ground surface. The RMG profile pit log is presented in the Test Boring and Profile Pit Log, Figure 4. The approximate locations of the profile pits are presented in the Engineering and Geology Map, Figure 8.

The engineering geology is presented in the Engineering and Geology Map, Figure 8.

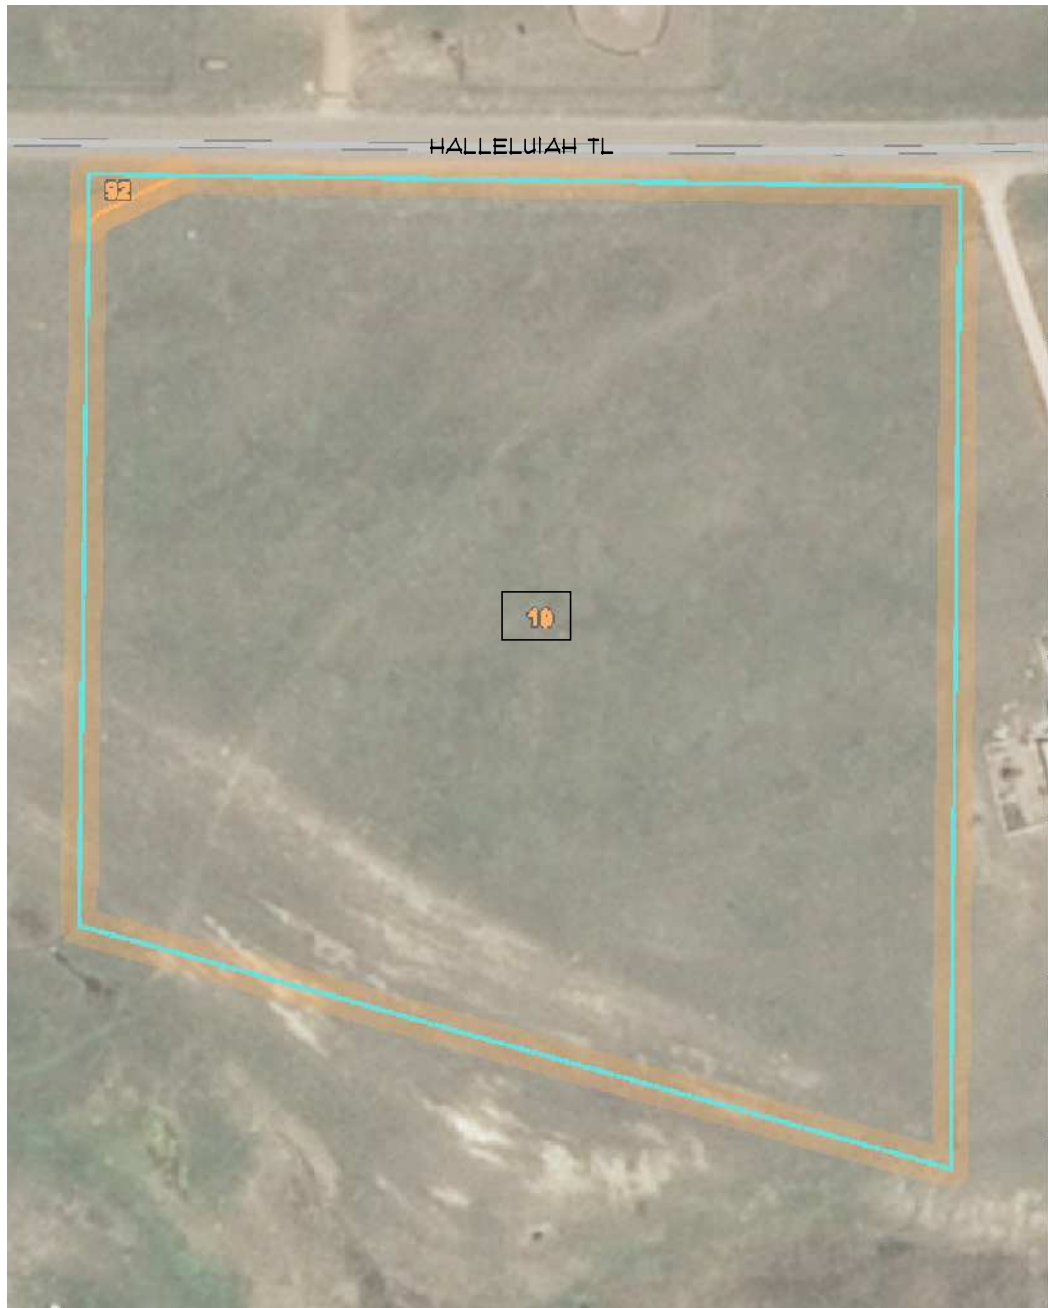
FIG No. 9

- 19 - Columbine gravelly sandy loam, 0 to 3 percent slopes.
- 92 - Tomah-Crowfoot loamy sands, 3 to 8 percent slopes.

The USDA Soil Survey Map is presented in Figure 9.

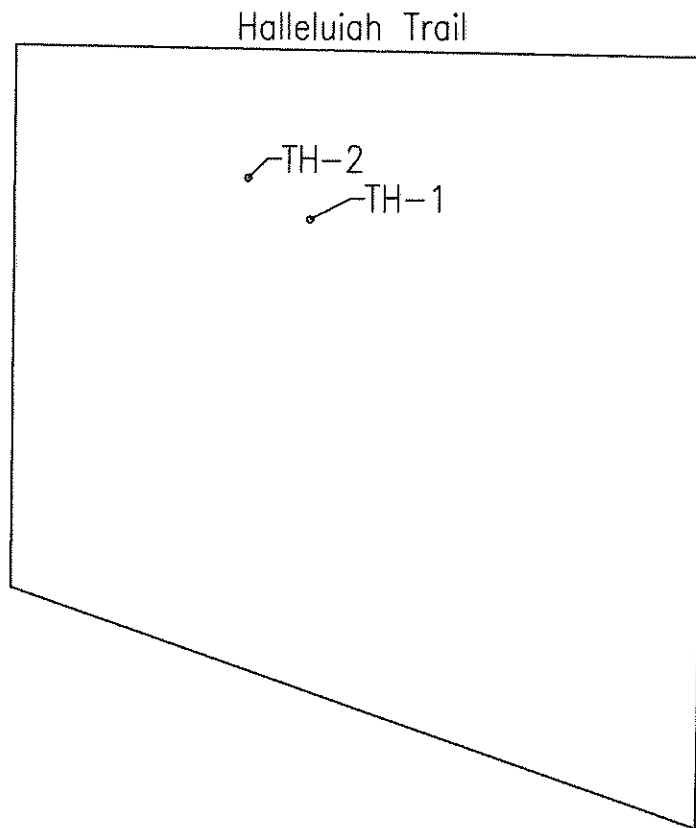
GEOQUEST LLC
SITE MAP

0 Halleluiah Trail
El Paso County
Colorado
Job #20-0429

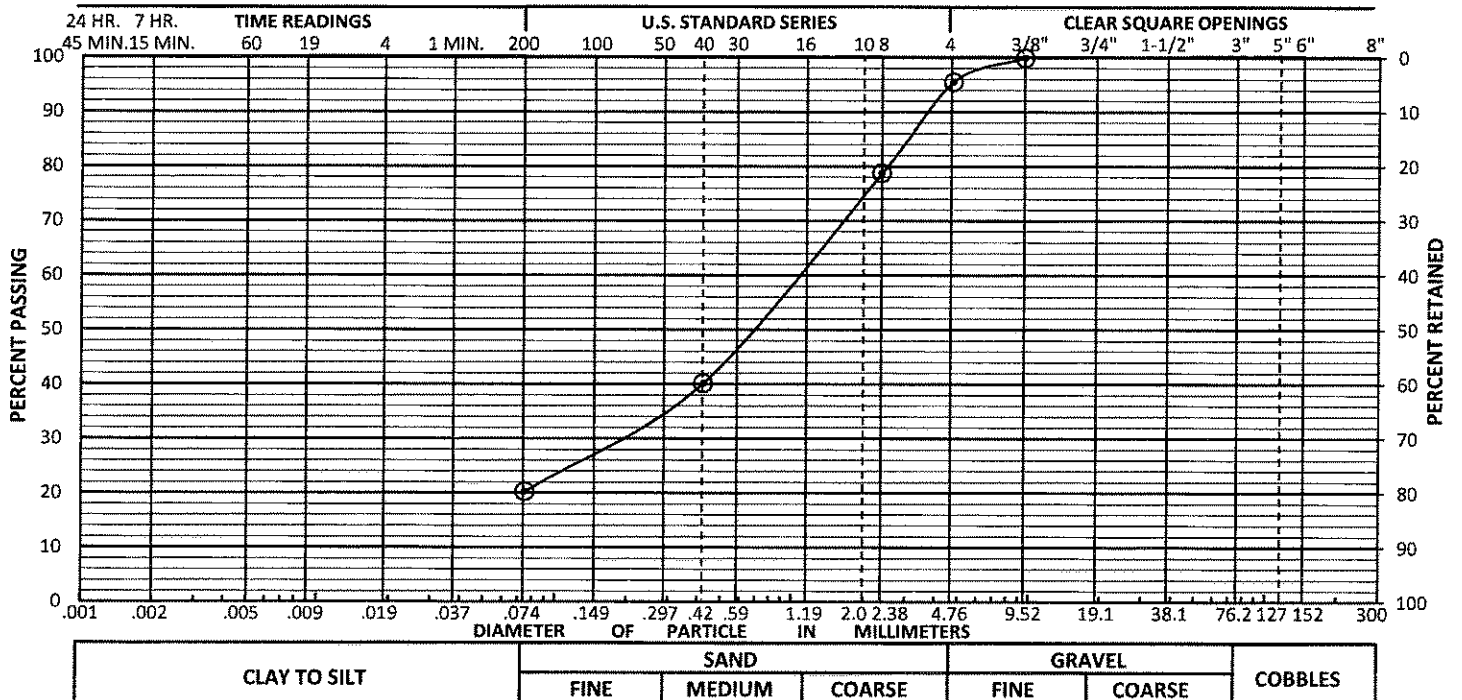
CLASSIFICATION SM
 GRAVEL 4.6 %
 SAND 75.2 %
 FINES 20.2 %

NOTES: 12.7 % Moisture Content

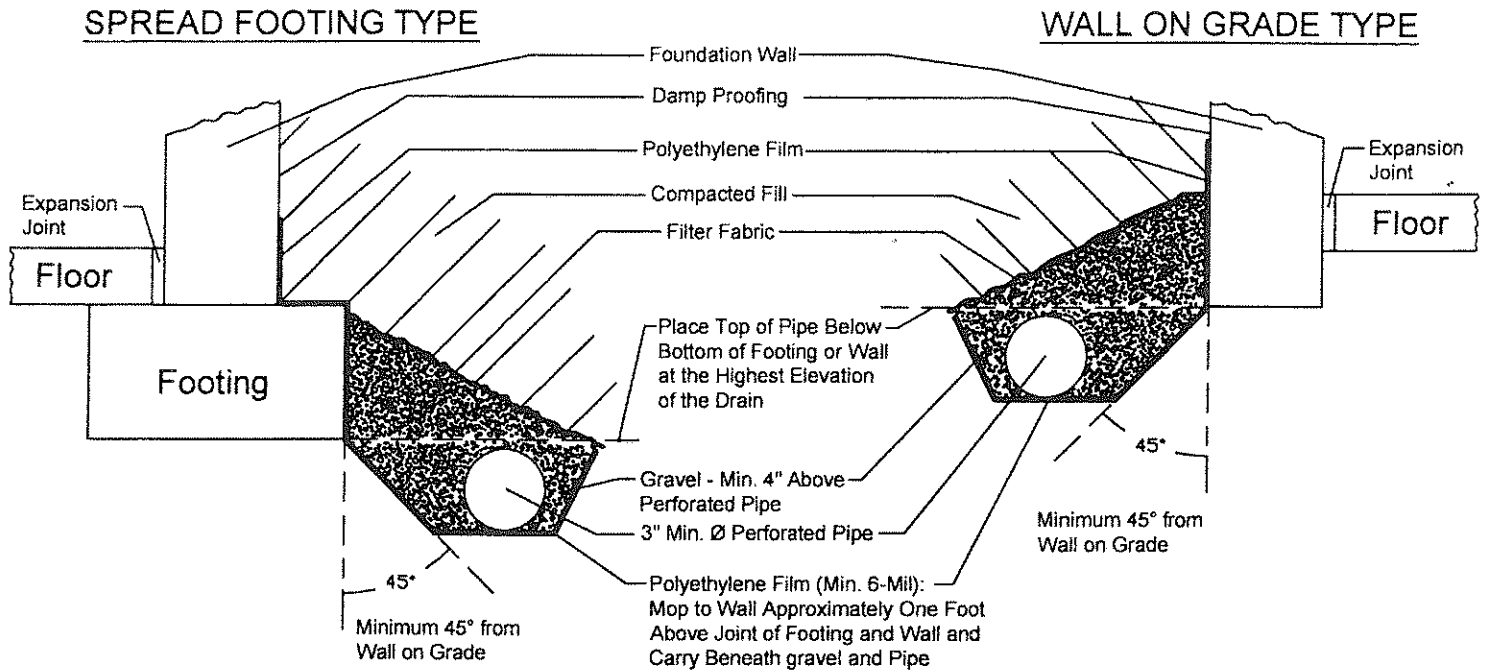
1. Gravel to be Not More Than 1-1/2" and Not Less Than 1/2" Diameter.
2. Perforated Pipe Diameter Varies With Expected Seepage. 3"Ø and 4"Ø are Most Common. ABS and PVC are Most Common Materials for Pipe. We approve the use of an "EZ Flow Drainage System" by Infiltrator. All specifications in this drain detail are still applicable.

3. Pipe to be Laid out in a Minimum Slope of 1" in 10'.
4. Gravity Outfall is Desired if Possible. Portion of Pipe in Area Not Drained Shall be Non-Perforated. Daylight Must be Maintained Clear of Debris in Order to Function Properly.

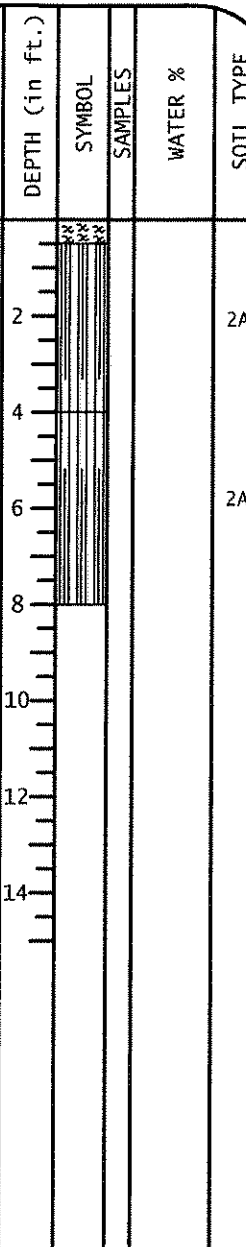
Fine-coarse Grained USDA Soil Texture: Sandy Loam
 Moderate Density USDA Soil Type: 2
 Moderate Moisture Content USDA Structure Shape: Granular
 Low-moderate Clay Content USDA Structure Grade: 2
 Low Cohesion Cementation Class: Non-cemented
 Low Plasticity Long Term Acceptance Rate (LTAR, Treatment Level 1): 0.60
 Light Brownish Grey Color
 10YR 6/2

Fine-coarse Grained USDA Soil Texture: Sandy Loam
 High Density USDA Soil Type: 2A
 High Moisture Content USDA Structure Shape: Massive
 Low-moderate Clay Content USDA Structure Grade: 0
 Low-moderate Cohesion Cementation Class: Moderately
 Low-moderate Plasticity Long Term Acceptance Rate (LTAR, Treatment Level 1): 0.50
 Light Yellowish Brown Color
 2.5Y 6/4
 Redox & Saturated @ 85"

LTAR to be Used for OWTS Sizing: 0.50GPD/SF (USDA Type 2A, Treatment soil, Treatment Level 1)
Depth to Groundwater (Permanent or Seasonal): Seasonal & Saturated @ 85"
Depth to Bedrock and Type: Sandstone @ 48"
Depth to Proposed Infiltrative Surface from Ground Surface: Above Grade (Uniformly pressure dosed STA)
Soil Treatment Area Slope and Direction: SE @ 4%

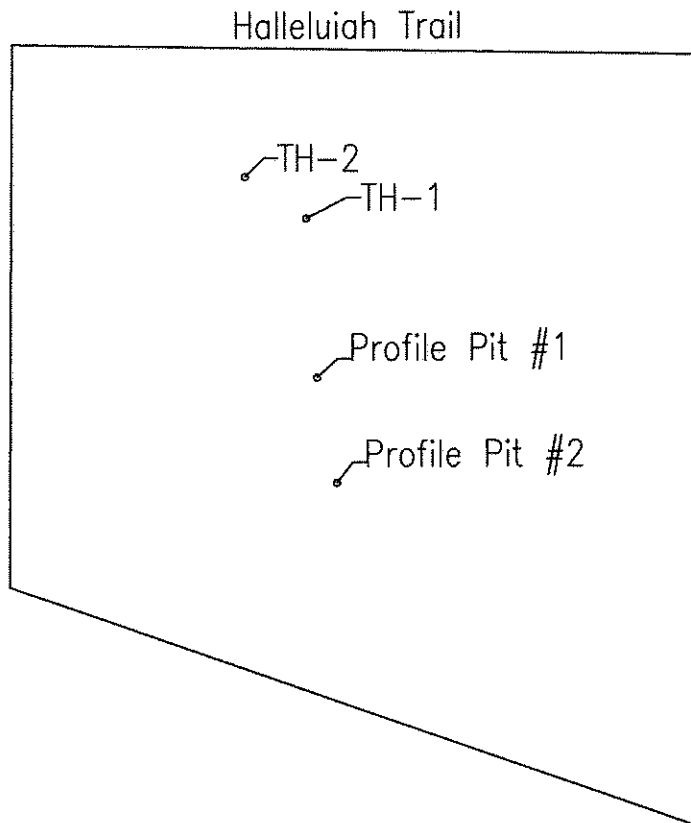
GEOQUEST LLC
SITE MAP

Location from Southeast Lot Corner to Profile Pit #1:
N. 40° W. - 451'

Location from Profile Pit #1 to Profile Pit #2:
S. 10° E. - 82'
