Re: Response to El Paso County, El Paso County Health, and CGS Review Comments
Halleluiah TI
EPC Schedule No. 4208000013
El Paso County, Colorado

RMG – Rocky Mountain Group (RMG) prepared the *Soils and Geology Study* and the *Wastewater Study* (RMG Job No. 177316, last dated August 2, 2021) for the proposed development project comprising two lots, each to contain on single-family residence located along Halleluiah Trail in El Paso County, Colorado. The report was reviewed by personnel of the Colorado Geological Survey (CGS) and personnel of El Paso County (EPC).

SOILS REPORT

PROFILE PIT EVALUATION

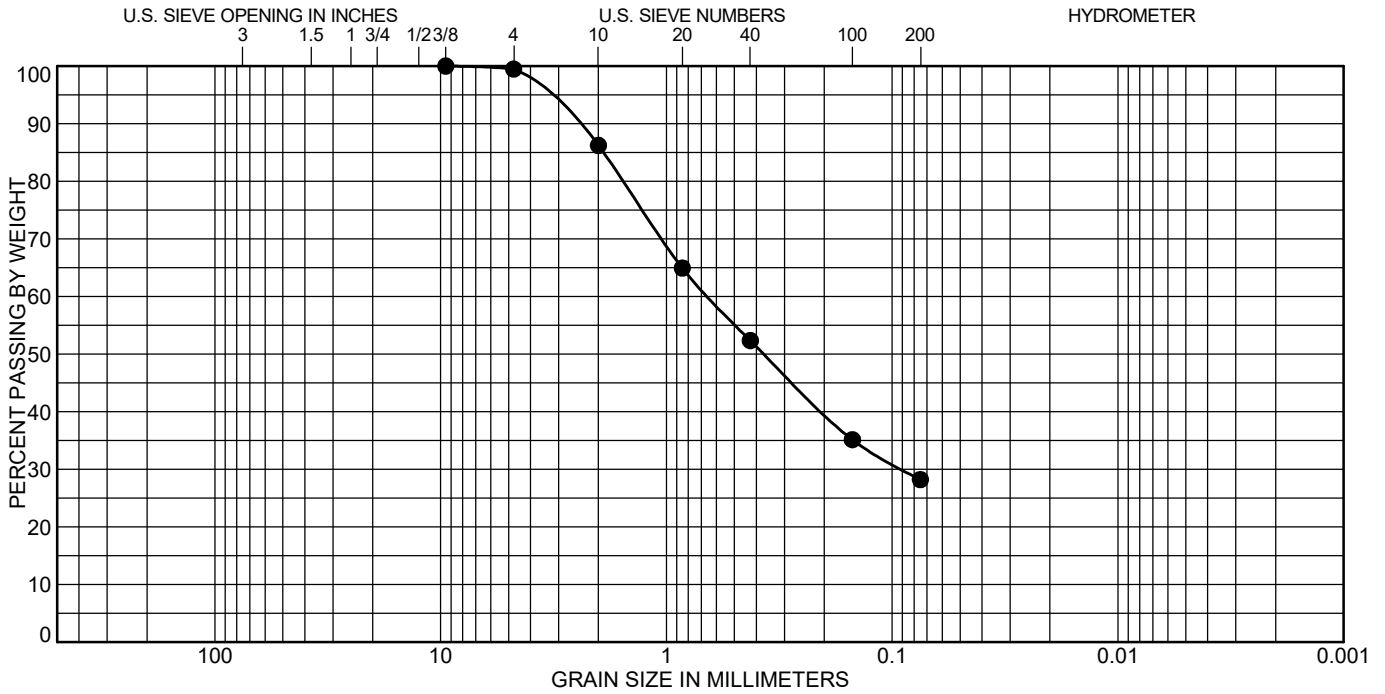
COBBLES	GRAVEL		SAND			SILT OR CLAY
	coarse	fine	coarse	medium	fine

Test Boring	Depth (ft)	Classification	LL	PL	PI
● 1	4.0	SILTY SAND(SM)	NP	NP	NP

The moisture content for the recovered samples was obtained in the RMG laboratory. RMG performed grain-size analysis and Atterberg Limits tests on selected samples for purposes of classification and to develop pertinent engineering properties. A Summary of Laboratory Test Results is presented in Figure 5. Soil Classification Data are presented in Figure 6.

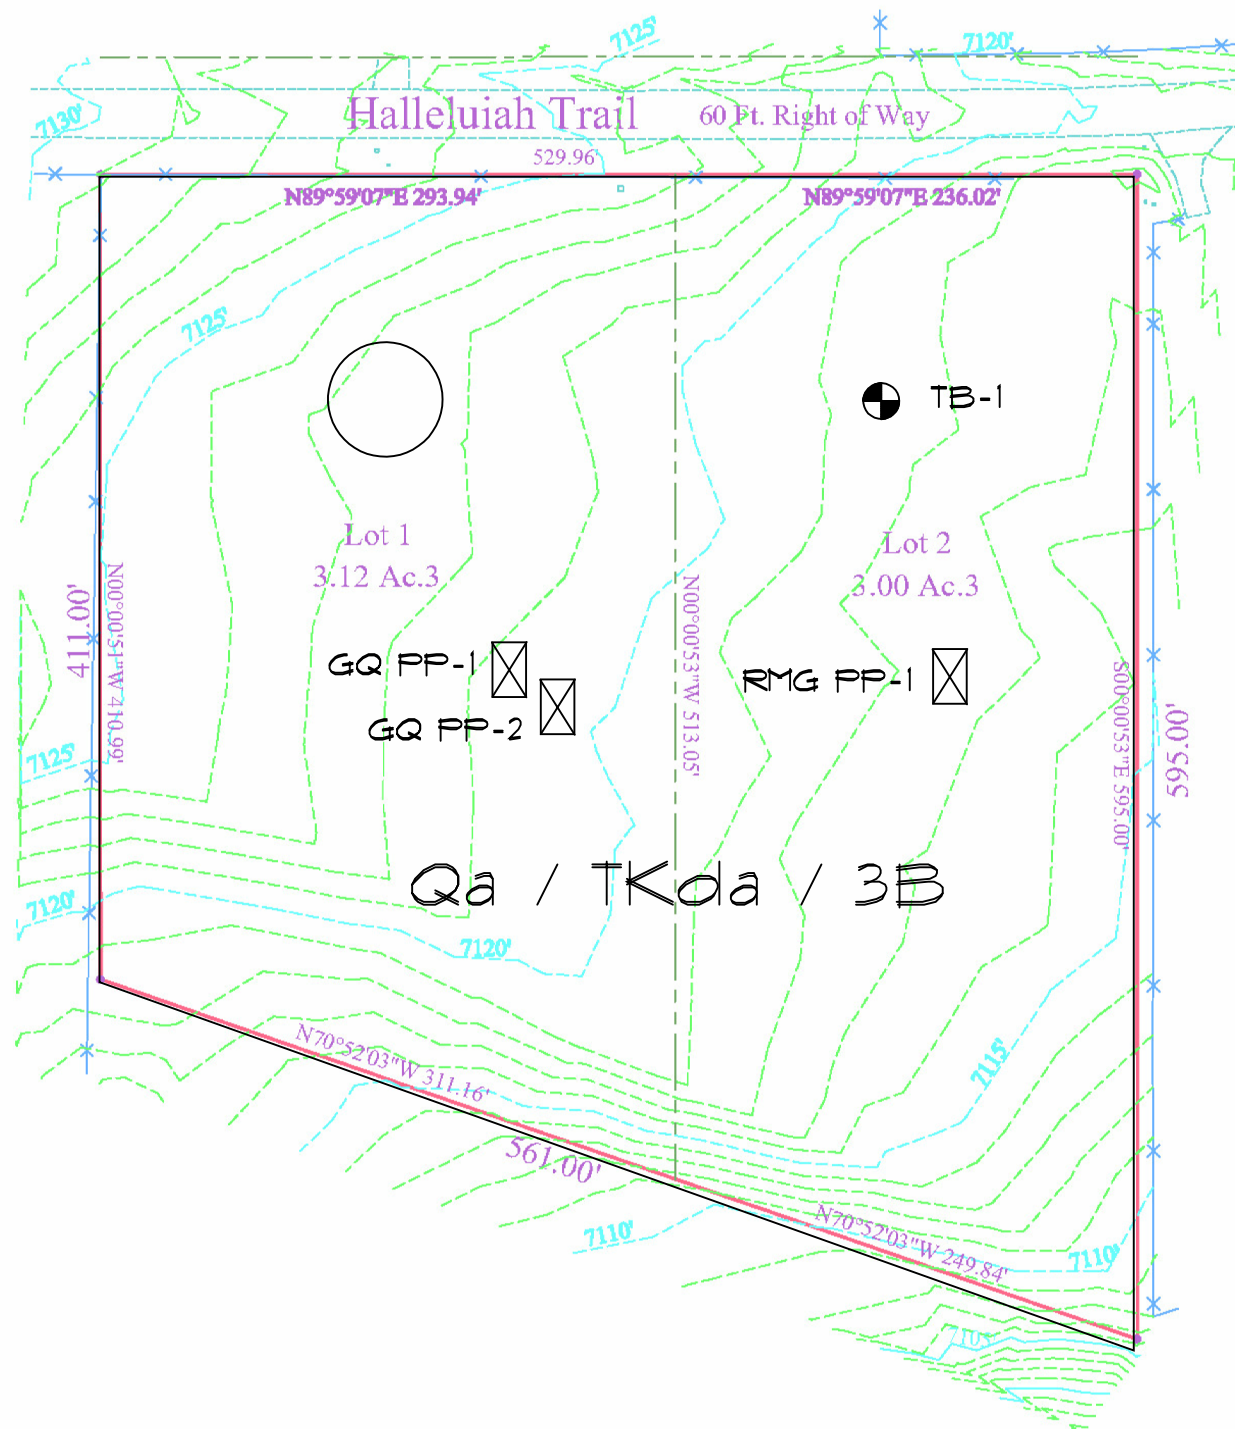
FIG-8

Geologic

- *Qa - Alluvium, undivided - (early Holocene and late Pleistocene)* - generally poorly sorted sand, silty and clayey sand with beds of very fine to medium pebble-gravel. The alluvium was encountered in the test borings performed by RMG and Geoquest LLC to depths ranging between 4 to 7 feet.
- *TKda - Dawson Formation* - The Dawson Formation underlies the entire site. *Tkda* typically is light gray to tan and typically consists of arkose, arkosic conglomerate, sandstone and interbedded gray claystone seams. The residual soils overlying this formation were derived from the in-situ weathering of the bedrock materials on-site and typically weather to brown or reddish brown.

The subsurface conditions below Lot 1 were investigated by Geoquest, LLC on May 12, 2020 as part of the site specific *Soil Report* referenced above. RMG performed one test boring on Lot 2 on June 24, 2020. The locations of Geoquest, LLC's and RMG's test borings and profile pits are presented on the Engineering and Geology Map, Figure 8.

Two profile pits were observed on Lot 1 by Geoquest, LLC. According to the *Profile Pit Evaluation* report (referenced above), the profile pits were excavated to approximately 8 feet. One additional profile pit was located on Lot 2 by RMG. The profile pit was excavated to approximately 8 feet below the existing ground surface. The RMG profile pit log is presented in the Test Boring and Profile Pit Log, Figure 4. The approximate locations of the profile pits are presented in the Engineering and Geology Map, Figure 8.

The engineering geology is presented in the Engineering and Geology Map, Figure 8.

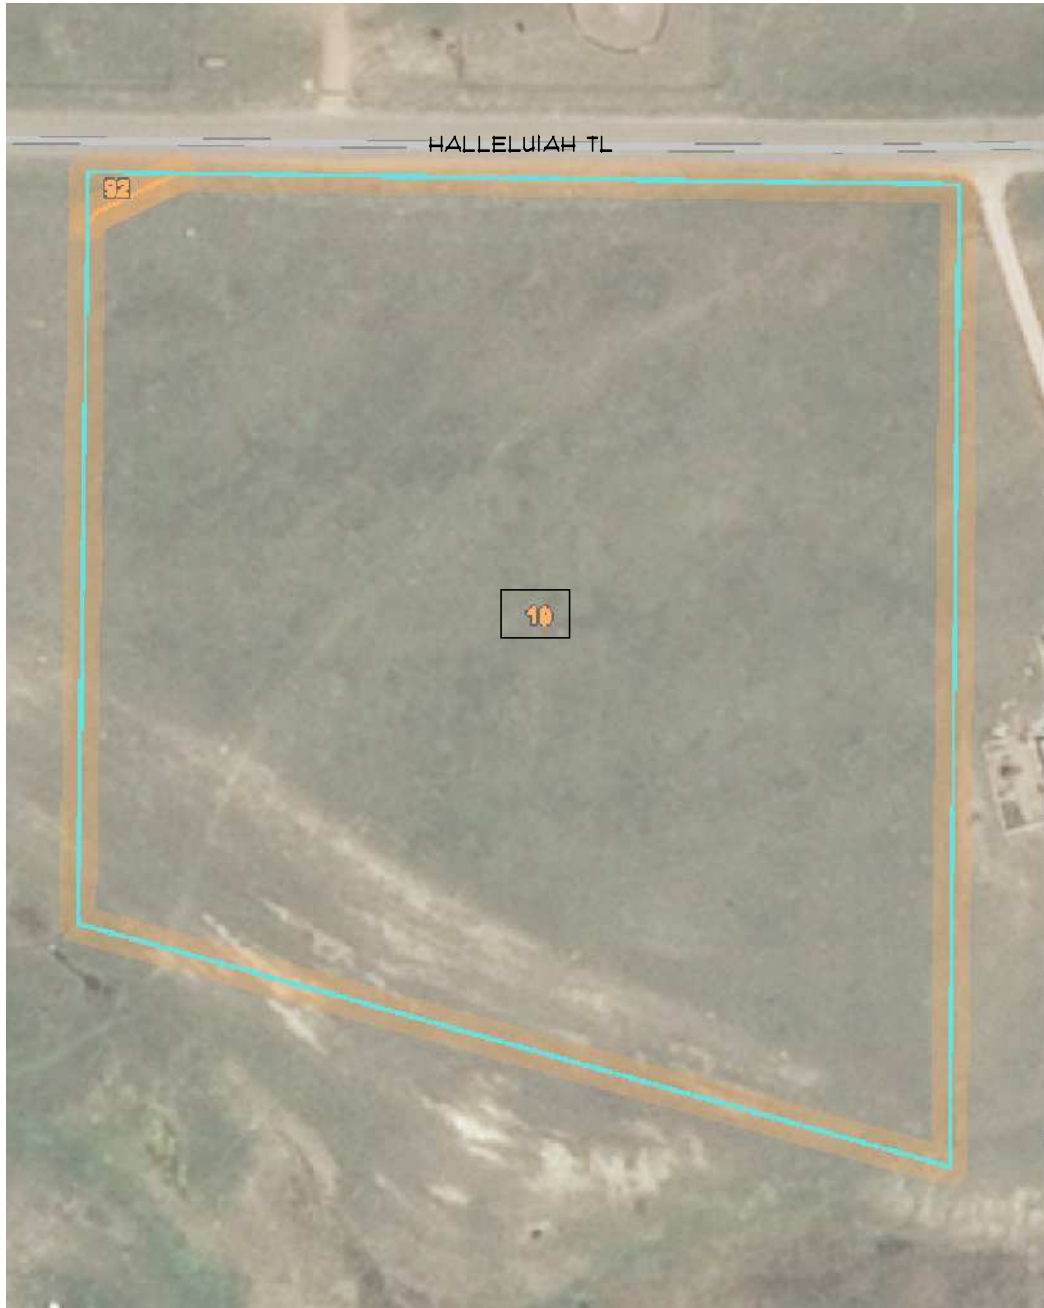
FIG No. 9

- 19 - Columbine gravelly sandy loam, 0 to 3 percent slopes.
- 92 - Tomah-Crowfoot loamy sands, 3 to 8 percent slopes.

The USDA Soil Survey Map is presented in Figure 9.

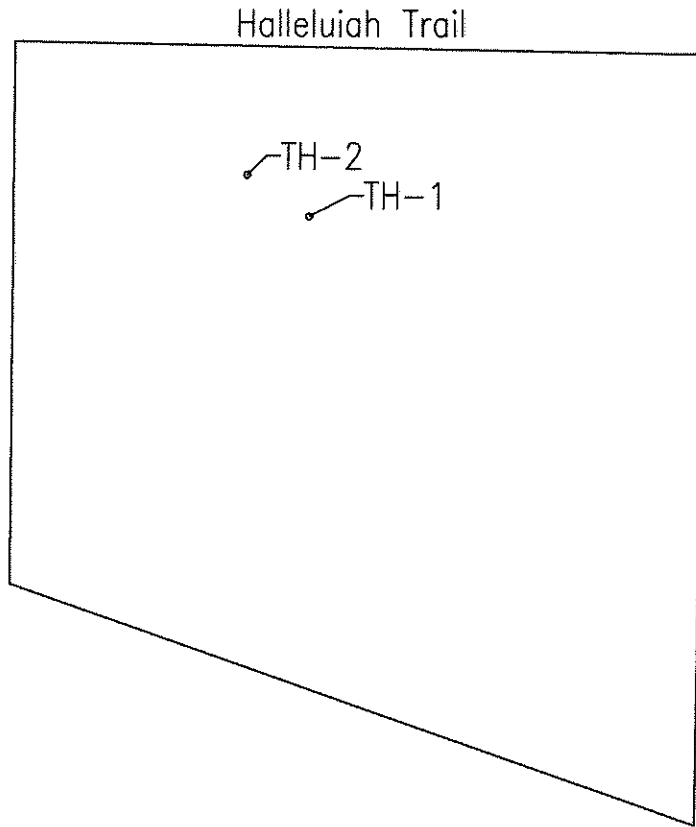
GEOQUEST LLC
SITE MAP

0 Halleluiah Trail
El Paso County
Colorado
Job #20-0429

0 50 100 150
GRAPHIC SCALE IN FEET
SCALE: 1" = 150'

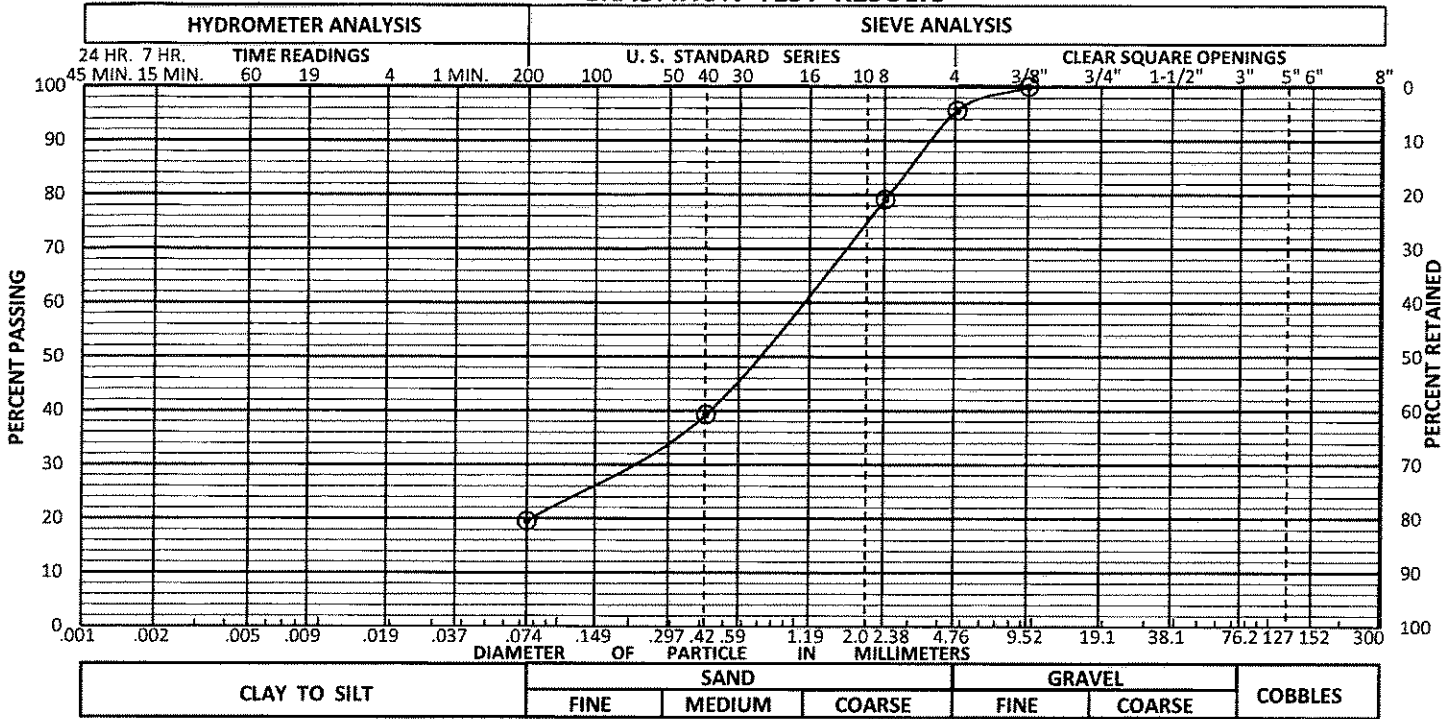
GRADATION TEST RESULTS

CLASSIFICATION SM
 GRAVEL 4.4 %
 SAND 76.1 %
 FINES 19.5 %
SAMPLE # 1 **HOLE #** TH-1 **DEPTH** 12 **FEET**

NOTES: 18.8 % Moisture Content

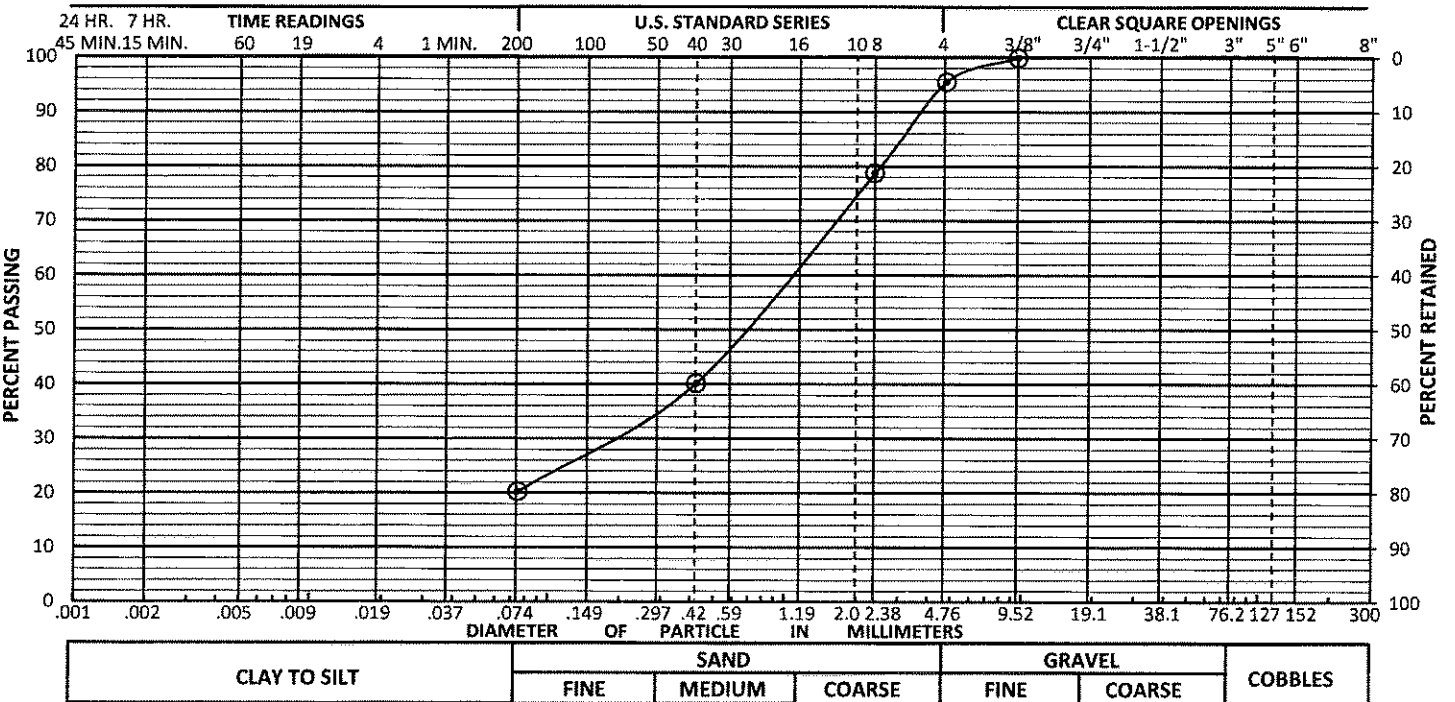
CLASSIFICATION SM
 GRAVEL 4.6 %
 SAND 75.2 %
 FINES 20.2 %
SAMPLE # 1 **HOLE #** TH-2 **DEPTH** 4 **FEET**

NOTES: 12.7% Moisture Content

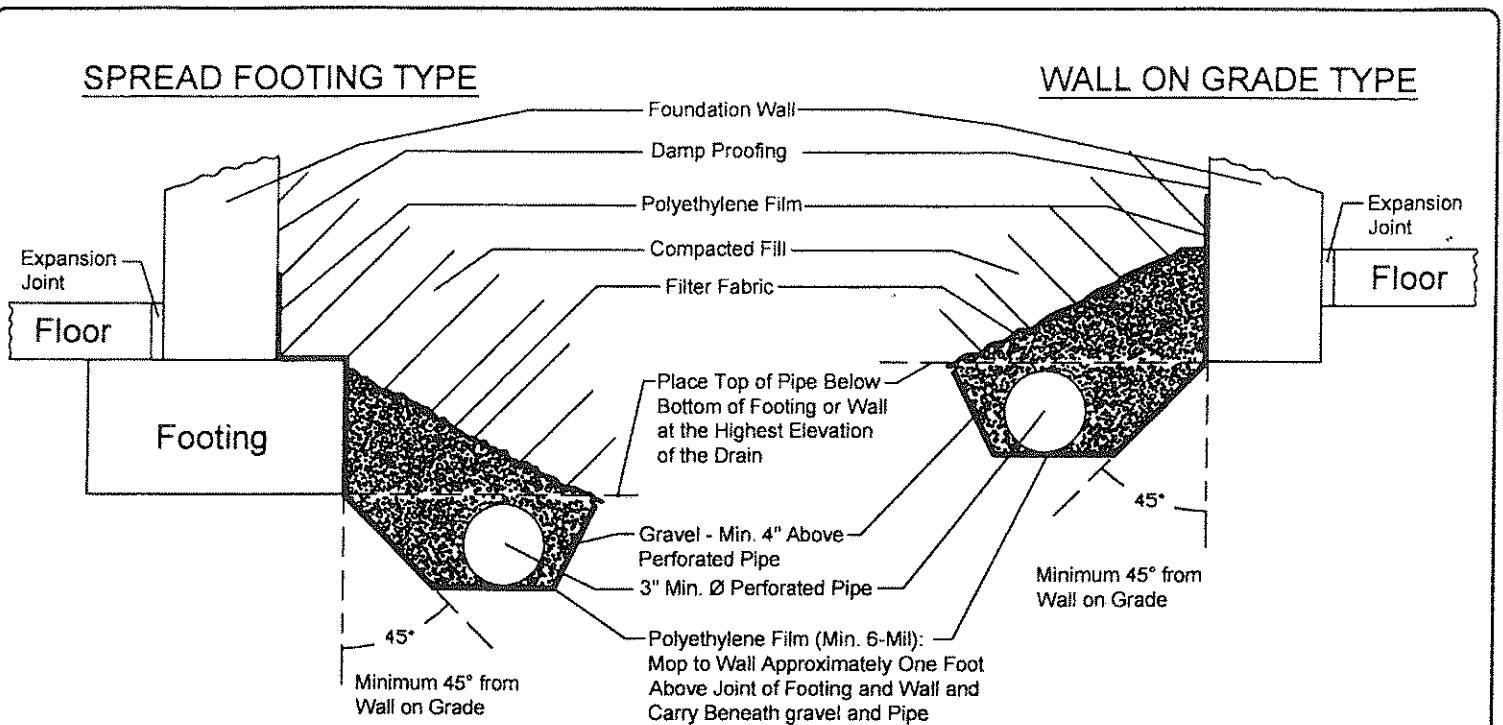
1. Gravel to be Not More Than 1-1/2" and Not Less Than 1/2" Diameter.
2. Perforated Pipe Diameter Varies With Expected Seepage. 3"Ø and 4"Ø are Most Common. ABS and PVC are Most Common Materials for Pipe. We approve the use of an "EZ Flow Drainage System" by Infiltrator. All specifications in this drain detail are still applicable.

3. Pipe to be Laid out in a Minimum Slope of 1" in 10'.
4. Gravity Outfall is Desired if Possible. Portion of Pipe in Area Not Drained Shall be Non-Perforated. Daylight Must be Maintained Clear of Debris in Order to Function Properly.

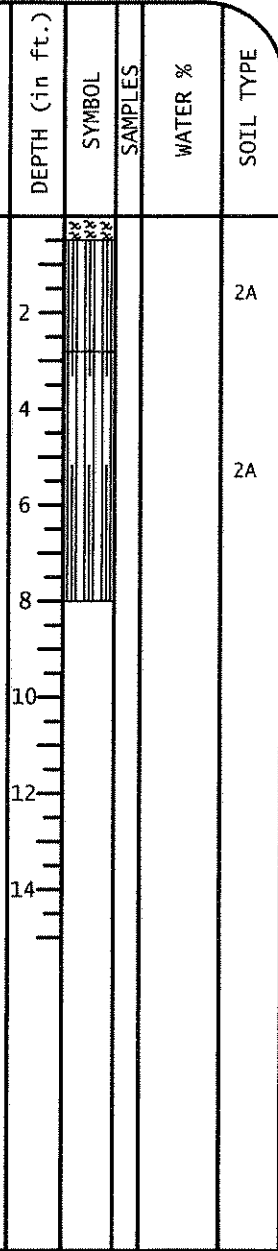
34"-8' Sandstone

Fine-coarse Grained	USDA Soil Texture: Sandy Loam
High Density	USDA Soil Type: 2A
High Moisture Content	USDA Structure Shape: Massive
Low-moderate Clay Content	USDA Structure Grade: 0
Low-moderate Cohesion	Cementation Class: Moderately
Low-moderate Plasticity	Long Term Acceptance Rate (LTAR, Treatment Level 1): 0.50
Pale Brown Color	
2.5Y 7/4

LTAR to be Used for OWTS Sizing: 0.50GPD/SF (USDA Type 2A, Treatment soil, Treatment Level 1)
Depth to Groundwater (Permanent or Seasonal): Not Encountered; Seasonal & Saturated @ 85" in Profile Pit 2
Depth to Bedrock and Type: Sandstone @ 34"
Depth to Proposed Infiltrative Surface from Ground Surface: Above Grade (Uniformly pressure dosed STA)
Soil Treatment Area Slope and Direction: SE @ 4%

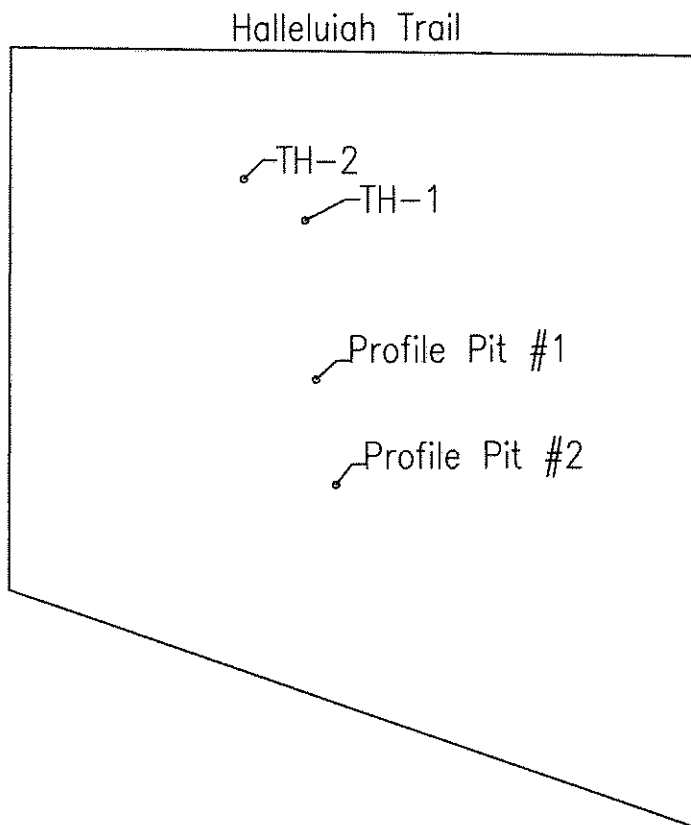
GEOQUEST LLC
SITE MAP

0 Halleluah Trail
El Paso County
Colorado
Job #20-0429

Location from Southeast Lot Corner to Profile Pit #1:

N. 40° W. - 451'
