**ENTECH**  
ENGINEERING, INC.

Re: Wastewater Study  
McLean Subdivision  
2415 Hodgen Road  
Parcel No. 61281-00-014  
El Paso County, Colorado  
Entech Job No. 231709

The project consists of subdividing 38.68-acres into two rural residential lots. An existing home and out buildings on Lot 1 will remain. The site is located east of the intersection of Hodgen Road and Roller Coaster Road on the southern side of Hodgen Road, in El Paso County, Colorado.

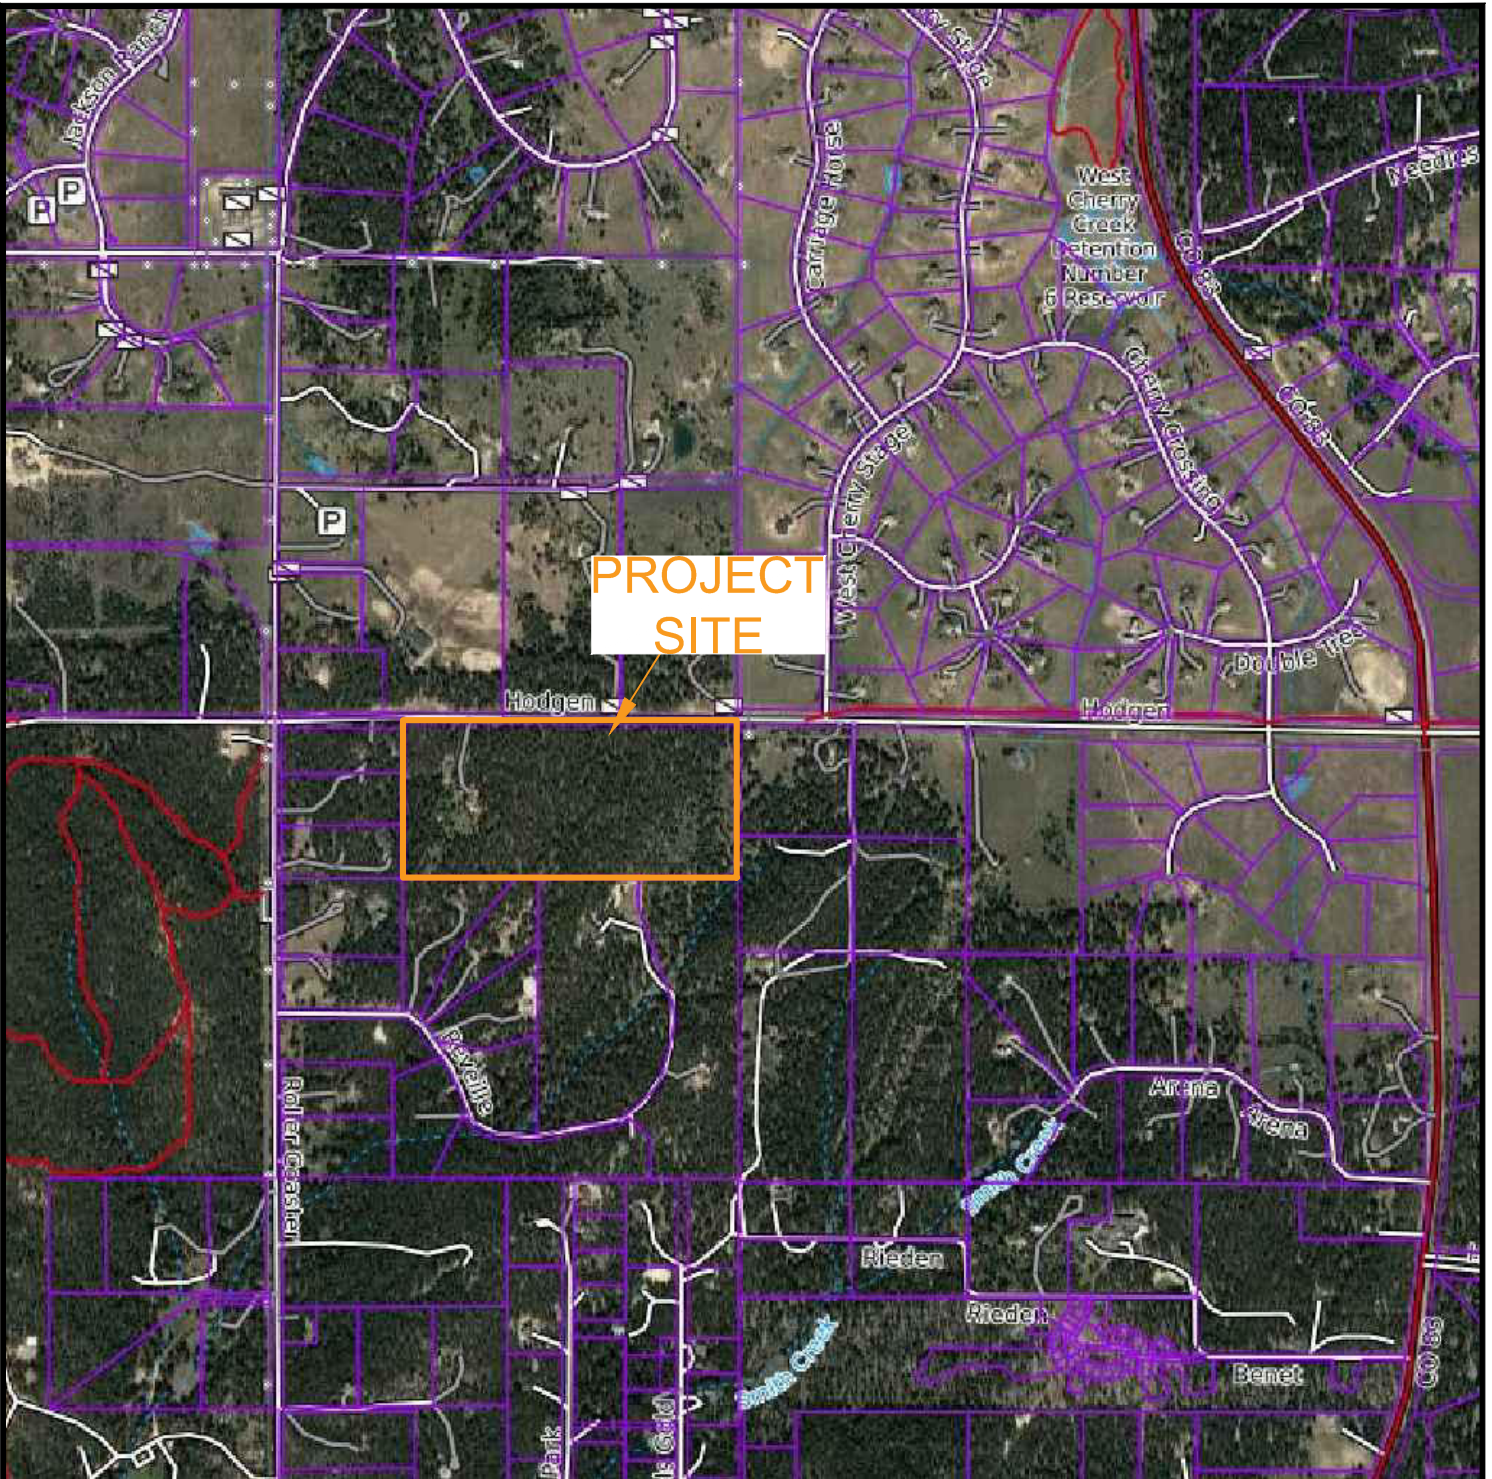
**FIG. 1**

PROJECT  
SITE

The site is located in a portion of the NE¼ of Section 28, Township 11 South, Range 66 West of the 6<sup>th</sup> Principal Meridian in El Paso County, Colorado. The site is located approximately 2½ miles east of Monument, Colorado, east of the intersection of Hodgen Road and Roller Coaster Road in El Paso County, Colorado. The location of the site is as shown on the Vicinity Map, Figure 1.

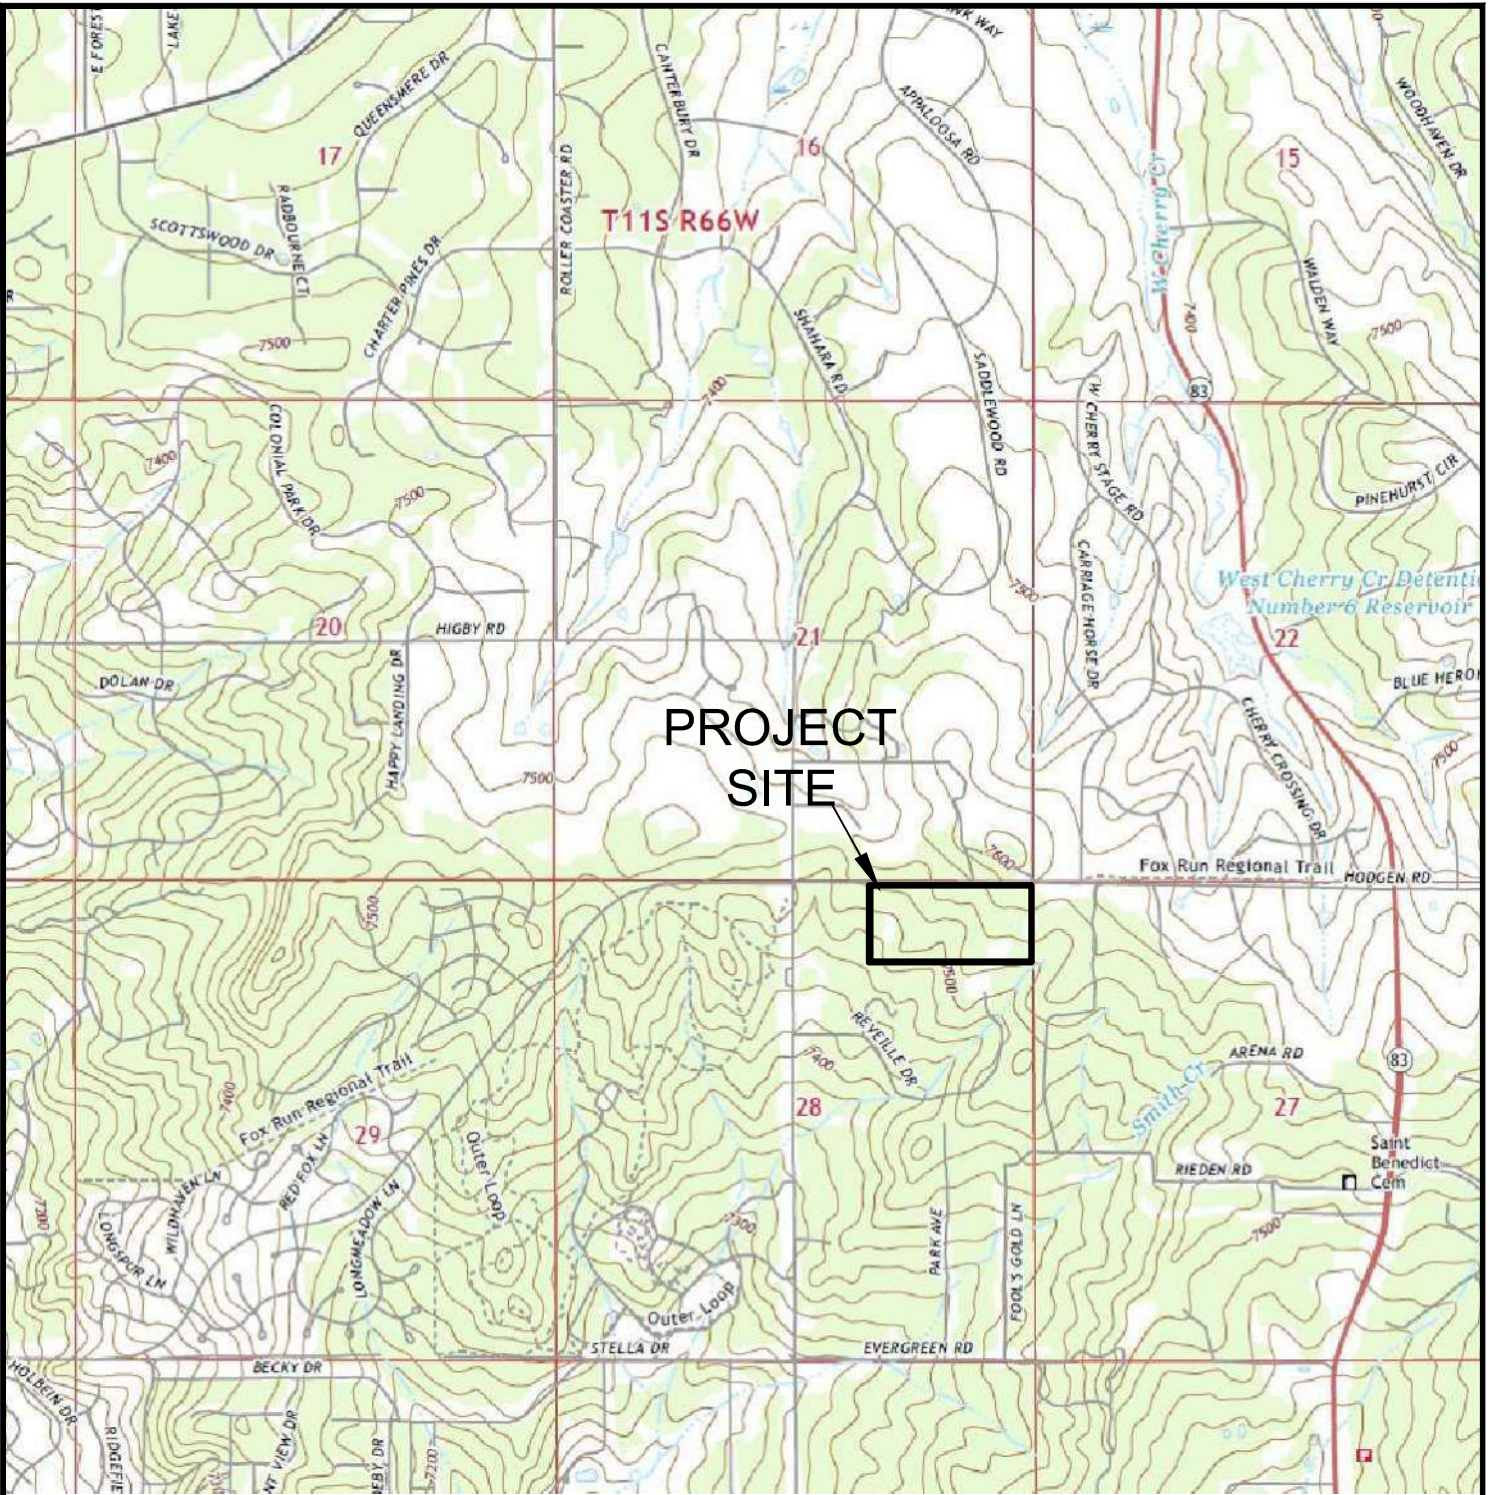
**FIG. 2**

**USGS TOPOGRAPHY MAP**

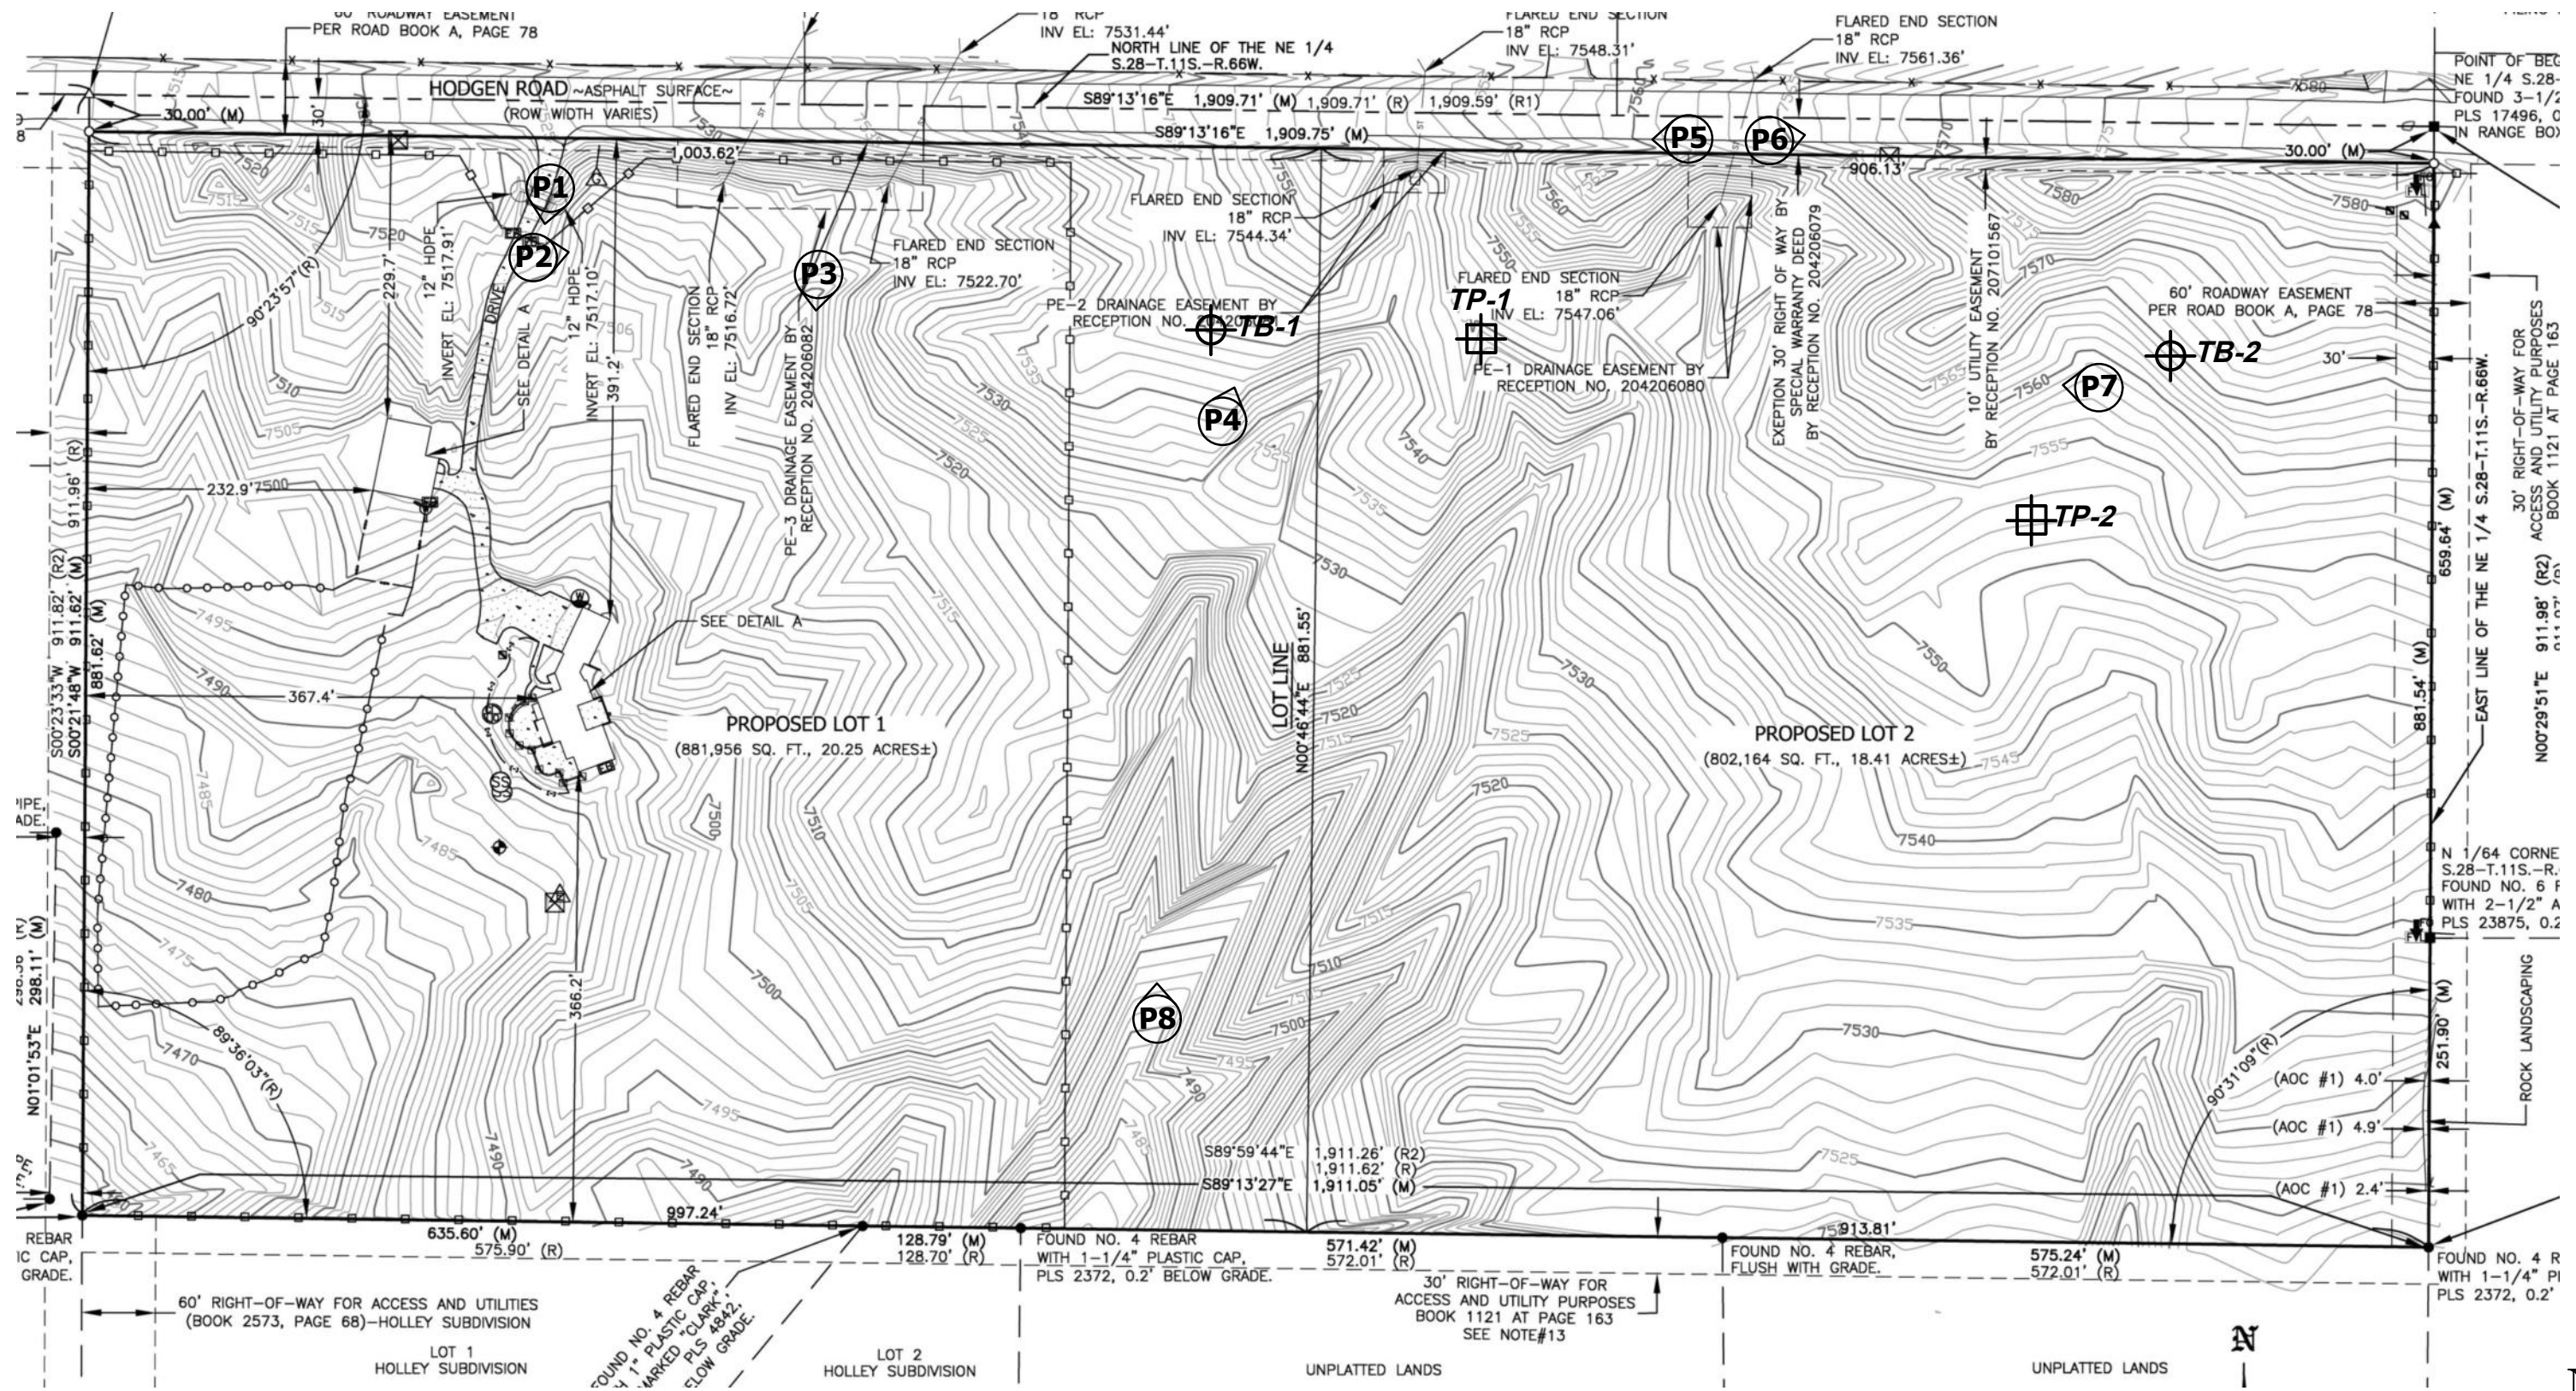
JOB NO.  
231709  
**FIG. 3**

- ⊕ - APPROXIMATE TEST BORING LOCATION AND NUMBER
- ⊞ - APPROXIMATE TEST PIT LOCATION AND NUMBER
- Ⓟ - APPROXIMATE PHOTOGRAPH LOCATION AND NUMBER

**SITE AND EXPLORATION PLAN**  
2415 HODGEN ROAD  
VERTEX CONSULTING SERVICES

Total acreage involved in the proposed subdivision is 38.68-acres. Two rural residential lots are proposed as part of the replat. The proposed lot sizes are 20.25 and 18.41-acres. The existing residence, outbuildings, on-site wastewater treatment system, and water well located on proposed Lot 1, will remain. The new lot will be serviced by individual water wells and on-site wastewater treatment system. The Site Plan with the proposed replat is presented in Figure 3.

Two test borings were drilled and two test pits were excavated on the site to determine general suitability for construction and the use of on-site wastewater treatment systems and general soil characteristics. The location of the test pit is indicated on the Site Plan/Test Pit Location Map, Figure 3. The Test Pit Log is presented in Appendix B. Results of this testing will be discussed later in this report.

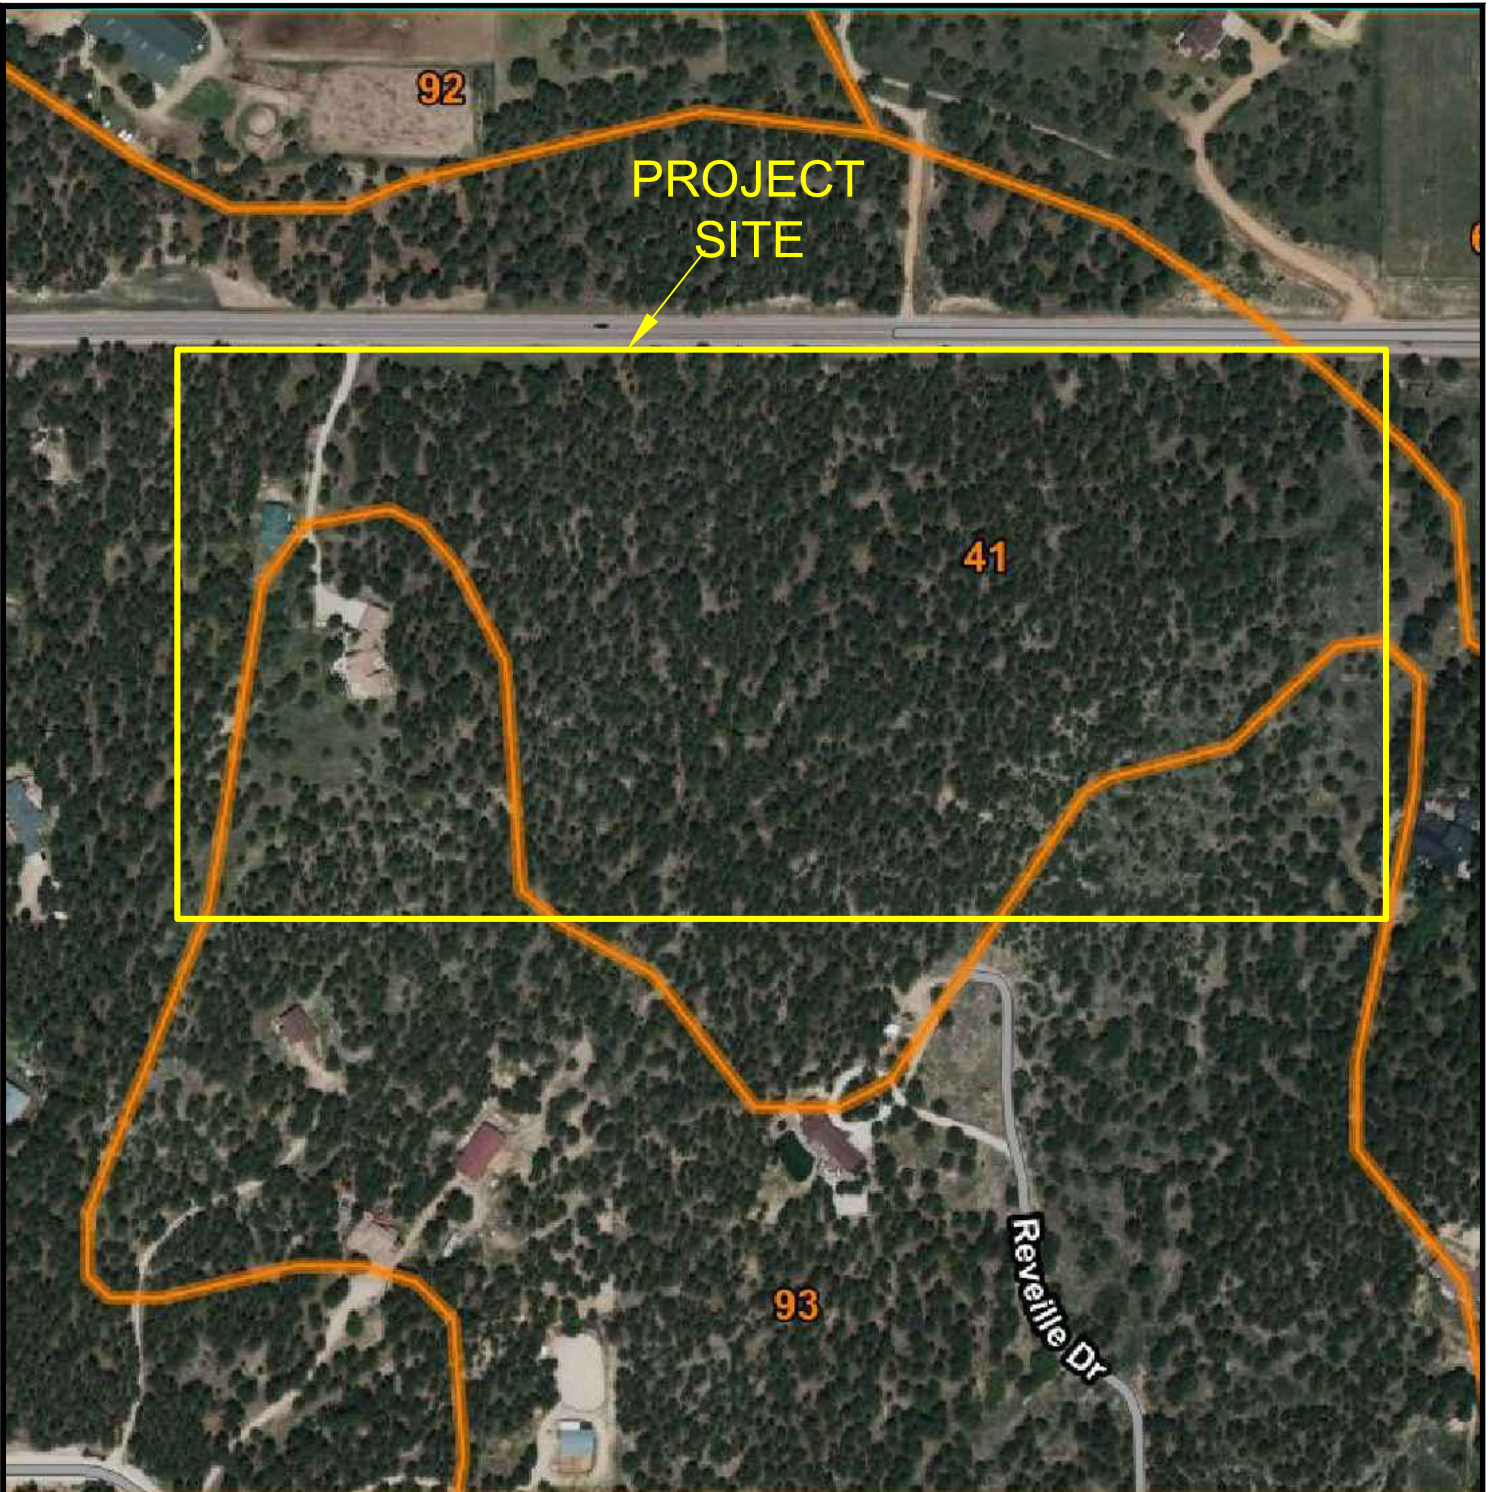
**FIG. 4**

**SOIL SURVEY MAP**  
2415 HODGEN RD  
VERTEX CONSULTING SERVICES

The Natural Resource Conservation Service (NRCS) (Reference 1, Figure 4), previously the Soil Conservation Service (Reference 2) has mapped three soil types on the site. Complete descriptions of the soil types are presented in Appendix D. In general, the soils consist of sandy loam to gravelly loamy sand. The soils are described as follows:

The Natural Resource Conservation Service (Reference 1), previously the Soil Conservation Service (Reference 2) has been mapped with three soil descriptions. The Soil Survey Map (Reference 1) is presented in Figure 4, and the Soil Survey Descriptions (Reference 2) are presented in Appendix D. The soils are described as having moderate to rapid percolation rates. Existing El Paso County Health Department septic records for the system on Lot 1 are included in Appendix E.

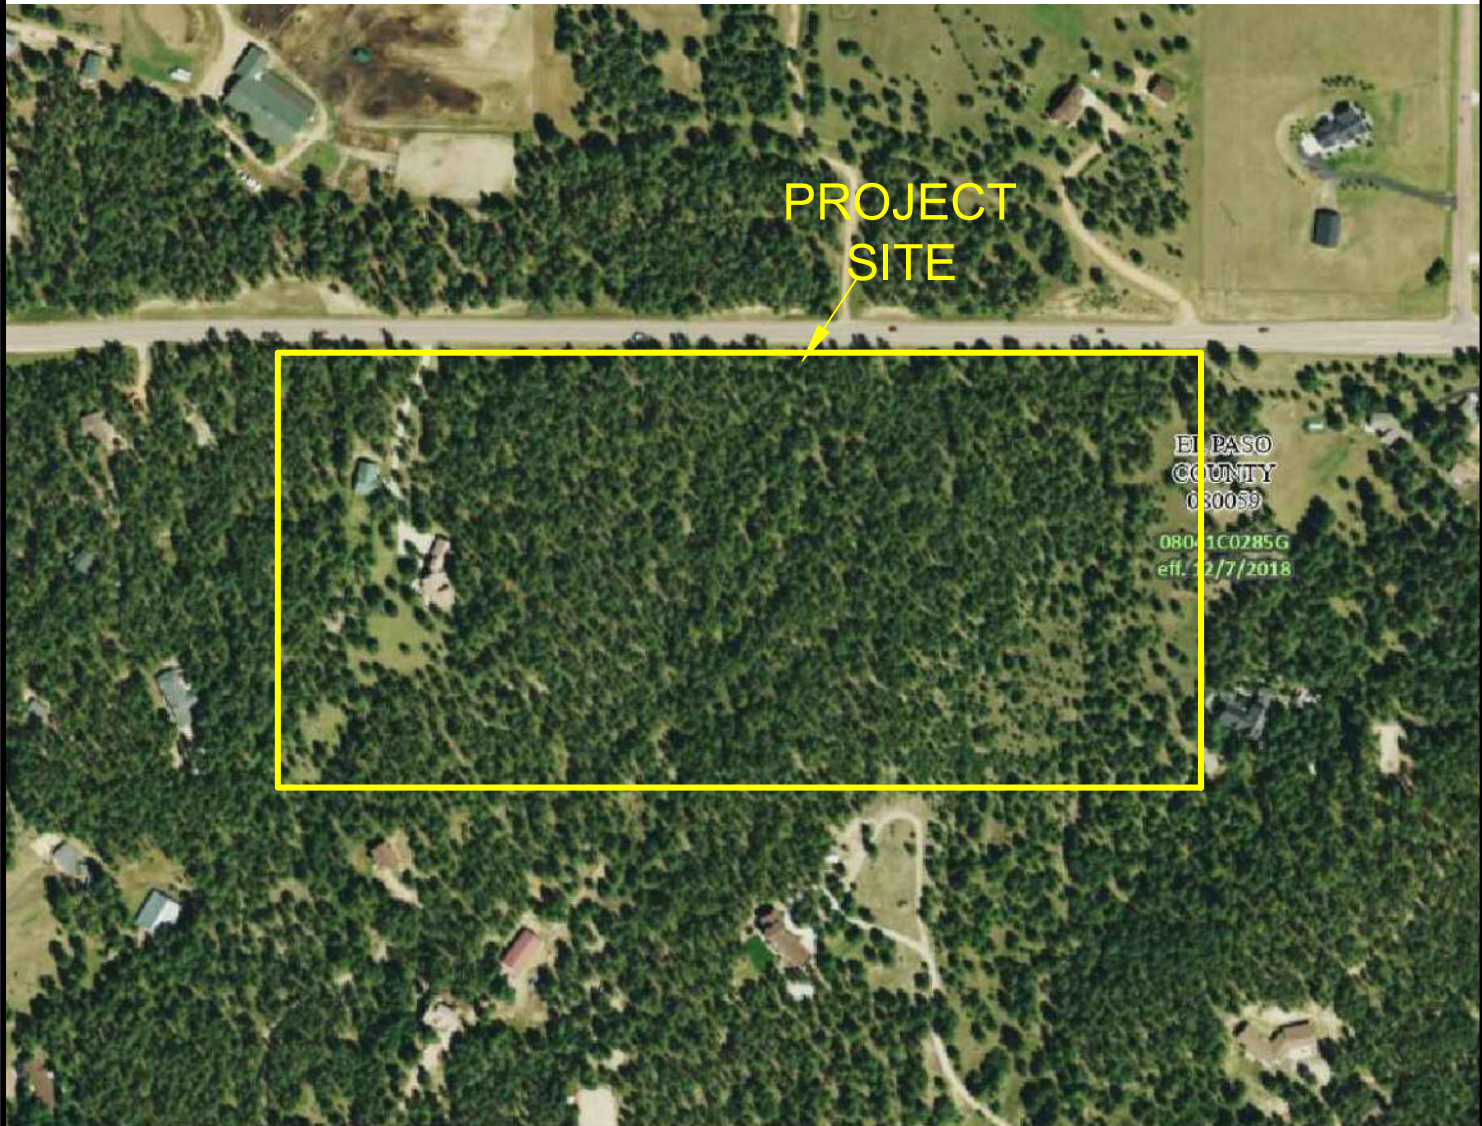
**FIG. 7**

**FEMA FLOODPLAIN MAP**

The site is not mapped within any floodplains according to the FEMA Map No. 08041CO285G, dated December 7, 2018 (Figure 8, Reference 6). Areas of potential seasonally shallow groundwater were observed on the site (Figure 6). In these areas, we would anticipate the potential for periodically high subsurface moisture conditions and frost heave potential. These

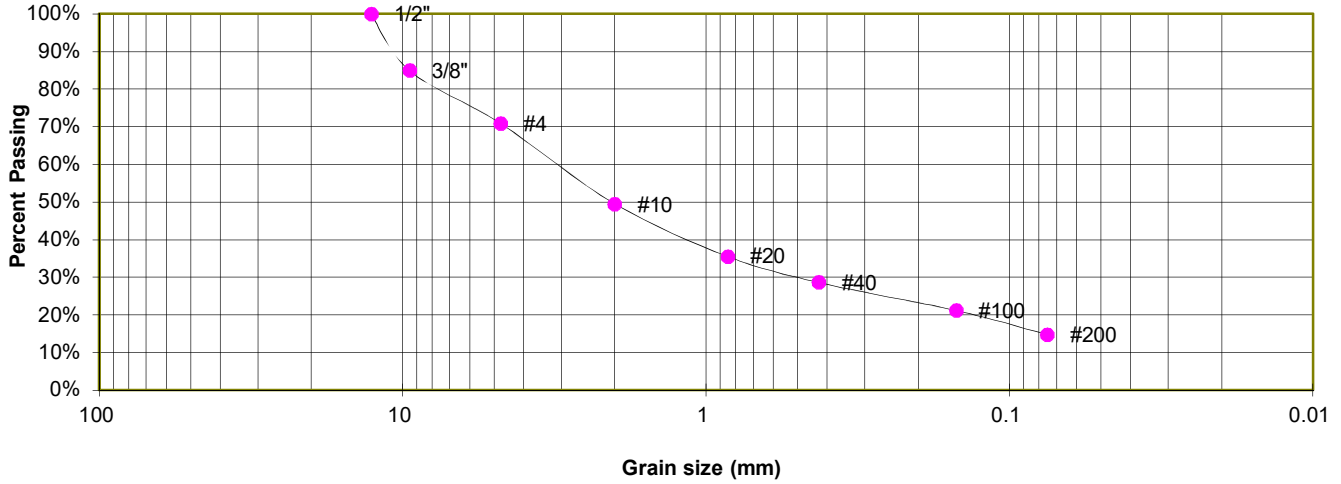
SOIL DESCRIPTION SAND, SILTY  
 SOIL TYPE 1

**GRAIN SIZE ANALYSIS**

U.S. Sieve #	Percent Finer
3"	
1 1/2"	
3/4"	
1/2"	100.0%
3/8"	85.0%
4	70.8%
10	49.5%
20	35.6%
40	28.6%
100	21.2%
200	14.8%

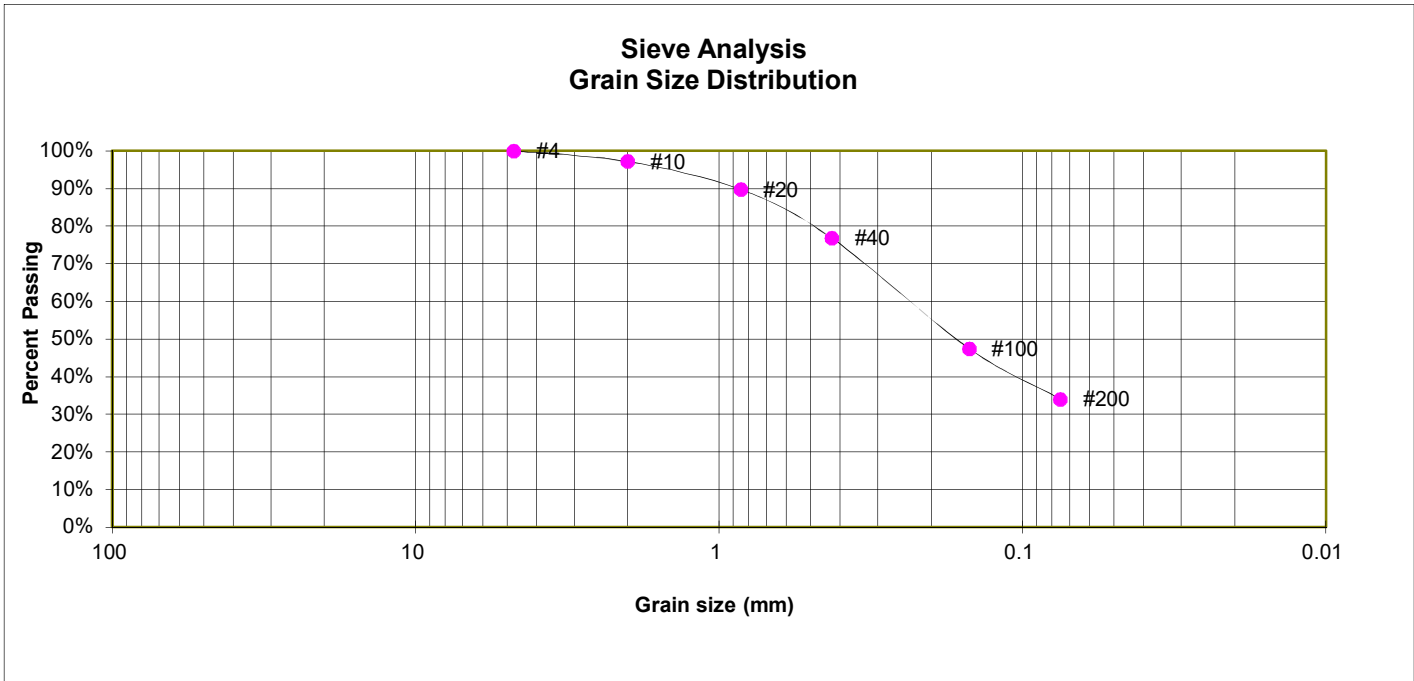
TEST BORING 1  
DEPTH (FT) 15

SOIL DESCRIPTION SANDSTONE (SAND, CLAYEY)  
SOIL TYPE 2

**GRAIN SIZE ANALYSIS**

U.S. Sieve #	Percent Finer
3"	
1 1/2"	
3/4"	
1/2"	
3/8"	
4	100.0%
10	97.2%
20	89.8%
40	76.8%
100	47.5%
200	34.1%

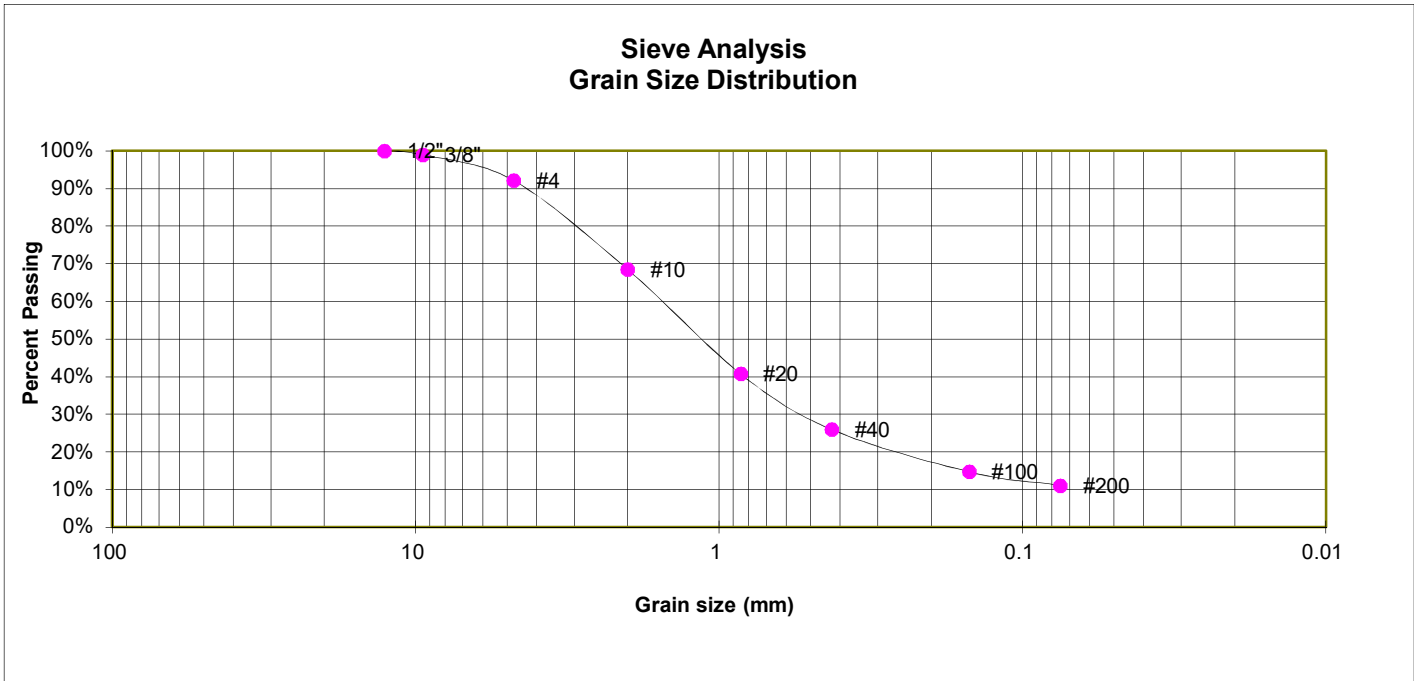
TEST BORING 2  
 DEPTH (FT) 10

SOIL DESCRIPTION SANDSTONE (SAND, WITH SILT)  
 SOIL TYPE 2

**GRAIN SIZE ANALYSIS**

U.S. Sieve #	Percent Finer
3"	
1 1/2"	
3/4"	
1/2"	100.0%
3/8"	99.0%
4	92.1%
10	68.5%
20	40.8%
40	25.9%
100	14.7%
200	11.0%

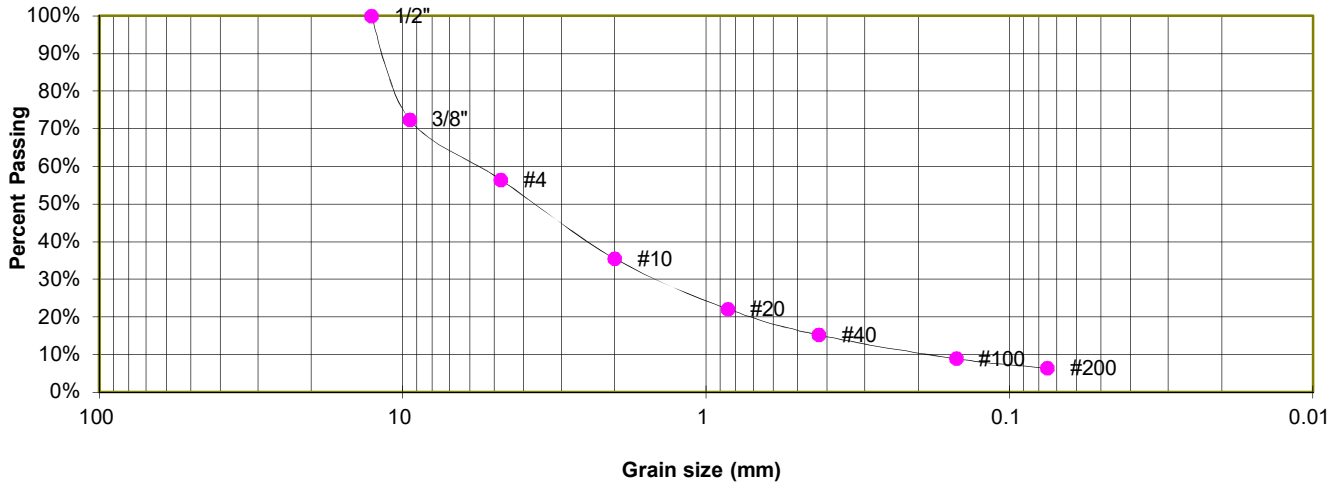
SOIL DESCRIPTION SAND, WITH SILT

#### GRAIN SIZE ANALYSIS

U.S. Sieve #	Percent Finer
3"	
1 1/2"	
3/4"	
1/2"	100.0%
3/8"	72.5%
4	56.5%
10	35.5%
20	22.2%
40	15.2%
100	8.9%
200	6.4%

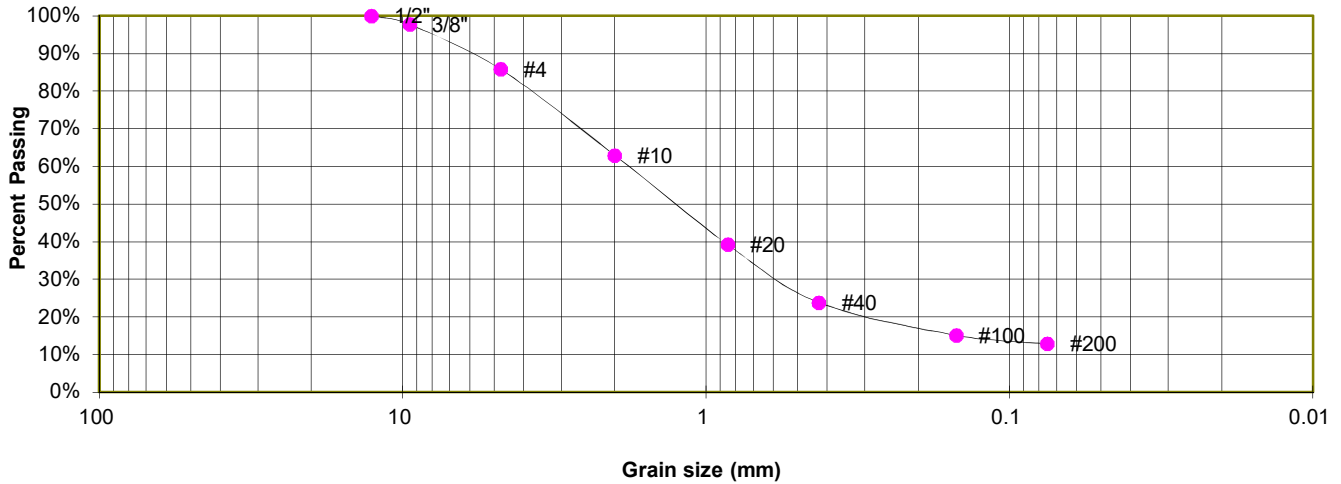
SOIL DESCRIPTION SAND, SILTY

#### GRAIN SIZE ANALYSIS

U.S. Sieve #	Percent Finer
3"	
1 1/2"	
3/4"	
1/2"	100.0%
3/8"	97.7%
4	85.8%
10	62.9%
20	39.3%
40	23.8%
100	15.1%
200	12.9%

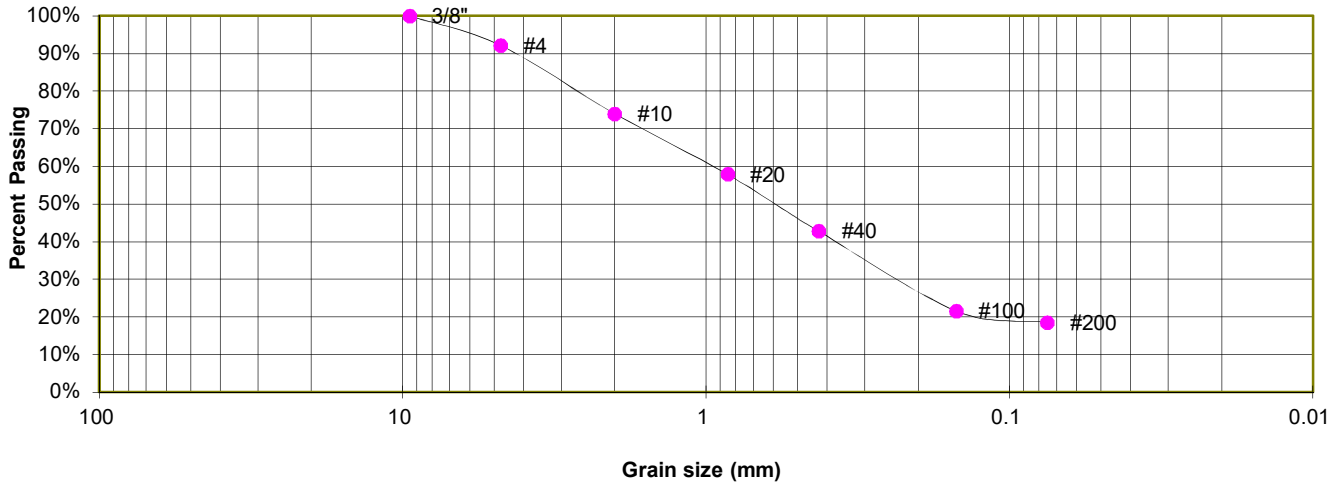
SOIL DESCRIPTION SAND, SILTY

#### GRAIN SIZE ANALYSIS

U.S. Sieve #	Percent Finer
3"	
1 1/2"	
3/4"	
1/2"	
3/8"	100.0%
4	92.1%
10	74.0%
20	57.9%
40	42.8%
100	21.6%
200	18.6%
