## Colorado Geological Survey

CTL | Thompson identifies potentially hydrocompactive soils (collapsible soils), existing uncontrolled fill stockpiles, and erodible soil as geologic hazards that may impact the site. However, the site is relatively flat, is not undermined, and does not appear to be exposed to any geologic hazards or geotechnical constraints that would preclude the proposed development.

Prepared for:

THE EQUITY GROUP  
90 South Cascade Avenue, Suite 1500  
Colorado Springs, Colorado 80903

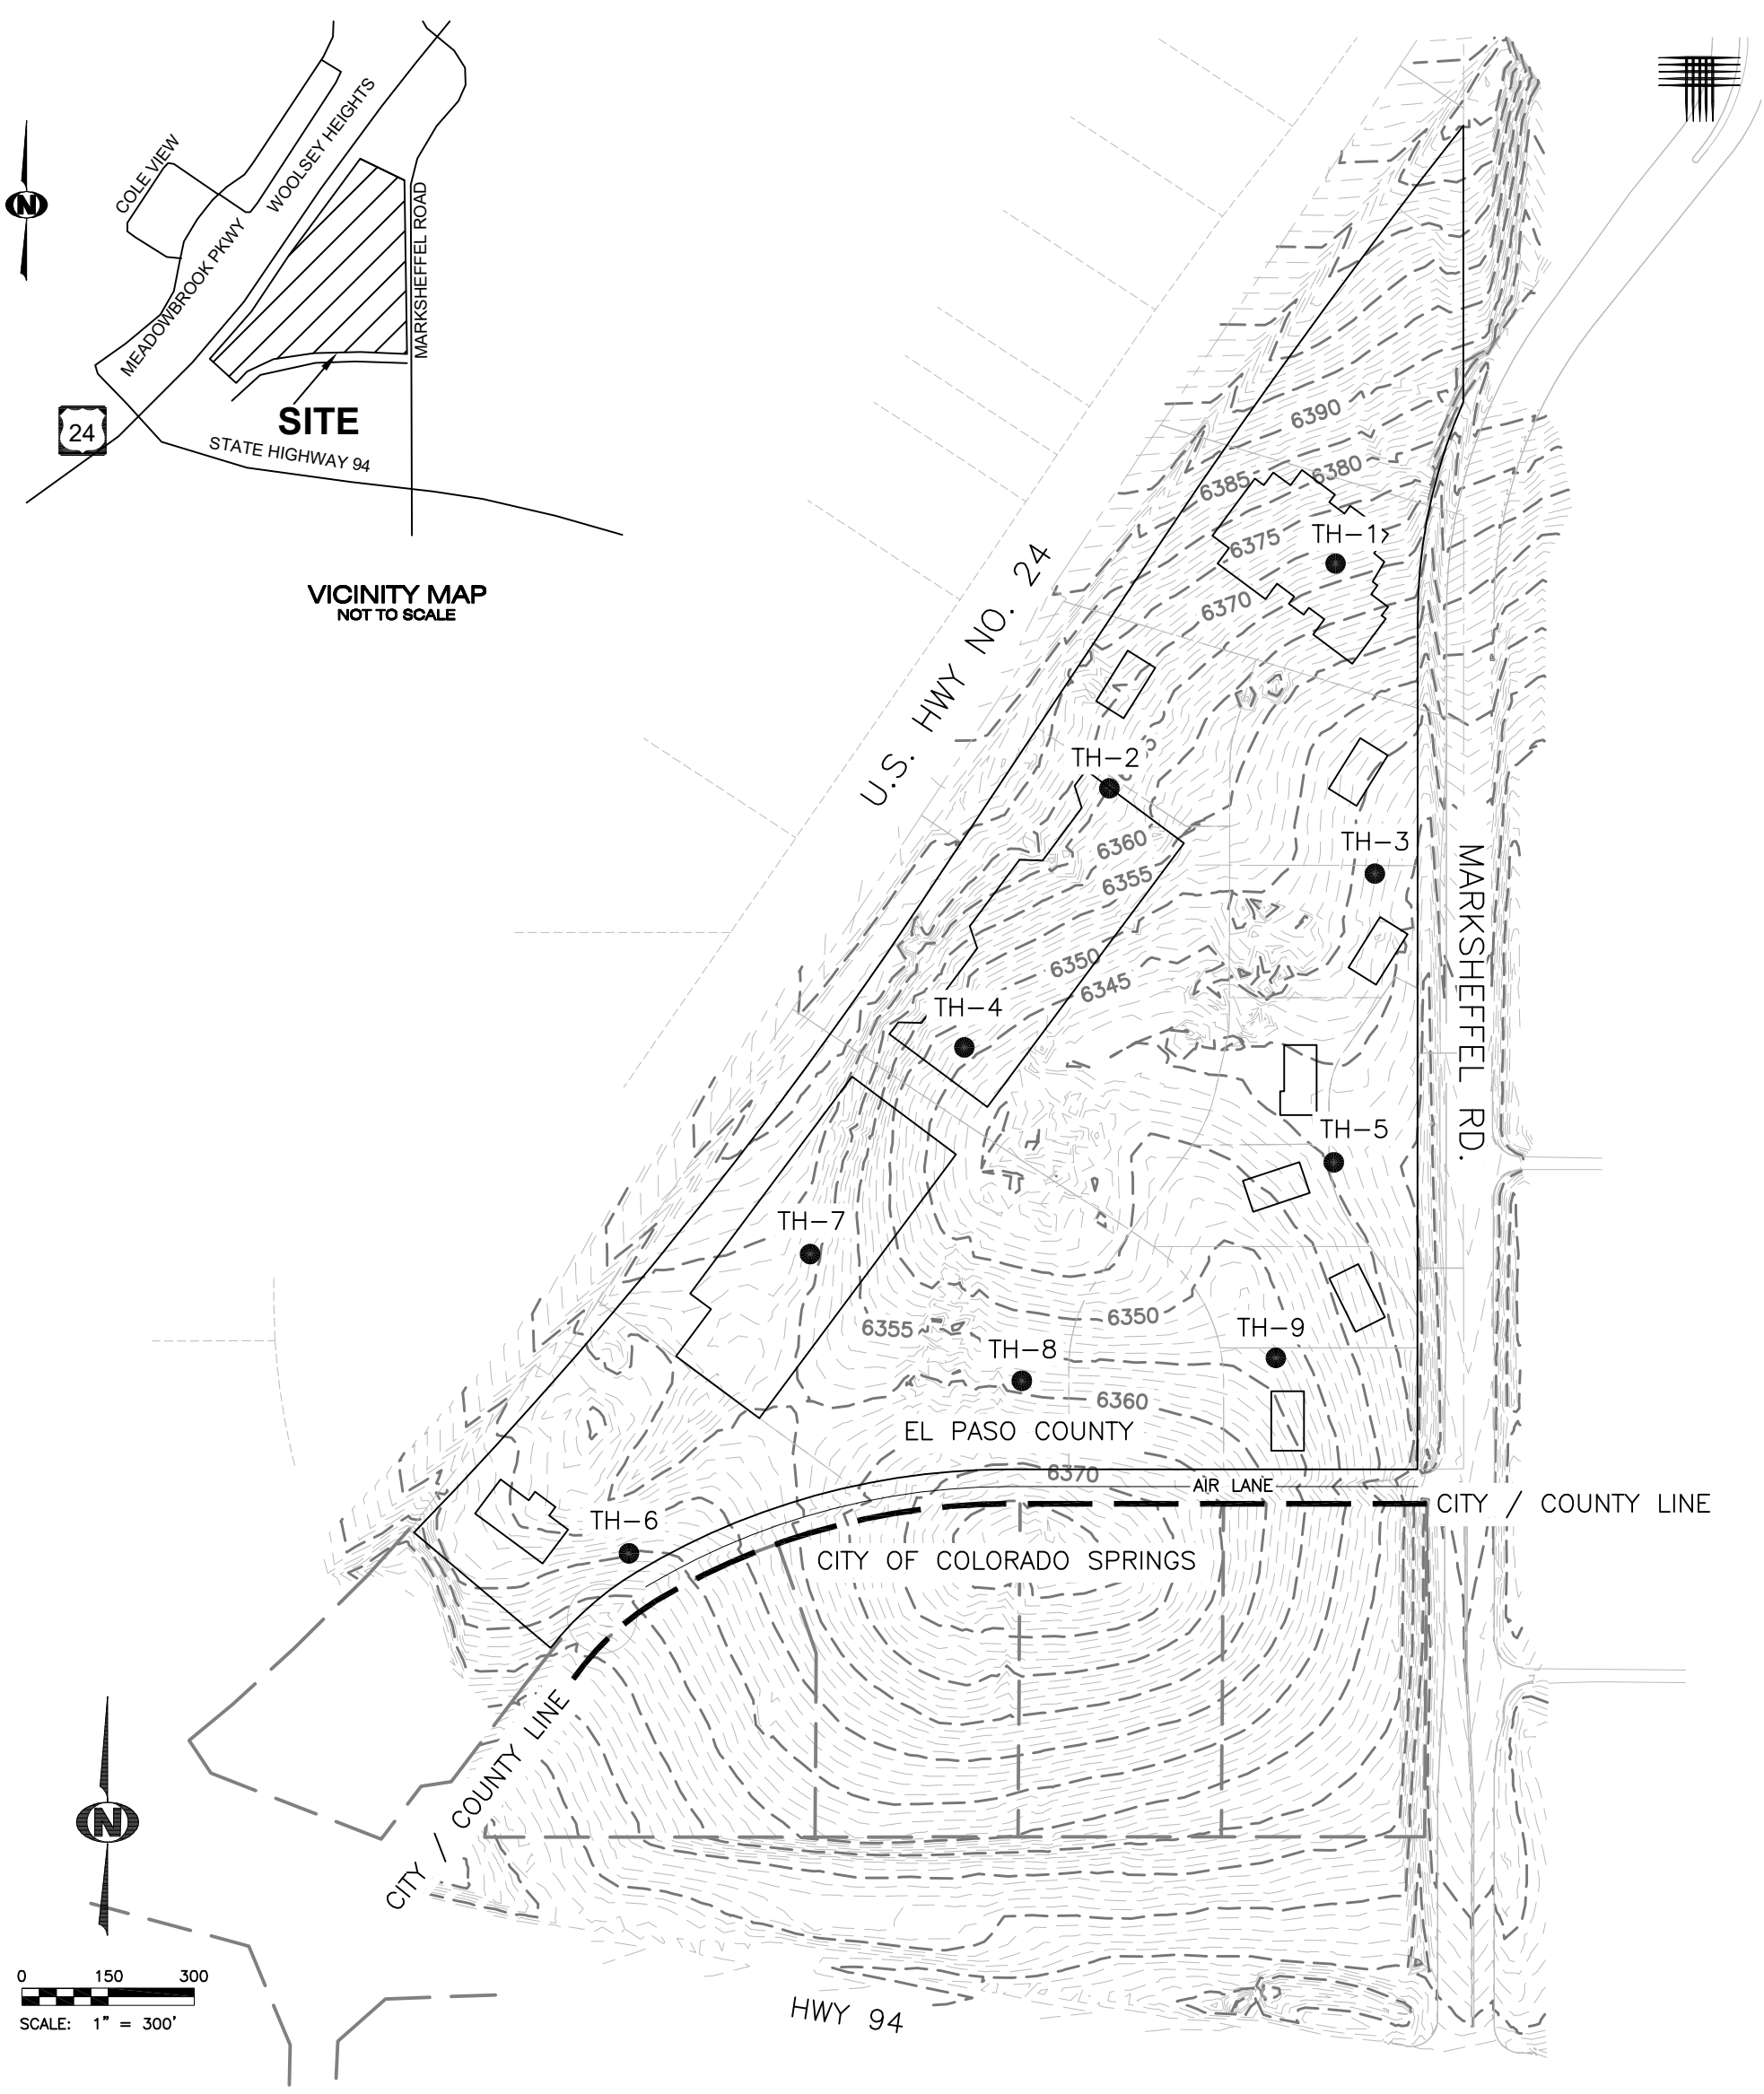
- LEGEND:
- TH-1  
● APPROXIMATE LOCATION OF EXPLORATORY BORING.
  - ≡≡≡ EXISTING TOPOGRAPHY
  - PROJECT LOT BOUNDARY
  - LOCATION OF PROPOSED BUILDING FOOTPRINT.

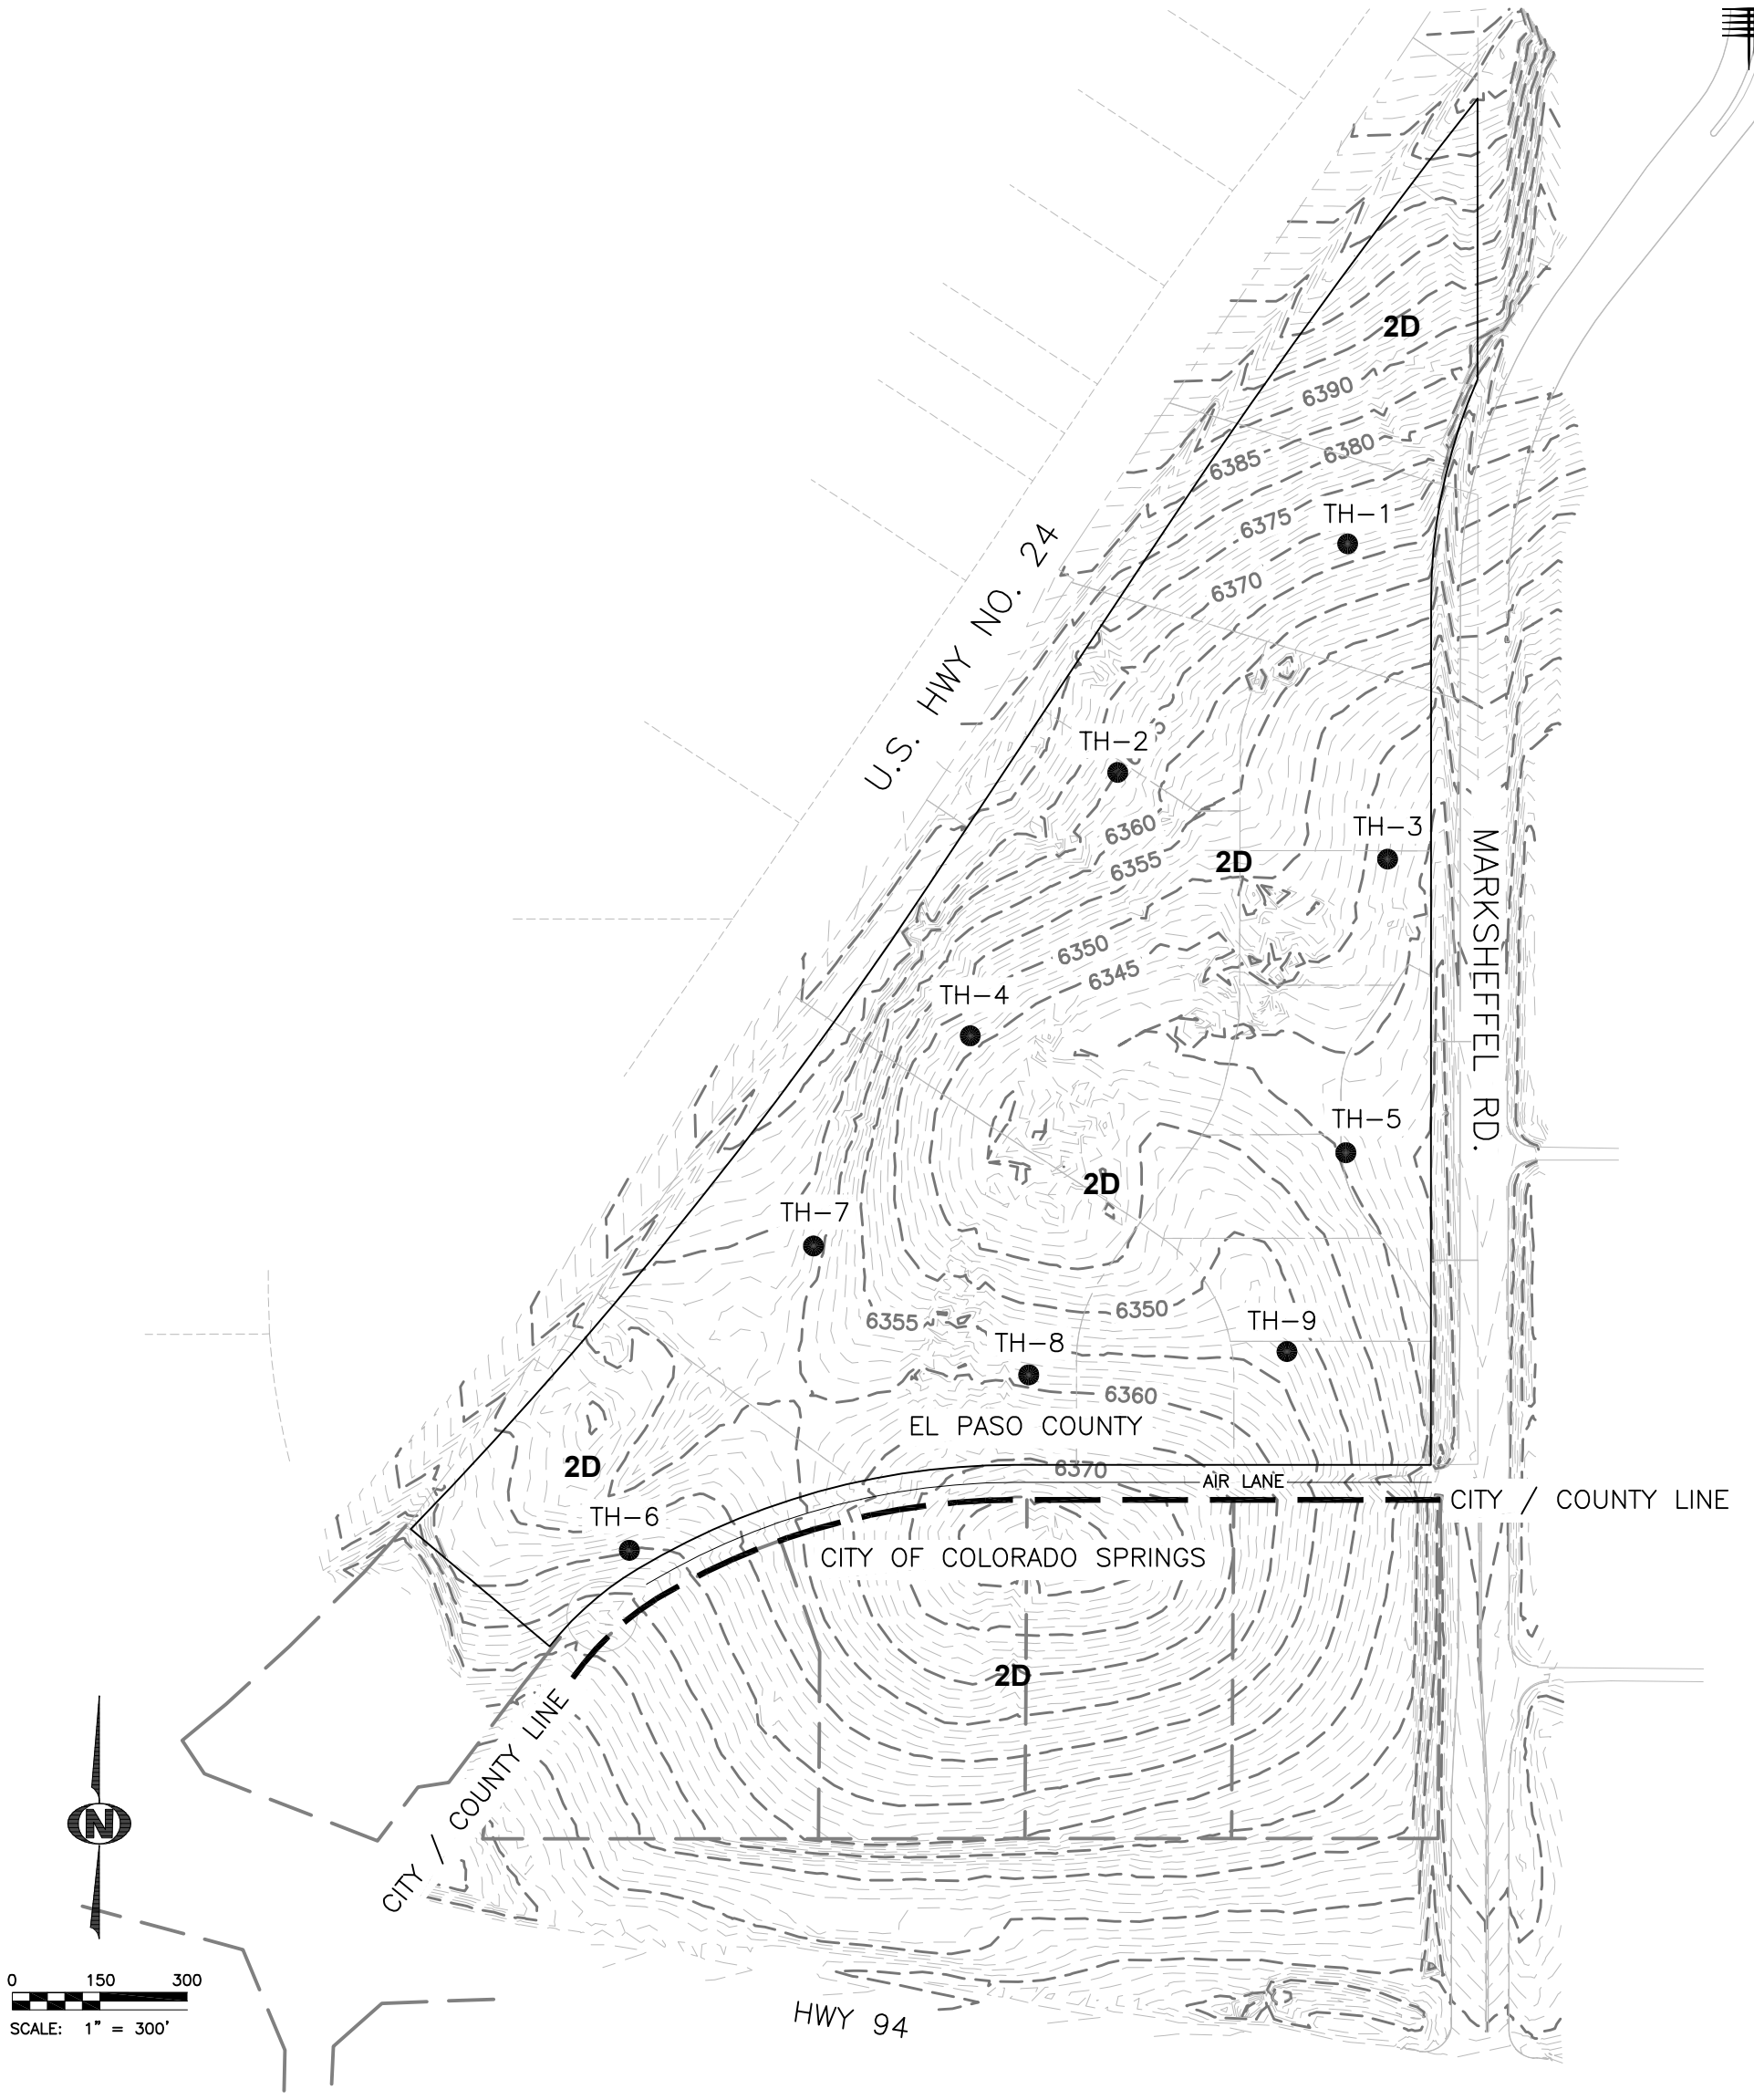
- NOTES:
1. BASE DRAWING WAS PROVIDED BY THOMAS AND THOMAS (PROJECT NO. 3532.01, DATED MAY 18, 2016).
  2. ALL BOUNDARIES SHOWN SHOULD BE CONSIDERED APPROXIMATE. THEY ARE BASED UPON A SUBJECTIVE INTERPRETATION OF PUBLISHED MAPS, AERIAL PHOTOGRAPHS, AND AN INITIAL FIELD RECONNAISSANCE. CHANGES IN THE MAPPED BOUNDARIES SHOWN ARE POSSIBLE AND SHOULD BE EXPECTED WITH MORE DETAILED WORK AND FURTHER INFORMATION. ALL INTERPRETATIONS AND CONDITIONS SHOWN ARE PRELIMINARY AND FOR INITIAL LAND-USE PLANNING ONLY.
  3. MAP LEGEND IS MODIFIED FROM CHARLES S. ROBINSON & ASSOCIATES, INC., GOLDEN, COLORADO, DATED 1977.

- LEGEND:
- TH-1      APPROXIMATE LOCATION OF EXPLORATORY BORING.
- PROJECT BOUNDARY
- ~~~~~      EXISTING TOPOGRAPHY

- ENGINEERING UNITS AND (MODIFIERS)
- 2D**      EOLIAN DEPOSITS GENERALLY ON FLAT TO GENTLE SLOPES OF UPLAND AREAS.

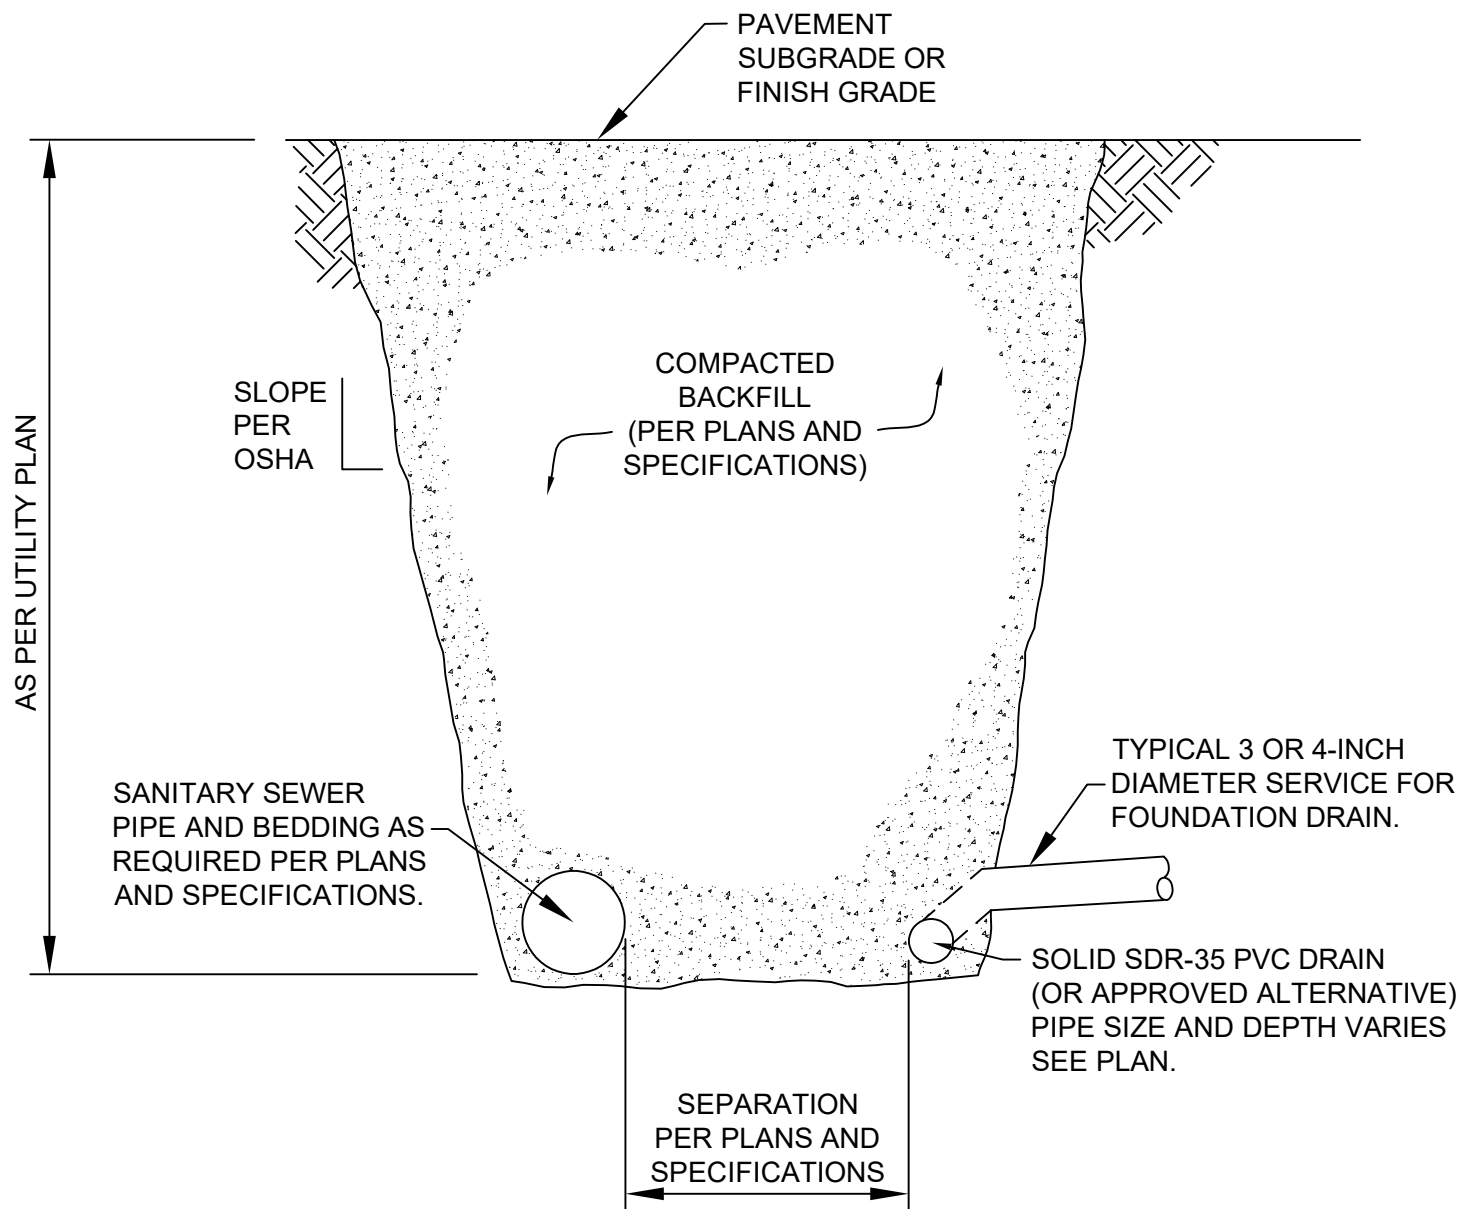
NOTE:  
TO BE USED IN CASES WHERE NO  
GROUND WATER IS KNOWN TO EXIST.

Underdrains incorporated into the design of sanitary sewer systems can provide a positive gravity outlet for individual, below-grade foundation drains, if desired. Where no groundwater is encountered in sanitary sewer excavations, “passive” underdrains may be used. A conceptual drain detail is shown in Fig. 4. The drain pipe should consist of smooth wall, rigid PVC pipe placed at a minimum slope of 0.5 percent. An “active” section of smooth, perforated or slotted, rigid PVC pipe should be placed for a minimum distance of one pipe length upstream of manholes. The perforated pipe should be encased in at least 6 inches of free-draining gravel, separated from the surrounding trench backfill by geotextile fabric. Seepage collars should be constructed at the manhole locations to force water flowing through pipe bedding into the underdrain. The seepage collars can be constructed of concrete or clay.

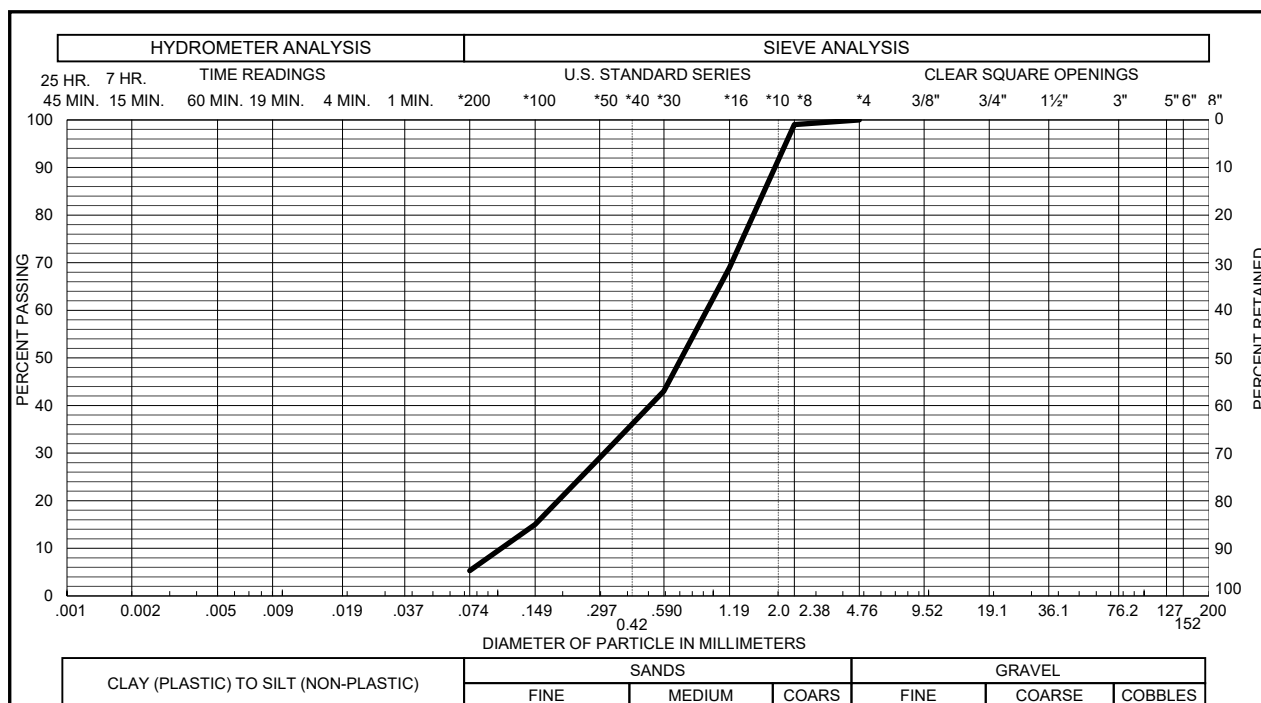
Sample of SAND, SLIGHTLY SILTY (SP-SM) GRAVEL 0 % SAND 95 %  
From TH - 1 AT 9 FEET SILT & CLAY 5 % LIQUID LIMIT      %  
PLASTICITY INDEX      %

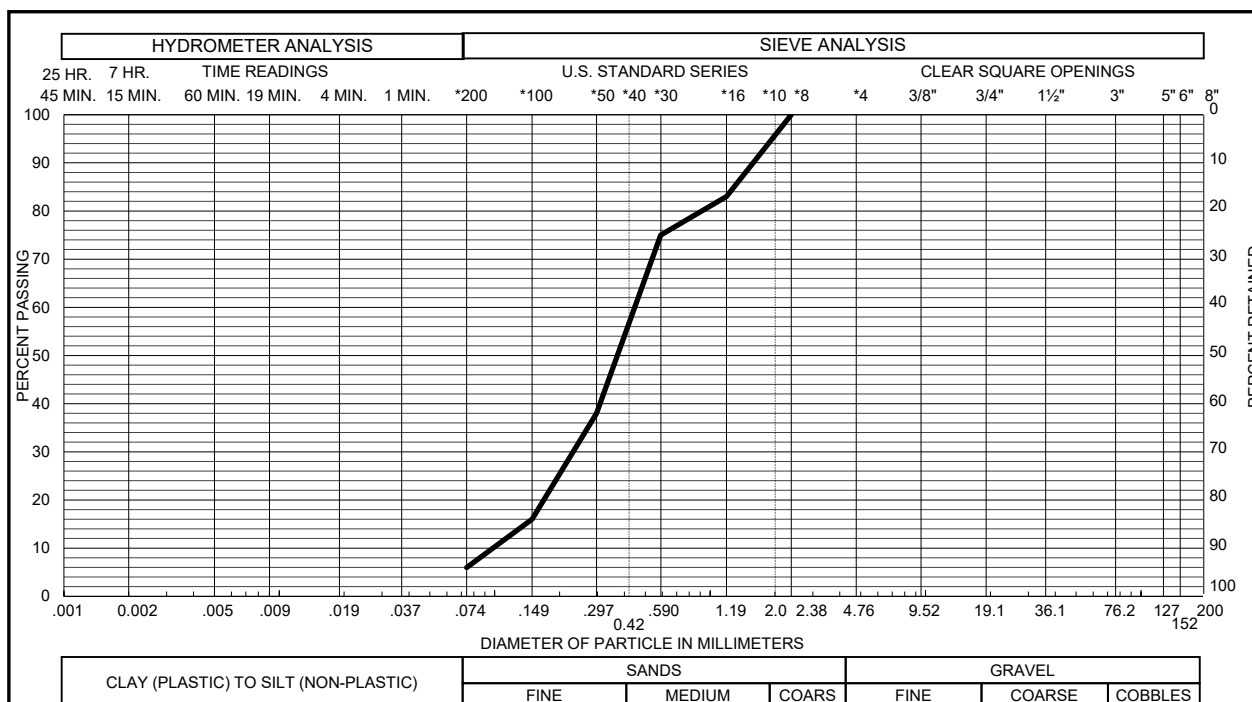
Sample of SAND, SLIGHTLY SILTY (SP-SM) GRAVEL 0 % SAND 94 %  
From TH - 2 AT 14 FEET SILT & CLAY 6 % LIQUID LIMIT      %  
PLASTICITY INDEX      %

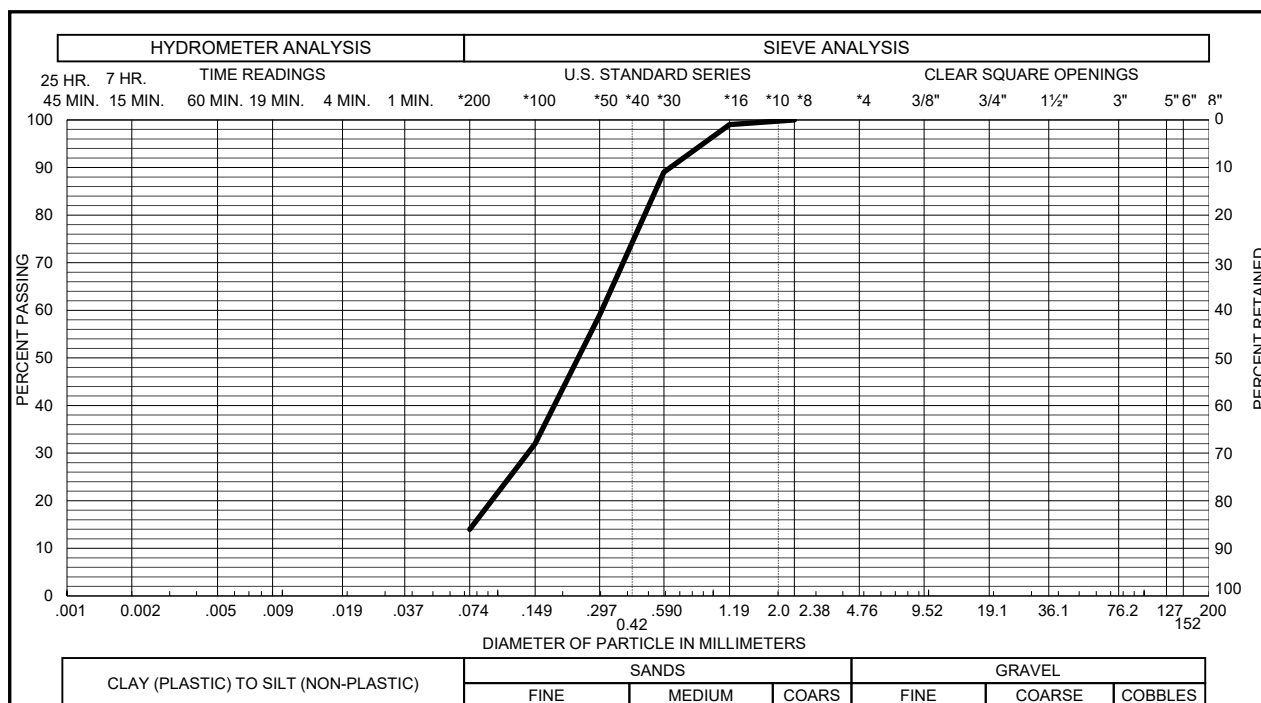
Sample of SAND, SILTY (SM) GRAVEL 0 % SAND 86 %  
From TH - 3 AT 19 FEET SILT & CLAY 14 % LIQUID LIMIT      %  
PLASTICITY INDEX      %

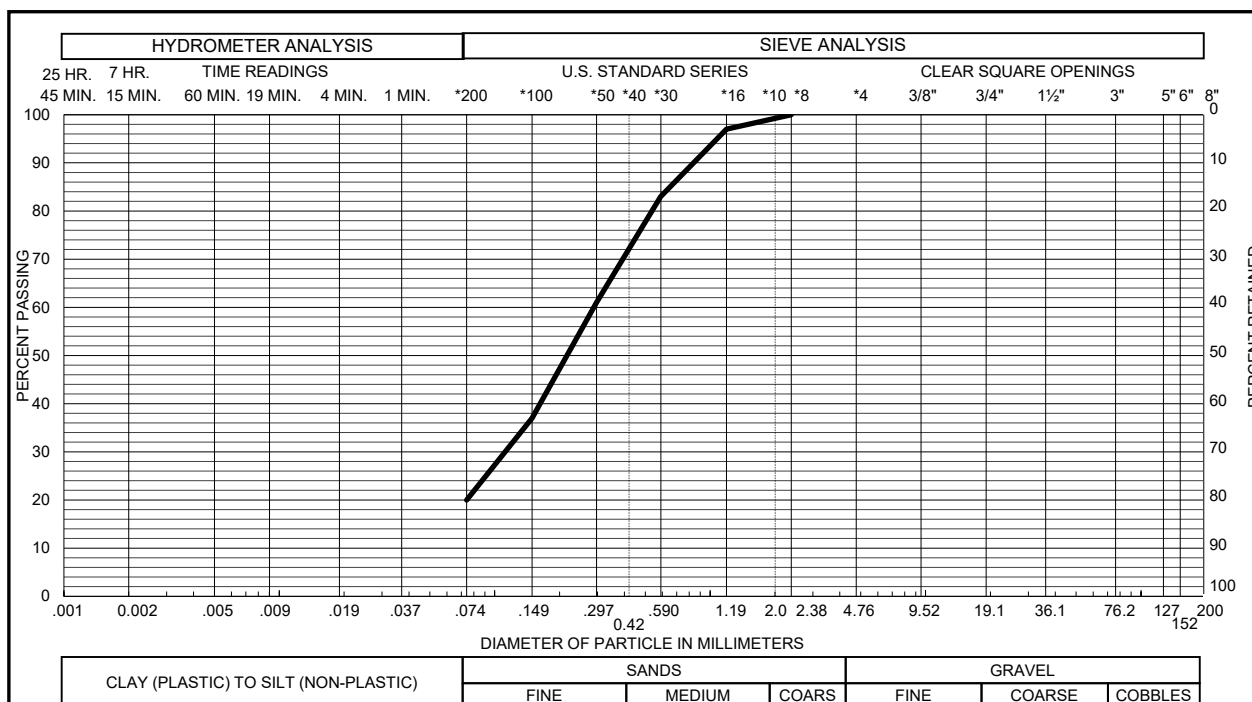
Sample of SAND, SILTY (SM) GRAVEL 0 % SAND 80 %  
From TH - 4 AT 24 FEET SILT & CLAY 20 % LIQUID LIMIT      %  
PLASTICITY INDEX      %

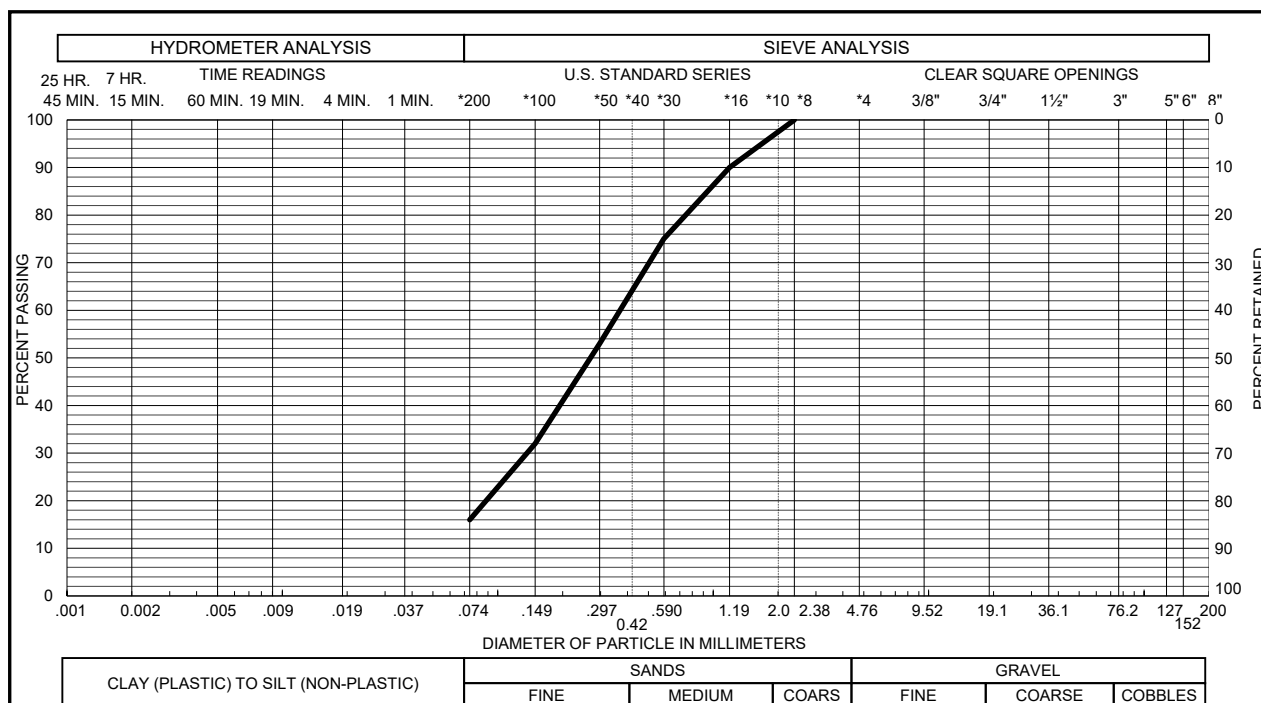
Sample of SAND, SILTY (SM) GRAVEL 0 % SAND 84 %  
From TH - 6 AT 4 FEET SILT & CLAY 16 % LIQUID LIMIT      %  
PLASTICITY INDEX      %

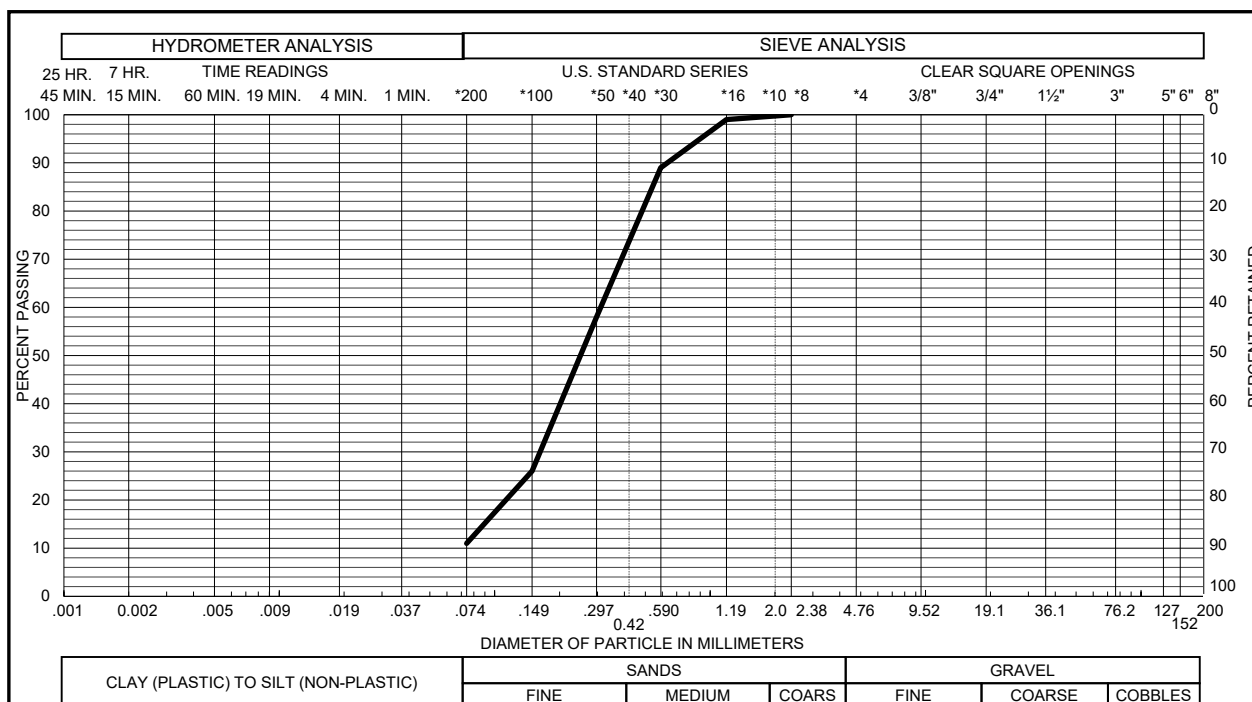
Sample of SAND, SLIGHTLY SILTY (SP-SM) GRAVEL 0 % SAND 89 %  
From TH - 7 AT 9 FEET SILT & CLAY 11 % LIQUID LIMIT      %  
PLASTICITY INDEX      %
