Subject: Review Comment Response  
Geologic Hazards Evaluation and  
Preliminary Geotechnical Investigation  
Crossroads North  
Marksheffel Road and State Highway 24  
El Paso County, Colorado  
Project No. CS18526.001-105

**GEOLOGIC HAZARDS EVALUATION AND  
PRELIMINARY GEOTECHNICAL INVESTIGATION  
CROSSROADS NORTH  
MARKSHEFFEL ROAD & STATE HIGHWAY 24  
EL PASO COUNTY, COLORADO**

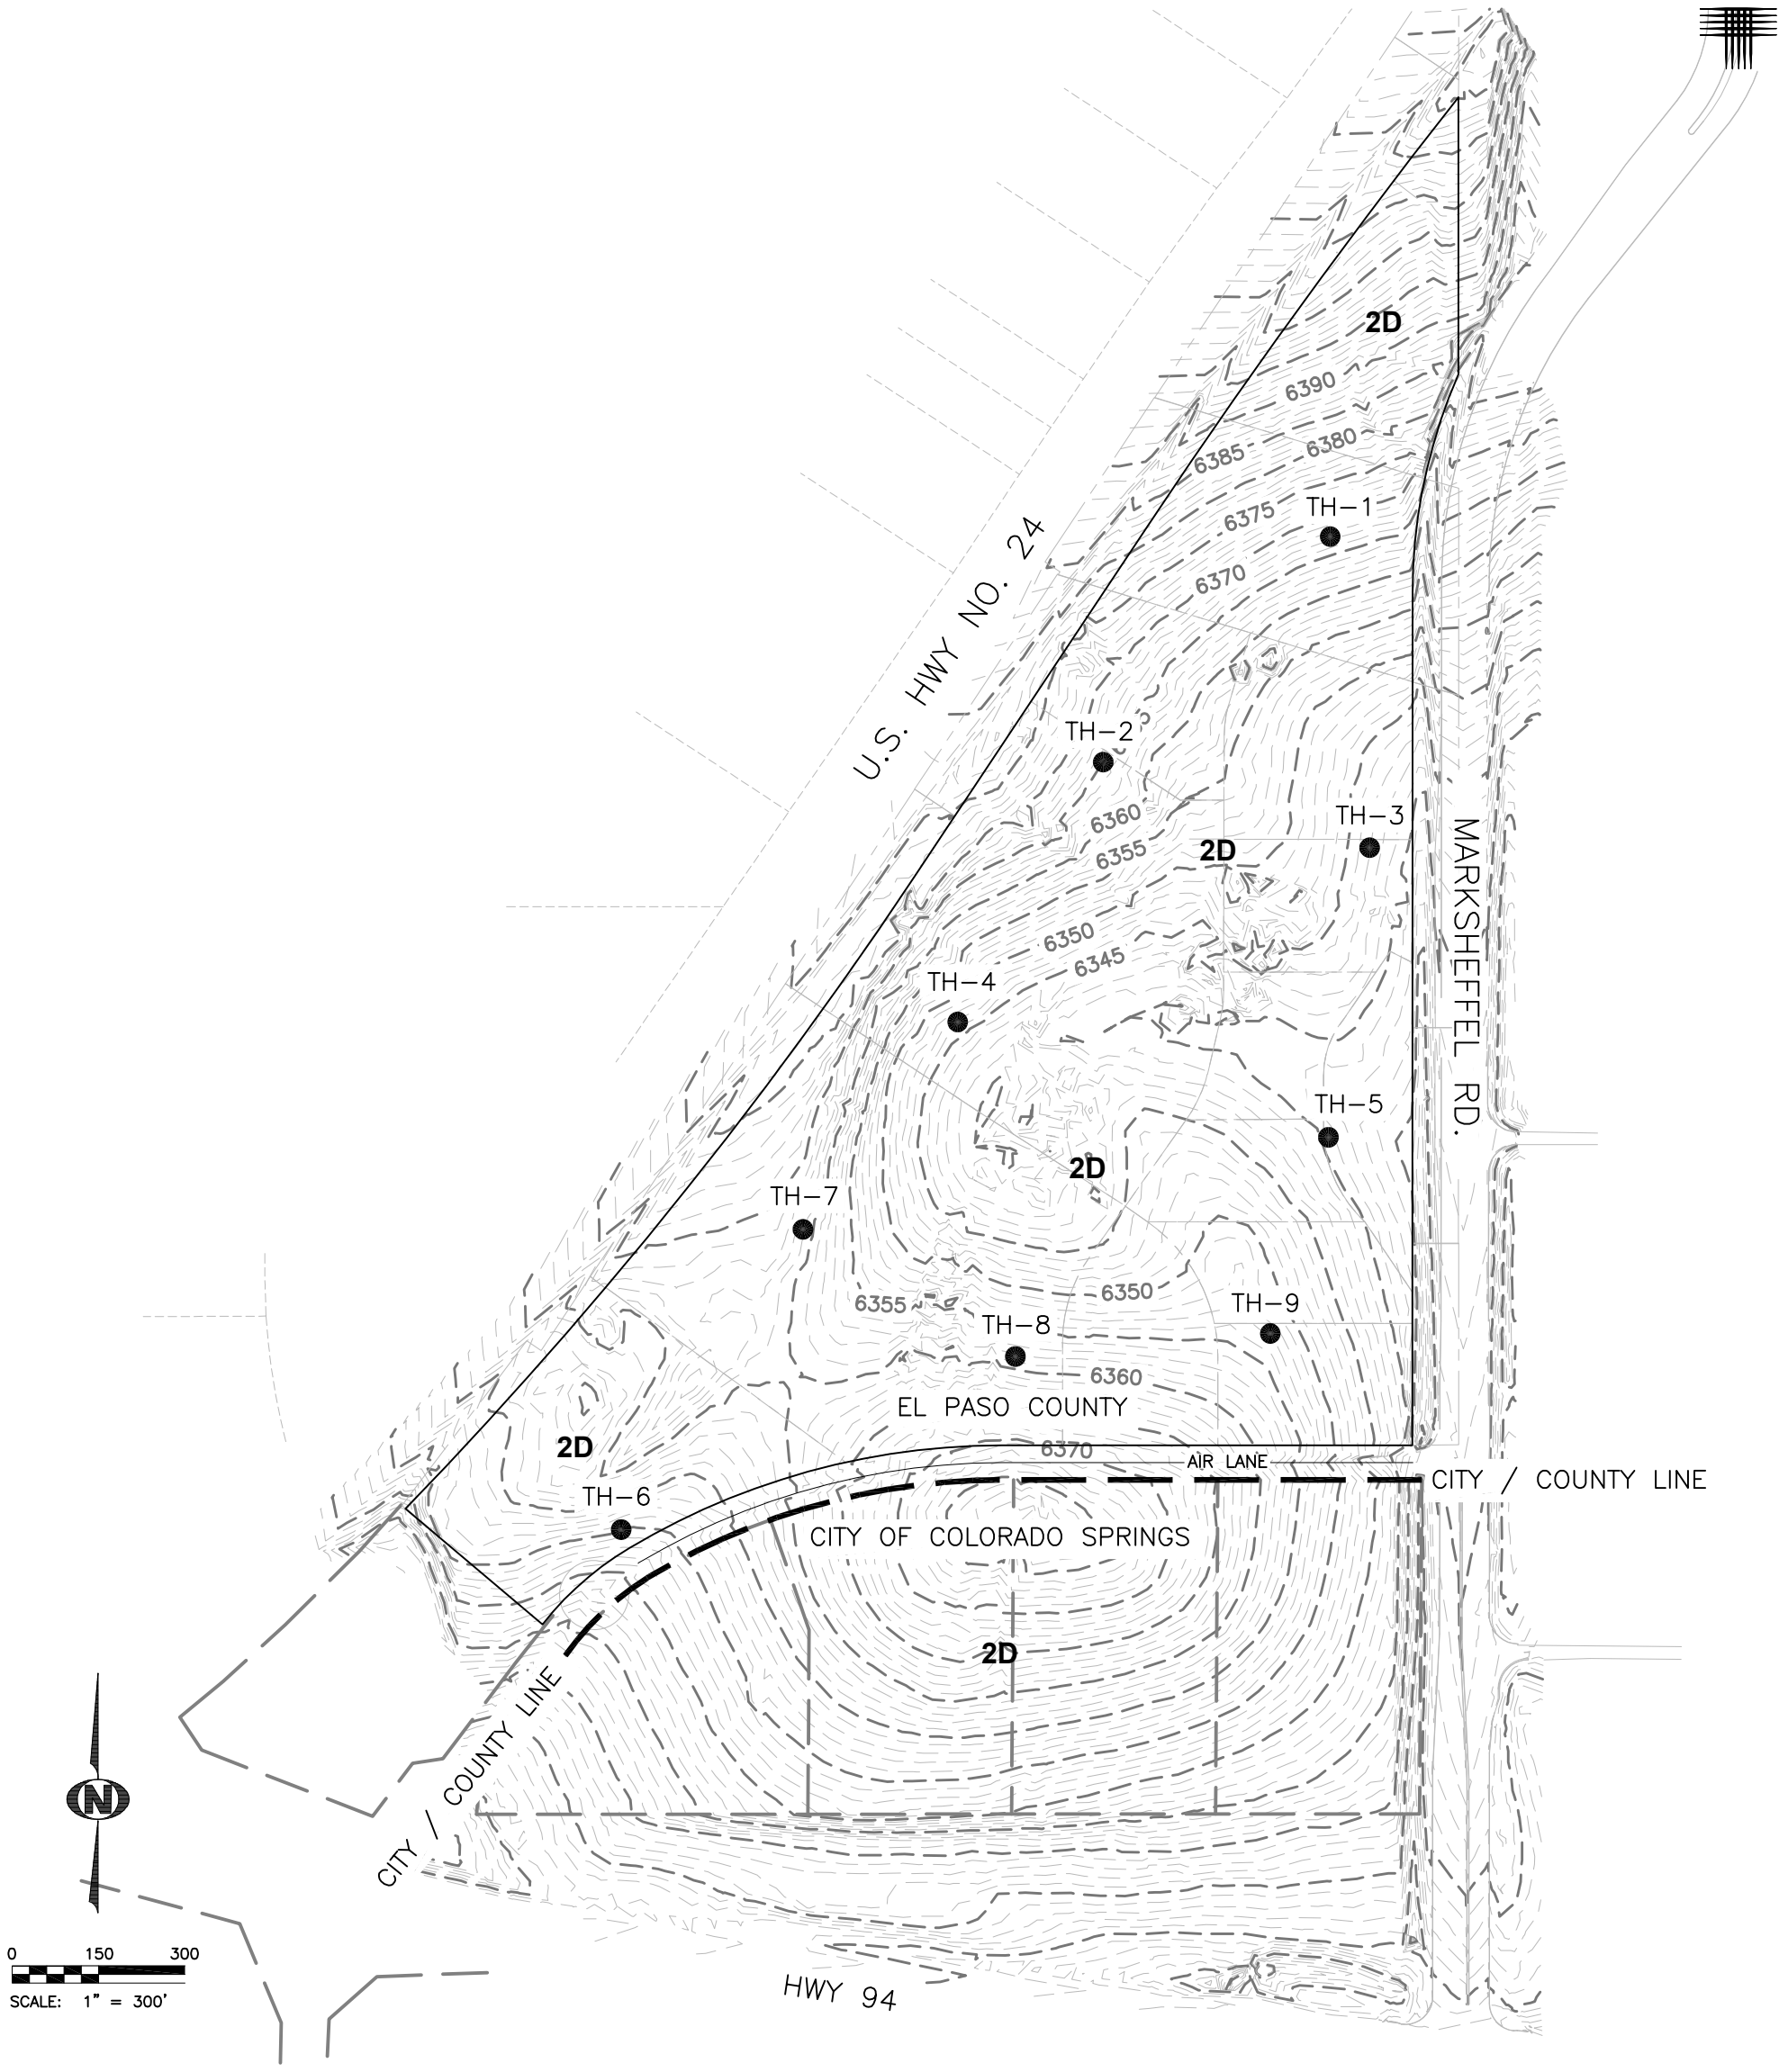
FIG. 3 – ENGINEERING CONDITIONS

- NOTES:
1. BASE DRAWING WAS PROVIDED BY THOMAS AND THOMAS (PROJECT NO. 3532.01, DATED MAY 18, 2016).
  2. ALL BOUNDARIES SHOWN SHOULD BE CONSIDERED APPROXIMATE. THEY ARE BASED UPON A SUBJECTIVE INTERPRETATION OF PUBLISHED MAPS, AERIAL PHOTOGRAPHS, AND AN INITIAL FIELD RECONNAISSANCE. CHANGES IN THE MAPPED BOUNDARIES SHOWN ARE POSSIBLE AND SHOULD BE EXPECTED WITH MORE DETAILED WORK AND FURTHER INFORMATION. ALL INTERPRETATIONS AND CONDITIONS SHOWN ARE PRELIMINARY AND FOR INITIAL LAND-USE PLANNING ONLY.
  3. MAP LEGEND IS MODIFIED FROM CHARLES S. ROBINSON & ASSOCIATES, INC., GOLDEN, COLORADO, DATED 1977.

ENGINEERING UNITS AND (MODIFIERS)

- 2D**      EOLIAN DEPOSITS GENERALLY ON FLAT TO GENTLE SLOPES OF UPLAND AREAS.

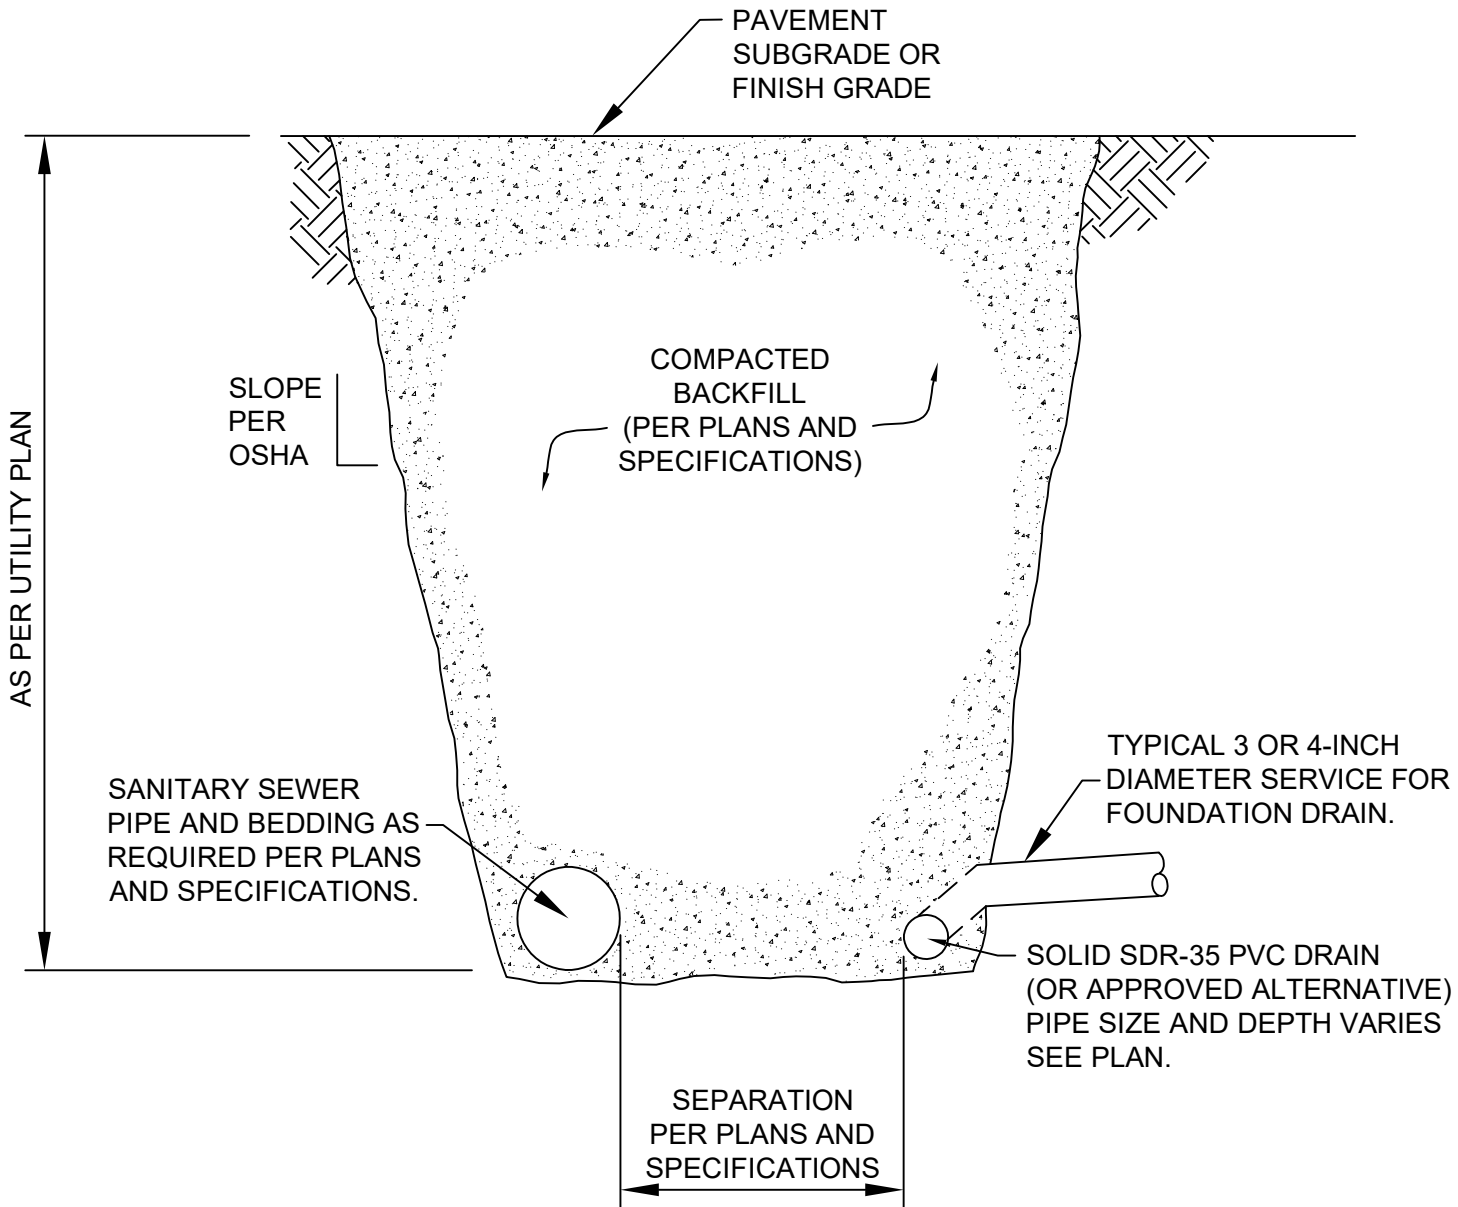
NOTE:  
TO BE USED IN CASES WHERE NO  
GROUND WATER IS KNOWN TO EXIST.

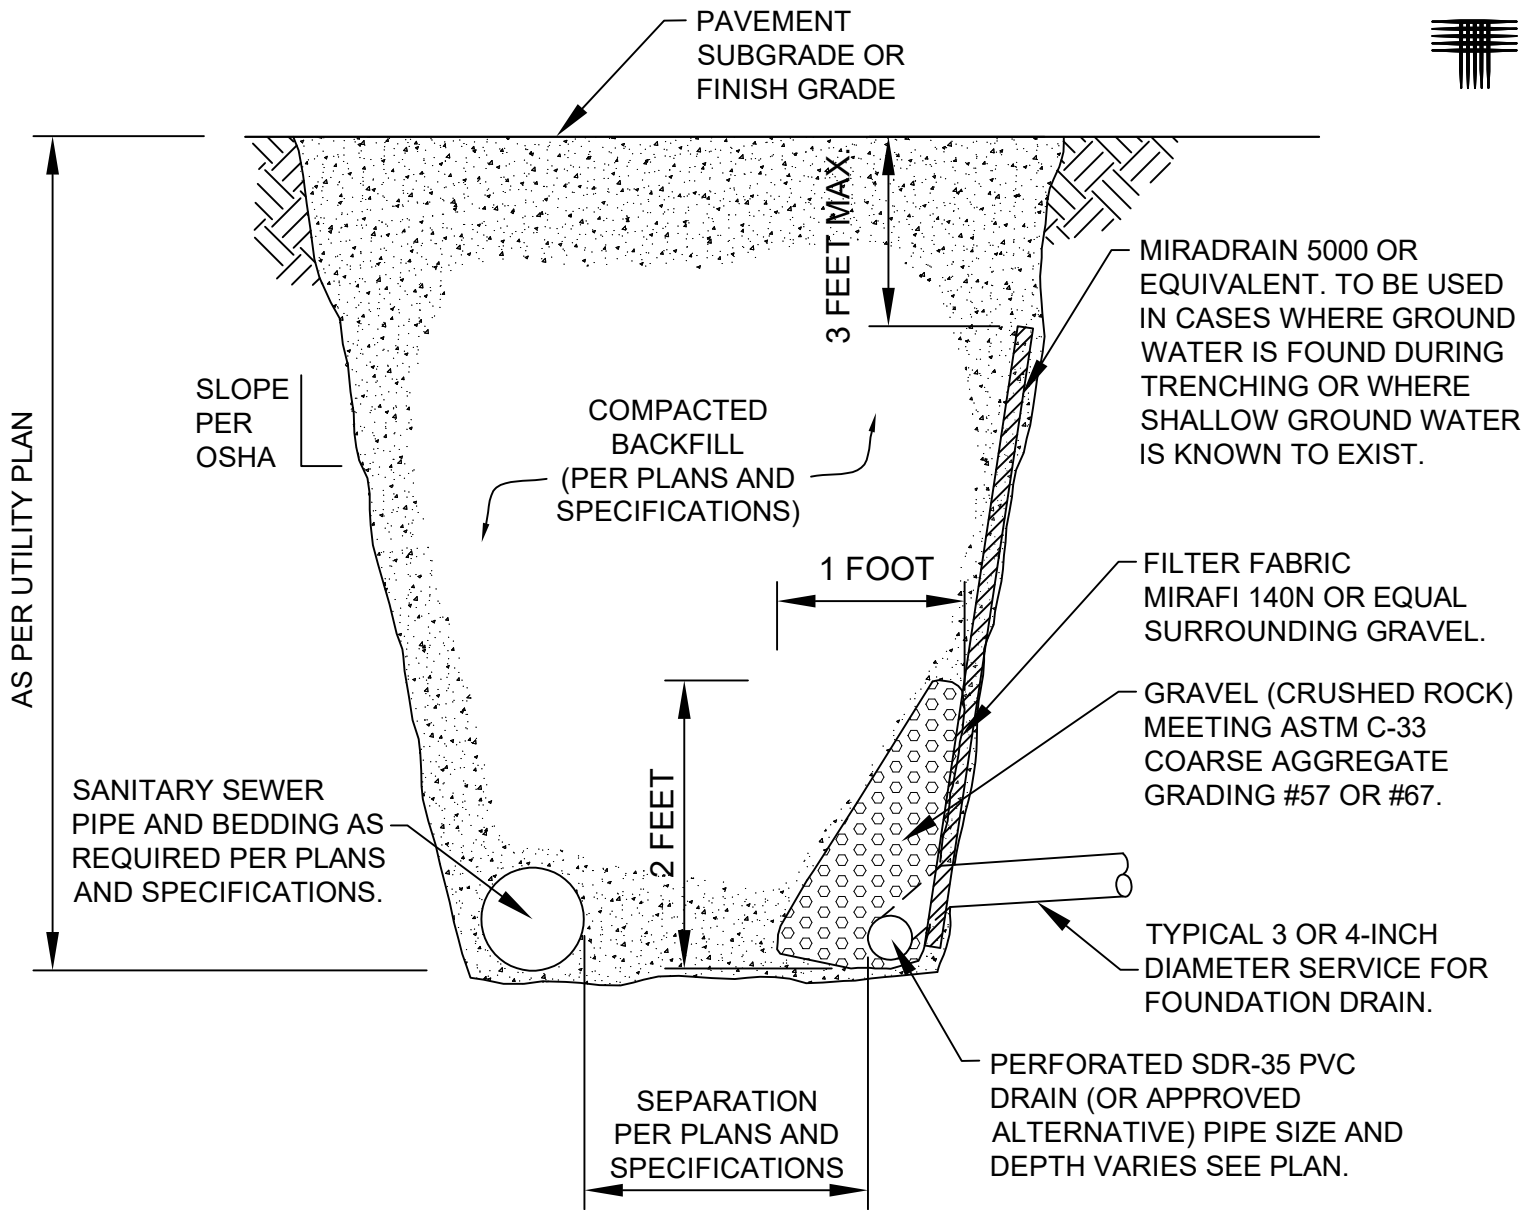
GRADING REQUIREMENTS FOR COARSE AGGREGATES PER ASTM C-33

SIZE NUMBER	NOMINAL SIZE (SIEVES WITH SQUARE OPENINGS)	AMOUNTS FINER THAN EACH LABORATORY SIEVE (SQUARE OPENINGS), WEIGHT PERCENT						
		1 1/2 INCH (37.5 mm)	1 INCH (25.0 mm)	3/4 INCH (19.0 mm)	1/2 INCH (12.5 mm)	3/8 INCH (9.5 mm)	NO. 4 (4.5 mm)	NO. 8 (2.36 mm)
67	3/4 INCH TO NO. 4 (19.0 TO 4.75 mm)	--	100	90 TO 100	--	20 TO 55	0 TO 10	0 TO 5
57	1 INCH TO NO. 4 (25.0 TO 9.5 mm)	100	95 TO 100	--	25 TO 60	--	0 TO 10	0 TO 5

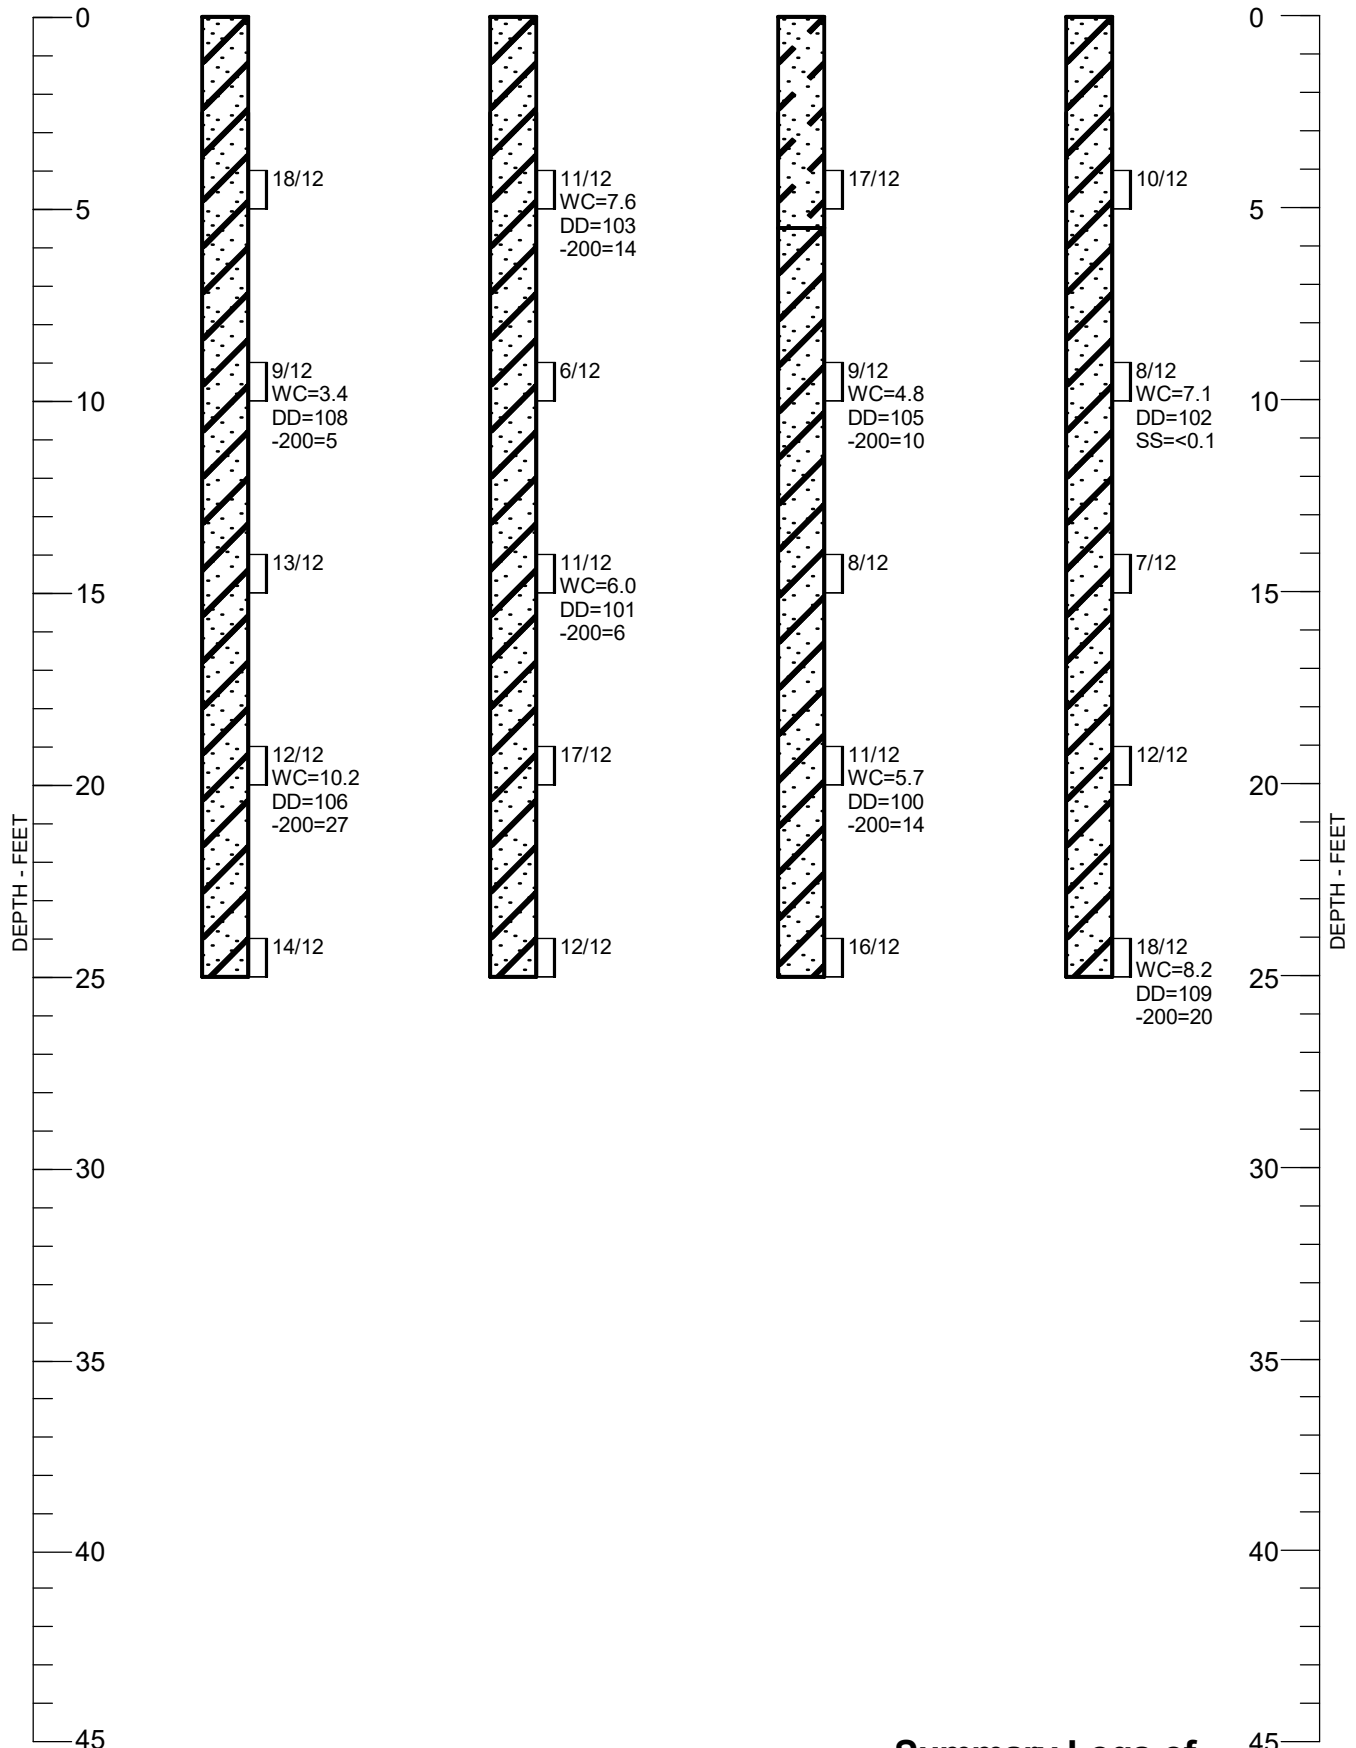
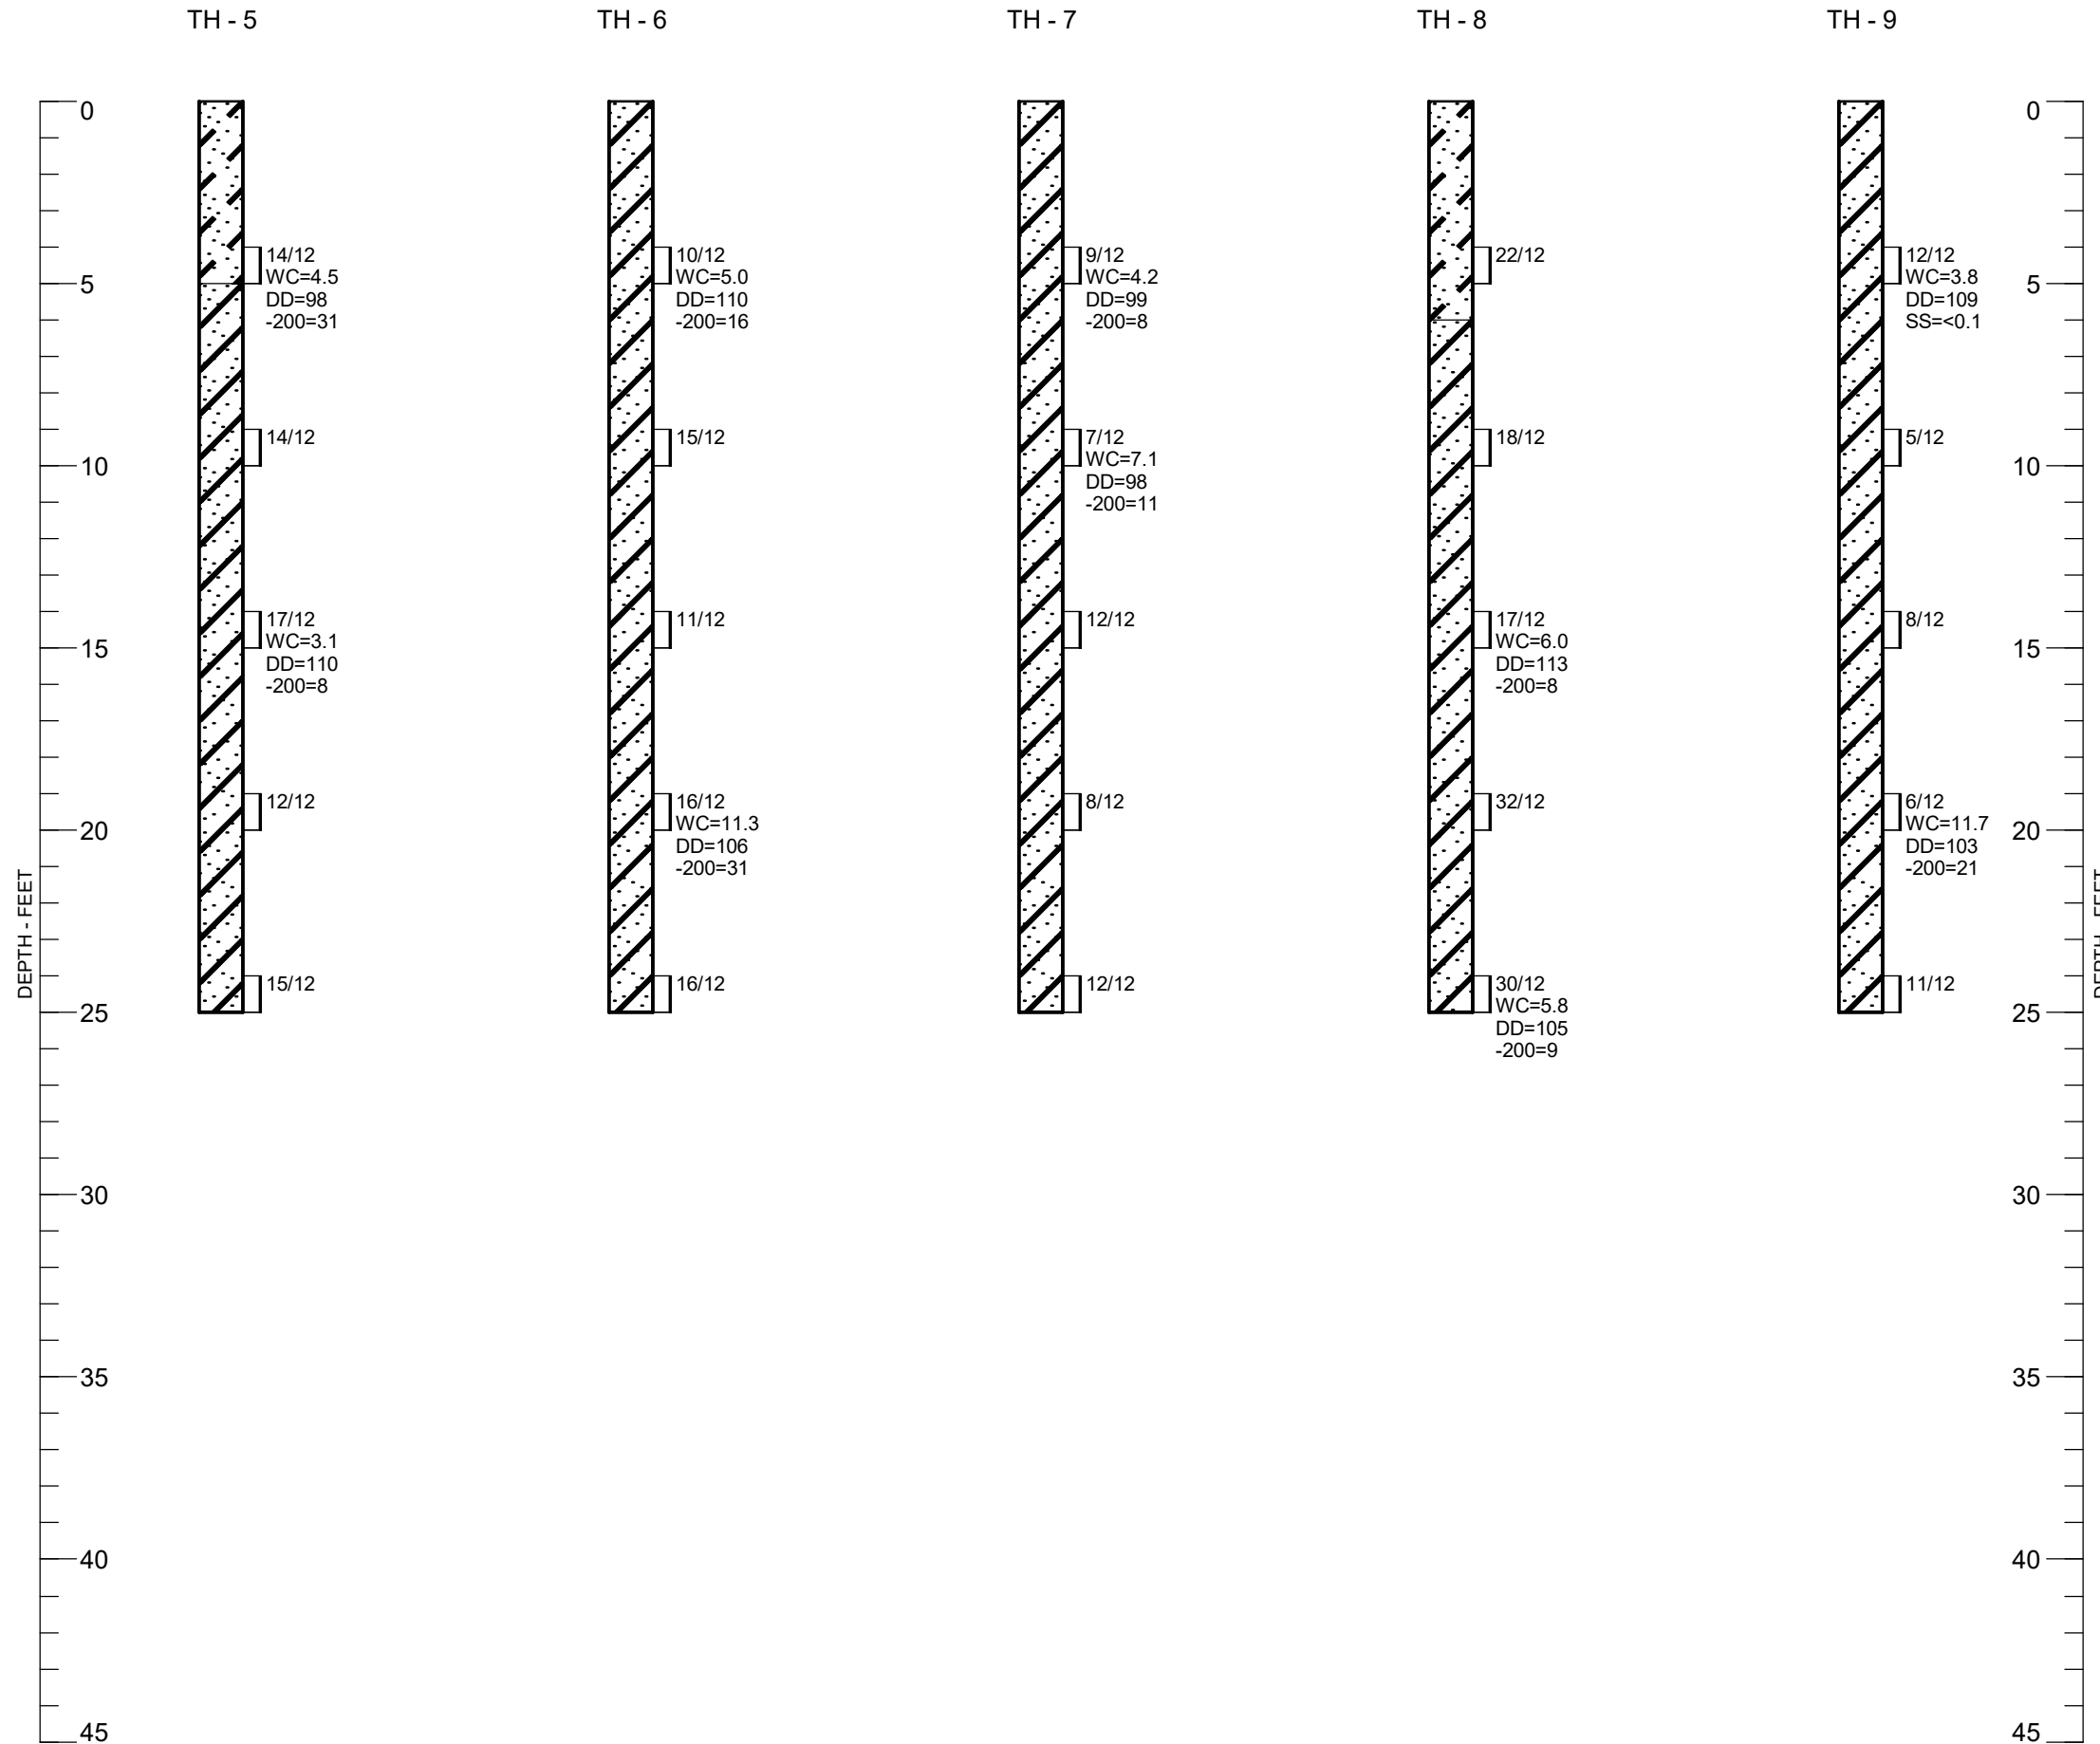
TH - 3

TH - 4

**LEGEND:**

- SAND, CLAYEY, MEDIUM DENSE, SLIGHTLY MOIST, LIGHT TO MEDIUM BROWN. (SC)
- SAND, SLIGHTLY SILTY TO SILTY, LOOSE TO MEDIUM DENSE, SLIGHTLY MOIST TO MOIST, LIGHT TO MEDIUM BROWN. (SP-SM, SM)
- DRIVE SAMPLE. THE SYMBOL 18/12 INDICATES 18 BLOWS OF A 140-POUND HAMMER FALLING 30 INCHES WERE REQUIRED TO DRIVE A 2.5-INCH O.D. SAMPLER 12 INCHES.

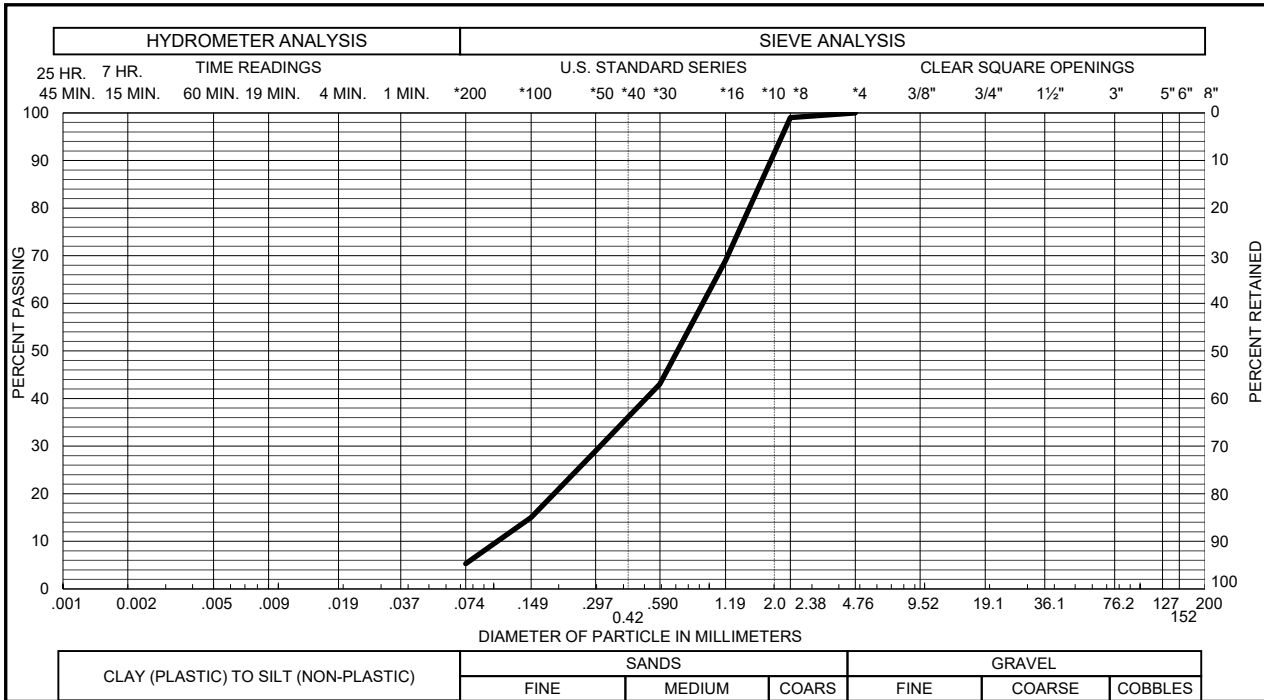
Sample of SAND, SLIGHTLY SILTY (SP-SM) GRAVEL 0 % SAND 95 %  
 From TH - 1 AT 9 FEET SILT & CLAY 5 % LIQUID LIMIT      %  
 PLASTICITY INDEX      %

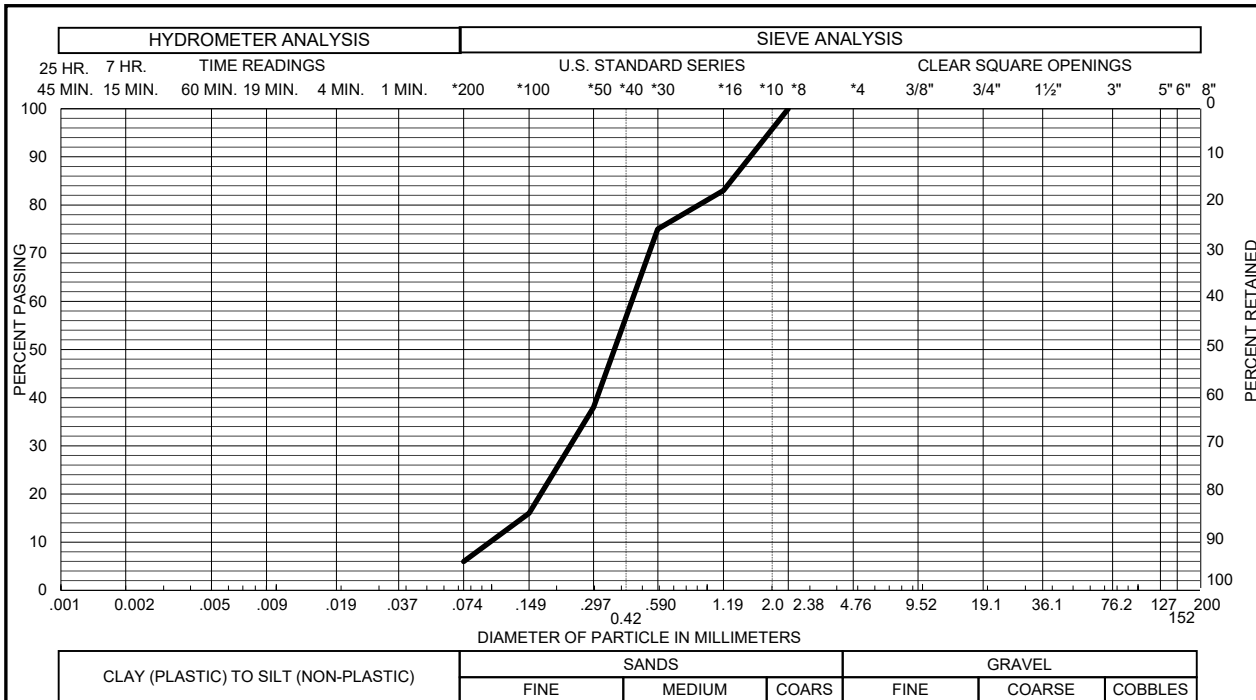
Sample of SAND, SLIGHTLY SILTY (SP-SM) GRAVEL 0 % SAND 94 %  
 From TH - 2 AT 14 FEET SILT & CLAY 6 % LIQUID LIMIT      %  
 PLASTICITY INDEX      %

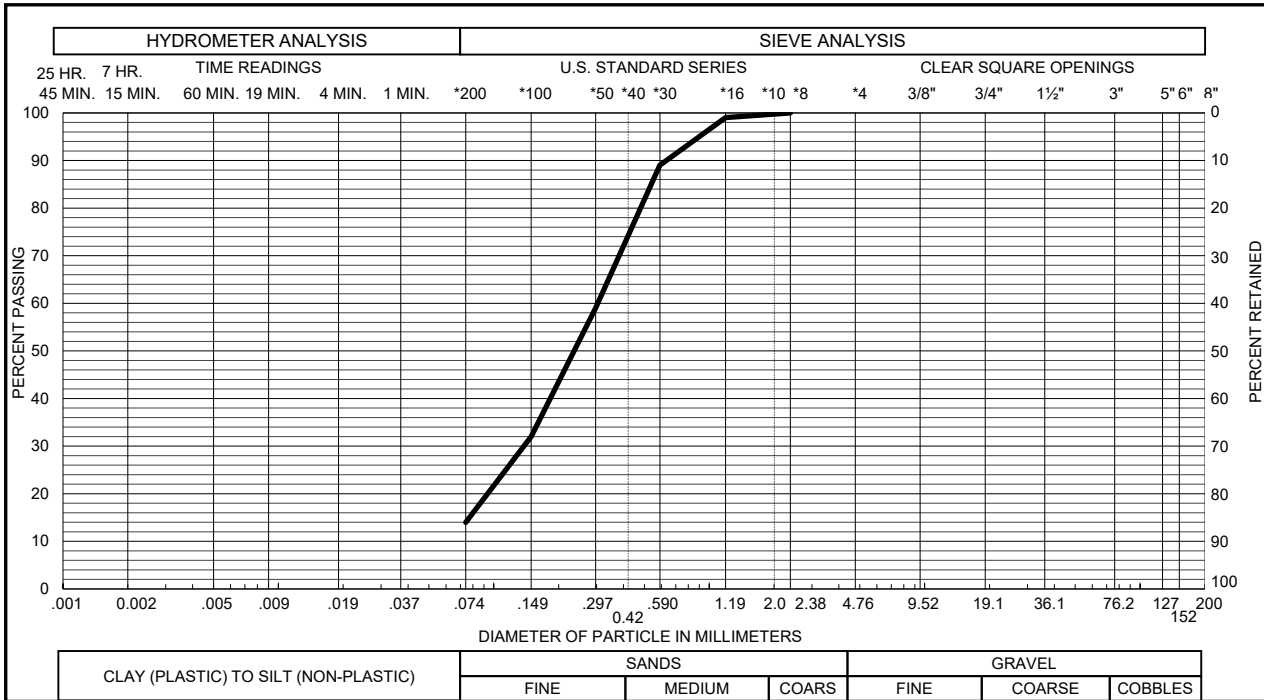
Sample of SAND, SILTY (SM) GRAVEL 0 % SAND 86 %  
 From TH - 3 AT 19 FEET SILT & CLAY 14 % LIQUID LIMIT     %   
 PLASTICITY INDEX     %

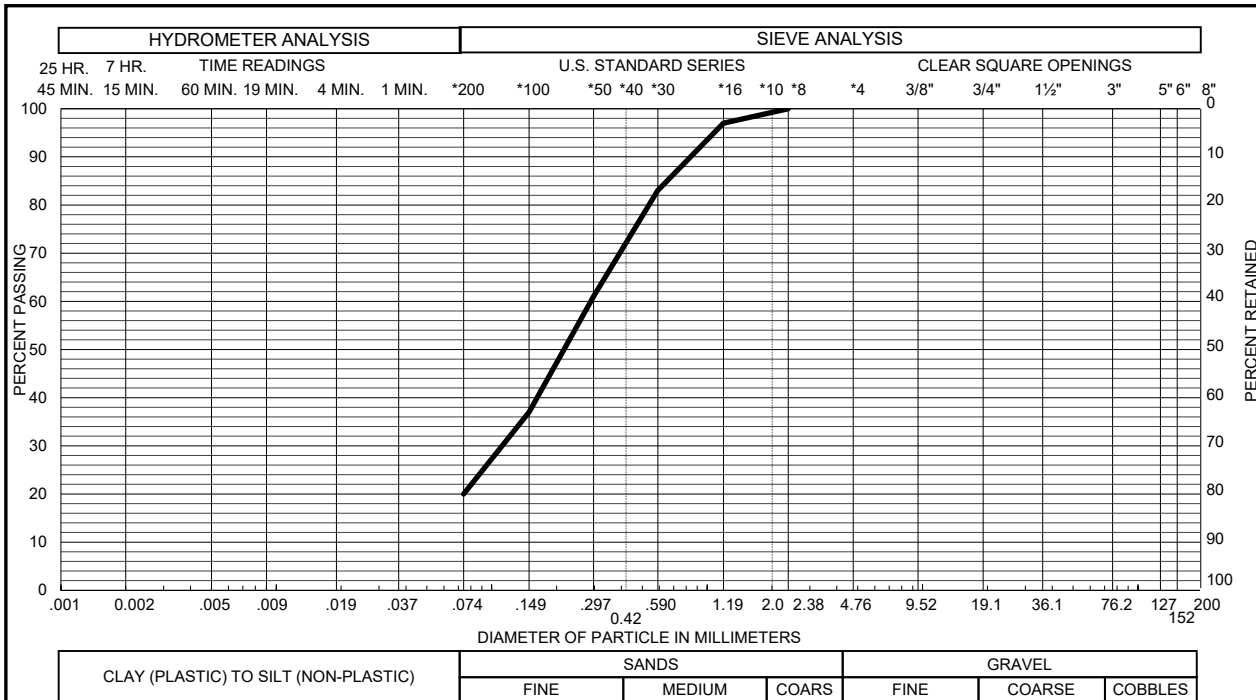
Sample of SAND, SILTY (SM) GRAVEL 0 % SAND 80 %  
 From TH - 4 AT 24 FEET SILT & CLAY 20 % LIQUID LIMIT     %   
 PLASTICITY INDEX     %

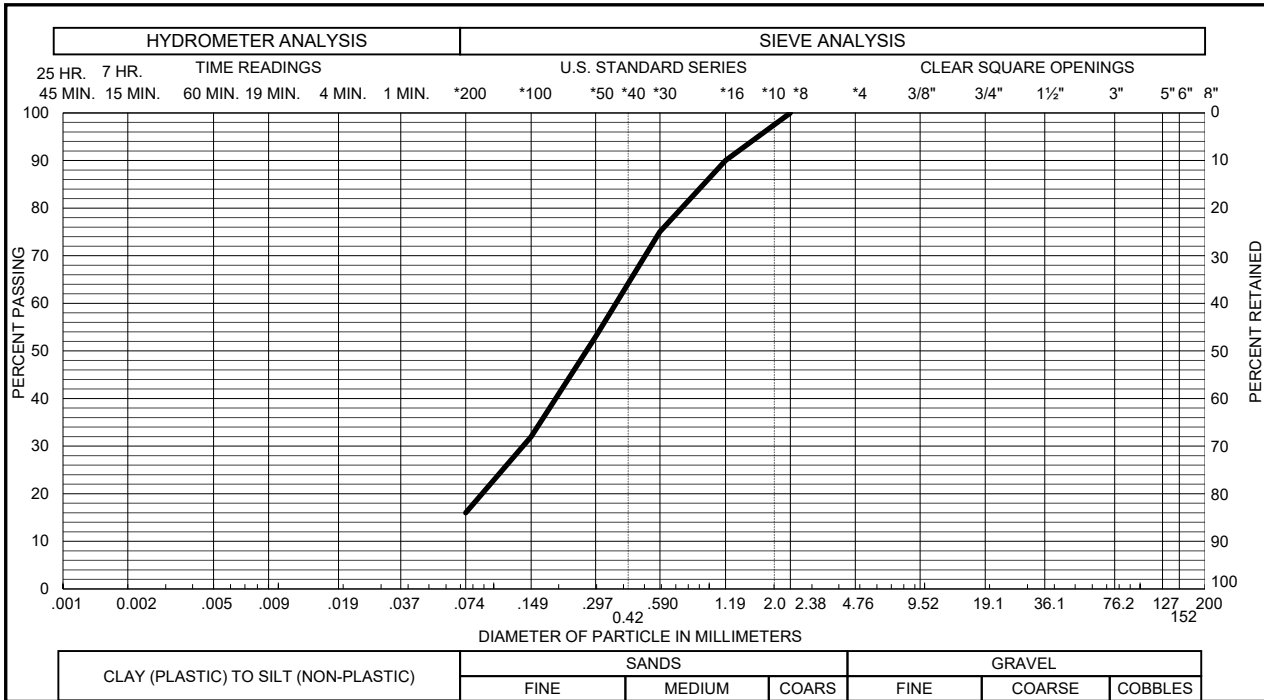
Sample of SAND, SILTY (SM) GRAVEL 0 % SAND 84 %  
 From TH - 6 AT 4 FEET SILT & CLAY 16 % LIQUID LIMIT     %   
 PLASTICITY INDEX     %

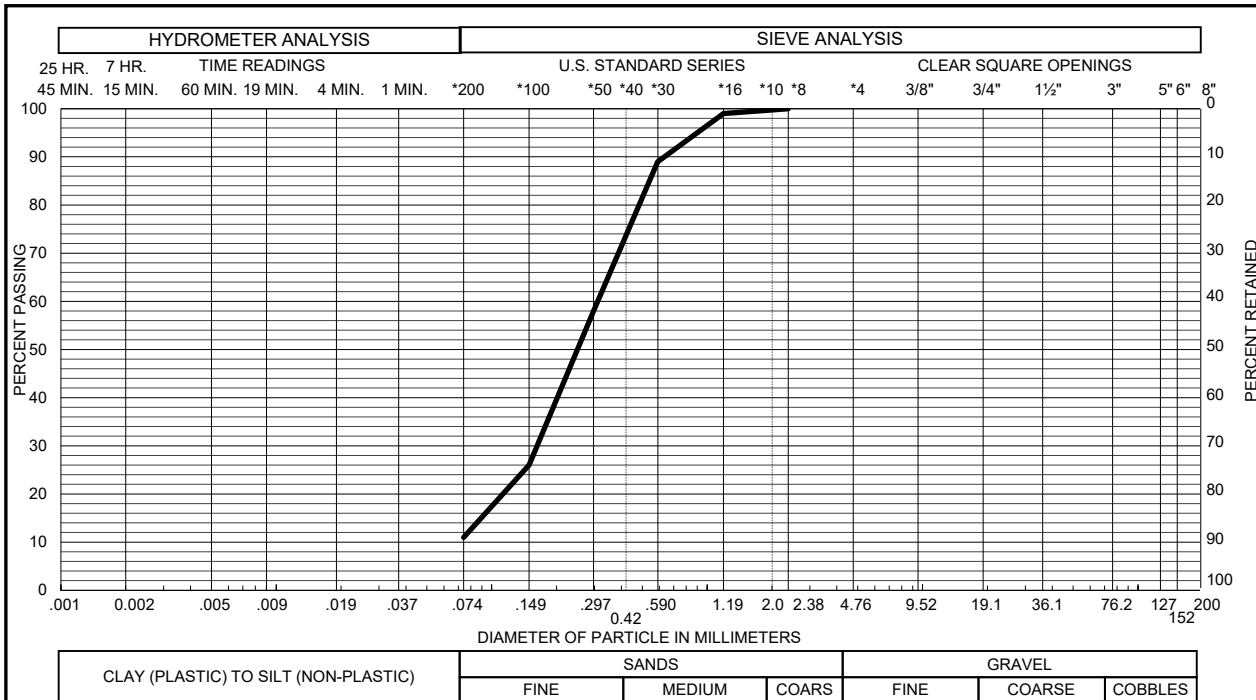
Sample of SAND, SLIGHTLY SILTY (SP-SM) GRAVEL 0 % SAND 89 %  
 From TH - 7 AT 9 FEET SILT & CLAY 11 % LIQUID LIMIT     %   
 PLASTICITY INDEX     %

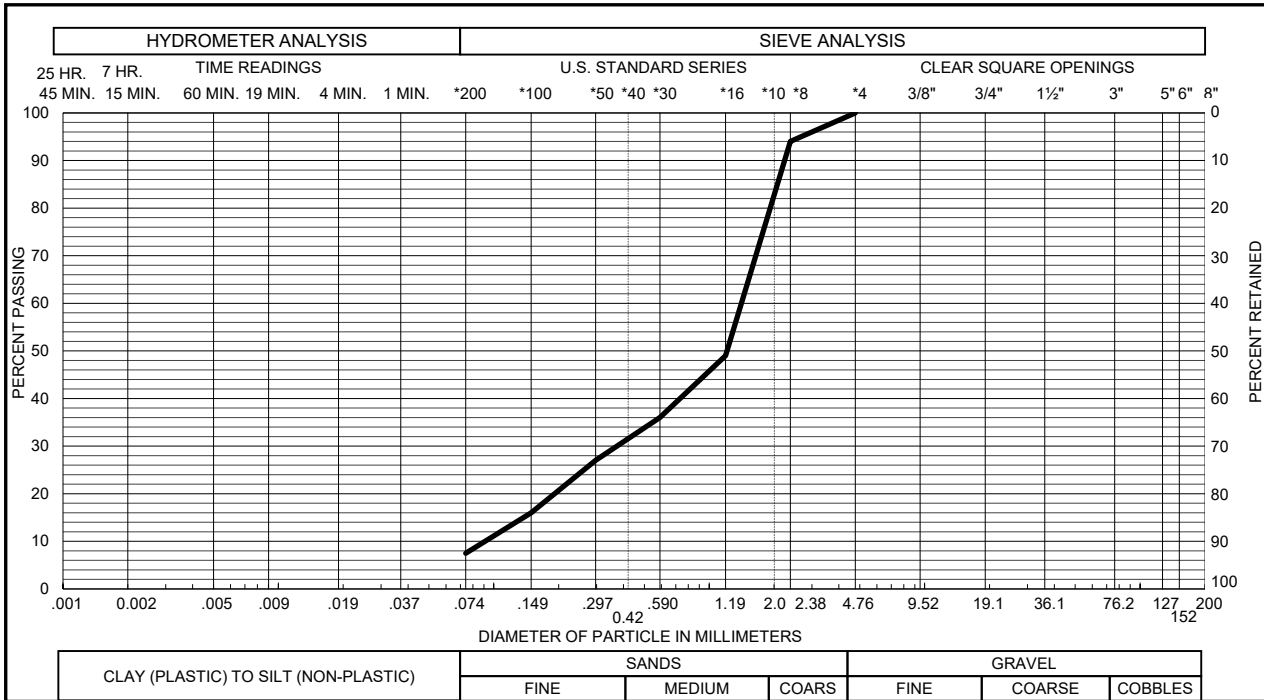
Sample of SAND, SLIGHTLY SILTY (SP-SM) GRAVEL 0 % SAND 92 %  
 From TH - 8 AT 14 FEET SILT & CLAY 8 % LIQUID LIMIT      %  
 PLASTICITY INDEX      %

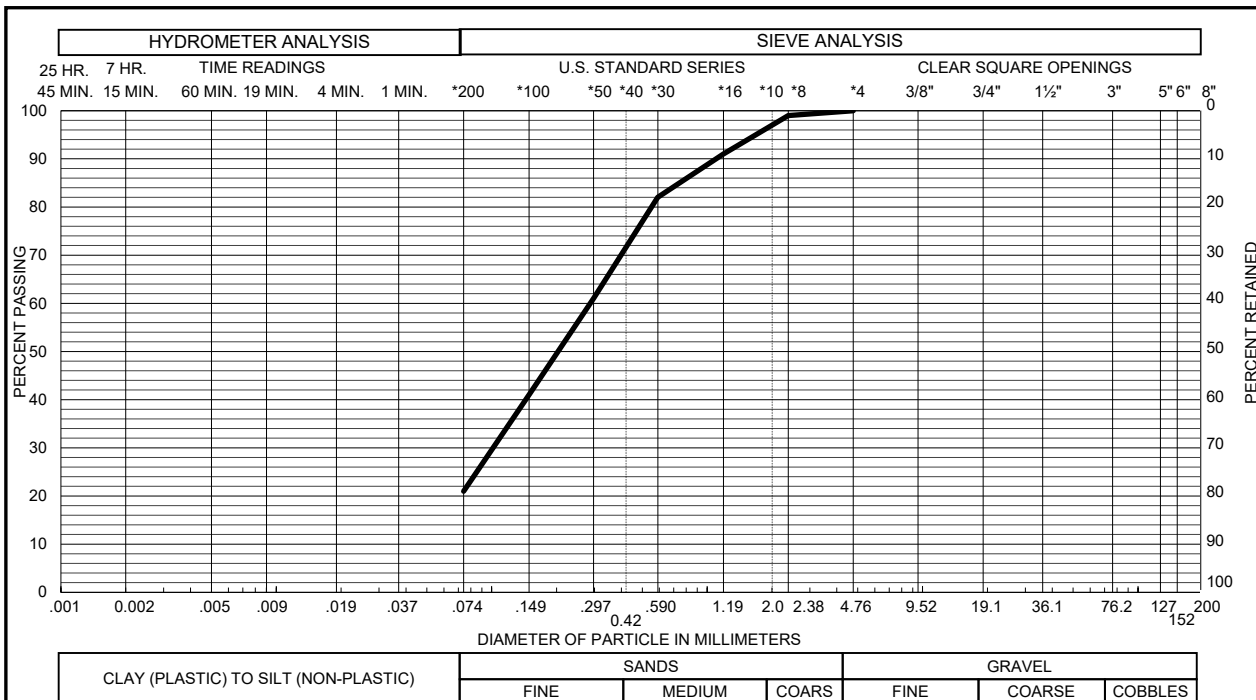
Sample of SAND, SILTY (SM) GRAVEL 0 % SAND 79 %  
 From TH - 9 AT 19 FEET SILT & CLAY 21 % LIQUID LIMIT      %  
 PLASTICITY INDEX      %
