GEOLOGY AND SOILS REPORT

**Riverbend Crossing, Filings No 1 and 2
Fountain, Colorado**

**Avatar Fountain, LP
P.O. Box 927215
San Diego, CA 92192**

JOB NO. 161921

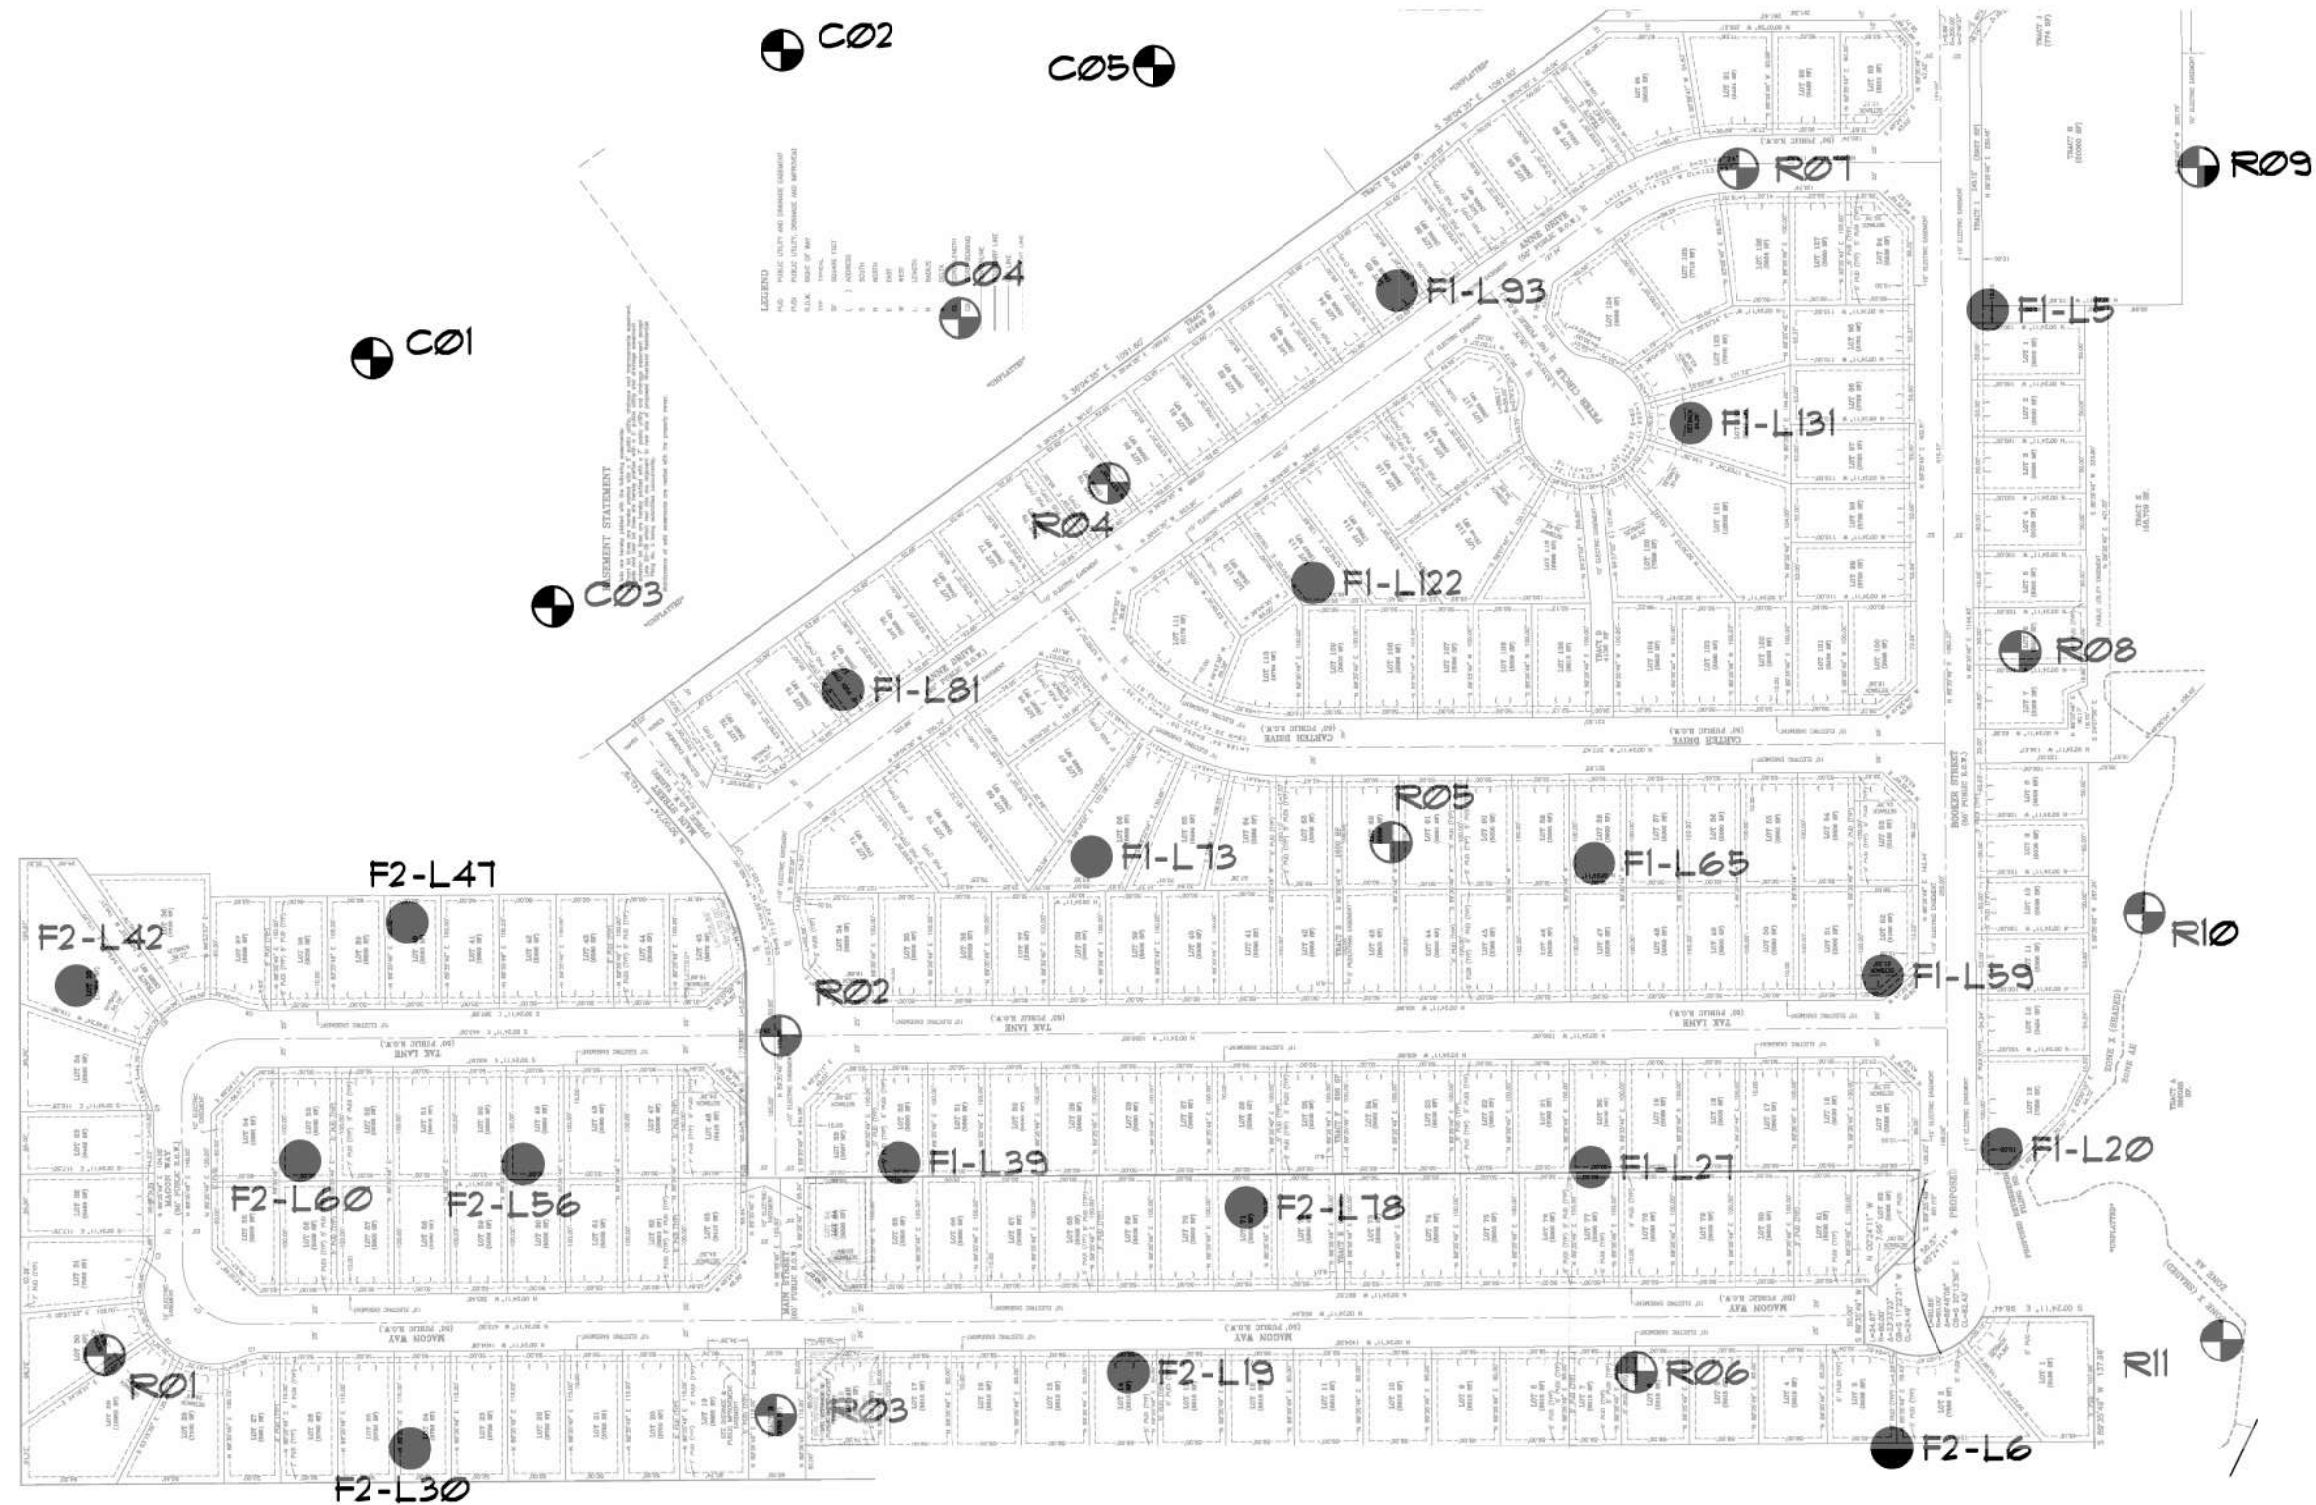
FIG-4

RIVERBEND CROSSING
FILING NO. 1 & 2
FOUNTAIN, COLORADO
AVATAR FOUNTAIN, LP

The test borings were drilled with a power-driven, continuous-flight auger drill rig. Samples were obtained during drilling of the test borings in general accordance with ASTM D-1586 and D-3550, utilizing a 2-inch O.D. Split Barrel Sampler and a 2½-inch O.D. California sampler, respectively. Results of the penetration tests are shown on the drilling logs. The Preliminary Concept Plan with Test Boring Locations is presented in Figure 4. An Explanation of Test Boring Logs, Test Boring Logs are presented in Appendix A.

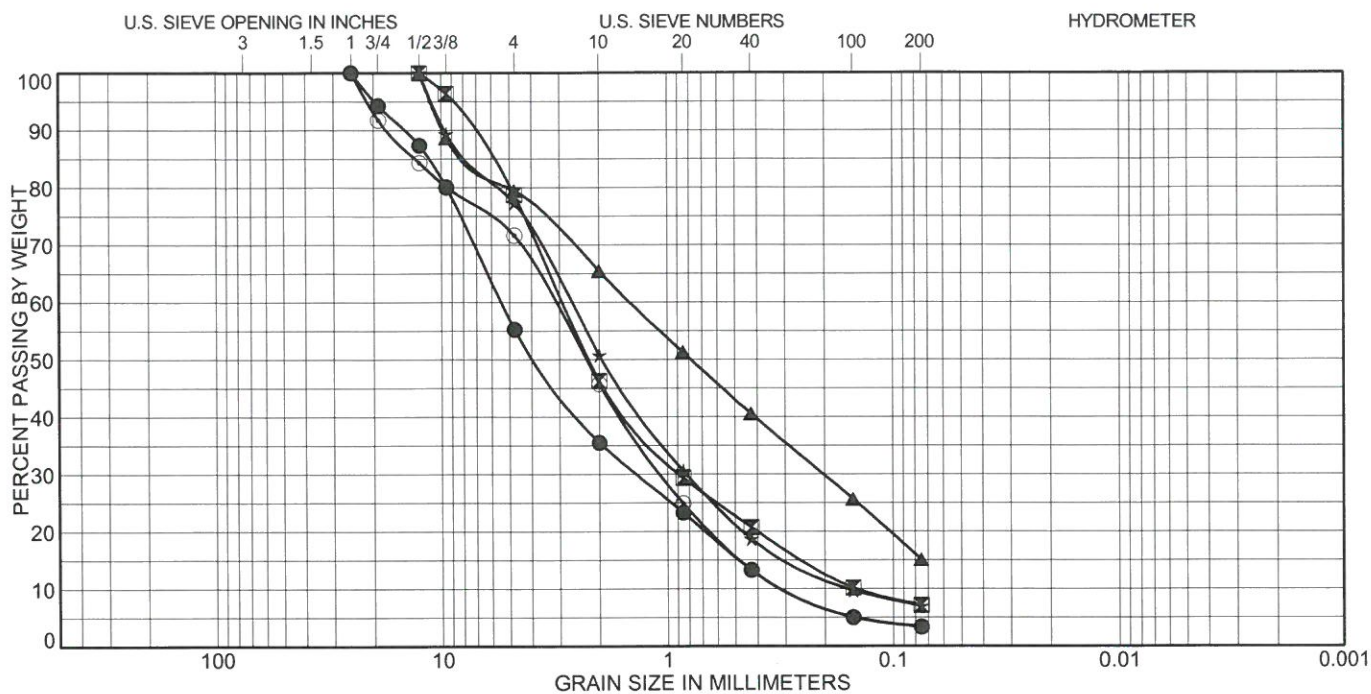
FIGURE No. 13

COBBLES	GRAVEL		SAND			SILT OR CLAY
	coarse	fine	coarse	medium	fine

Test Boring	Depth (ft)	Classification	LL	PL	PI
● C01	9.0	WELL-GRADED SAND with GRAVEL(SW)	NP	NP	NP
⊠ C02	14.0	WELL-GRADED SAND with SILT and GRAVEL(SW-SM)	NP	NP	NP
▲ C03	4.0	SILTY SAND with GRAVEL(SM)	NP	NP	NP
★ C04	9.0	WELL-GRADED SAND with SILT and GRAVEL(SW-SM)	NP	NP	NP
⊙ C05	14.0	WELL-GRADED SAND with GRAVEL(SW)	NP	NP	NP

The moisture content for the recovered samples was obtained in the laboratory. Grain-size analysis, Atterberg Limits, and Denver Swell/Consolidation tests were performed on selected samples for purposes of classification and to develop pertinent engineering properties. A Summary of Laboratory Test Results is presented in Figure 12. Soil Classification Data are presented in Figures 13 through 16. Swell/Consolidation Test Results are presented in Figure 17.

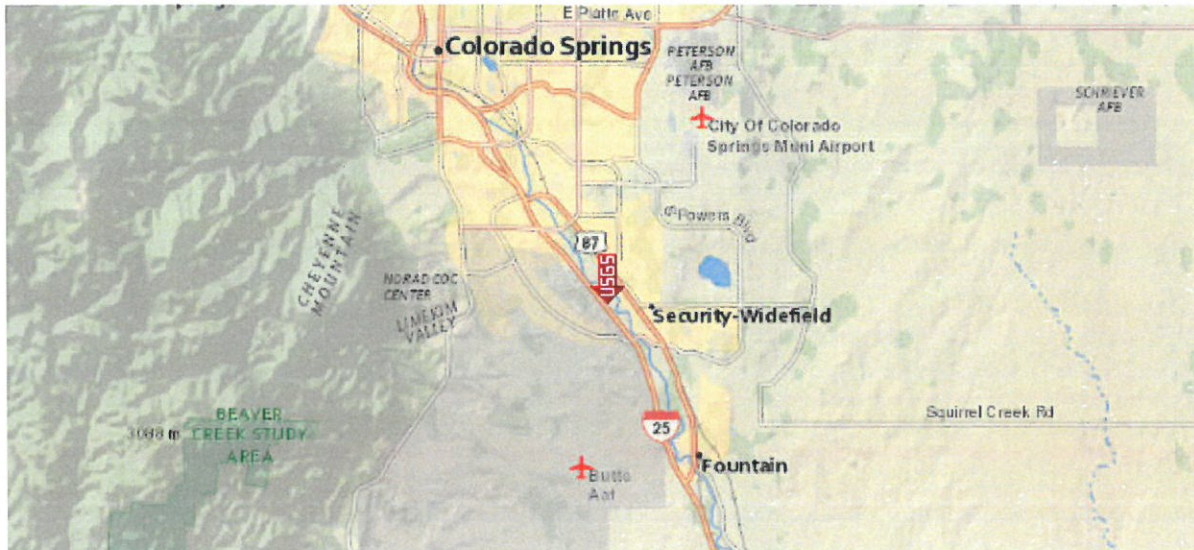
Site Soil Classification Site Class D - "Stiff Soil"

USGS-Provided Output

$S_s = 0.175 \text{ g}$	$S_{MS} = 0.280 \text{ g}$	$S_{DS} = 0.187 \text{ g}$
$S_1 = 0.060 \text{ g}$	$S_{M1} = 0.145 \text{ g}$	$S_{D1} = 0.097 \text{ g}$
