Re: Wastewater Study  
Mountain's Edge Subdivision  
McClelland Road & Farmhouse Court  
Parcel No. 32000-00-740  
El Paso County, Colorado

As requested, personnel of Entech Engineering, Inc. performed a wastewater study for the 30.6-acre parcel to be replatted into five (5) rural residential lots to evaluate the conditions with respect to on-site wastewater treatment suitability.

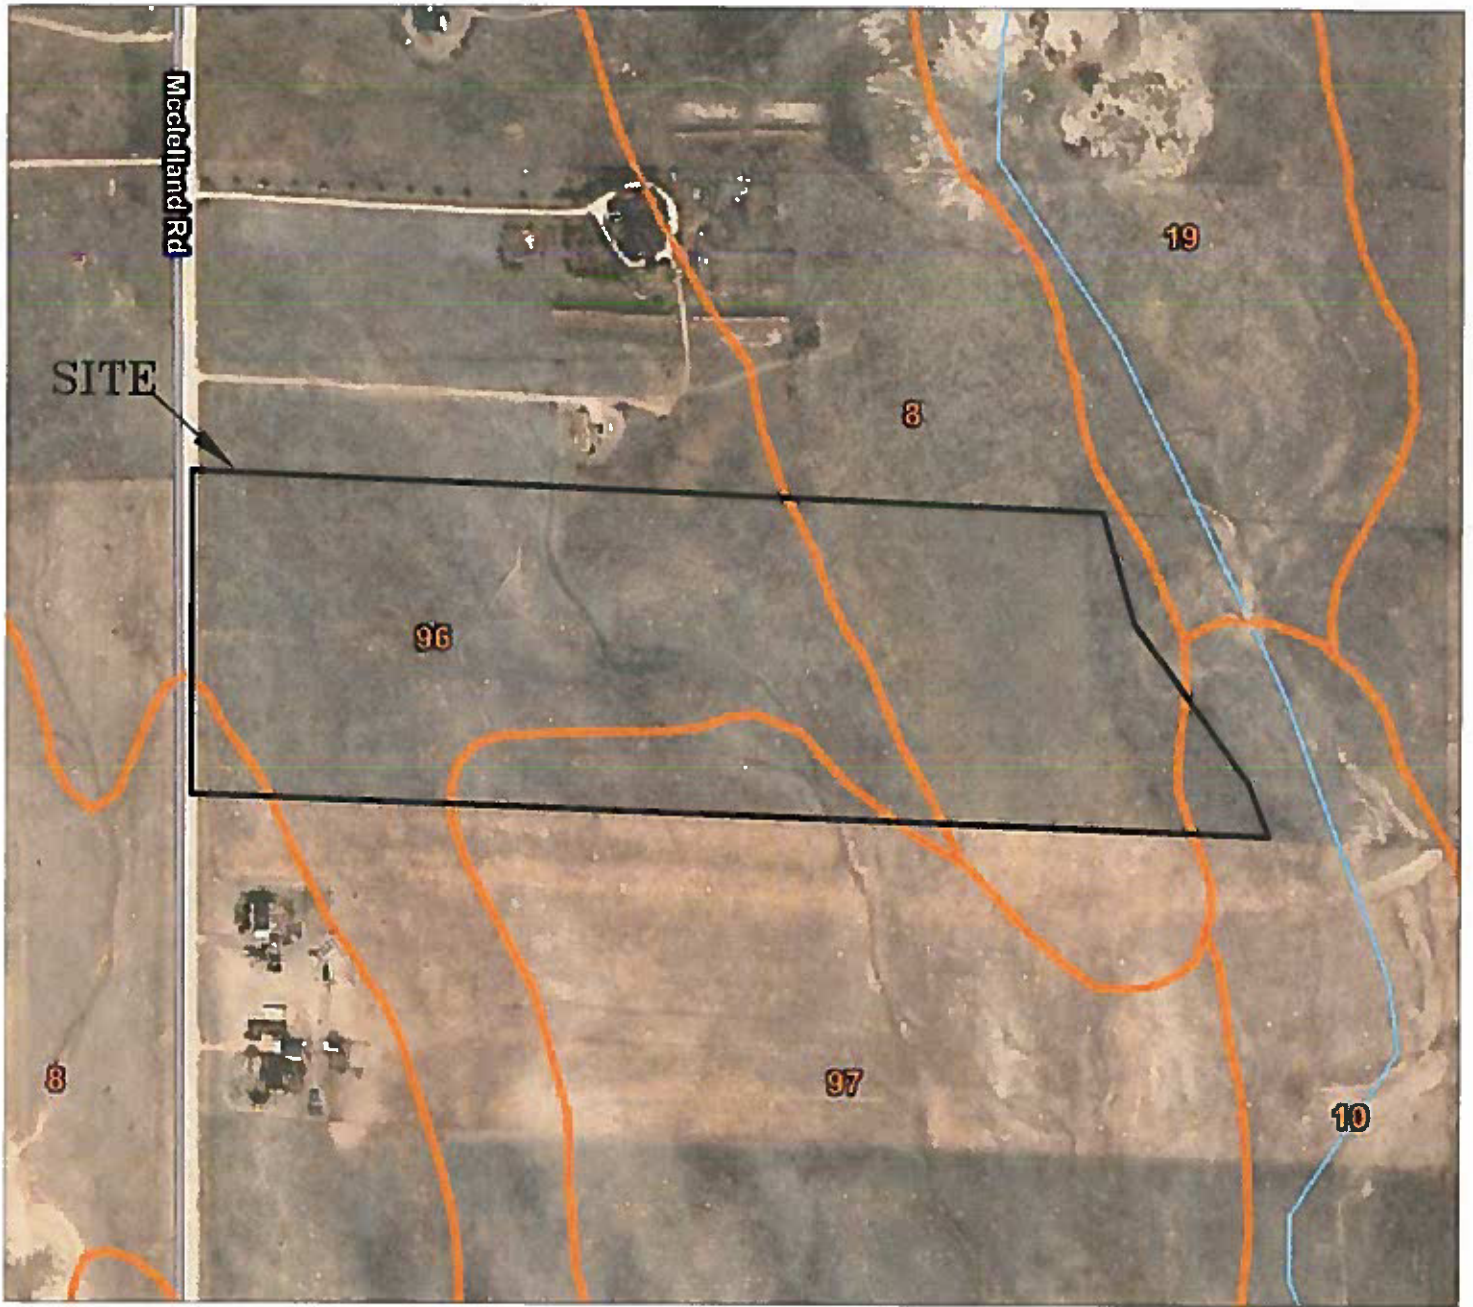
FIG NO.:  
 4

**SOIL SURVEY MAP**  
**DIDLEAU SUBDIVISION**  
**HERRING ROAD & FOREST HEIGHTS CIRCLE**  
**EL PASO COUNTY, CO.**  
**FOR: LDC, INC.**

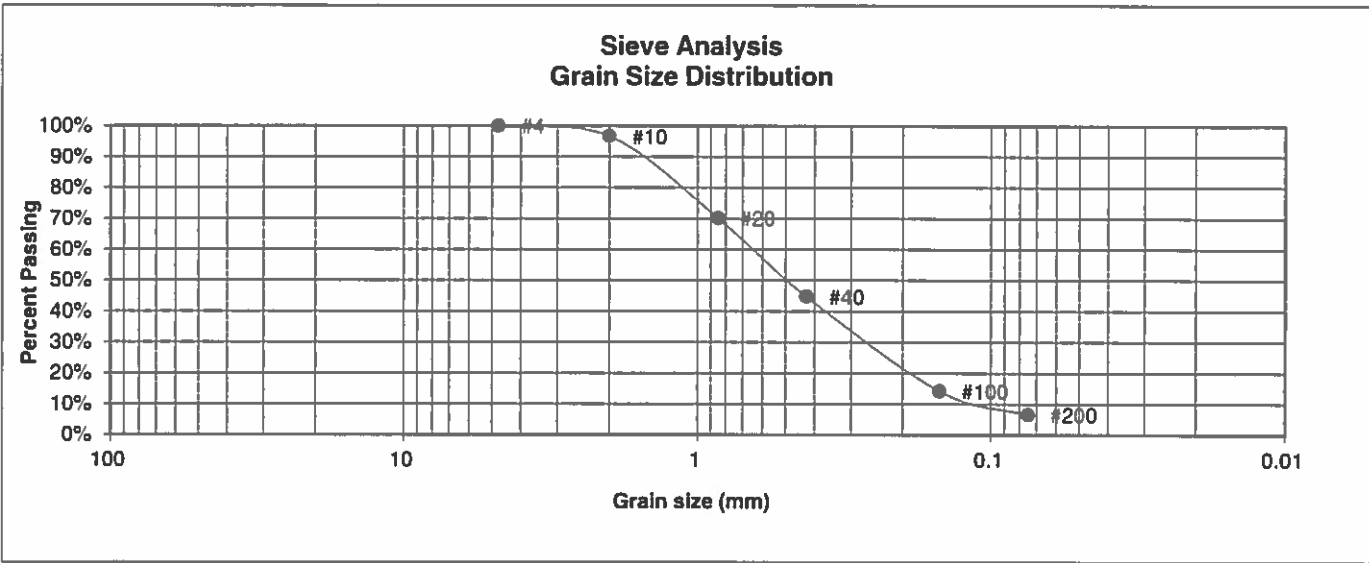
FIG NO.:  
*C-1*

BORING NO.	TP-1	<u>UNIFIED CLASSIFICATION</u>	SM-SP	<u>TEST BY</u>	BL
DEPTH(ft)	2-3	<u>AASHTO CLASSIFICATION</u>		<u>JOB NO.</u>	200989
CLIENT	WILLIAM GUMAN				
PROJECT	McCLELLAND ROAD

U.S. Sieve #	Percent Finer
3"	
1 1/2"	
3/4"	
1/2"	
3/8"	
4	100.0%
10	96.7%
20	70.1%
40	44.8%
100	14.2%
200	6.6%
