June 2, 2020
Revised April 27, 2021

ENTECH
ENGINEERING, INC.

Re: Wastewater Study
Mountain's Edge Subdivision
McClelland Road & Farmhouse Court
Parcel No. 32000-00-740
El Paso County, Colorado

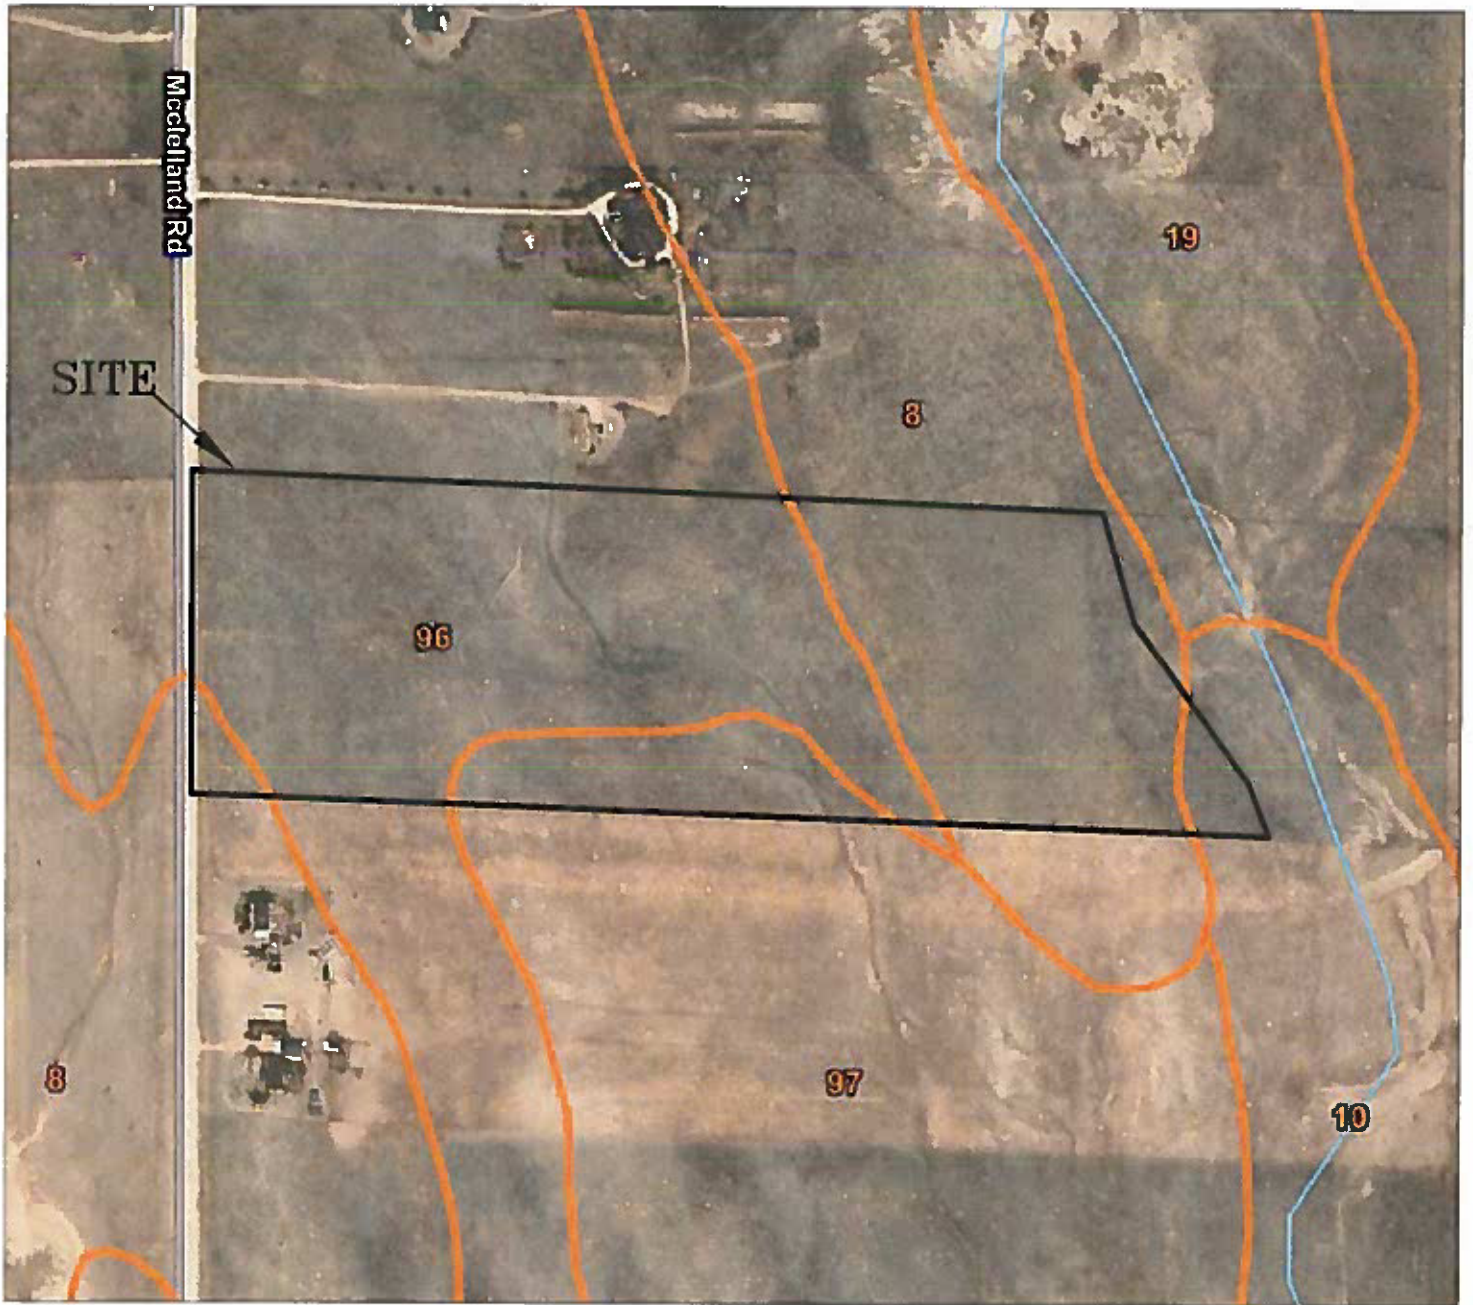
FIG NO.:
 4

SOIL SURVEY MAP
 DIDLEAU SUBDIVISION
 HERRING ROAD & FOREST HEIGHTS CIRCLE
 EL PASO COUNTY, CO.
 FOR: LDC, INC.

The soils have been described to have moderate to rapid permeabilities. The soils are described as well suited for use as homesites. Possible hazards with soils erosion are present on the site. The erosion potential can be controlled with vegetation. The soils have been described to have moderate erosion hazards (Reference 2).

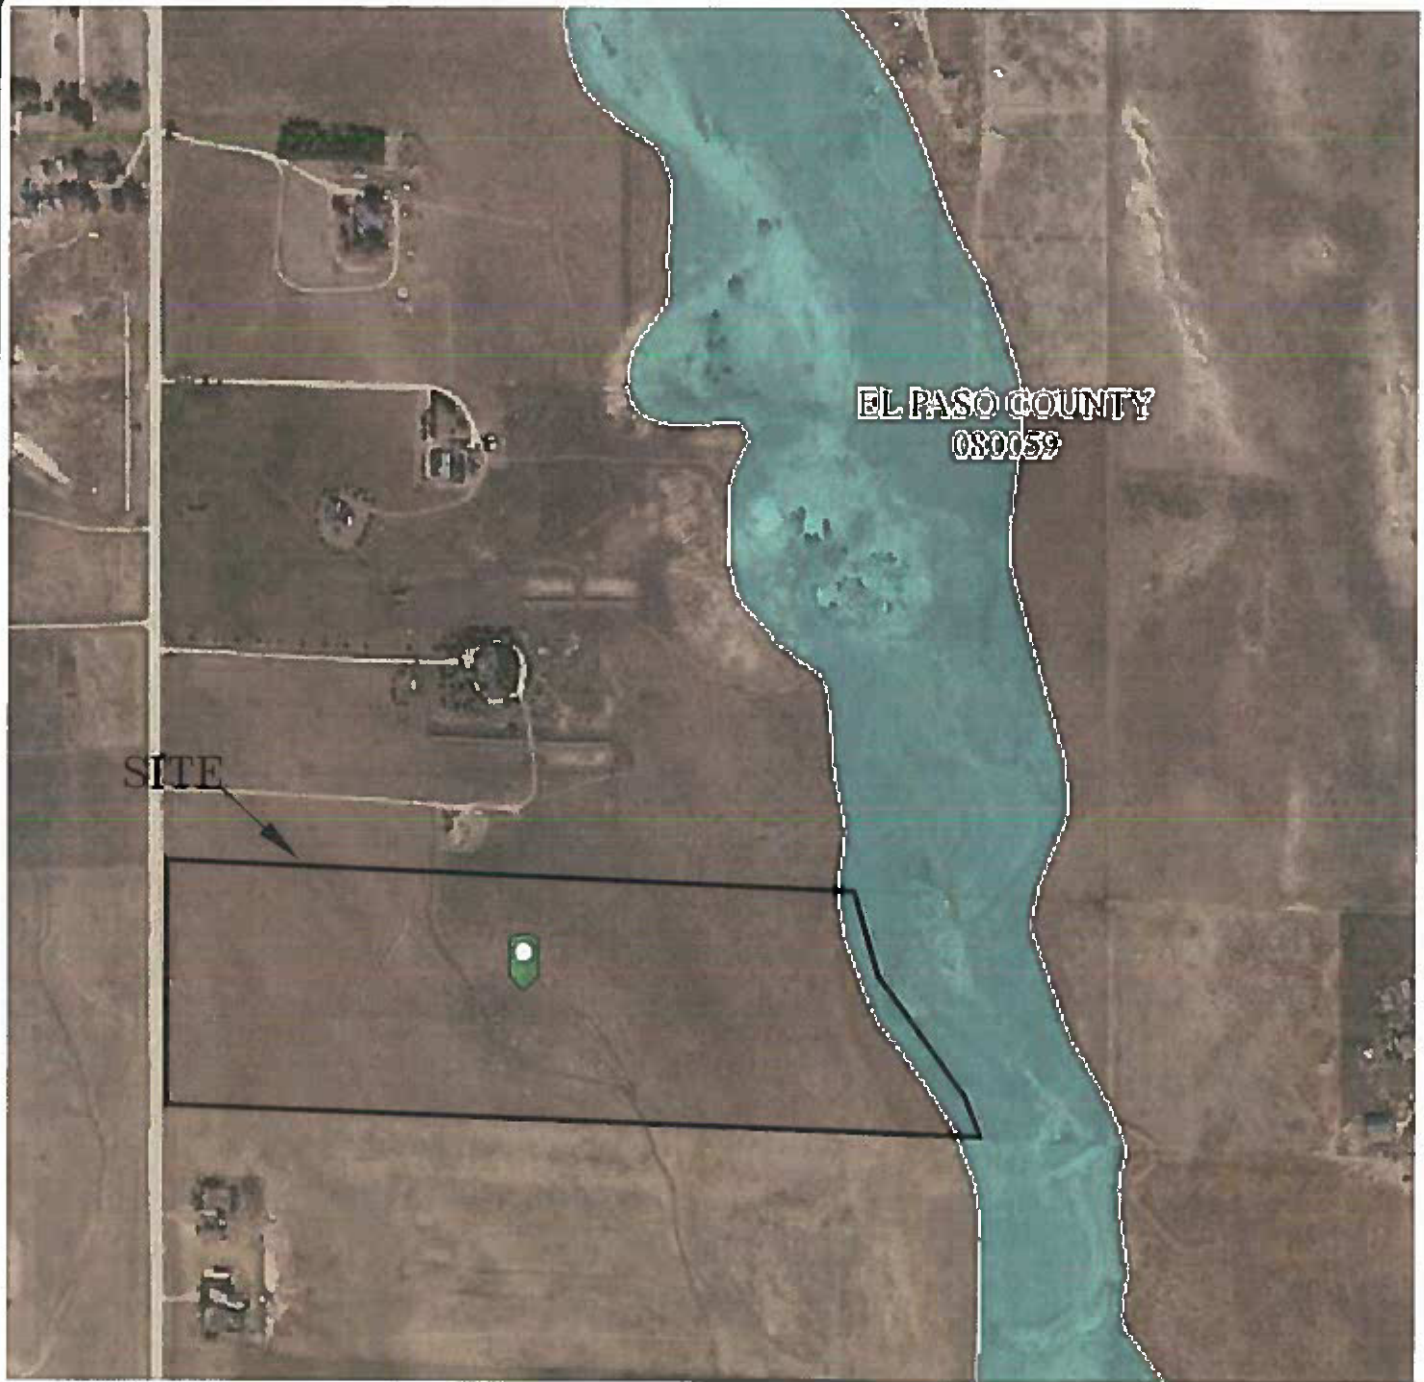
DATE CHECKED	
DATE	8/1/20
SCALE	AS SHOWN
JOB NO.	200889
FIGURE NO.	
	C

- LEGEND:**
- POSSIBLE OWTS LOCATIONS
 - POSSIBLE OWTS ALTERNATE LOCATIONS
 - POSSIBLE HOUSE LOCATIONS
 - AREAS WHERE OWTS ARE NOT RECOMMENDED
 - W** - WATER WELLS MUST BE A MINIMUM OF 100 FT FROM OWTS ABSORPTION FIELDS
 - SEASONAL GROUNDWATER AREAS ARE NOT SUITABLE FOR OWTS LOCATIONS

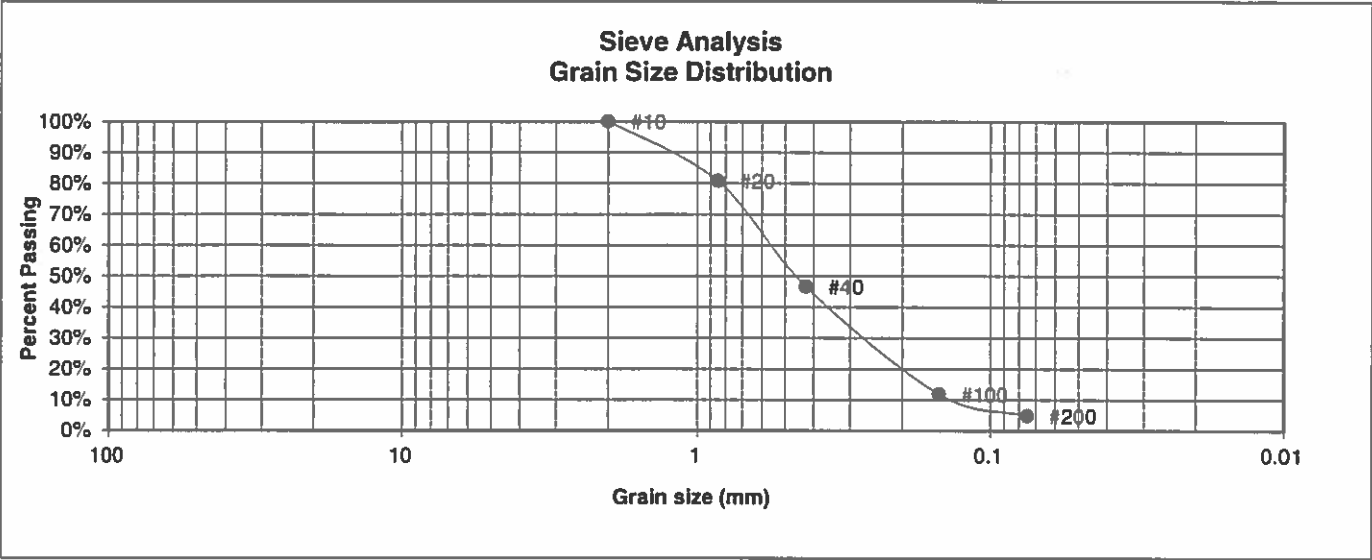
FIG NO.:
C-2

BORING NO.	TP-1	<u>UNIFIED CLASSIFICATION</u>	SP	<u>TEST BY</u>	BL
DEPTH(ft)	6-8	<u>AASHTO CLASSIFICATION</u>		<u>JOB NO.</u>	200989
CLIENT	WILLIAM GUMAN				
PROJECT	McCLELLAND ROAD

<u>U.S. Sieve #</u>	<u>Percent Finer</u>	<u>Atterberg Limits</u>
3"		Plastic Limit
1 1/2"		Liquid Limit
3/4"		Plastic Index
1/2"		
3/8"		
4		<u>Swell</u>
10	100.0%	Moisture at start
20	80.8%	Moisture at finish
40	46.7%	Moisture increase
100	11.9%	Initial dry density (pcf)
200	4.9%	Swell (psf)

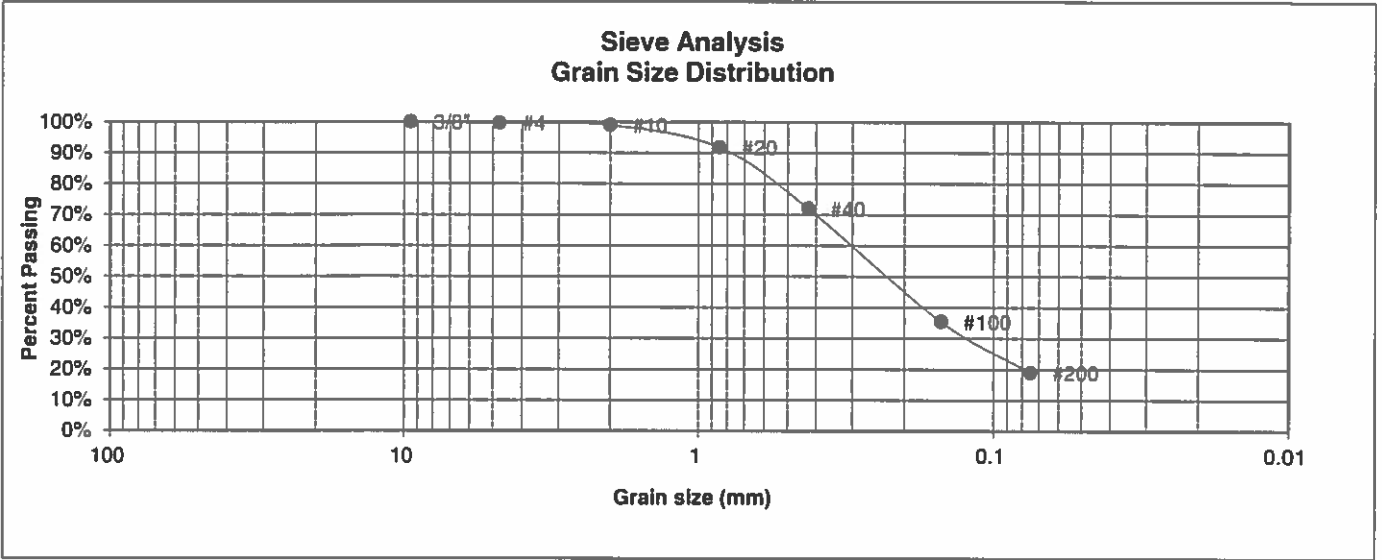
FIG NO.:
C-3

BORING NO.	TP-2	UNIFIED CLASSIFICATION	SC	TEST BY	BL
DEPTH(ft)	2-3	AASHTO CLASSIFICATION		JOB NO.	200989
CLIENT	WILLIAM GUMAN				
PROJECT	McCLELLAND ROAD

U.S. Sieve #	Percent Finer
3"	
1 1/2"	
3/4"	
1/2"	
3/8"	100.0%
4	99.7%
10	98.9%
20	91.8%
40	71.9%
100	35.4%
200	19.0%

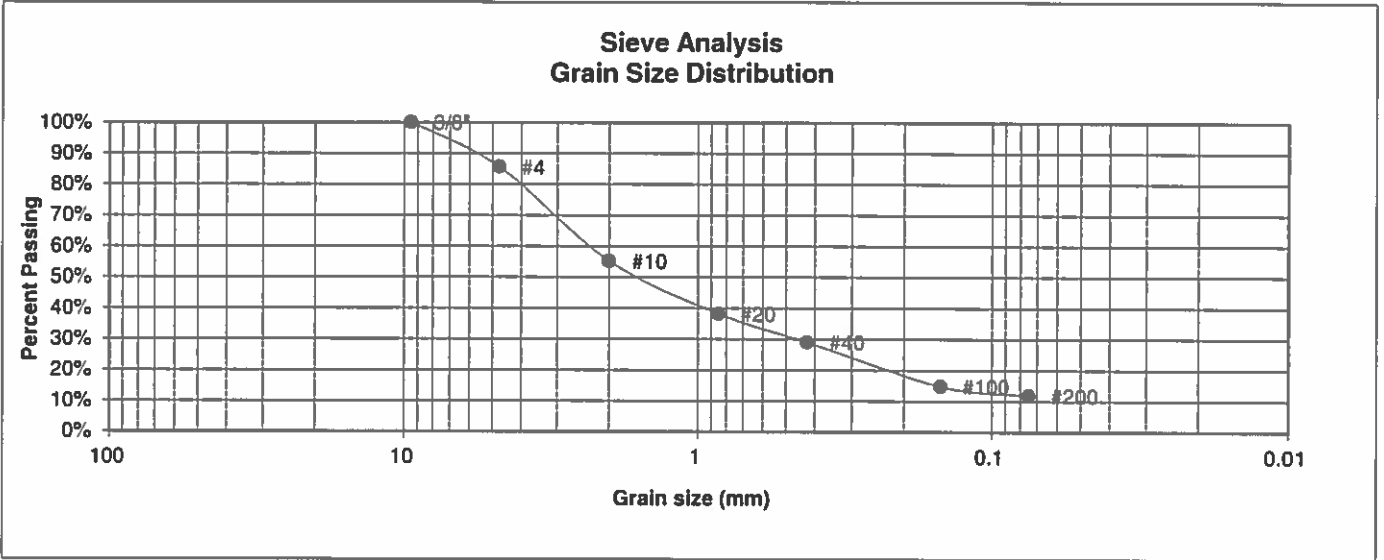
FIG NO.:
C-4

BORING NO.	TP-2	<u>UNIFIED CLASSIFICATION</u>	SM-SW	<u>TEST BY</u>	BL
DEPTH(ft)	5-7	<u>AASHTO CLASSIFICATION</u>		<u>JOB NO.</u>	200989
CLIENT	WILLIAM GUMAN				
PROJECT	McCLELLAND ROAD

U.S. Sieve #	Percent Finer
3"	
1 1/2"	
3/4"	
1/2"	
3/8"	100.0%
4	85.6%
10	55.2%
20	38.2%
40	29.0%
100	14.8%
200	11.8%

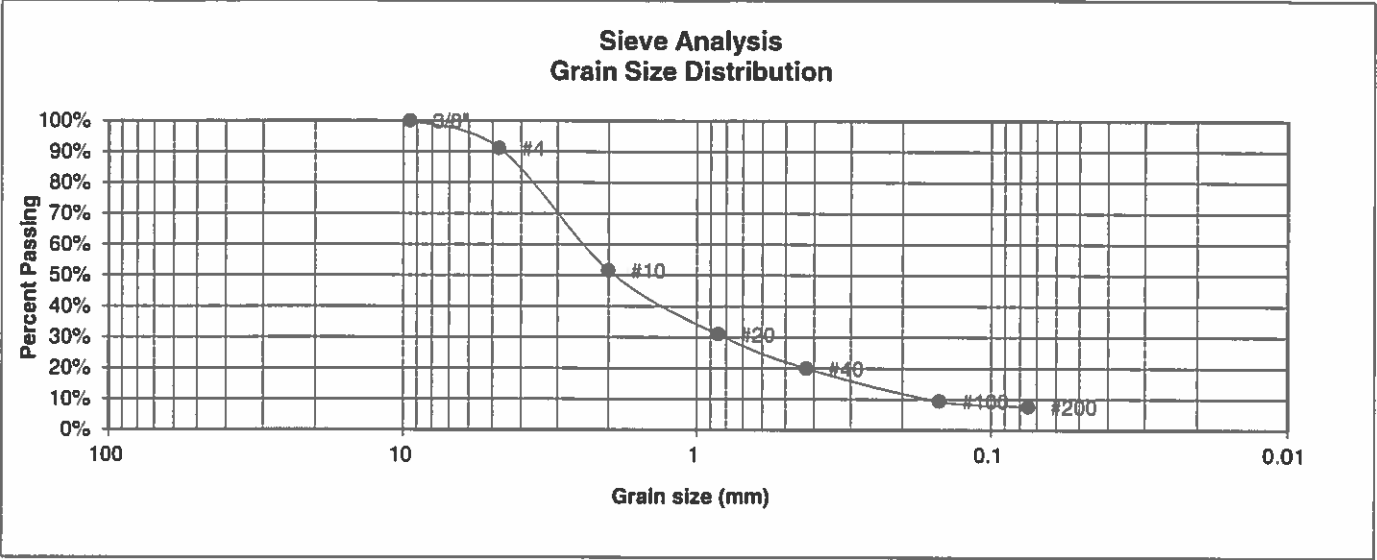
FIG NO.:
C-5

BORING NO.	TP-3	UNIFIED CLASSIFICATION	SM-SW	TEST BY	BL
DEPTH(ft)	2-3	AASHTO CLASSIFICATION		JOB NO.	200989
CLIENT	WILLIAM GUMAN				
PROJECT	McCLELLAND ROAD

U.S. Sieve #	Percent Finer
3"	
1 1/2"	
3/4"	
1/2"	
3/8"	100.0%
4	91.1%
10	51.6%
20	31.0%
40	19.9%
100	9.4%
200	7.6%
