Final Channel Design Report
East Fork Jimmy Camp Creek
Creekside at Lorson Ranch Filing No. 1

El Paso County, Colorado

Prepared by:
Kiowa
Engineering Corporation

Kiowa Project No. 18020
August 7, 2019

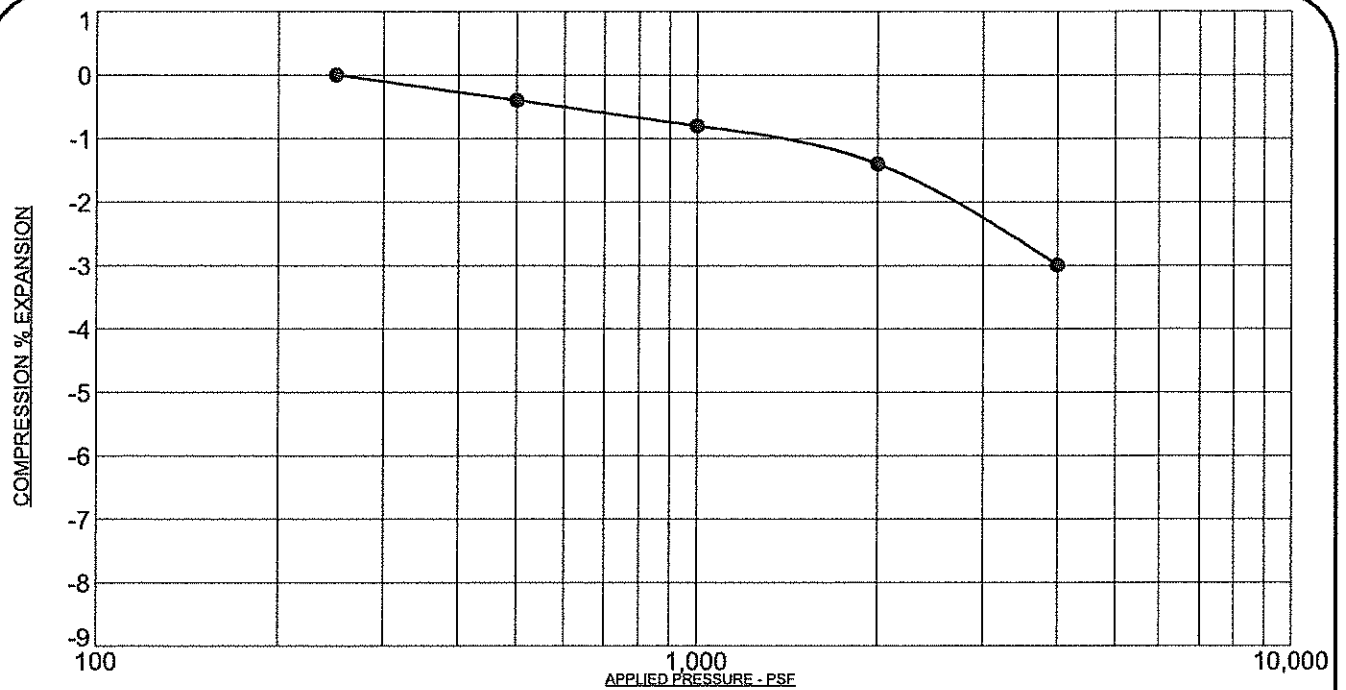
PROJECT: Creekside at Lorson Ranch, Filing No. 1 El Paso County, Colorado
 SAMPLE DESCRIPTION: CLAY, SANDY
 NOTE: SAMPLE WAS INUNDATED WITH WATER AT 1,000 PSF

SAMPLE LOCATION: 10 @ 14 FT
 NATURAL DRY UNIT WEIGHT: 77.4 PCF
 NATURAL MOISTURE CONTENT: 20.9%
 PERCENT SWELL/COMPRESSION: 0.0

Soil laboratory testing was performed as part of this investigation. The laboratory tests included moisture content, dry density, grain-size analyses, Atterberg Limits and Swell/Consolidation tests. A Summary of Laboratory Test Results is presented in Figure 12. Soils Classification Data is presented in Figures 13 and 15. Swell/Consolidation Test Results are presented in Figures 16 through 18.

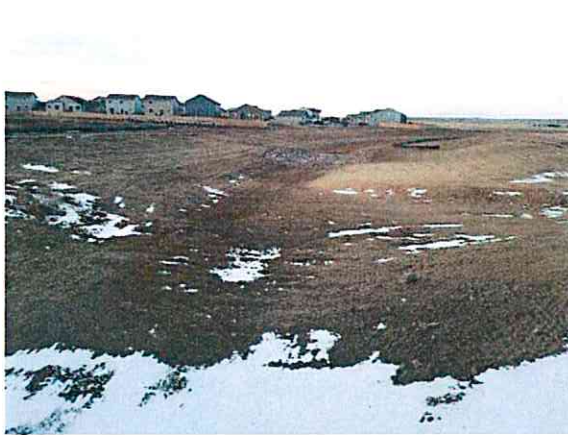
Channel upstream of Fontaine Blvd.

Grading and channel improvements based on the proposed plan presented in the 2017 CLOMR were constructed in 2018. Improvements include channelization, five drop structures, and bridge crossings of the channel at Fontaine Boulevard and Lorson Boulevard. Both bridge structures consist of prefabricated Contech O-848 48' span bridge structures (see Appendix for details). The CLOMR materials including hydraulic model were updated based on asbuilt field survey and are presented in this report.

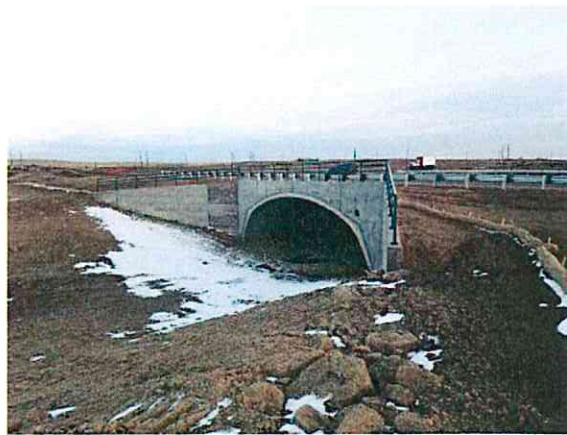
Fontaine Blvd. 48' Contech Bridge.
