ENTECH
ENGINEERING, INC.

**GEOLOGIC HAZARD STUDY
SOUTH 8TH STREET
PARCEL NO. 74242-00-038
COLORADO SPRINGS, COLORADO**

November 30, 2020
Revised January 18, 2023

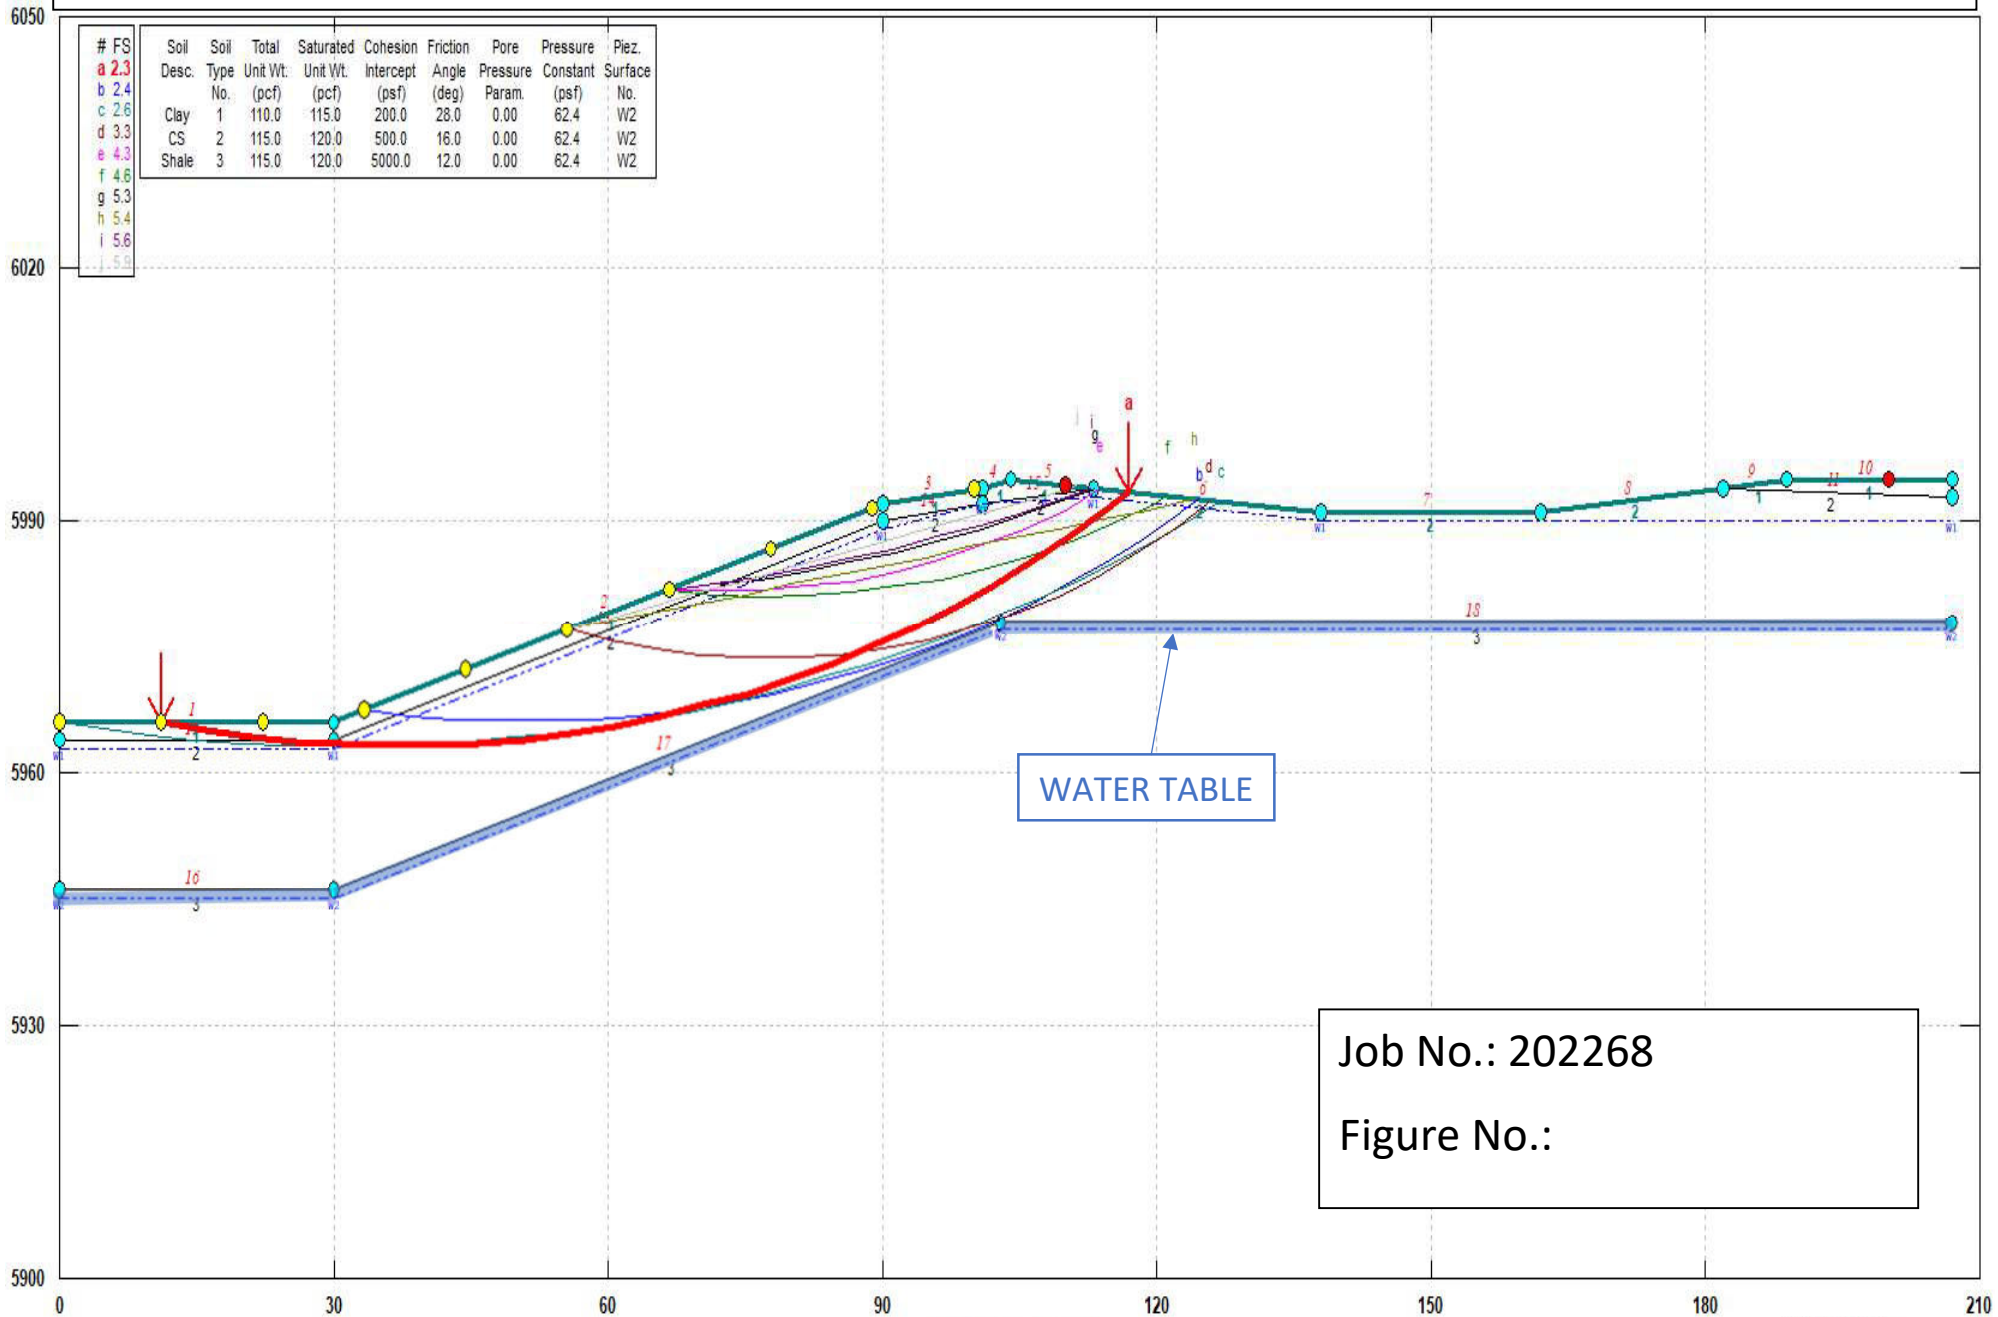
VICEROY – VUE DE LA PARC – A-A PROPOSED

Soil strength values were based on similar soils in the area (References 8, and 9), and are included in Appendices D and F. Factors of safety were calculated by the Modified Bishop Method for Circular Failure Surfaces. The slope profile was constructed with the soil types encountered in the test borings from the subsurface soil investigation. Although groundwater was not encountered, groundwater levels were evaluated in accordance with levels that may be anticipated in the area and also for sensitivity analysis. Structural loads from the proposed pond were used in the analysis. Based on our drilling, the probability of groundwater up to the excavation level is considered low provided surface and subsurface drainage systems are maintained. Factors of safety of 1.5 are recommended for areas of critical structures such as buildings. Factors of safety of 1.3 are recommended for non-critical areas such as detention ponds. Due to the proximity of the full spectrum detention basin to the slope, we recommend lining the detention pond with an impermeable membrane liner. Slope stability analysis results are included in Appendix E.

Figure No.	Section	Analysis	Water Table	F.O.S	Description
E-1	A-A'	Existing (Circular)	High	2.3	Initiation and termination points of analysis modified to encompass existing slope. Circular failure surface analyzed.
E-2	A-A'	Existing (Circular)	High	1.5	Initiation and termination points of analysis modified to encompass the proposed retaining wall, full spectrum detention basin slope with pond loading and an elevated water table. Circular failure surface analyzed.

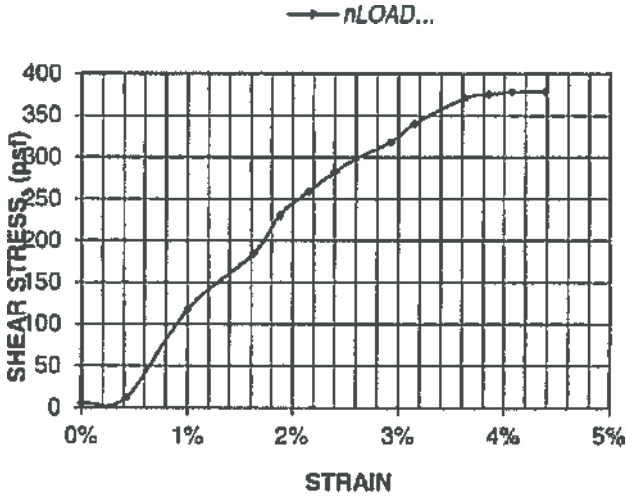
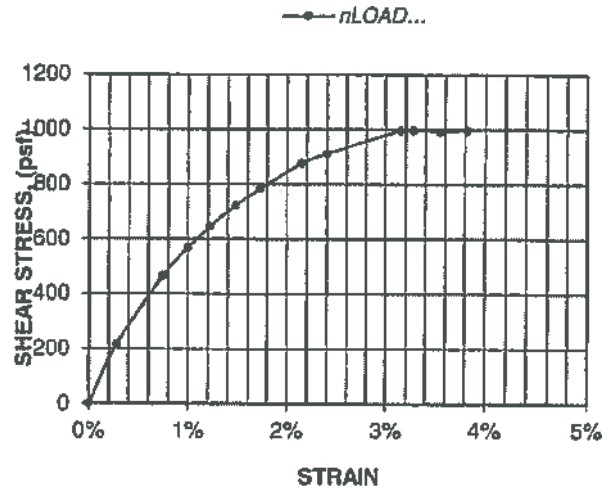
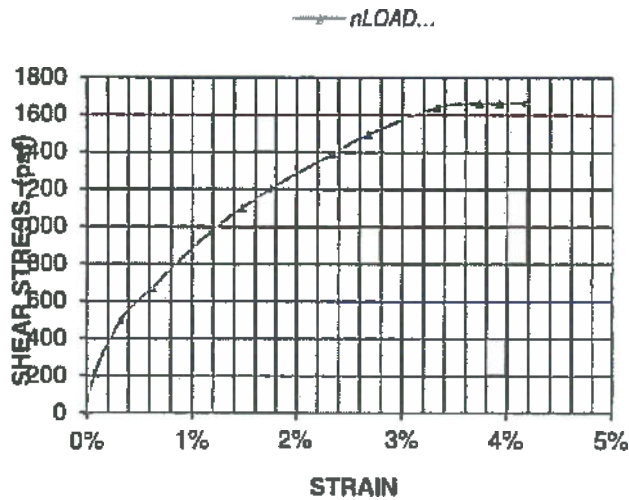
SHEAR STRESS vs SAMPLE STRAIN
