GEOLOGIC HAZARD EVALUATION AND
PRELIMINARY GEOTECHNICAL INVESTIGATION

ROWLEY PROPERTY
MARKSHEFFEL ROAD AND COLORADO TECH DRIVE
COLORADO SPRINGS, COLORADO

Project No. CS20042-115

May 11, 2026

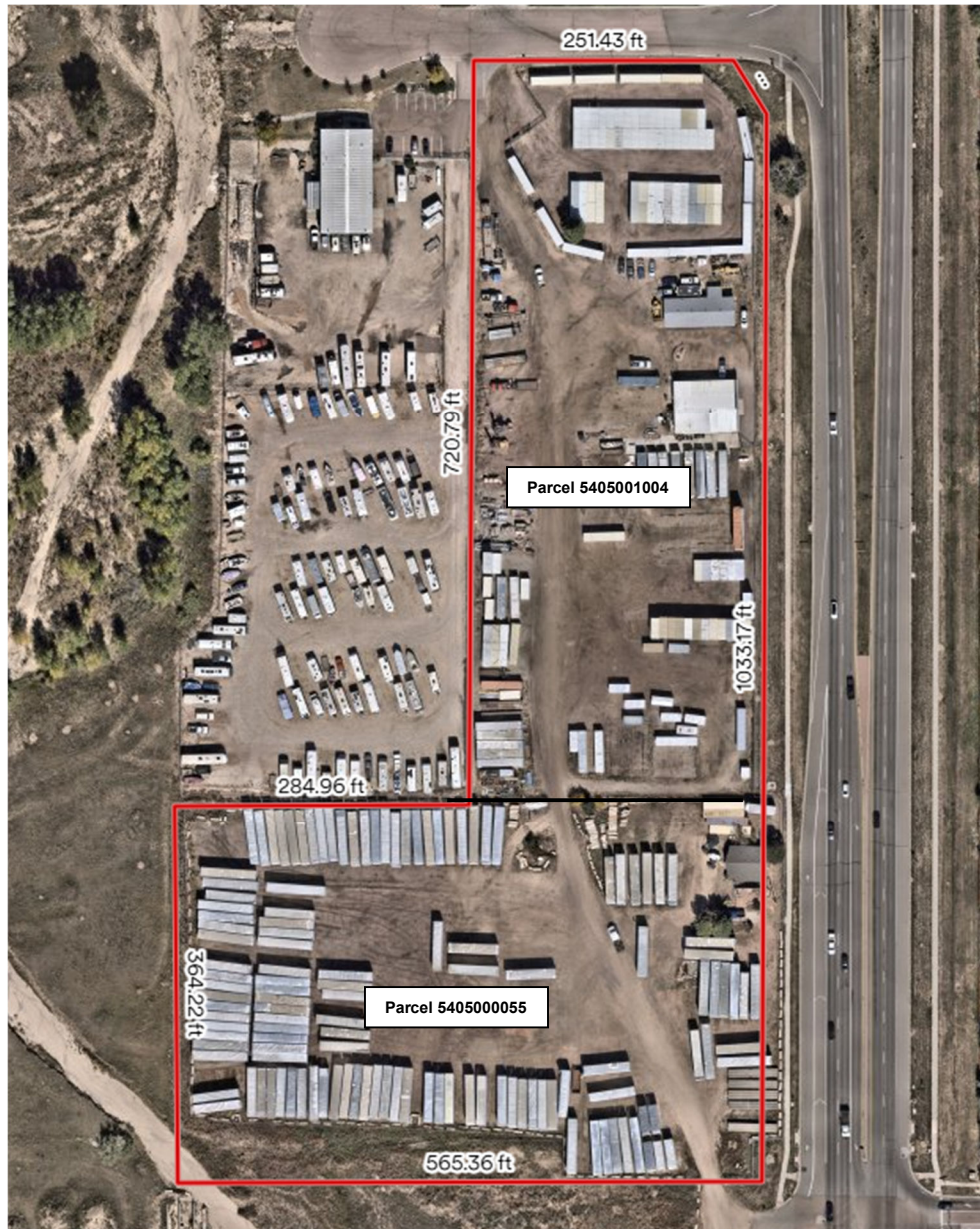
Near Map Aerial Image of Northern Site

The northern site consists of two separate parcels (Parcel Nos. 5404001004 and 540000055) that comprise 9 acres of land. At the time of this report, the northern site was predominantly utilized as storage for numerous containers and semi-trailers. Two relatively small, single-story buildings are located in the northern portion of the site adjacent to Marksheffel Road. Similar land used for storage is located west of the northern parcel. A minor, unchanneled tributary of the East Fork Sand Creek is located west of the northern site. The northern site is generally devoid of vegetation. The overall topography is relatively flat with a very gently descent to the south and southwest. An aerial image of the site with approximate parcel boundaries is shown below.

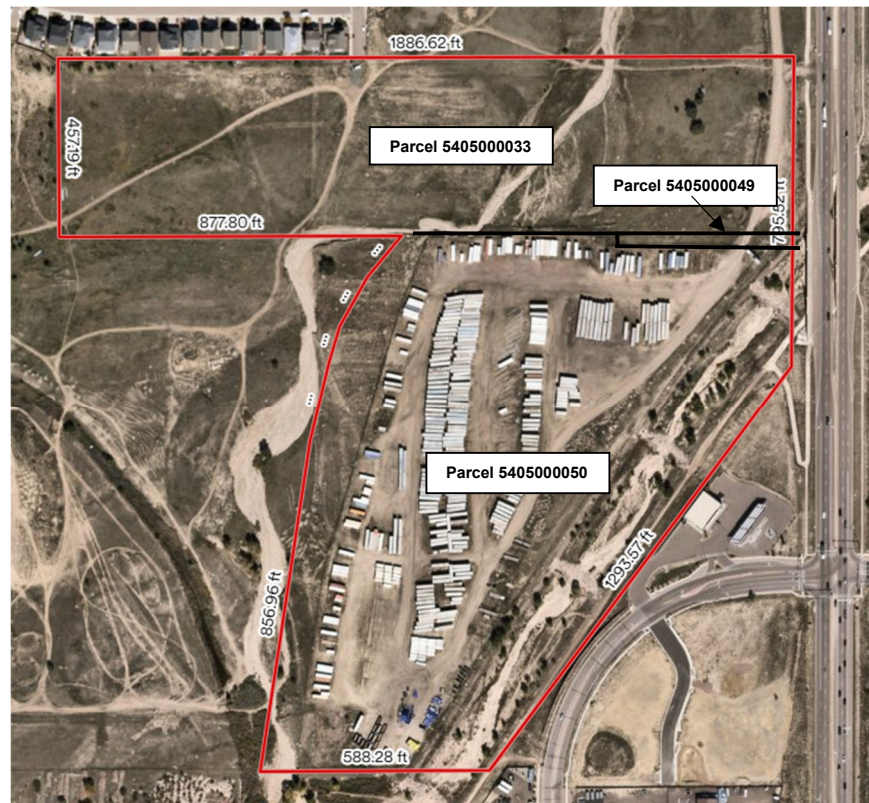
Near Map Aerial Image of Southern Site

A minor, unchanneled tributary to the Sand Creek East Fork crosses the 19-acre parcel from north to south and lies to the west of the 31-acres site, forming a confluence at the Sand Creek East Fork, just south of the southernmost property boundary. Over the past 25 years, the tributary creek has shifted toward the west. Both creeks are considered seasonal and were observed to be dry at the time of our investigation. A couple of dirt vehicle paths extend across the 19-acre parcel. The majority of the 31-acre parcel has been disturbed by clearing of vegetation and leveling the surface for parking of semi-trailers. Vacant, undeveloped land is located to the north and west of the site. Single-family residences are present to the northwest and Marksheffel Road and Meadowbrook Drive are located to the east and southeast, respectively. The overall topography includes a very gentle descent to the south and southwest. An aerial image of the southern site with approximate parcel boundaries is shown below.

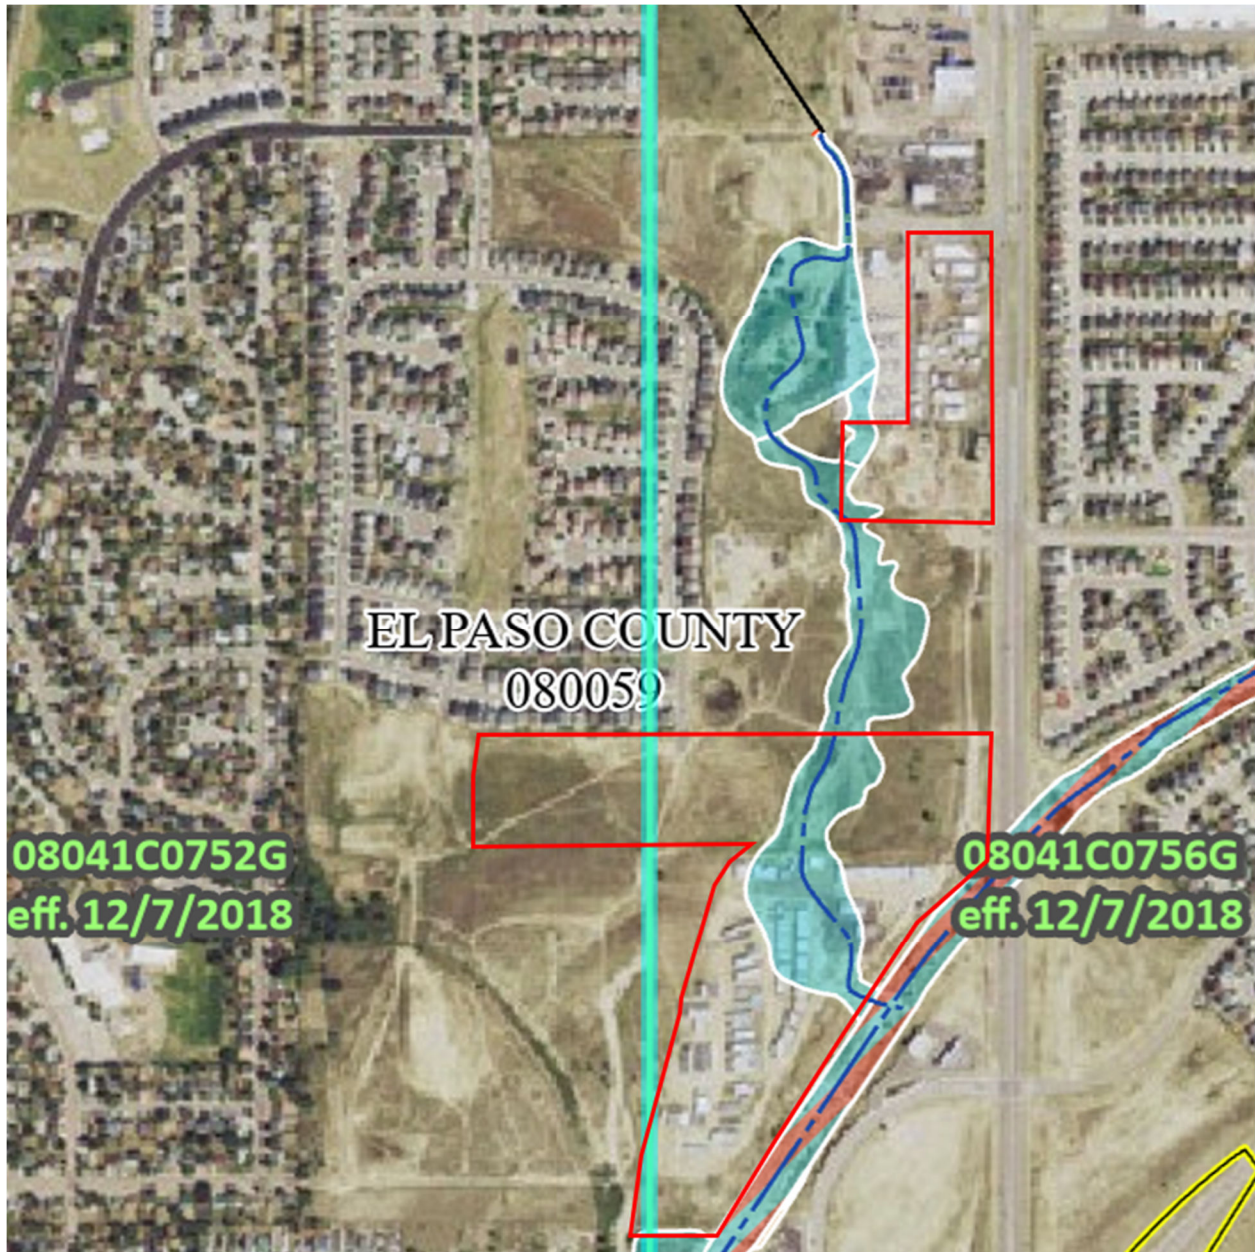
*Clip from FEMA Flood Map Service Center mapping.
100-year floodplain in blue and approximate project area outlined in red.*

The FEMA panels covering the project site include Map Numbers 08041C0752G and 08041C0756G effective 12/7/2018. FEMA Map No. 08041C752G includes the west half of parcel 5405000033, and FEMA Map No. 0841C07556G includes coverage for the remainder of the parcels that make up the site.

Based on review of FEMA Mapping, portions of the site lie within the 100-year floodplain. The mapping of the 100-year floodplain, including Zones AE and AO mapping in the FEMA panels, have a 1% chance of being subject to inundation annually. Special flood hazards exist along the west edge of Parcel No. 5405000055 and across Parcels 540500003, 5405000049, and 5405000050. The western edge of the northern parcel 5405000055 lies within the mapped Zone AO, and the southern parcels 5405000033, 5405000049, and 5405000050 lies within Zone AE mapping. The project Civil Engineer should determine the extents of the flood mapping for the site, the flood potential, and design surface drainage. Parcel numbers are designated by the El Paso County Assessor and each corresponding number is identified in Fig. 1 of this report.

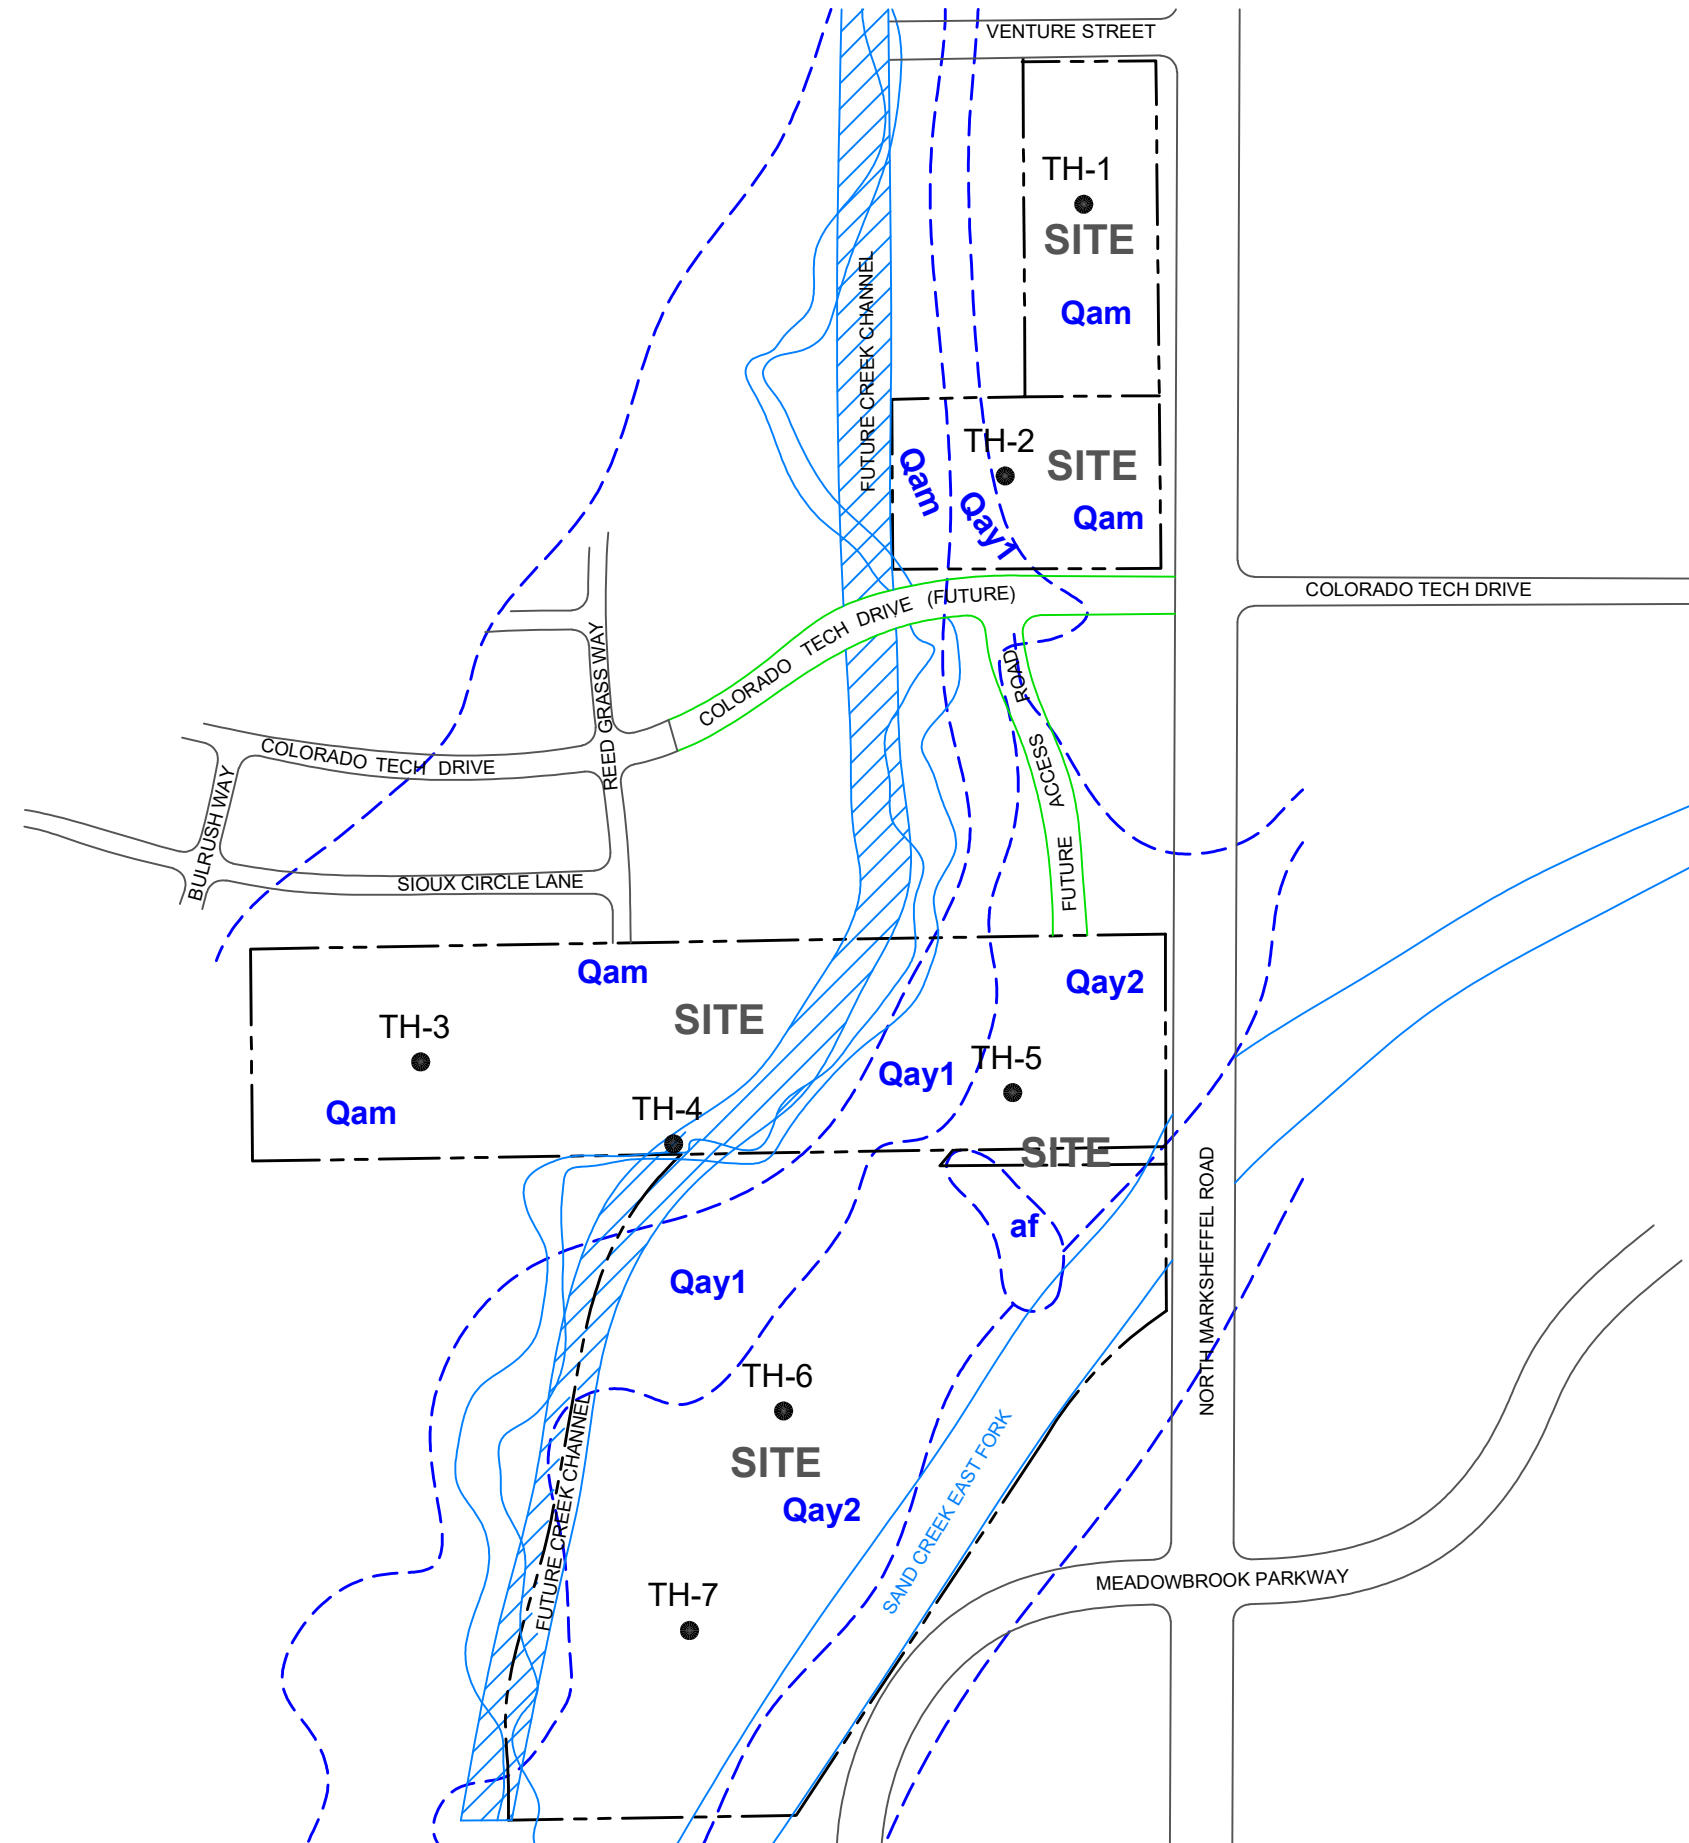
FIG. 2 – SURFICIAL GEOLOGIC CONDITIONS

1. ALL BOUNDARIES SHOWN SHOULD BE CONSIDERED APPROXIMATE. THEY ARE BASED UPON A SUBJECTIVE INTERPRETATION OF PUBLISHED MAPS, AERIAL PHOTOGRAPHS AND AN INITIAL FIELD RECONNAISSANCE. CHANGES IN THE MAPPED BOUNDARIES SHOWN ARE POSSIBLE AND SHOULD BE EXPECTED WITH MORE DETAILED WORK AND FURTHER INFORMATION. ALL INTERPRETATIONS AND CONDITIONS SHOWN ARE PRELIMINARY AND FOR INITIAL LAND-USE PLANNING ONLY.
2. MAP LEGEND IS MODIFIED FROM CHARLES S. ROBINSON & ASSOCIATES, INC., GOLDEN, COLORADO, DATED 1977.

The surficial geology at the site was evaluated by reviewing published geologic maps and our site reconnaissance and subsurface exploration. The Elsmere Quadrangle map published by the Colorado Geological Survey (CGS), by Richard F. Madole, and Jon P. Thorson, 2002¹ was reviewed for the project site. Our borings generally confirm the CGS mapping. The various deposits mapped at the site are described in more detail based on the Geologic Map descriptions in the following sections. Mapping shown below was obtained from the USGS National Geologic Map Database. Our interpretation of the geologic mapping is also depicted in Fig. 2 of this report.

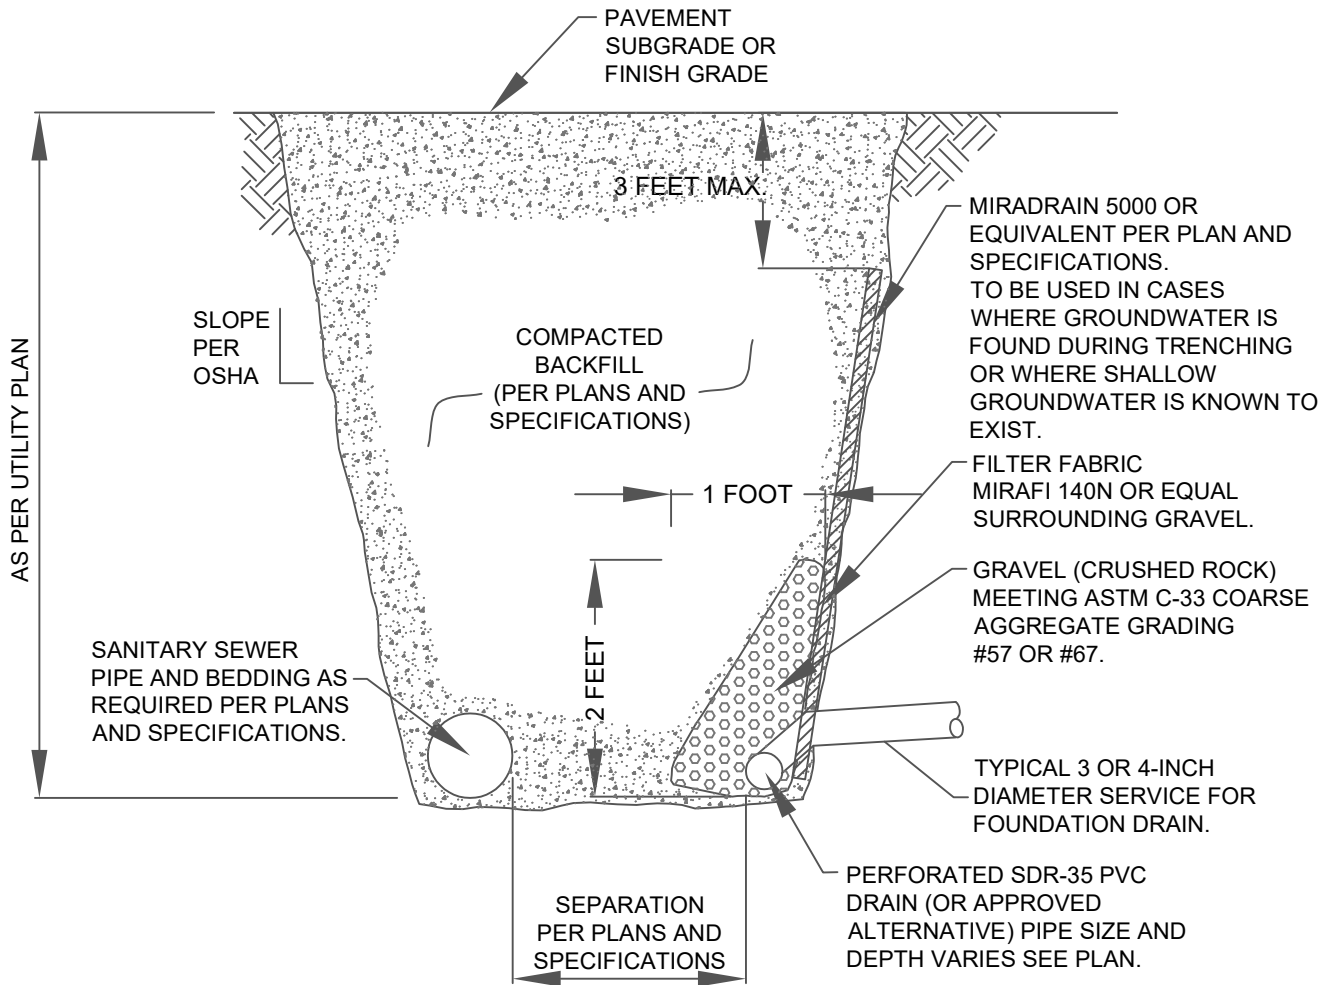
FIG. 4 – ACTIVE UNDERDRAIN BESIDE SEWER

NOTE:
TO BE USED IN CASES WHERE GROUNDWATER IS FOUND DURING TRENCHING OR WHERE SHALLOW GROUNDWATER IS KNOWN TO EXIST, AND UPSTREAM OF MANHOLES.

months. Groundwater may impact basement construction. This condition can be mitigated by installing drain systems around below-grade spaces and providing a gravity outfall.

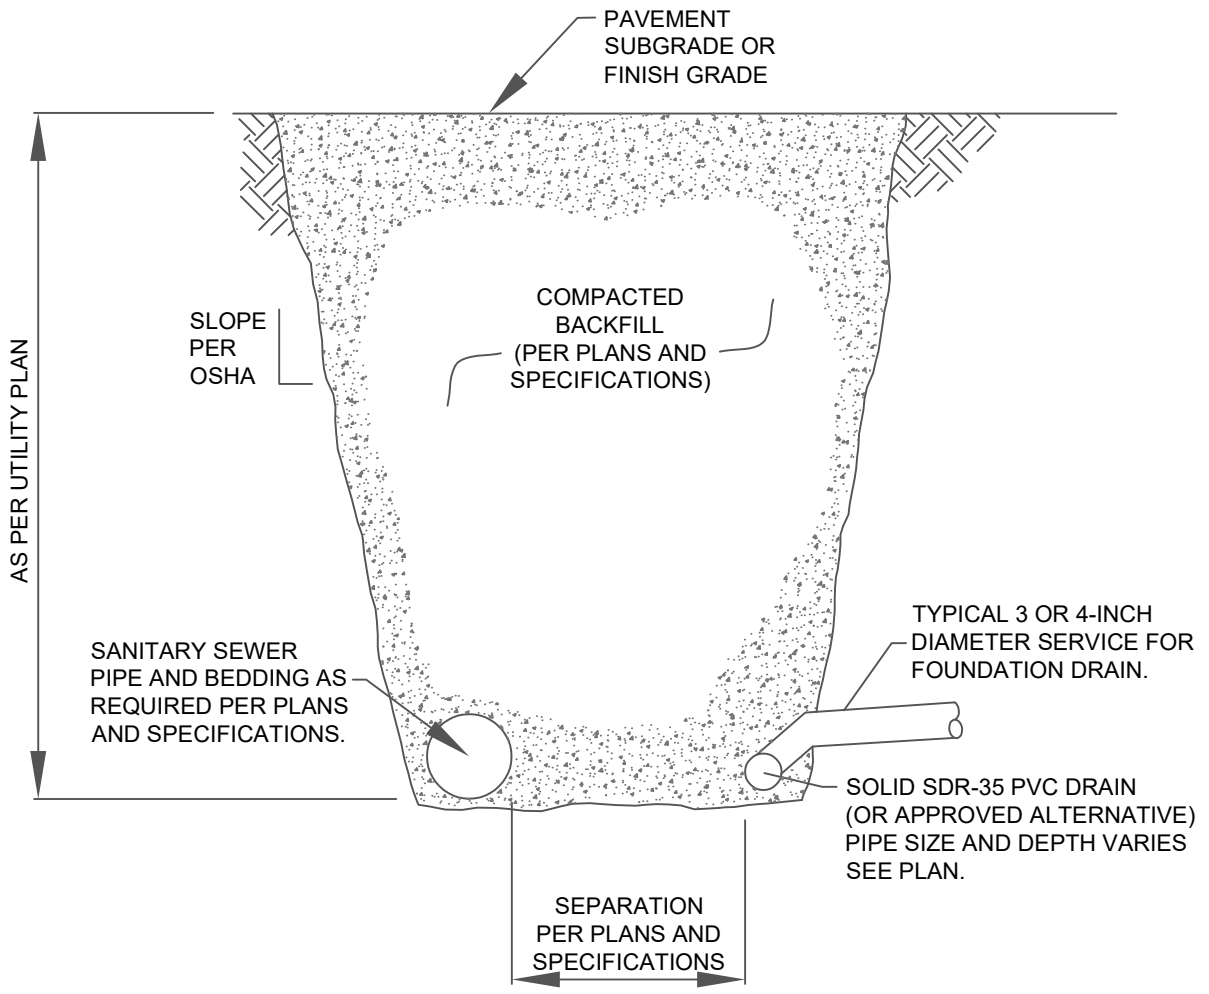
FIG. 5 – PASSIVE DRAIN BESIDE SEWER

NOTE:
TO BE USED IN CASES WHERE NO
GROUNDWATER IS KNOWN TO EXIST.

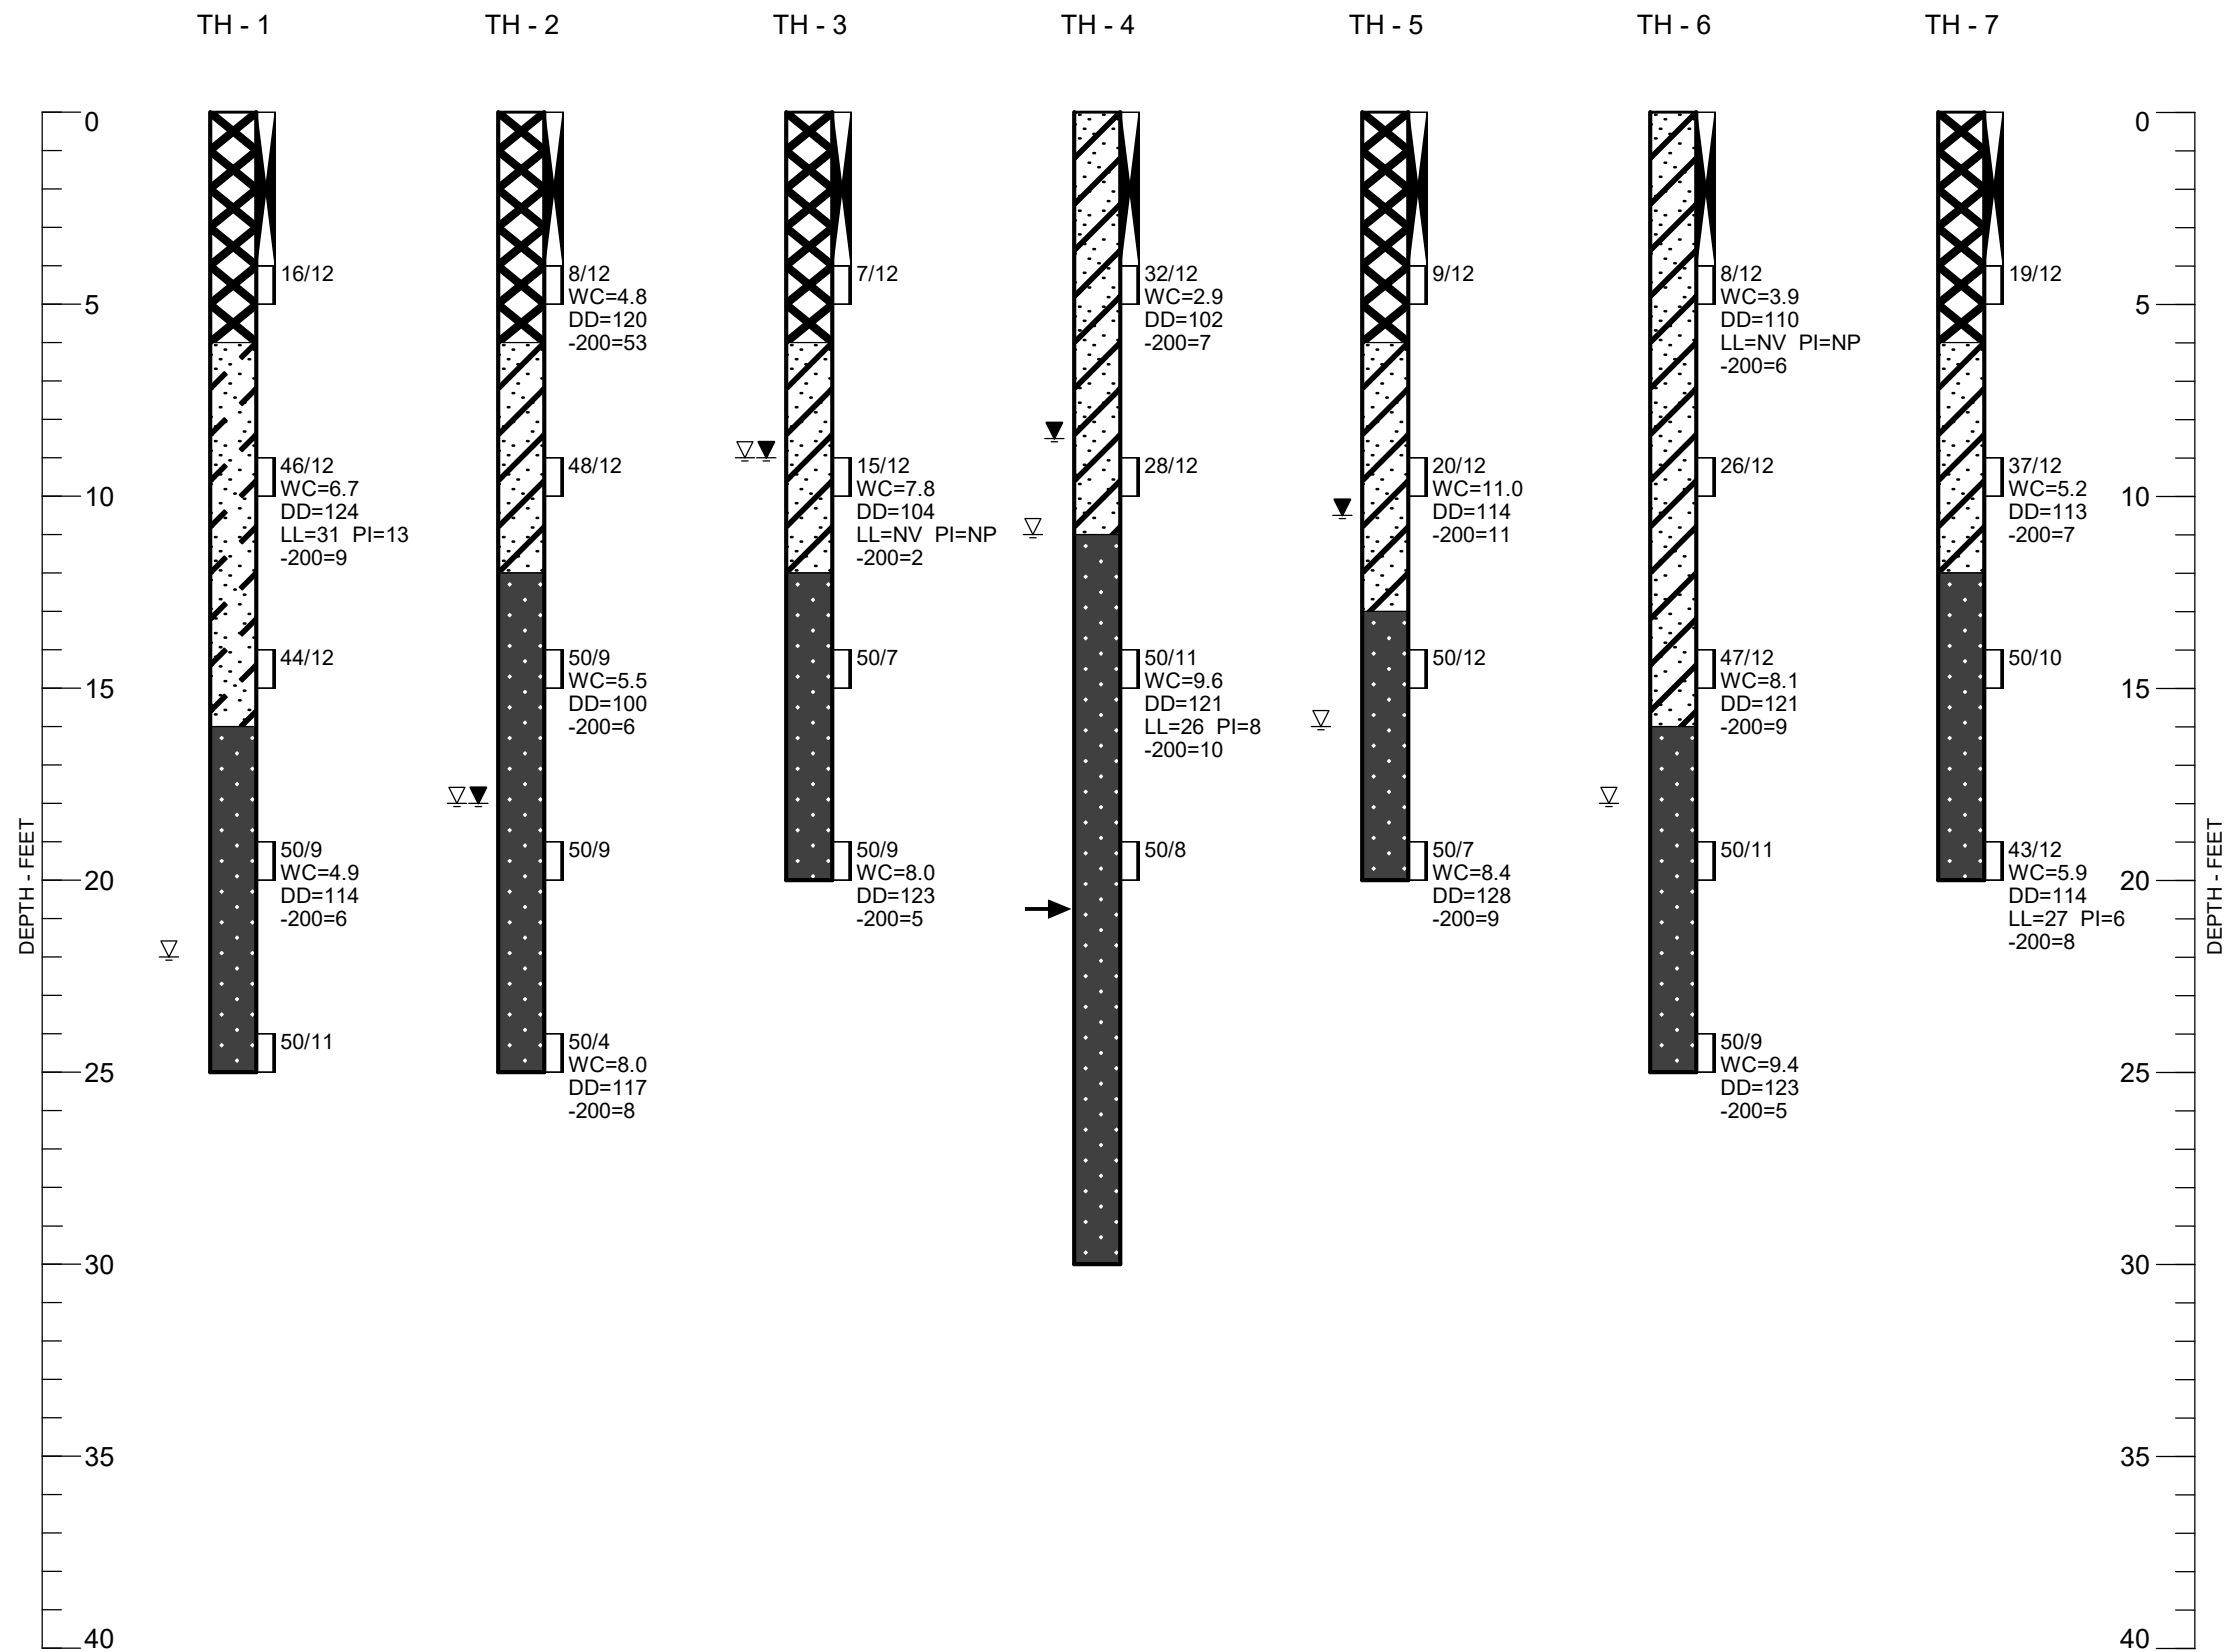
SUMMARY LOGS OF EXPLORATORY BORINGS

- FILL, SAND, SILTY TO CLAYEY AND CLAY, VERY SANDY, LOOSE TO MEDIUM DENSE (SAND), MEDIUM STIFF TO STIFF (CLAY), SLIGHTLY MOIST TO MOIST, BROWN TO DARK BROWN.
- SAND, SLIGHTLY CLAYEY, DENSE, SLIGHTLY MOIST TO MOIST, LIGHT BROWN TO BROWN (SW-SC, SC).
- SAND, CLEAN TO SLIGHTLY SILTY, LOOSE TO DENSE, SLIGHTLY MOIST TO MOIST, LIGHT BROWN TO BROWN (SP, SP-SM)
- BEDROCK. SANDSTONE, SLIGHTLY SILTY, MEDIUM HARD TO VERY HARD, SLIGHTLY MOIST TO MOIST, LIGHT BROWN TO BROWN.
- DRIVE SAMPLE. THE SYMBOL 16/12 INDICATES 16 BLOWS OF A 140-POUND HAMMER FALLING 30 INCHES WERE REQUIRED TO DRIVE A 2.5-INCH O.D. SAMPLER 12 INCHES.
- INDICATES BULK SAMPLE OBTAINED FROM AUGER CUTTINGS.
- GROUNDWATER LEVEL MEASURED AT TIME OF DRILLING.
- GROUNDWATER LEVEL MEASURED ONE DAY AFTER DRILLING.
- INDICATES DEPTH WHERE THE TEST HOLE CAVED DURING DRILLING.

The soils encountered during this investigation generally consisted of areas of suspect quality, silty or clayey sand and very sandy clay fill. Natural, slightly silty to slightly clayey sand soils with occasional clayey lenses were found at the ground surface or underlying existing fill. Sandstone bedrock was encountered in the borings underlying the natural soils. Some of the pertinent engineering characteristics of the soils and bedrock encountered and groundwater conditions are discussed in the following paragraphs.

At the time of drilling, groundwater was encountered at depths between 9 and 22 feet below existing ground surfaces in six of the seven borings. Delayed groundwater measurements were conducted one day following the completion of our drilling operation. Groundwater was measured at depths of between 8.5 and 18 feet in four of the seven borings. One boring was found to be collapsed at the time of our delayed measurements. Groundwater levels will fluctuate with seasonal precipitation and landscaping irrigation. A seasonal fluctuation of 3 to 5 feet is typical for this area. Our borings were drilled during the winter season when groundwater levels are typically found to be lowest. High groundwater conditions generally occur in mid to late summer season. Shallow groundwater levels found in exploratory borings TH-3, TH-4, and TH-5 may influence development and foundation design, depending on final grading and foundation depths.

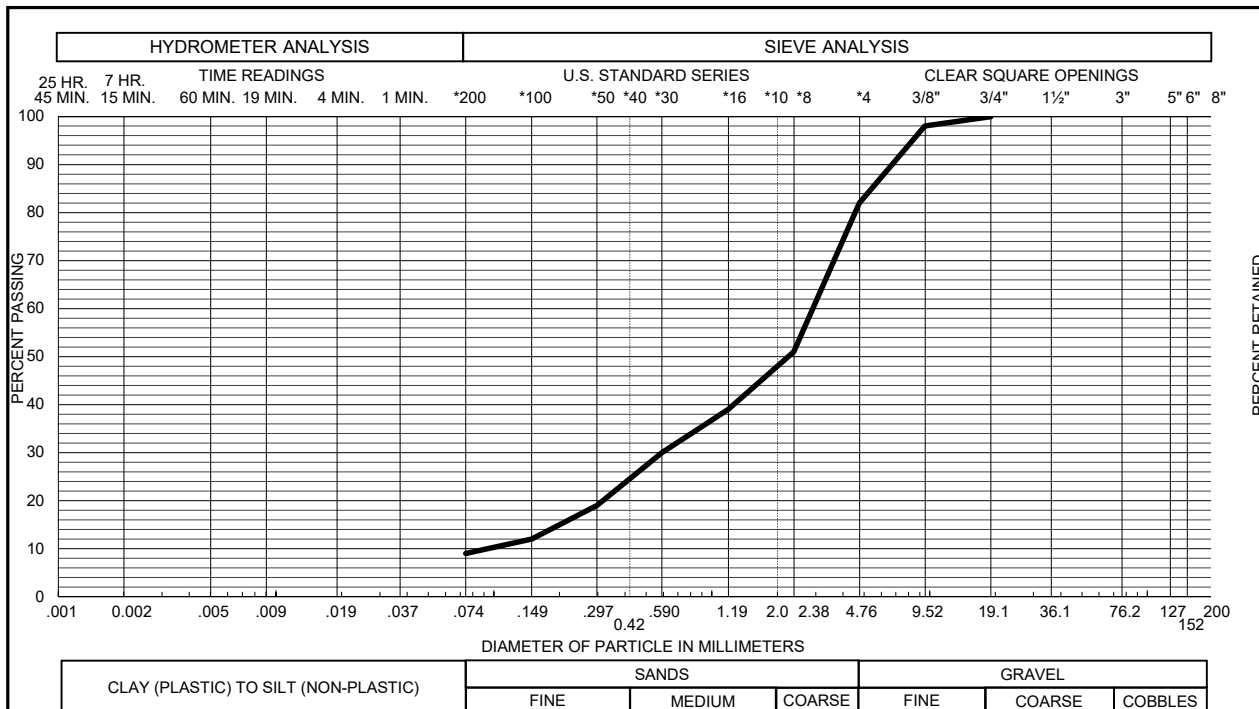
Sample of **SAND, SLIGHTLY CLAYEY (SW-SC)** GRAVEL 18 % SAND 73 %
 From **TH - 1 AT 9 FEET** SILT & CLAY 9 % LIQUID LIMIT 31 %
 PLASTICITY INDEX 13 %

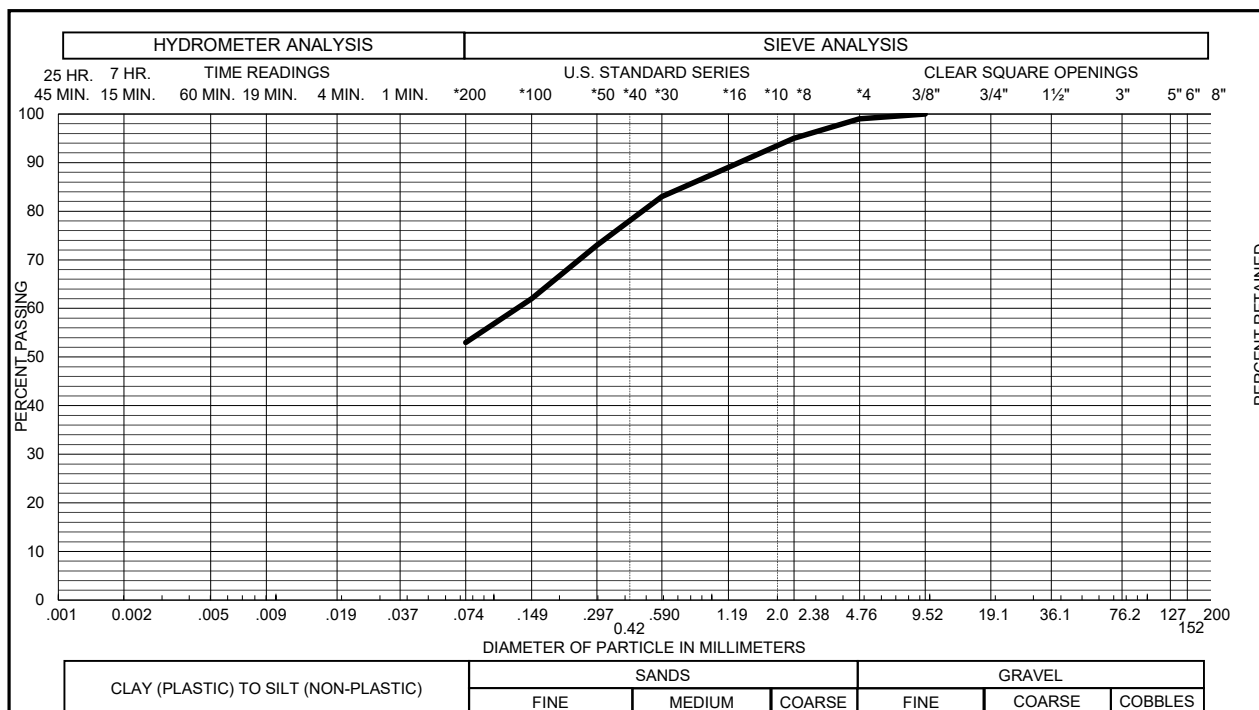
Sample of **FILL, CLAY, VERY SANDY** GRAVEL 1 % SAND 46 %
 From **TH - 2 AT 4 FEET** SILT & CLAY 53 % LIQUID LIMIT %
 PLASTICITY INDEX %

Existing fill was encountered in five of the seven borings and consisted of silty or clayey sand and very sandy clay. The fill extended to depths of about 6 feet below existing ground surface. The fill was judged to be loose to medium dense or medium stiff to stiff based on the results of field penetration resistance tests. The measured moisture content of a sample of fill was 4.8 percent and the sample contained 53 percent silt and clay-sized particles (passing the No. 200 sieve).

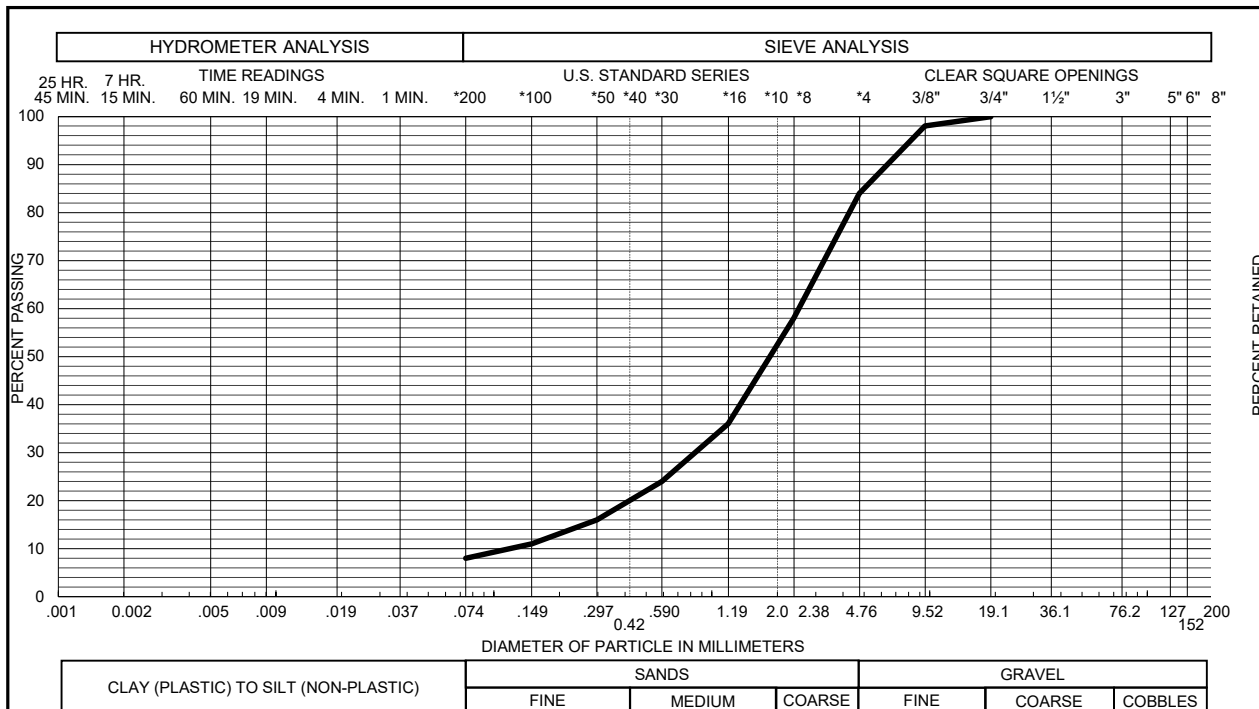
Sample of **SANDSTONE, SLIGHTLY SILTY** GRAVEL 16 % SAND 76 %
 From **TH - 2 AT 24 FEET** SILT & CLAY 8 % LIQUID LIMIT %
 PLASTICITY INDEX %

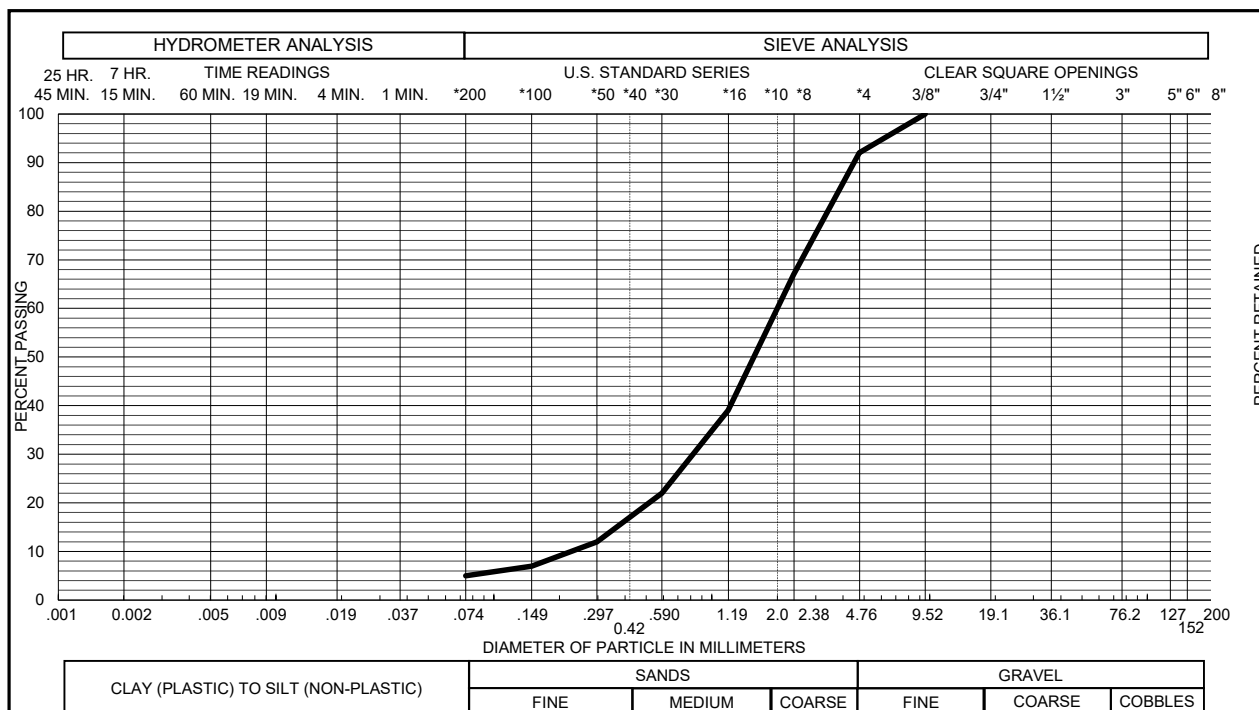
Sample of **SANDSTONE, SLIGHTLY SILTY** GRAVEL 8 % SAND 87 %
 From **TH - 3 AT 19 FEET** SILT & CLAY 5 % LIQUID LIMIT %
 PLASTICITY INDEX %

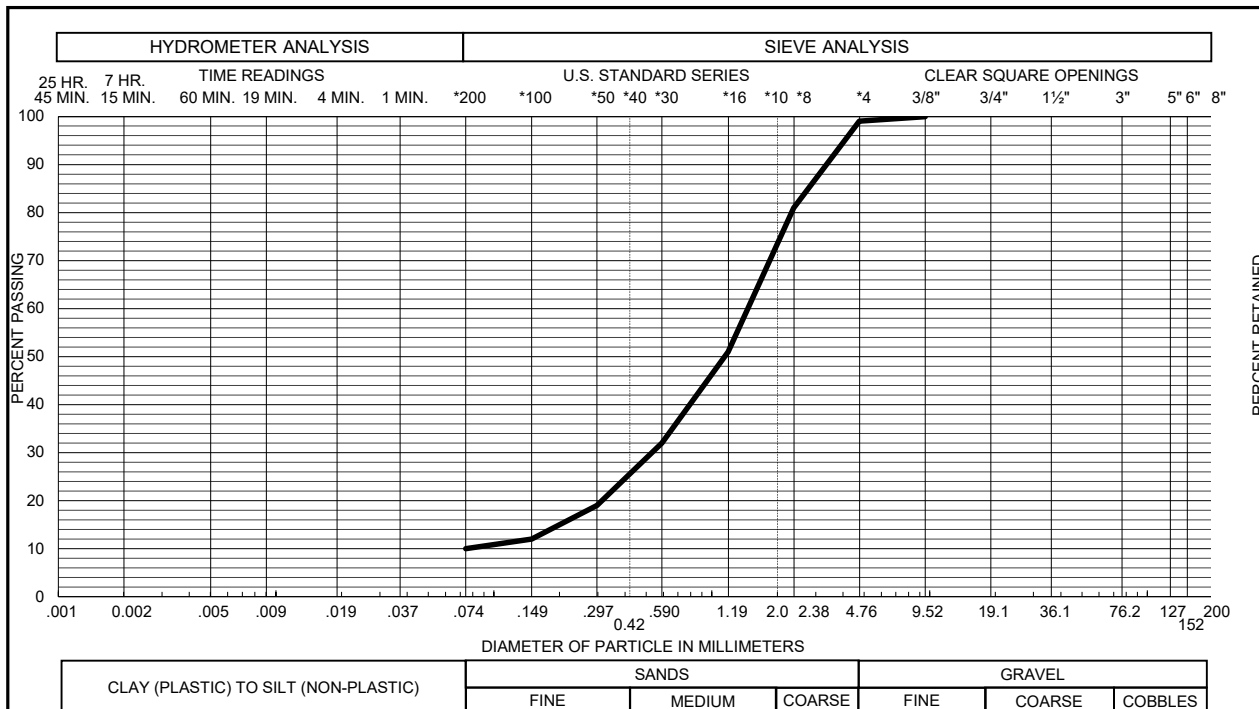
Sample of **SANDSTONE, SLIGHTLY CLAYEY** GRAVEL 1 % SAND 89 %
 From **TH - 4 AT 14 FEET** SILT & CLAY 10 % LIQUID LIMIT 26 %
 PLASTICITY INDEX 8 %

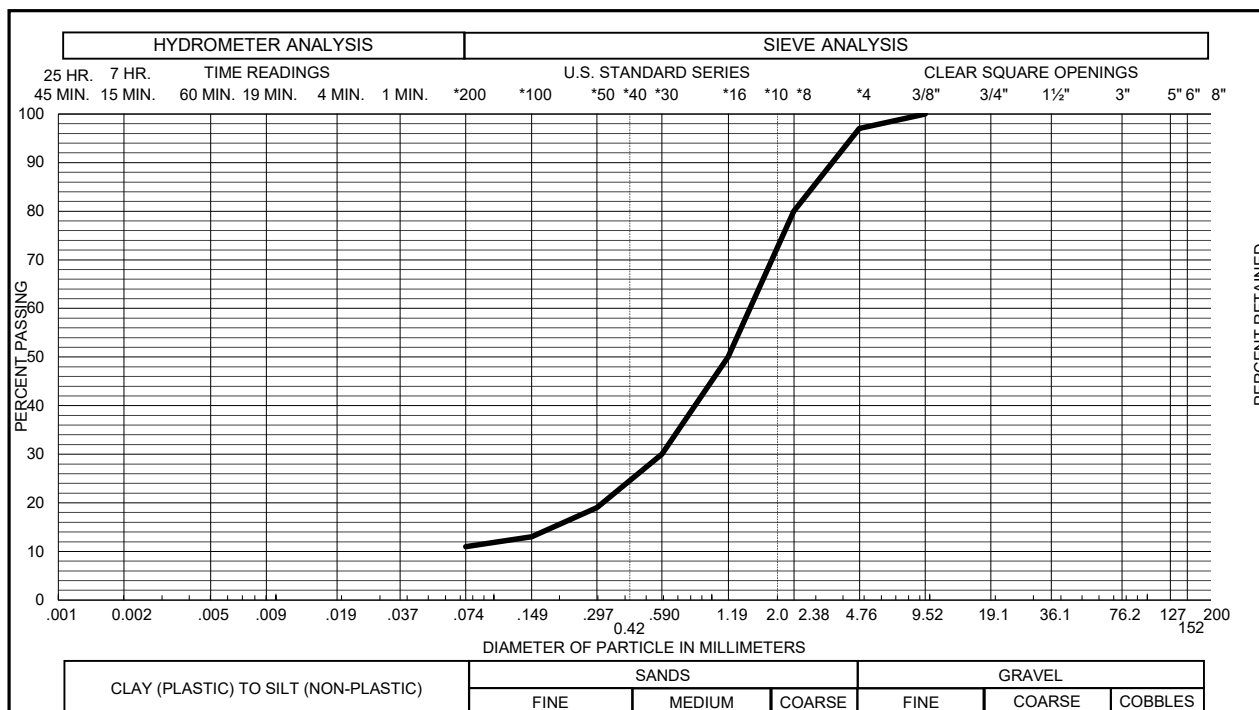
Sample of **SAND, SLIGHTLY SILTY (SP-SM)** GRAVEL 3 % SAND 86 %
 From **TH - 5 AT 9 FEET** SILT & CLAY 11 % LIQUID LIMIT %
 PLASTICITY INDEX %

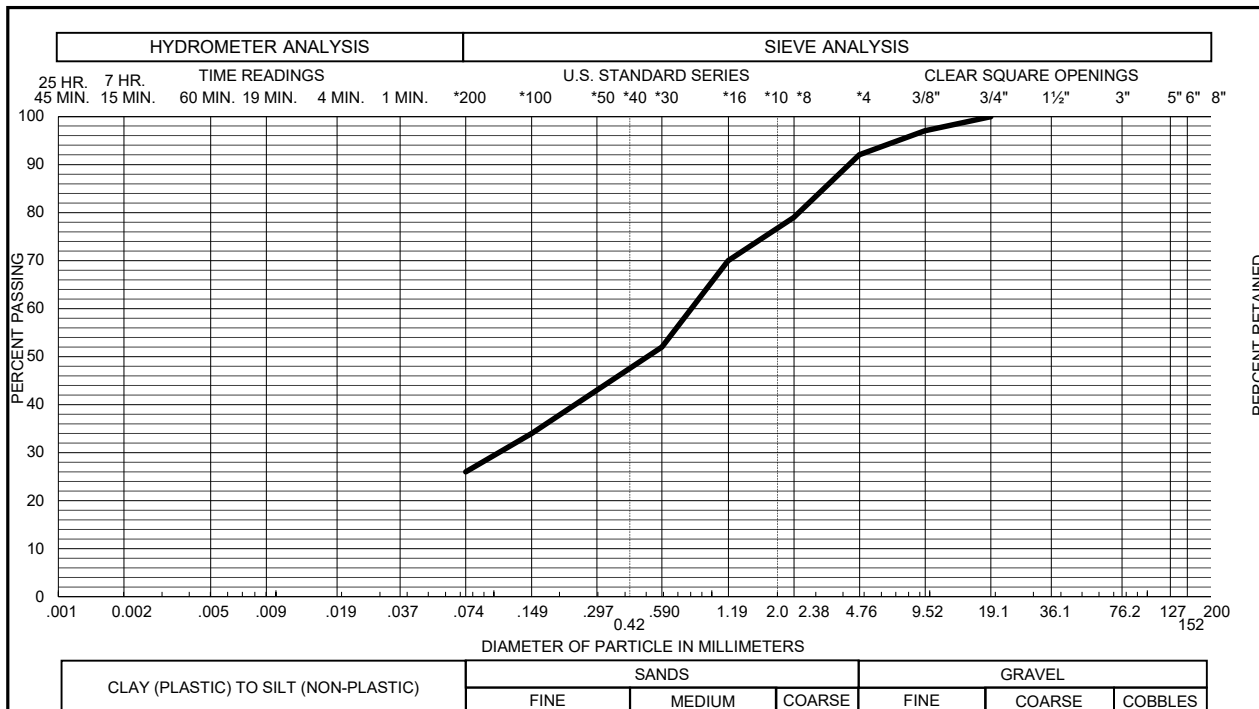
Sample of **SAND, CLAYEY (SC)** GRAVEL **8 %** SAND **66 %**
 From **COMBO - 1 AT 0 FEET** SILT & CLAY **26 %** LIQUID LIMIT **24 %**
 PLASTICITY INDEX **6 %**
