## GEOLOGIC HAZARD EVALUATION AND PRELIMINARY GEOTECHNICAL INVESTIGATION

ROWLEY PROPERTY  
MARKSHEFFEL ROAD AND COLORADO TECH DRIVE  
COLORADO SPRINGS, COLORADO

Project No. CS20042-115

May 11, 2026

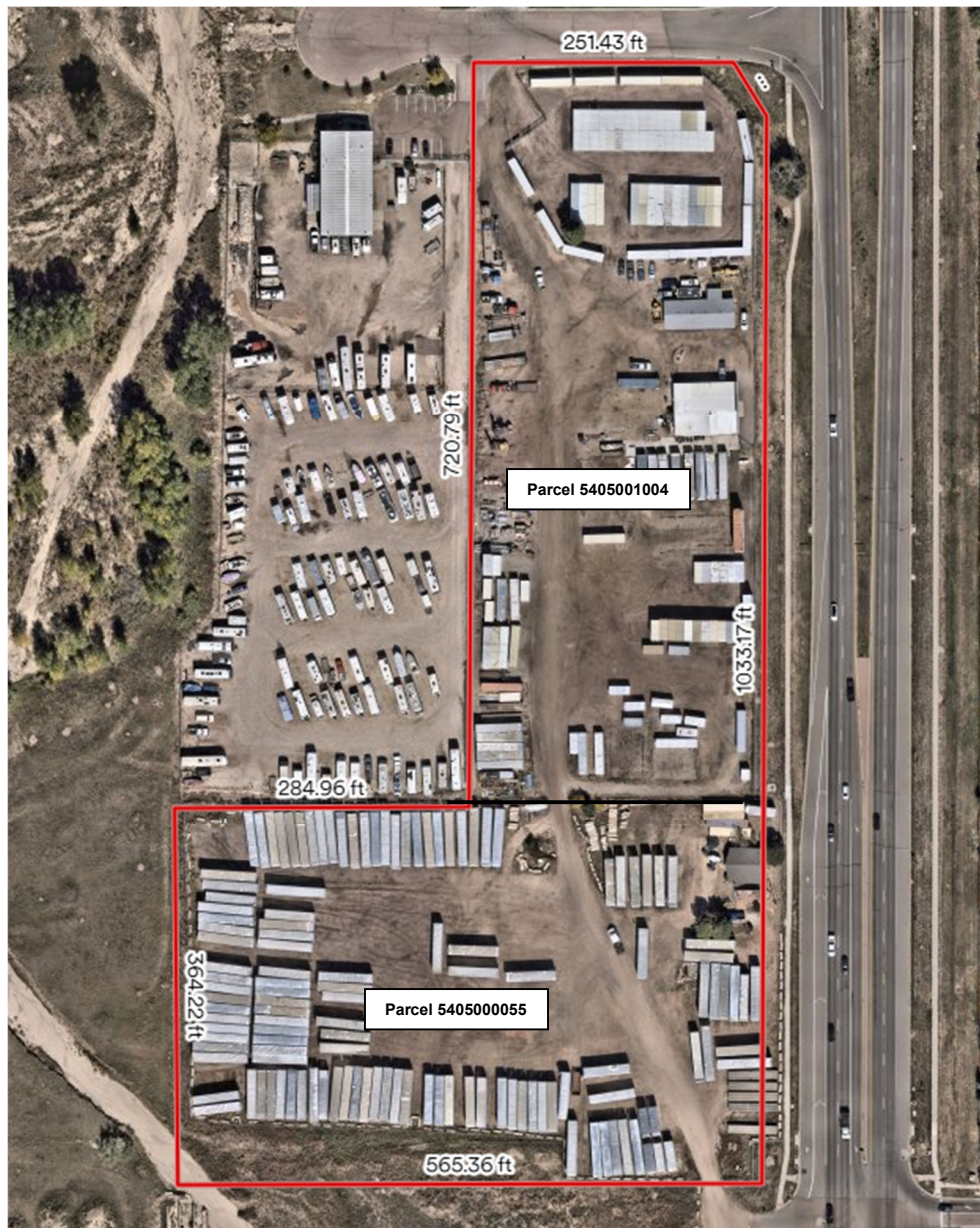
*Near Map Aerial Image of Northern Site*

The northern site consists of two separate parcels (Parcel Nos. 5404001004 and 540000055) that comprise 9 acres of land. At the time of this report, the northern site was predominantly utilized as storage for numerous containers and semi-trailers. Two relatively small, single-story buildings are located in the northern portion of the site adjacent to Marksheffel Road. Similar land used for storage is located west of the northern parcel. A minor, unchanneled tributary of the East Fork Sand Creek is located west of the northern site. The northern site is generally devoid of vegetation. The overall topography is relatively flat with a very gently descent to the south and southwest. An aerial image of the site with approximate parcel boundaries is shown below.

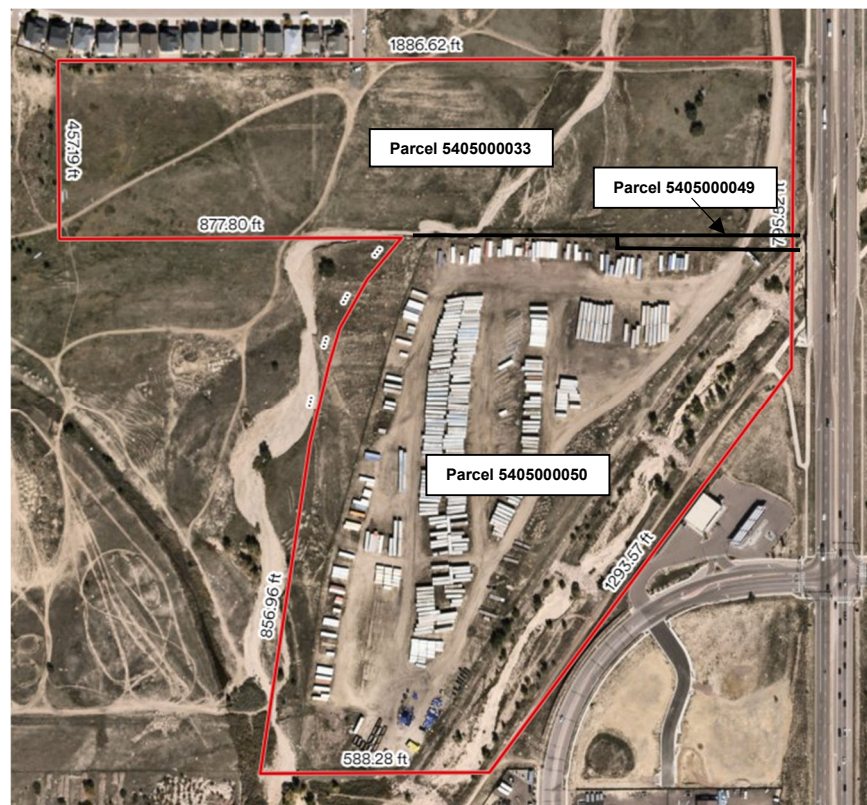
*Near Map Aerial Image of Southern Site*

A minor, unchanneled tributary to the Sand Creek East Fork crosses the 19-acre parcel from north to south and lies to the west of the 31-acres site, forming a confluence at the Sand Creek East Fork, just south of the southernmost property boundary. Over the past 25 years, the tributary creek has shifted toward the west. Both creeks are considered seasonal and were observed to be dry at the time of our investigation. A couple of dirt vehicle paths extend across the 19-acre parcel. The majority of the 31-acre parcel has been disturbed by clearing of vegetation and leveling the surface for parking of semi-trailers. Vacant, undeveloped land is located to the north and west of the site. Single-family residences are present to the northwest and Marksheffel Road and Meadowbrook Drive are located to the east and southeast, respectively. The overall topography includes a very gentle descent to the south and southwest. An aerial image of the southern site with approximate parcel boundaries is shown below.
