Re: Response to CGS Comments
Lots 1-50, Carriage Meadows South at Lorson Ranch, Filing No. 2
El Paso County, Colorado

RMG – Rocky Mountain Group (RMG) prepared the *Geology and Soils Study* (RMG Job No. 172445, last dated October 7, 2019) for the proposed development to consist of 50 multi-family residential lots on 85.32 acres located south and east of the intersection of Marksheffel Road and Fontaine Boulevard in El Paso County, Colorado. The report was reviewed by personnel of the Colorado Geological Survey (CGS). A copy of the review comment from CGS was provided to us by personnel of Thomas + Thomas. This comment appears to have been downloaded from the El Paso County EDARP system, and is included at the end of this document.

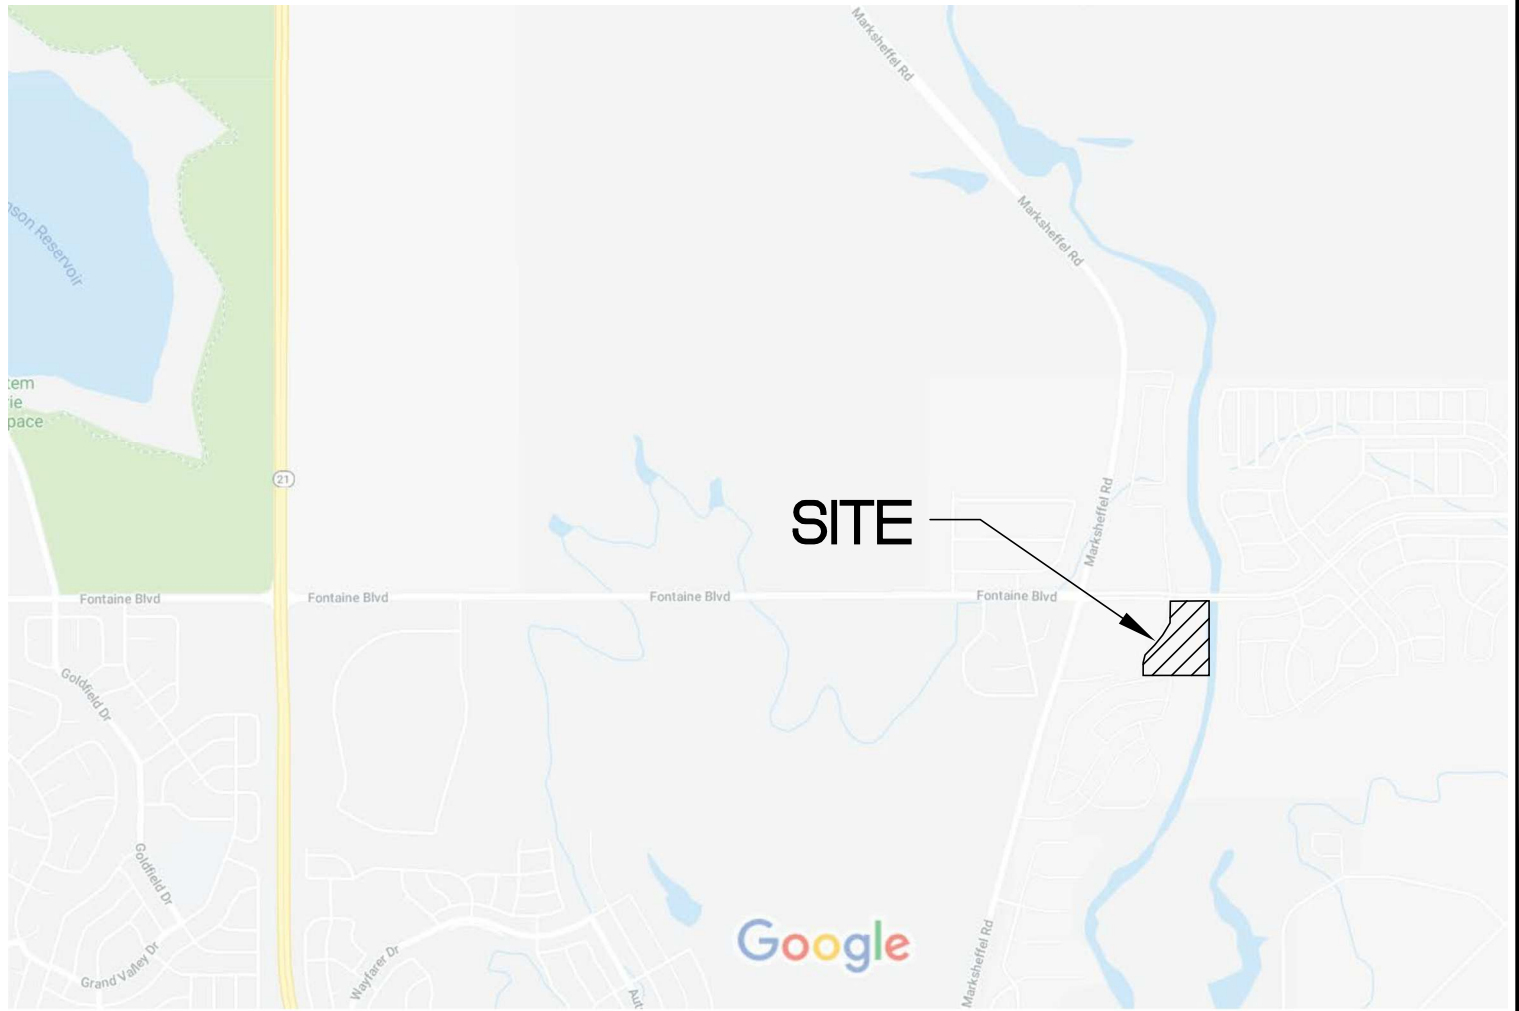
FIG No. 1

REFERENCE
NOT TO SCALE

The project lies in a portion of the northeast one-quarter of Section 22 and a portion of the northwest one-quarter of Section 23, Township 15 South, Range 65 West of the 6th Principal Meridian in El Paso County, Colorado. The site is located approximately 1/2 mile to the south and east of the intersection of Marksheffel Road and Fontaine Boulevard. The approximate location of the site is shown on the Site Vicinity Map, Figure 1.

The site consists of one parcel with a total acreage of approximately 5.32 acres. The included parcel has a Schedule No. of 5522105006 and is currently zoned *PUD – Planned Unit Development*. The zoning is to remain PUD. It is our understanding the proposed site development is to consist of multi-family construction on 50 lots. The development is to utilize sewer services provided by Widefield Water and Sanitation District. Individual wells and on-site wastewater treatment systems are not proposed. Figure 1 presents the general boundaries of our investigation.

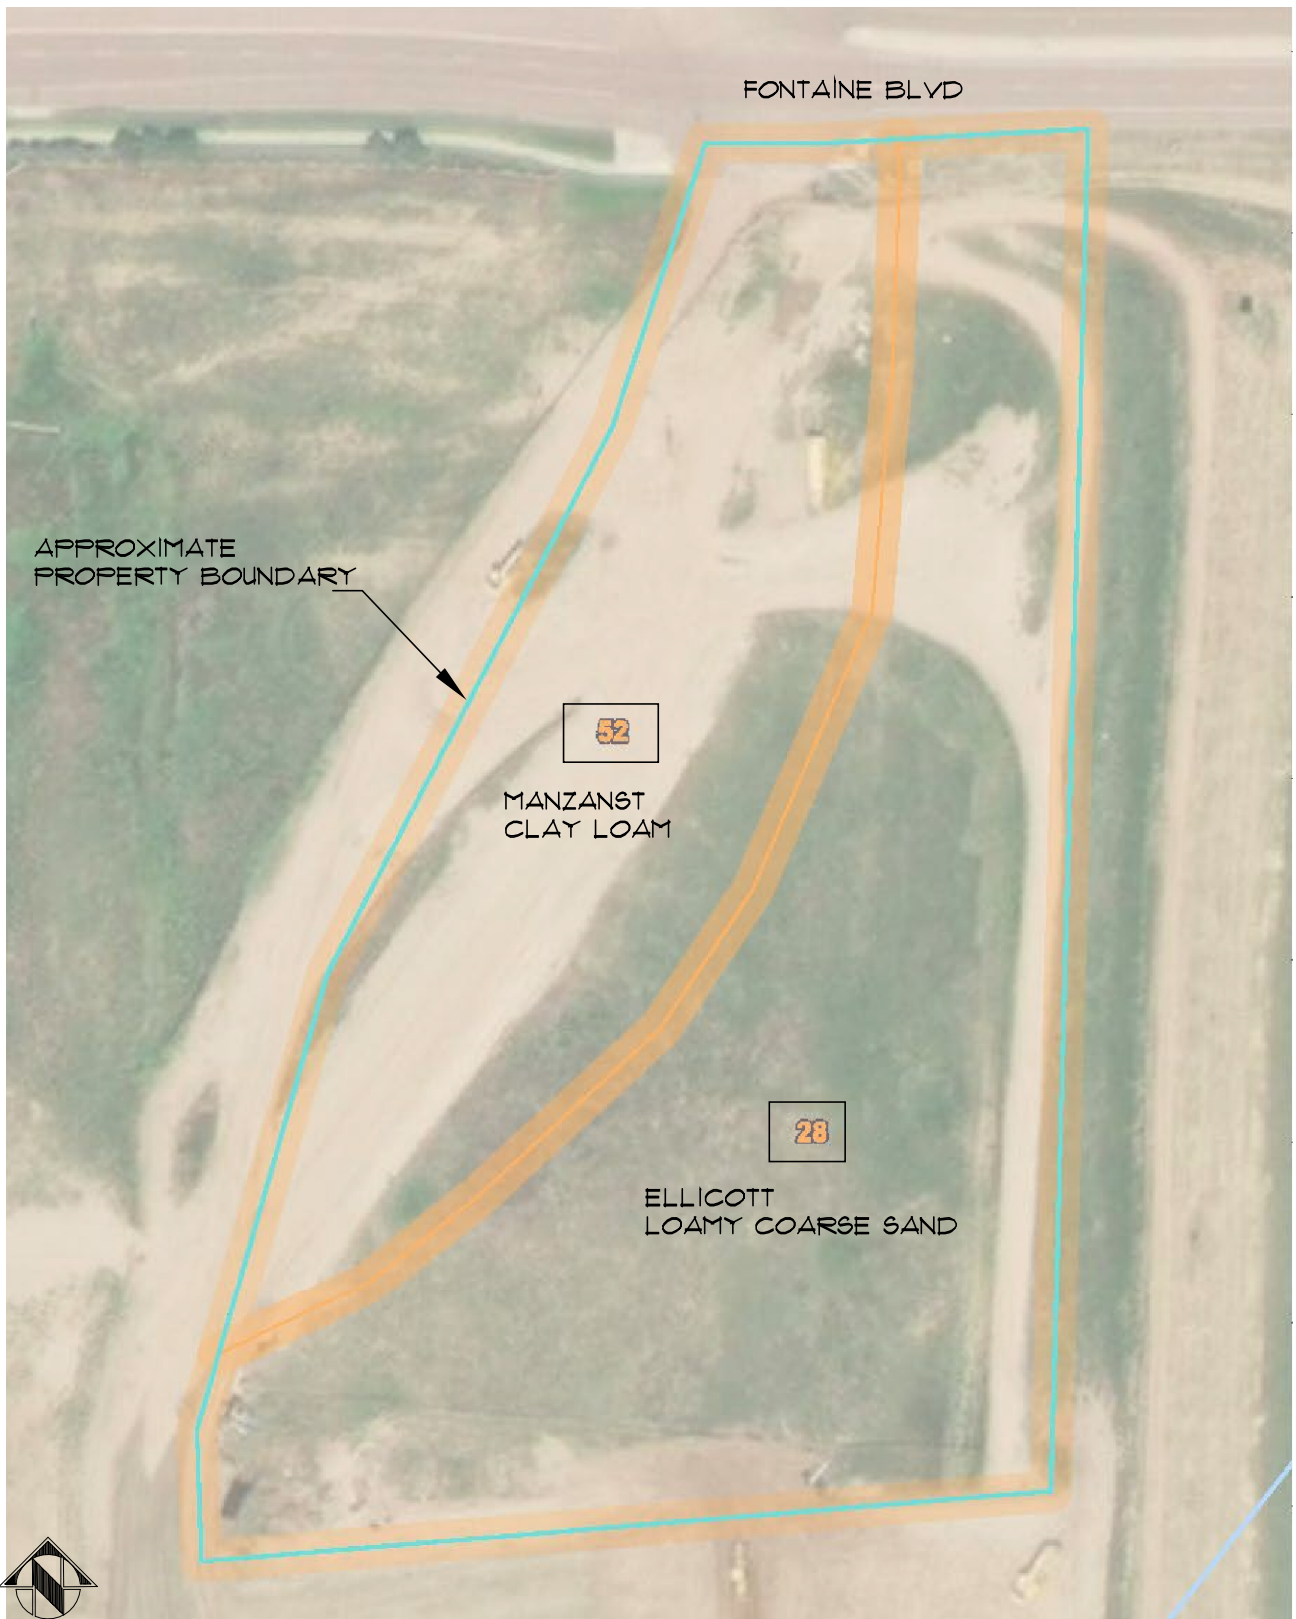
FIG No. 8

APPROXIMATE
PROPERTY BOUNDARY

FONTAINE BLVD

The USDA Soil Survey Map is presented in Figure 8.
