SOILS AND GEOLOGY STUDY

**Hillside at Lorson Ranch – “Area I”
El Paso County, Colorado**

JOB NO. 181988

January 3, 2022

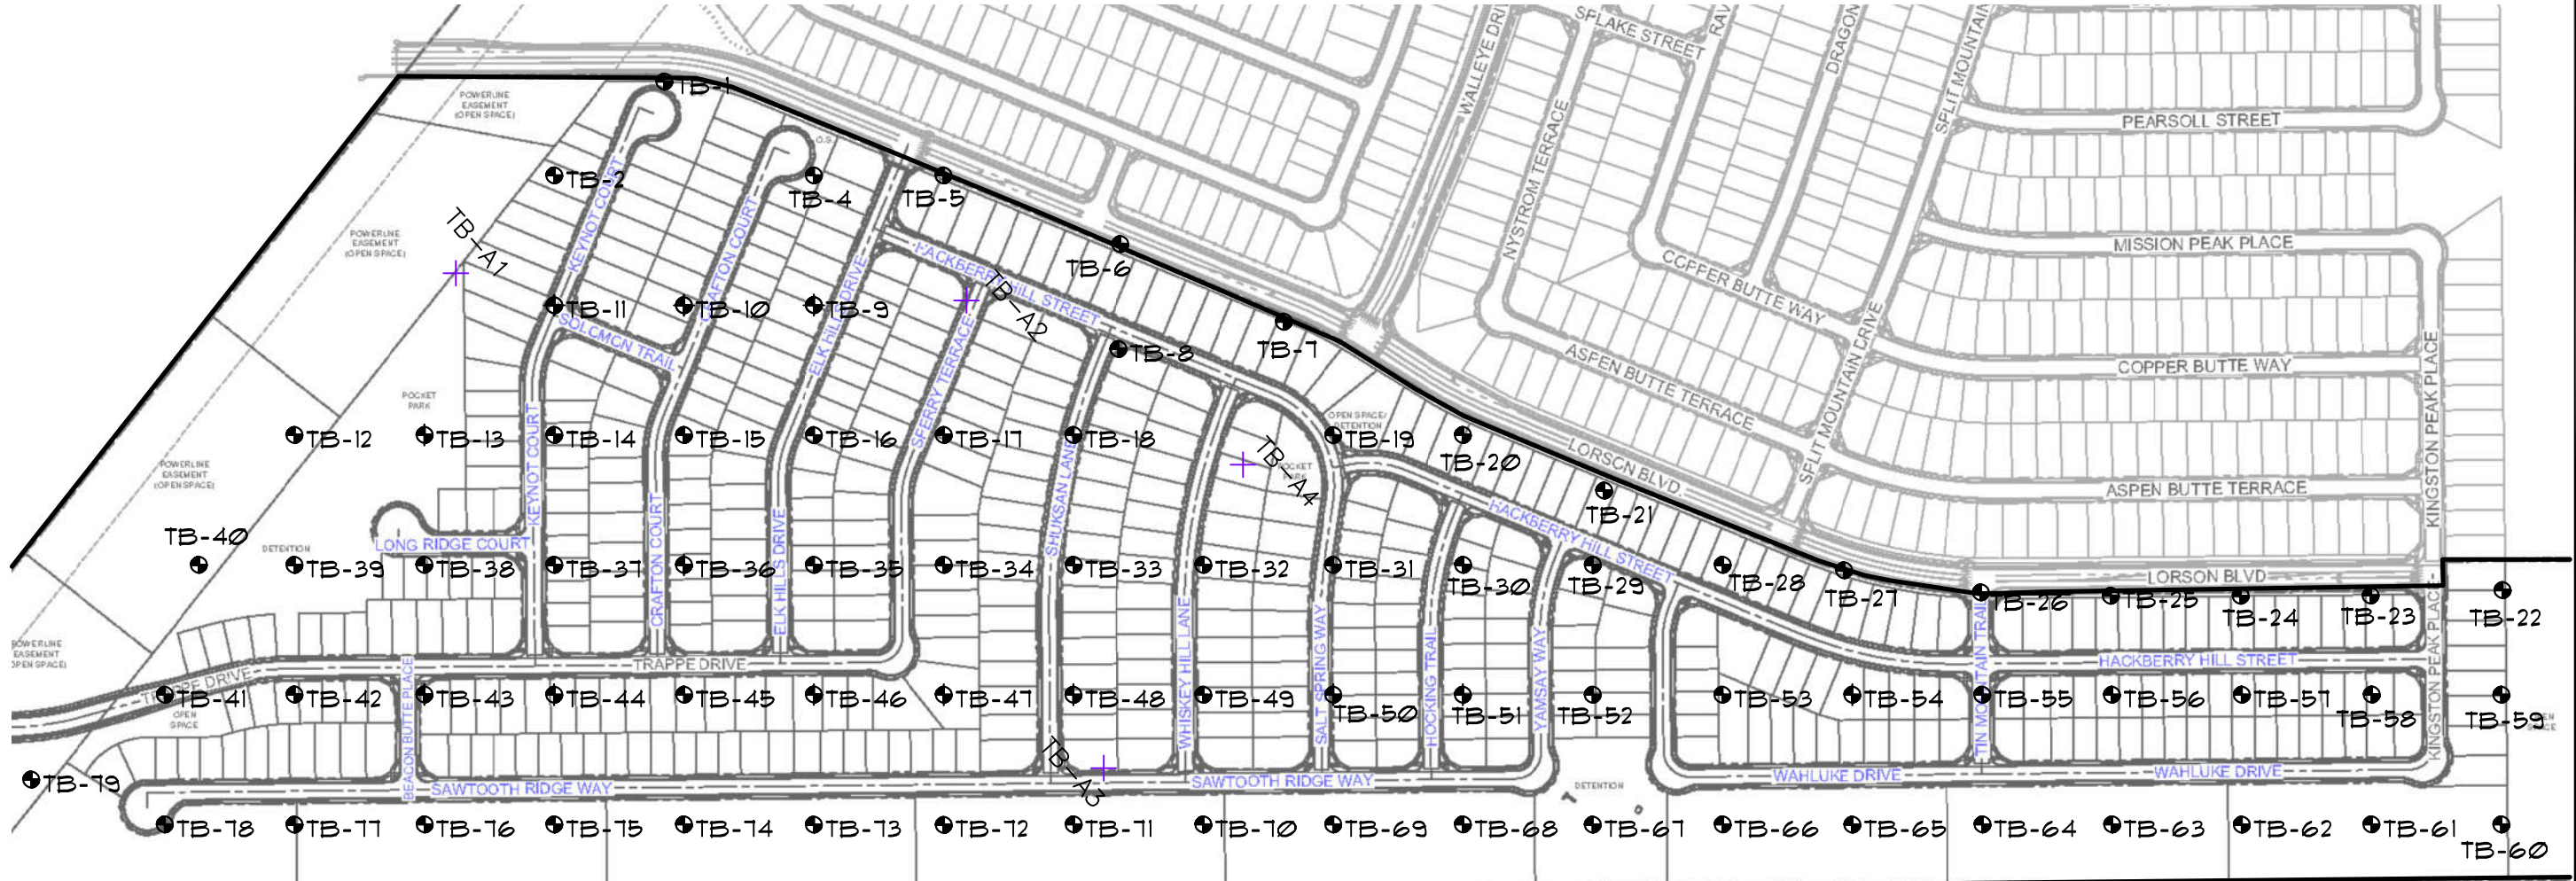
SHEET No.
FIG-2

PROPOSED LOT LAYOUT
WITH TEST BORING
LOCATIONS

● DENOTES APPROXIMATE
LOCATION OF TEST BORING

The proposed site development is to consist of 494 single-family residential units. The majority of the lots reportedly range from 3,825 to 6,600 square feet. Eight “buffer” lots, approximately 5 acres each along the southern boundary, are to provide transition from the smaller lots within the new Hillside at Lorson Ranch subdivision to the existing Peaceful Valley Lake Estates to the south. Entrance into the subdivision is to be provided from the west by extending the existing Trappe Drive and Lorson Boulevard, from the east by extending Kingston Peak Place, and from the north by two interior roadways (Elk Hills Drive and Tin Mountain Trail) extending south from Lorson Boulevard. Additional proposed land usage includes landscaped easements, parks, open spaces, trail corridors, utility easements, and drainage and detention facilities. The Proposed Lot Layout With Test Boring Locations plan is presented in Figure 2.

The subsurface conditions within the property were explored by drilling 78 exploratory test borings to depths of approximately 12 to 20 feet below the existing ground surface. The test boring locations are presented on the Proposed Lot Layout With Test Boring Locations plan, Figure 2. Additionally, 6 preliminary test borings were performed in March of 2020. The Test Boring Logs for these preliminary borings are included in Appendix B.

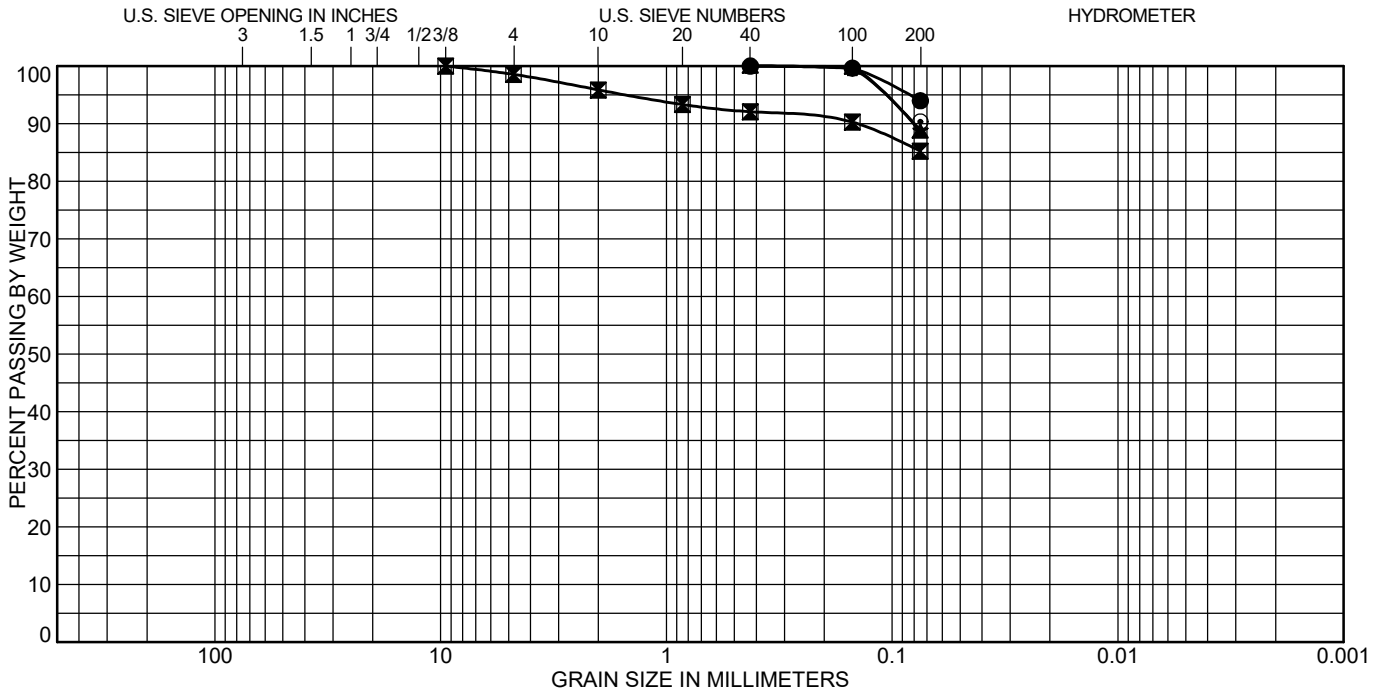
FIGURE No. 44

Test Boring	Depth (ft)	Classification	LL	PL	PI
● 2	9.0	LEAN CLAY(CL)	38	18	20
☒ 11	4.0	LEAN CLAY(CL)	38	14	24
▲ 25	14.0	LEAN CLAY(CL)	38	13	25
★ 26	4.0	LEAN CLAY(CL)	39	14	25
⊙ 28	14.0	LEAN CLAY(CL)	39	15	24

Soil laboratory testing was performed as part of this investigation. The laboratory tests included moisture content, dry density, grain-size analyses, Atterberg Limits and Swell/Consolidation tests. A Summary of Laboratory Test Results is presented in Figure 43. Soils Classification Data is presented in Figures 44 through 47. Swell/Consolidation Test Results are presented in Figures 48 through 84.

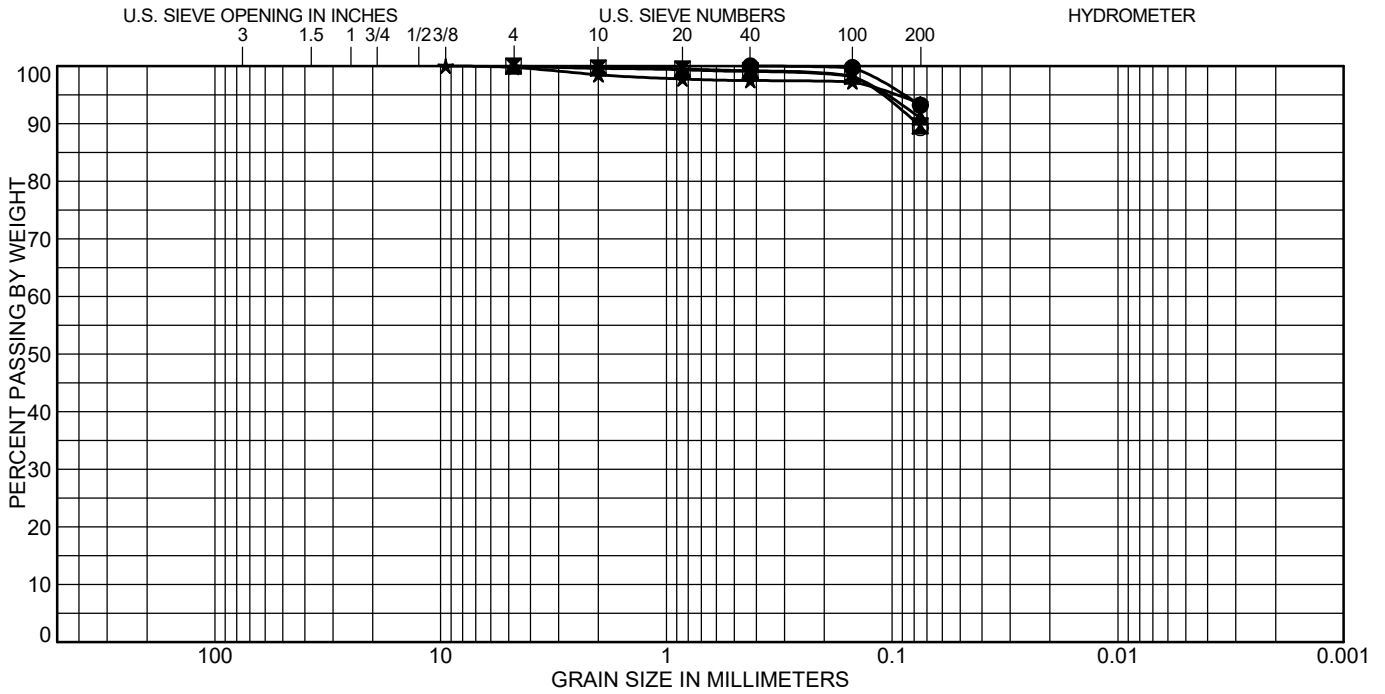
FIGURE No. 45

Test Boring	Depth (ft)	Classification	LL	PL	PI
● 30	4.0	LEAN CLAY(CL)	44	13	31
☒ 37	9.0	LEAN CLAY(CL)	36	14	22
▲ 44	9.0	LEAN CLAY(CL)	47	14	33
★ 47	14.0	LEAN CLAY(CL)	39	15	24
◎ 52	4.0	LEAN CLAY(CL)	34	16	18

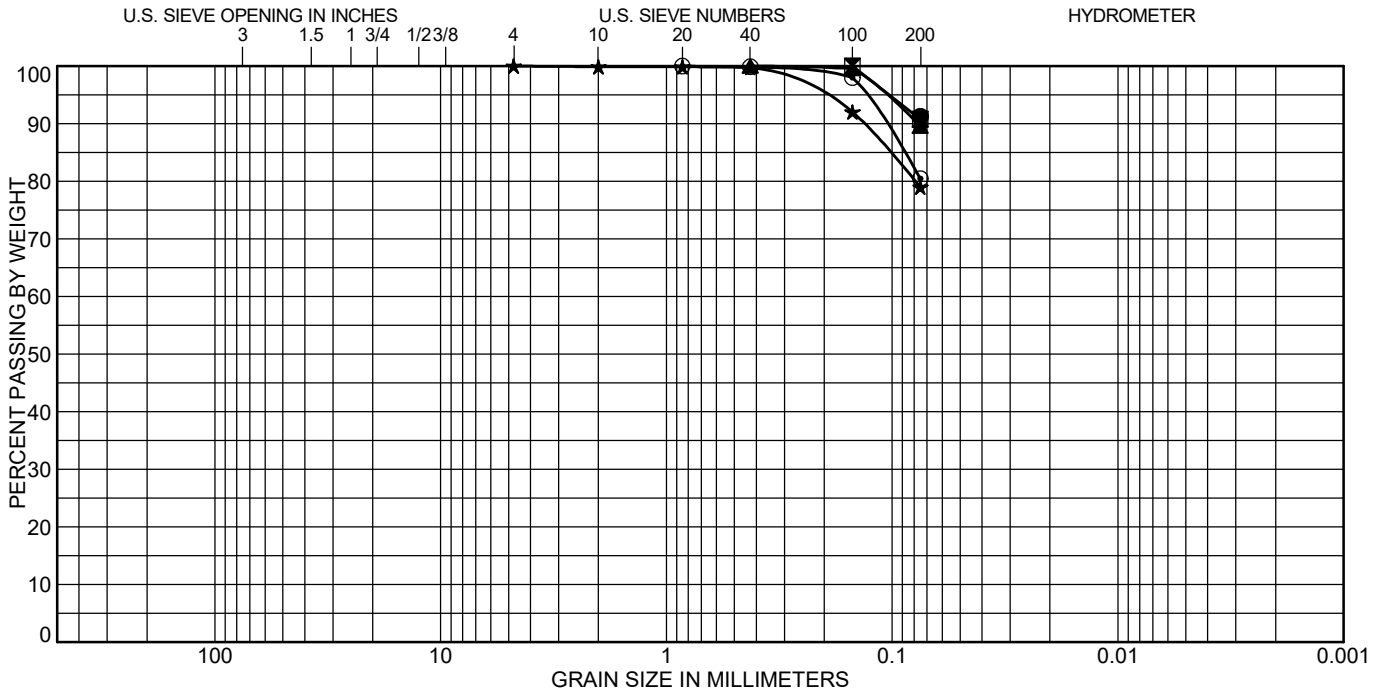
FIGURE No. 46

Test Boring	Depth (ft)	Classification	LL	PL	PI
● 57	19.0	LEAN CLAY(CL)	40	17	23
☒ 60	9.0	LEAN CLAY(CL)	33	16	17
▲ 67	9.0	LEAN CLAY(CL)	31	15	16
★ 68	14.0	LEAN CLAY with SAND(CL)	33	13	20
⊙ 74	9.0	LEAN CLAY with SAND(CL)	37	11	26

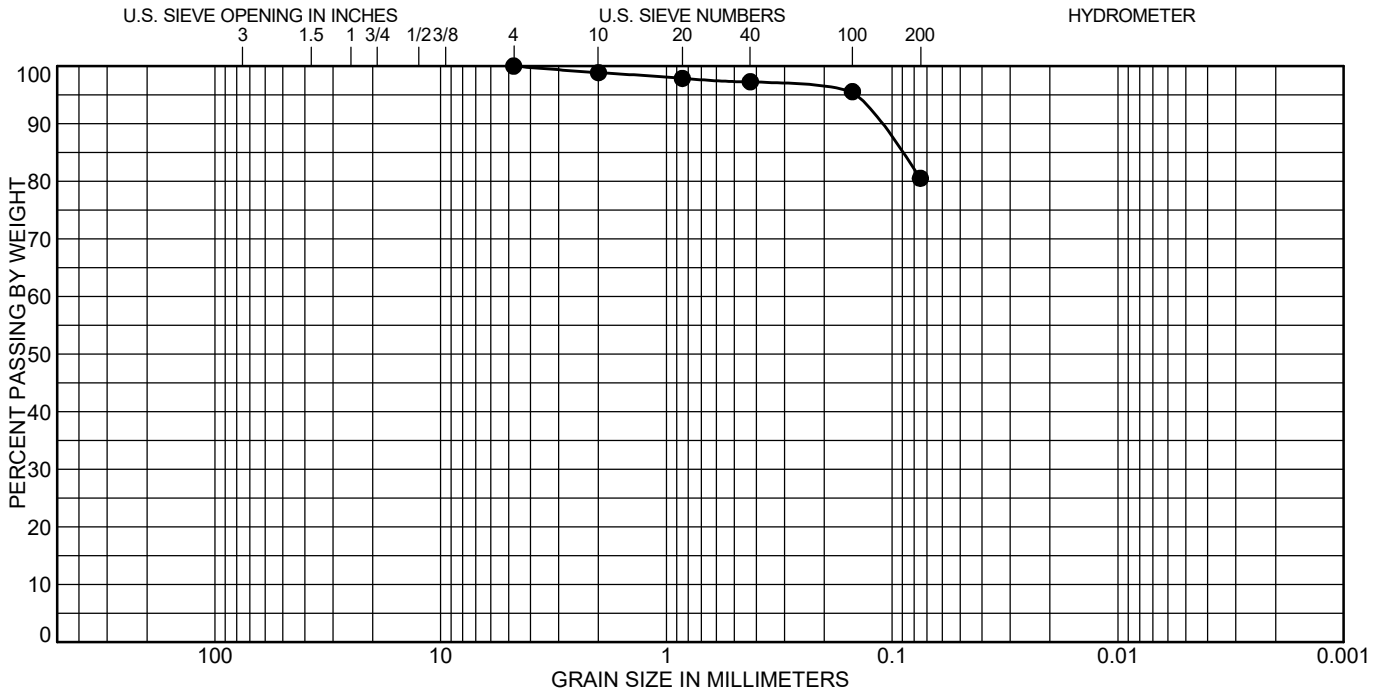
FIGURE No. 47

Test Boring	Depth (ft)	Classification	LL	PL	PI
● 77	14.0	LEAN CLAY with SAND(CL)	35	12	23

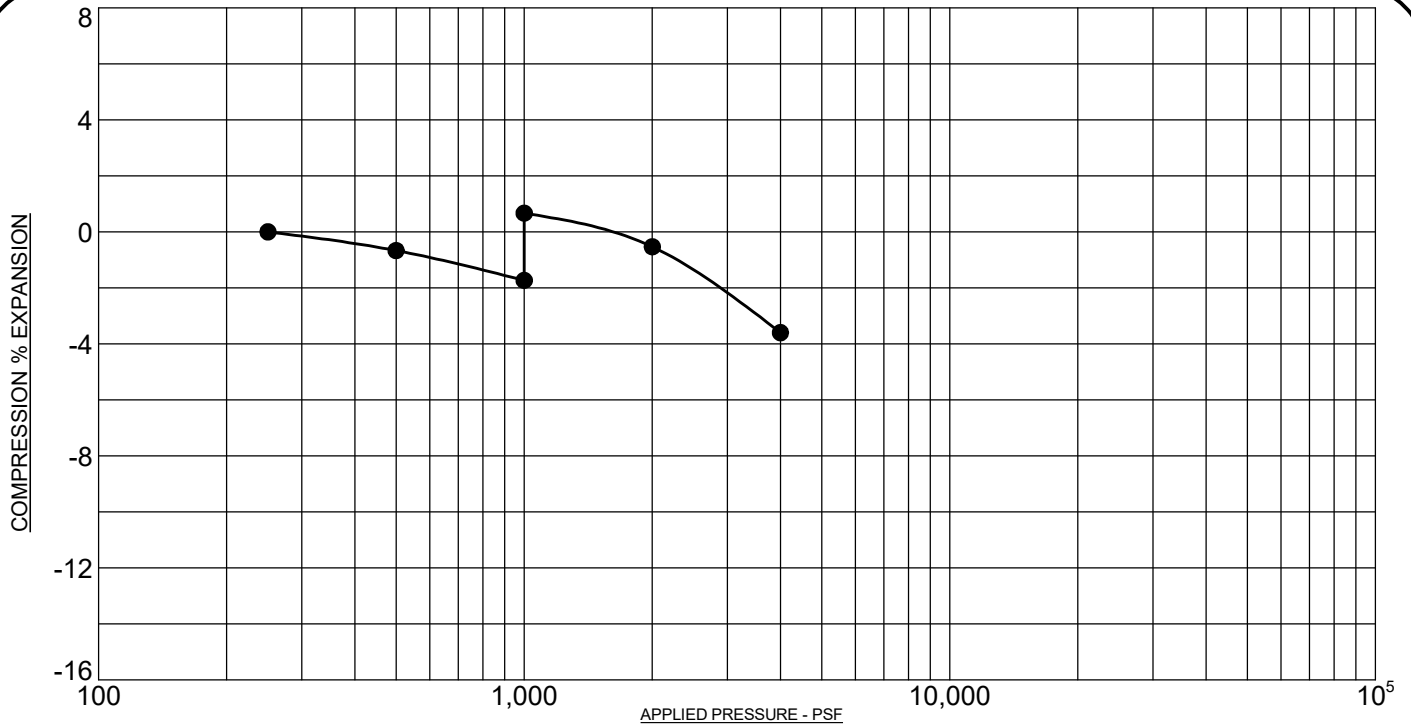
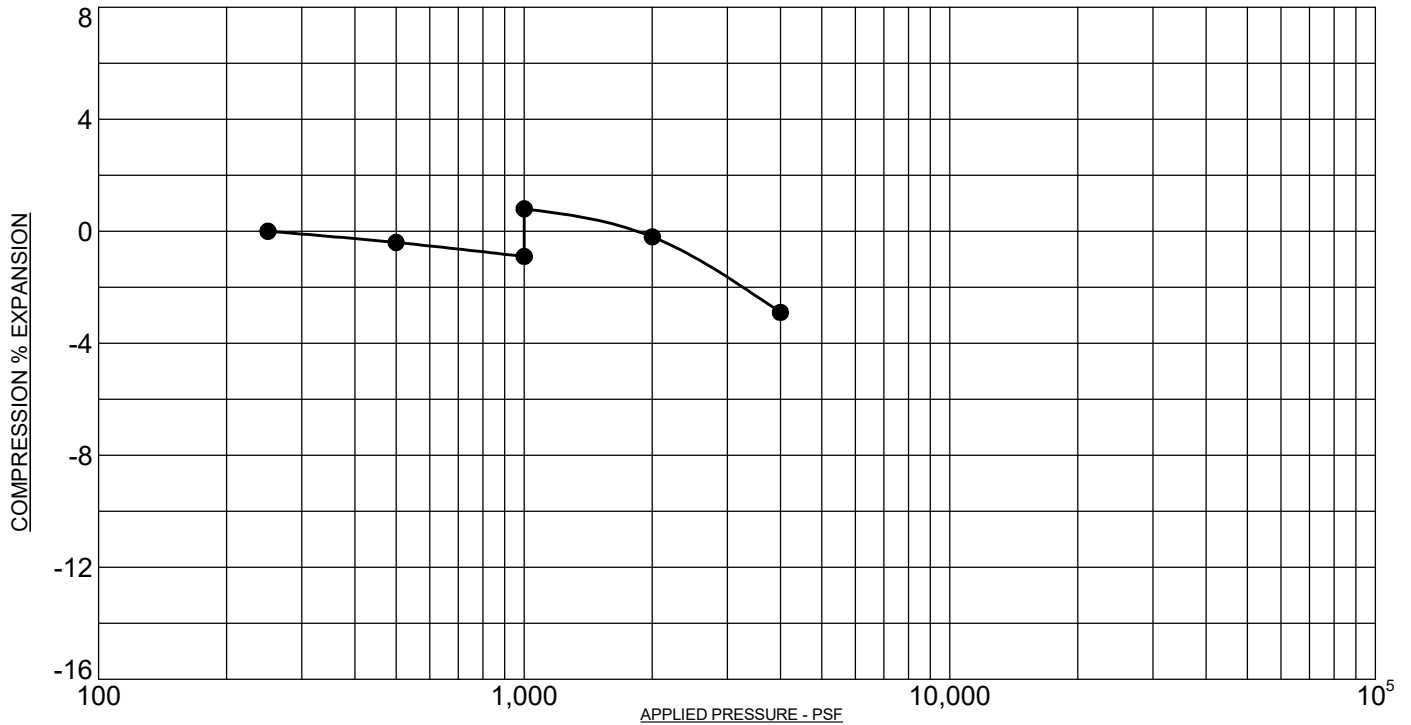
FIGURE No. 48

PROJECT: Lorson Boulevard, Area I, El Paso County, Colorado
 SAMPLE DESCRIPTION: CLAYSTONE, SANDY
 NOTE: SAMPLE WAS INUNDATED WITH WATER AT 1,000 PSF

SAMPLE LOCATION: 1 @ 14 FT
 NATURAL DRY UNIT WEIGHT: 108.2 PCF
 NATURAL MOISTURE CONTENT: 11.5%
 PERCENT SWELL/COMPRESSION: 2.4

SAMPLE LOCATION: 2 @ 9 FT
 NATURAL DRY UNIT WEIGHT: 105.5 PCF
 NATURAL MOISTURE CONTENT: 10.6%
 PERCENT SWELL/COMPRESSION: 1.7

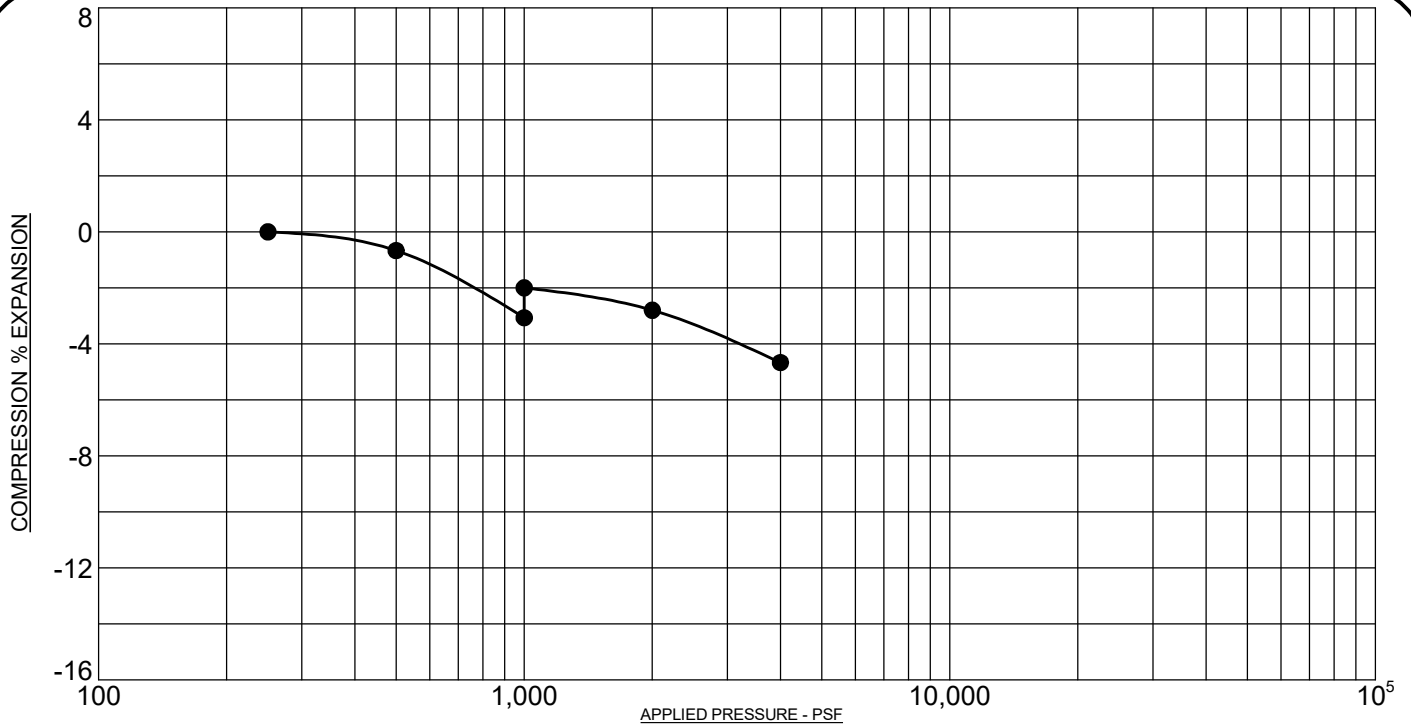
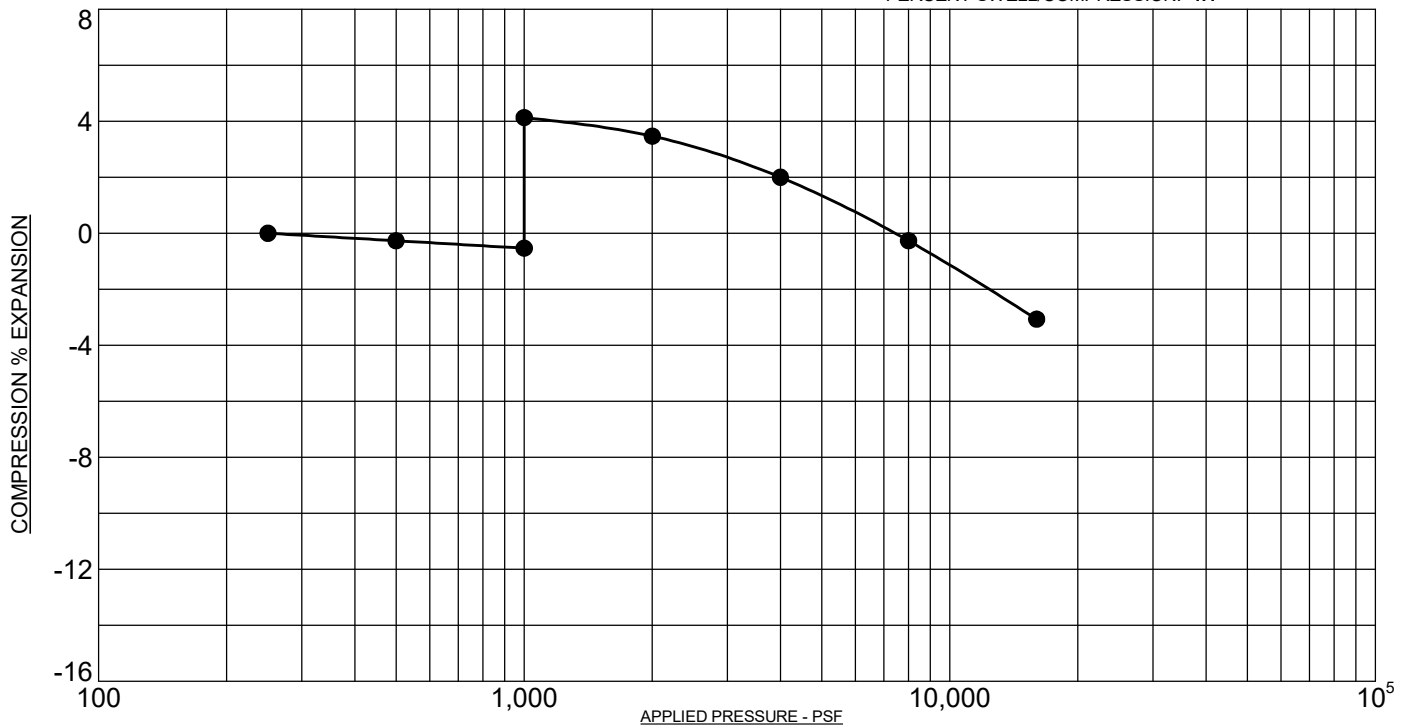
FIGURE No. 49

PROJECT: Lorson Boulevard, Area I, El Paso County, Colorado
 SAMPLE DESCRIPTION: CLAYSTONE, SANDY
 NOTE: SAMPLE WAS INUNDATED WITH WATER AT 1,000 PSF

SAMPLE LOCATION: 4 @ 14 FT
 NATURAL DRY UNIT WEIGHT: 118.4 PCF
 NATURAL MOISTURE CONTENT: 11.3%
 PERCENT SWELL/COMPRESSION: 1.1

SAMPLE LOCATION: 5 @ 9 FT
 NATURAL DRY UNIT WEIGHT: 126.6 PCF
 NATURAL MOISTURE CONTENT: 11.6%
 PERCENT SWELL/COMPRESSION: 4.7

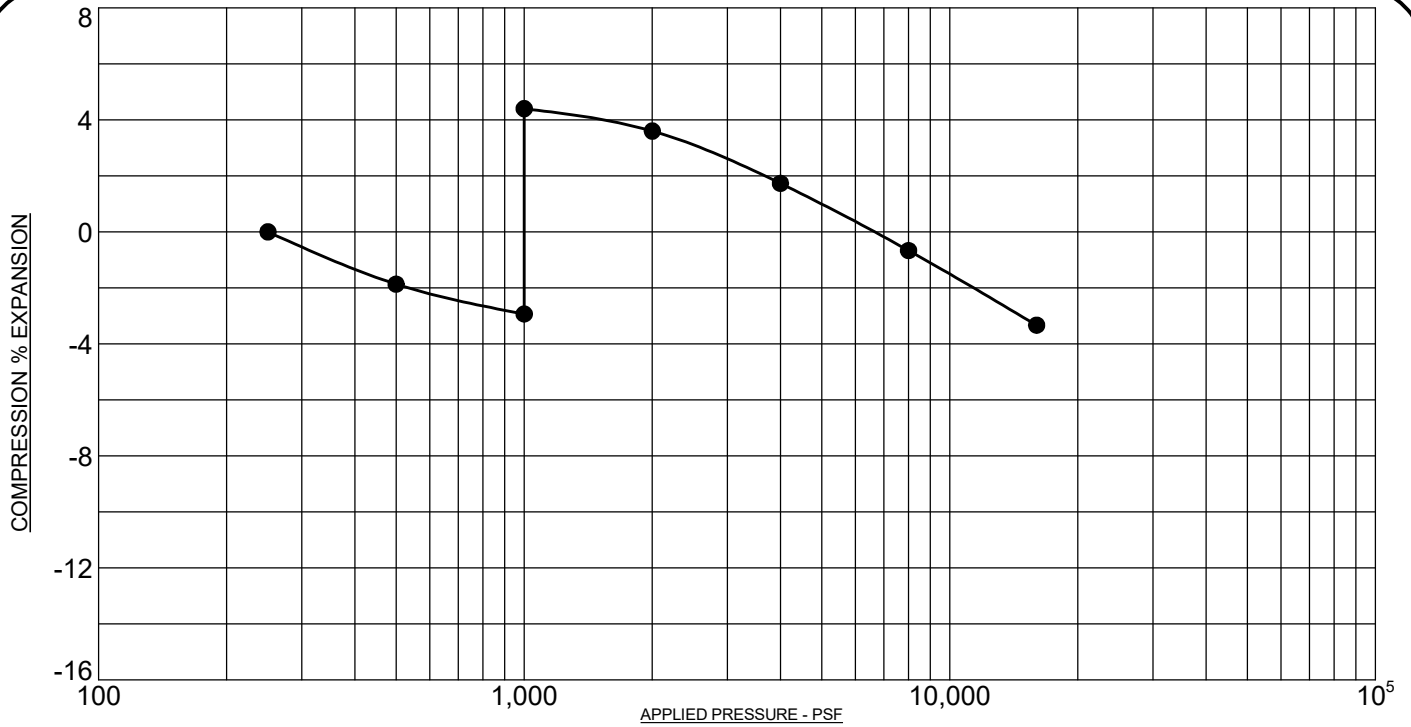
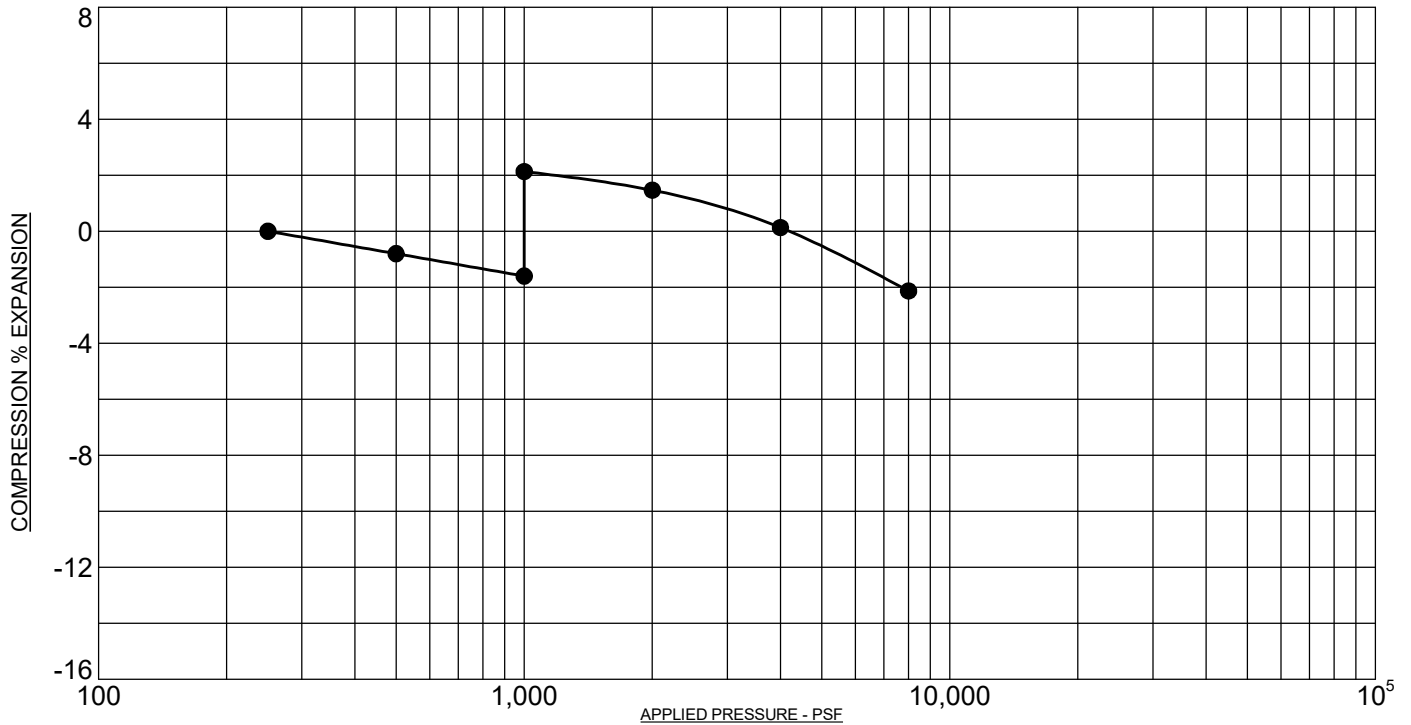
FIGURE No. 50

PROJECT: Lorson Boulevard, Area I, El Paso County, Colorado
 SAMPLE DESCRIPTION: CLAYSTONE, SANDY
 NOTE: SAMPLE WAS INUNDATED WITH WATER AT 1,000 PSF

SAMPLE LOCATION: 6 @ 14 FT
 NATURAL DRY UNIT WEIGHT: 108.9 PCF
 NATURAL MOISTURE CONTENT: 12.8%
 PERCENT SWELL/COMPRESSION: 7.3

SAMPLE LOCATION: 7 @ 9 FT
 NATURAL DRY UNIT WEIGHT: 113.6 PCF
 NATURAL MOISTURE CONTENT: 14.3%
 PERCENT SWELL/COMPRESSION: 3.7

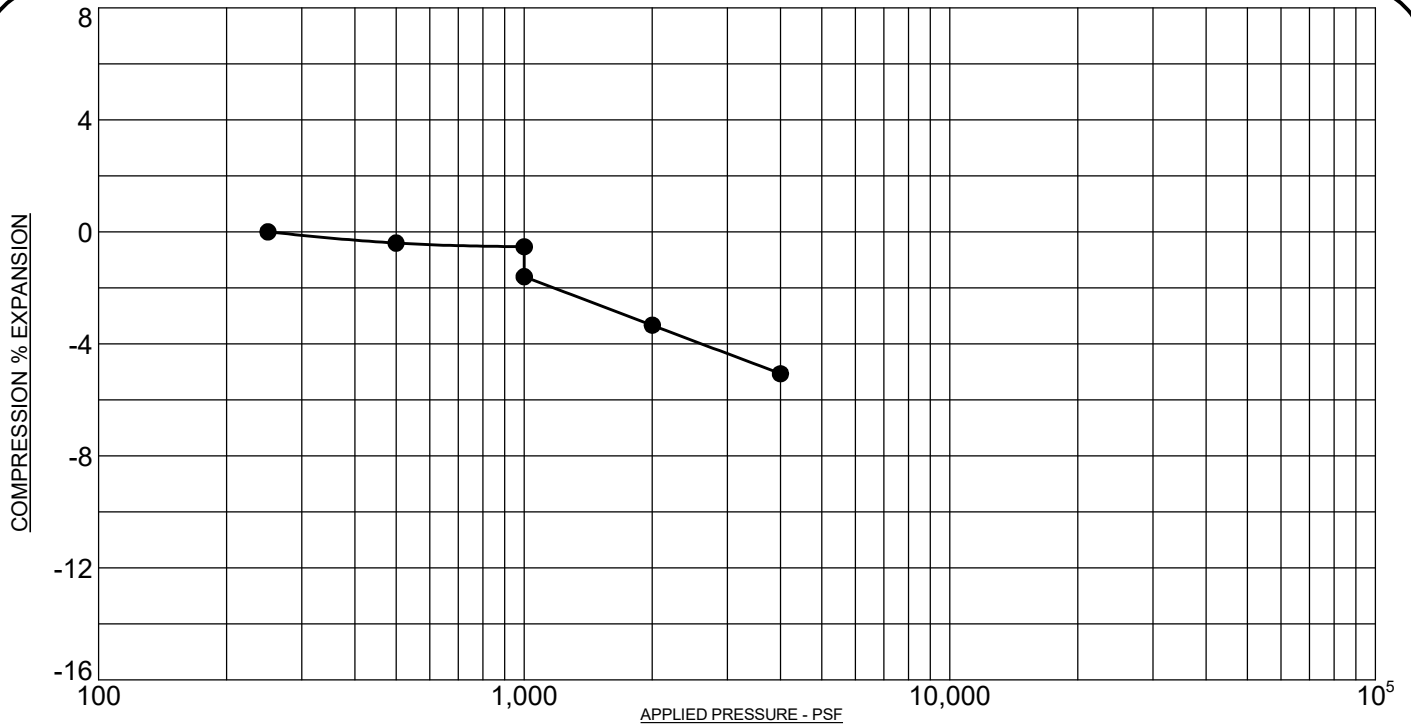
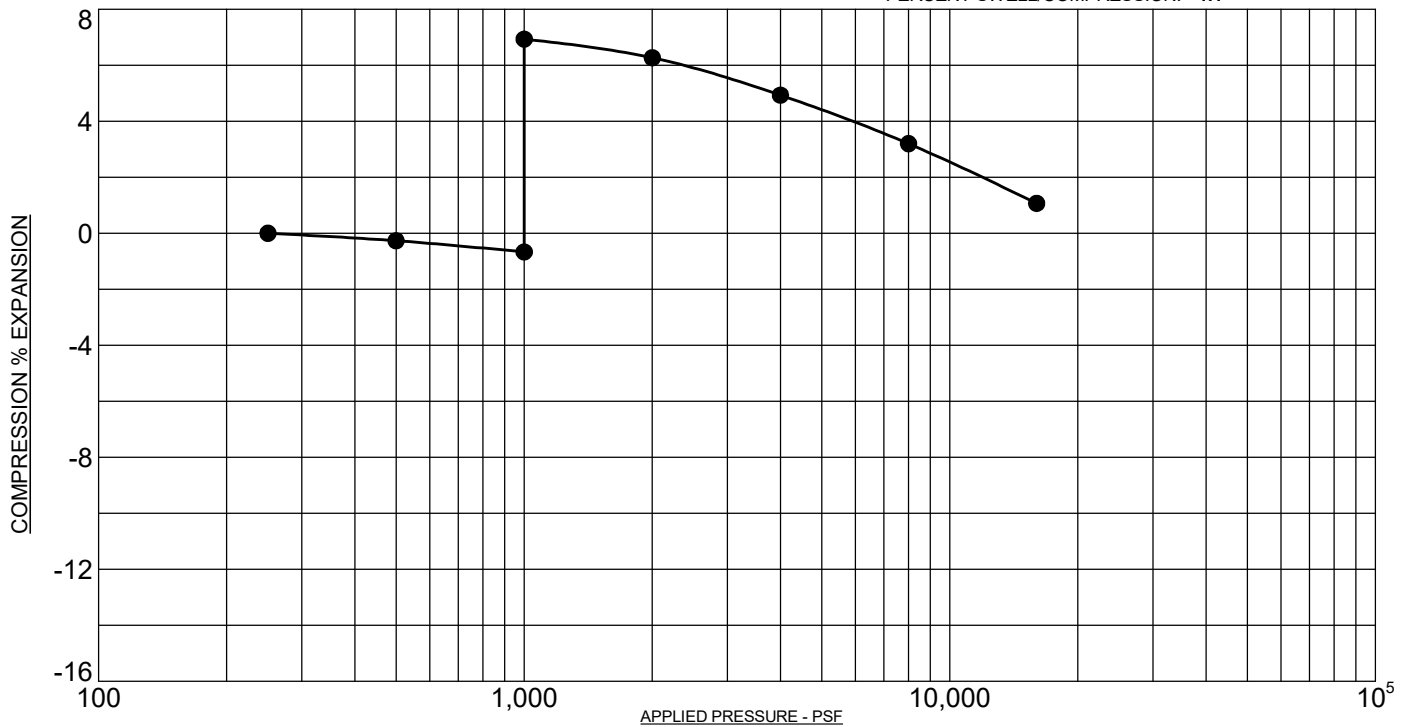
FIGURE No. 51

PROJECT: Lorson Boulevard, Area I, El Paso County, Colorado
 SAMPLE DESCRIPTION: CLAYSTONE, SANDY
 NOTE: SAMPLE WAS INUNDATED WITH WATER AT 1,000 PSF

SAMPLE LOCATION: 8 @ 4 FT
 NATURAL DRY UNIT WEIGHT: 104.0 PCF
 NATURAL MOISTURE CONTENT: 17.8%
 PERCENT SWELL/COMPRESSION: - 1.1

SAMPLE LOCATION: 9 @ 14 FT
 NATURAL DRY UNIT WEIGHT: 129.3 PCF
 NATURAL MOISTURE CONTENT: 10.6%
 PERCENT SWELL/COMPRESSION: 7.6

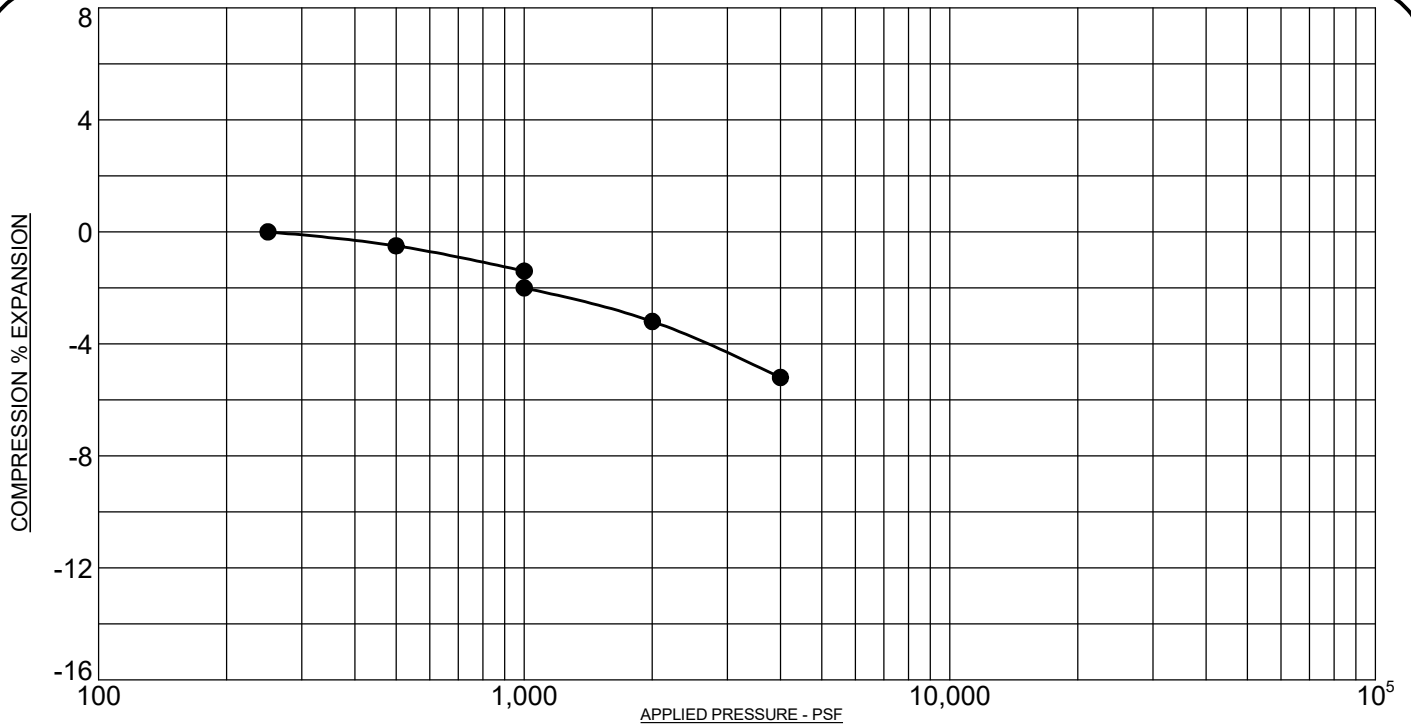
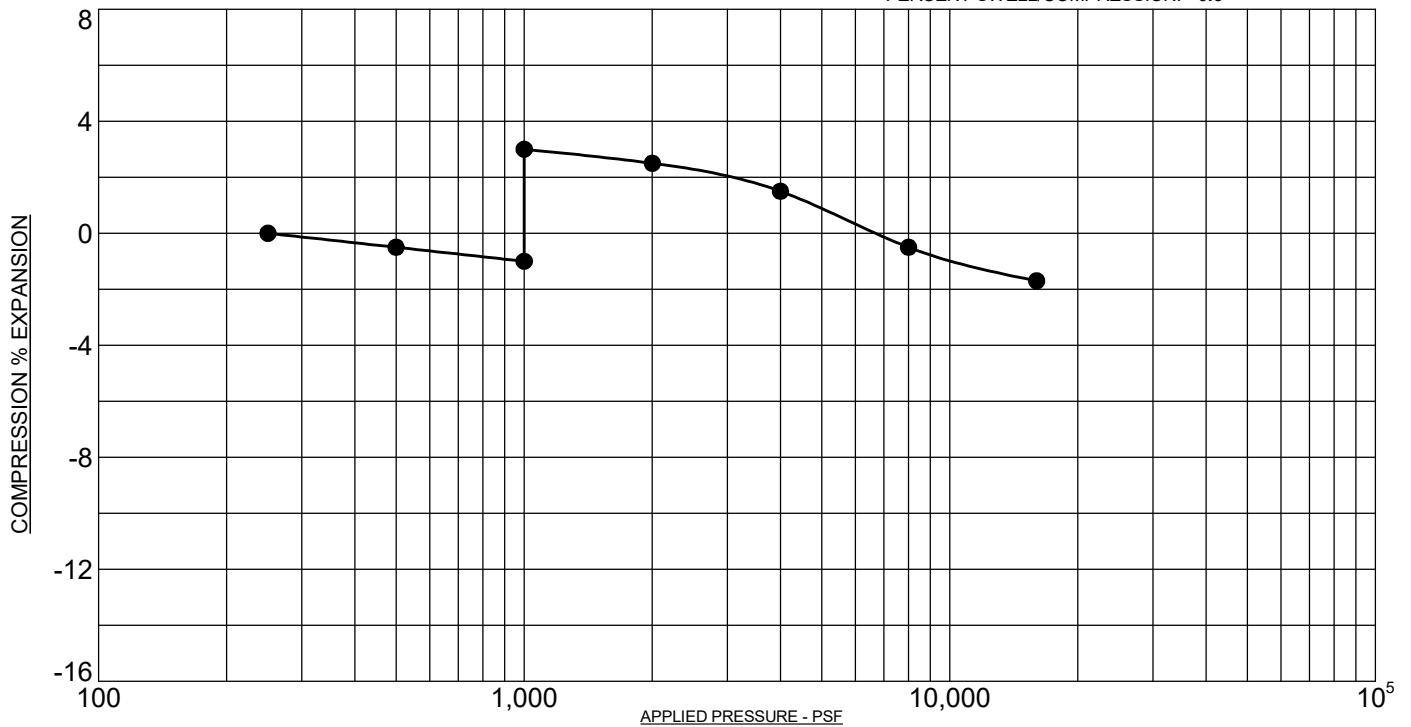
FIGURE No. 52

PROJECT: Lorson Boulevard, Area I, El Paso County, Colorado
 SAMPLE DESCRIPTION: CLAYSTONE, SANDY
 NOTE: SAMPLE WAS INUNDATED WITH WATER AT 1,000 PSF

SAMPLE LOCATION: 11 @ 4 FT
 NATURAL DRY UNIT WEIGHT: 108.4 PCF
 NATURAL MOISTURE CONTENT: 11.5%
 PERCENT SWELL/COMPRESSION: - 0.6

SAMPLE LOCATION: 12 @ 14 FT
 NATURAL DRY UNIT WEIGHT: 124.3 PCF
 NATURAL MOISTURE CONTENT: 9.6%
 PERCENT SWELL/COMPRESSION: 4.0

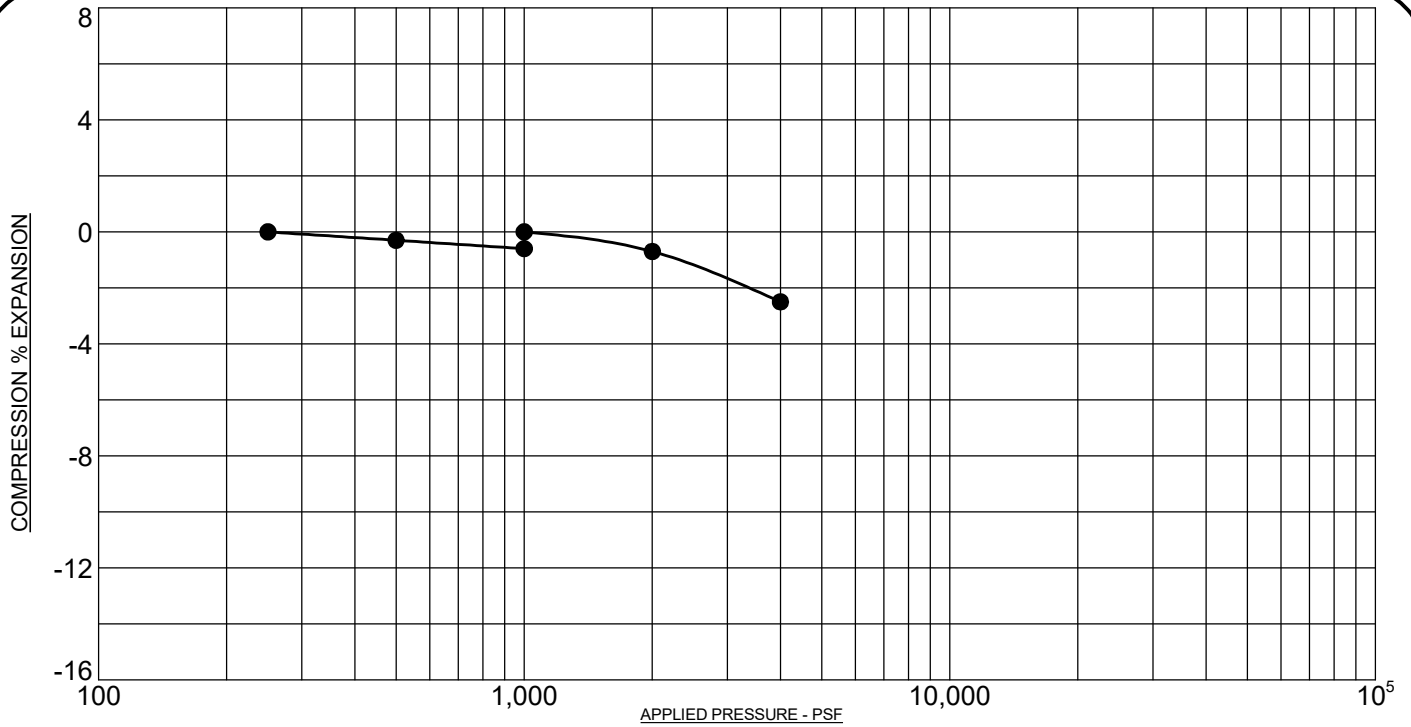
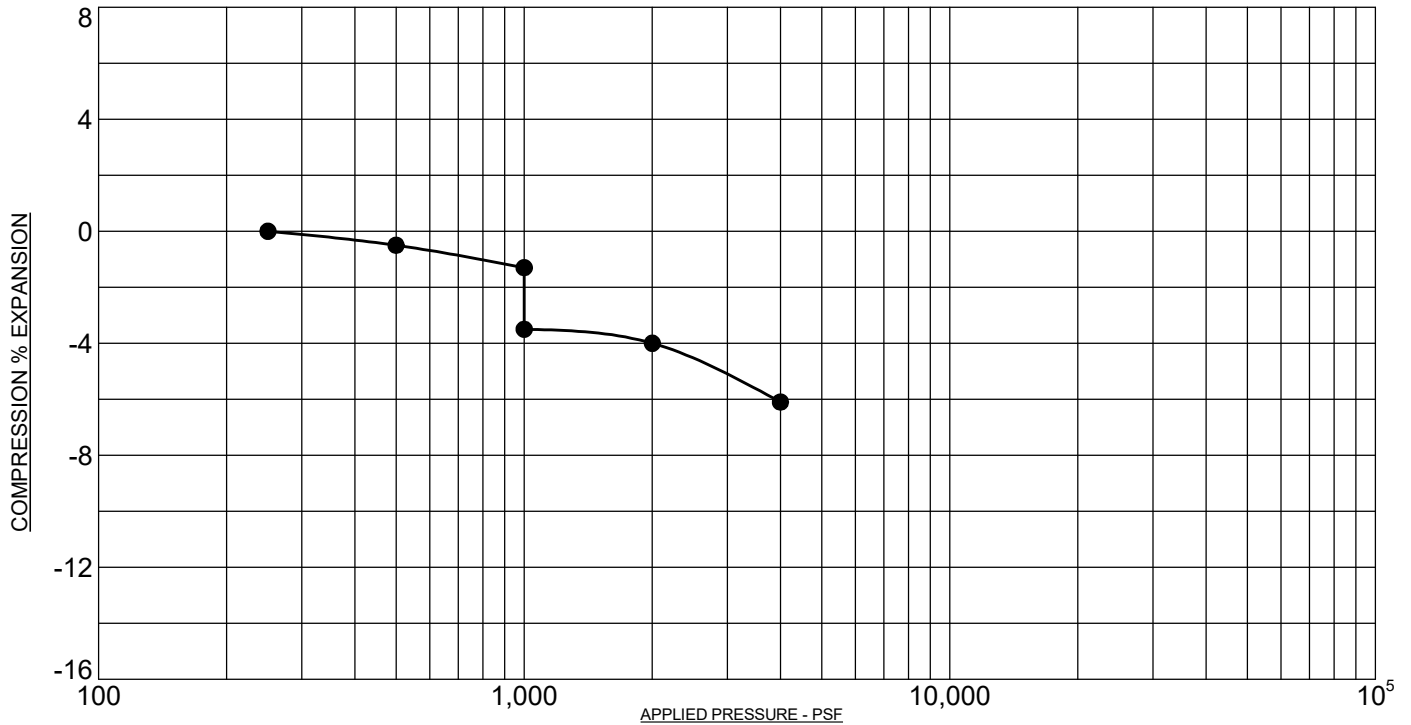
FIGURE No. 53

PROJECT: **Lorson Boulevard, Area I, El Paso County, Colorado**
 SAMPLE DESCRIPTION: **CLAY, SANDY**
 NOTE: **SAMPLE WAS INUNDATED WITH WATER AT 1,000 PSF**

SAMPLE LOCATION: **13 @ 9 FT**
 NATURAL DRY UNIT WEIGHT: **104.5 PCF**
 NATURAL MOISTURE CONTENT: **8.0%**
 PERCENT SWELL/COMPRESSION: **0.6**

PROJECT: **Lorson Boulevard, Area I, El Paso County, Colorado**
 SAMPLE DESCRIPTION: **CLAYSTONE, SANDY**
 NOTE: **SAMPLE WAS INUNDATED WITH WATER AT 1,000 PSF**

SAMPLE LOCATION: **14 @ 14 FT**
 NATURAL DRY UNIT WEIGHT: **112.2 PCF**
 NATURAL MOISTURE CONTENT: **10.5%**
 PERCENT SWELL/COMPRESSION: **- 2.2**

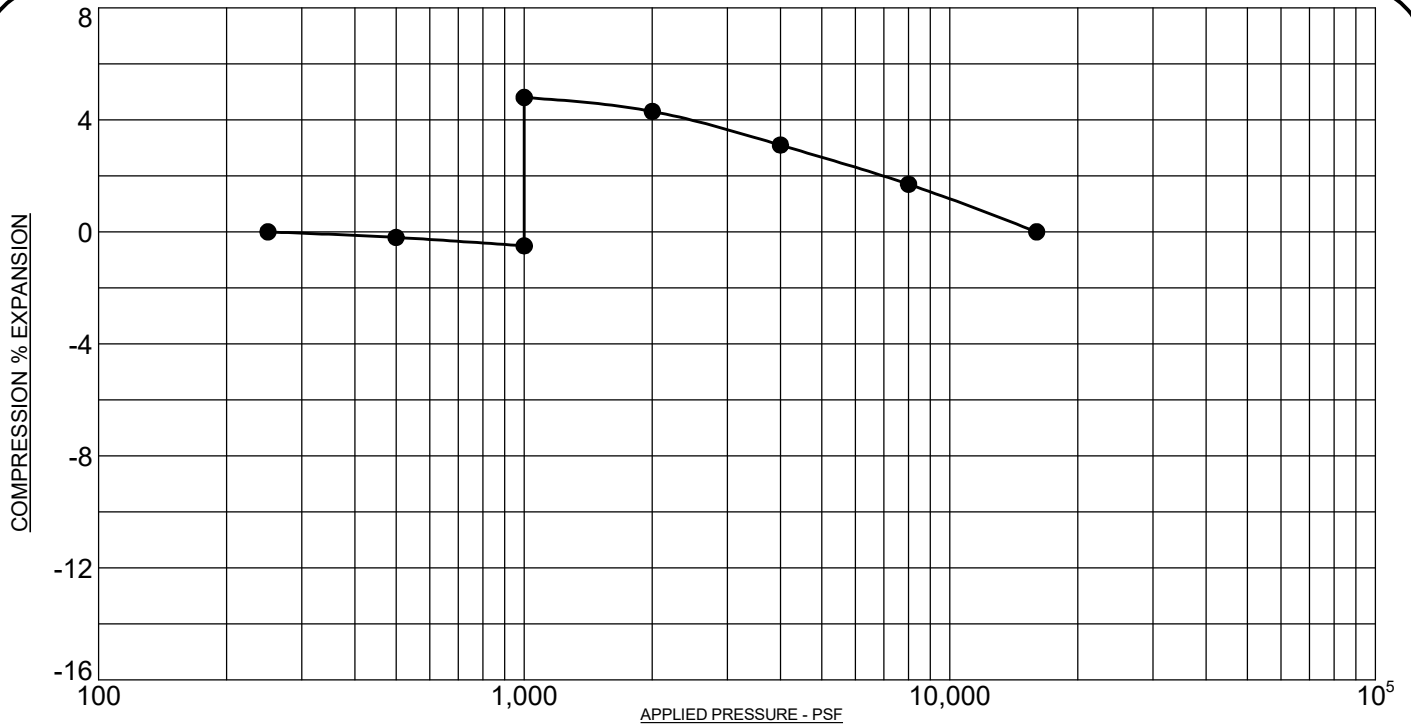
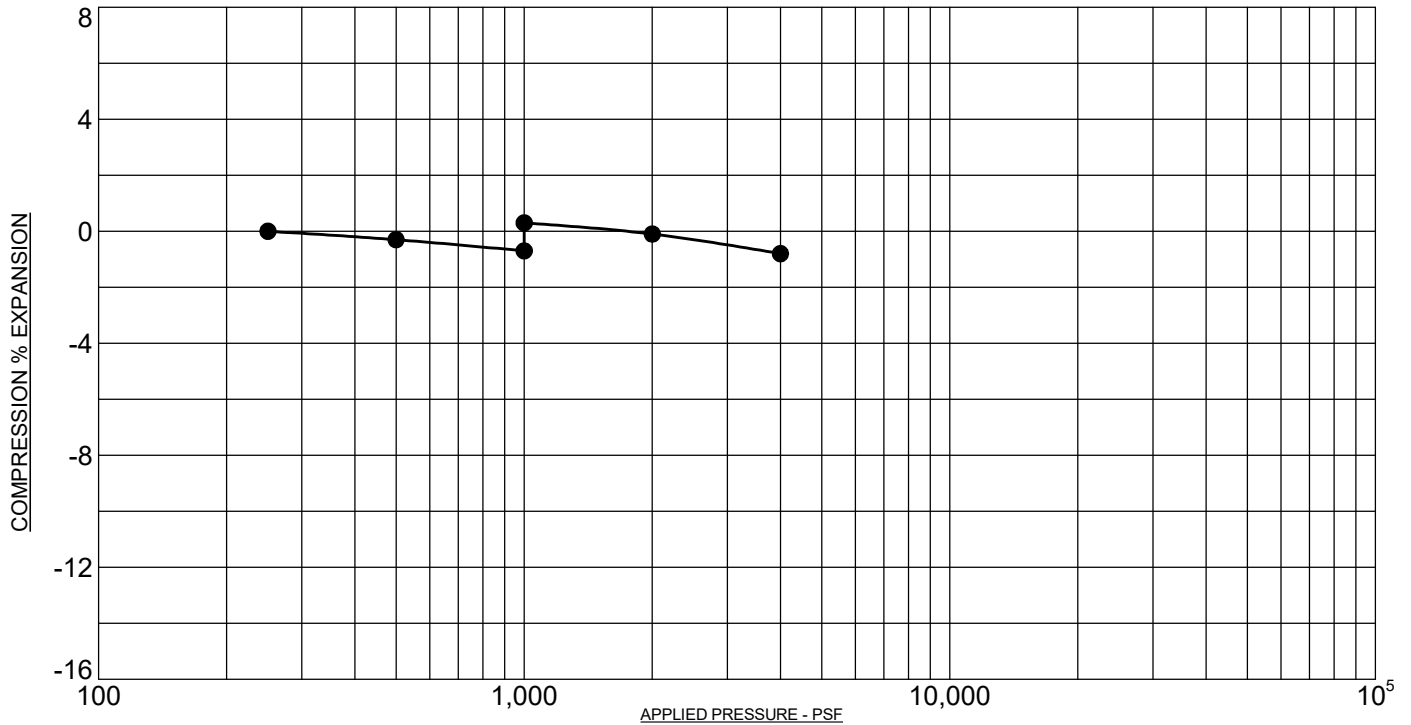
FIGURE No. 54

PROJECT: **Lorson Boulevard, Area I, El Paso County, Colorado**
 SAMPLE DESCRIPTION: **CLAYSTONE, SANDY**
 NOTE: **SAMPLE WAS INUNDATED WITH WATER AT 1,000 PSF**

SAMPLE LOCATION: **15 @ 19 FT**
 NATURAL DRY UNIT WEIGHT: **115.1 PCF**
 NATURAL MOISTURE CONTENT: **10.9%**
 PERCENT SWELL/COMPRESSION: **5.3**

SAMPLE LOCATION: **16 @ 9 FT**
 NATURAL DRY UNIT WEIGHT: **120.2 PCF**
 NATURAL MOISTURE CONTENT: **12.6%**
 PERCENT SWELL/COMPRESSION: **1.0**
