SOILS AND GEOLOGY STUDY

**Hillside at Lorson Ranch – “Area I”
El Paso County, Colorado**

JOB NO. 181988

January 3, 2022

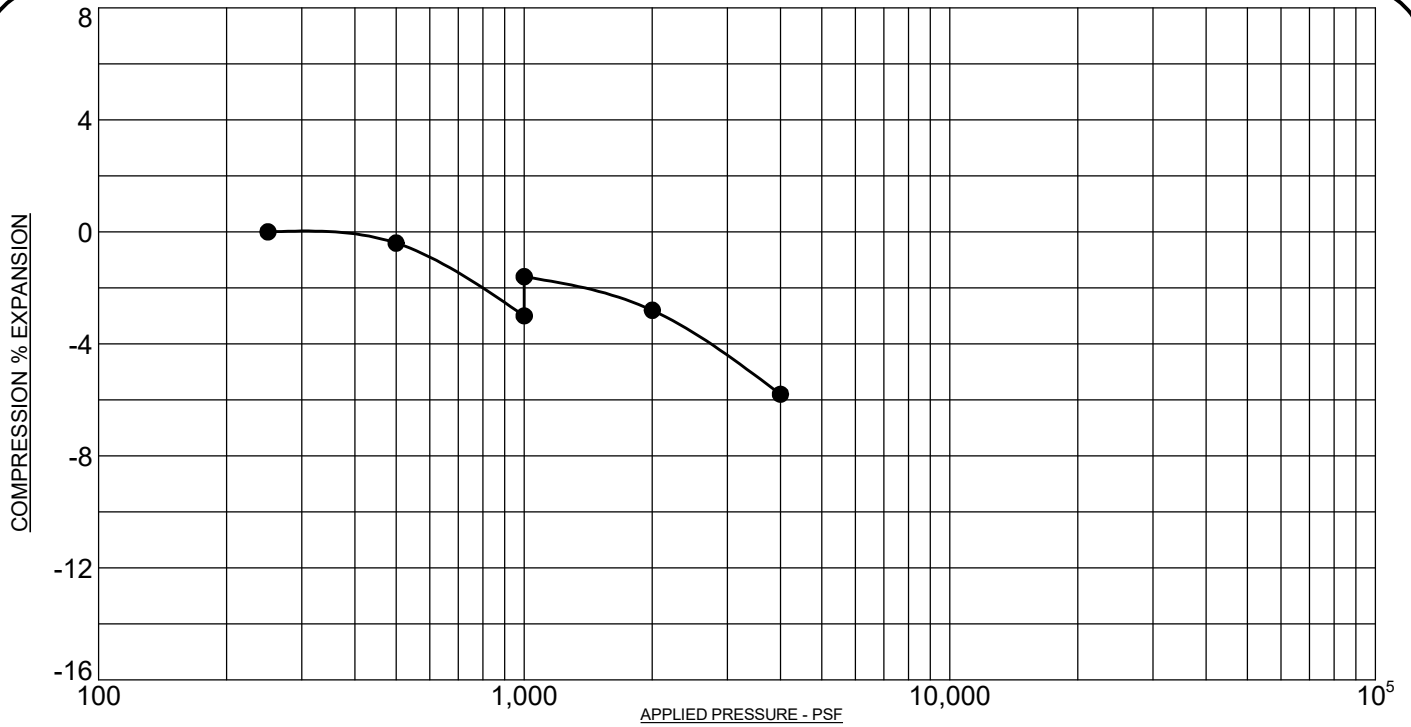
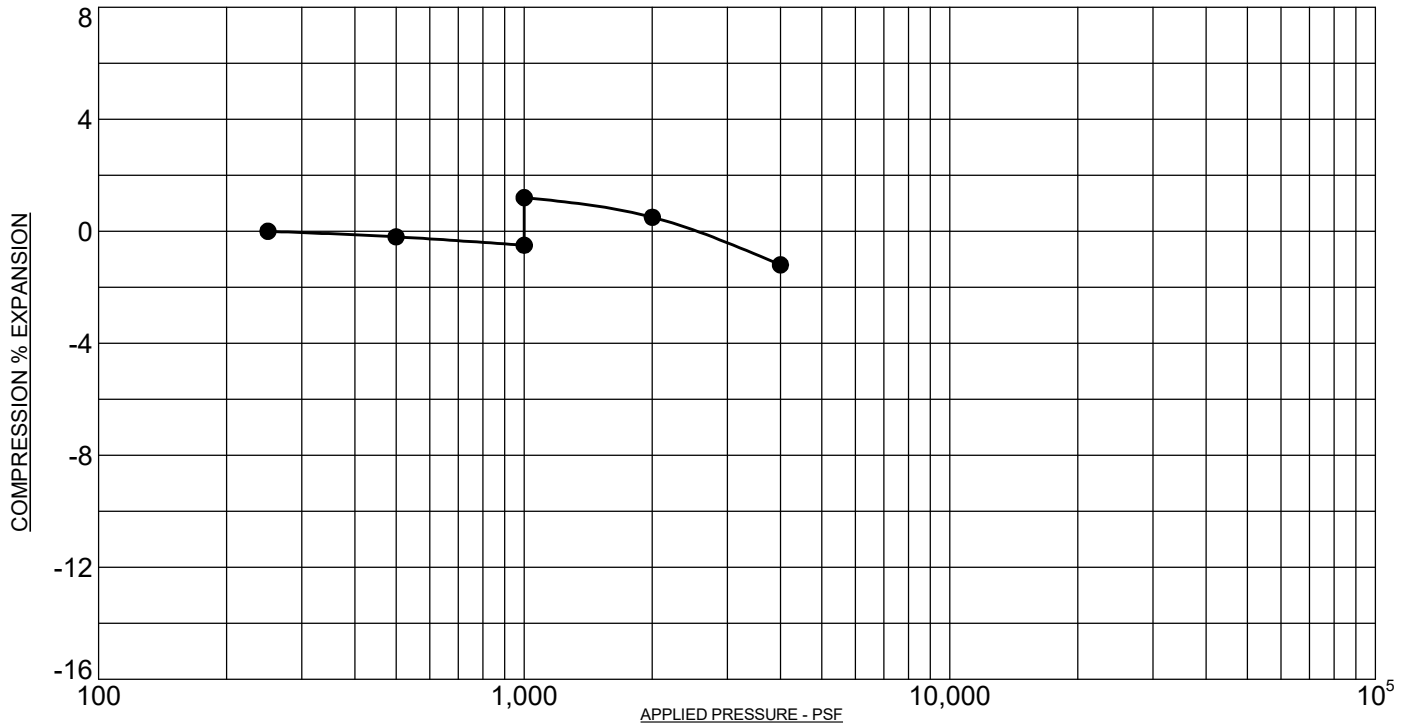
FIGURE No. 55

PROJECT: Lorson Boulevard, Area I, El Paso County, Colorado
 SAMPLE DESCRIPTION: CLAY, SANDY
 NOTE: SAMPLE WAS INUNDATED WITH WATER AT 1,000 PSF

SAMPLE LOCATION: 17 @ 9 FT
 NATURAL DRY UNIT WEIGHT: 114.0 PCF
 NATURAL MOISTURE CONTENT: 11.2%
 PERCENT SWELL/COMPRESSION: 1.4

PROJECT: Lorson Boulevard, Area I, El Paso County, Colorado
 SAMPLE DESCRIPTION: CLAYSTONE, SANDY
 NOTE: SAMPLE WAS INUNDATED WITH WATER AT 1,000 PSF

SAMPLE LOCATION: 18 @ 14 FT
 NATURAL DRY UNIT WEIGHT: 105.5 PCF
 NATURAL MOISTURE CONTENT: 12.3%
 PERCENT SWELL/COMPRESSION: 1.7

Soil laboratory testing was performed as part of this investigation. The laboratory tests included moisture content, dry density, grain-size analyses, Atterberg Limits and Swell/Consolidation tests. A Summary of Laboratory Test Results is presented in Figure 43. Soils Classification Data is presented in Figures 44 through 47. Swell/Consolidation Test Results are presented in Figures 48 through 84.

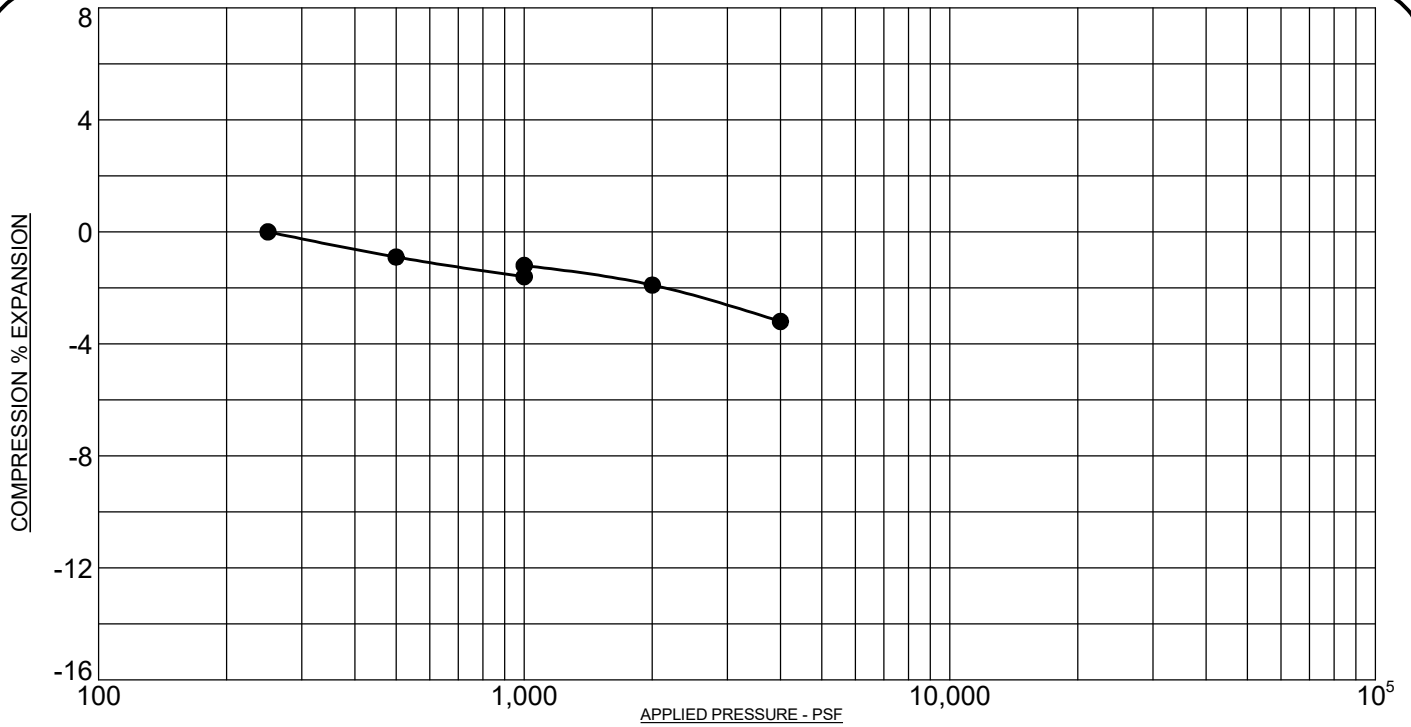
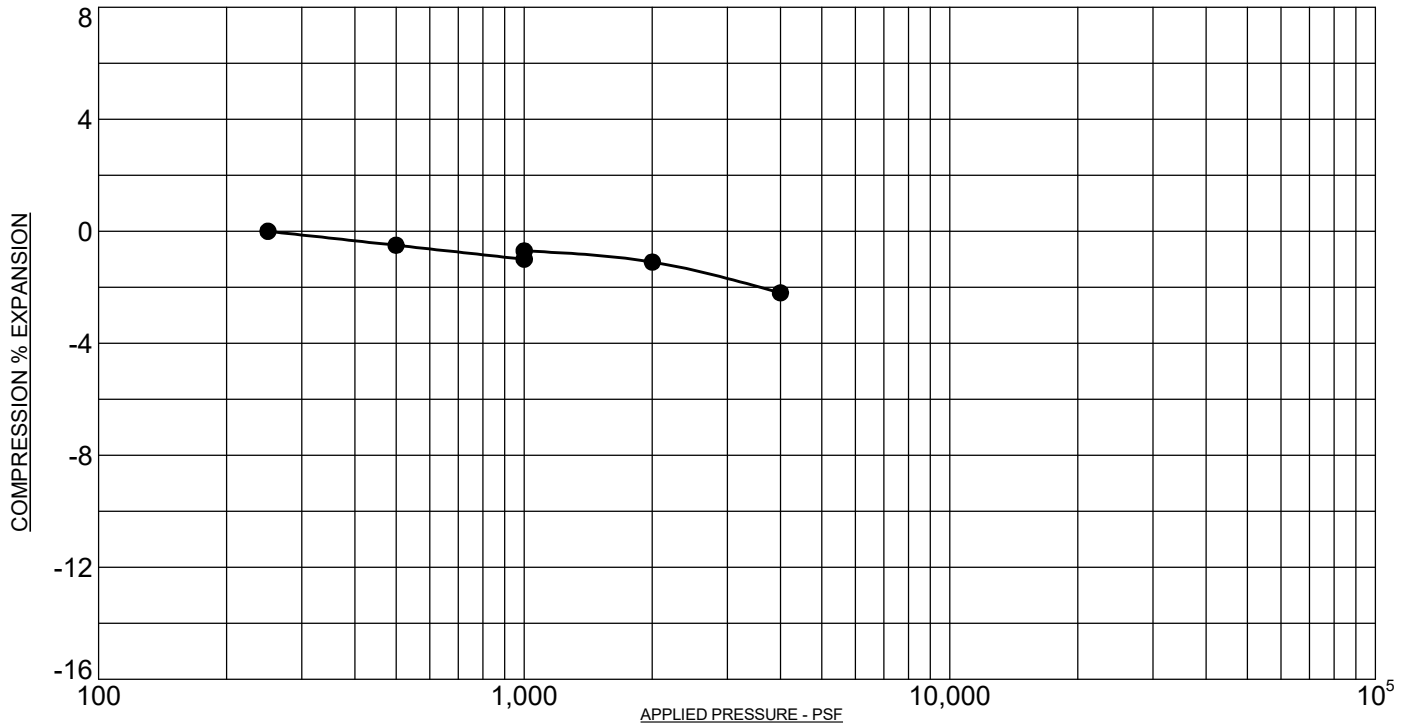
FIGURE No. 56

PROJECT: Lorson Boulevard, Area I, El Paso County, Colorado
 SAMPLE DESCRIPTION: CLAYSTONE, SANDY
 NOTE: SAMPLE WAS INUNDATED WITH WATER AT 1,000 PSF

SAMPLE LOCATION: 19 @ 9 FT
 NATURAL DRY UNIT WEIGHT: 112.3 PCF
 NATURAL MOISTURE CONTENT: 16.8%
 PERCENT SWELL/COMPRESSION: 0.4

SAMPLE LOCATION: 20 @ 14 FT
 NATURAL DRY UNIT WEIGHT: 112.3 PCF
 NATURAL MOISTURE CONTENT: 12.9%
 PERCENT SWELL/COMPRESSION: 0.3

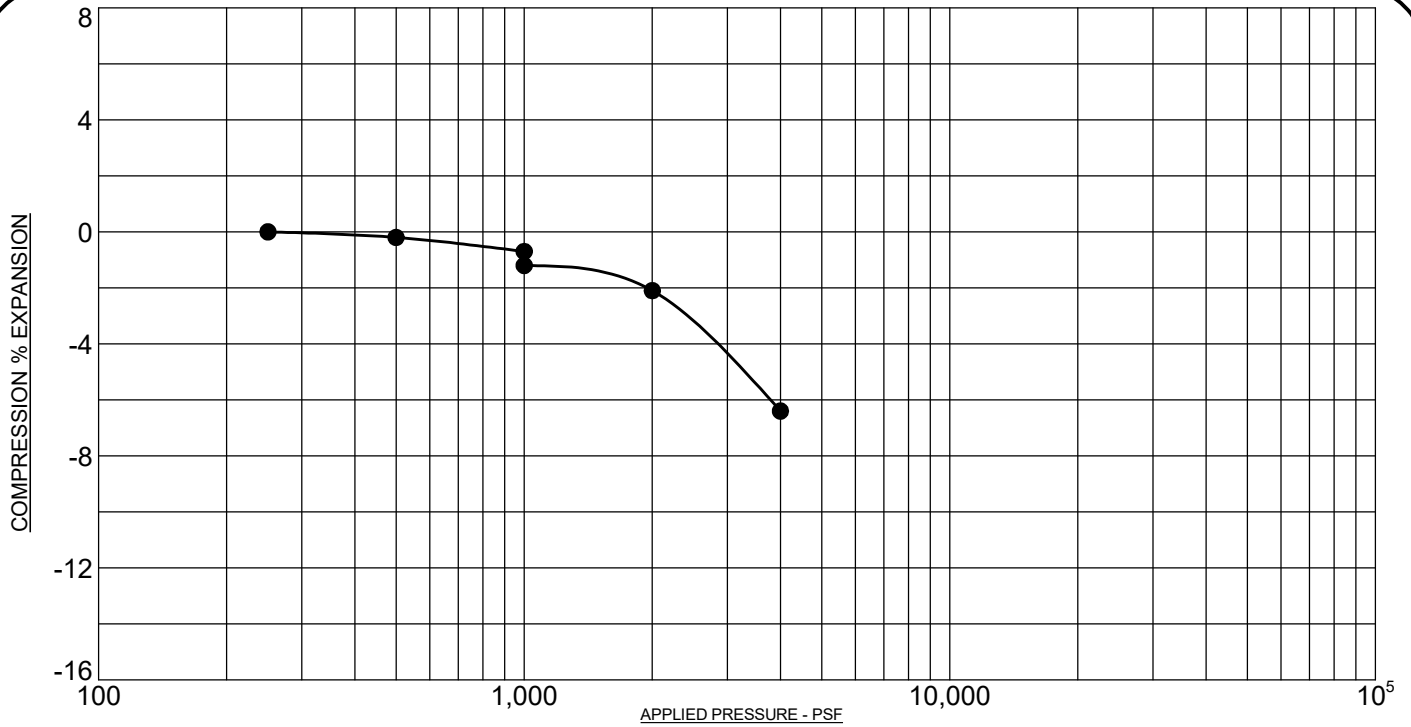
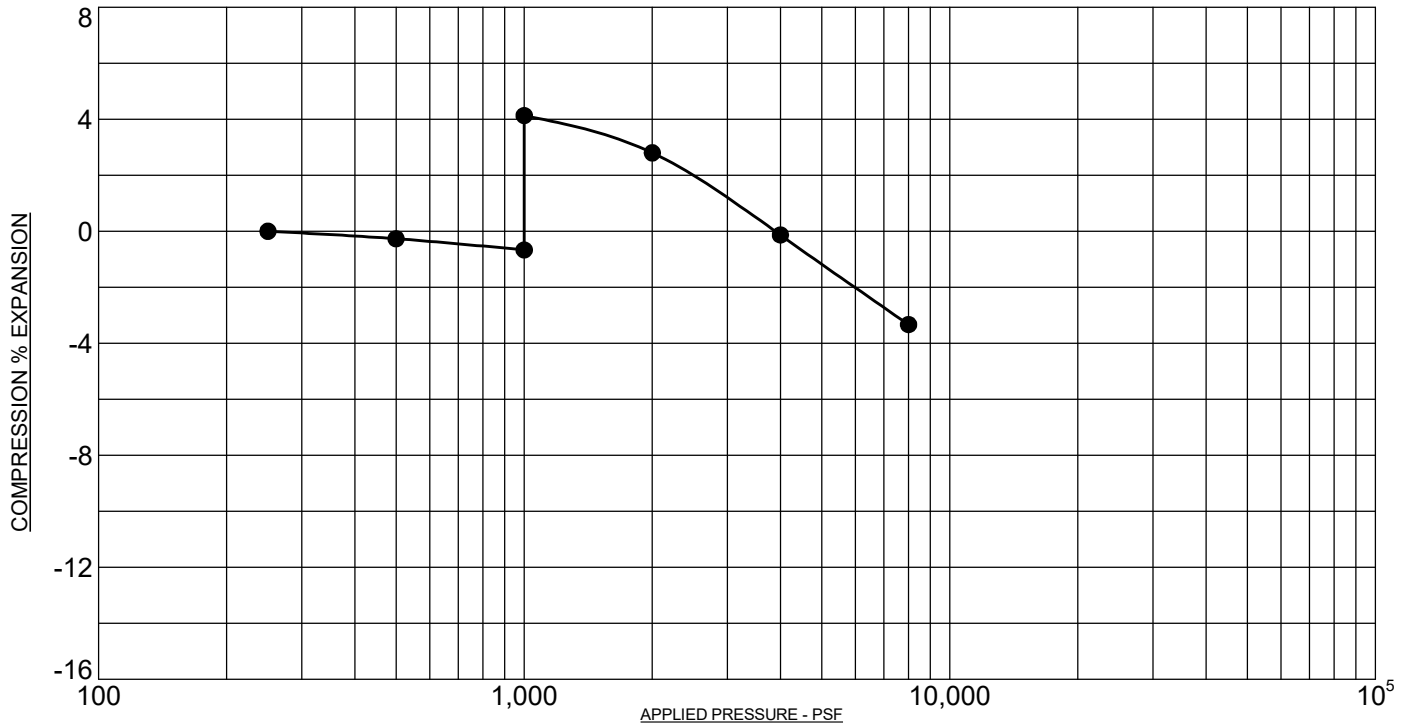
FIGURE No. 57

PROJECT: Lorson Boulevard, Area I, El Paso County, Colorado
 SAMPLE DESCRIPTION: CLAYSTONE, SANDY
 NOTE: SAMPLE WAS INUNDATED WITH WATER AT 1,000 PSF

SAMPLE LOCATION: 21 @ 9 FT
 NATURAL DRY UNIT WEIGHT: 108.3 PCF
 NATURAL MOISTURE CONTENT: 9.4%
 PERCENT SWELL/COMPRESSION: - 0.5

SAMPLE LOCATION: 22 @ 9 FT
 NATURAL DRY UNIT WEIGHT: 122.1 PCF
 NATURAL MOISTURE CONTENT: 7.9%
 PERCENT SWELL/COMPRESSION: 4.8

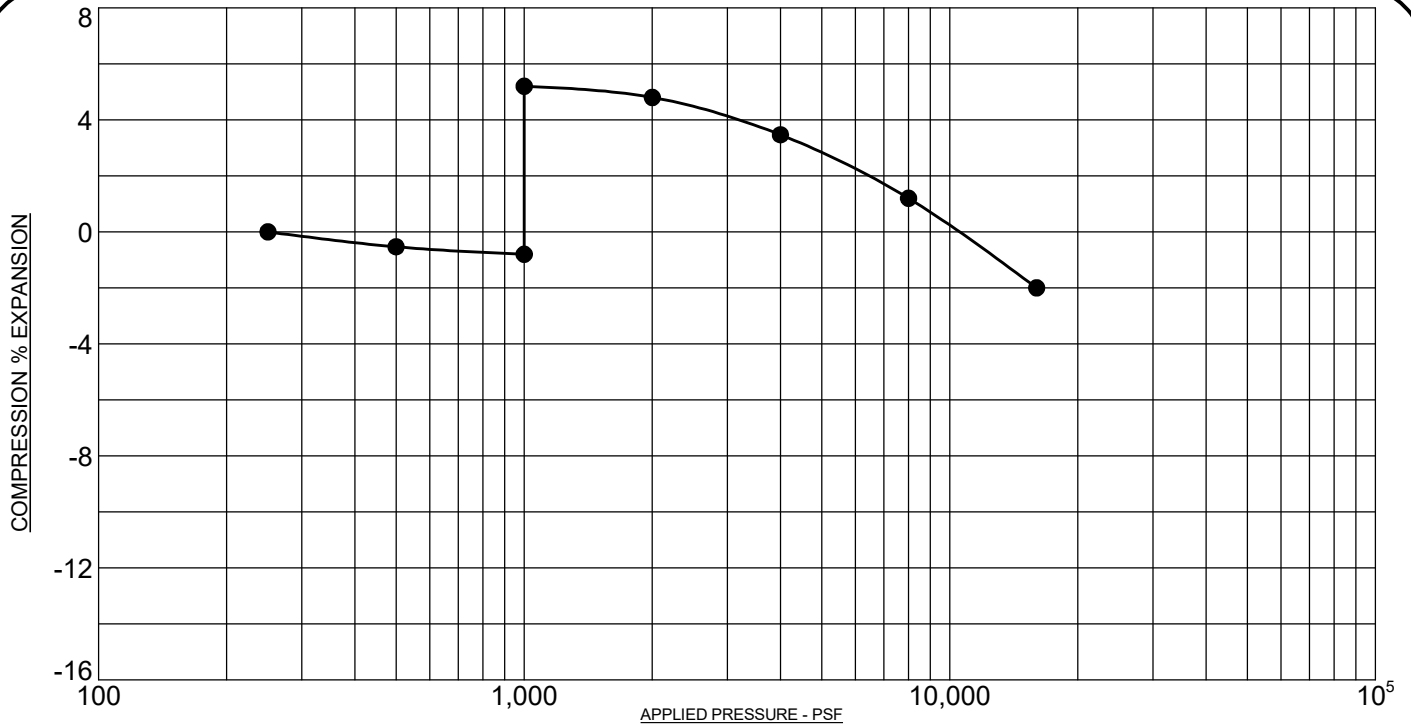
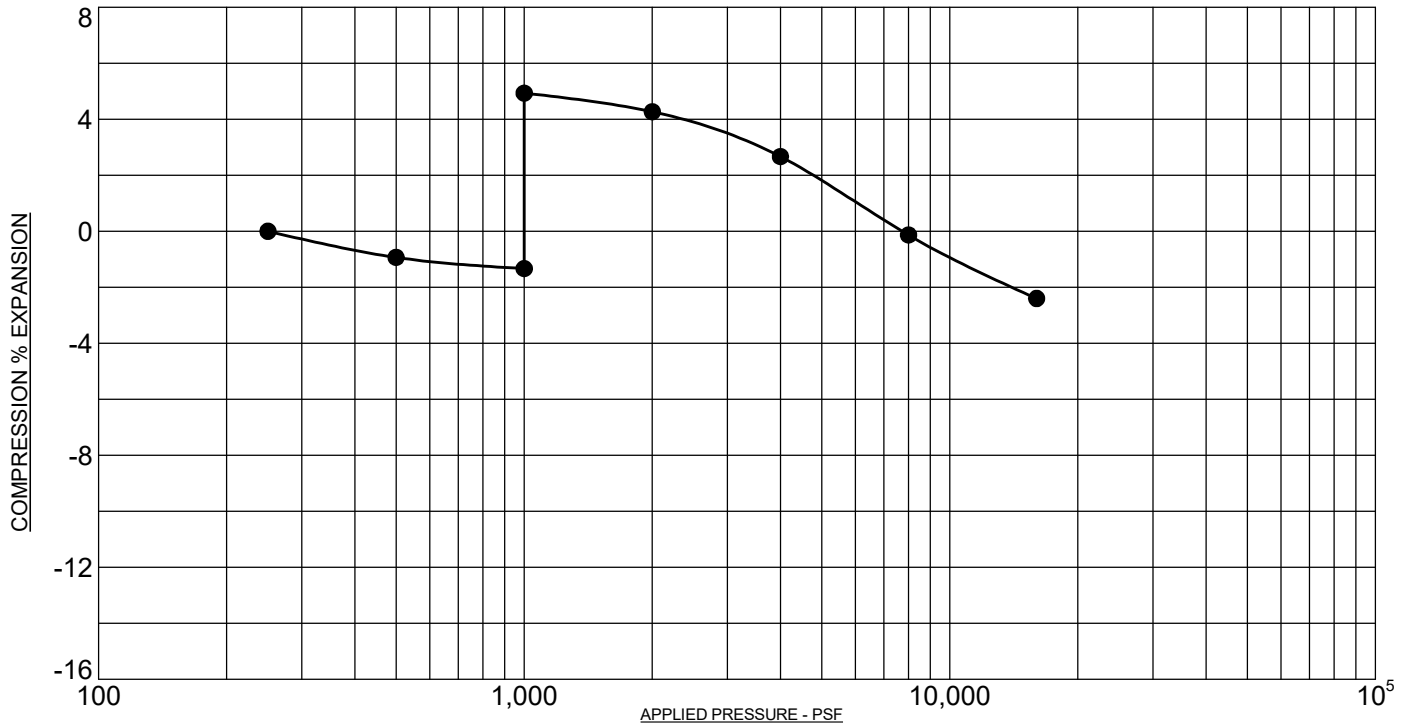
FIGURE No. 58

PROJECT: Lorson Boulevard, Area I, El Paso County, Colorado
 SAMPLE DESCRIPTION: CLAYSTONE, SANDY
 NOTE: SAMPLE WAS INUNDATED WITH WATER AT 1,000 PSF

SAMPLE LOCATION: 23 @ 19 FT
 NATURAL DRY UNIT WEIGHT: 126.4 PCF
 NATURAL MOISTURE CONTENT: 8.5%
 PERCENT SWELL/COMPRESSION: 6.0

SAMPLE LOCATION: 24 @ 14 FT
 NATURAL DRY UNIT WEIGHT: 123.7 PCF
 NATURAL MOISTURE CONTENT: 7.9%
 PERCENT SWELL/COMPRESSION: 6.3

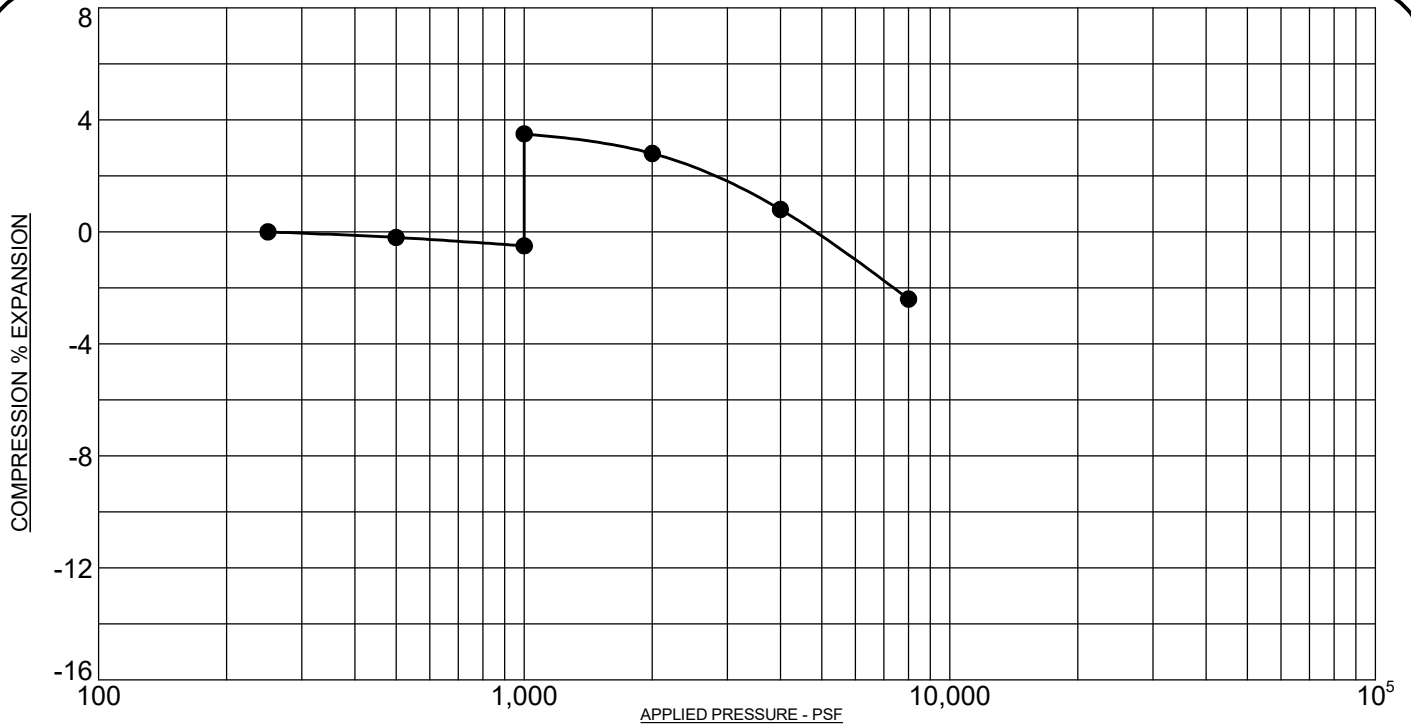
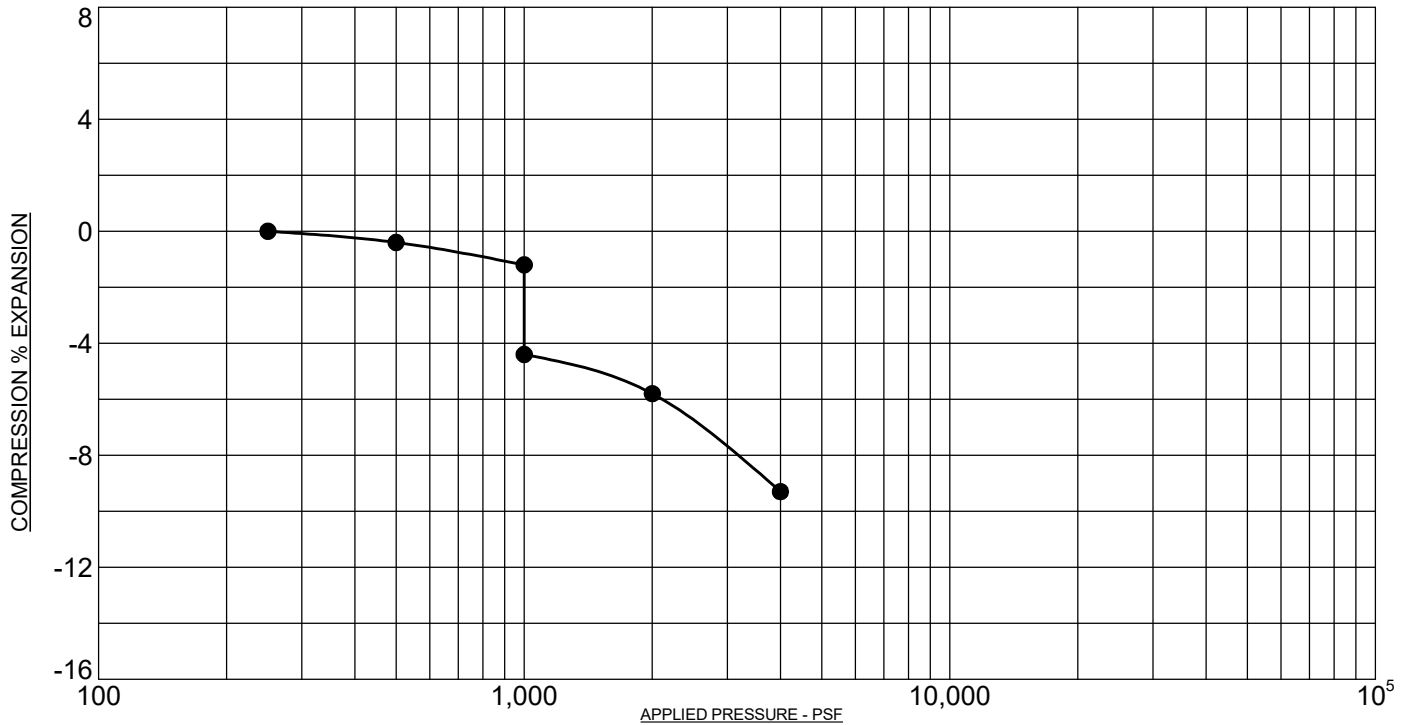
FIGURE No. 59

PROJECT: Lorson Boulevard, Area I, El Paso County, Colorado
 SAMPLE DESCRIPTION: CLAY, SANDY
 NOTE: SAMPLE WAS INUNDATED WITH WATER AT 1,000 PSF

SAMPLE LOCATION: 25 @ 9 FT
 NATURAL DRY UNIT WEIGHT: 112.3 PCF
 NATURAL MOISTURE CONTENT: 7.9%
 PERCENT SWELL/COMPRESSION: 4.0

SAMPLE LOCATION: 26 @ 4 FT
 NATURAL DRY UNIT WEIGHT: PCF
 NATURAL MOISTURE CONTENT: %
 PERCENT SWELL/COMPRESSION: - 3.2

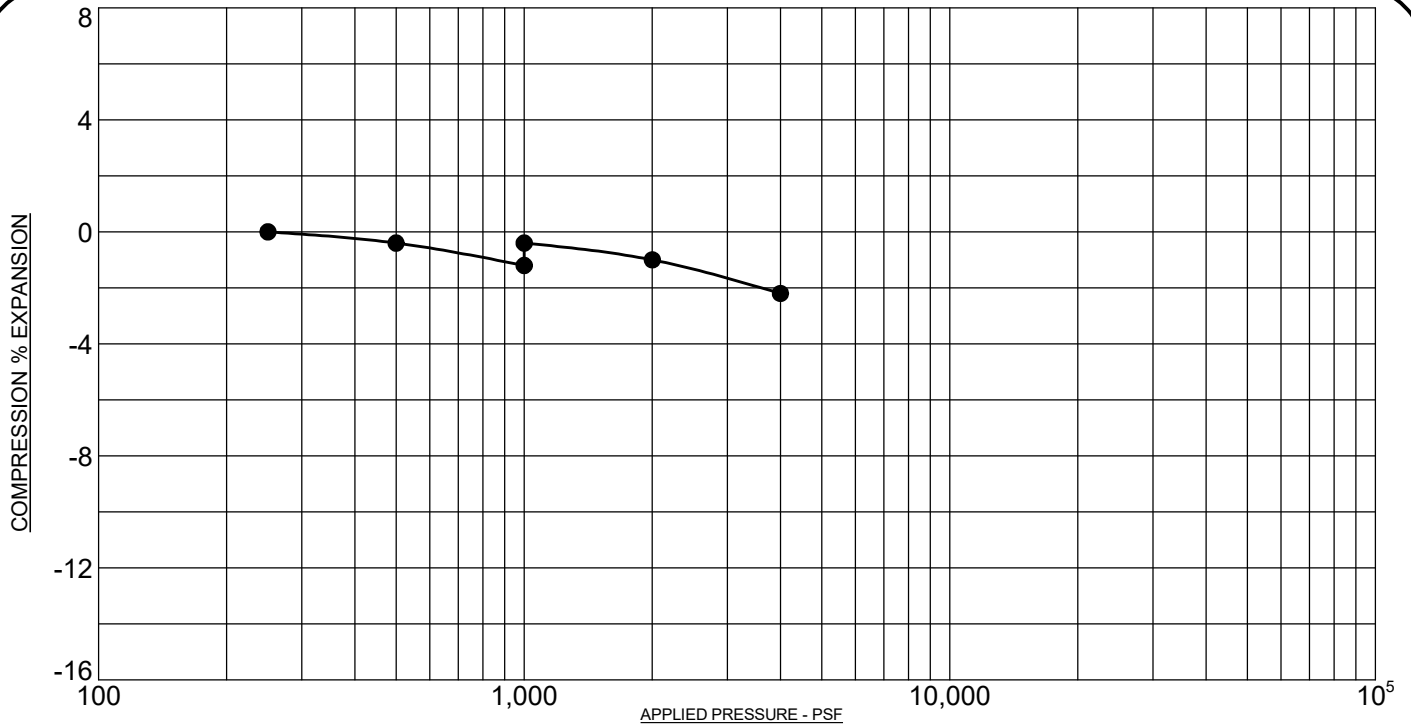
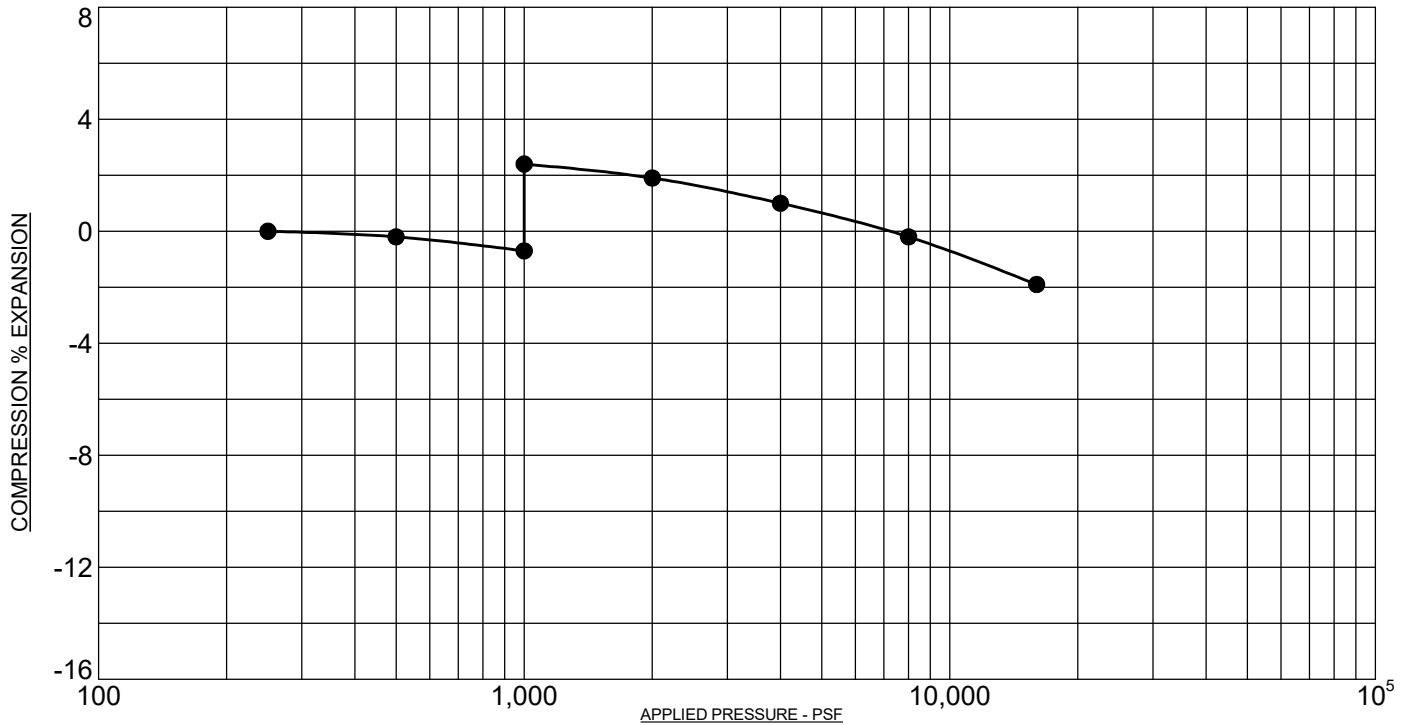
FIGURE No. 60

PROJECT: Lorson Boulevard, Area I, El Paso County, Colorado
 SAMPLE DESCRIPTION: CLAYSTONE, SANDY
 NOTE: SAMPLE WAS INUNDATED WITH WATER AT 1,000 PSF

SAMPLE LOCATION: 27 @ 14 FT
 NATURAL DRY UNIT WEIGHT: 114.1 PCF
 NATURAL MOISTURE CONTENT: 11.1%
 PERCENT SWELL/COMPRESSION: 0.8

SAMPLE LOCATION: 28 @ 14 FT
 NATURAL DRY UNIT WEIGHT: PCF
 NATURAL MOISTURE CONTENT: %
 PERCENT SWELL/COMPRESSION: 3.1

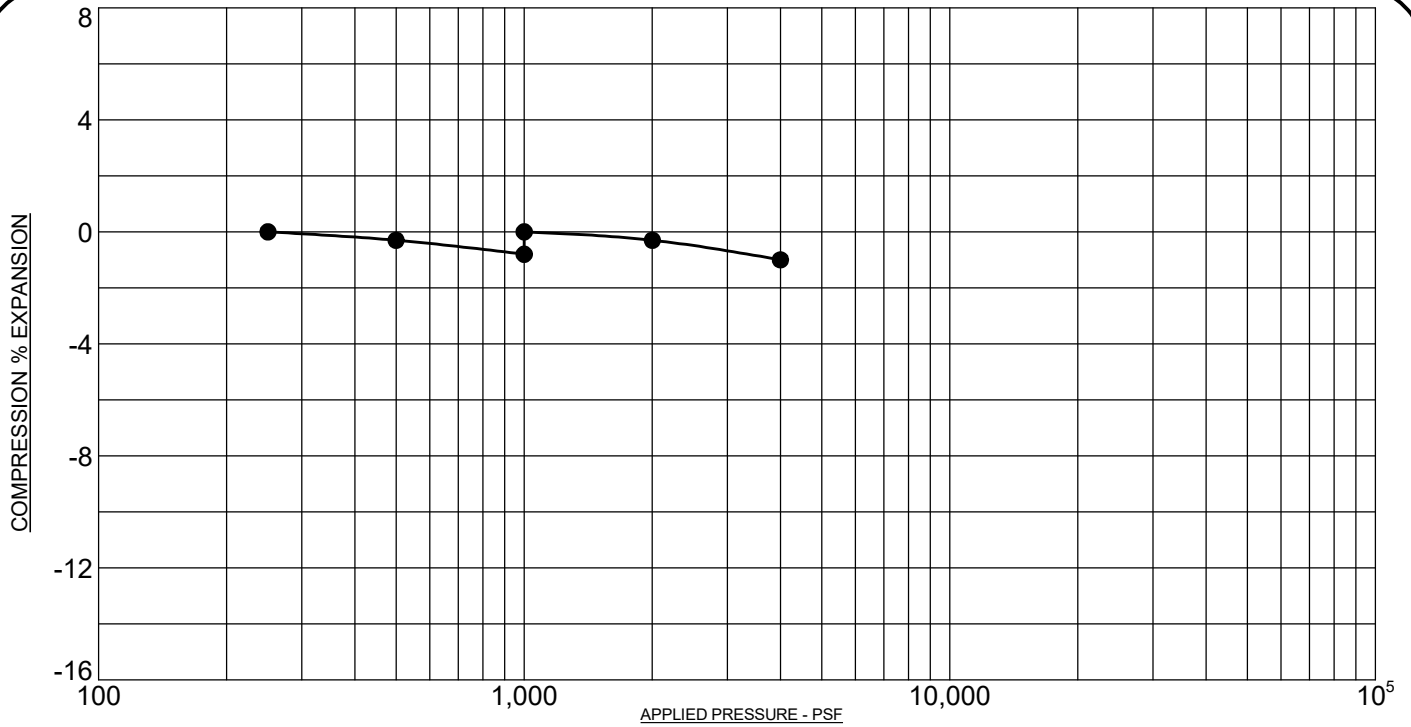
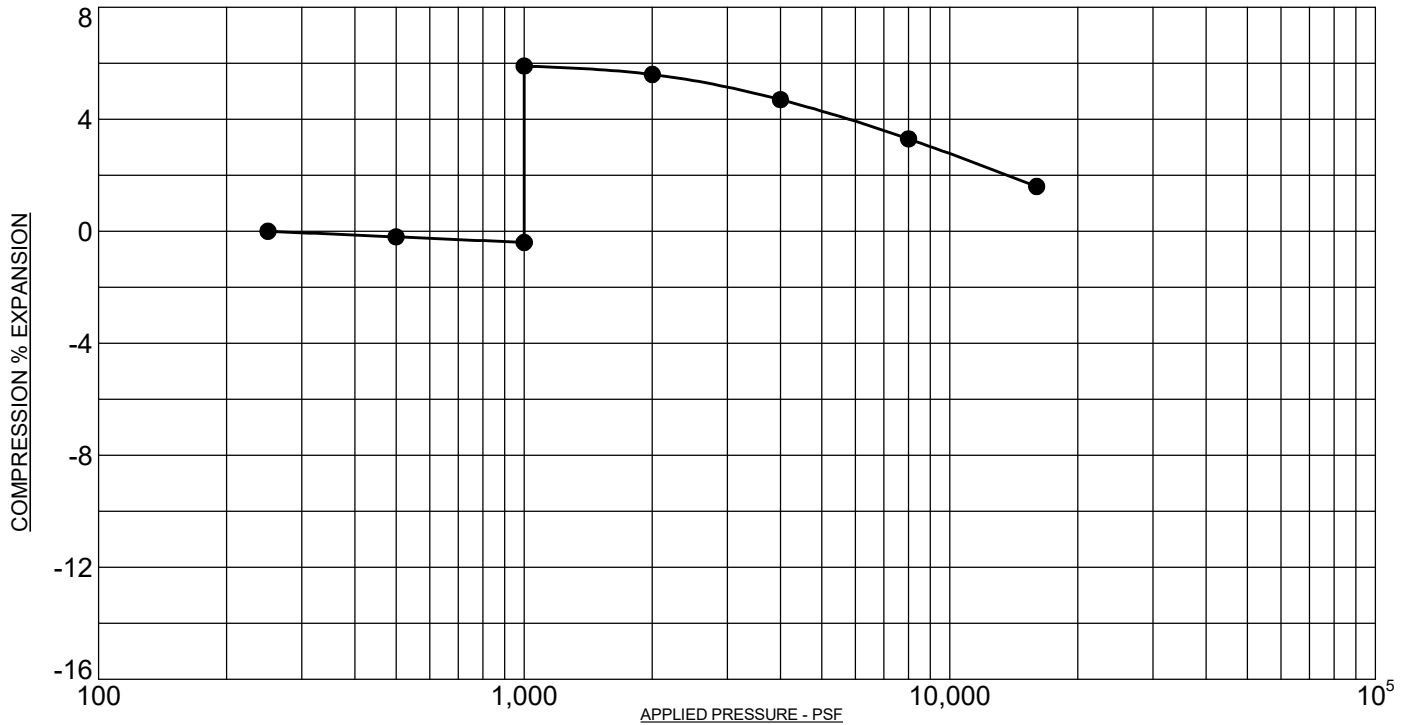
FIGURE No. 61

PROJECT: Lorson Boulevard, Area I, El Paso County, Colorado
 SAMPLE DESCRIPTION: CLAY, SANDY
 NOTE: SAMPLE WAS INUNDATED WITH WATER AT 1,000 PSF

SAMPLE LOCATION: 29 @ 9 FT
 NATURAL DRY UNIT WEIGHT: 117.5 PCF
 NATURAL MOISTURE CONTENT: 12.6%
 PERCENT SWELL/COMPRESSION: 0.8

PROJECT: Lorson Boulevard, Area I, El Paso County, Colorado
 SAMPLE DESCRIPTION: CLAYSTONE, SANDY
 NOTE: SAMPLE WAS INUNDATED WITH WATER AT 1,000 PSF

SAMPLE LOCATION: 30 @ 14 FT
 NATURAL DRY UNIT WEIGHT: 128.6 PCF
 NATURAL MOISTURE CONTENT: 11.1%
 PERCENT SWELL/COMPRESSION: 6.3

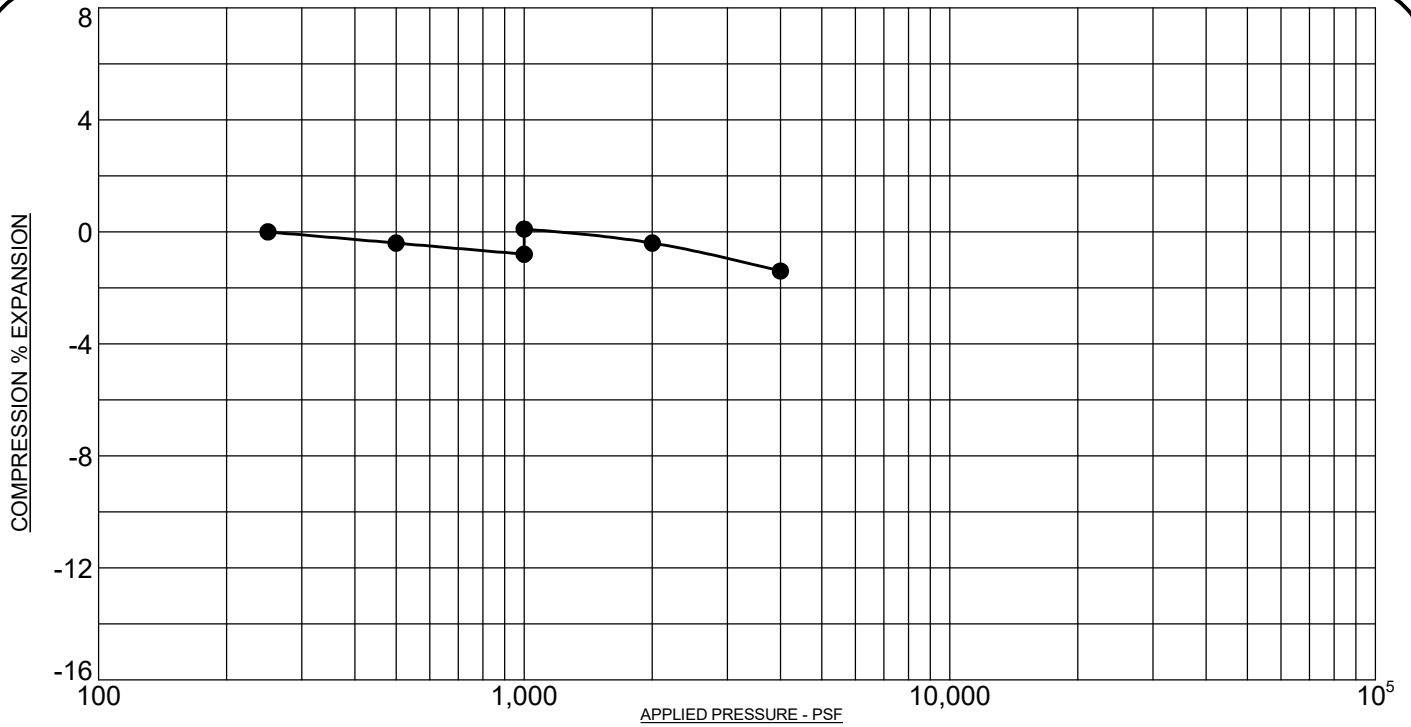
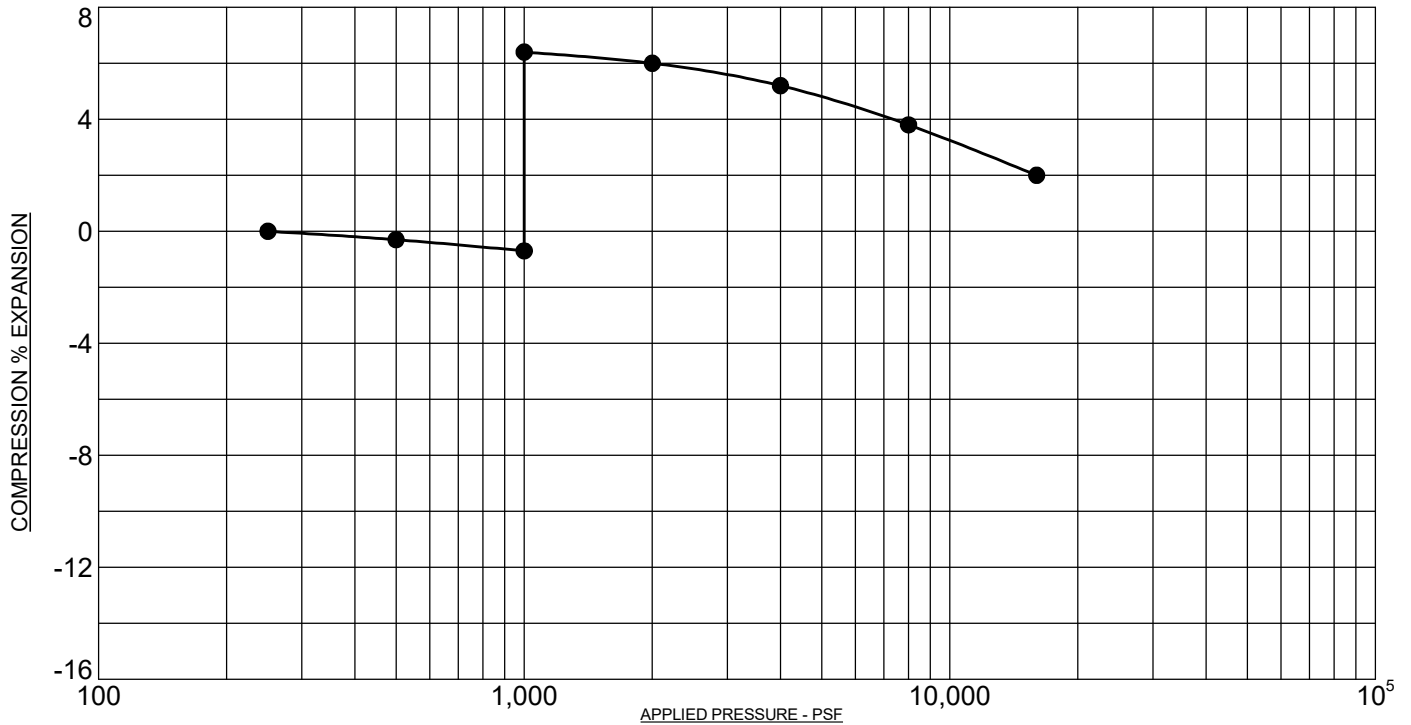
FIGURE No. 62

PROJECT: Lorson Boulevard, Area I, El Paso County, Colorado
 SAMPLE DESCRIPTION: CLAYSTONE, SANDY
 NOTE: SAMPLE WAS INUNDATED WITH WATER AT 1,000 PSF

SAMPLE LOCATION: 31 @ 9 FT
 NATURAL DRY UNIT WEIGHT: 119.3 PCF
 NATURAL MOISTURE CONTENT: 11.4%
 PERCENT SWELL/COMPRESSION: 0.9

SAMPLE LOCATION: 32 @ 14 FT
 NATURAL DRY UNIT WEIGHT: 129.2 PCF
 NATURAL MOISTURE CONTENT: 12.5%
 PERCENT SWELL/COMPRESSION: 7.1

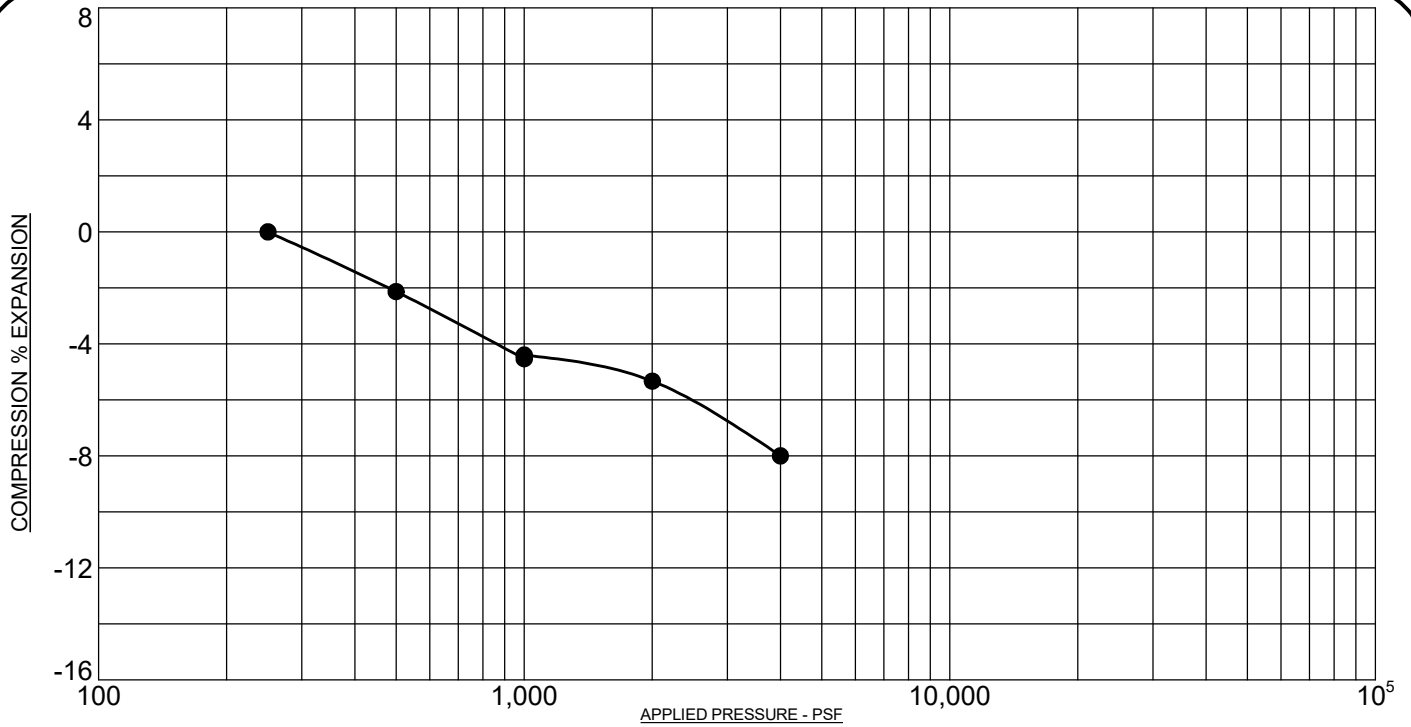
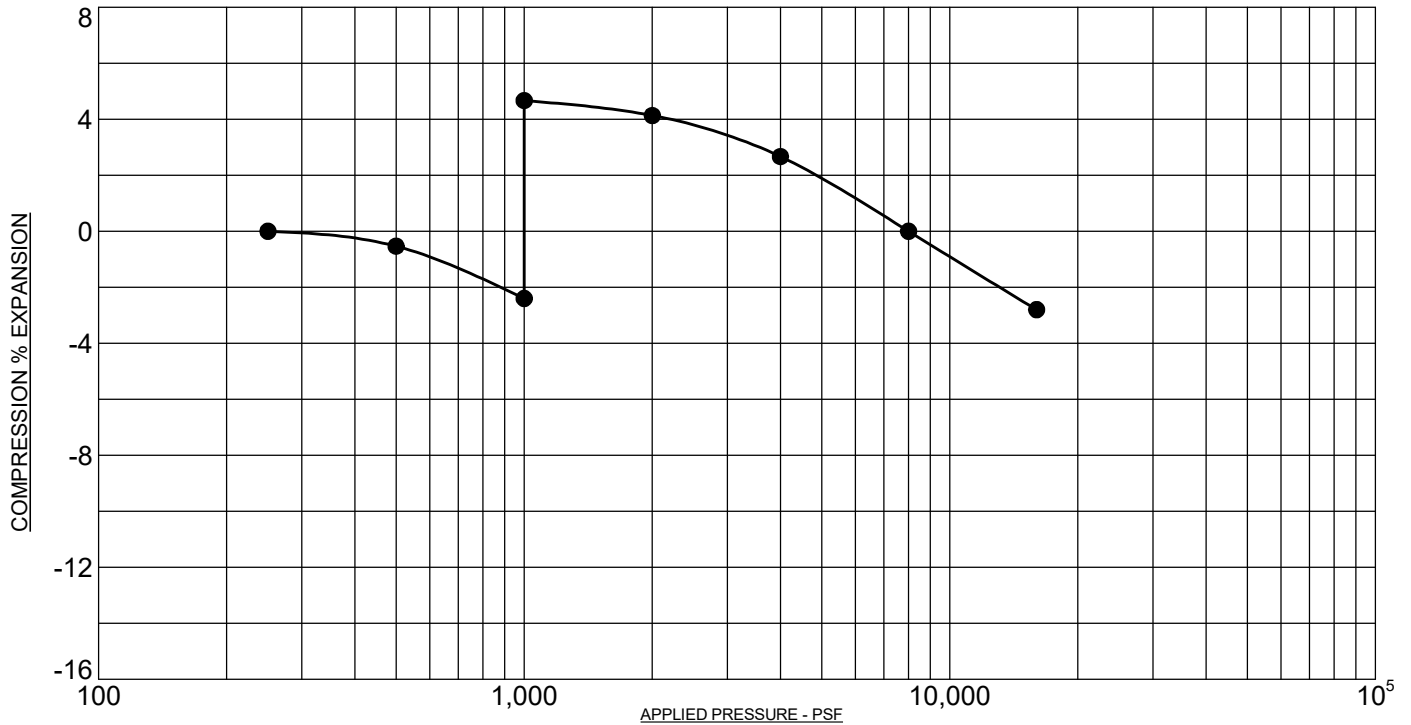
FIGURE No. 63

PROJECT: Lorson Boulevard, Area I, El Paso County, Colorado
 SAMPLE DESCRIPTION: CLAYSTONE, SANDY
 NOTE: SAMPLE WAS INUNDATED WITH WATER AT 1,000 PSF

SAMPLE LOCATION: 33 @ 9 FT
 NATURAL DRY UNIT WEIGHT: 113.6 PCF
 NATURAL MOISTURE CONTENT: 7.1%
 PERCENT SWELL/COMPRESSION: 0.1

PROJECT: Lorson Boulevard, Area I, El Paso County, Colorado
 SAMPLE DESCRIPTION: CLAY, SANDY
 NOTE: SAMPLE WAS INUNDATED WITH WATER AT 1,000 PSF

SAMPLE LOCATION: 34 @ 4 FT
 NATURAL DRY UNIT WEIGHT: 129.6 PCF
 NATURAL MOISTURE CONTENT: 8.7%
 PERCENT SWELL/COMPRESSION: 7.1

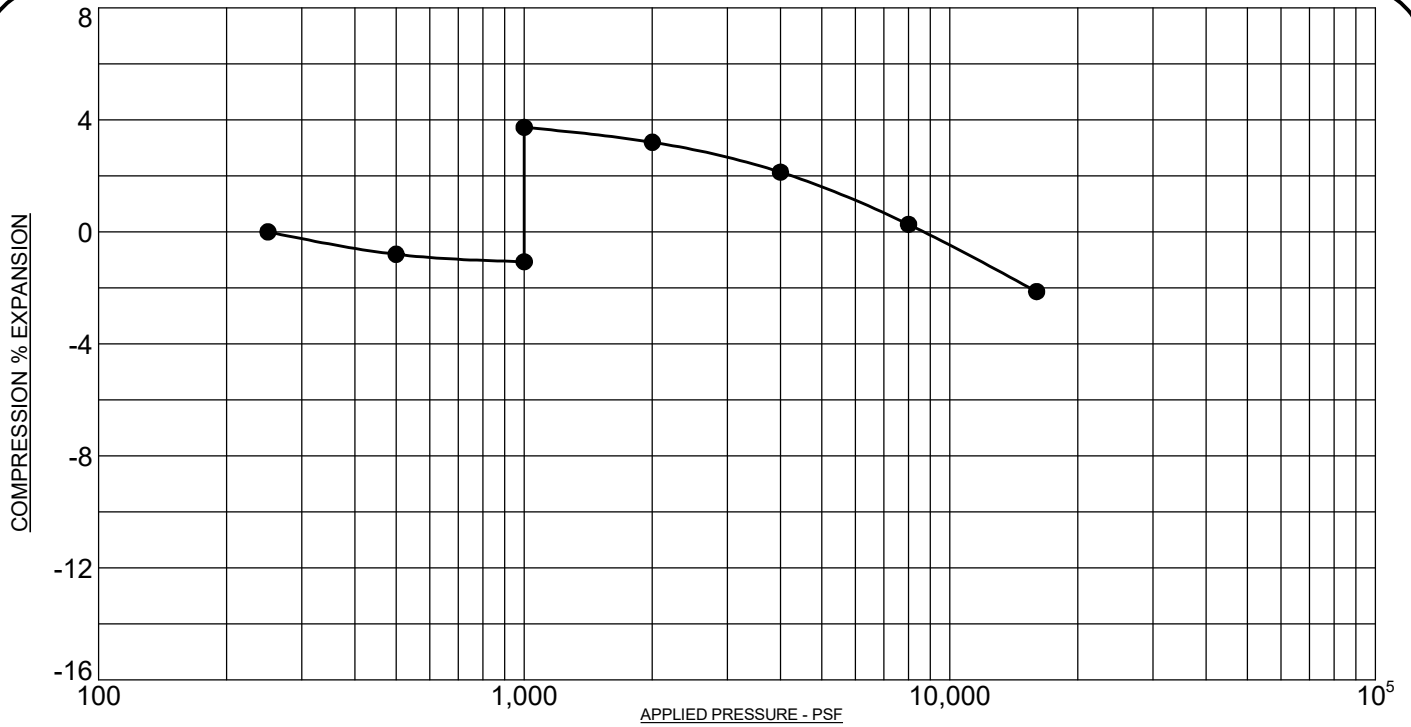
PROJECT: **Lorson Boulevard, Area I, El Paso County, Colorado**
 SAMPLE DESCRIPTION: **CLAY, SANDY**
 NOTE: **SAMPLE WAS INUNDATED WITH WATER AT 1,000 PSF**

SAMPLE LOCATION: **35 @ 9 FT**
 NATURAL DRY UNIT WEIGHT: **119.2 PCF**
 NATURAL MOISTURE CONTENT: **12.0%**
 PERCENT SWELL/COMPRESSION: **4.8**

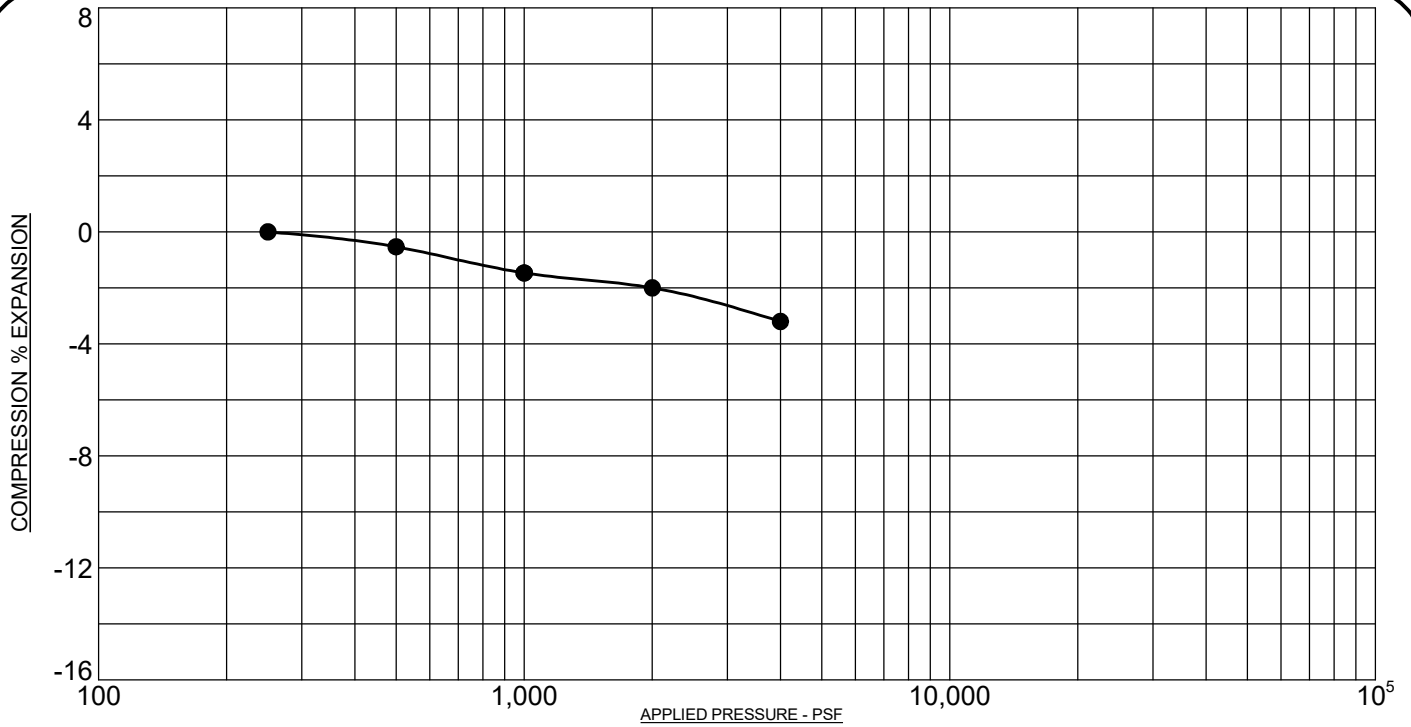
FIGURE No. 64

PROJECT: **Lorson Boulevard, Area I, El Paso County, Colorado**
 SAMPLE DESCRIPTION: **CLAY, SANDY**
 NOTE: **SAMPLE WAS INUNDATED WITH WATER AT 1,000 PSF**

SAMPLE LOCATION: **37 @ 9 FT**
 NATURAL DRY UNIT WEIGHT: **113.7 PCF**
 NATURAL MOISTURE CONTENT: **16.7%**
 PERCENT SWELL/COMPRESSION: **0.0**

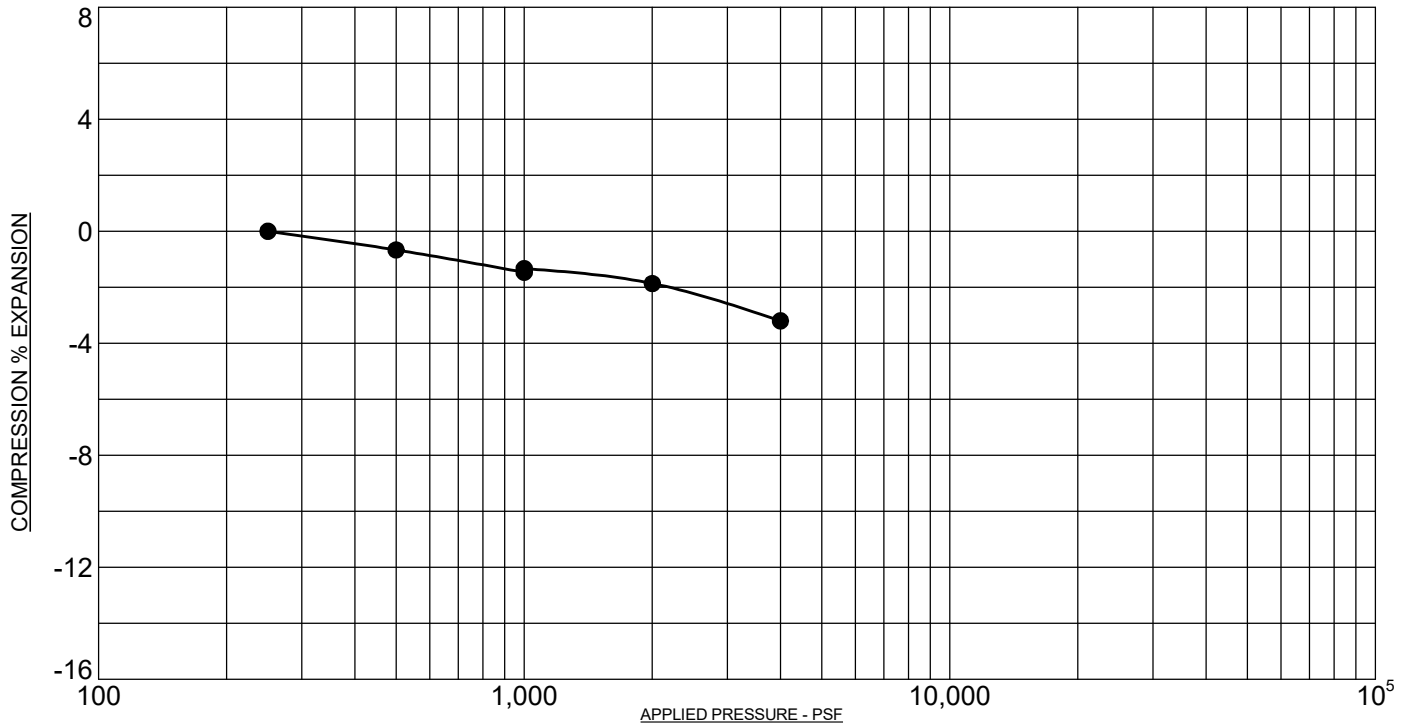
PROJECT: **Lorson Boulevard, Area I, El Paso County, Colorado**
 SAMPLE DESCRIPTION: **CLAY, SANDY**
 NOTE: **SAMPLE WAS INUNDATED WITH WATER AT 1,000 PSF**

SAMPLE LOCATION: **38 @ 9 FT**
 NATURAL DRY UNIT WEIGHT: **113.7 PCF**
 NATURAL MOISTURE CONTENT: **14.1%**
 PERCENT SWELL/COMPRESSION: **0.1**
