SOILS AND GEOLOGY STUDY

**Hillside at Lorson Ranch – “Area I”
El Paso County, Colorado**

JOB NO. 181988

January 3, 2022

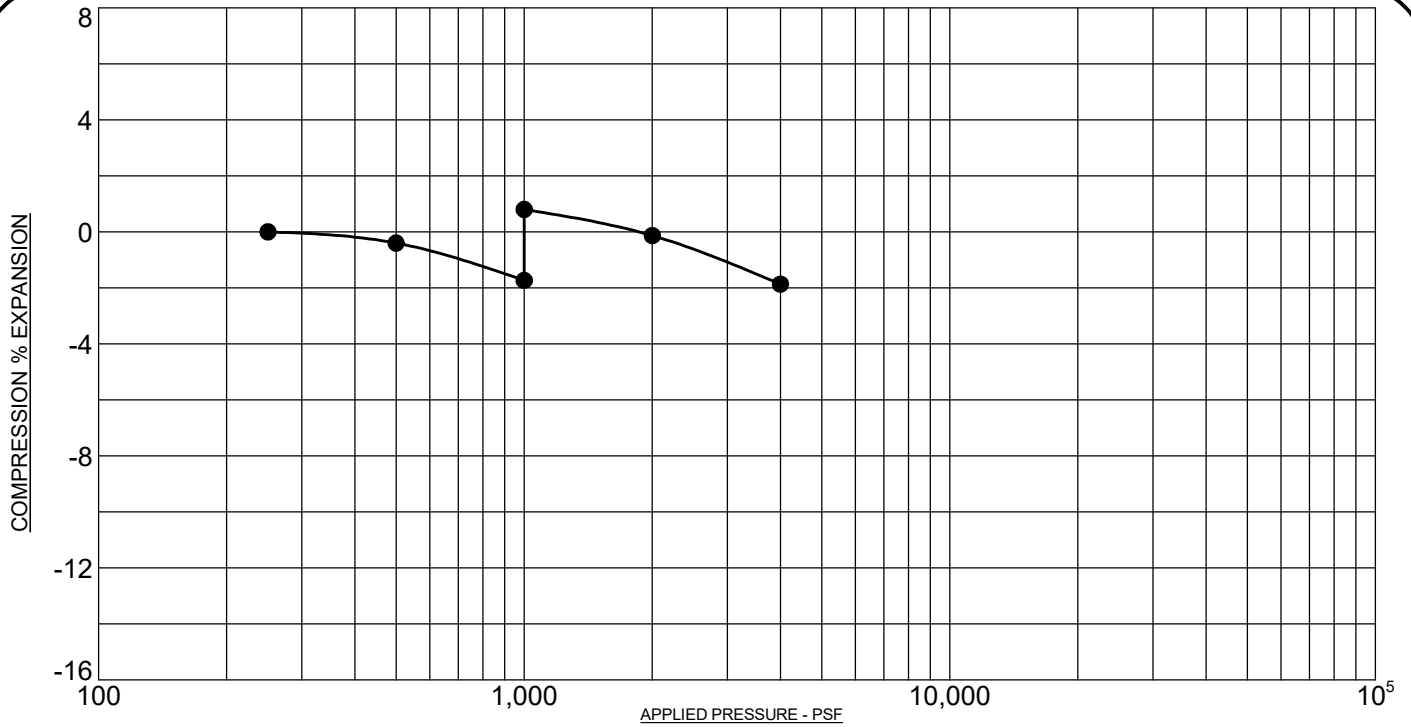
FIGURE No. 65

PROJECT: Lorson Boulevard, Area I, El Paso County, Colorado
 SAMPLE DESCRIPTION: CLAYSTONE, SANDY
 NOTE: SAMPLE WAS INUNDATED WITH WATER AT 1,000 PSF

SAMPLE LOCATION: 39 @ 14 FT
 NATURAL DRY UNIT WEIGHT: 118.0 PCF
 NATURAL MOISTURE CONTENT: 11.6%
 PERCENT SWELL/COMPRESSION: 2.5

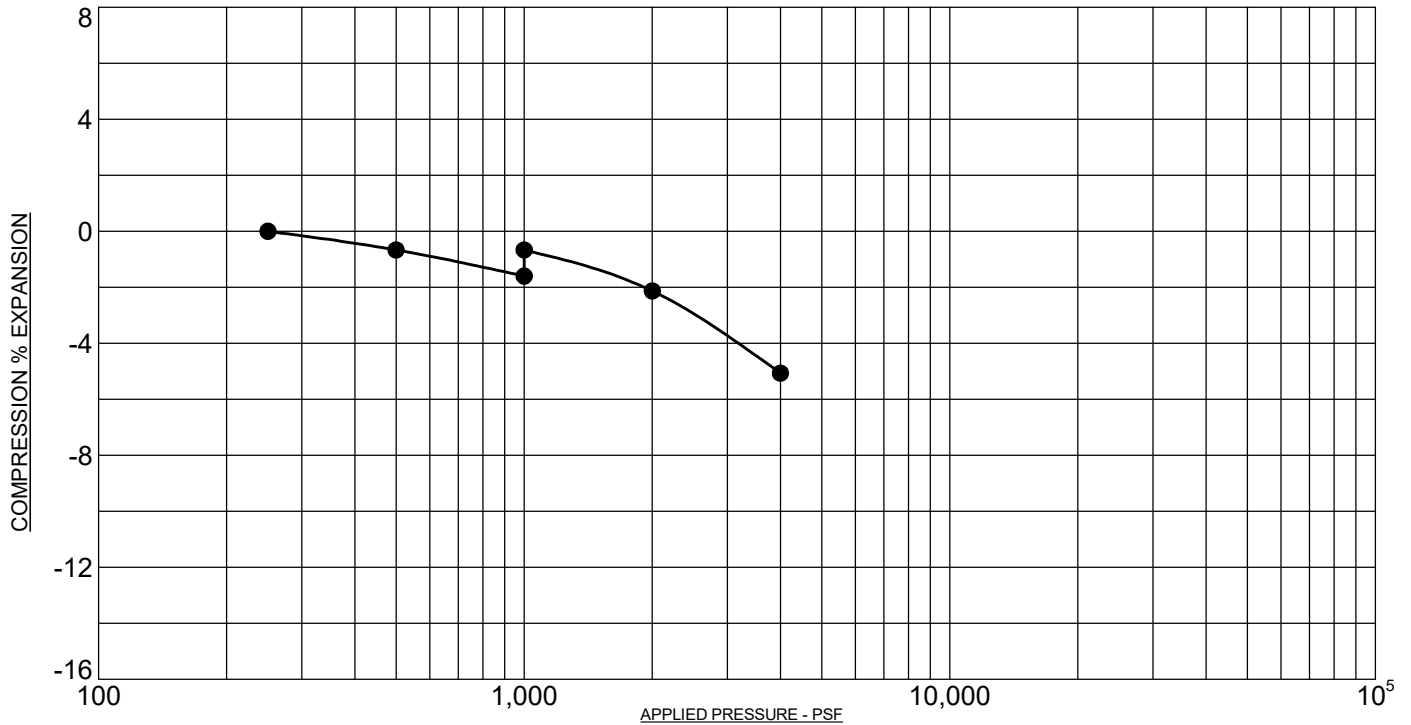
PROJECT: Lorson Boulevard, Area I, El Paso County, Colorado
 SAMPLE DESCRIPTION: CLAY, SANDY
 NOTE: SAMPLE WAS INUNDATED WITH WATER AT 1,000 PSF

SAMPLE LOCATION: 40 @ 4 FT
 NATURAL DRY UNIT WEIGHT: 108.0 PCF
 NATURAL MOISTURE CONTENT: 9.6%
 PERCENT SWELL/COMPRESSION: 0.9

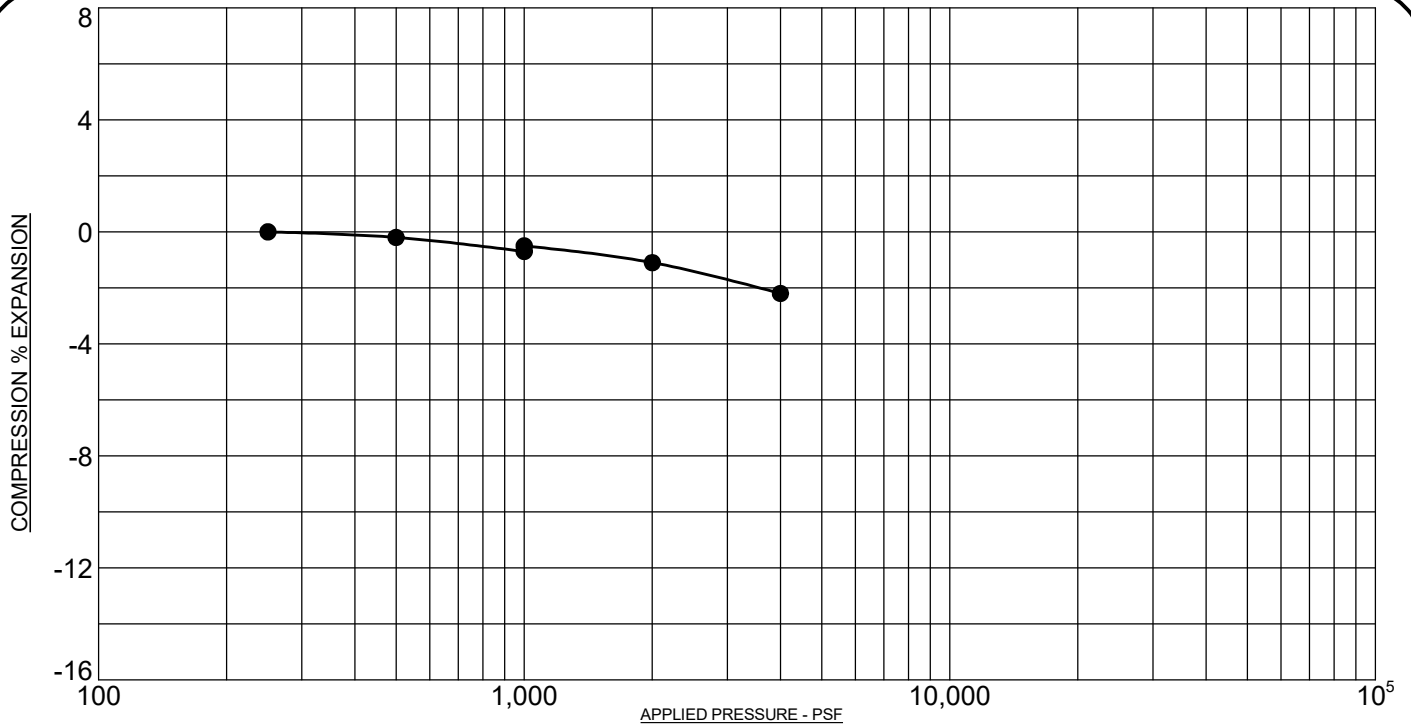
FIGURE No. 66

PROJECT: Lorson Boulevard, Area I, El Paso County, Colorado
 SAMPLE DESCRIPTION: CLAYSTONE, SANDY
 NOTE: SAMPLE WAS INUNDATED WITH WATER AT 1,000 PSF

SAMPLE LOCATION: 41 @ 9 FT
 NATURAL DRY UNIT WEIGHT: 118.1 PCF
 NATURAL MOISTURE CONTENT: 11.2%
 PERCENT SWELL/COMPRESSION: 0.2

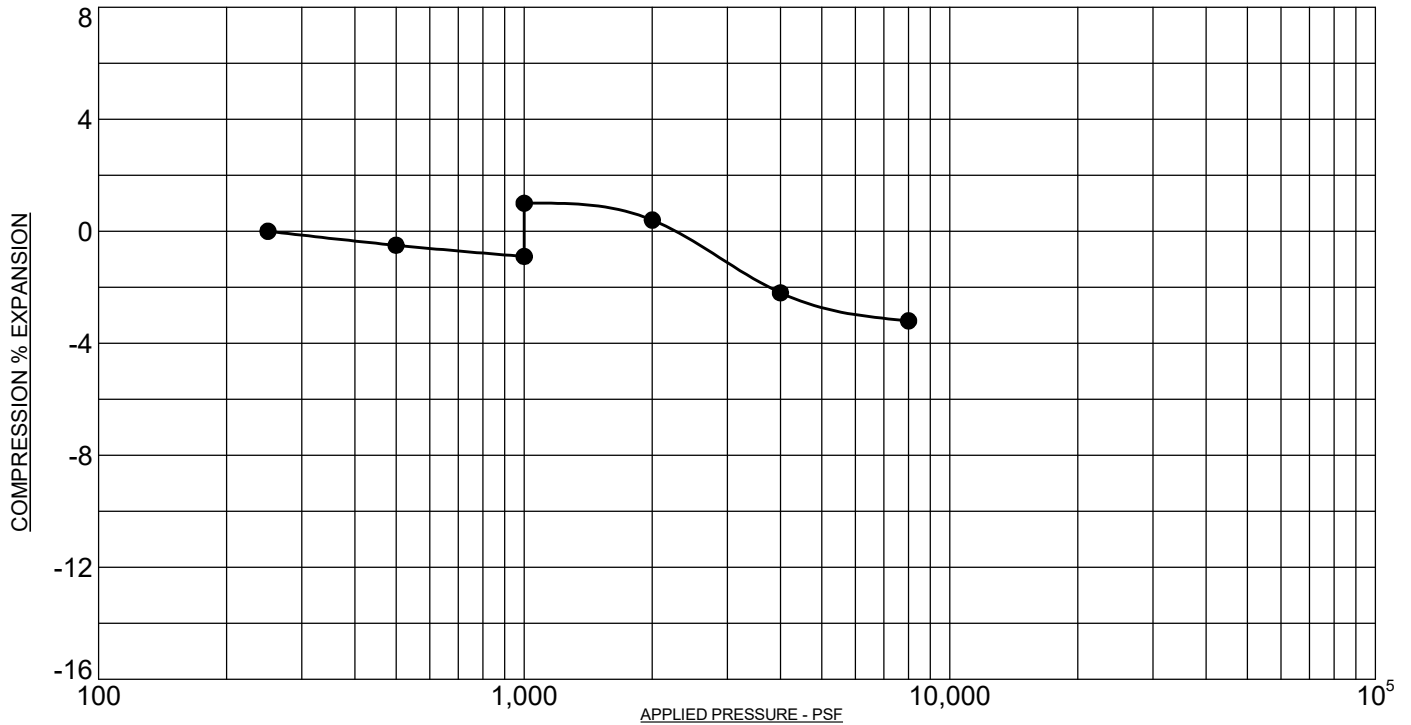
PROJECT: Lorson Boulevard, Area I, El Paso County, Colorado
 SAMPLE DESCRIPTION: CLAYSTONE, SANDY
 NOTE: SAMPLE WAS INUNDATED WITH WATER AT 1,000 PSF

SAMPLE LOCATION: 42 @ 14 FT
 NATURAL DRY UNIT WEIGHT: 117.0 PCF
 NATURAL MOISTURE CONTENT: 11.3%
 PERCENT SWELL/COMPRESSION: 1.9

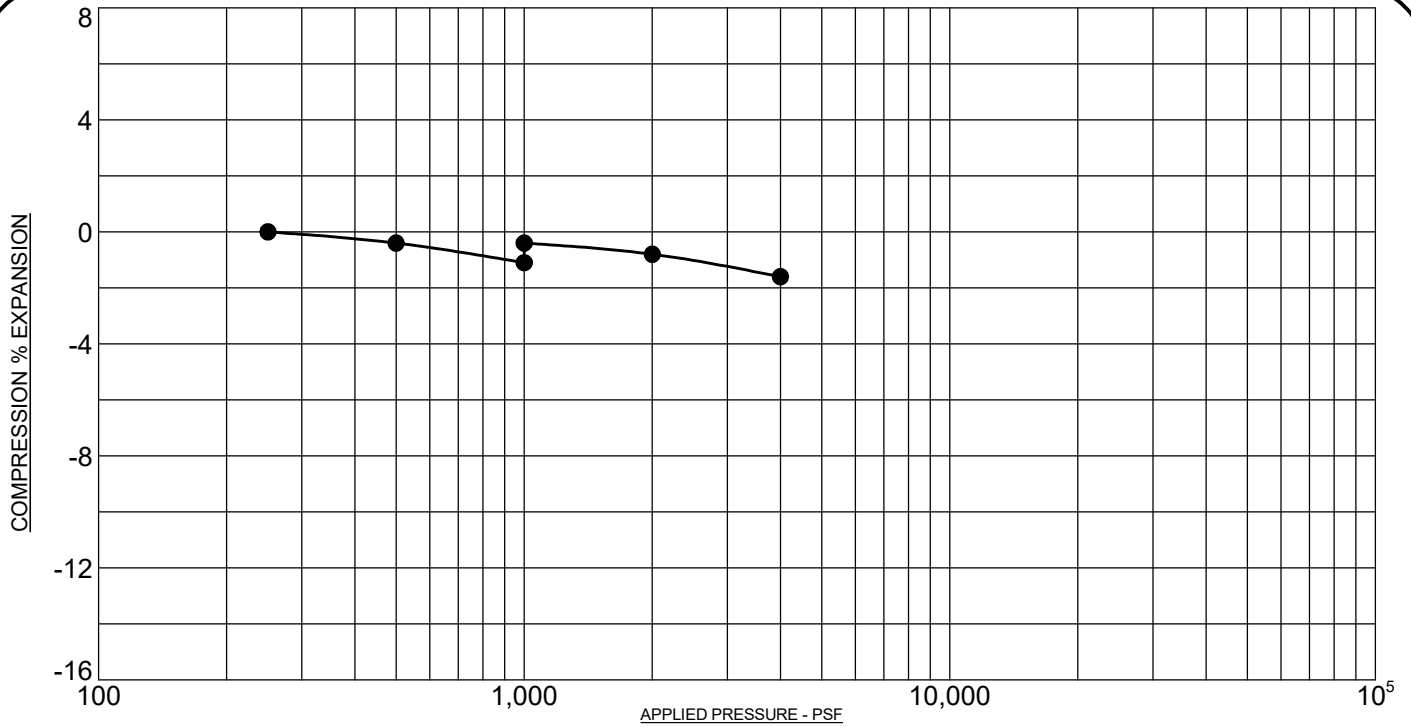
FIGURE No. 67

PROJECT: Lorson Boulevard, Area I, El Paso County, Colorado
 SAMPLE DESCRIPTION: CLAYSTONE, SANDY
 NOTE: SAMPLE WAS INUNDATED WITH WATER AT 1,000 PSF

SAMPLE LOCATION: 43 @ 14 FT
 NATURAL DRY UNIT WEIGHT: 114.3 PCF
 NATURAL MOISTURE CONTENT: 11.7%
 PERCENT SWELL/COMPRESSION: 0.7

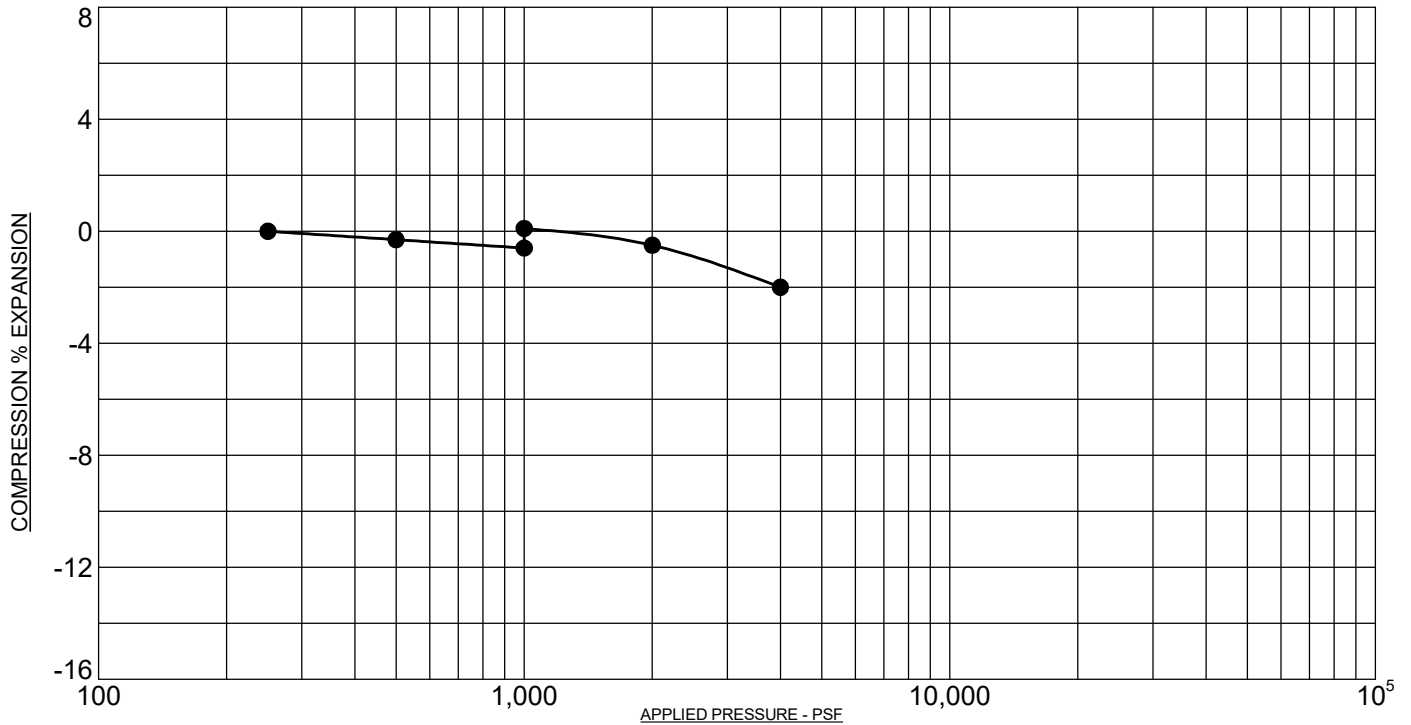
PROJECT: Lorson Boulevard, Area I, El Paso County, Colorado
 SAMPLE DESCRIPTION: CLAYSTONE, SANDY
 NOTE: SAMPLE WAS INUNDATED WITH WATER AT 1,000 PSF

SAMPLE LOCATION: 44 @ 9 FT
 NATURAL DRY UNIT WEIGHT: 121.7 PCF
 NATURAL MOISTURE CONTENT: 10.8%
 PERCENT SWELL/COMPRESSION: 0.7

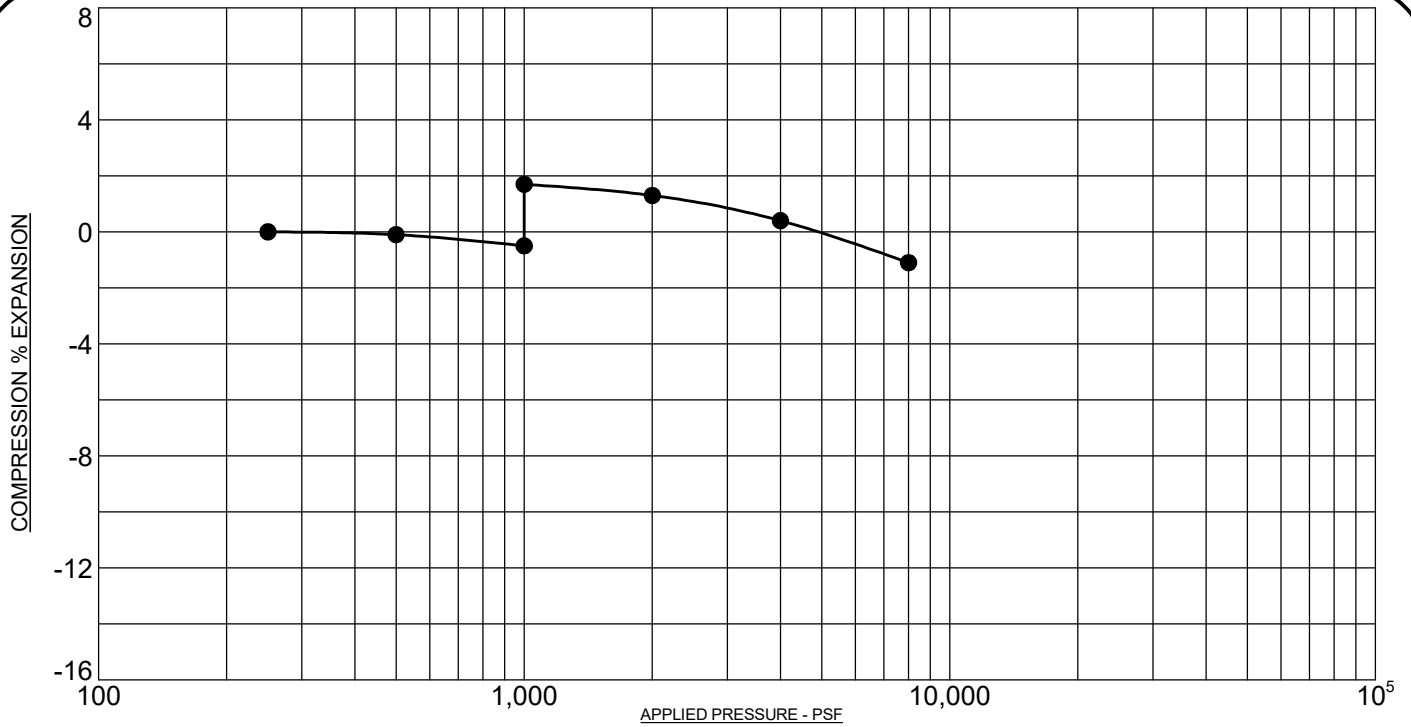
FIGURE No. 68

PROJECT: Lorson Boulevard, Area I, El Paso County, Colorado
 SAMPLE DESCRIPTION: CLAYSTONE, SANDY
 NOTE: SAMPLE WAS INUNDATED WITH WATER AT 1,000 PSF

SAMPLE LOCATION: 45 @ 14 FT
 NATURAL DRY UNIT WEIGHT: 120.6 PCF
 NATURAL MOISTURE CONTENT: 12.0%
 PERCENT SWELL/COMPRESSION: 2.2

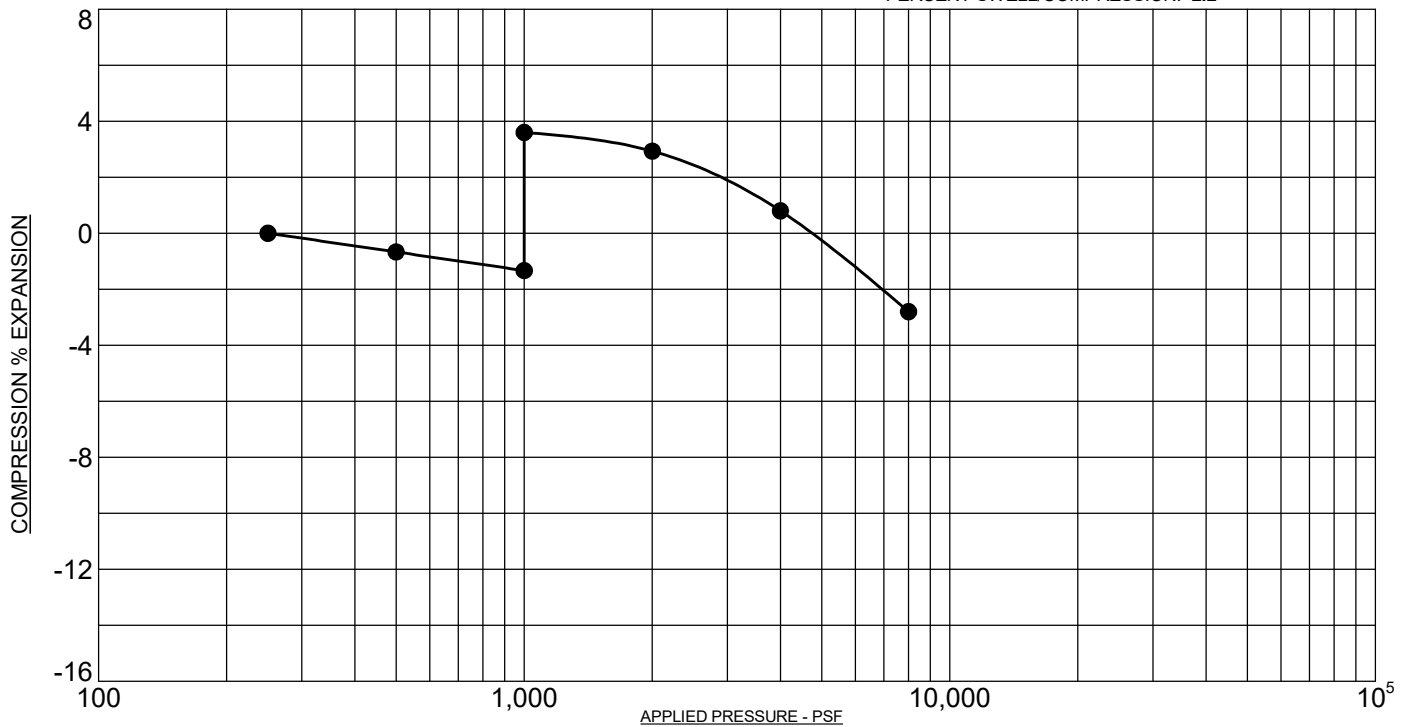
PROJECT: Lorson Boulevard, Area I, El Paso County, Colorado
 SAMPLE DESCRIPTION: CLAYSTONE, SANDY
 NOTE: SAMPLE WAS INUNDATED WITH WATER AT 1,000 PSF

SAMPLE LOCATION: 46 @ 9 FT
 NATURAL DRY UNIT WEIGHT: 119.5 PCF
 NATURAL MOISTURE CONTENT: 10.4%
 PERCENT SWELL/COMPRESSION: 4.9

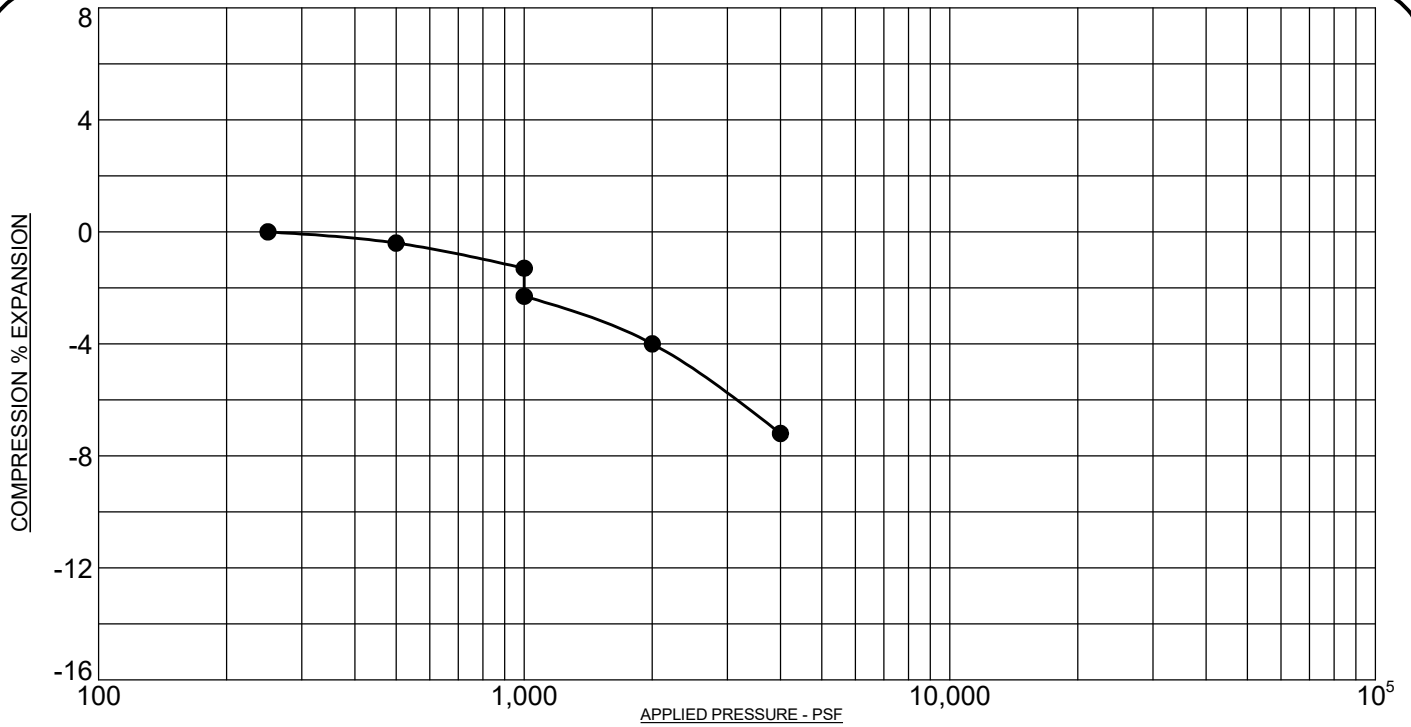
FIGURE No. 69

PROJECT: **Lorson Boulevard, Area I, El Paso County, Colorado**
 SAMPLE DESCRIPTION: **CLAYSTONE, SANDY**
 NOTE: **SAMPLE WAS INUNDATED WITH WATER AT 1,000 PSF**

SAMPLE LOCATION: **47 @ 14 FT**
 NATURAL DRY UNIT WEIGHT: **109.0 PCF**
 NATURAL MOISTURE CONTENT: **11.6%**
 PERCENT SWELL/COMPRESSION: **- 1.0**

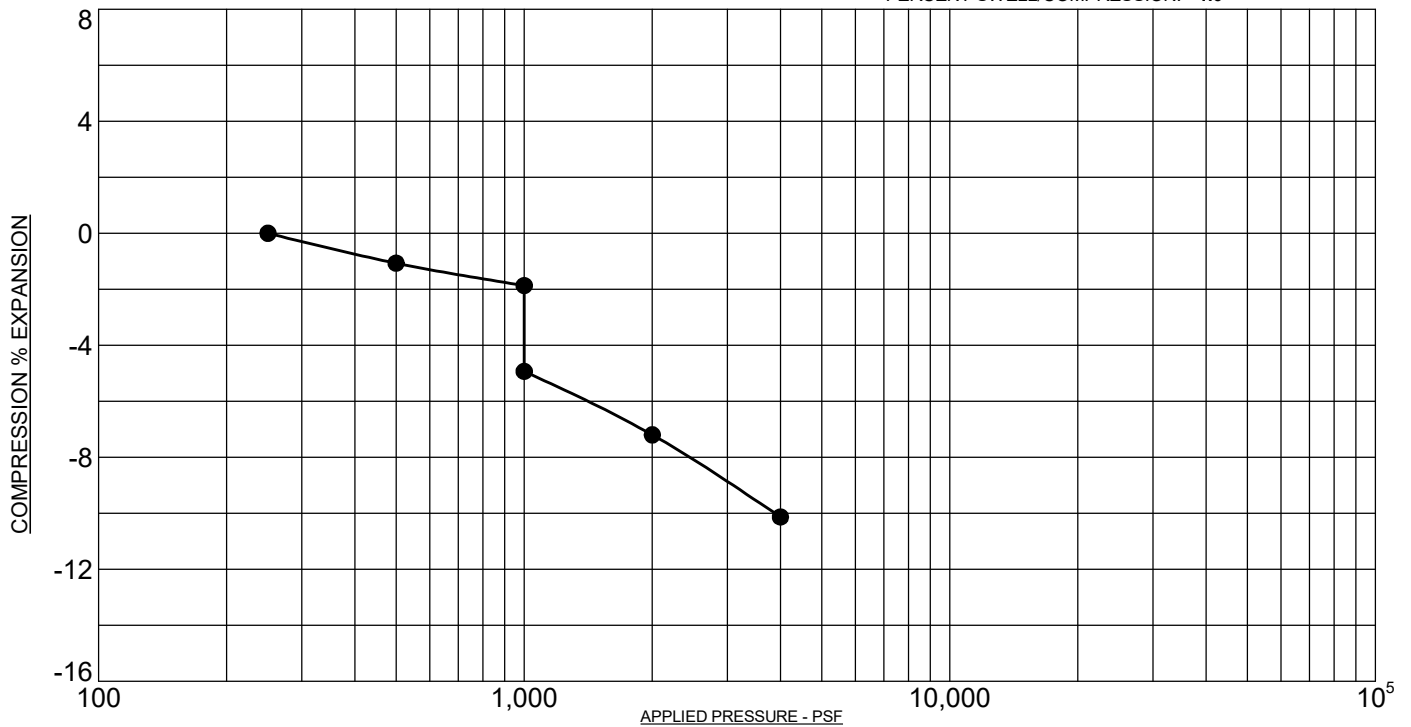
PROJECT: **Lorson Boulevard, Area I, El Paso County, Colorado**
 SAMPLE DESCRIPTION: **CLAYSTONE, SANDY**
 NOTE: **SAMPLE WAS INUNDATED WITH WATER AT 1,000 PSF**

SAMPLE LOCATION: **48 @ 9 FT**
 NATURAL DRY UNIT WEIGHT: **99.4 PCF**
 NATURAL MOISTURE CONTENT: **12.1%**
 PERCENT SWELL/COMPRESSION: **- 3.1**

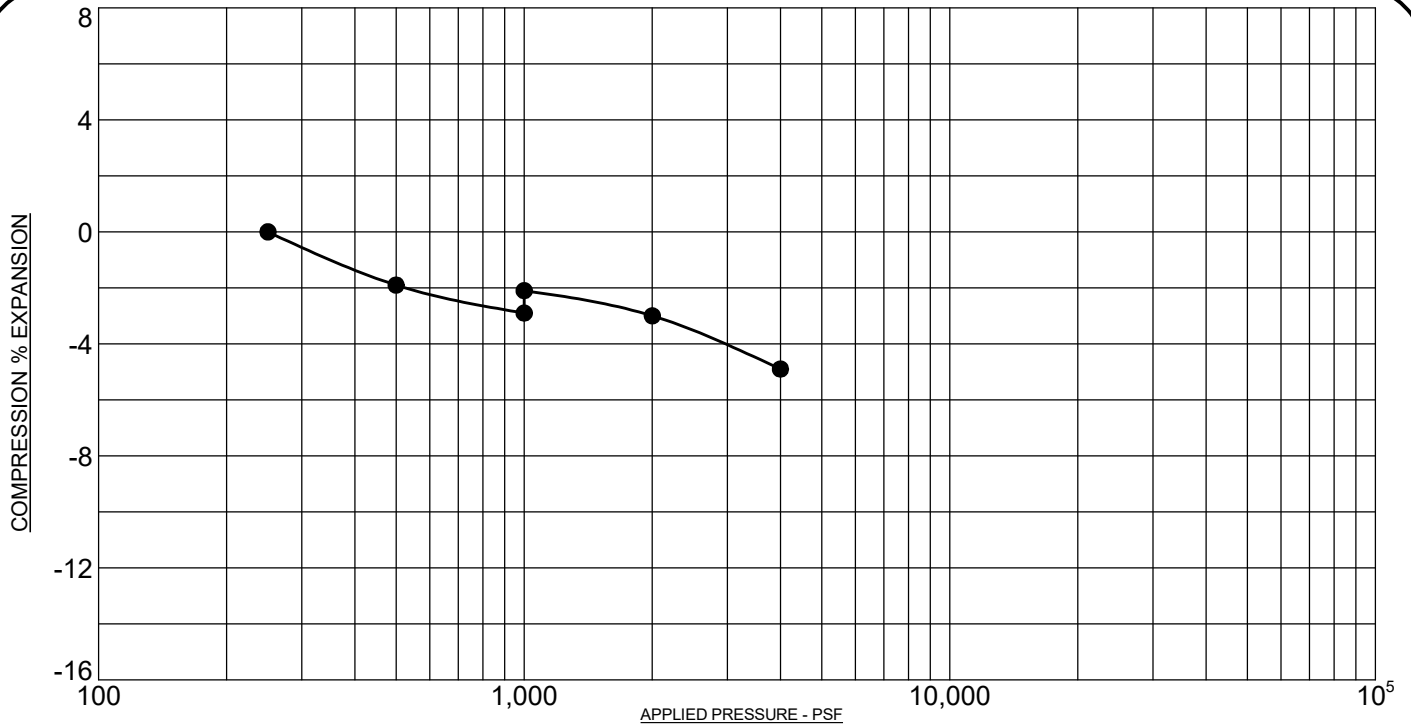
FIGURE No. 70

PROJECT: **Lorson Boulevard, Area I, El Paso County, Colorado**
 SAMPLE DESCRIPTION: **CLAYSTONE, SANDY**
 NOTE: **SAMPLE WAS INUNDATED WITH WATER AT 1,000 PSF**

SAMPLE LOCATION: **49 @ 14 FT**
 NATURAL DRY UNIT WEIGHT: **112.3 PCF**
 NATURAL MOISTURE CONTENT: **12.7%**
 PERCENT SWELL/COMPRESSION: **0.8**

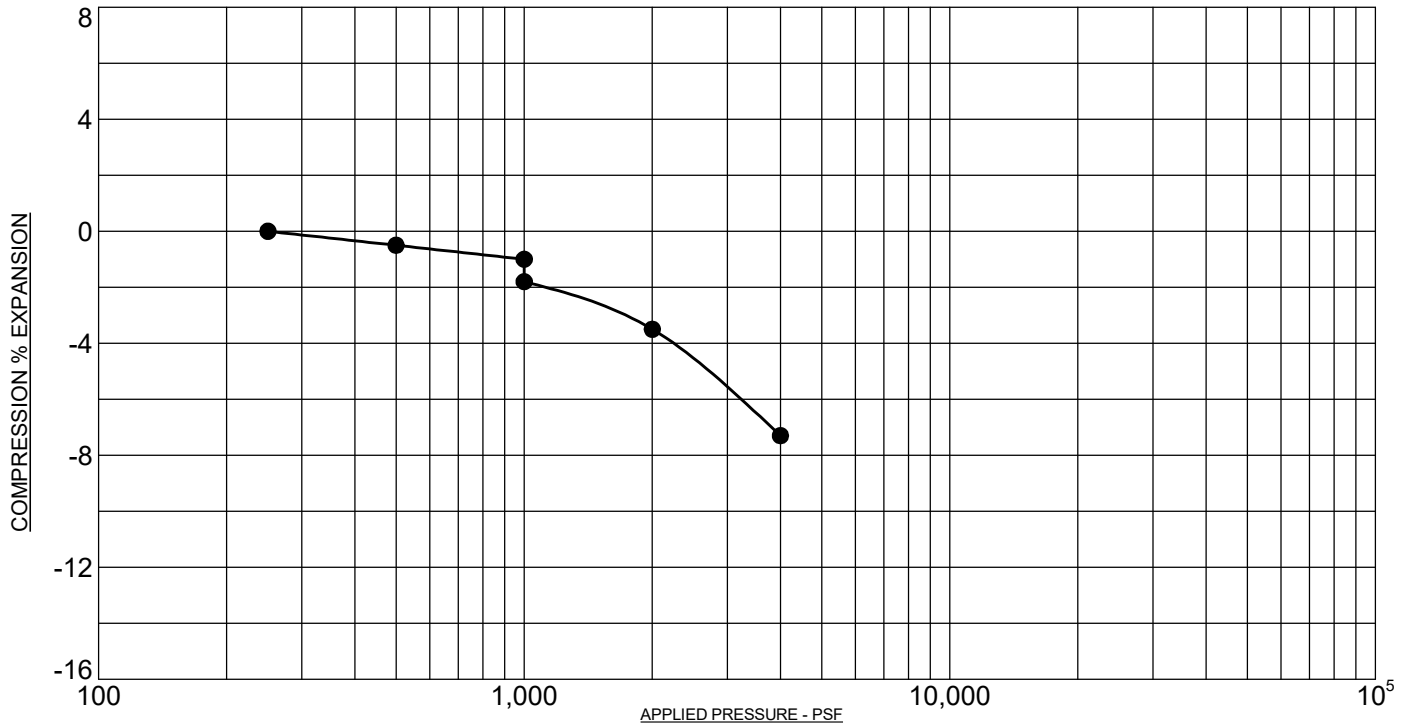
PROJECT: **Lorson Boulevard, Area I, El Paso County, Colorado**
 SAMPLE DESCRIPTION: **CLAYSTONE, SANDY**
 NOTE: **SAMPLE WAS INUNDATED WITH WATER AT 1,000 PSF**

SAMPLE LOCATION: **50 @ 9 FT**
 NATURAL DRY UNIT WEIGHT: **105.2 PCF**
 NATURAL MOISTURE CONTENT: **10.7%**
 PERCENT SWELL/COMPRESSION: **-0.8**

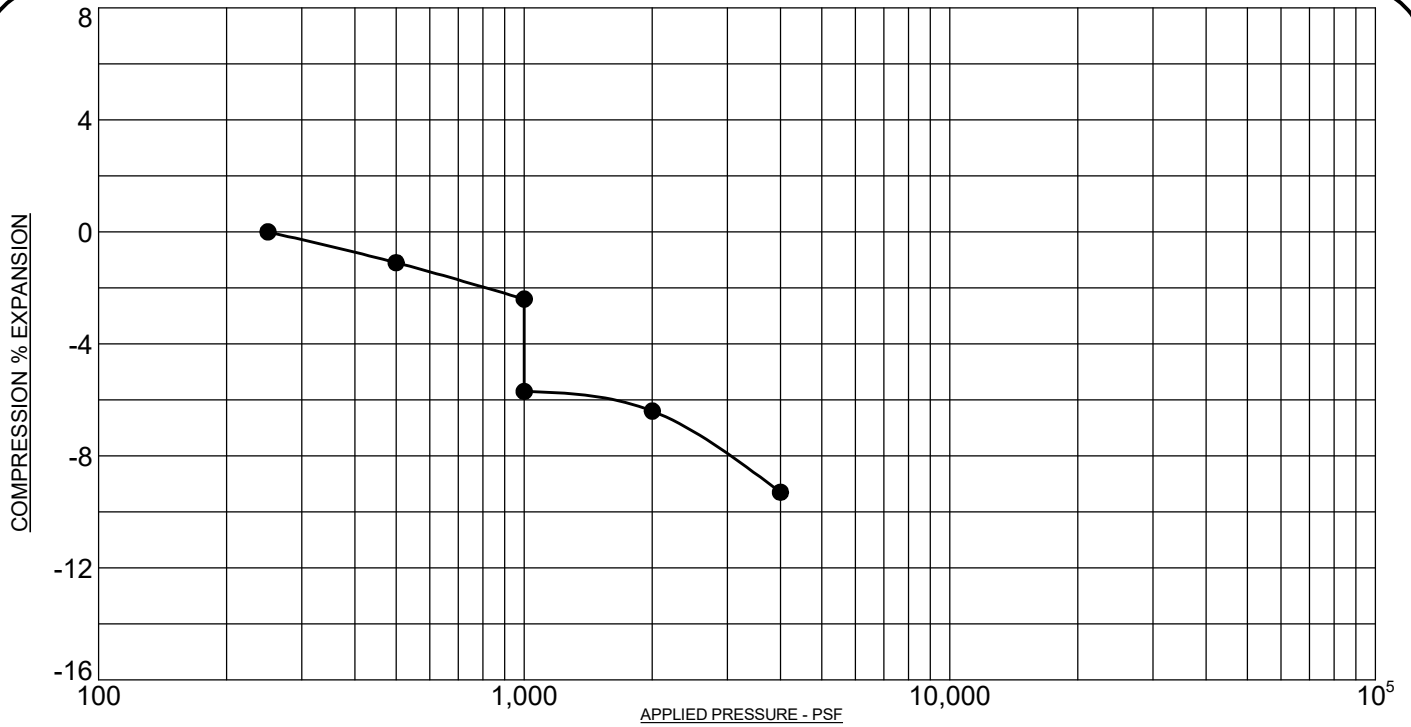
FIGURE No. 71

PROJECT: Lorson Boulevard, Area I, El Paso County, Colorado
 SAMPLE DESCRIPTION: CLAYSTONE, SANDY
 NOTE: SAMPLE WAS INUNDATED WITH WATER AT 1,000 PSF

SAMPLE LOCATION: 51 @ 9 FT
 NATURAL DRY UNIT WEIGHT: 108.9 PCF
 NATURAL MOISTURE CONTENT: 9.9%
 PERCENT SWELL/COMPRESSION: - 3.3

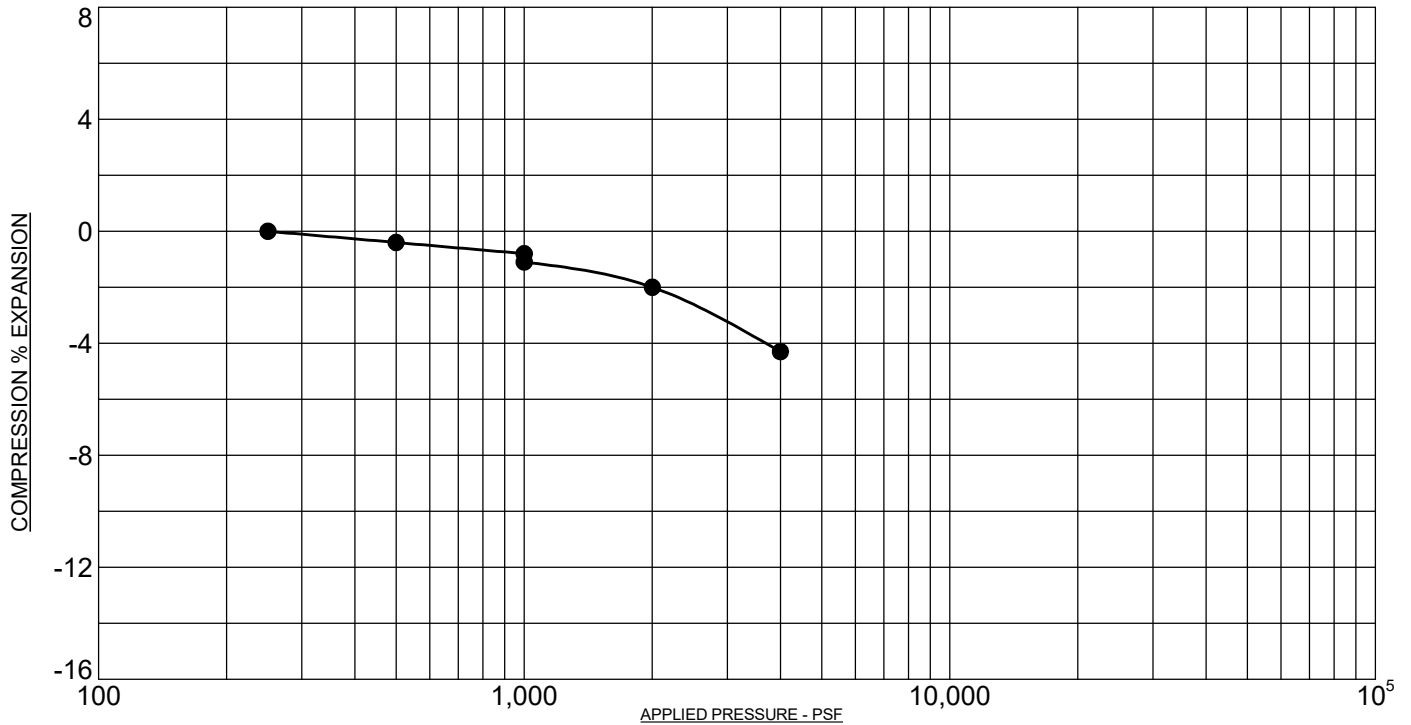
PROJECT: Lorson Boulevard, Area I, El Paso County, Colorado
 SAMPLE DESCRIPTION: CLAY, SANDY
 NOTE: SAMPLE WAS INUNDATED WITH WATER AT 1,000 PSF

SAMPLE LOCATION: 52 @ 4 FT
 NATURAL DRY UNIT WEIGHT: 103.9 PCF
 NATURAL MOISTURE CONTENT: 7.0%
 PERCENT SWELL/COMPRESSION: - 0.3

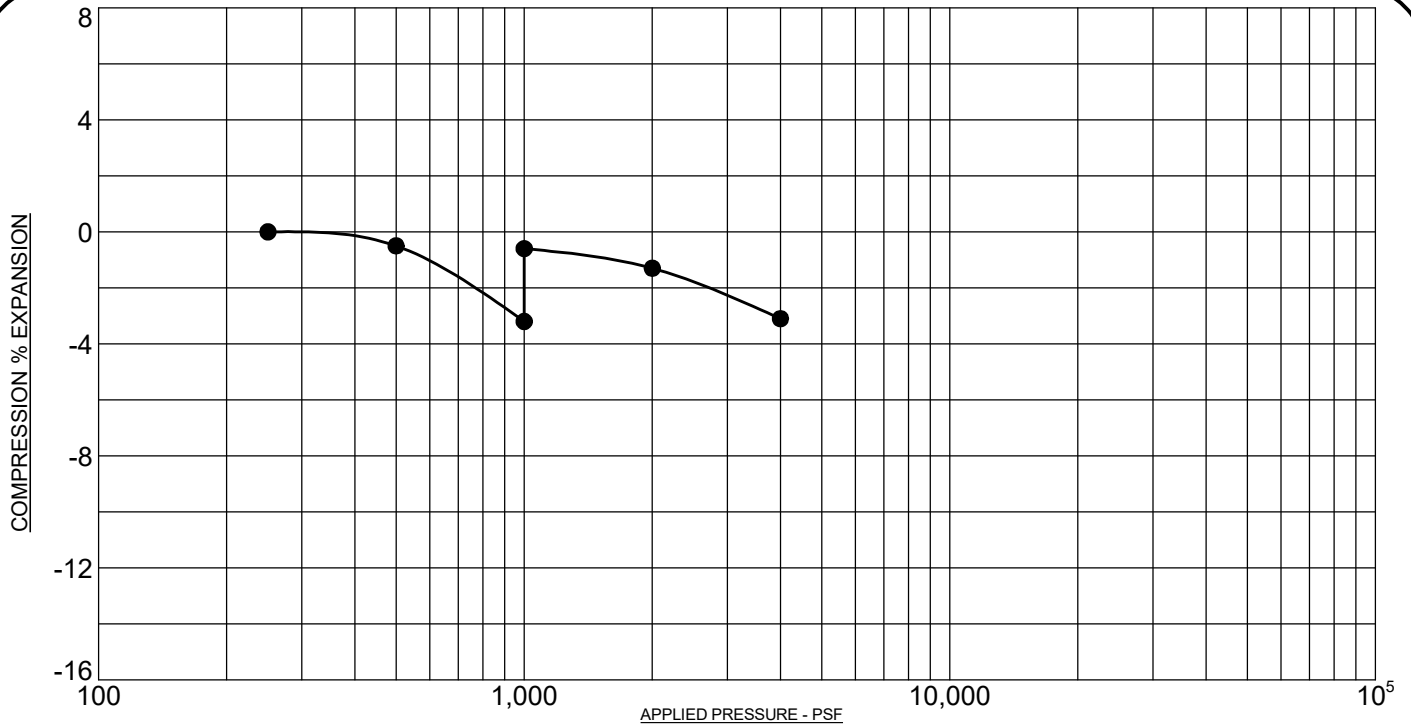
FIGURE No. 72

PROJECT: Lorson Boulevard, Area I, El Paso County, Colorado
 SAMPLE DESCRIPTION: CLAYSTONE, SANDY
 NOTE: SAMPLE WAS INUNDATED WITH WATER AT 1,000 PSF

SAMPLE LOCATION: 53 @ 9 FT
 NATURAL DRY UNIT WEIGHT: 112.1 PCF
 NATURAL MOISTURE CONTENT: 8.6%
 PERCENT SWELL/COMPRESSION: 2.6

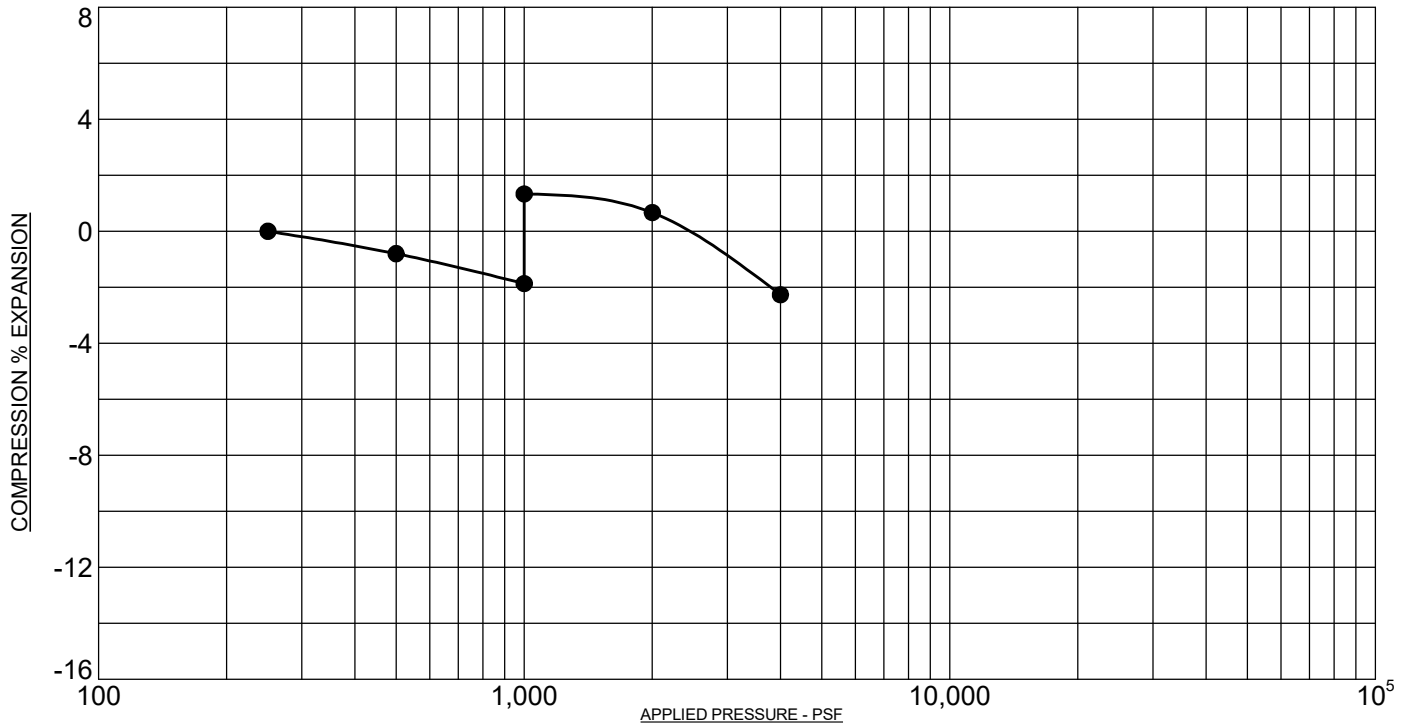
PROJECT: Lorson Boulevard, Area I, El Paso County, Colorado
 SAMPLE DESCRIPTION: CLAYSTONE, SANDY
 NOTE: SAMPLE WAS INUNDATED WITH WATER AT 1,000 PSF

SAMPLE LOCATION: 54 @ 14 FT
 NATURAL DRY UNIT WEIGHT: 119.0 PCF
 NATURAL MOISTURE CONTENT: 10.7%
 PERCENT SWELL/COMPRESSION: 3.2

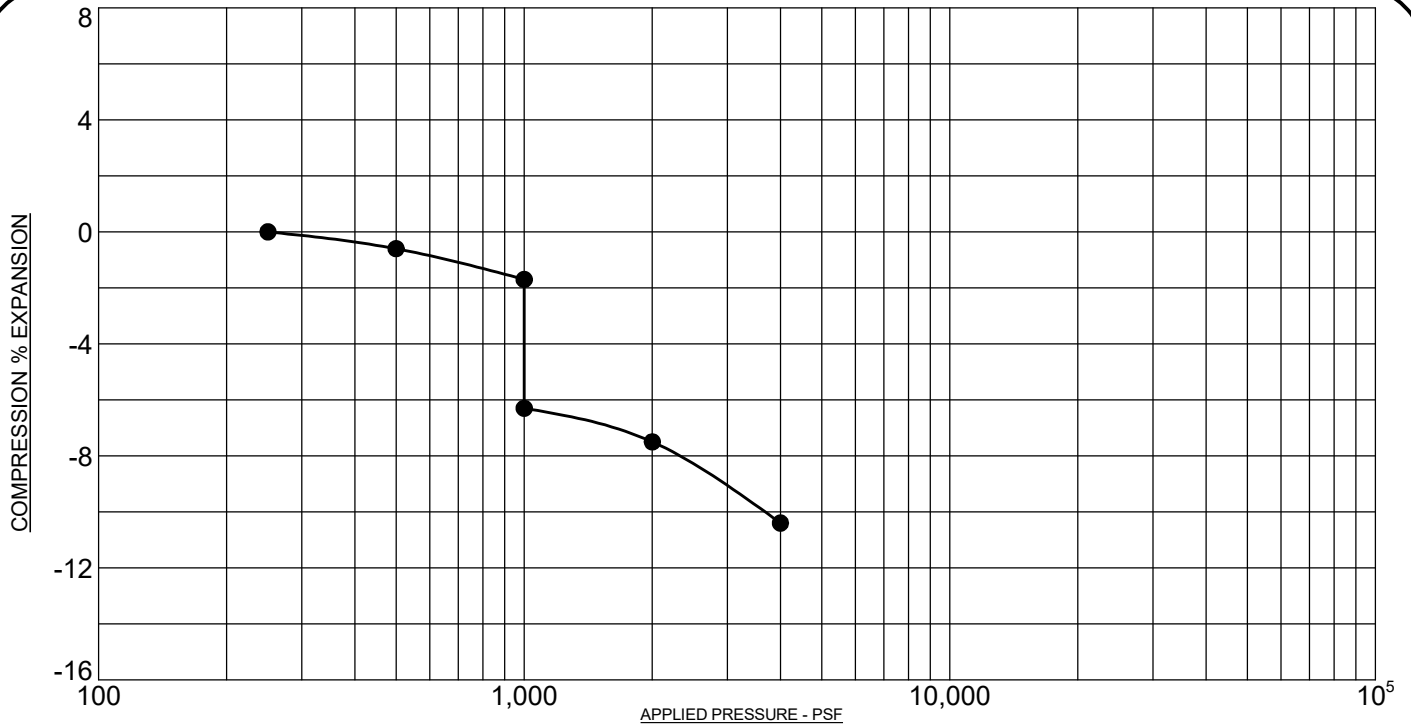
FIGURE No. 73

PROJECT: Lorson Boulevard, Area I, El Paso County, Colorado
 SAMPLE DESCRIPTION: CLAY, SANDY
 NOTE: SAMPLE WAS INUNDATED WITH WATER AT 1,000 PSF

SAMPLE LOCATION: 55 @ 9 FT
 NATURAL DRY UNIT WEIGHT: 99.6 PCF
 NATURAL MOISTURE CONTENT: 7.8%
 PERCENT SWELL/COMPRESSION: - 4.6

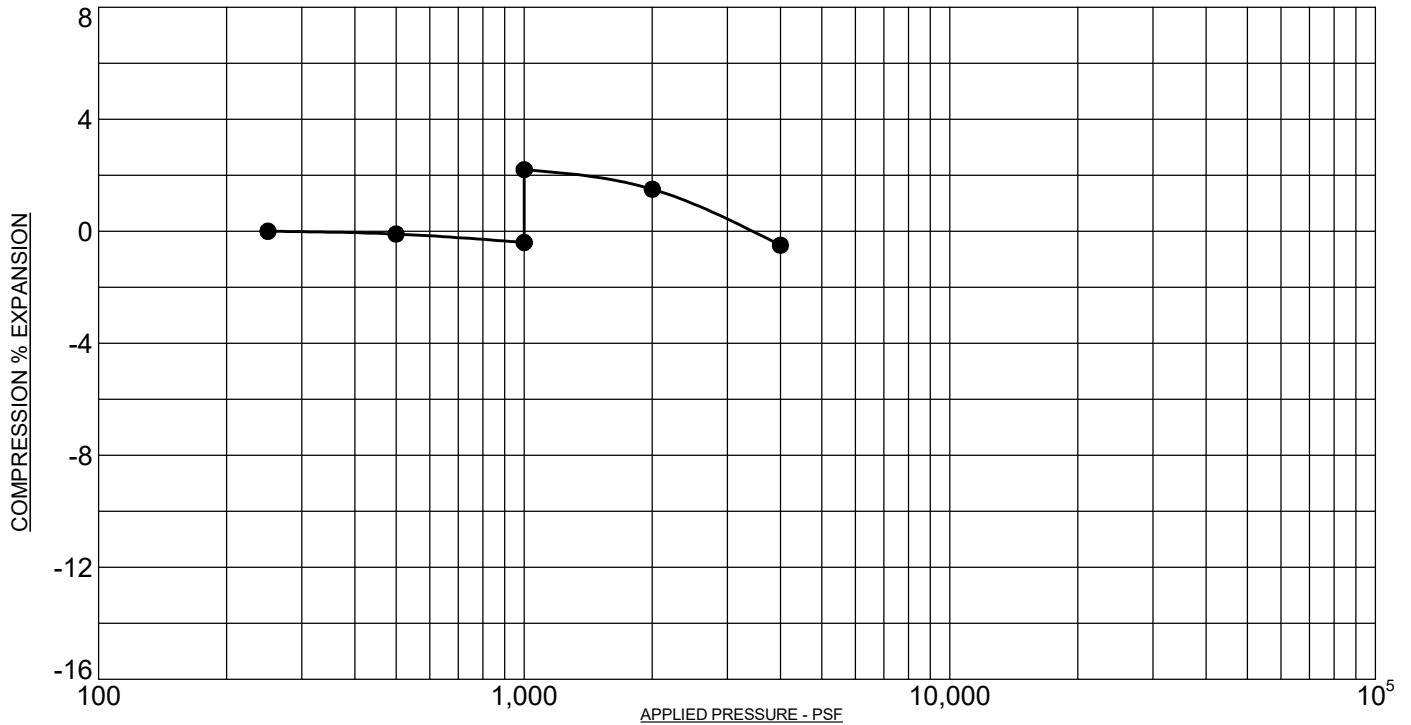
PROJECT: Lorson Boulevard, Area I, El Paso County, Colorado
 SAMPLE DESCRIPTION: CLAY, SANDY
 NOTE: SAMPLE WAS INUNDATED WITH WATER AT 1,000 PSF

SAMPLE LOCATION: 56 @ 14 FT
 NATURAL DRY UNIT WEIGHT: 112.2 PCF
 NATURAL MOISTURE CONTENT: 8.9%
 PERCENT SWELL/COMPRESSION: 2.6

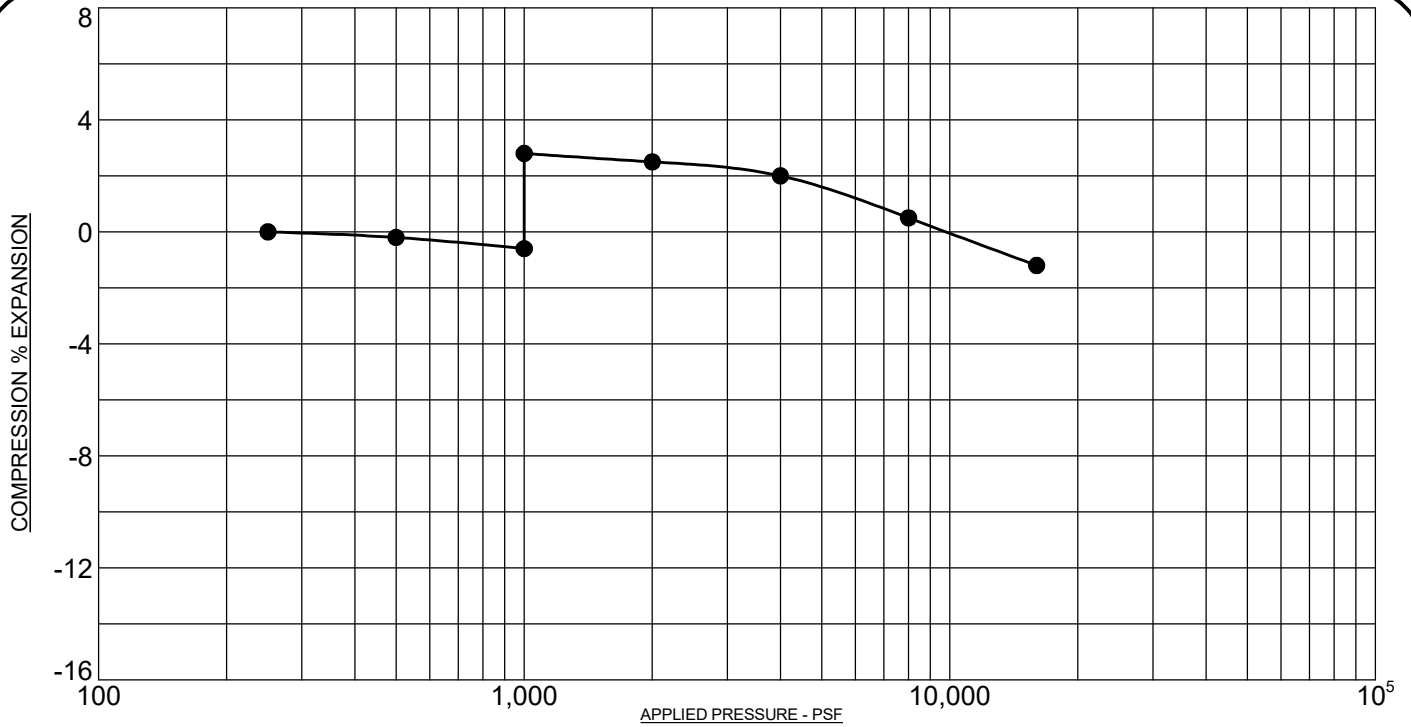
FIGURE No. 74

PROJECT: Lorson Boulevard, Area I, El Paso County, Colorado
 SAMPLE DESCRIPTION: CLAYSTONE, SANDY
 NOTE: SAMPLE WAS INUNDATED WITH WATER AT 1,000 PSF

SAMPLE LOCATION: 57 @ 19 FT
 NATURAL DRY UNIT WEIGHT: 125.5 PCF
 NATURAL MOISTURE CONTENT: 9.9%
 PERCENT SWELL/COMPRESSION: 3.4

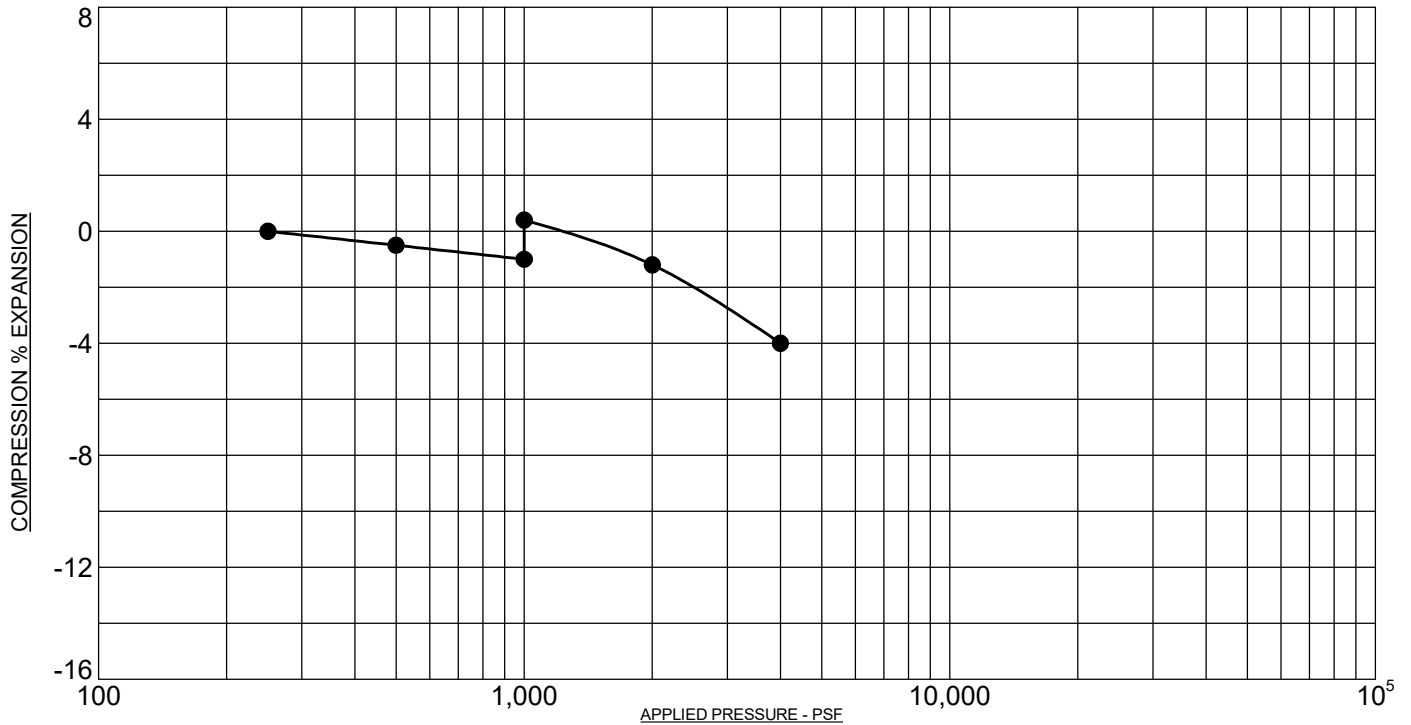
PROJECT: Lorson Boulevard, Area I, El Paso County, Colorado
 SAMPLE DESCRIPTION: CLAY, SANDY
 NOTE: SAMPLE WAS INUNDATED WITH WATER AT 1,000 PSF

SAMPLE LOCATION: 58 @ 14 FT
 NATURAL DRY UNIT WEIGHT: 105.9 PCF
 NATURAL MOISTURE CONTENT: 9.5%
 PERCENT SWELL/COMPRESSION: 1.4

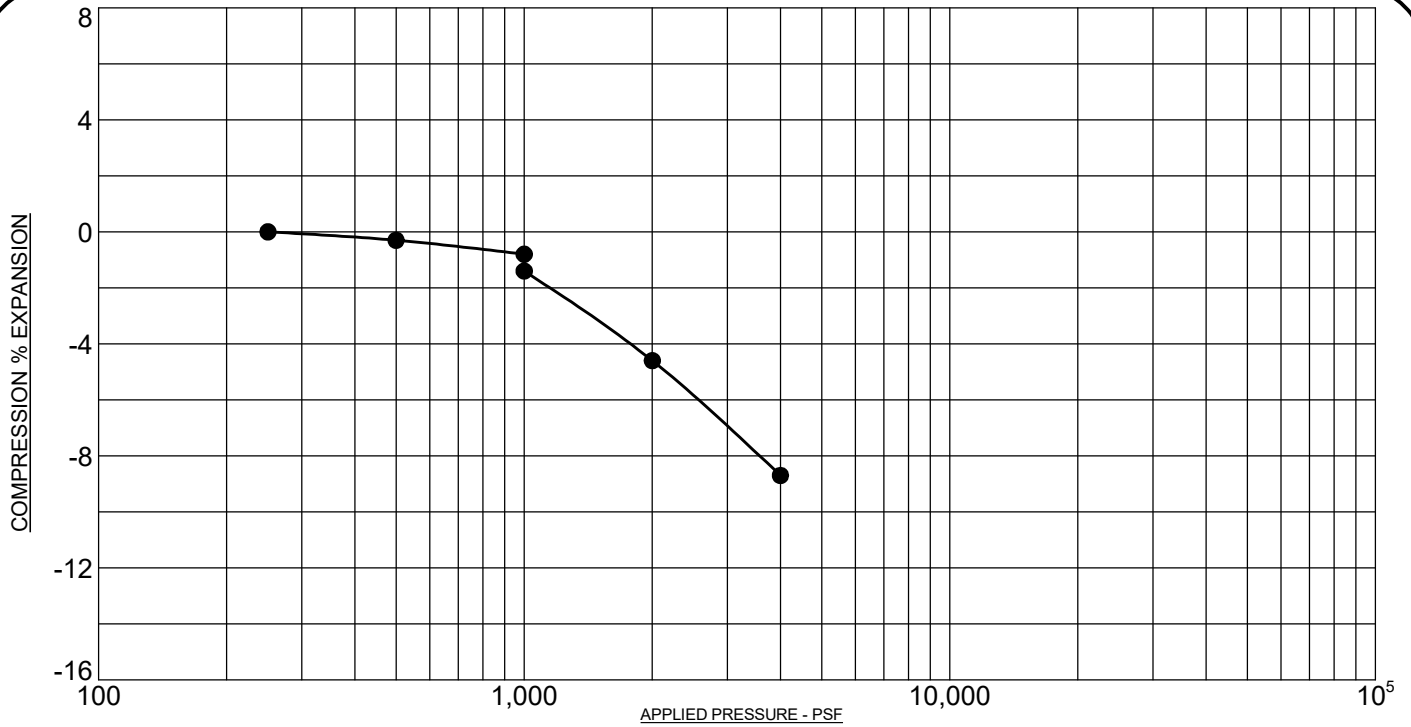
FIGURE No. 75

PROJECT: **Lorson Boulevard, Area I, El Paso County, Colorado**
 SAMPLE DESCRIPTION: **CLAY, SANDY**
 NOTE: **SAMPLE WAS INUNDATED WITH WATER AT 1,000 PSF**

SAMPLE LOCATION: **60 @ 9 FT**
 NATURAL DRY UNIT WEIGHT: **87.8 PCF**
 NATURAL MOISTURE CONTENT: **8.9%**
 PERCENT SWELL/COMPRESSION: **- 0.6**
