SOILS AND GEOLOGY STUDY

**Hillside at Lorson Ranch – “Area I”
El Paso County, Colorado**

JOB NO. 181988

January 3, 2022

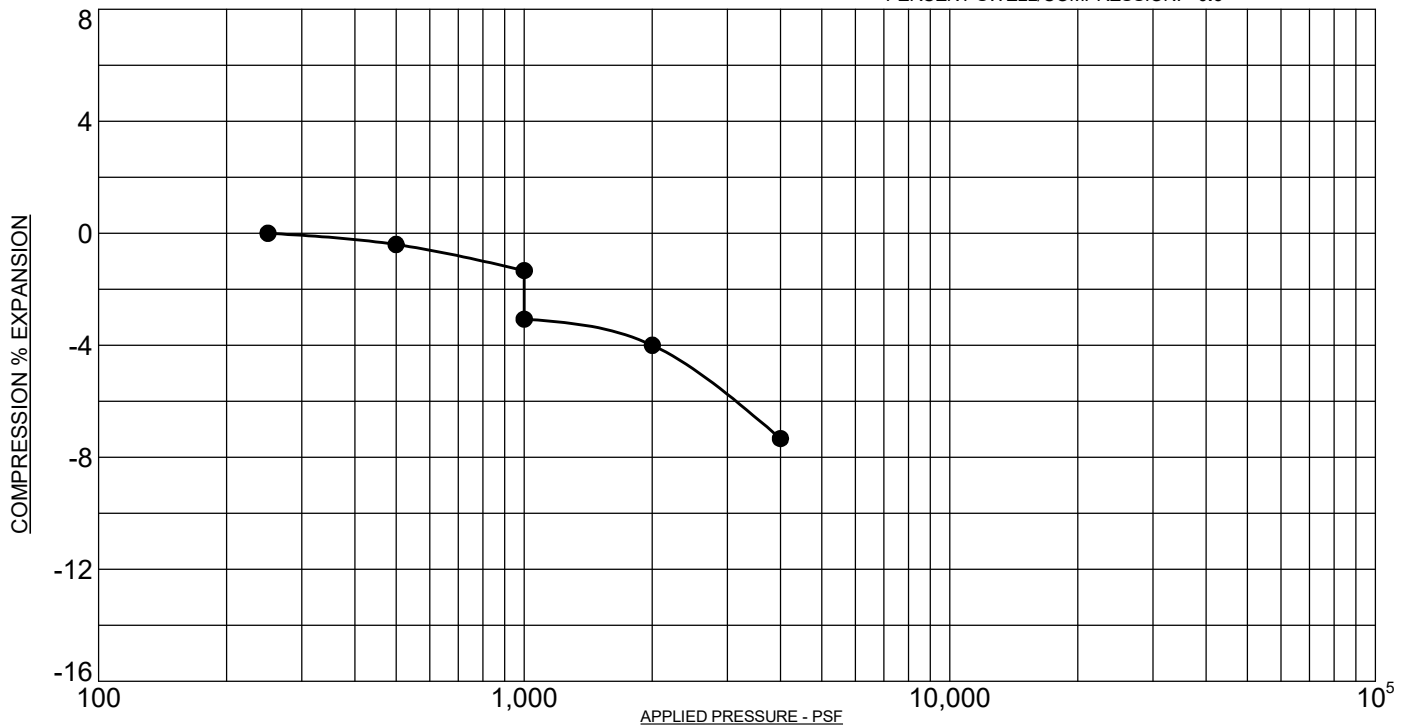
PROJECT: **Lorson Boulevard, Area I, El Paso County, Colorado**
 SAMPLE DESCRIPTION: **CLAY, SANDY**
 NOTE: **SAMPLE WAS INUNDATED WITH WATER AT 1,000 PSF**

SAMPLE LOCATION: **61 @ 14 FT**
 NATURAL DRY UNIT WEIGHT: **95.7 PCF**
 NATURAL MOISTURE CONTENT: **9.7%**
 PERCENT SWELL/COMPRESSION: **- 1.7**

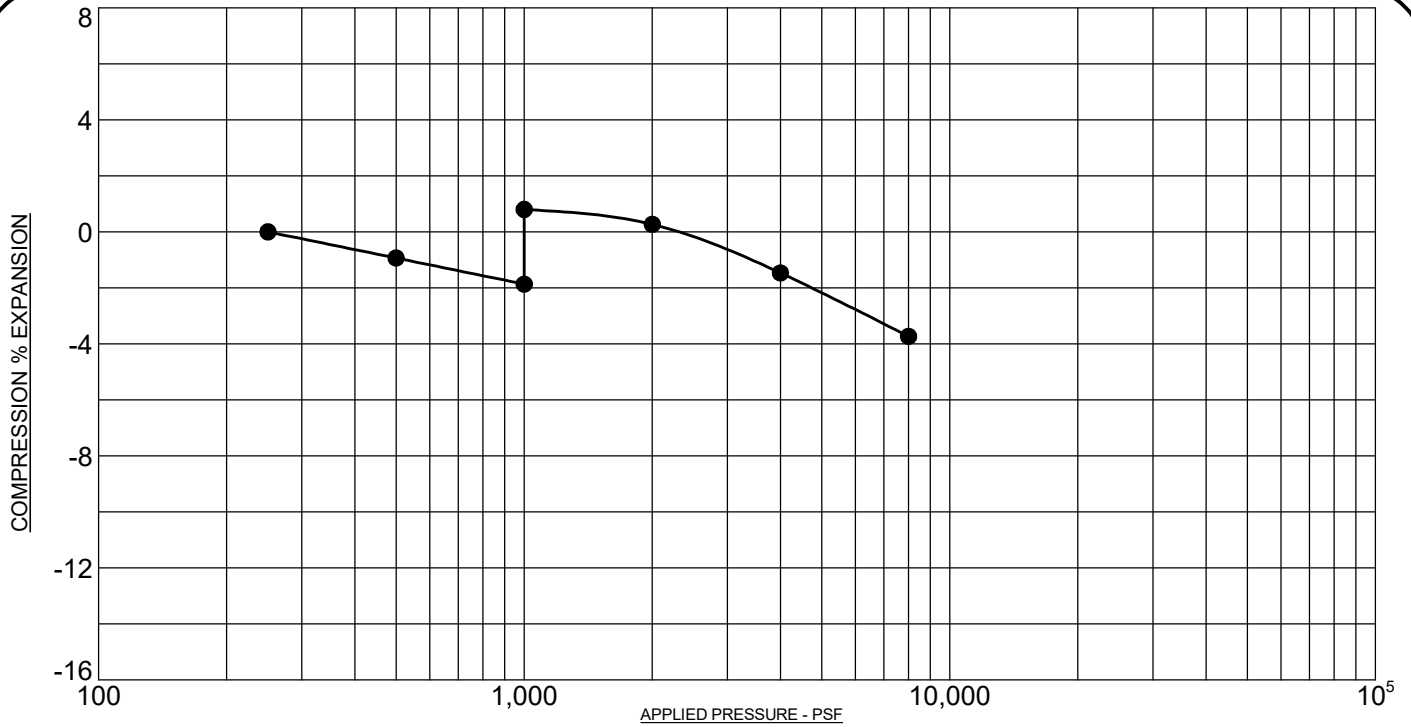
FIGURE No. 76

PROJECT: Lorson Boulevard, Area I, El Paso County, Colorado
 SAMPLE DESCRIPTION: CLAYSTONE, SANDY
 NOTE: SAMPLE WAS INUNDATED WITH WATER AT 1,000 PSF

SAMPLE LOCATION: 63 @ 14 FT
 NATURAL DRY UNIT WEIGHT: 110.9 PCF
 NATURAL MOISTURE CONTENT: 12.4%
 PERCENT SWELL/COMPRESSION: 2.7

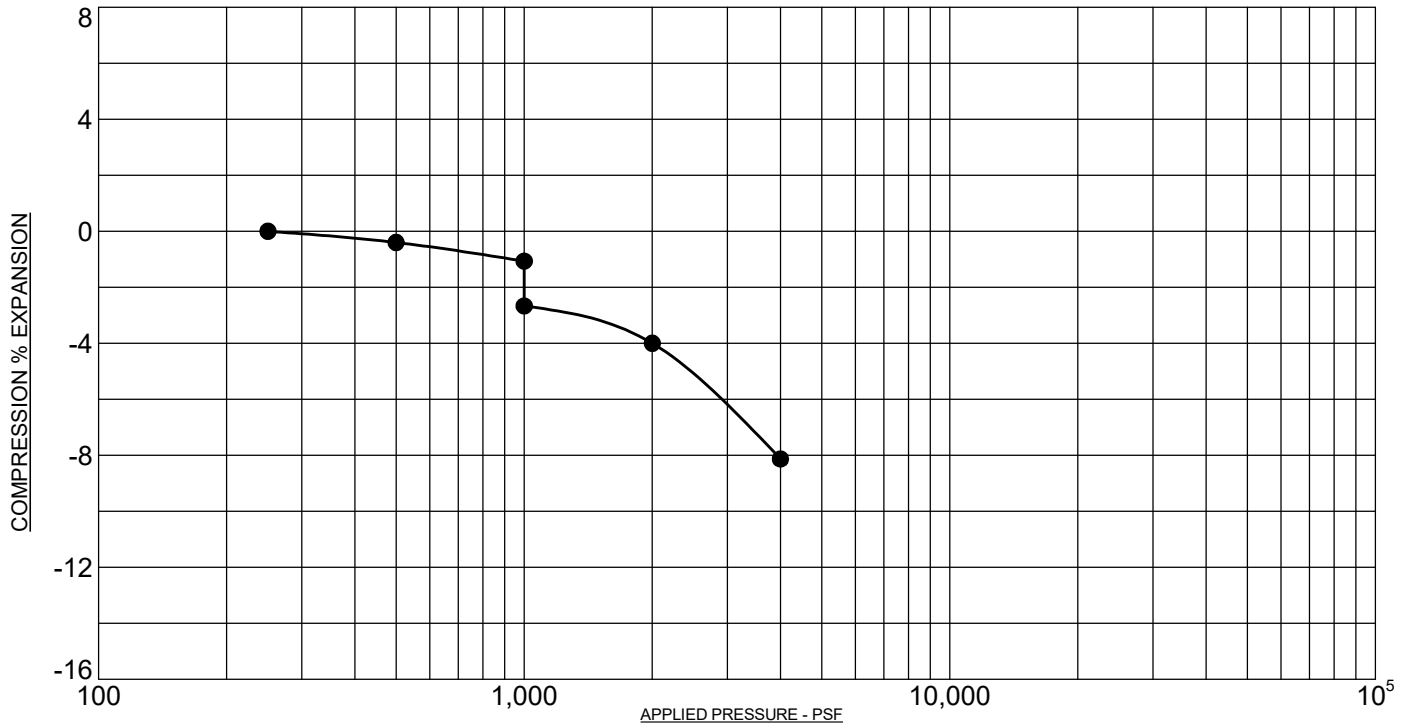
PROJECT: Lorson Boulevard, Area I, El Paso County, Colorado
 SAMPLE DESCRIPTION: CLAY, SANDY
 NOTE: SAMPLE WAS INUNDATED WITH WATER AT 1,000 PSF

SAMPLE LOCATION: 64 @ 9 FT
 NATURAL DRY UNIT WEIGHT: 99.7 PCF
 NATURAL MOISTURE CONTENT: 9.3%
 PERCENT SWELL/COMPRESSION: -1.6

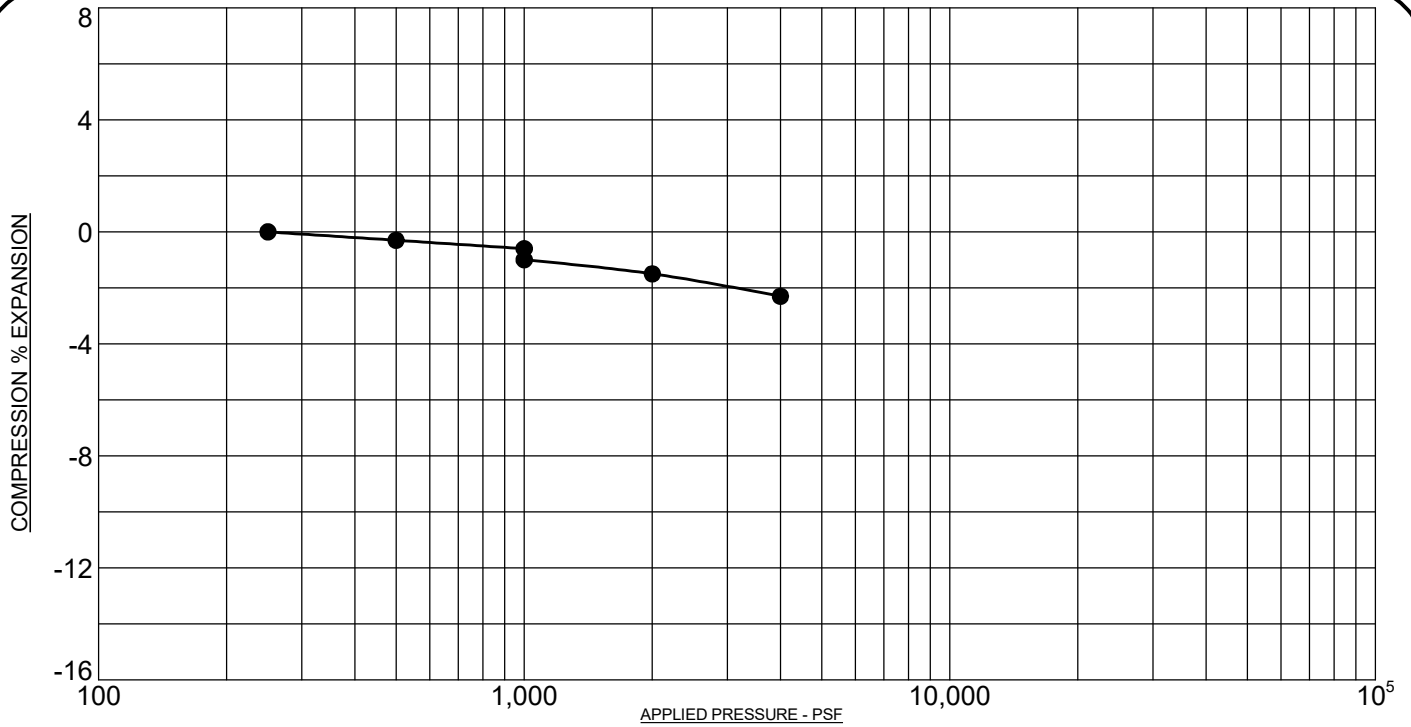
FIGURE No. 77

PROJECT: Lorson Boulevard, Area I, El Paso County, Colorado
 SAMPLE DESCRIPTION: CLAYSTONE, SANDY
 NOTE: SAMPLE WAS INUNDATED WITH WATER AT 1,000 PSF

SAMPLE LOCATION: 65 @ 9 FT
 NATURAL DRY UNIT WEIGHT: 92.7 PCF
 NATURAL MOISTURE CONTENT: 9.6%
 PERCENT SWELL/COMPRESSION: - 0.4

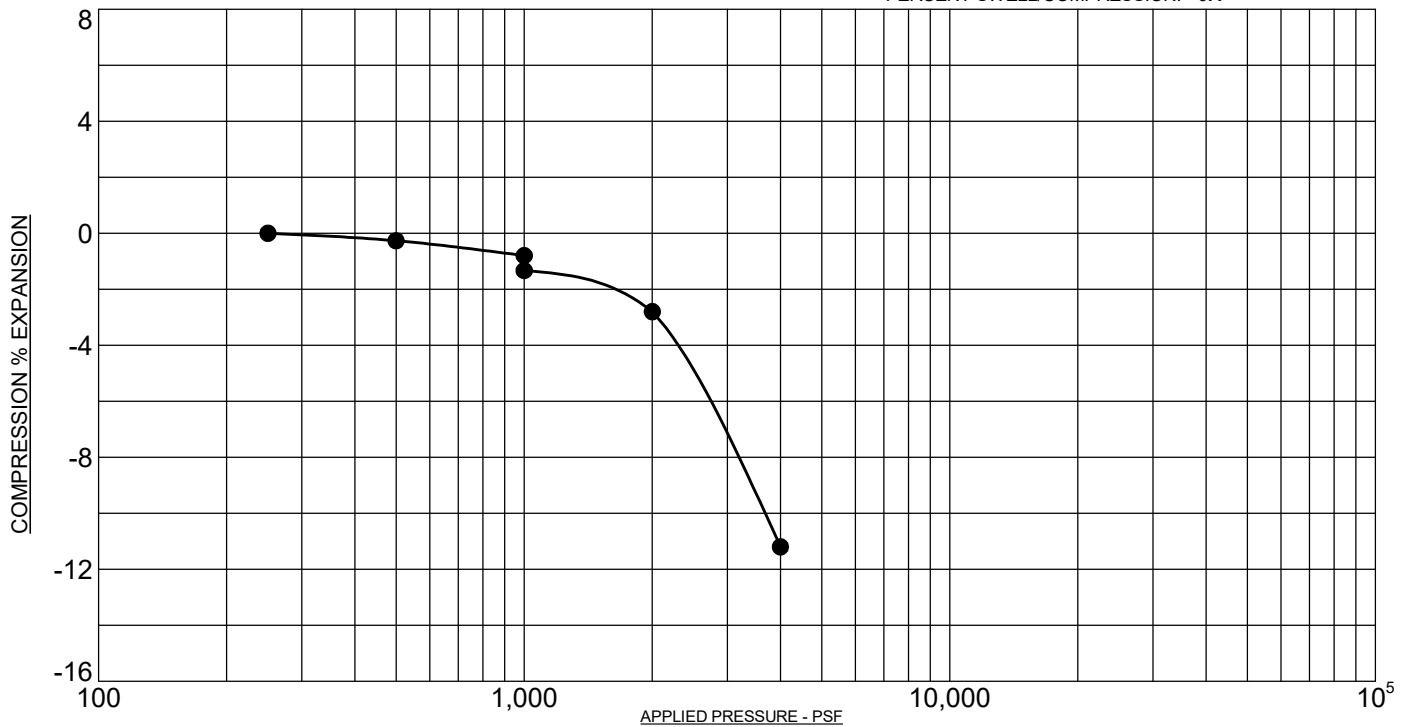
PROJECT: Lorson Boulevard, Area I, El Paso County, Colorado
 SAMPLE DESCRIPTION: CLAY, SANDY
 NOTE: SAMPLE WAS INUNDATED WITH WATER AT 1,000 PSF

SAMPLE LOCATION: 66 @ 4 FT
 NATURAL DRY UNIT WEIGHT: 98.1 PCF
 NATURAL MOISTURE CONTENT: 7.7%
 PERCENT SWELL/COMPRESSION: - 0.5

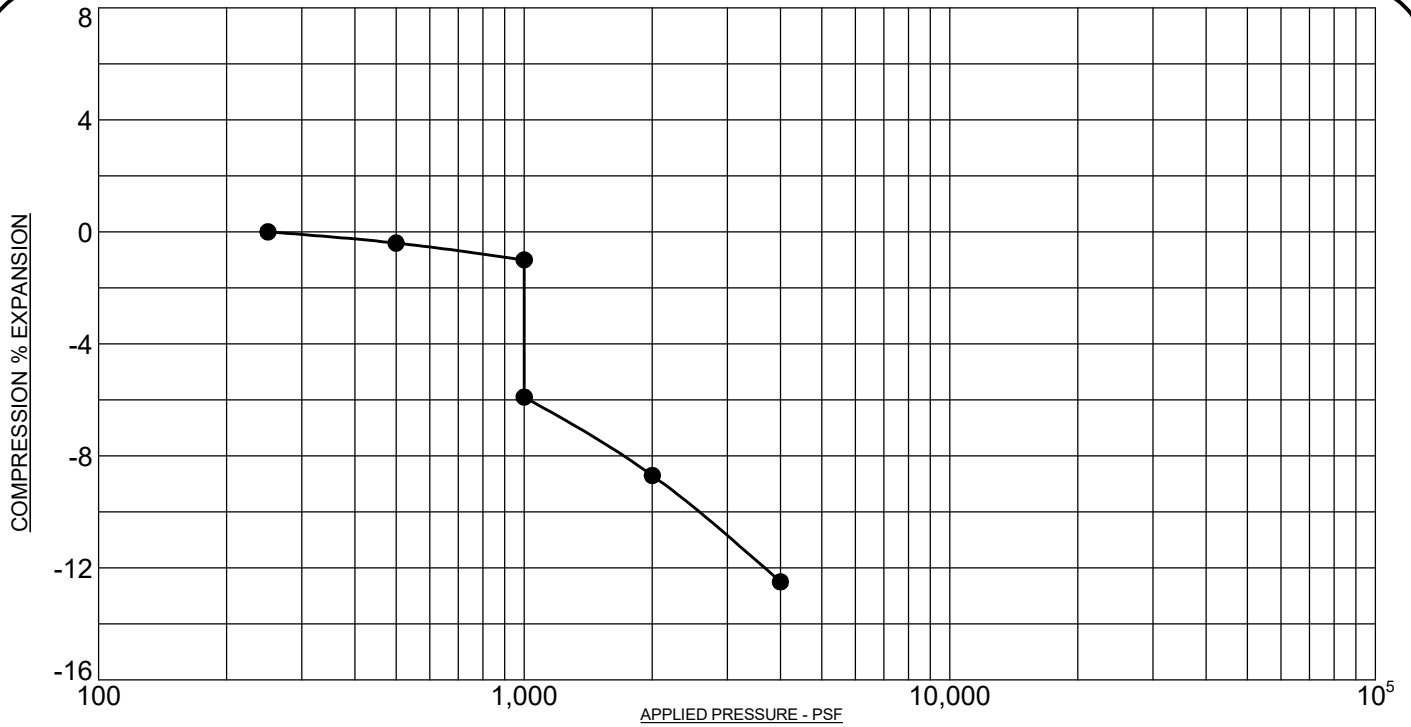
FIGURE No. 78

PROJECT: Lorson Boulevard, Area I, El Paso County, Colorado
 SAMPLE DESCRIPTION: CLAY, SANDY
 NOTE: SAMPLE WAS INUNDATED WITH WATER AT 1,000 PSF

SAMPLE LOCATION: 67 @ 9 FT
 NATURAL DRY UNIT WEIGHT: 88.1 PCF
 NATURAL MOISTURE CONTENT: 7.1%
 PERCENT SWELL/COMPRESSION: - 4.9

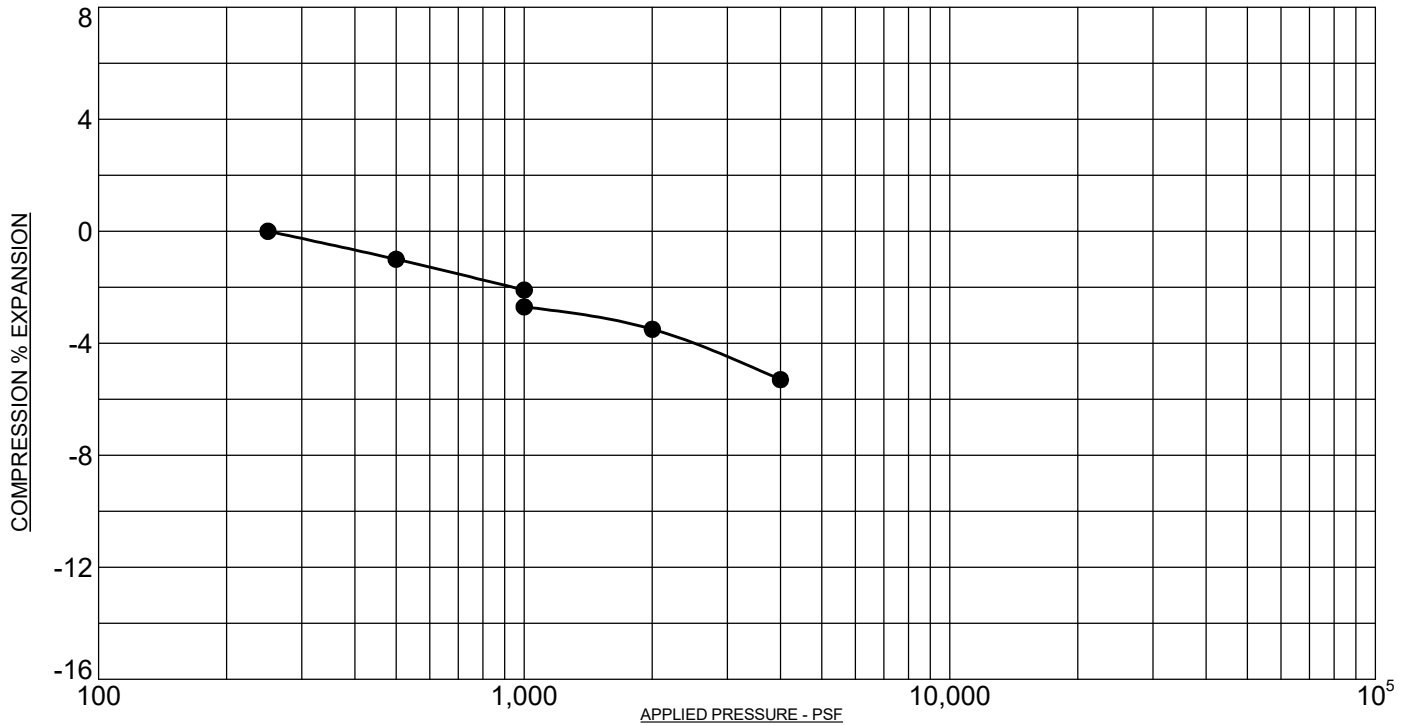
PROJECT: Lorson Boulevard, Area I, El Paso County, Colorado
 SAMPLE DESCRIPTION: CLAYSTONE, SANDY
 NOTE: SAMPLE WAS INUNDATED WITH WATER AT 1,000 PSF

SAMPLE LOCATION: 69 @ 14 FT
 NATURAL DRY UNIT WEIGHT: 107.0 PCF
 NATURAL MOISTURE CONTENT: 11.6%
 PERCENT SWELL/COMPRESSION: - 0.6

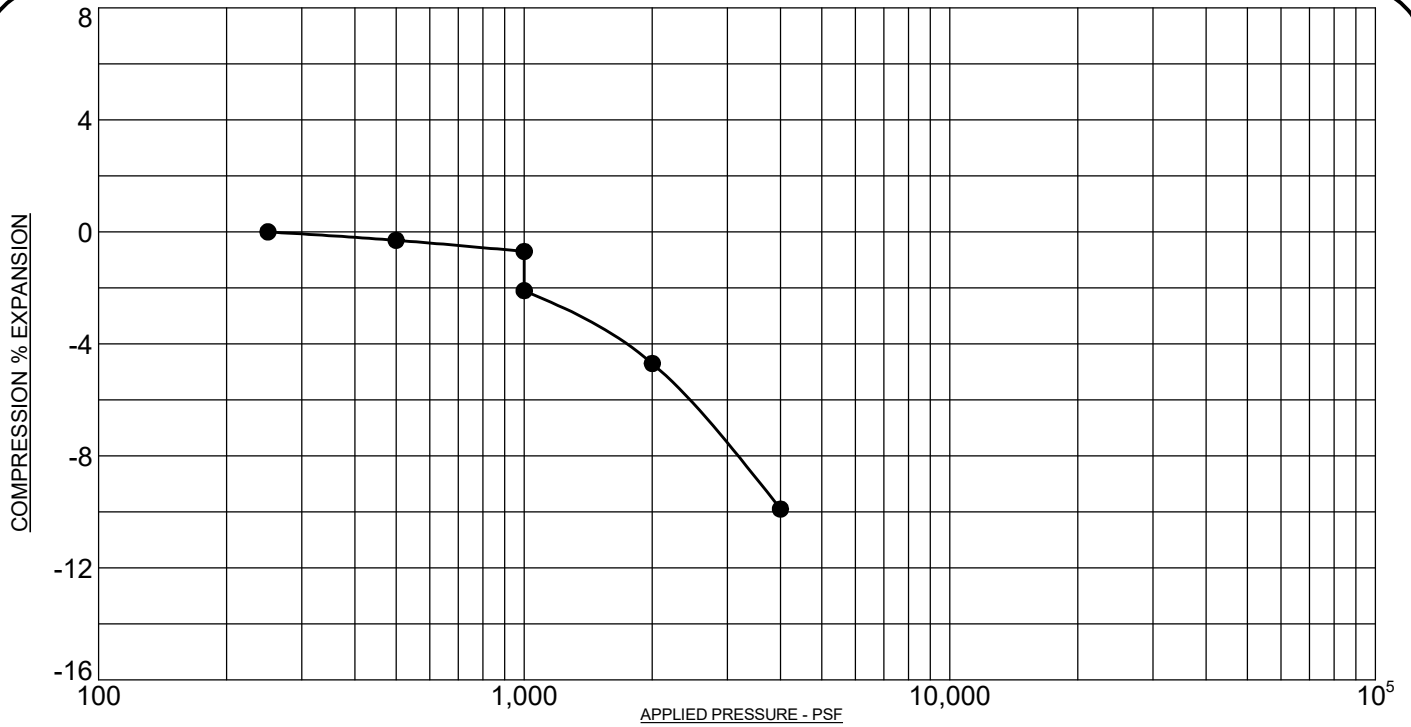
FIGURE No. 79

PROJECT: Lorson Boulevard, Area I, El Paso County, Colorado
 SAMPLE DESCRIPTION: CLAY, SANDY
 NOTE: SAMPLE WAS INUNDATED WITH WATER AT 1,000 PSF

SAMPLE LOCATION: 70 @ 4 FT
 NATURAL DRY UNIT WEIGHT: 91.8 PCF
 NATURAL MOISTURE CONTENT: 8.2%
 PERCENT SWELL/COMPRESSION: - 1.4

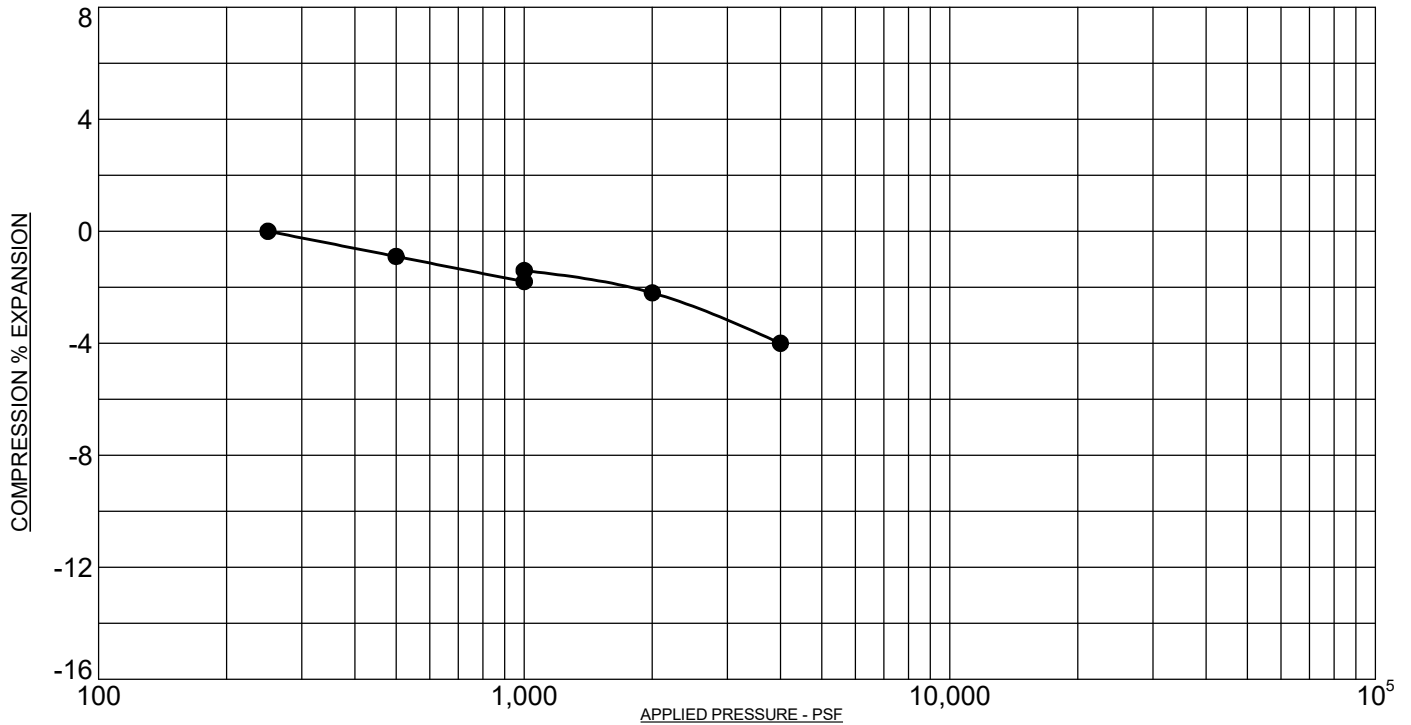
PROJECT: Lorson Boulevard, Area I, El Paso County, Colorado
 SAMPLE DESCRIPTION: CLAYSTONE, SANDY
 NOTE: SAMPLE WAS INUNDATED WITH WATER AT 1,000 PSF

SAMPLE LOCATION: 71 @ 14 FT
 NATURAL DRY UNIT WEIGHT: 112.1 PCF
 NATURAL MOISTURE CONTENT: 11.4%
 PERCENT SWELL/COMPRESSION: 0.4

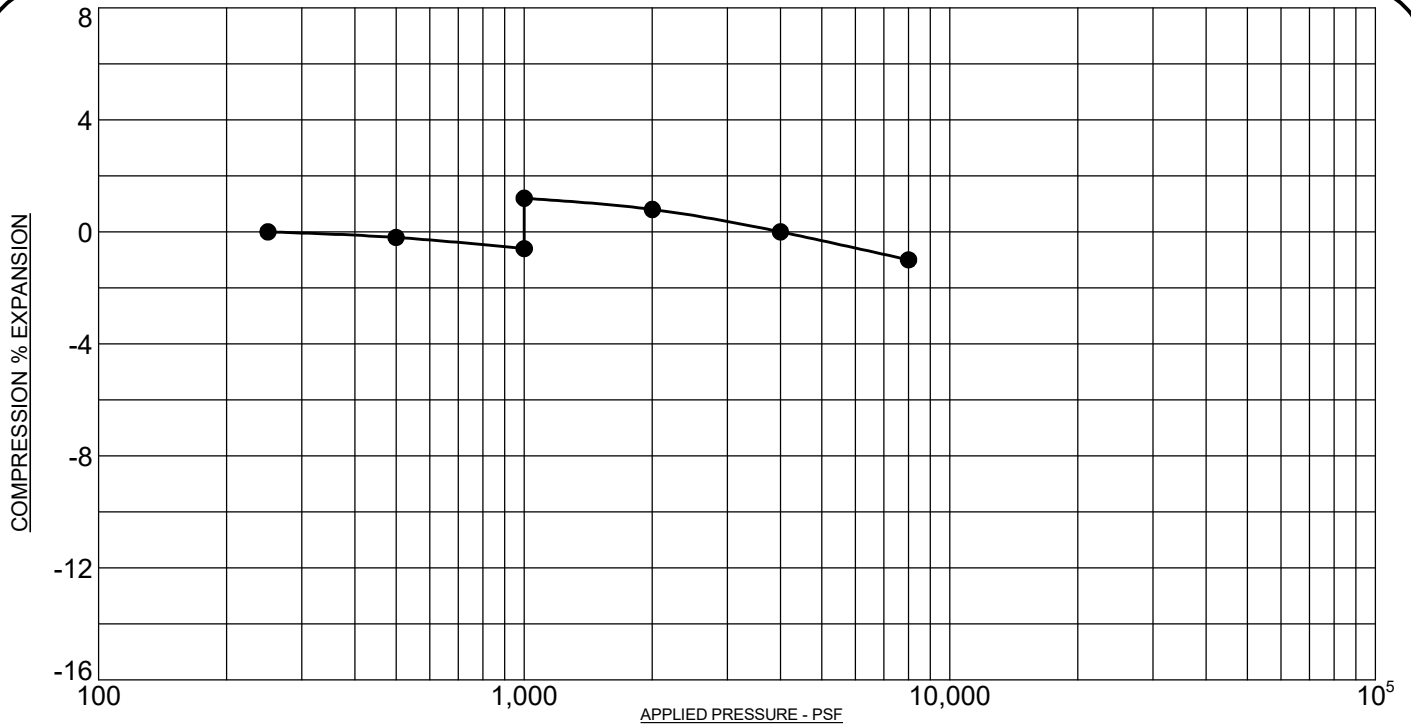
FIGURE No. 80

PROJECT: Lorson Boulevard, Area I, El Paso County, Colorado
 SAMPLE DESCRIPTION: CLAYSTONE, SANDY
 NOTE: SAMPLE WAS INUNDATED WITH WATER AT 1,000 PSF

SAMPLE LOCATION: 72 @ 9 FT
 NATURAL DRY UNIT WEIGHT: 118.7 PCF
 NATURAL MOISTURE CONTENT: 11.7%
 PERCENT SWELL/COMPRESSION: 1.8

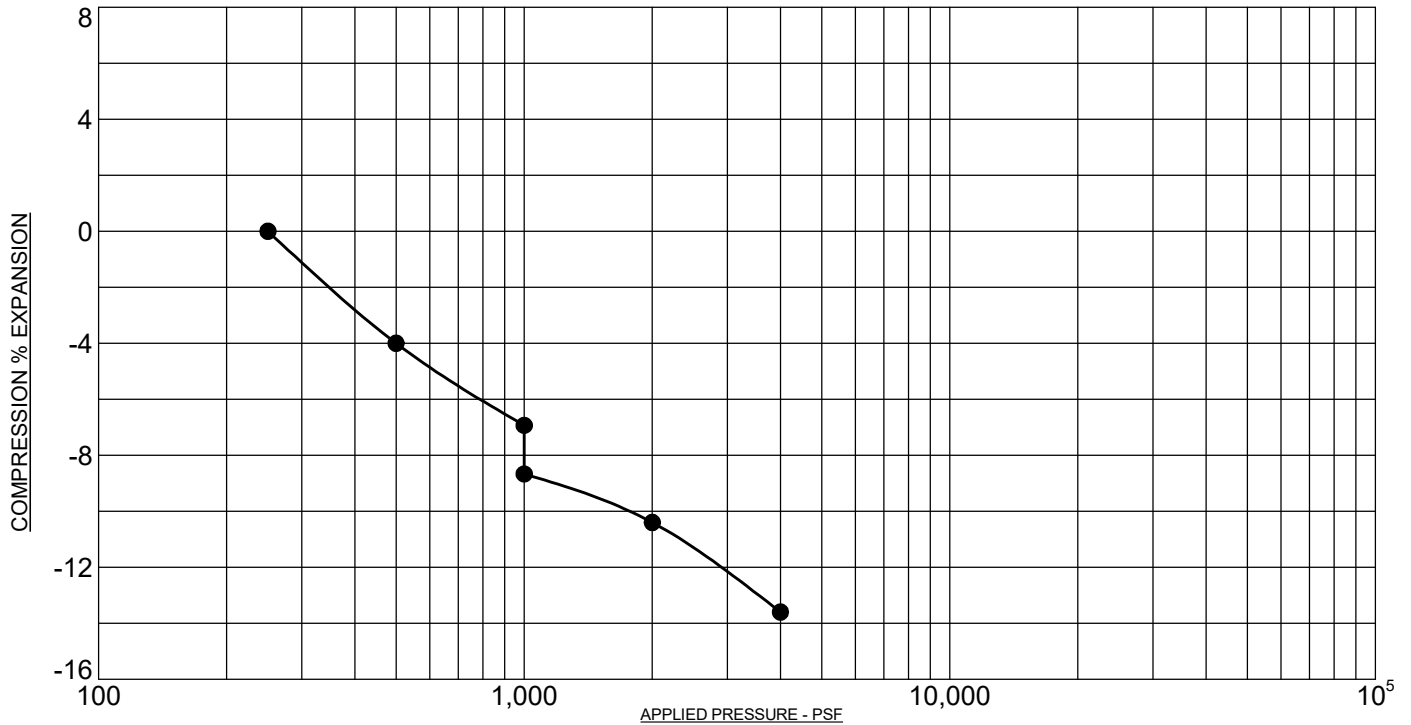
PROJECT: Lorson Boulevard, Area I, El Paso County, Colorado
 SAMPLE DESCRIPTION: CLAY, SANDY
 NOTE: SAMPLE WAS INUNDATED WITH WATER AT 1,000 PSF

SAMPLE LOCATION: 73 @ 9 FT
 NATURAL DRY UNIT WEIGHT: 114.0 PCF
 NATURAL MOISTURE CONTENT: 11.6%
 PERCENT SWELL/COMPRESSION: -1.7

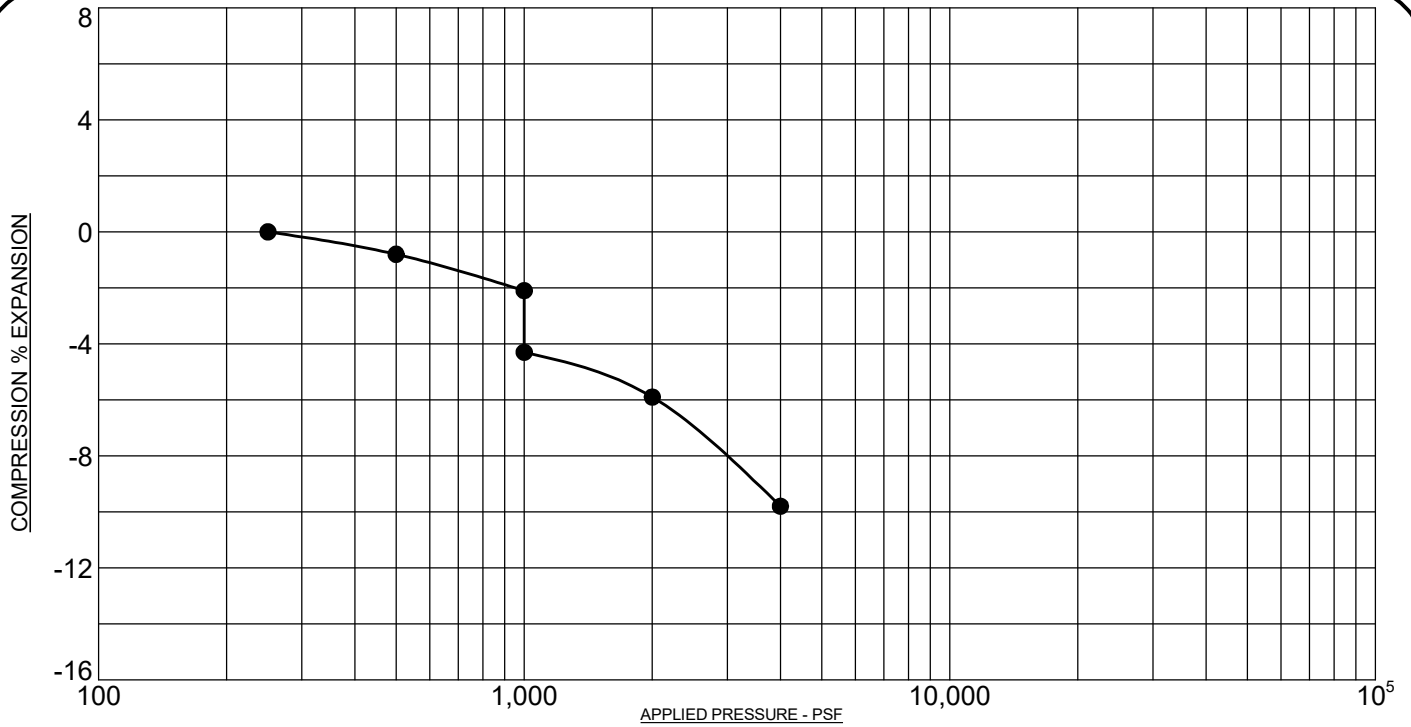
FIGURE No. 81

PROJECT: Lorson Boulevard, Area I, El Paso County, Colorado
 SAMPLE DESCRIPTION: CLAYSTONE, SANDY
 NOTE: SAMPLE WAS INUNDATED WITH WATER AT 1,000 PSF

SAMPLE LOCATION: 75 @ 9 FT
 NATURAL DRY UNIT WEIGHT: 103.5 PCF
 NATURAL MOISTURE CONTENT: 7.3%
 PERCENT SWELL/COMPRESSION: - 2.2

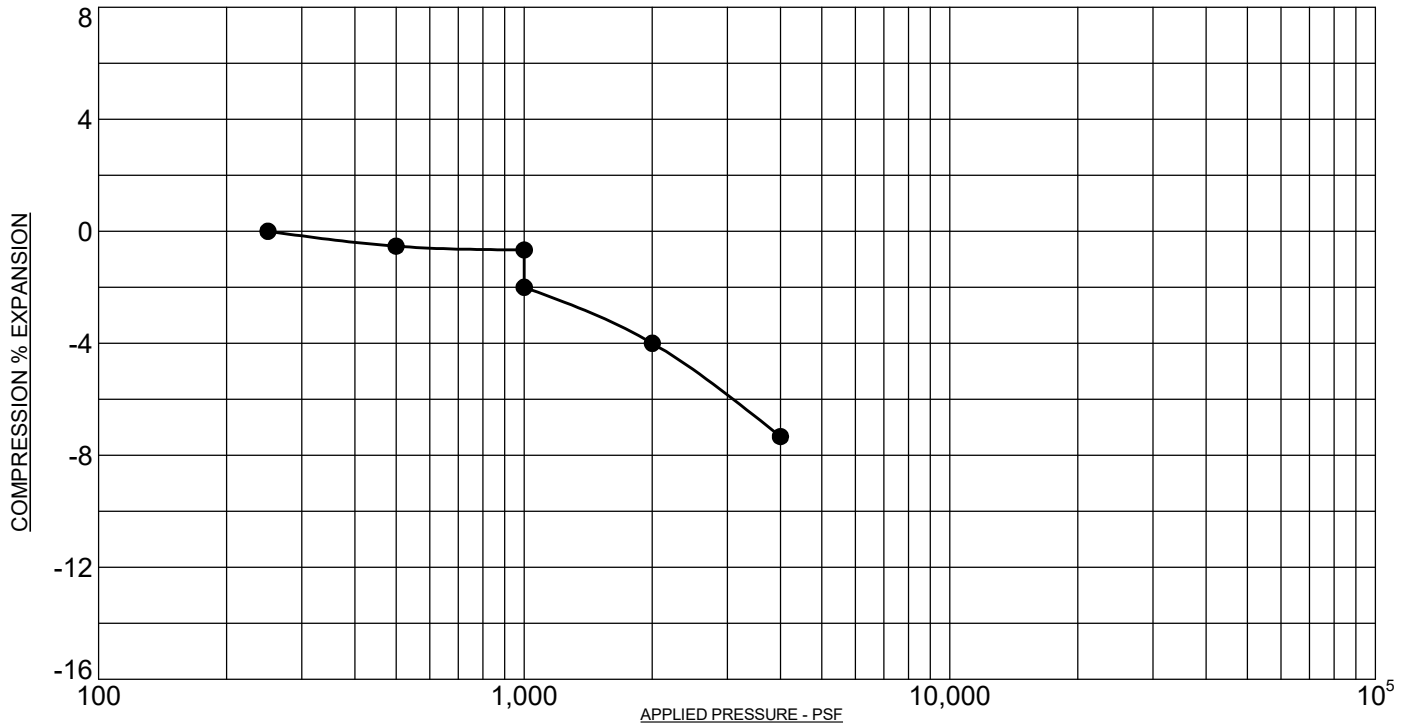
PROJECT: Lorson Boulevard, Area I, El Paso County, Colorado
 SAMPLE DESCRIPTION: CLAYSTONE, SANDY
 NOTE: SAMPLE WAS INUNDATED WITH WATER AT 1,000 PSF

SAMPLE LOCATION: 76 @ 4 FT
 NATURAL DRY UNIT WEIGHT: 100.5 PCF
 NATURAL MOISTURE CONTENT: 11.6%
 PERCENT SWELL/COMPRESSION: - 1.3

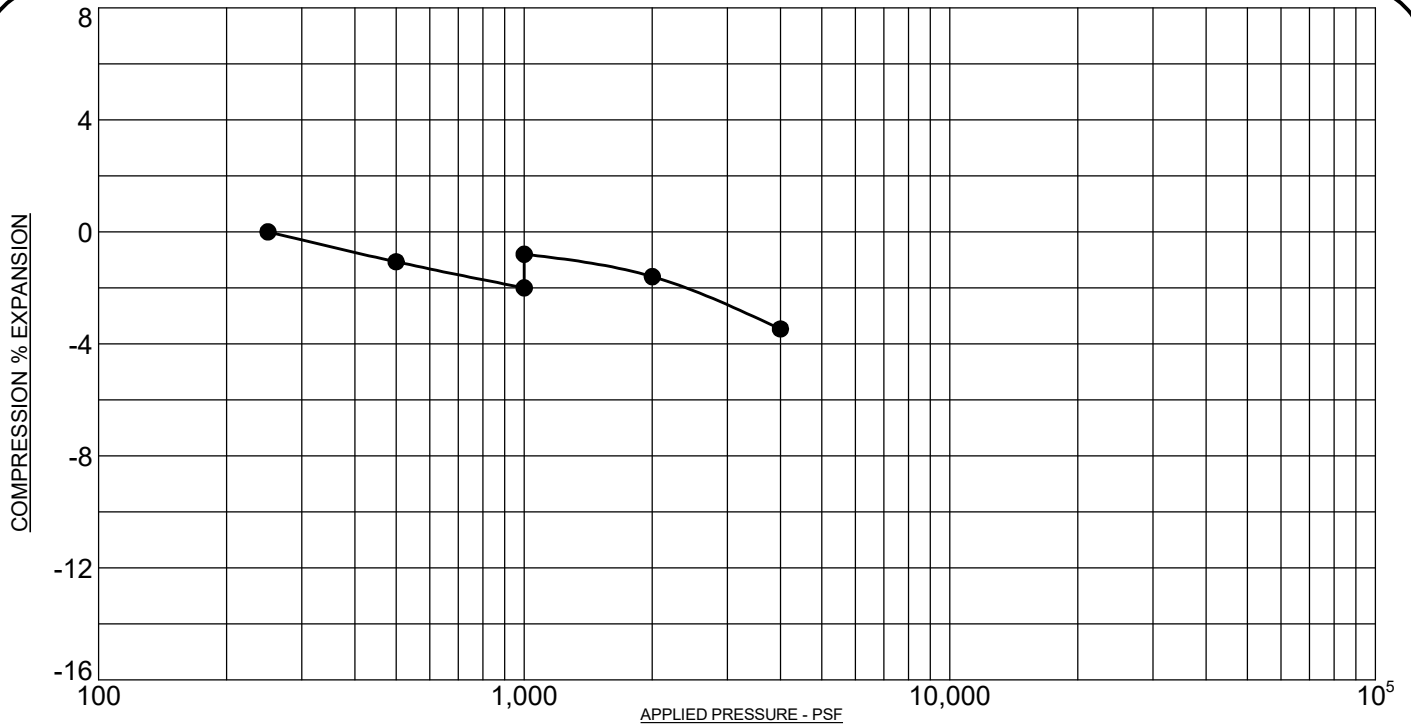
FIGURE No. 82

PROJECT: Lorson Boulevard, Area I, El Paso County, Colorado
 SAMPLE DESCRIPTION: CLAYSTONE, SANDY
 NOTE: SAMPLE WAS INUNDATED WITH WATER AT 1,000 PSF

SAMPLE LOCATION: 77 @ 14 FT
 NATURAL DRY UNIT WEIGHT: 119.4 PCF
 NATURAL MOISTURE CONTENT: 10.0%
 PERCENT SWELL/COMPRESSION: 1.2

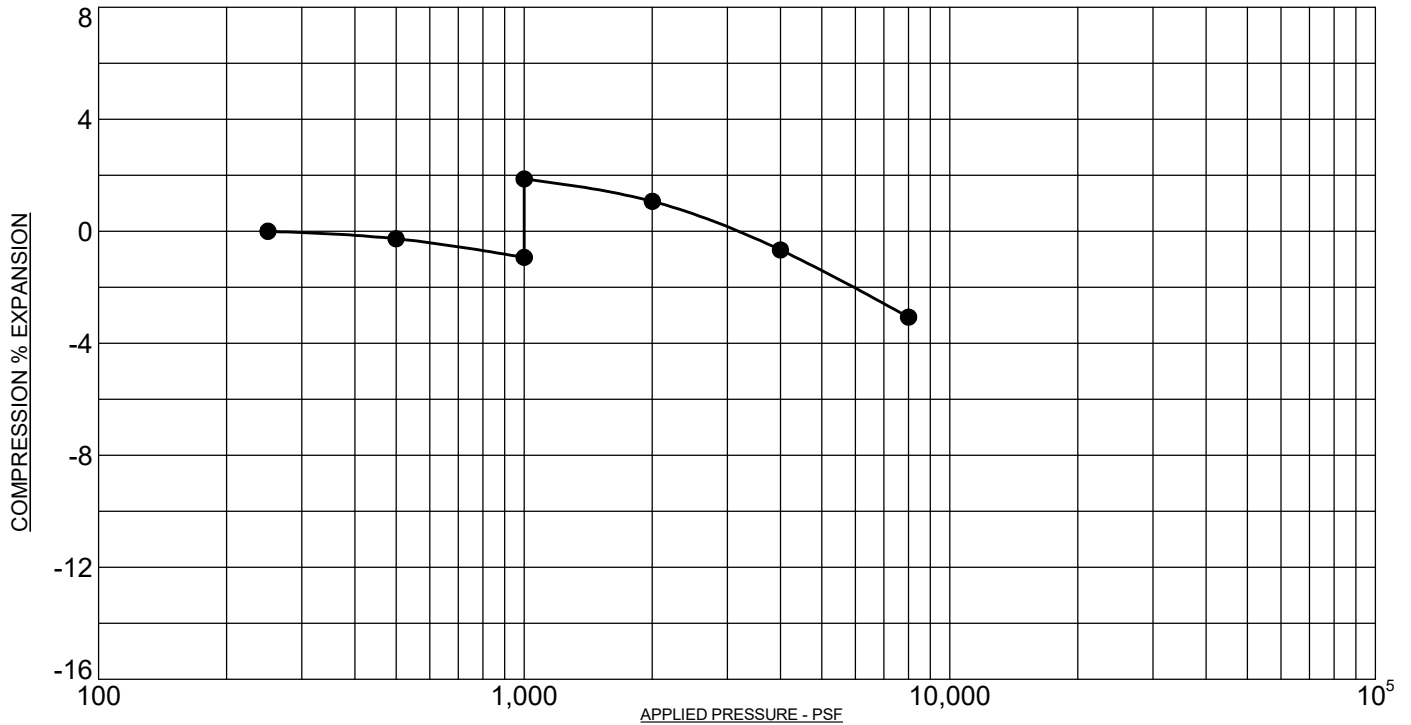
PROJECT: Lorson Boulevard, Area I, El Paso County, Colorado
 SAMPLE DESCRIPTION: CLAYSTONE, SANDY
 NOTE: SAMPLE WAS INUNDATED WITH WATER AT 1,000 PSF

SAMPLE LOCATION: 78 @ 9 FT
 NATURAL DRY UNIT WEIGHT: 114.0 PCF
 NATURAL MOISTURE CONTENT: 11.8%
 PERCENT SWELL/COMPRESSION: 2.8

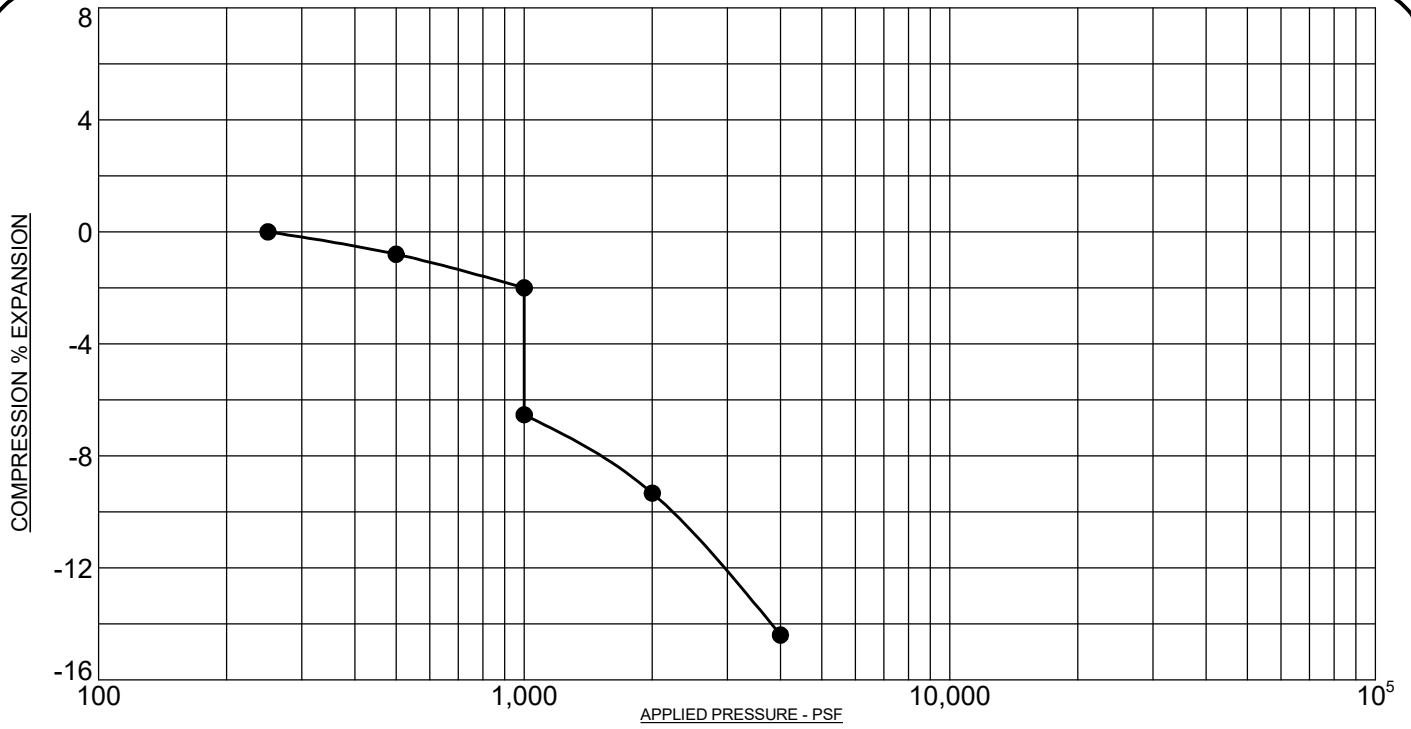
FIGURE No. 83

PROJECT: Lorson Boulevard, Area I, El Paso County, Colorado
 SAMPLE DESCRIPTION: CLAY, SANDY
 NOTE: SAMPLE WAS INUNDATED WITH WATER AT 1,000 PSF

SAMPLE LOCATION: 79 @ 4 FT
 NATURAL DRY UNIT WEIGHT: 101.1 PCF
 NATURAL MOISTURE CONTENT: 6.4%
 PERCENT SWELL/COMPRESSION: - 4.5

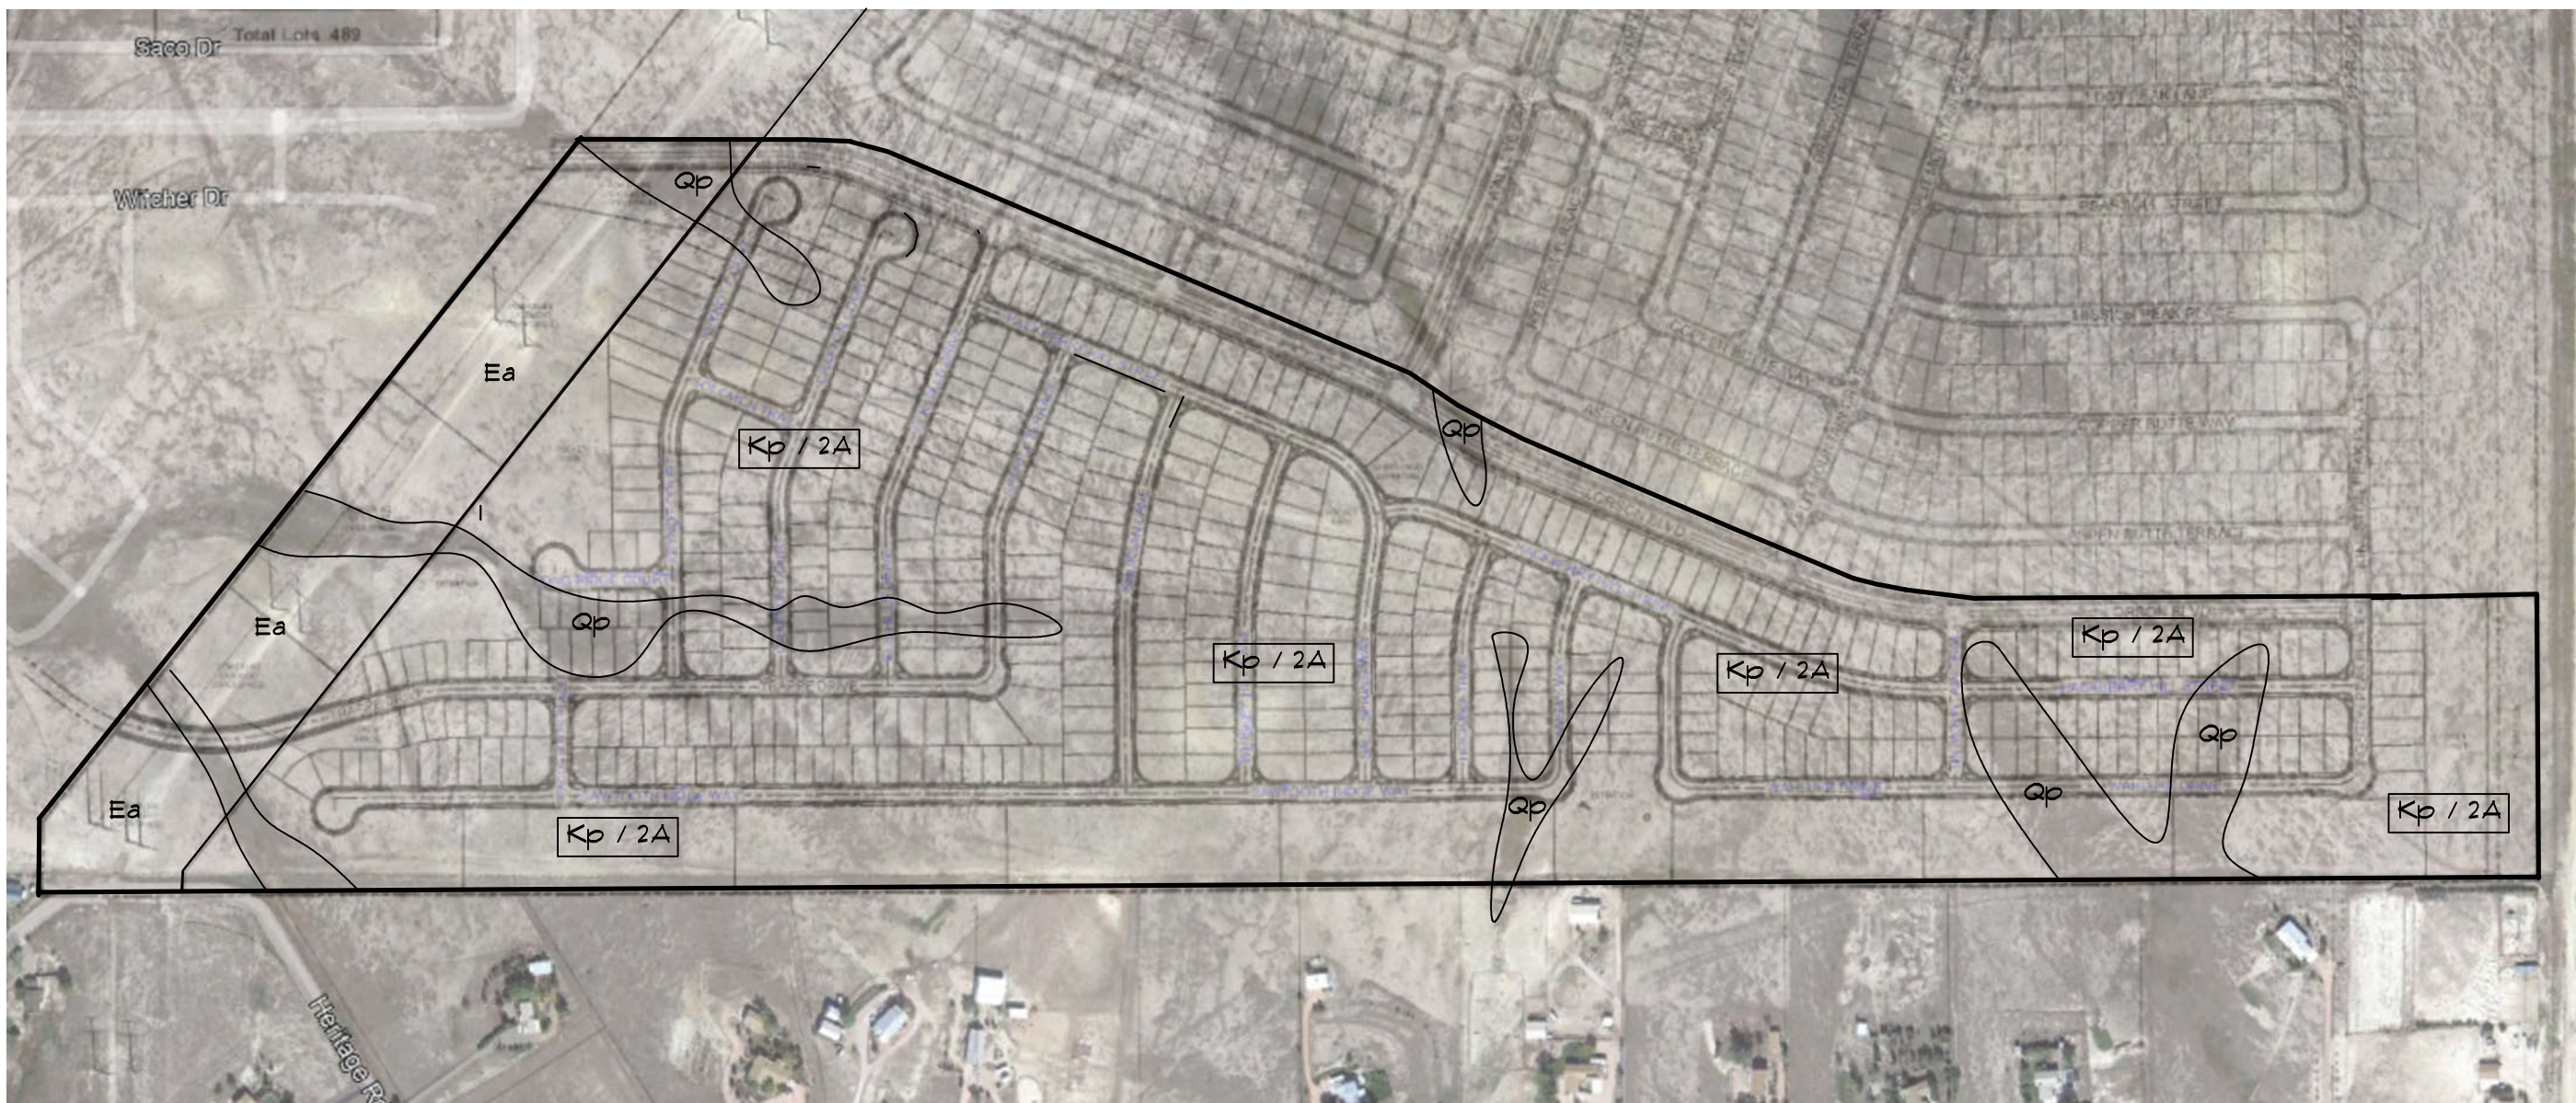
FIG-85

GEOLOGIC UNITS

- *Qp - Piney Creek Alluvium* - silty to gravelly humus-rich alluvium along/within all valleys. The alluvium was encountered in the borings across the site at various depths and is anticipated in the low-lying areas.
- *Kp - Pierre Shale, cone-in-cone zone of Lavington (1933)* dark-gray to tan-gray to olive-gray, subblocky to finely fissile non-calcareous shale, silty shale with thin bentonite beds and very fine grained-grained sandstone. Thickness of this zone is approximately 2,290 (Scott and Cobban, 1986). Residual clay and claystone were encountered in all the borings across the site up to depths of 20 feet.

Based on our field observations, the USDA map, and the Geologic Map of the Fountain Quadrangle, an interpreted geologic map of significant surficial deposits and features was mapped for the site. The identified geologic conditions affecting the development are presented in the Engineering and Geology Map, Figure 85.

The engineering geology is presented in the Engineering and Geology Map, Figure 85.

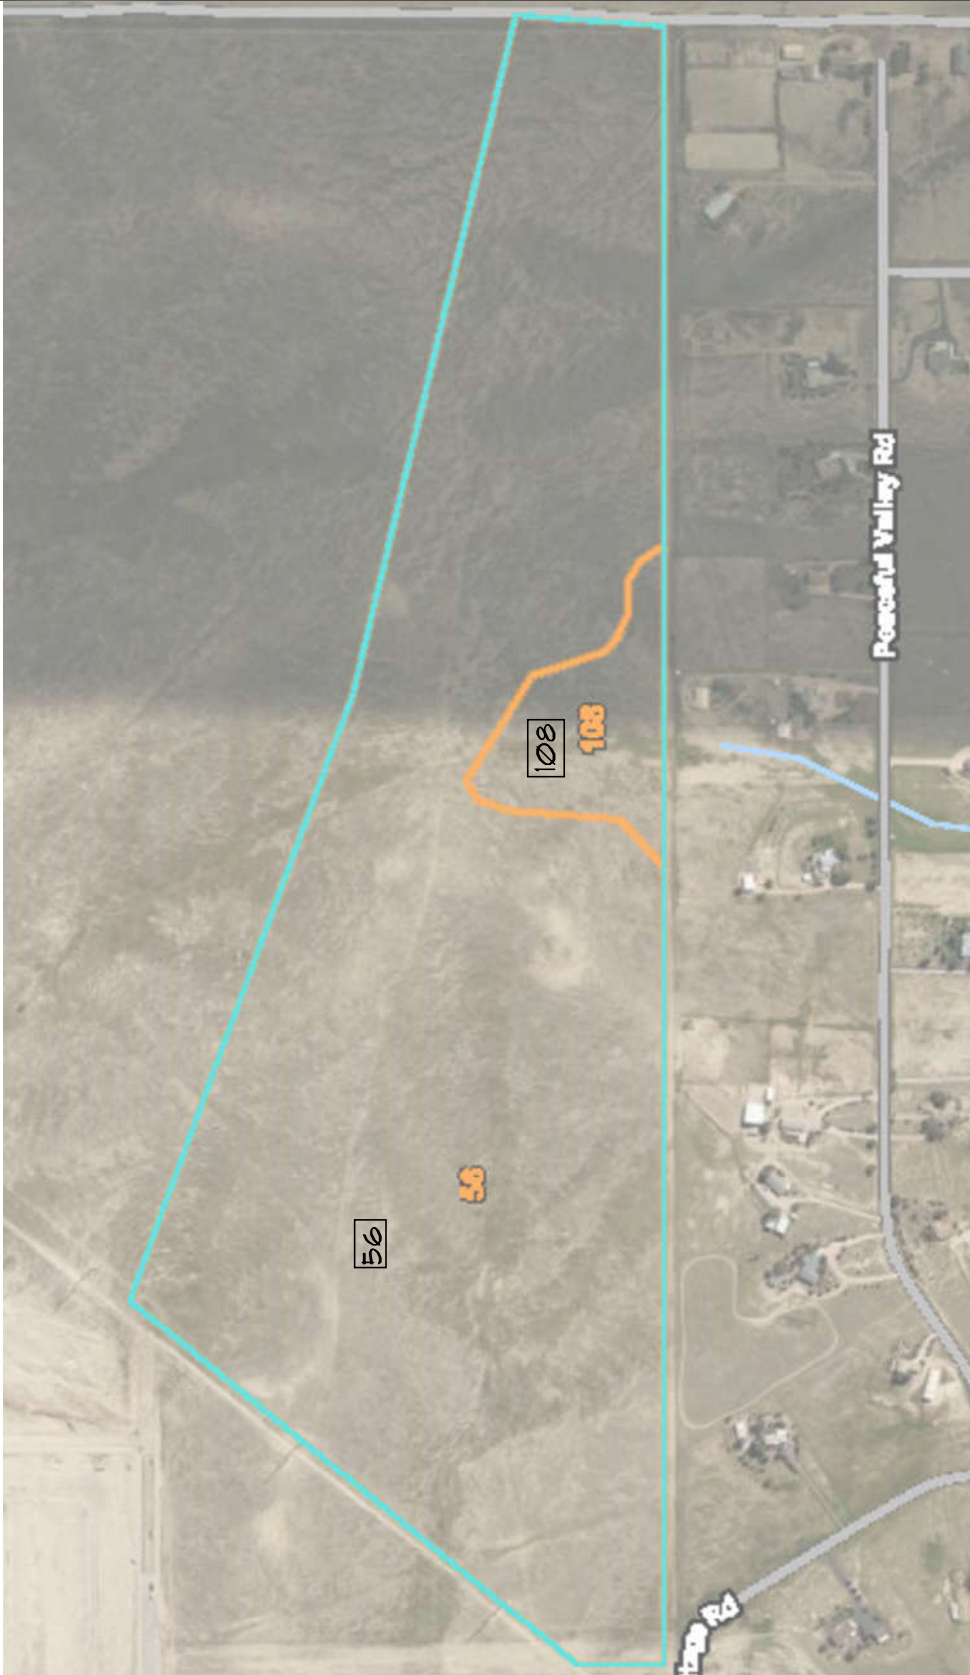
FIG No. 86

- 56 - Nelson-Tassel, fine sandy loam, 3 to 18 percent slopes
- 108 - Wiley silty loam, 3 to 9 percent slopes

The USDA Soil Survey Map is presented in Figure 86 and the FEMA Map is presented in Figure 87.
