SOILS AND GEOLOGY STUDY

**Hillside at Lorson Ranch – “Area I”
El Paso County, Colorado**

JOB NO. 181988

January 3, 2022

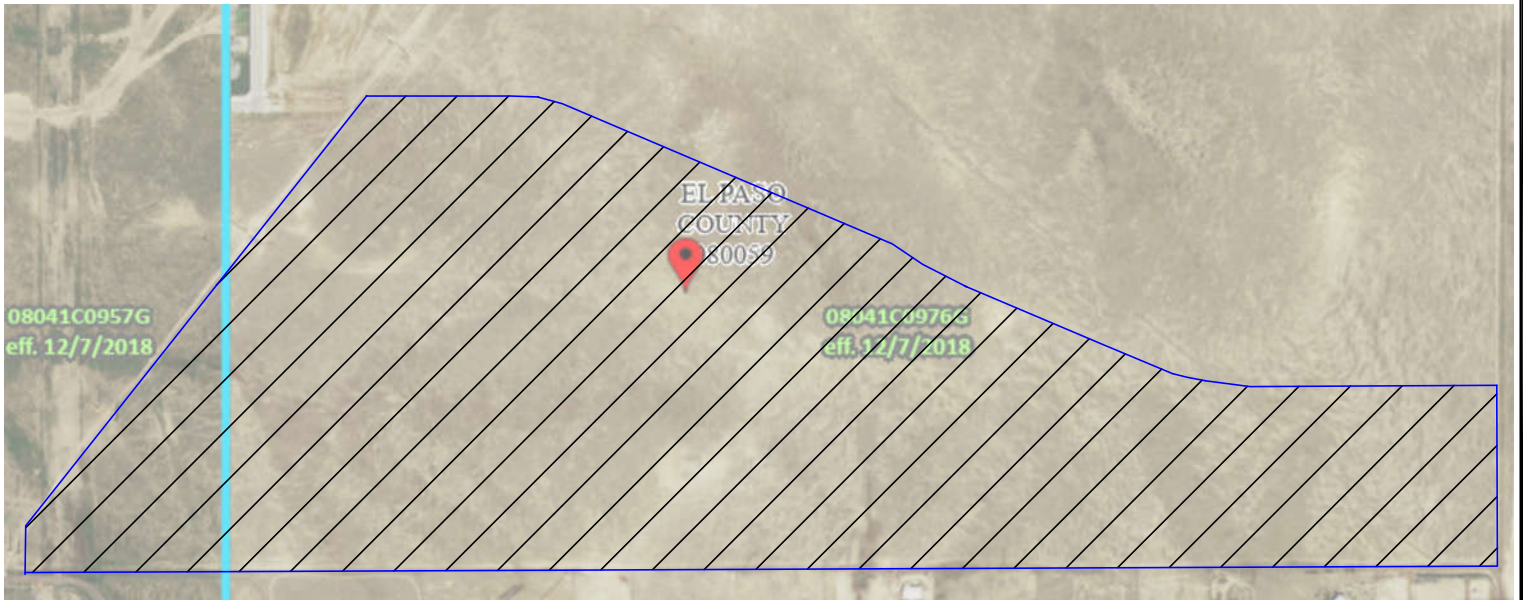
ENTIRE SITE IS ZONE X

The USDA Soil Survey Map is presented in Figure 86 and the FEMA Map is presented in Figure 87.

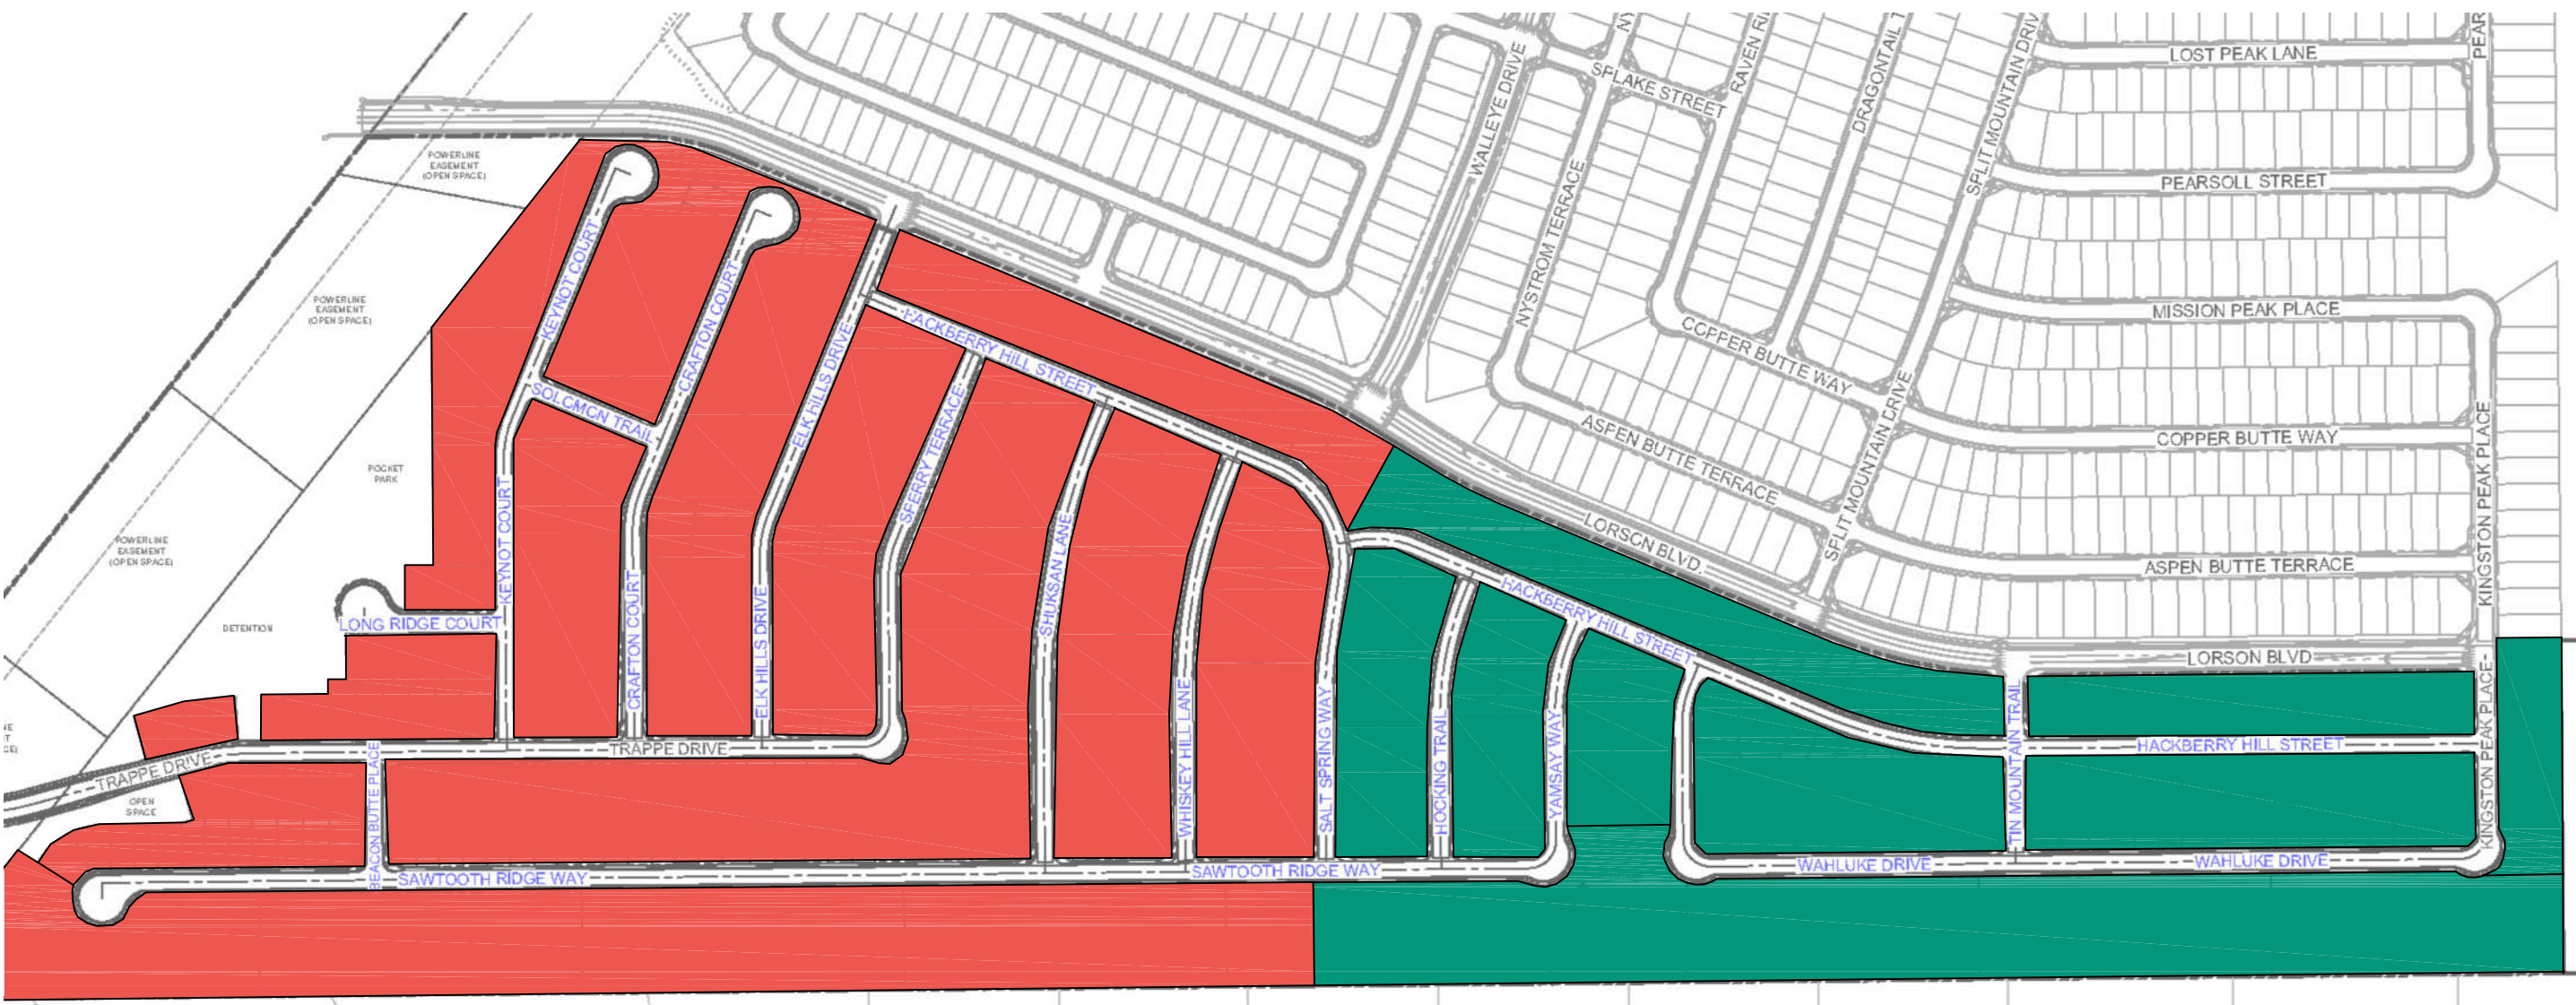
SUBEXCAVATION
 RECOMMENDATIONS

SUBEXCAVATION TO:
8 FEET BELOW AND **8 FEET**
 (LATERALLY) BEYOND **SPREAD**
FOOTING FOUNDATION COMPONENTS

SUBEXCAVATION TO:
10 FEET BELOW AND **10 FEET**
 (LATERALLY) BEYOND **SPREAD**
FOOTING FOUNDATION COMPONENTS
