Re: Preliminary Soil, Geology, Geologic Hazard, and Wastewater Study
Parcel No. 51000-00-493
Winsome Subdivision
17480 Meridian Road North
El Paso County, Colorado

**PRELIMINARY SOIL, GEOLOGY, GEOLOGIC HAZARD,
AND WASTEWATER STUDY,
WINSOME SUBDIVISION
PARCEL NO. 51000-00-493
17480 MERIDIAN ROAD NORTH
EL PASO COUNTY, COLORADO**

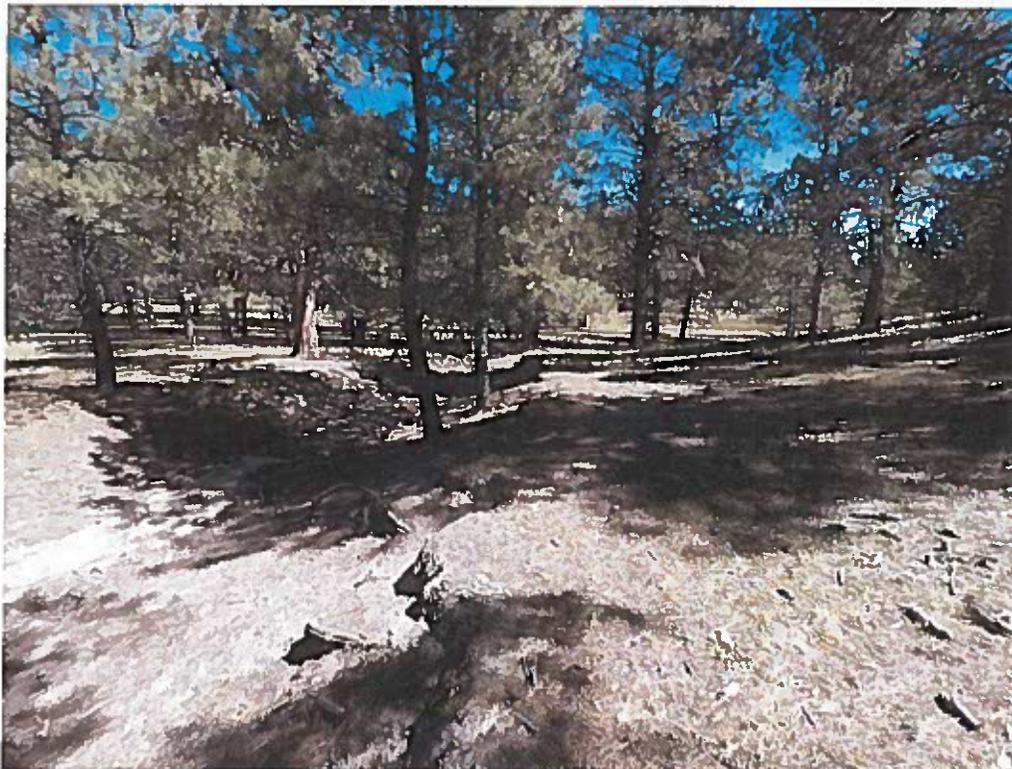
Looking east along drainage in the northern portion of the site.

The topography of the site consists of rolling hills that vary from gradually to moderately sloping generally to the southeast and northwest. West Kiowa Creek bisects the site. Steep slopes are located along some of the drainages on the site. The drainages on site flow in a northeasterly direction through the central portion of the site. Water was observed in West Kiowa Creek at the time of this investigation. The site boundaries are indicated on the USGS Map, Figure 2. Previous land uses have included grazing and pasture land. The site contains primarily field grasses and weeds. Site photographs, taken September 12 and 15, 2018, are included in Appendix A.
