**SOILS AND GEOLOGY STUDY  
HANCOCK SUBDIVISION  
15220 LEATHER CHAPS DRIVE  
EL PASO COUNTY, COLORADO**

March 16, 2026  
Revised July 2, 2026

Entech Job No. 230921  
LLL/JCG

**PCD No. VR254**

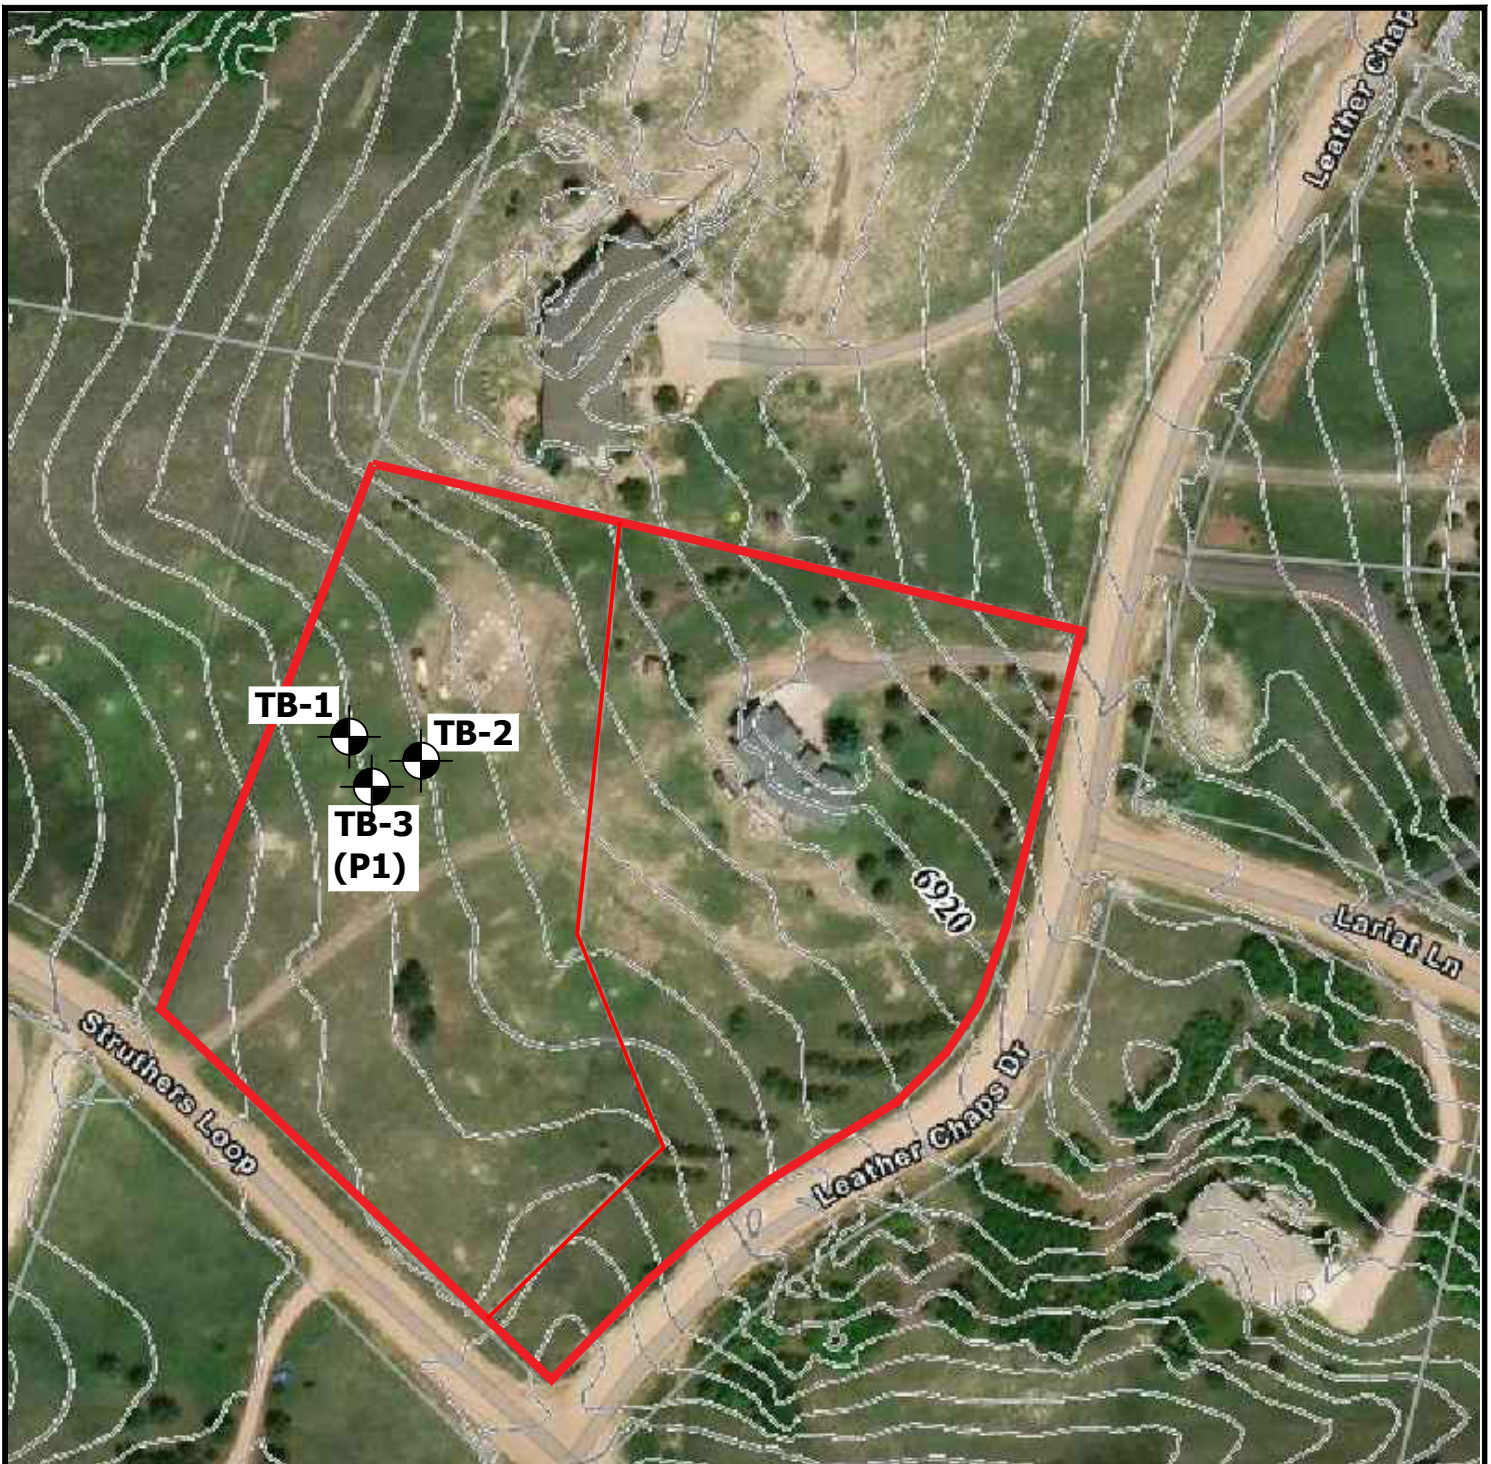
**FIG. 3**

**TB- APPROXIMATE TEST BORING LOCATION AND NUMBER**

The project consists of the subdividing of the 5.05-acre parcel into a 2-lot rural residential subdivision. The lots will be approximately 2.5 acres and will have water service from Donala Water and Sanitation District, and individual on-site wastewater treatment systems (OWTS). The existing metal building and future residence will be located on Lot 1, and the existing residence, and OWTS remain on Lot 2. The existing water well on Lot 2 will be capped. The proposed lot configuration is shown in the Site and Exploration Plan (Figure 3).

The locations of the test borings are indicated on the Site and Exploration Plan (Figure 3). The Test Boring Log, and Laboratory Test Results are included in Appendix B. The results of the testing will be discussed later in this report.

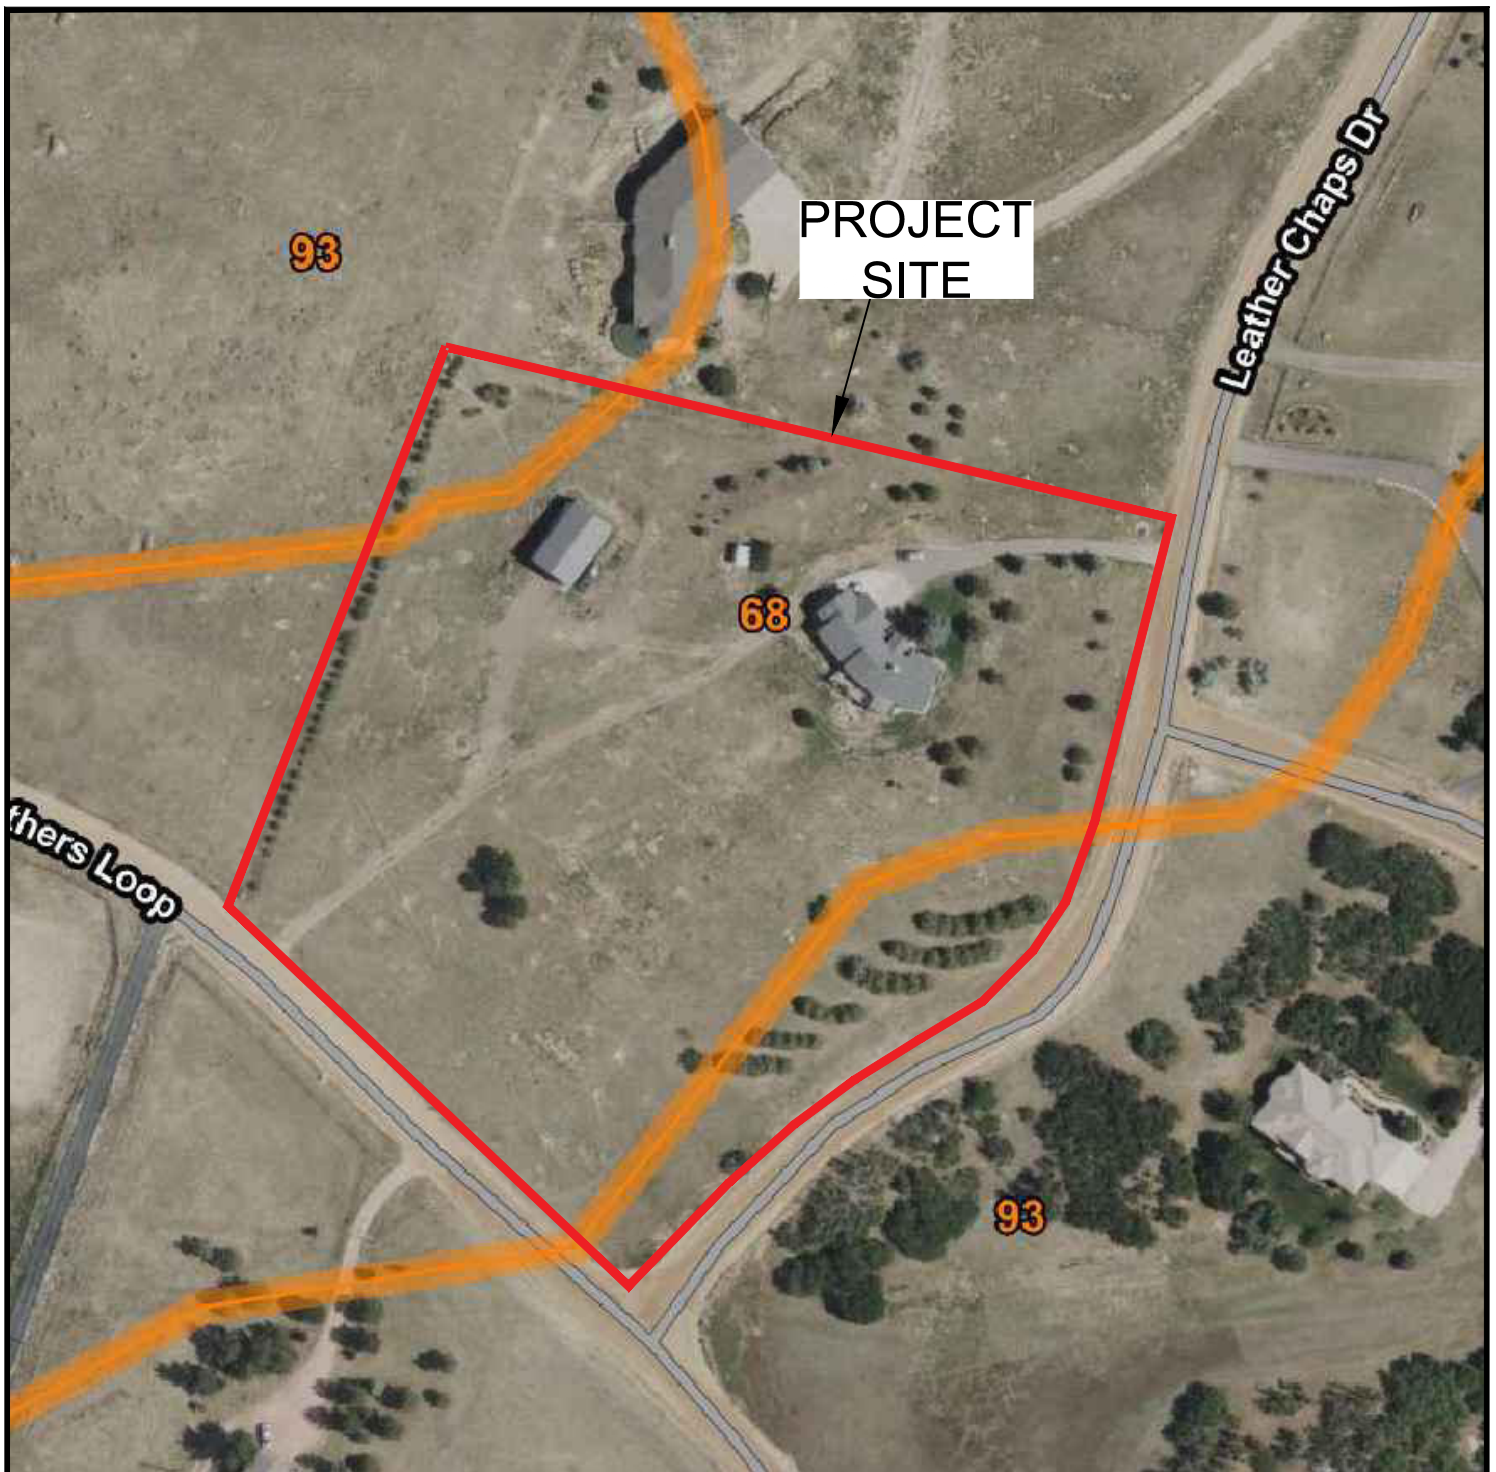
**FIG. 4**

**SOIL SURVEY MAP**  
15220 LEATHER CHAPS DRIVE  
BILL AND VICKIE HANCOCK

The Natural Resource Conservation Service (Reference 2), previously the Soil Conservation Service (Reference 3), has mapped two soil types on the site (Figure 4). In general, they are loamy sands. The soils are described in Exhibit 1 below.

Complete descriptions of each soil type are presented in Appendix D. The soils have generally been described as having moderately high to high permeabilities. Limitations on development include limited ability to support a load, shrink-swell potential, slopes, and frost action potential. Possible hazards with soil erosion are present on the site. The erosion potential can be controlled with vegetation. The soil has been described to have moderate erosion hazards.

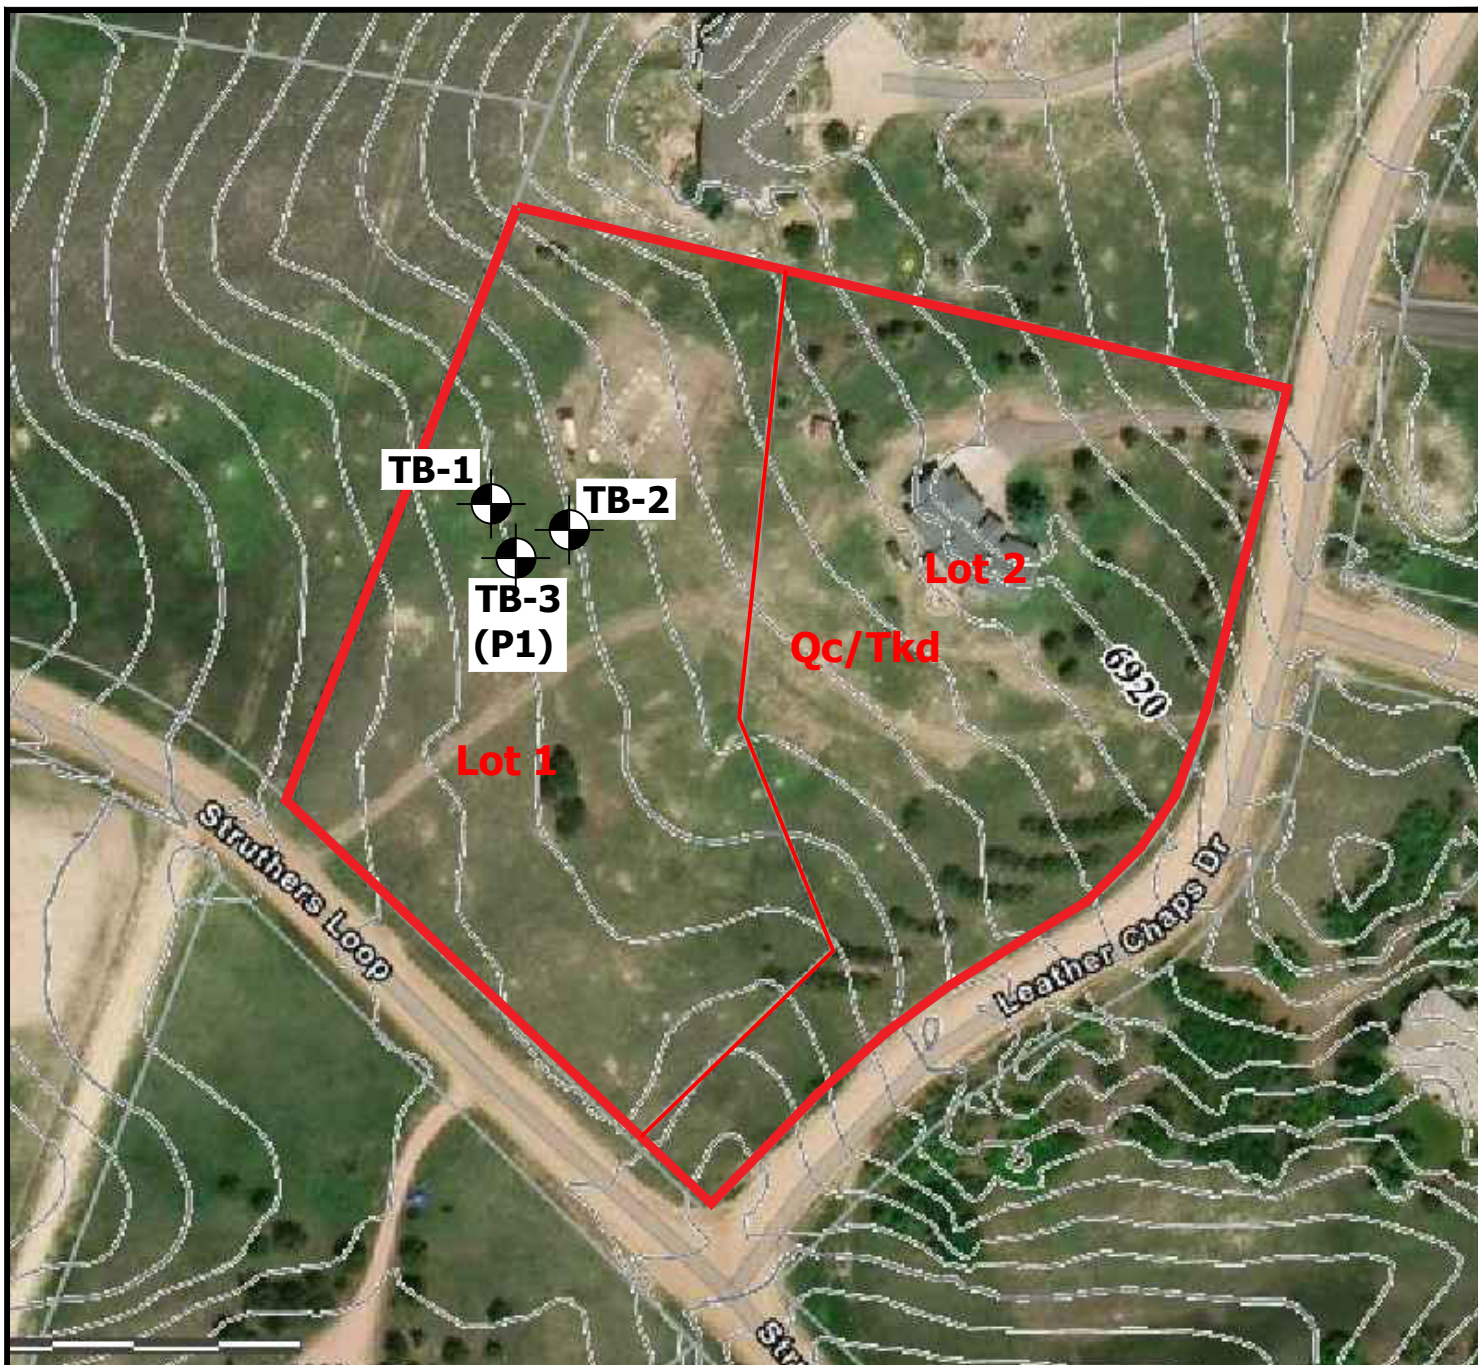
**FIG. 6**

Qc/Tkd- Colluvium of Quaternary Age Overlying the Dawson Formation of Tertiary to Cretaceous Age:  
Sheetwash and residual soil deposits overlying arkosic sandstone with interbedded siltstone and claystone

The Geologic Map of the Monument Quadrangle showing the site is presented in Figure 5 (Reference 7). The Geology/Engineering Geology Map prepared for the site is presented in Figure 6. One mappable unit was identified on this site that is described as follows:

The soils listed above were mapped from site-specific mapping, the *Geologic Map of the Monument Quadrangle* distributed by the Colorado Geological Survey in 2002 (Reference 4), the *Geologic Map of the Pikeview Quadrangle* distributed by the Colorado Geological Survey in 2001 (Reference 5), the *Geologic Map of the Colorado Springs-Castle Rock Area*, distributed by the US Geological Survey in 1979 (Reference 6), and the *Geologic Map of the Denver 1° x 2° Quadrangle*, distributed by the US Geological Survey in 1981 (Reference 7). The Test Borings and Test Pit Logs used in evaluating the site are included in Appendix B. The Geology/Engineering Geology Map prepared for the site is presented in Figure 6.

Detailed mapping has been performed on this site to produce a Geology/Engineering Geology Map (Figure 6). This map shows the location of various geologic conditions the developers should monitor during the planning, design, and construction stages of the project. No significant geologic hazards were identified on the site; however, the following constraints have been identified on the site: potentially expansive soils, loose soils, and the potential for elevated radon levels. These constraints and the recommended mitigation techniques are discussed below.

The site is not mapped within any floodplains according to FEMA Map No. 08041C0287G (Figure 6, Reference 11). No drainages are located on the site. Specific drainage studies and floodplain locations are beyond the scope of this report. Groundwater was not encountered in the borings drilled on the site, and the piezometer has been dry to a depth of 20 feet. However, redoximorphic features were encountered at shallow depths in the test pits evaluated by JDM (Reference 3, Appendix D).

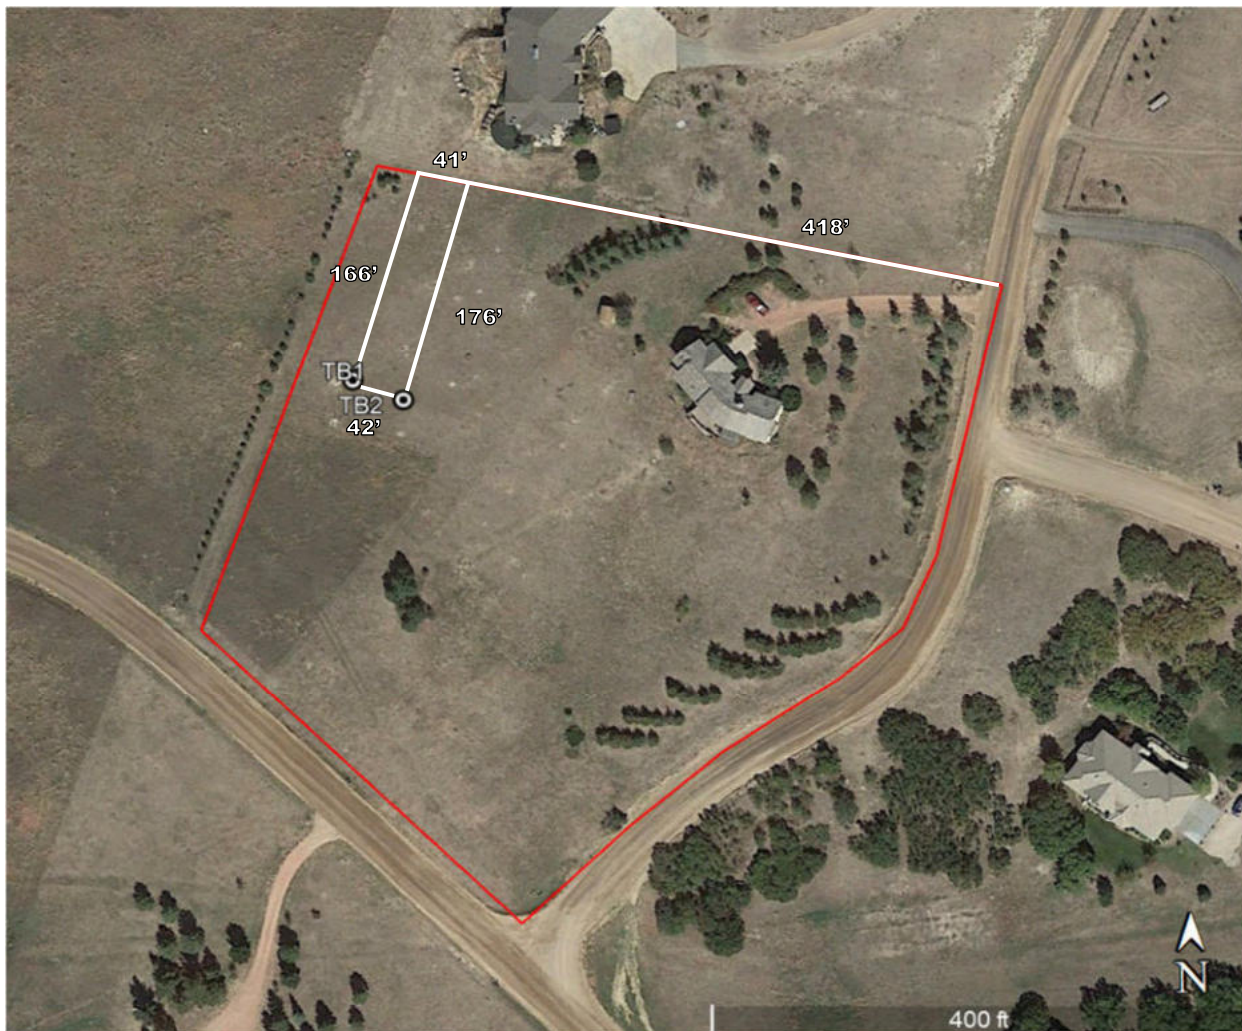
## SITE AND EXPLORATION PLAN

15220 LEATHER CHAPS DRIVE  
BILL AND VICKIE HANCOCK
