ENTECH
ENGINEERING, INC.

**SOILS AND GEOLOGY STUDY
HANCOCK SUBDIVISION
15220 LEATHER CHAPS DRIVE
EL PASO COUNTY, COLORADO**

Entech Job No. 230921
LLL/JCG

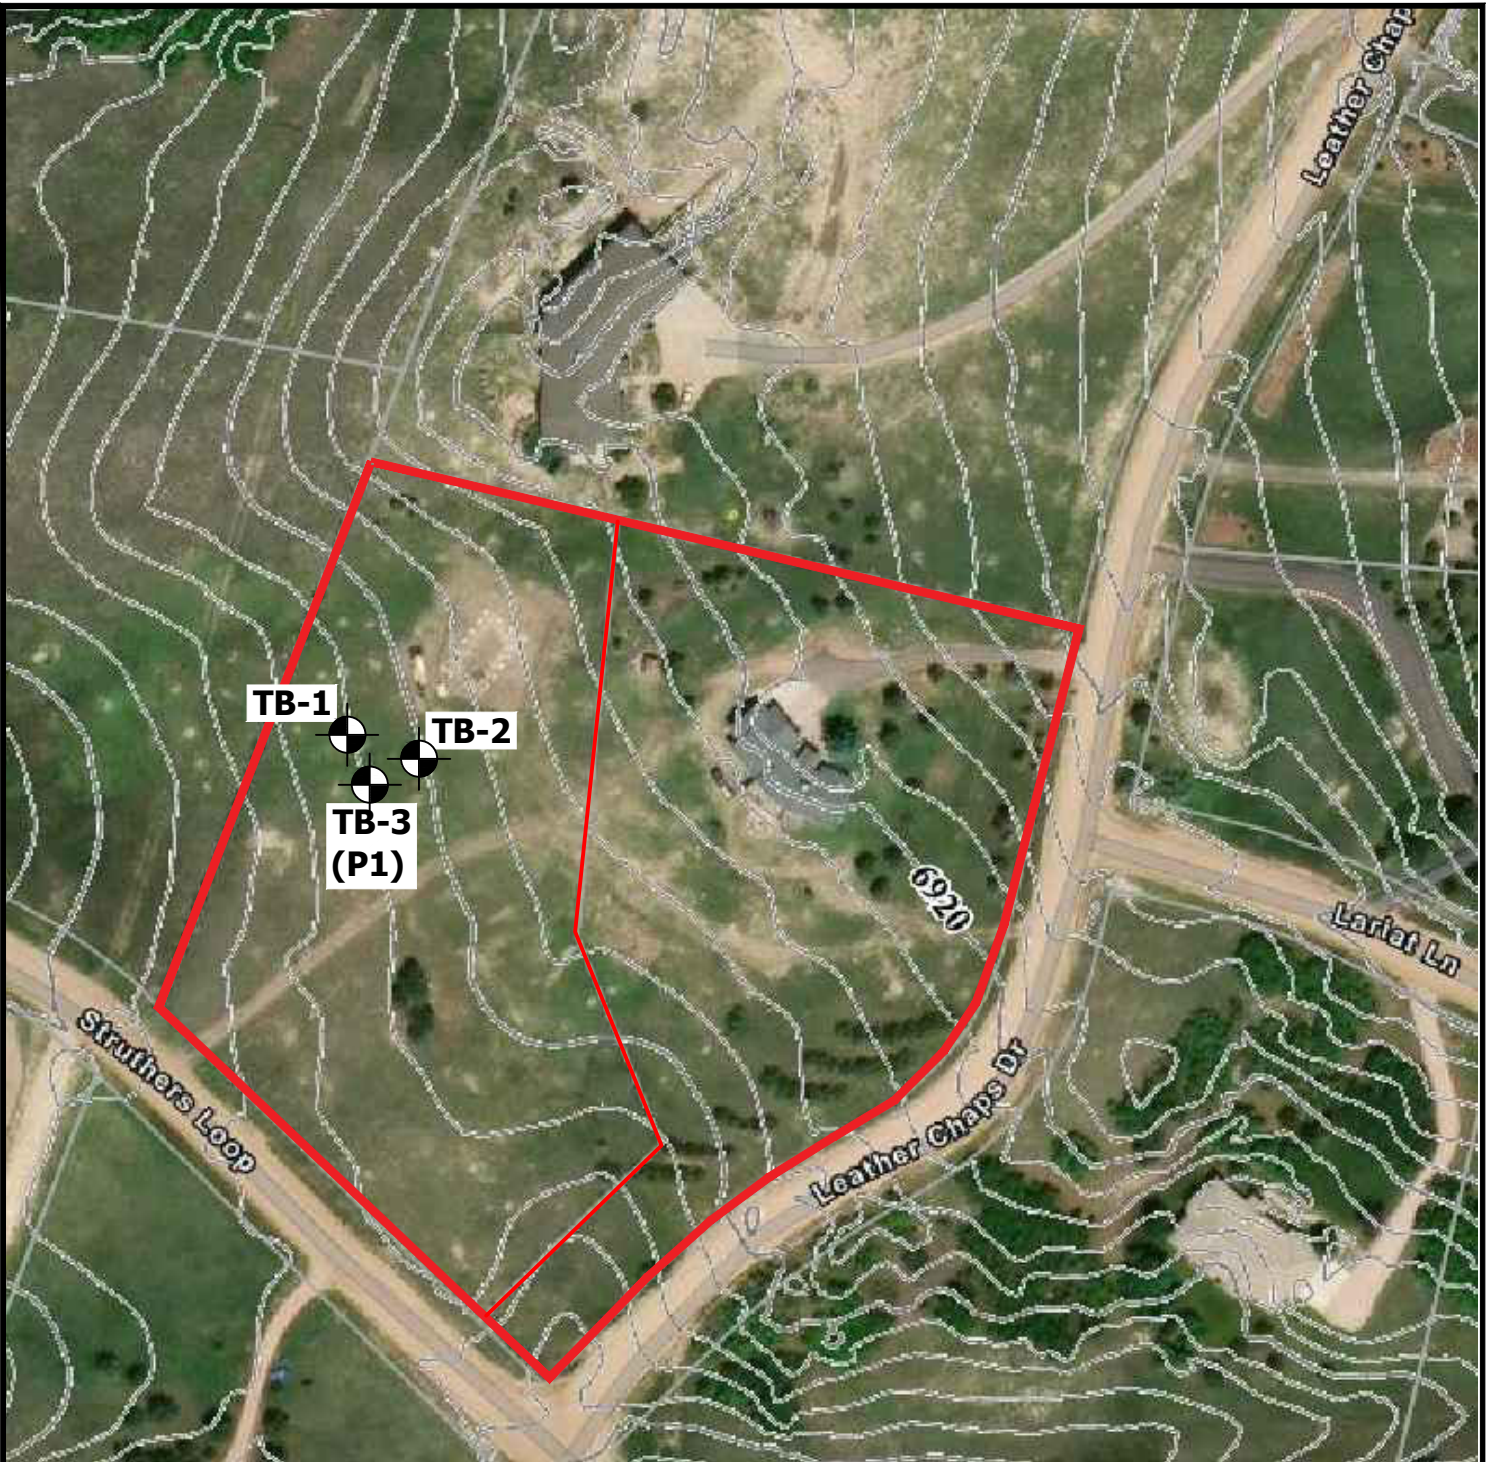
FIG. 3

**TB- APPROXIMATE TEST BORING LOCATION AND NUMBER**

The project consists of the subdividing of the 5.05-acre parcel into a 2-lot rural residential subdivision. The lots will be approximately 2.5 acres and will be serviced by an individual water well and an on-site wastewater treatment system (OWTS). The existing metal building and future residence will be located on Lot 1, and the existing residence, OWTS, and water well will remain on Lot 2. The proposed lot configuration is shown in the Site and Exploration Plan (Figure 3).

The locations of the test borings are indicated on the Site and Exploration Plan (Figure 3). The Test Boring Log, and Laboratory Test Results are included in Appendix B. The results of the testing will be discussed later in this report.

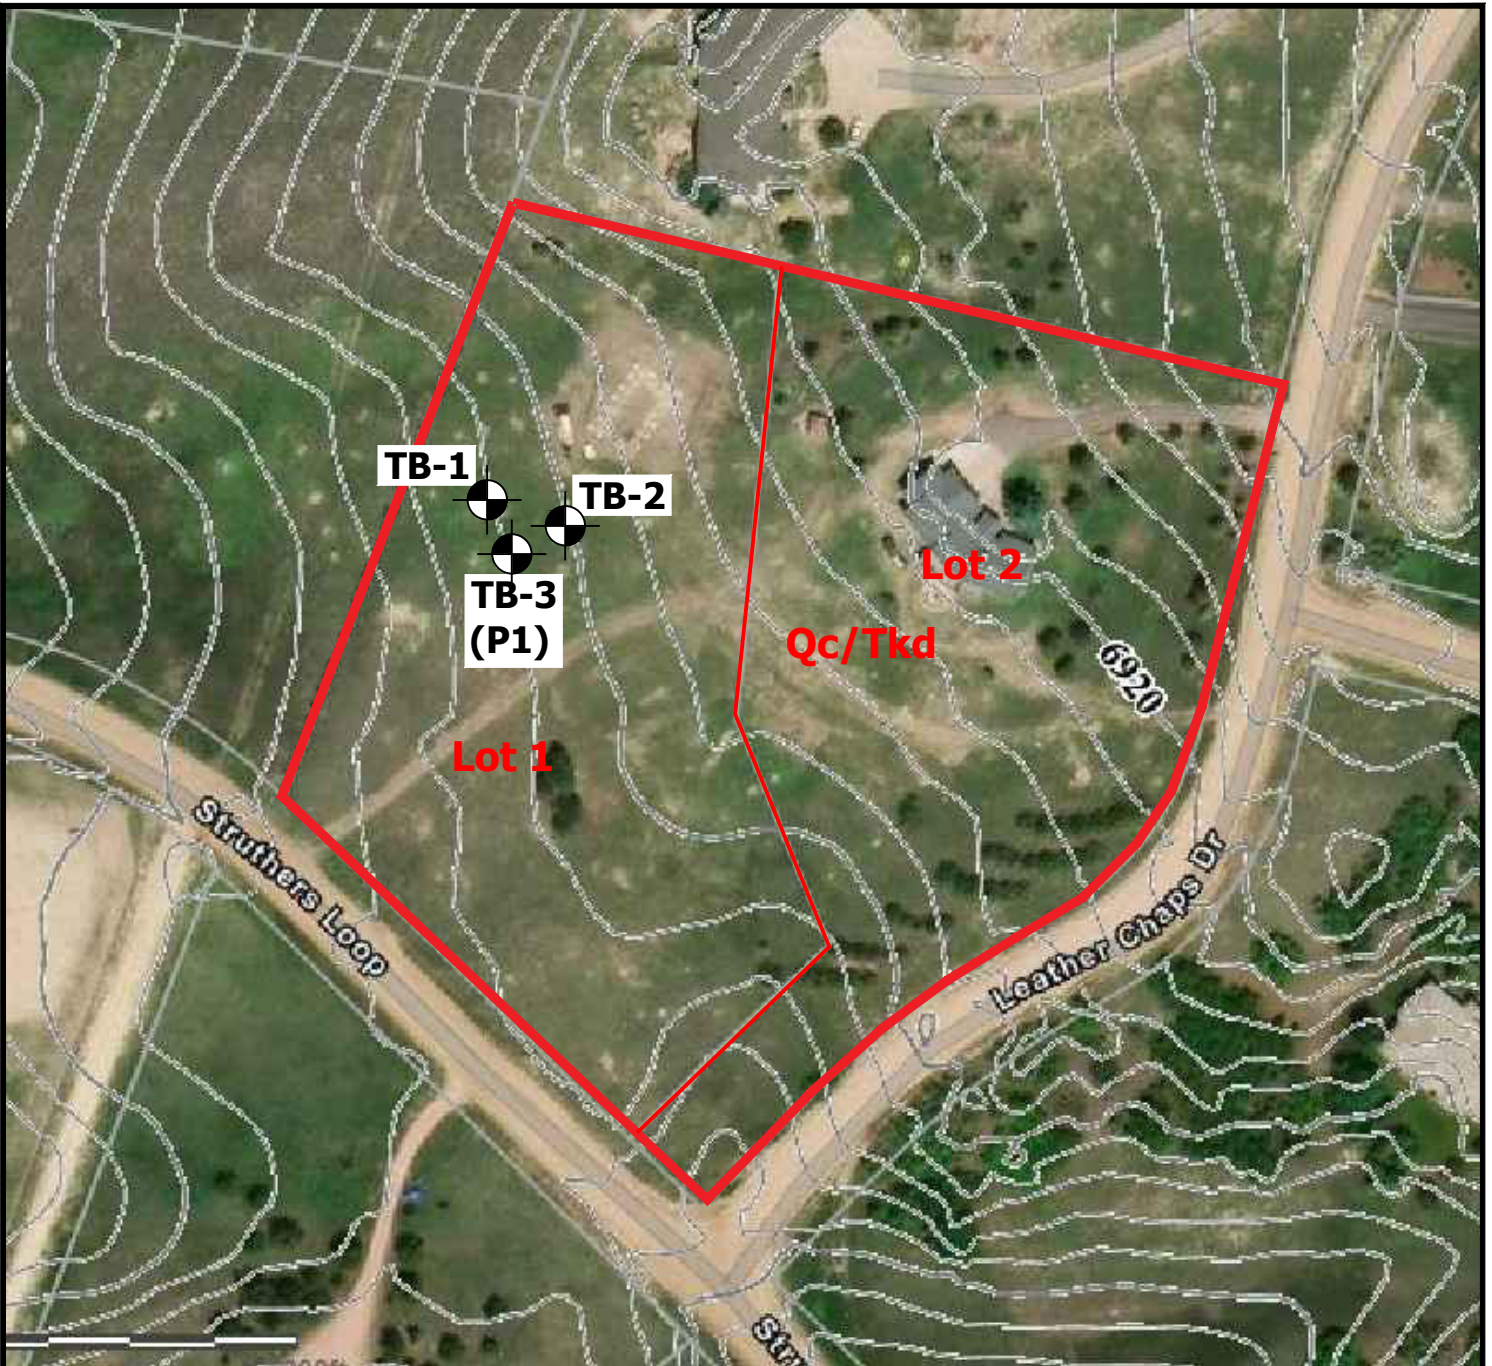
FIG. 6

Qc/Tkd- Colluvium of Quaternary Age Overlying the Dawson Formation of Tertiary to Cretaceous Age:
 Sheetwash and residual soil deposits overlying arkosic sandstone with interbedded siltstone and claystone

The Geologic Map of the Monument Quadrangle showing the site is presented in Figure 5 (Reference 7). The Geology/Engineering Geology Map prepared for the site is presented in Figure 6. One mappable unit was identified on this site that is described as follows:

Detailed mapping has been performed on this site to produce a Geology/Engineering Geology Map (Figure 6). This map shows the location of various geologic conditions the developers should monitor during the planning, design, and construction stages of the project. No significant geologic hazards were identified on the site; however, the following constraints have been identified on the site: potentially expansive soils, loose soils, and the potential for elevated radon levels. These constraints and the recommended mitigation techniques are discussed below.

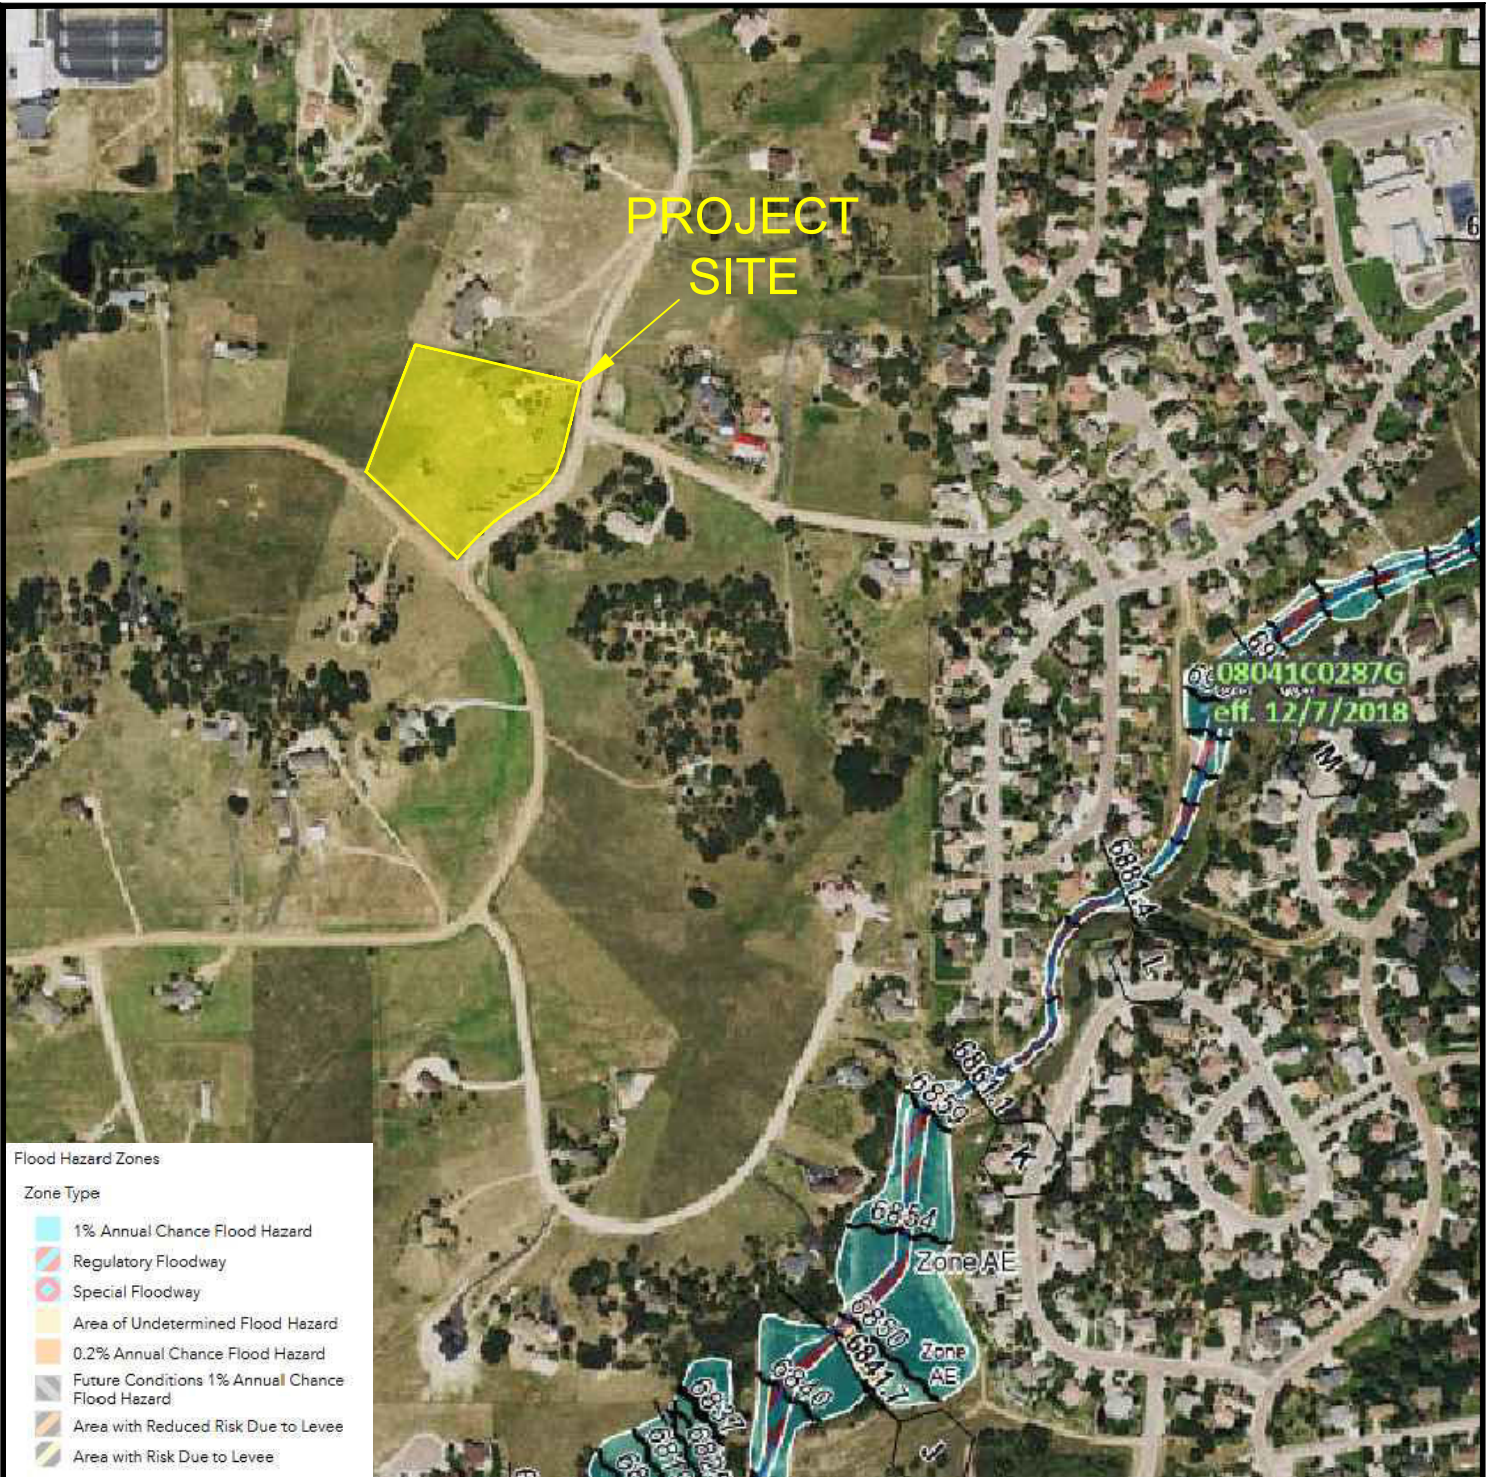
Flood Hazard Zones

The site is not mapped within any floodplains according to FEMA Map No. 08041C0287G (Figure 6, Reference 11). No drainages are located on the site. Specific drainage studies and floodplain locations are beyond the scope of this report. Groundwater was not encountered in the borings drilled on the site, and the piezometer has been dry to a depth of 20 feet. However, redoximorphic features were encountered at shallow depths in the test pits evaluated by JDM (Reference 3, Appendix D).

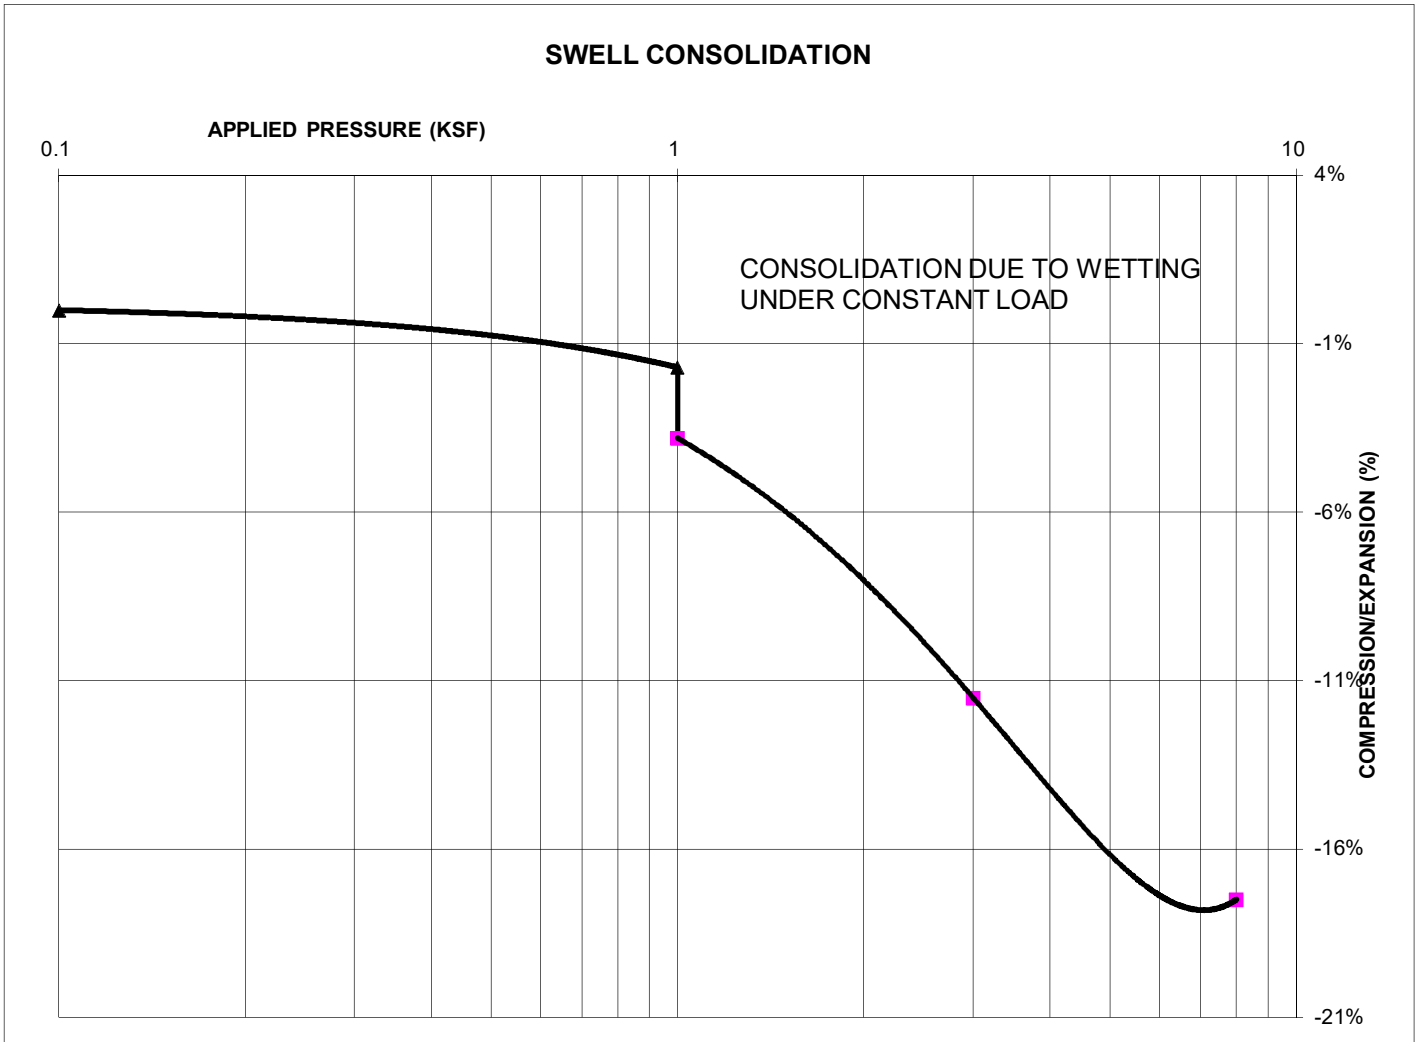
TEST BORING 3
DEPTH (FT) 2-3

SOIL DESCRIPTION CLAY, WITH SAND

SWELL/CONSOLIDATION TEST RESULTS

NATURAL UNIT DRY WEIGHT (PCF): 86
NATURAL MOISTURE CONTENT: 22.1%
SWELL/CONSOLIDATION (%): -2.1%

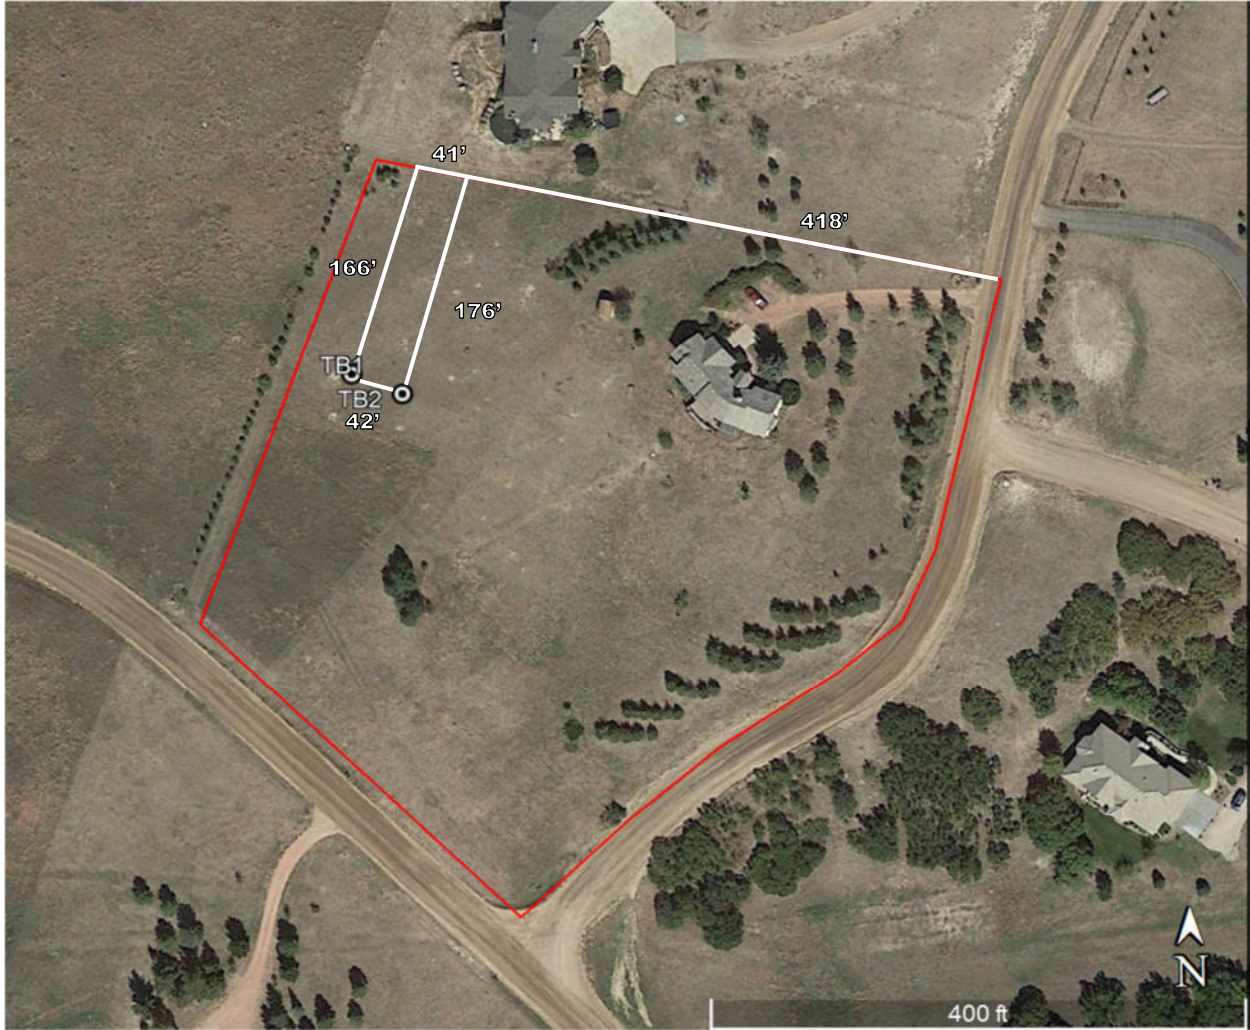
SITE AND EXPLORATION PLAN

15220 LEATHER CHAPS DRIVE
BILL AND VICKIE HANCOCK

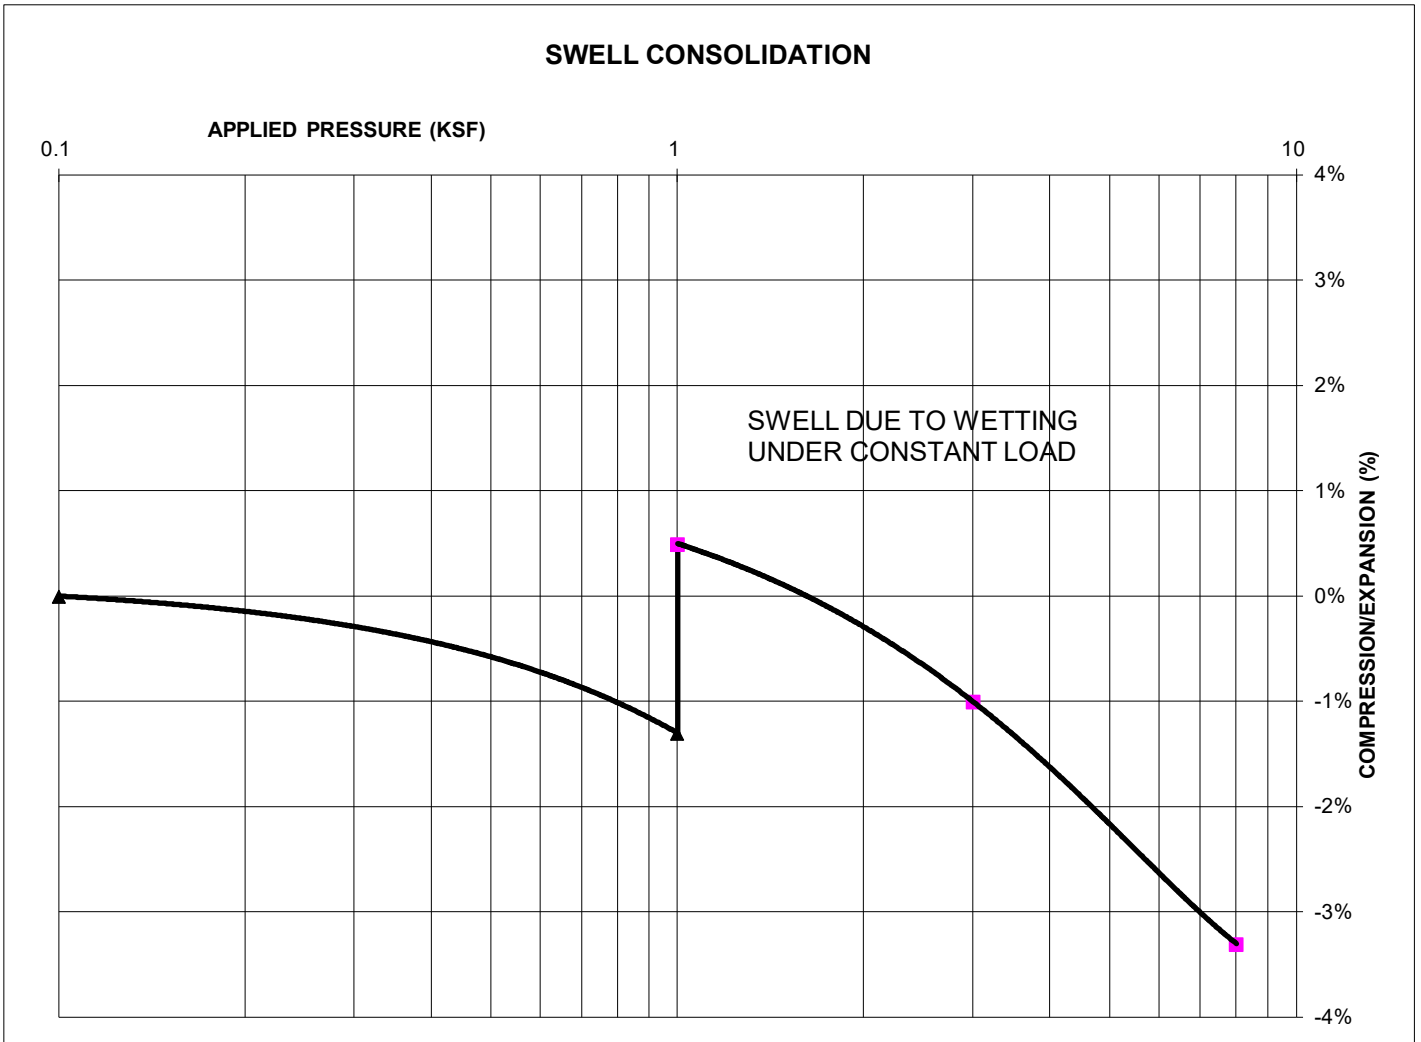
TEST BORING 2
DEPTH (FT) 10

SOIL DESCRIPTION CLAY, SANDY

SWELL/CONSOLIDATION TEST RESULTS

NATURAL UNIT DRY WEIGHT (PCF): 118
NATURAL MOISTURE CONTENT: 14.6%
SWELL/CONSOLIDATION (%): 1.8%
