# WASTEWATER DISPOSAL REPORT

HANCOCK SUBDIVISION II, A REPLAT OF LOT 39 CHAPARRAL HILLS

Project Number W0665.24001

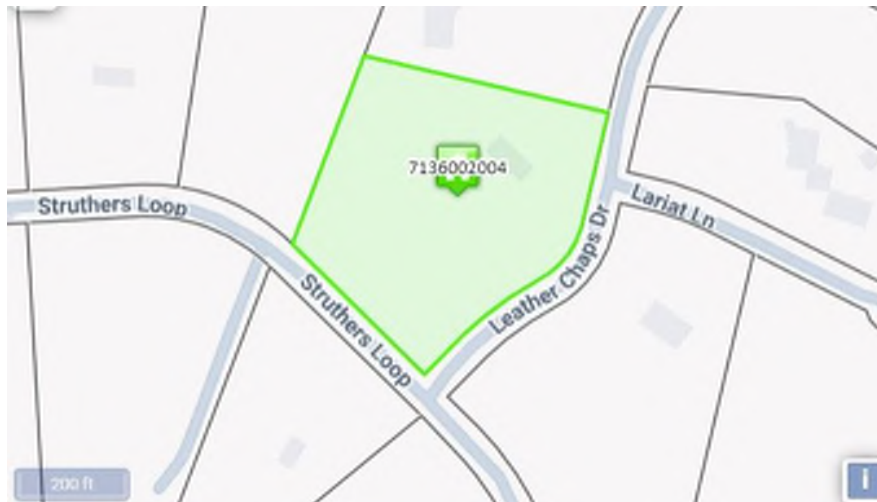
Figure 1-2-1 El Paso County Parcel Designation

The Owner wishes to subdivide Lot 39 Chaparral Hills (EPC parcel no. 7136002004) into two (2) lots through the El Paso County Land Development and Planning Process. See Figures 1-2-1 and 1-2-2. The Owner of the 5.04-acre parcel lives in an existing home on proposed Lot 2, while proposed Lot 1 will be developed, once subdivided, with an additional single-family home. A commitment has been obtained from the Donala Water and Sanitation District (Donala or District) to provide water service to both lots (Lot 2 will abandon an existing, exempt well). Though an Order of Inclusion (**Appendix A – Donala Water and Sanitation District Service Commitment and Inclusion Order**) was filed in July of 2022 which placed the entirety of Lot 39 Chaparral Hills within the Donala Water and Sanitation District service boundary, the Owner is not seeking to obtain sewer service from the District for either proposed lot (both lot owners will be water-only customers.) The Owner wishes to utilize all or portions of the existing septic treatment equipment on the property, including absorption fields, with necessary improvements, to serve both the existing home on Lot 2 and a proposed single-family residence on Lot 1. Currently, two separate absorption fields are being utilized to treat wastewater from the exiting home; this system consists of an original leach field (constructed in 1989) and a second leach field (constructed in 1994 as part of repairs permitted through El Paso County.)

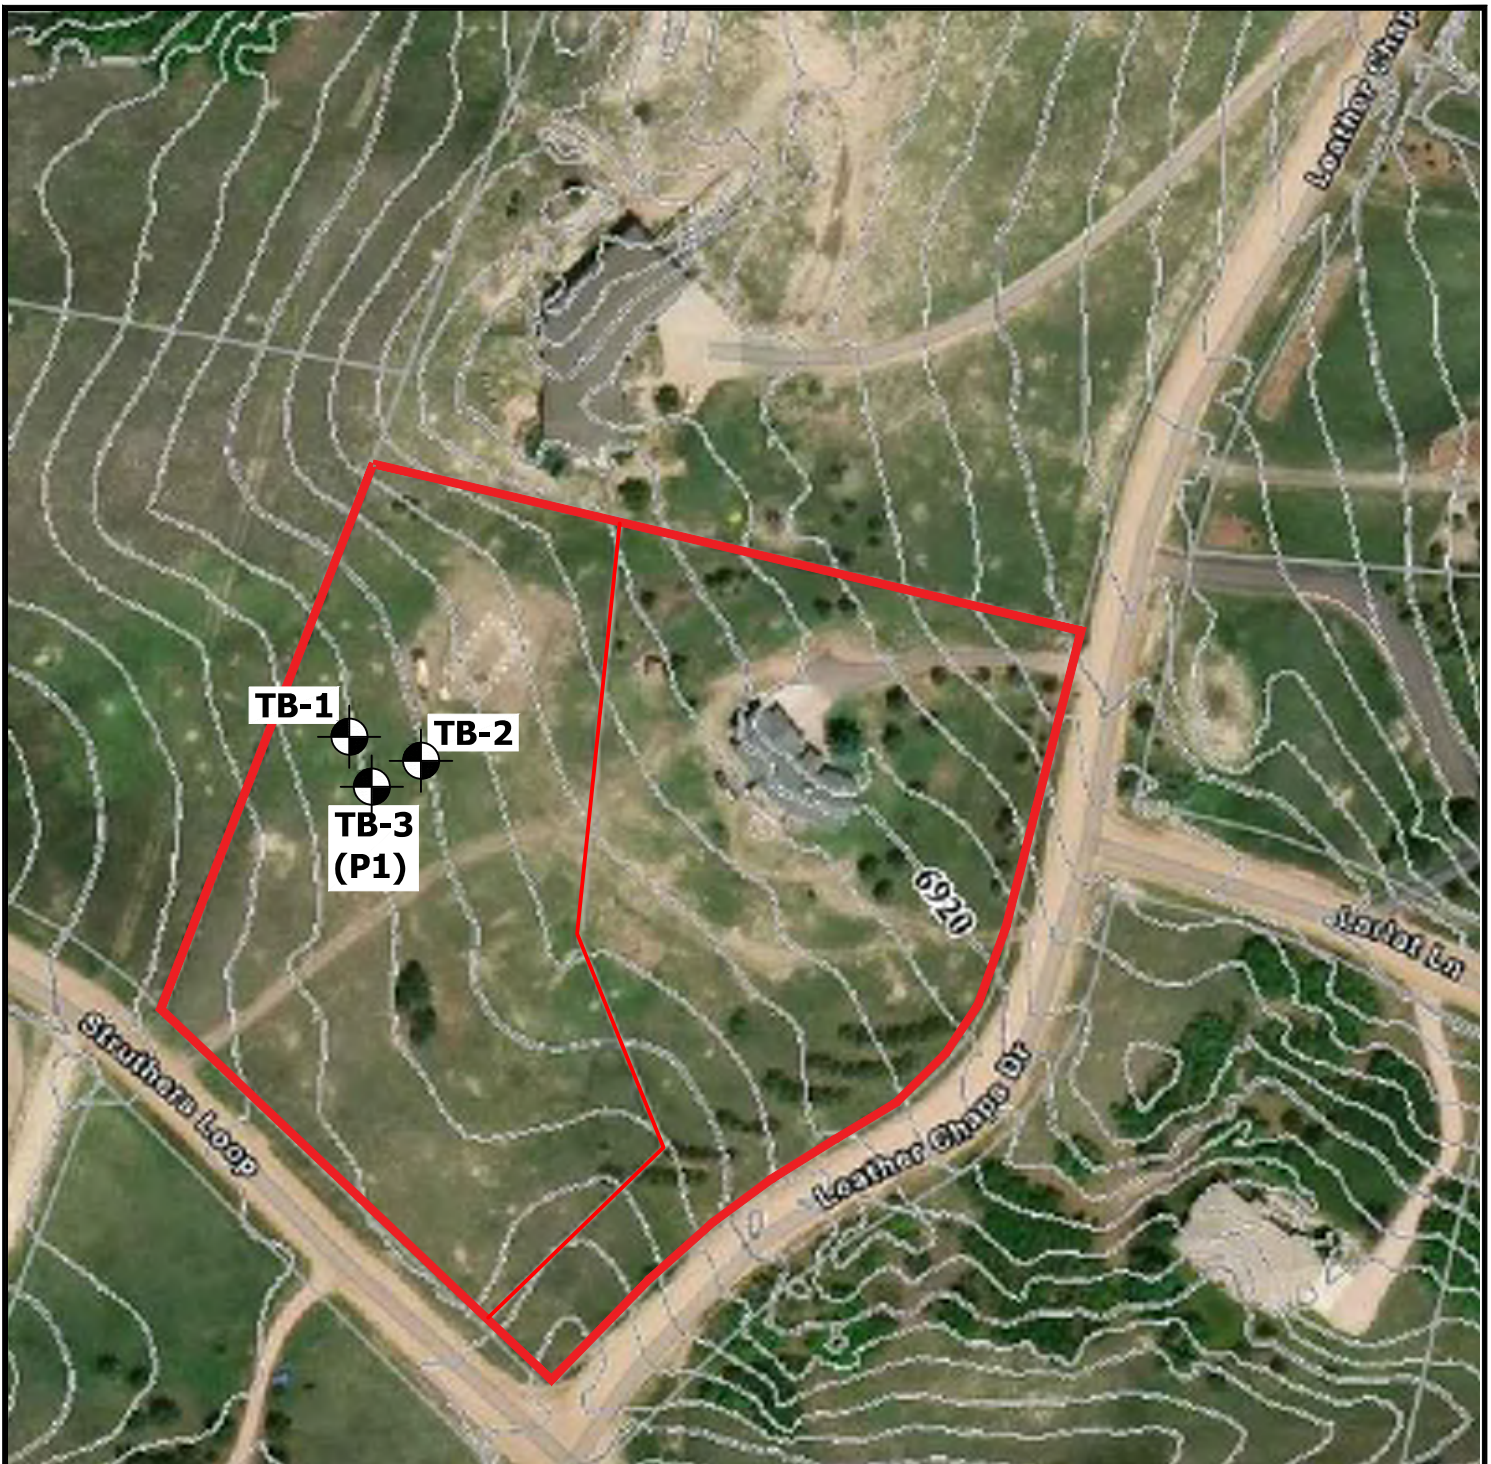
**FIG. 3**

**TB- APPROXIMATE TEST BORING LOCATION AND NUMBER**

The project consists of the subdividing of the 5.05-acre parcel into a 2-lot rural residential subdivision. The lots will be approximately 2.5 acres and will be serviced by an individual water well and an on-site wastewater treatment system (OWTS). The existing metal building and future residence will be located on Lot 1, and the existing residence, OWTS, and water well will remain on Lot 2. The proposed lot configuration is shown in the Site and Exploration Plan (Figure 3).

The locations of the test borings are indicated on the Site and Exploration Plan (Figure 3). The Test Boring Log, and Laboratory Test Results are included in Appendix B. The results of the testing will be discussed later in this report.

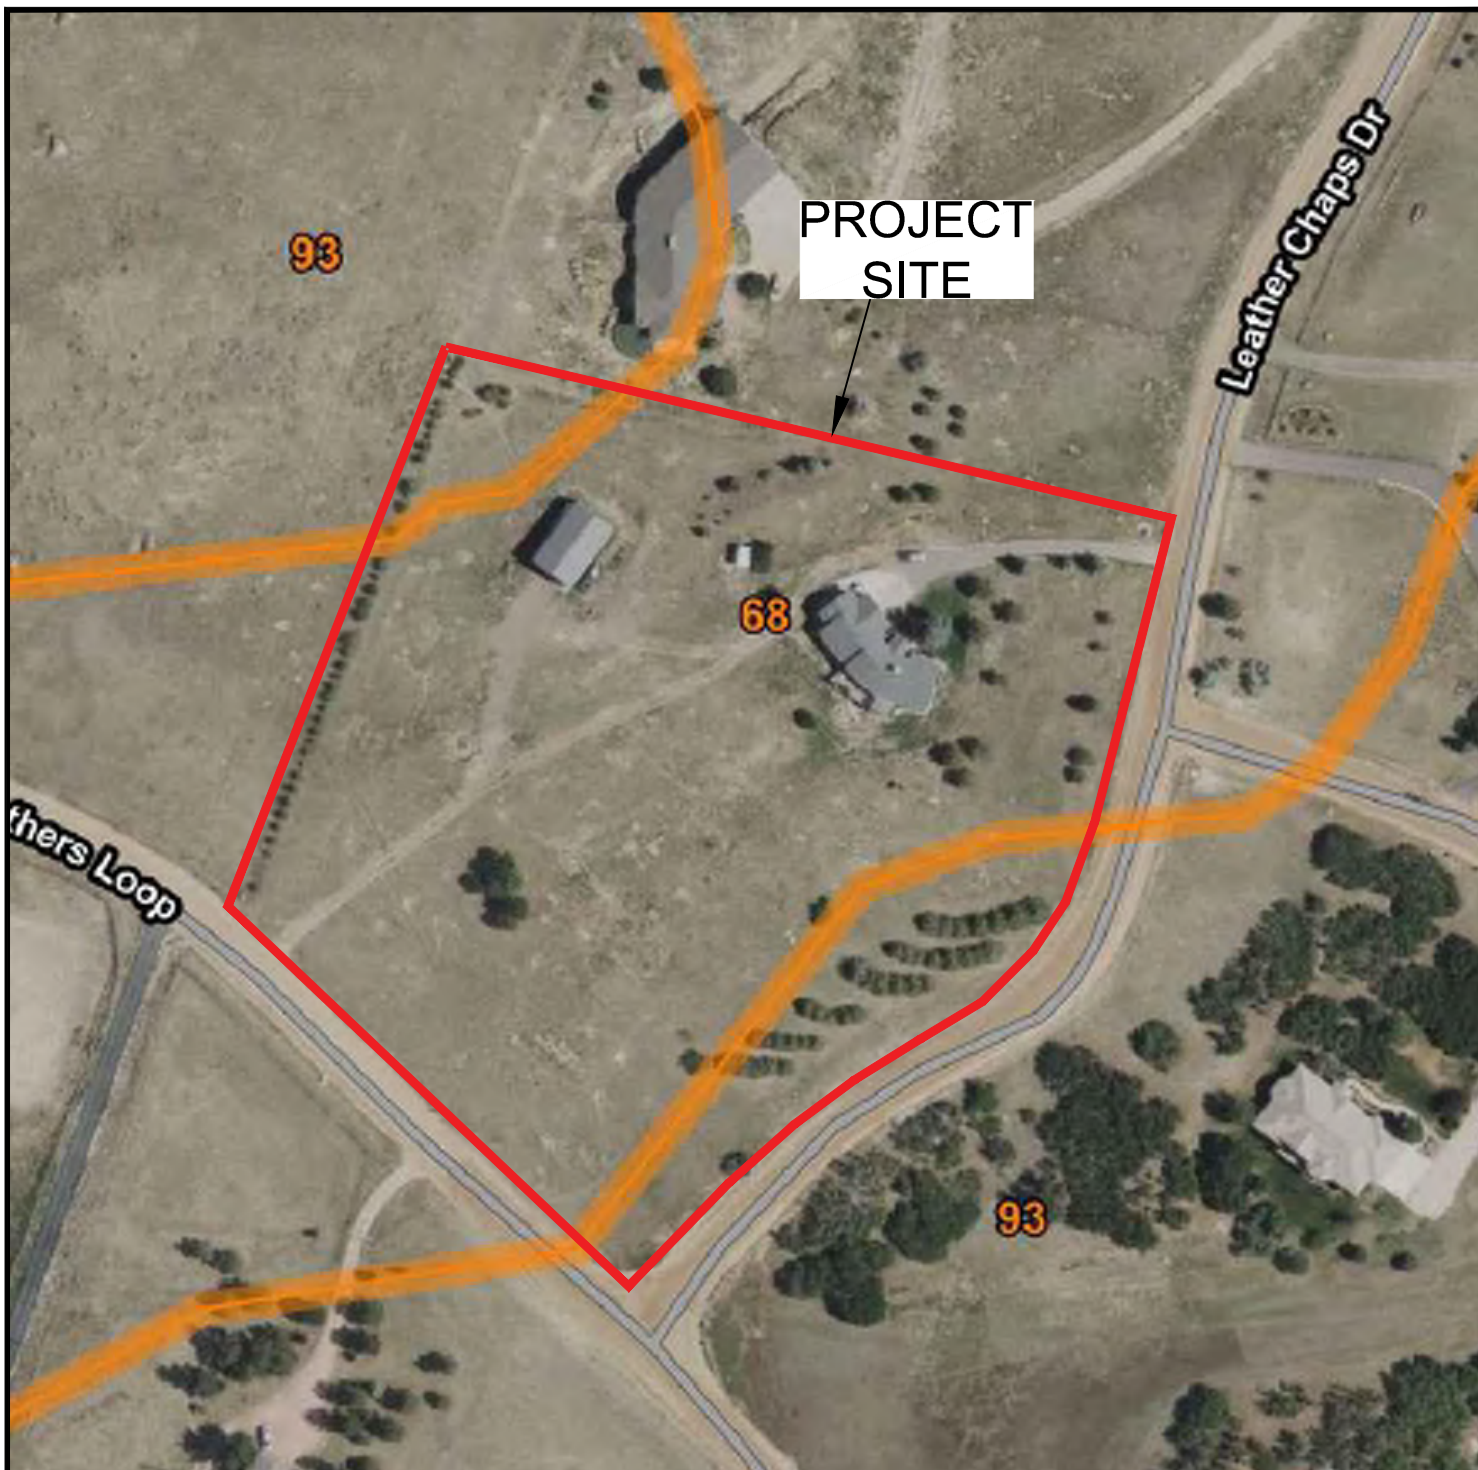
**JOB NO.**  
**230921**  
**FIG. 4**

**SOIL SURVEY MAP**  
15220 LEATHER CHAPS DRIVE  
BILL AND VICKIE HANCOCK

The Natural Resource Conservation Service (Reference 2), previously the Soil Conservation Service (Reference 3), has mapped two soil types on the site (Figure 4). In general, they are loamy sands. The soils are described in Exhibit 1 below.

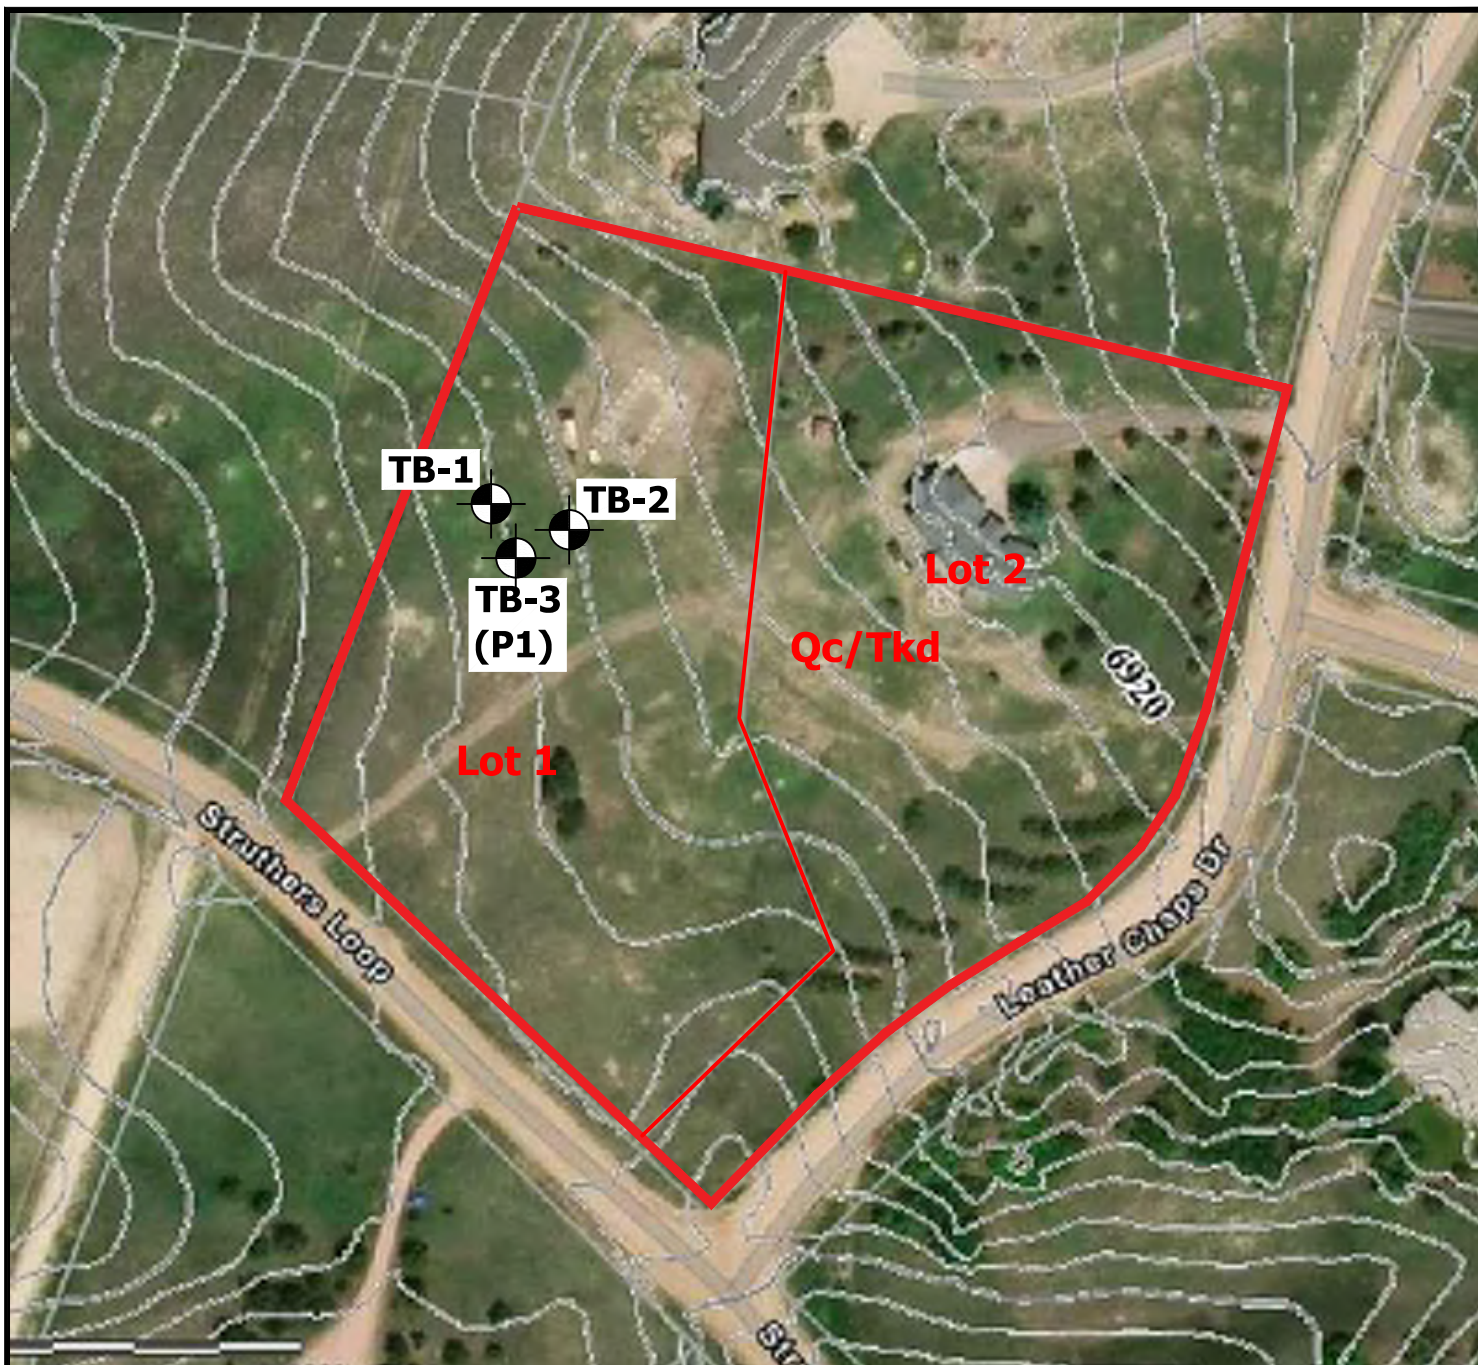
**FIG. 6**

Qc/Tkd- **Colluvium of Quaternary Age Overlying the Dawson Formation of Tertiary to Cretaceous Age:**  
Sheetwash and residual soil deposits overlying arkosic sandstone with interbedded siltstone and claystone

The soils listed above were mapped from site-specific mapping, the *Geologic Map of the Monument Quadrangle* distributed by the Colorado Geological Survey in 2002 (Reference 4), the *Geologic Map of the Pikeview Quadrangle* distributed by the Colorado Geological Survey in 2001 (Reference 5), the *Geologic Map of the Colorado Springs-Castle Rock Area*, distributed by the US Geological Survey in 1979 (Reference 6), and the *Geologic Map of the Denver 1° x 2° Quadrangle*, distributed by the US Geological Survey in 1981 (Reference 7). The Test Borings and Test Pit Logs used in evaluating the site are included in Appendix B. The Geology/Engineering Geology Map prepared for the site is presented in Figure 6.

Detailed mapping has been performed on this site to produce a Geology/Engineering Geology Map (Figure 6). This map shows the location of various geologic conditions the developers should monitor during the planning, design, and construction stages of the project. No significant geologic hazards were identified on the site; however, the following constraints have been identified on the site: potentially expansive soils, loose soils, and the potential for elevated radon levels. These constraints and the recommended mitigation techniques are discussed below.

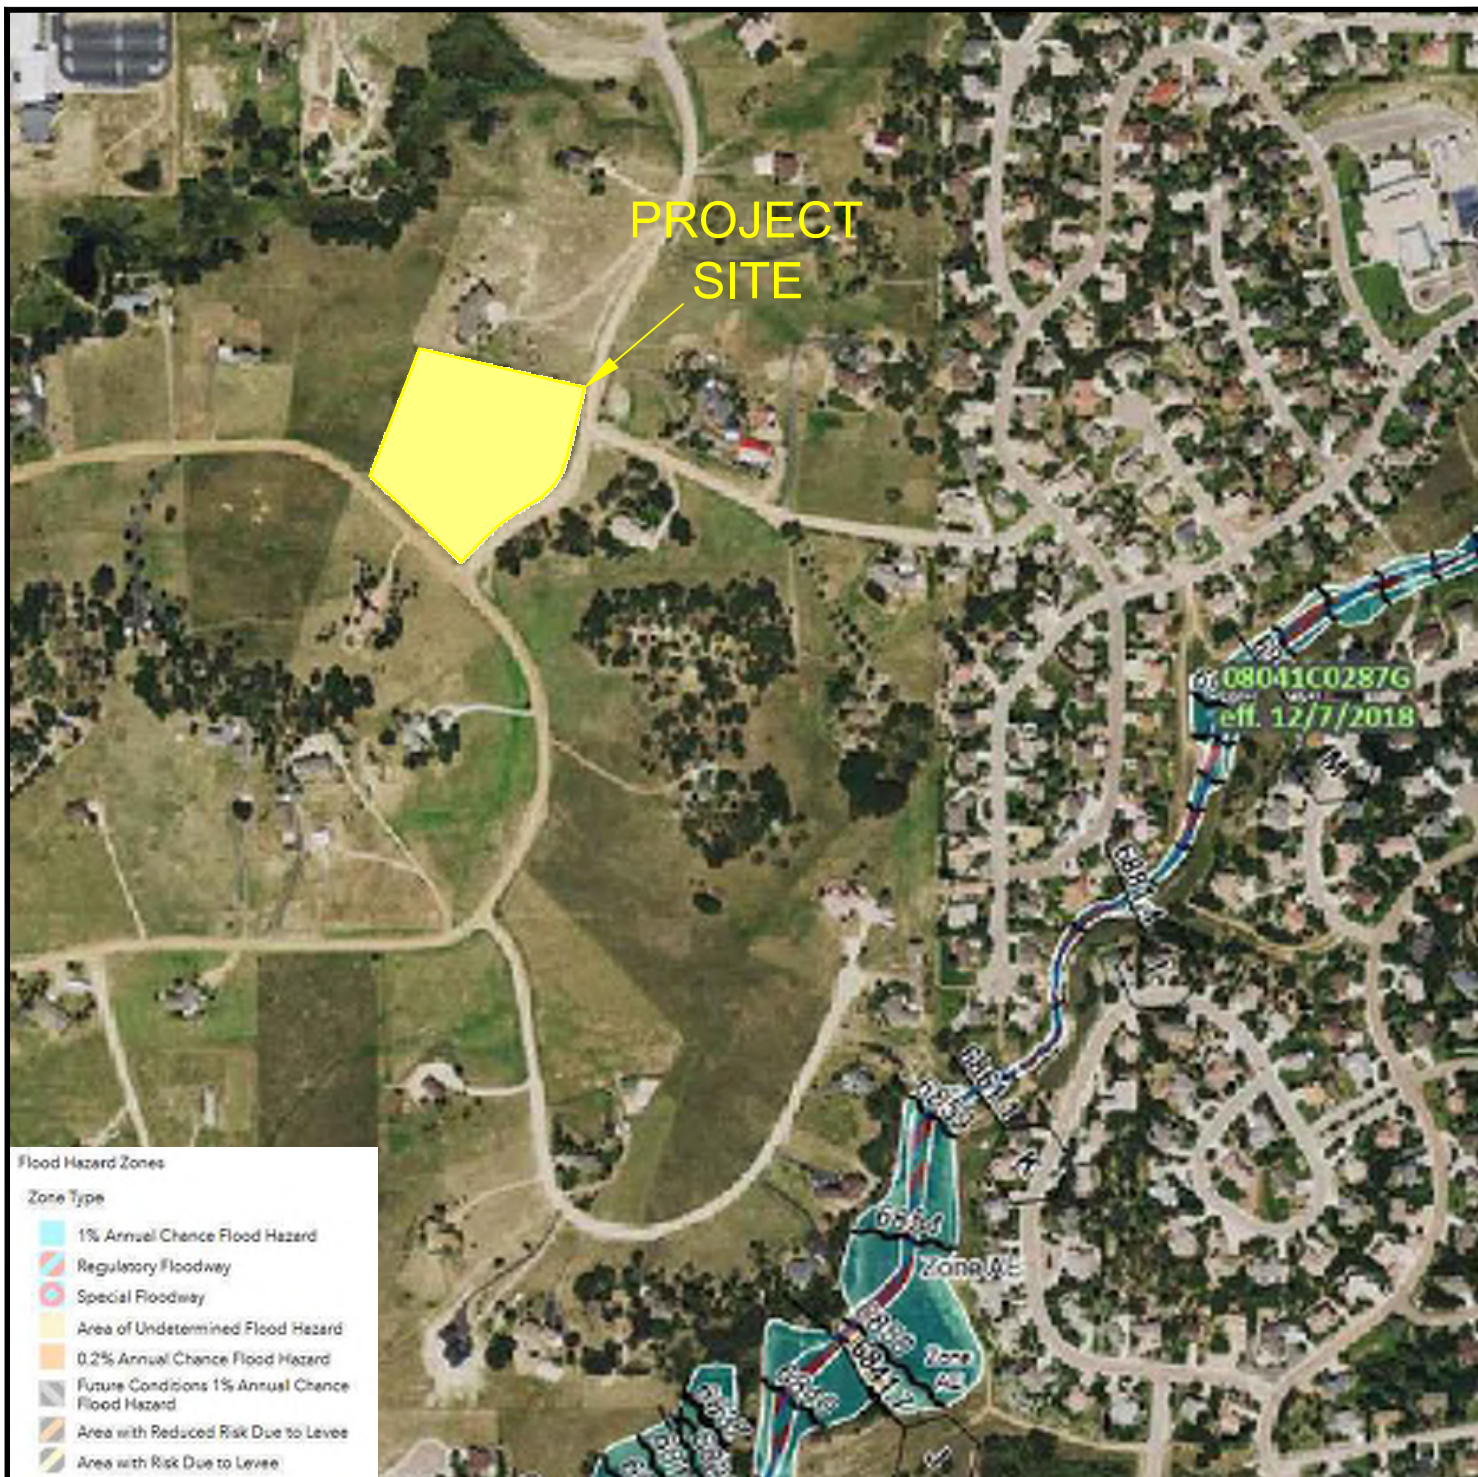
**FIG. 7**

**FEMA FLOODPLAIN MAP**  
15220 LEATHER CHAPS DRIVE  
BILL AND VICKIE HANCOCK

The site is not mapped within any floodplains according to FEMA Map No. 08041C0287G (Figure 6, Reference 11). No drainages are located on the site. Specific drainage studies and floodplain locations are beyond the scope of this report. Groundwater was not encountered in the borings drilled on the site, and the piezometer has been dry to a depth of 20 feet. However, redoximorphic features were encountered at shallow depths in the test pits evaluated by JDM (Reference 3, Appendix D).

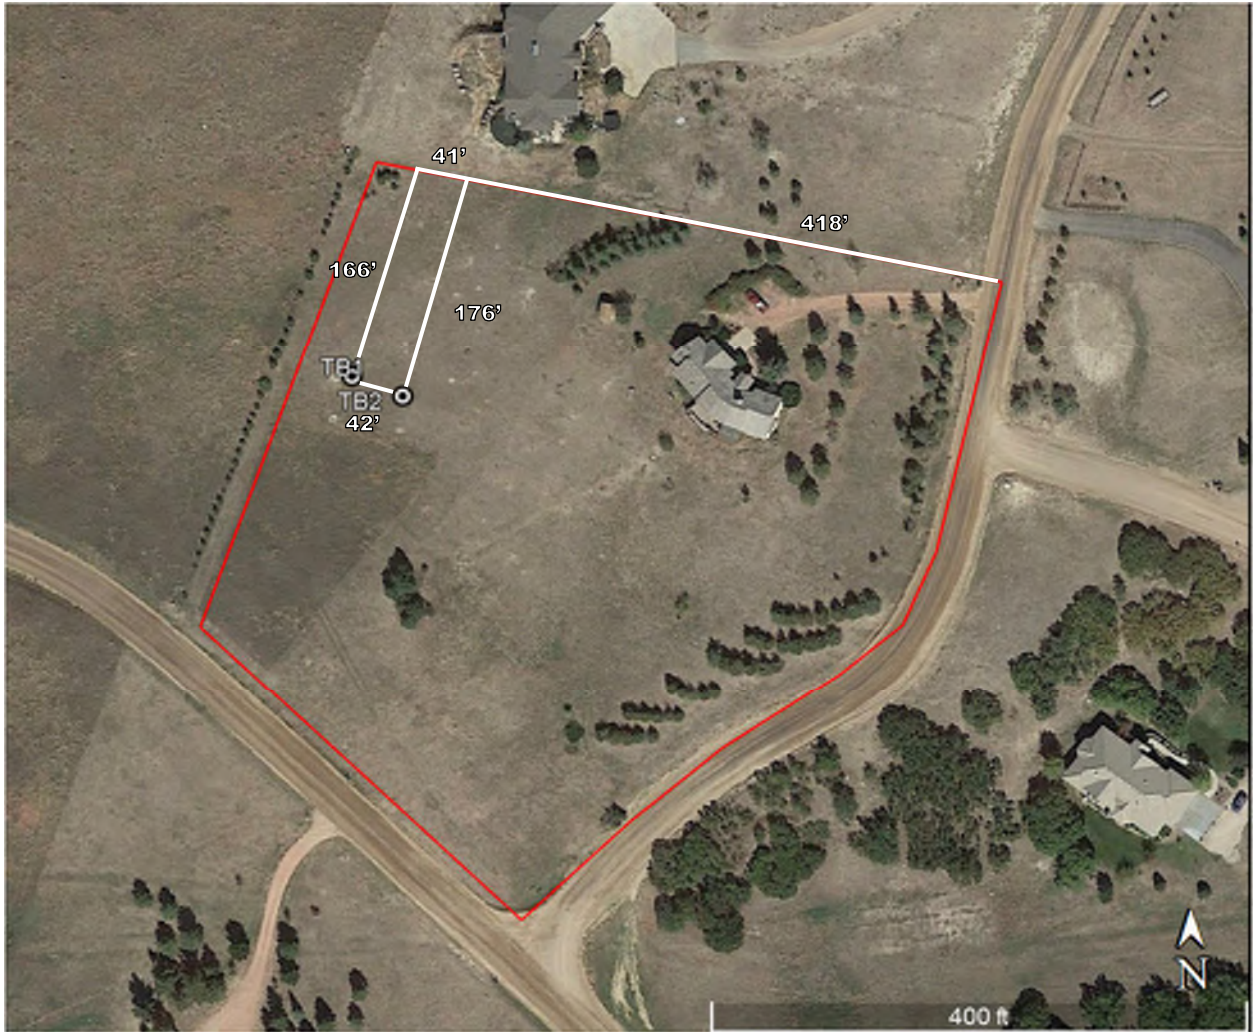
**FIG. 1**

## SITE AND EXPLORATION PLAN

15220 LEATHER CHAPS DRIVE  
BILL AND VICKIE HANCOCK

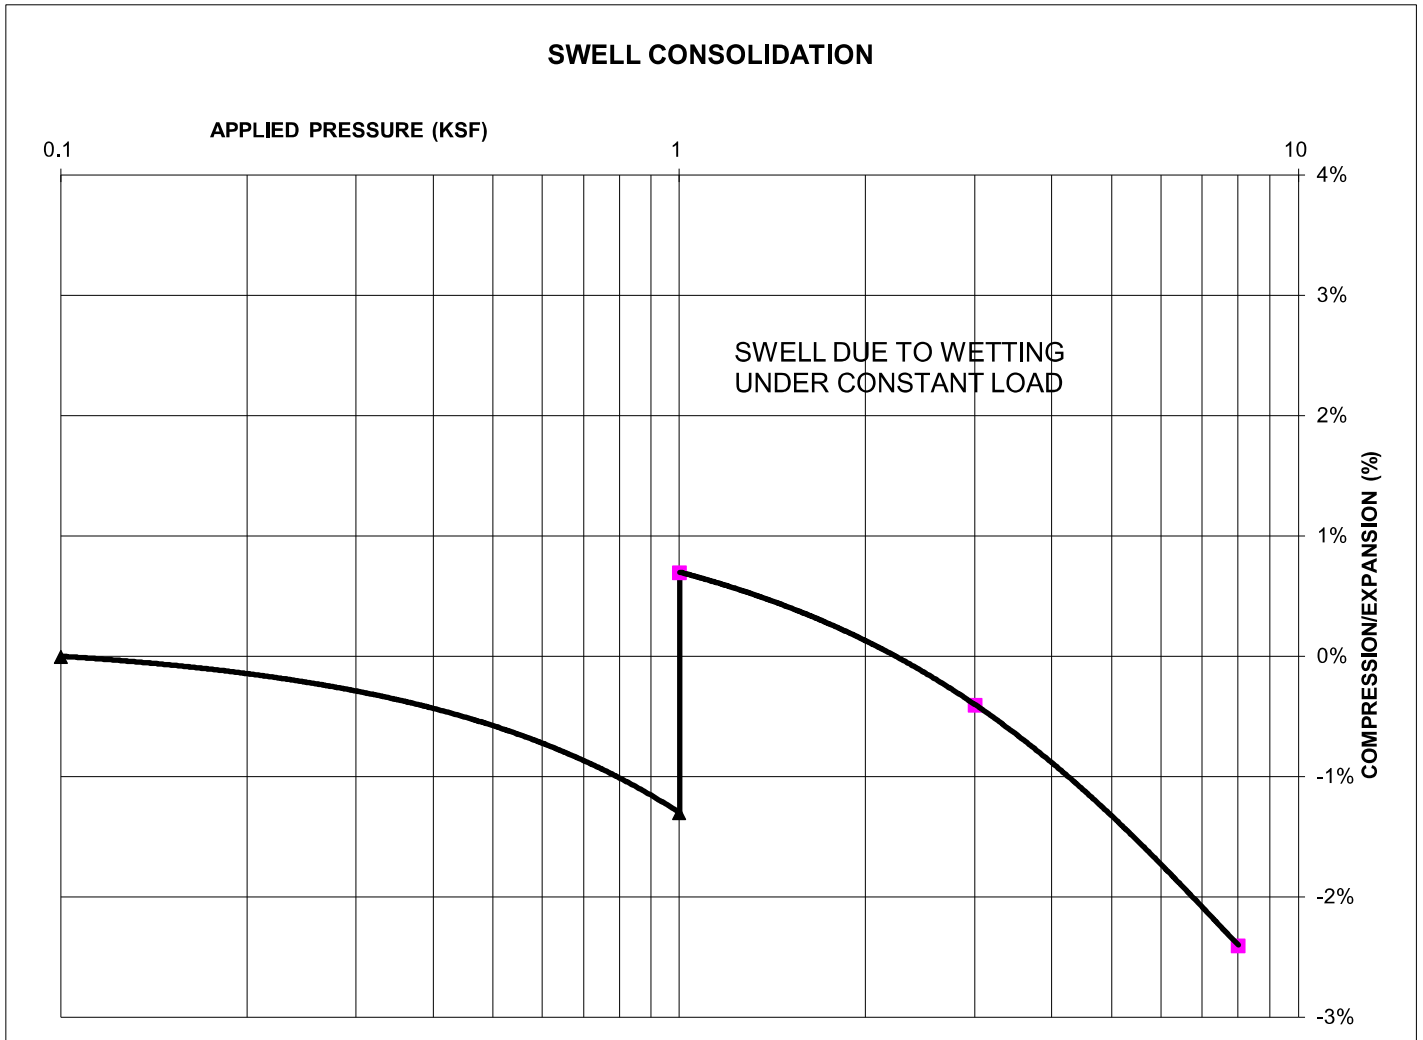
TEST BORING 1  
DEPTH (FT) 15

SOIL DESCRIPTION CLAYSTONE. (CLAY, SANDY)

**SWELL/CONSOLIDATION TEST RESULTS**

NATURAL UNIT DRY WEIGHT (PCF): 100  
NATURAL MOISTURE CONTENT: 24.6%  
SWELL/CONSOLIDATION (%): 2.0%

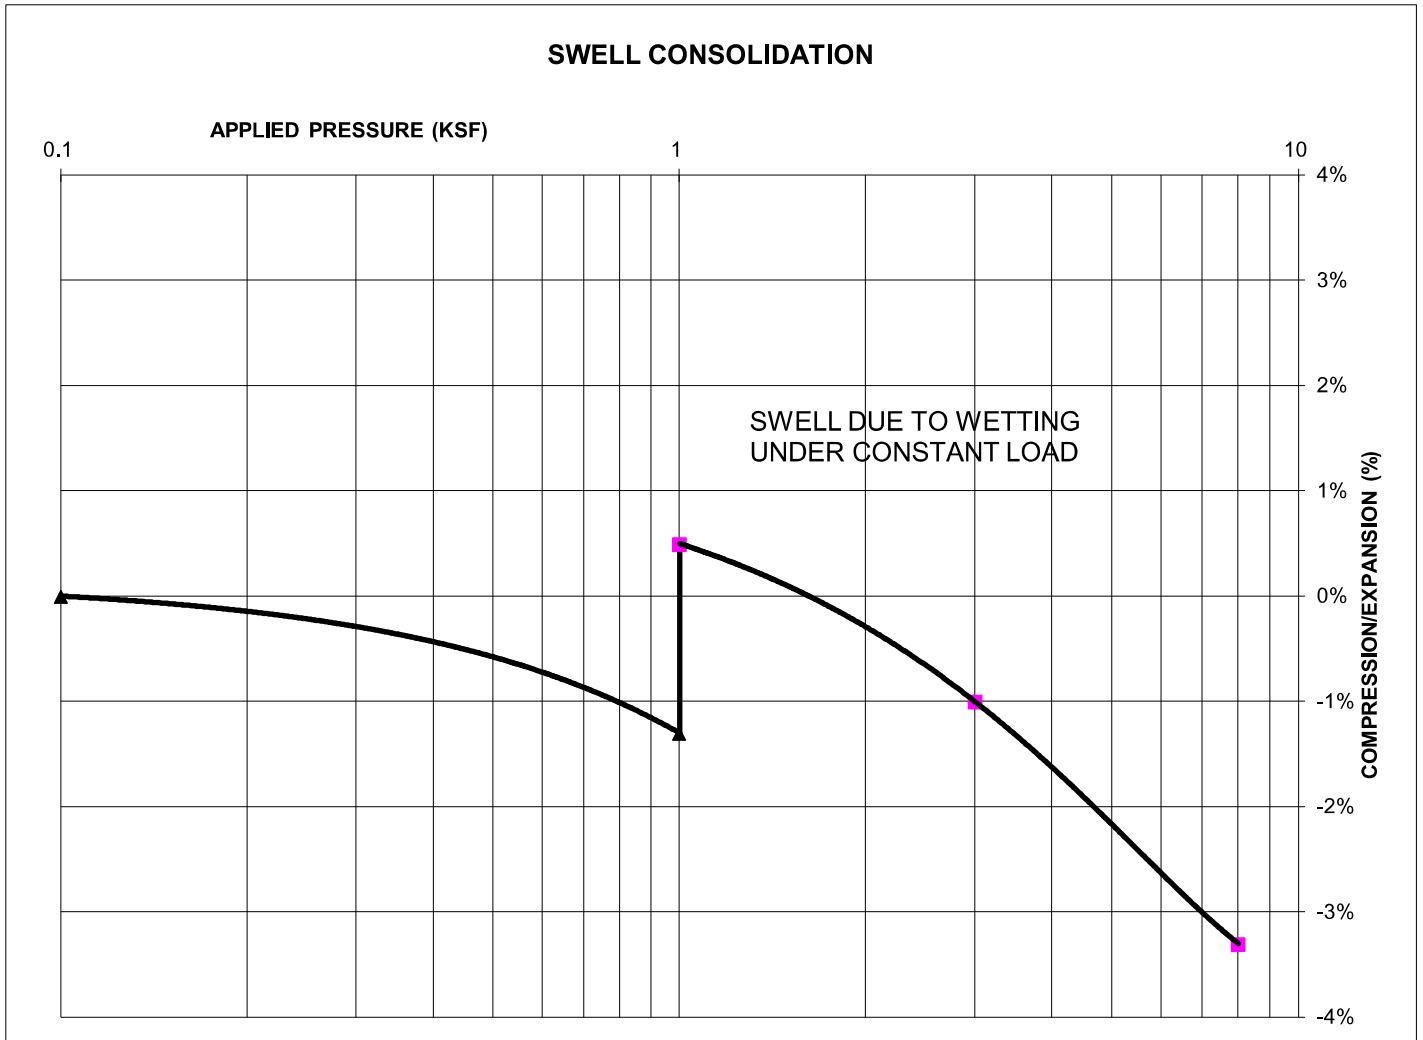
TEST BORING 2  
DEPTH (FT) 10

SOIL DESCRIPTION CLAY, SANDY

**SWELL/CONSOLIDATION TEST RESULTS**

NATURAL UNIT DRY WEIGHT (PCF): 118  
NATURAL MOISTURE CONTENT: 14.6%  
SWELL/CONSOLIDATION (%): 1.8%

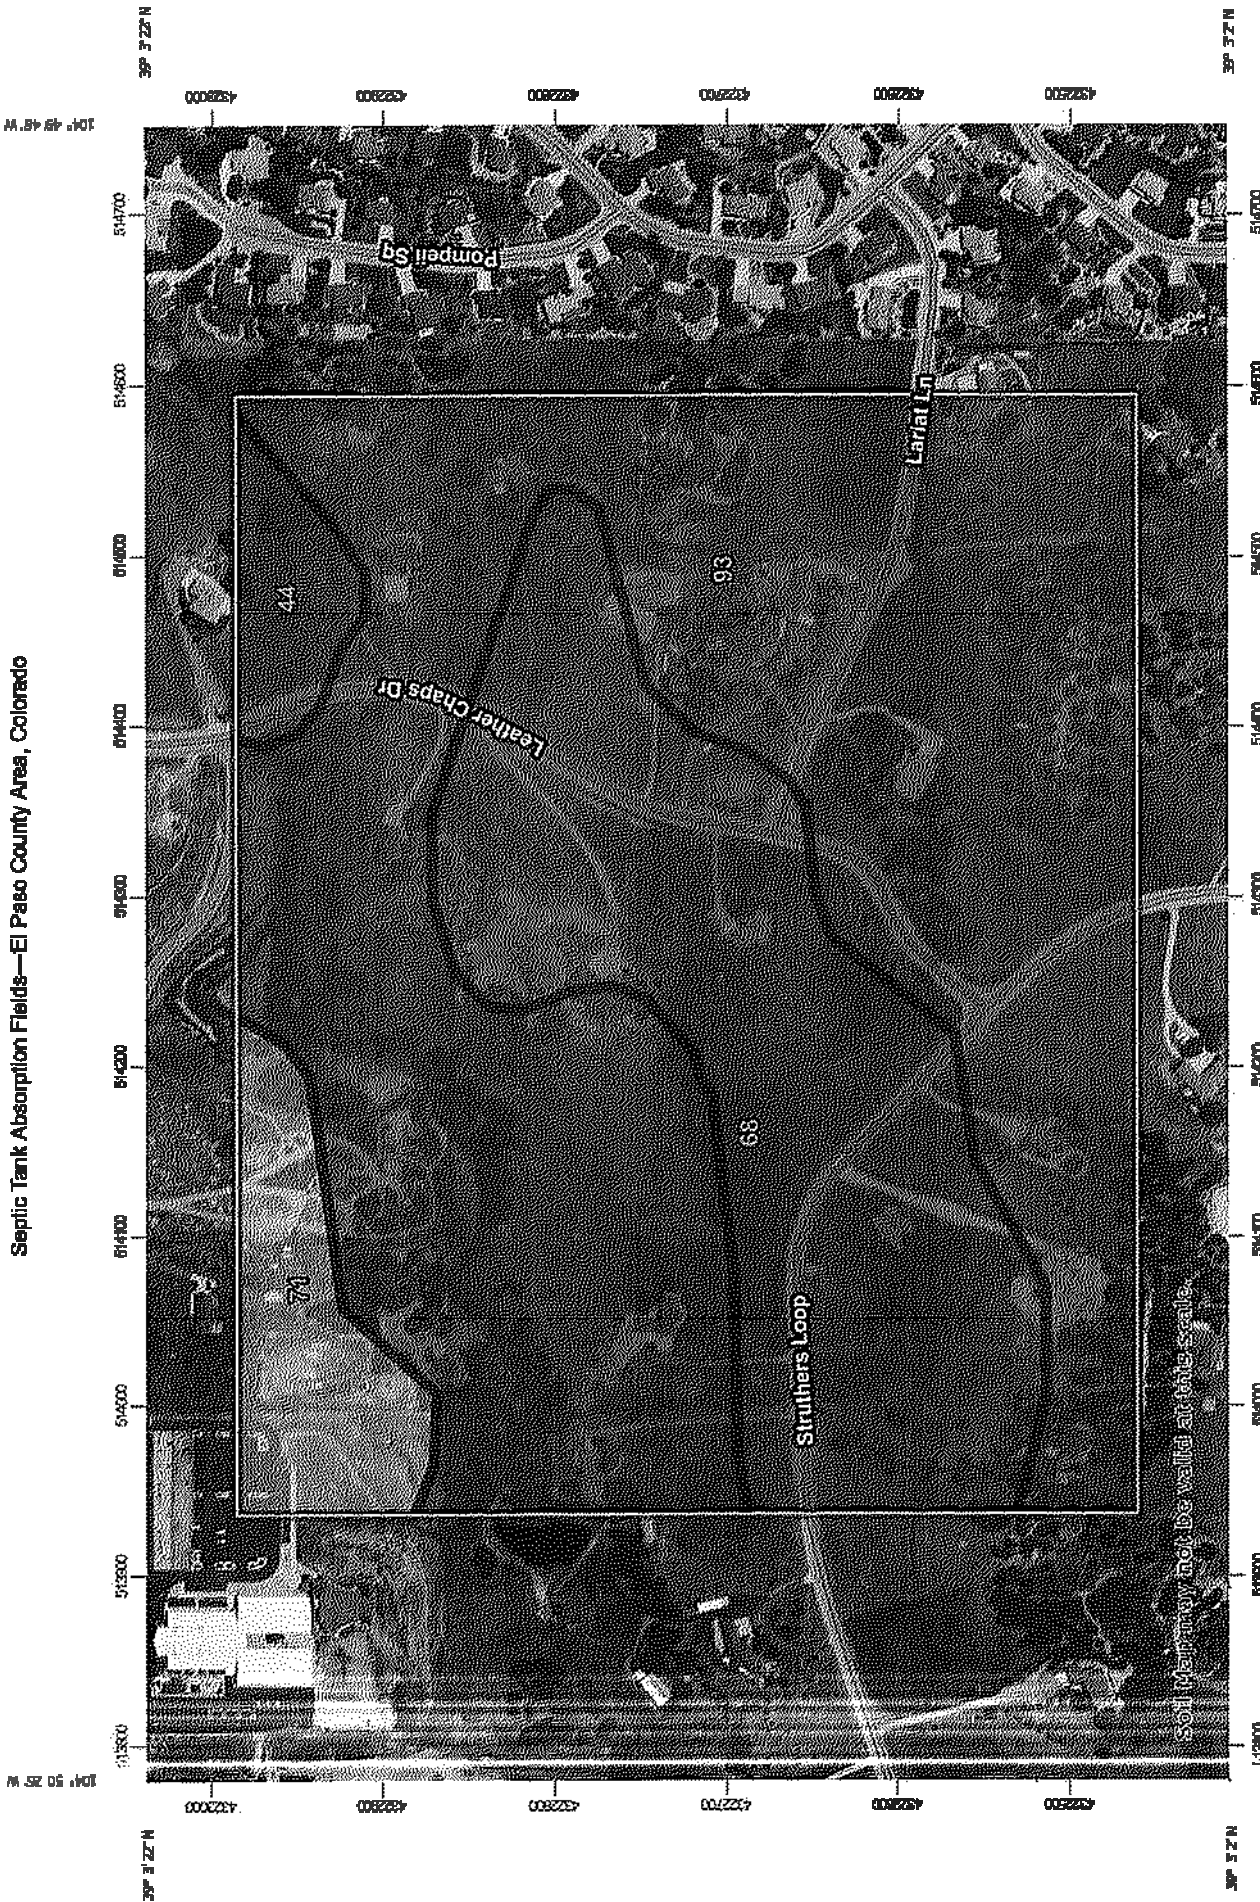
# Septic Tank Absorption Fields—El Paso County Area, Colorado

Map Scale: 1:4,150 if printed on A landscape (11" x 8.5") sheet.
