Re: Soils and Geology Study  
10650 Black Forest Road  
Parcel No. 52190-00-101  
El Paso County, Colorado  
Entech Job No. 221371

The project consists of subdividing 24.79-acres; four rural residential lots are proposed as part of the subdivision. The site is located northwest of the intersection of Black Forest Road and Old Ranch Road, in El Paso County, Colorado.

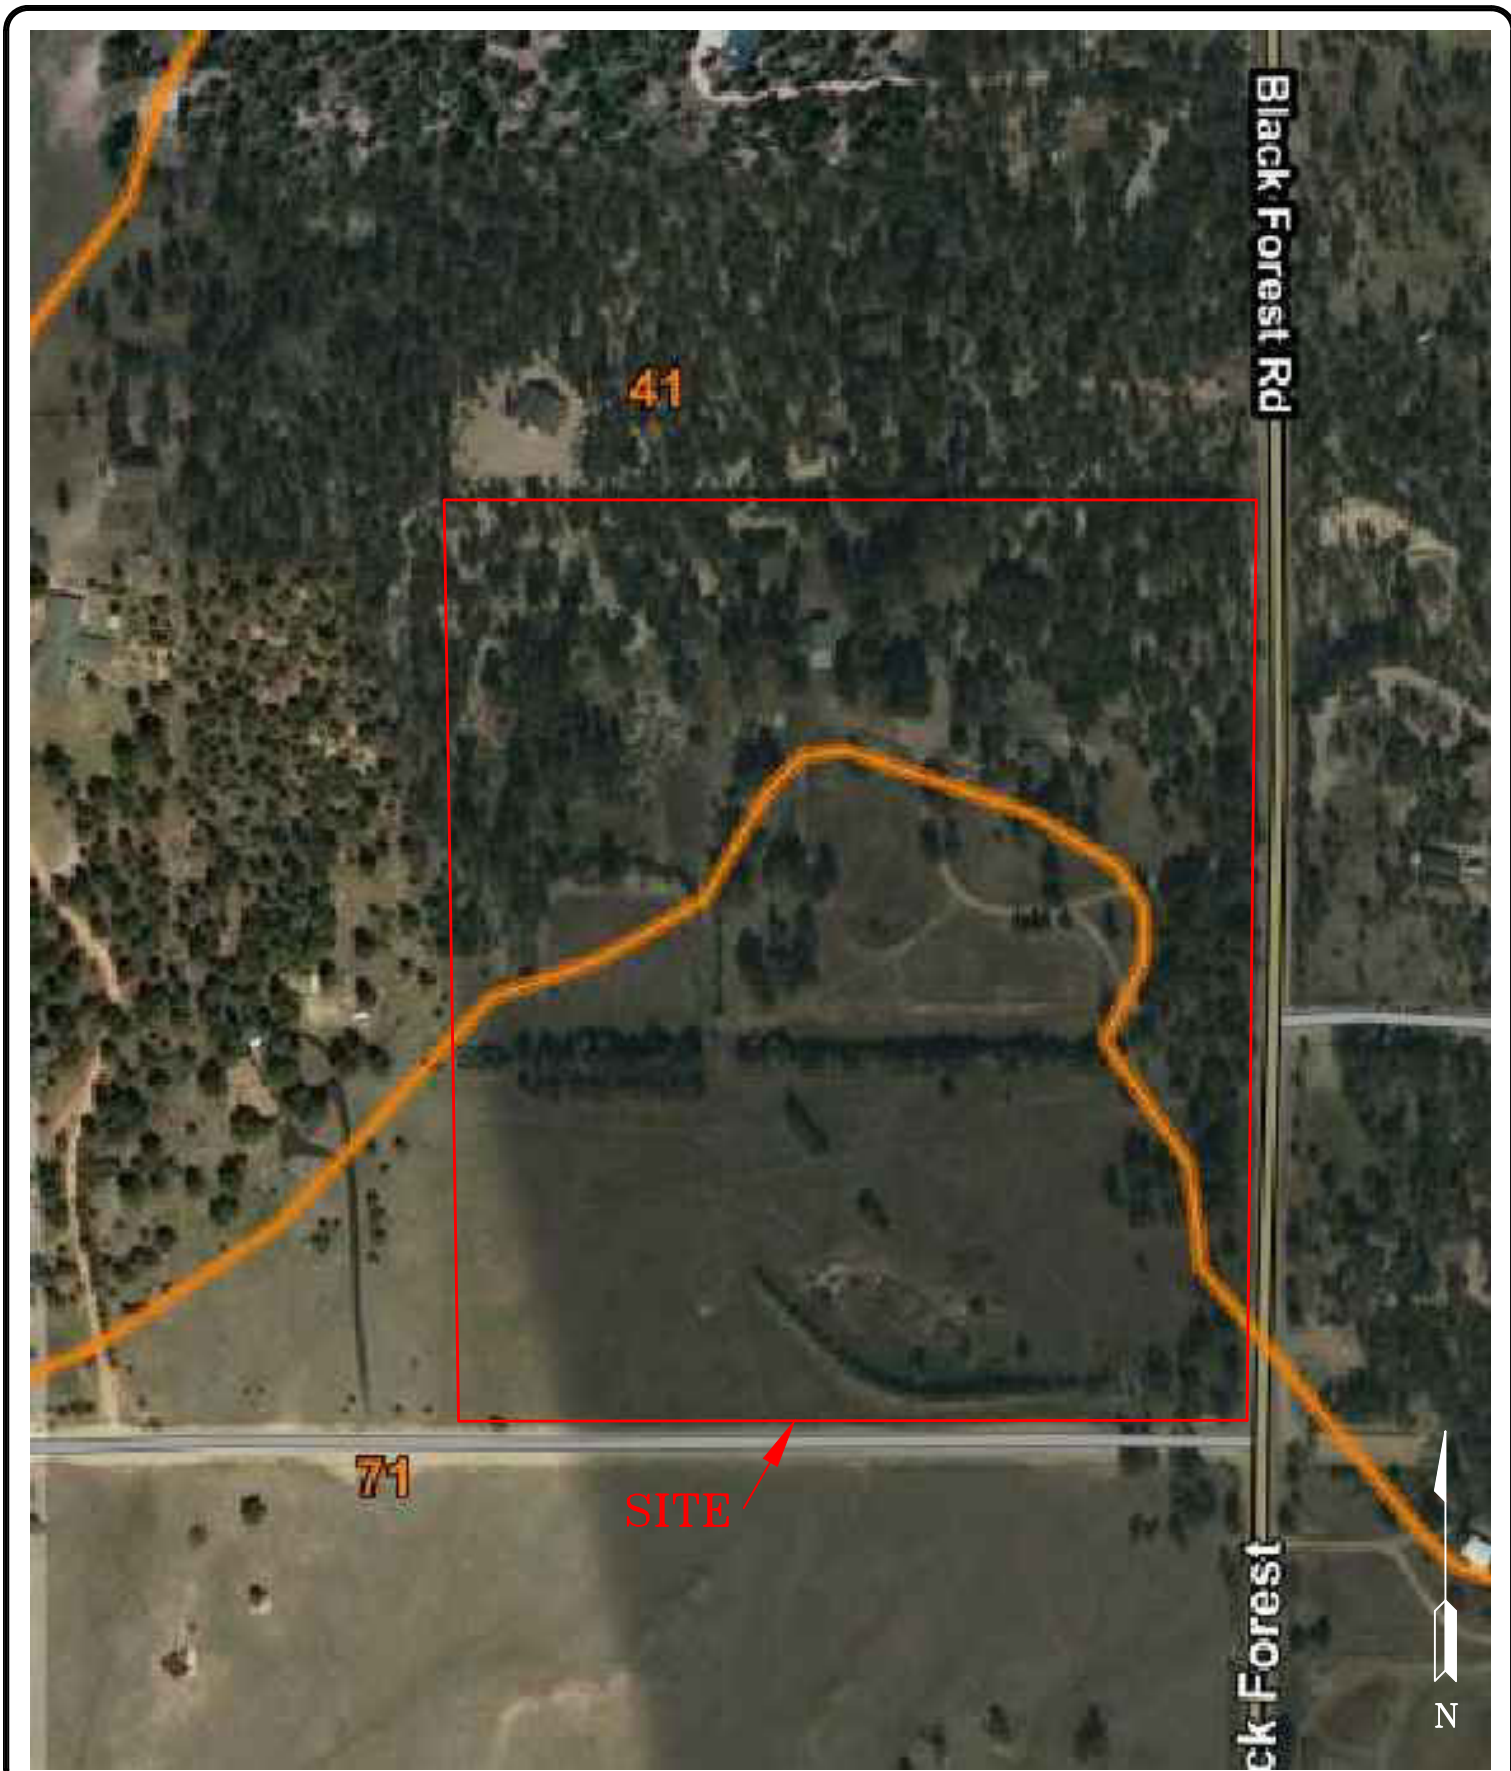
FIG NO.:  
4

SOIL SURVEY MAP  
10650 BLACK FOREST ROAD  
EL PASO COUNTY, CO.  
FOR: TAHER NABULSI

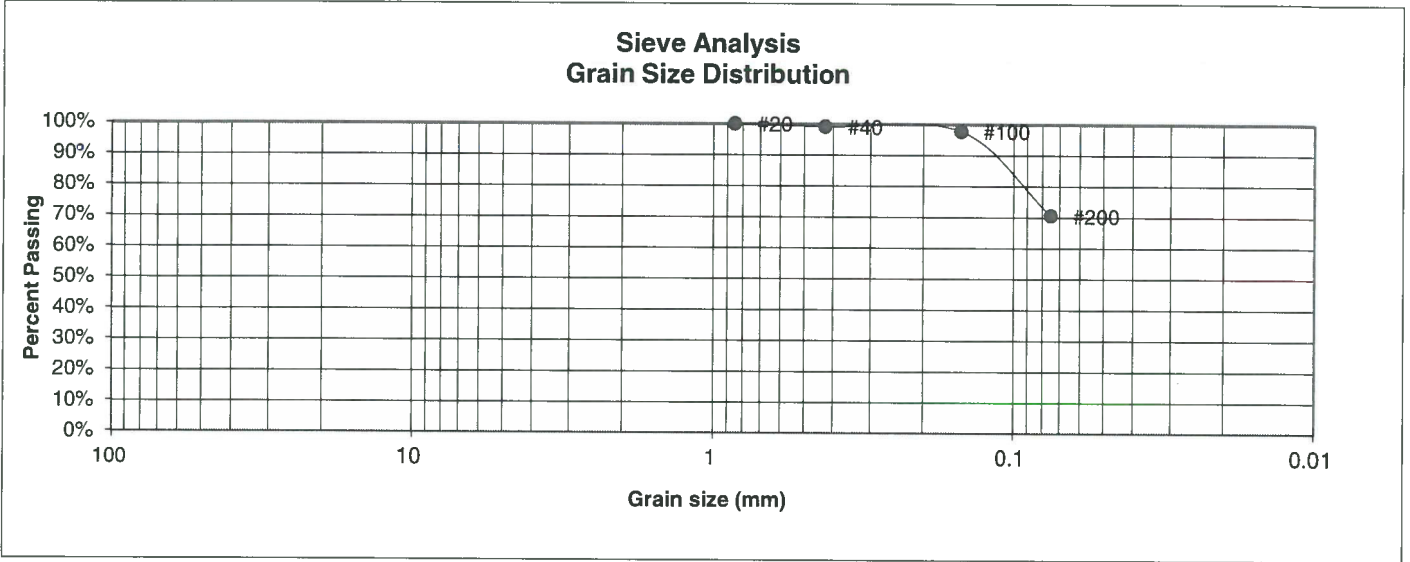
<u>UNIFIED CLASSIFICATION</u>	CL	<u>CLIENT</u>	TAHER NABULSI
<u>SOIL TYPE #</u>	2	<u>PROJECT</u>	10650 BLACK FOREST RD.
<u>TEST BORING #</u>	2	<u>JOB NO.</u>	221371
<u>DEPTH (FT)</u>	15	<u>TEST BY</u>	BL

<u>U.S. Sieve #</u>	<u>Percent Finer</u>
3"	
1 1/2"	
3/4"	
1/2"	
3/8"	
4	
10	
20	100.0%
40	99.1%
100	97.7%
200	70.5%

<u>Atterberg Limits</u>	
Plastic Limit	23
Liquid Limit	37
Plastic Index	14
