**ENTECH**  
ENGINEERING, INC.

September 9, 2022  
Revised May 22, 2023  
Revised April 22, 2024

Re: OWTS – Wastewater Study  
10650 Black Forest Road  
Parcel No. 52190-00-101  
El Paso County, Colorado  
Entech Job No. 221371

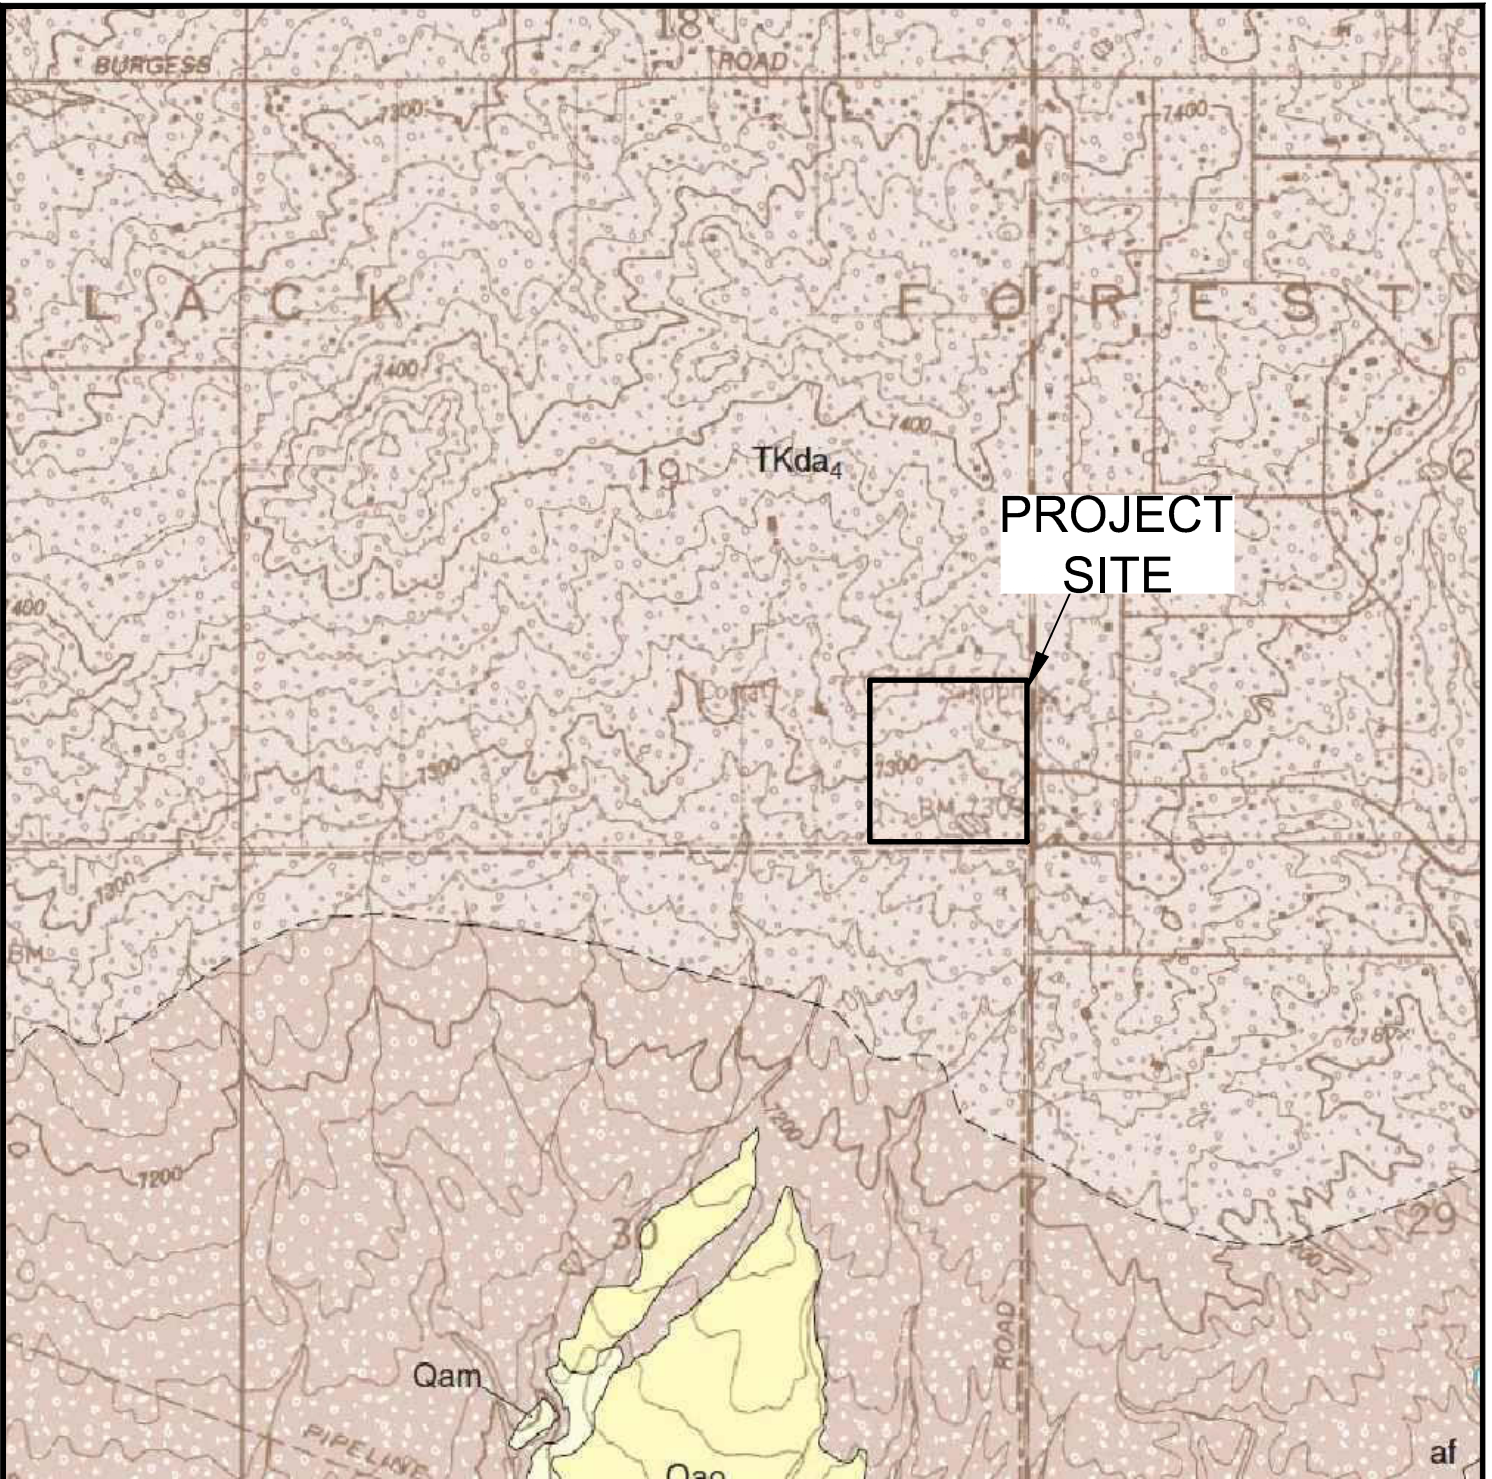
**FIG. 5**

**GEOLOGIC MAP OF THE FALCON  
NORTHWEST QUADRANGLE**  
10650 BLACK FOREST ROAD  
TAHER NABULSI

The geology of the site was evaluated using the *Geologic Map of the Falcon NW Quadrangle*, by Madole in 2003, (Reference 4, Figure 5). The Geology Map for the site is presented in Figure 6. Two mappable units were identified on this site which is described as follows:

The soils listed above were mapped from site-specific mapping, the *Geologic Map of the Falcon NW Quadrangle* distributed by the Colorado Geologic Survey in 2003 (Reference 4, Figure 5), the *Geologic Map of the Colorado Springs-Castle Rock Area*, distributed by the US Geological Survey in 1979 (Reference 5), and the *Geologic Map of the Pueblo 1° x 2° Quadrangle*, distributed by the US Geological Survey in 1978 (Reference 6). The test borings were used in evaluating the site and are included in Appendix B. The Geology Map prepared for the site is presented in Figure 6.

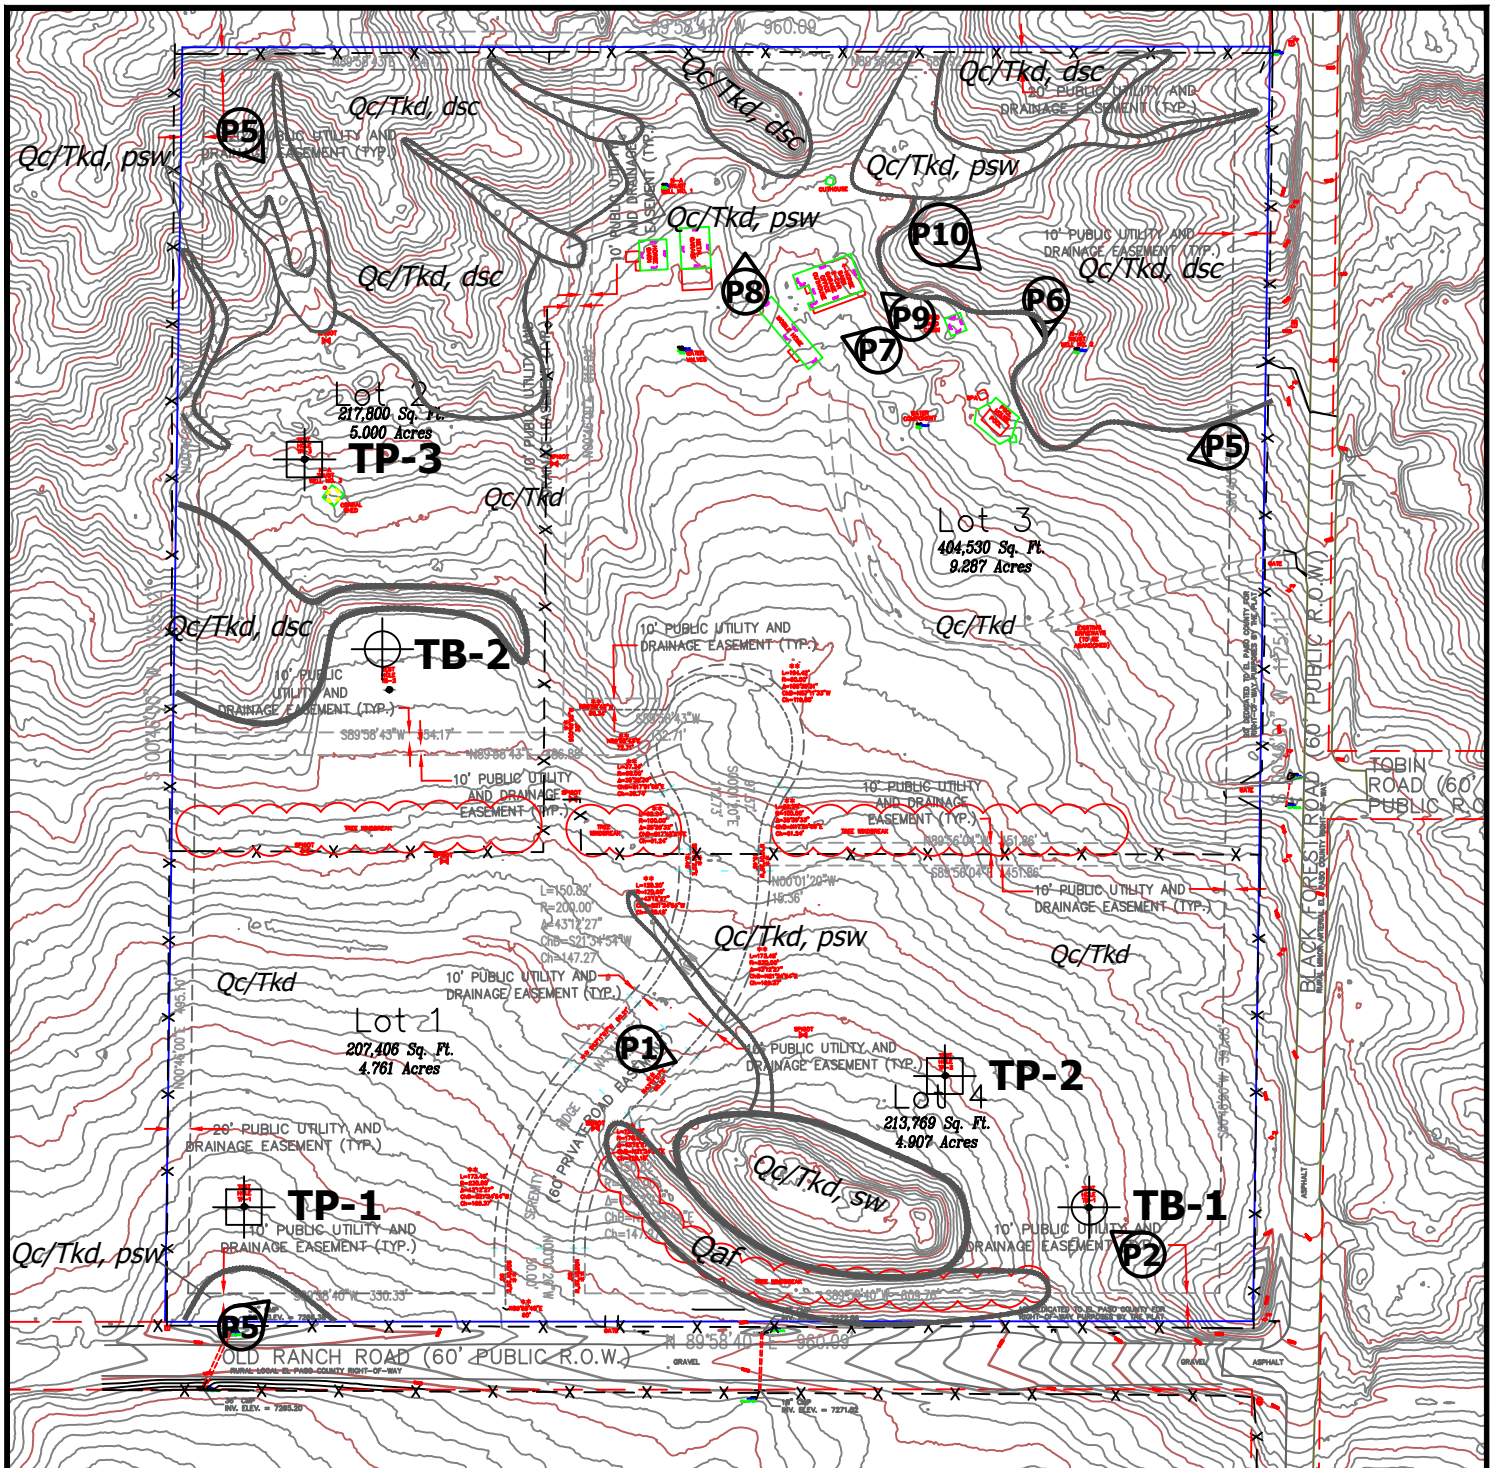
**FIG. 6**

**Legend:**

Qaf - Artificially Man Made Fill of of Quaternary Age

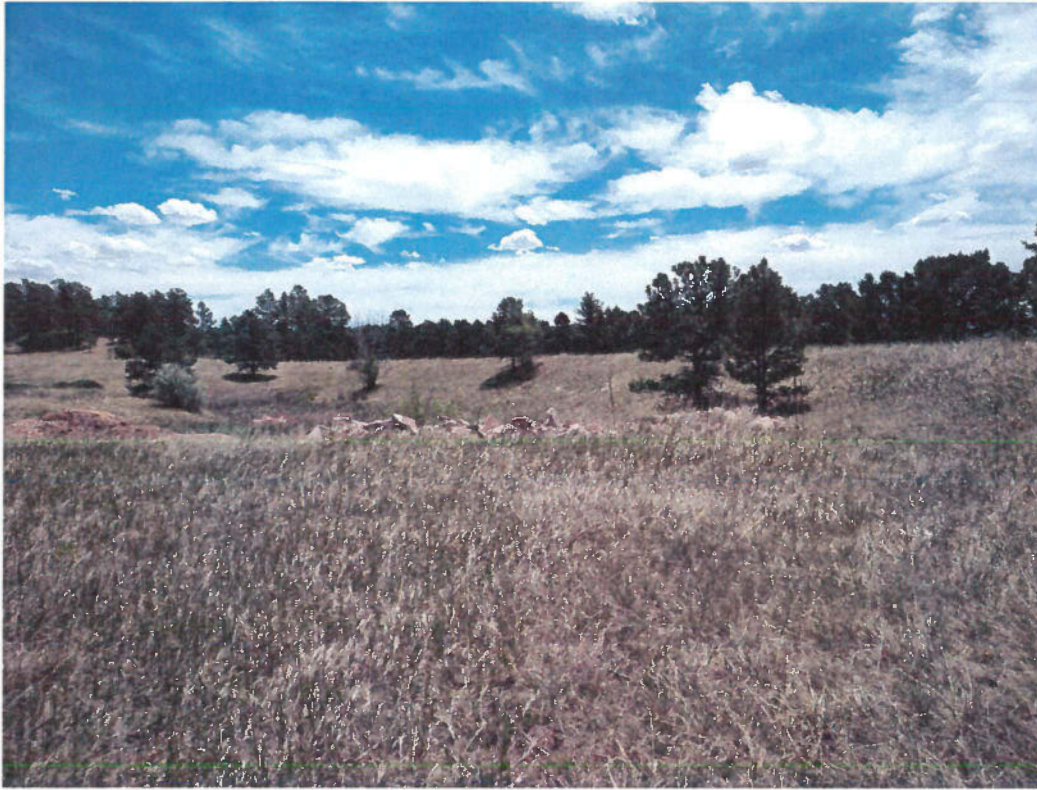
**Looking east from the northwest side of the pond.**

Several minor drainage swales are located across the property with a low-lying potentially seasonally shallow groundwater area in the southwest portion of the site and a pond in the southeastern portion of the site. Water was not observed in the pond or minor drainage swales at the time of this investigation. These areas are indicated in the Geology/Engineering Geology Map (Figure 6) and are discussed below. Due to the size of the proposed lots these areas can be avoided or redirected around proposed structures or proposed soil treatment areas. The anticipated building areas are not affected by these areas. The site does not lie within any floodplain zones according to the FEMA Map No. 08041CO527G dated December 7, 2018 (Figure 7, Reference 7). Exact locations of floodplain and specific drainage studies are beyond the scope of this report. Individual wastewater treatment systems must be located a minimum of 25 feet from dry gulches and 50 feet from water courses, drainage ponds or floodplains.

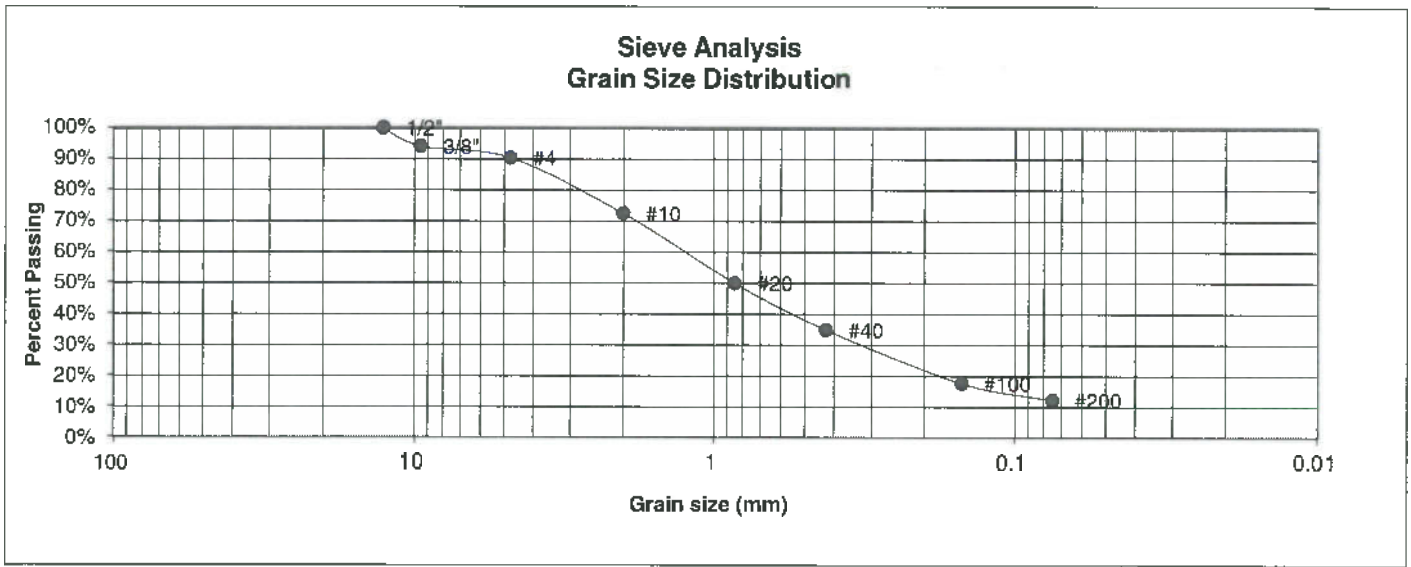
FIG NO.:  
6-2

<b>UNIFIED CLASSIFICATION</b>	SM	<b>CLIENT</b>	TAHER NABULSI
<b>SOIL TYPE #</b>	1	<b>PROJECT</b>	10650 BLACK FOREST RD.
<b>TEST BORING #</b>	TP-2	<b>JOB NO.</b>	221371
<b>DEPTH (FT)</b>	3.5	<b>TEST BY</b>	BL

U.S. Sieve #	Percent Finer
3"	
1 1/2"	
3/4"	
1/2"	100.0%
3/8"	94.1%
4	90.4%
10	72.5%
20	50.0%
40	34.9%
100	17.6%
200	12.2%

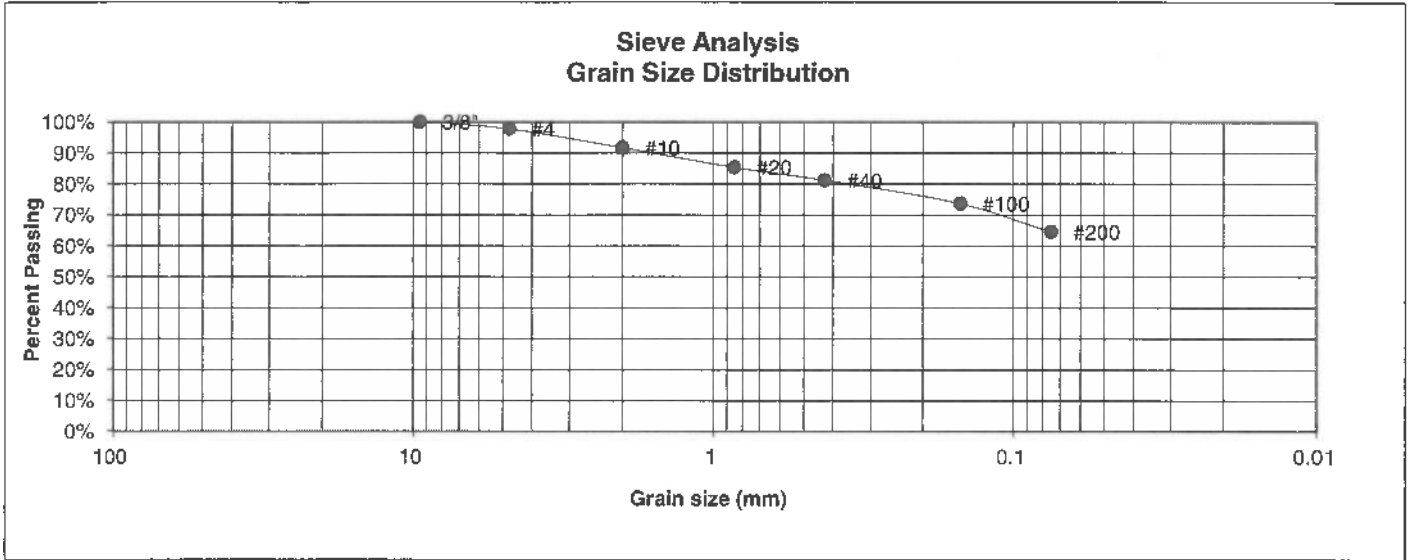
FIG NO.:  
6-3

<b>UNIFIED CLASSIFICATION</b>	CL	<b>CLIENT</b>	TAHER NABULSI
<b>SOIL TYPE #</b>	2	<b>PROJECT</b>	10650 BLACK FOREST RD.
<b>TEST BORING #</b>	TP-2	<b>JOB NO.</b>	221371
<b>DEPTH (FT)</b>	7.5	<b>TEST BY</b>	BL

U.S. Sieve #	Percent Finer
3"	
1 1/2"	
3/4"	
1/2"	
3/8"	100.0%
4	97.8%
10	91.6%
20	85.3%
40	81.2%
100	73.7%
200	64.5%

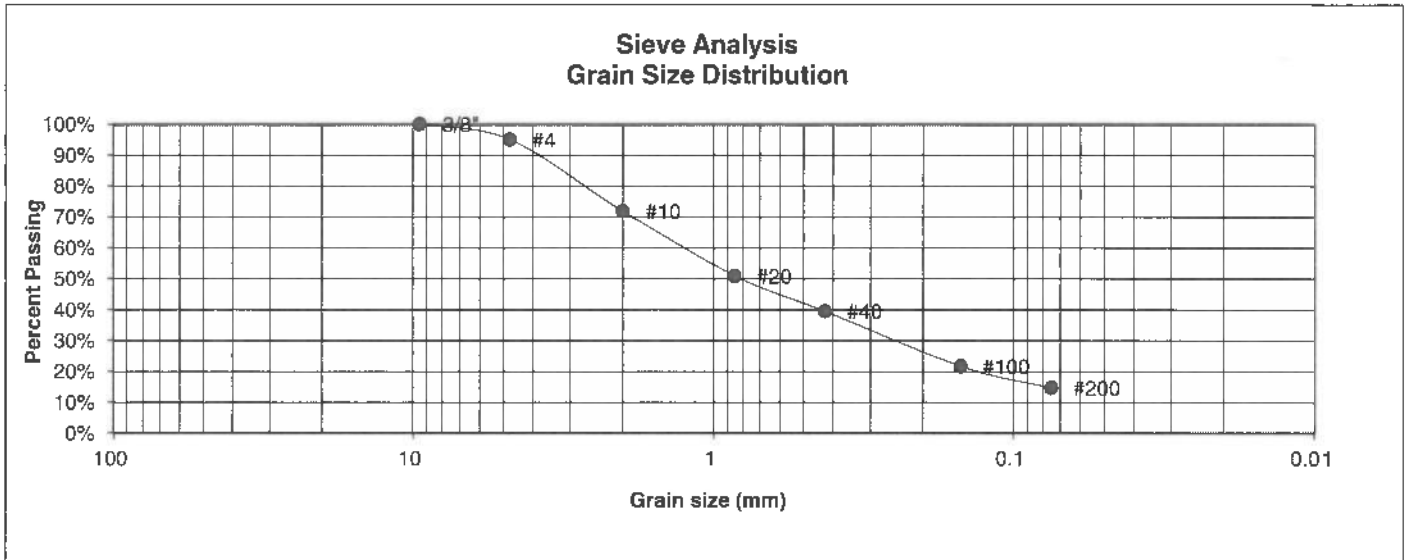
FIG NO.:  
C-4

UNIFIED CLASSIFICATION	SM	CLIENT	TAHER NABULSI
SOIL TYPE #	1	PROJECT	10650 BLACK FOREST RD.
TEST BORING #	TP-3	JOB NO.	221371
DEPTH (FT)	5.5	TEST BY	BL

U.S. Sieve #	Percent Finer
3"	
1 1/2"	
3/4"	
1/2"	
3/8"	100.0%
4	95.1%
10	71.9%
20	51.0%
40	39.5%
100	21.7%
200	14.7%

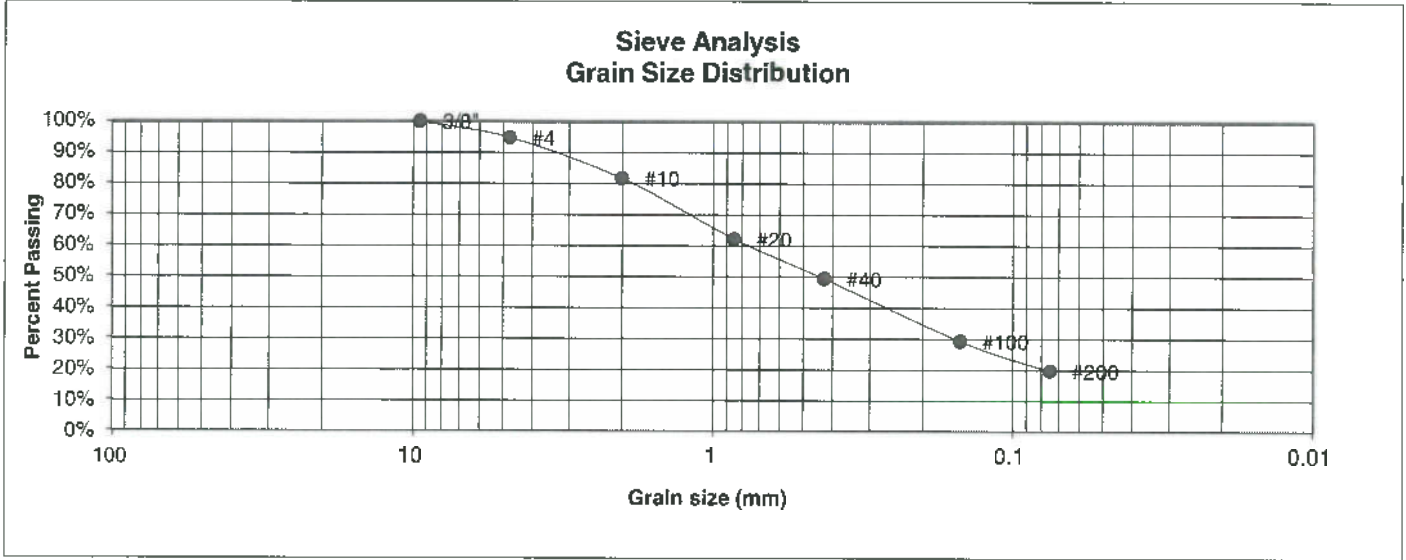
C-6

UNIFIED CLASSIFICATION	SM	CLIENT	TAHER NABULSI
SOIL TYPE #	1	PROJECT	10650 BLACK FOREST RD.
TEST BORING #	2	JOB NO.	221371
DEPTH (FT)	5	TEST BY	BL

U.S. Sieve #	Percent Finer
3"	
1 1/2"	
3/4"	
1/2"	
3/8"	100.0%
4	94.8%
10	81.8%
20	62.2%
40	49.4%
100	29.3%
200	19.7%

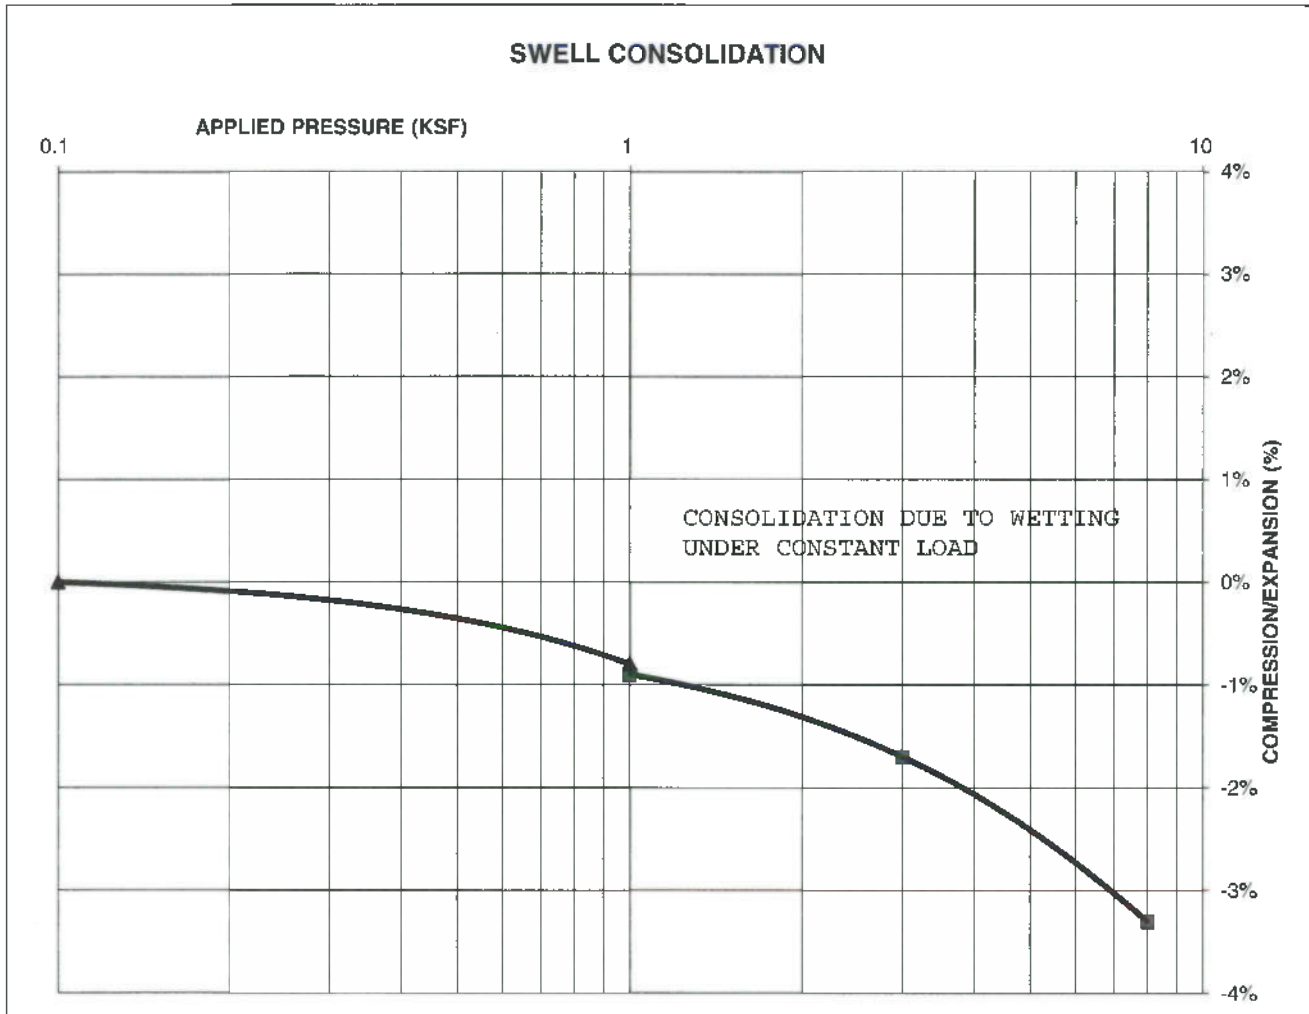
TEST BORING #	1	DEPTH(ft)	10
DESCRIPTION	CL	SOIL TYPE	2
NATURAL UNIT DRY WEIGHT (PCF)			121
NATURAL MOISTURE CONTENT			8.8%
SWELL/CONSOLIDATION (%)			-0.1%
