ENTECH
ENGINEERING, INC.

Re: Soils and Geology Study
10650 Black Forest Road
Parcel No. 52190-00-101
El Paso County, Colorado
Entech Job No. 221371

The project consists of subdividing 24.79-acres; four rural residential lots are proposed as part of the subdivision. The site is located northwest of the intersection of Black Forest Road and Old Ranch Road, in El Paso County, Colorado.

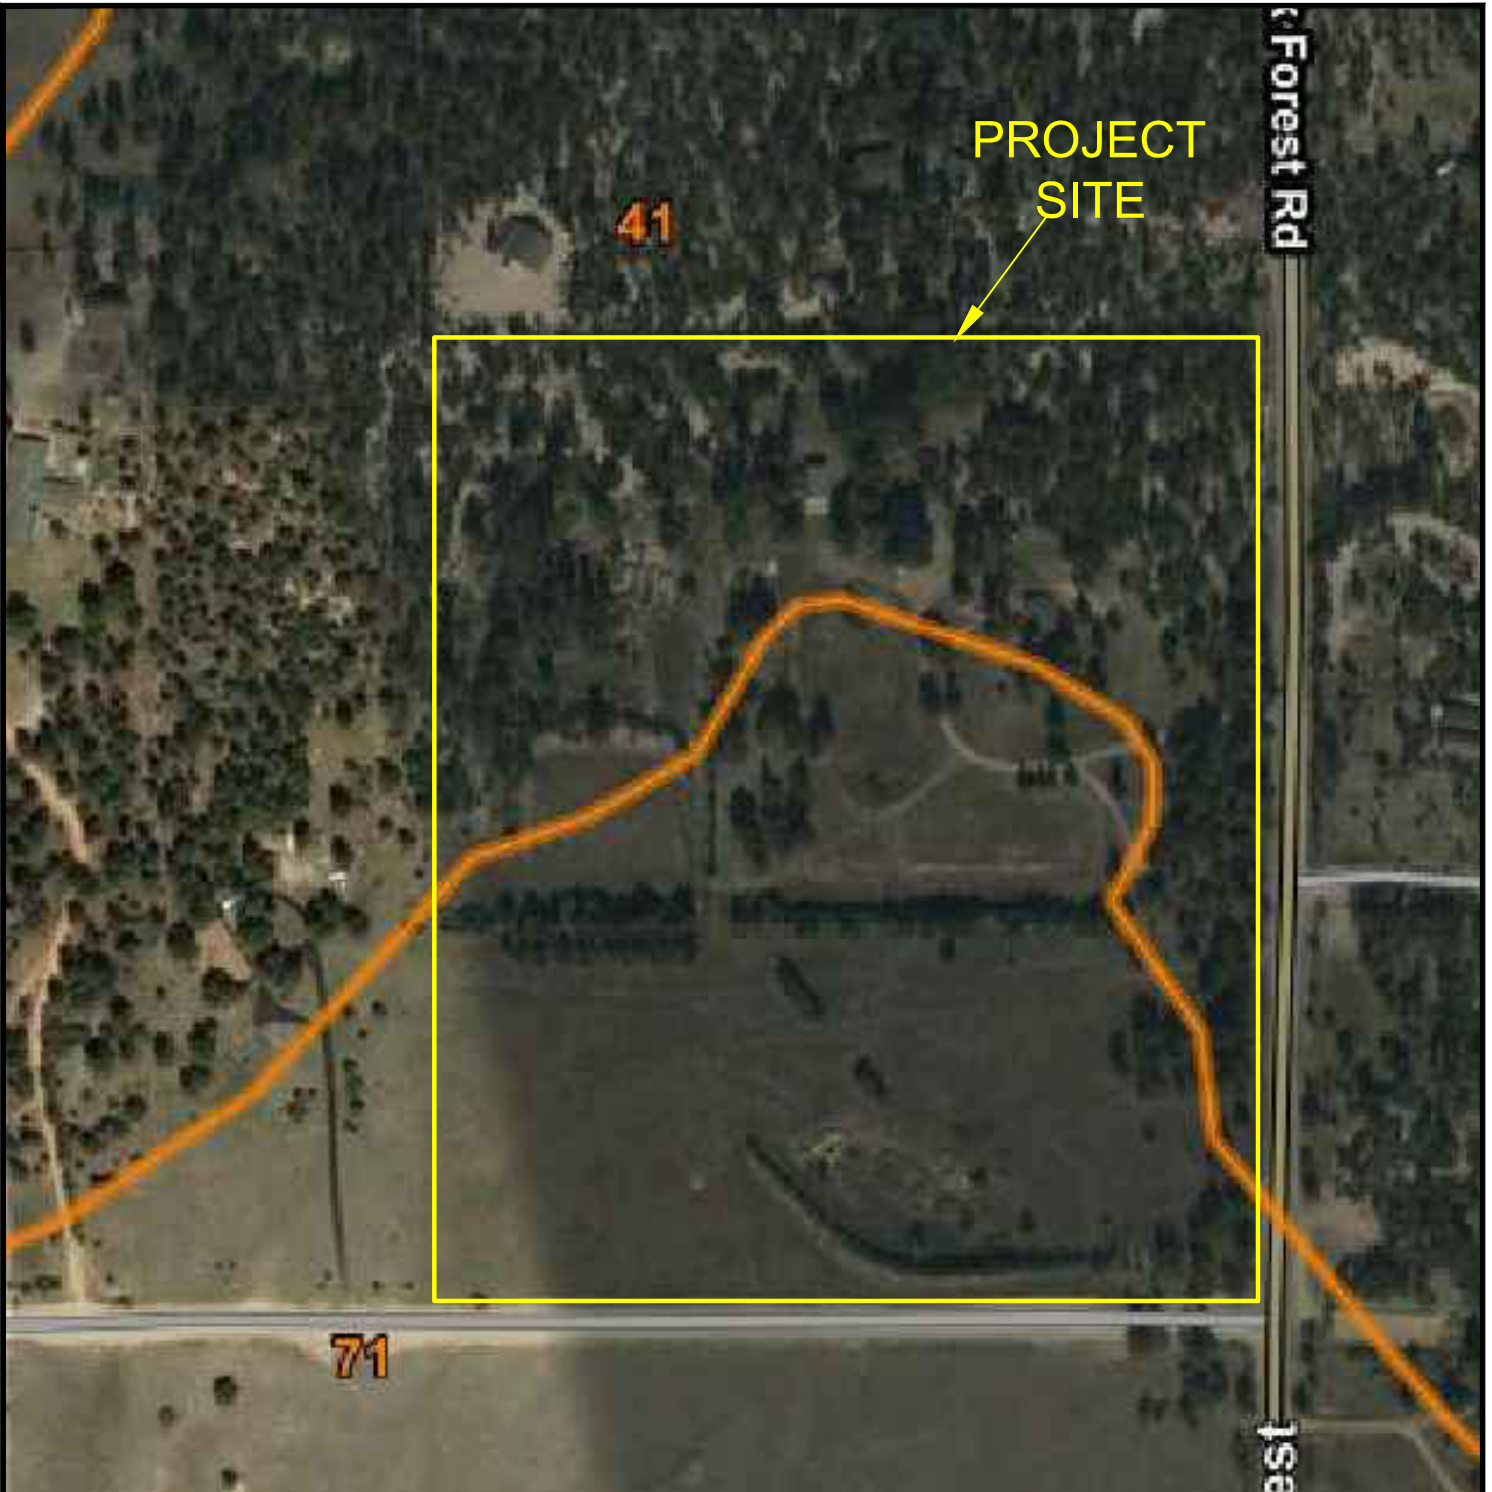
FIG. 4

SOIL SURVEY MAP

The Natural Resource Conservation Service (NRCS) (Reference 1, Figure 4), previously the Soil Conservation Service (Reference 2) has mapped three soil types on the site. Complete descriptions of the soil types are presented in Appendix D. In general, the soils consist of gravelly loamy sand to sandy loam. The soils are described as follows:

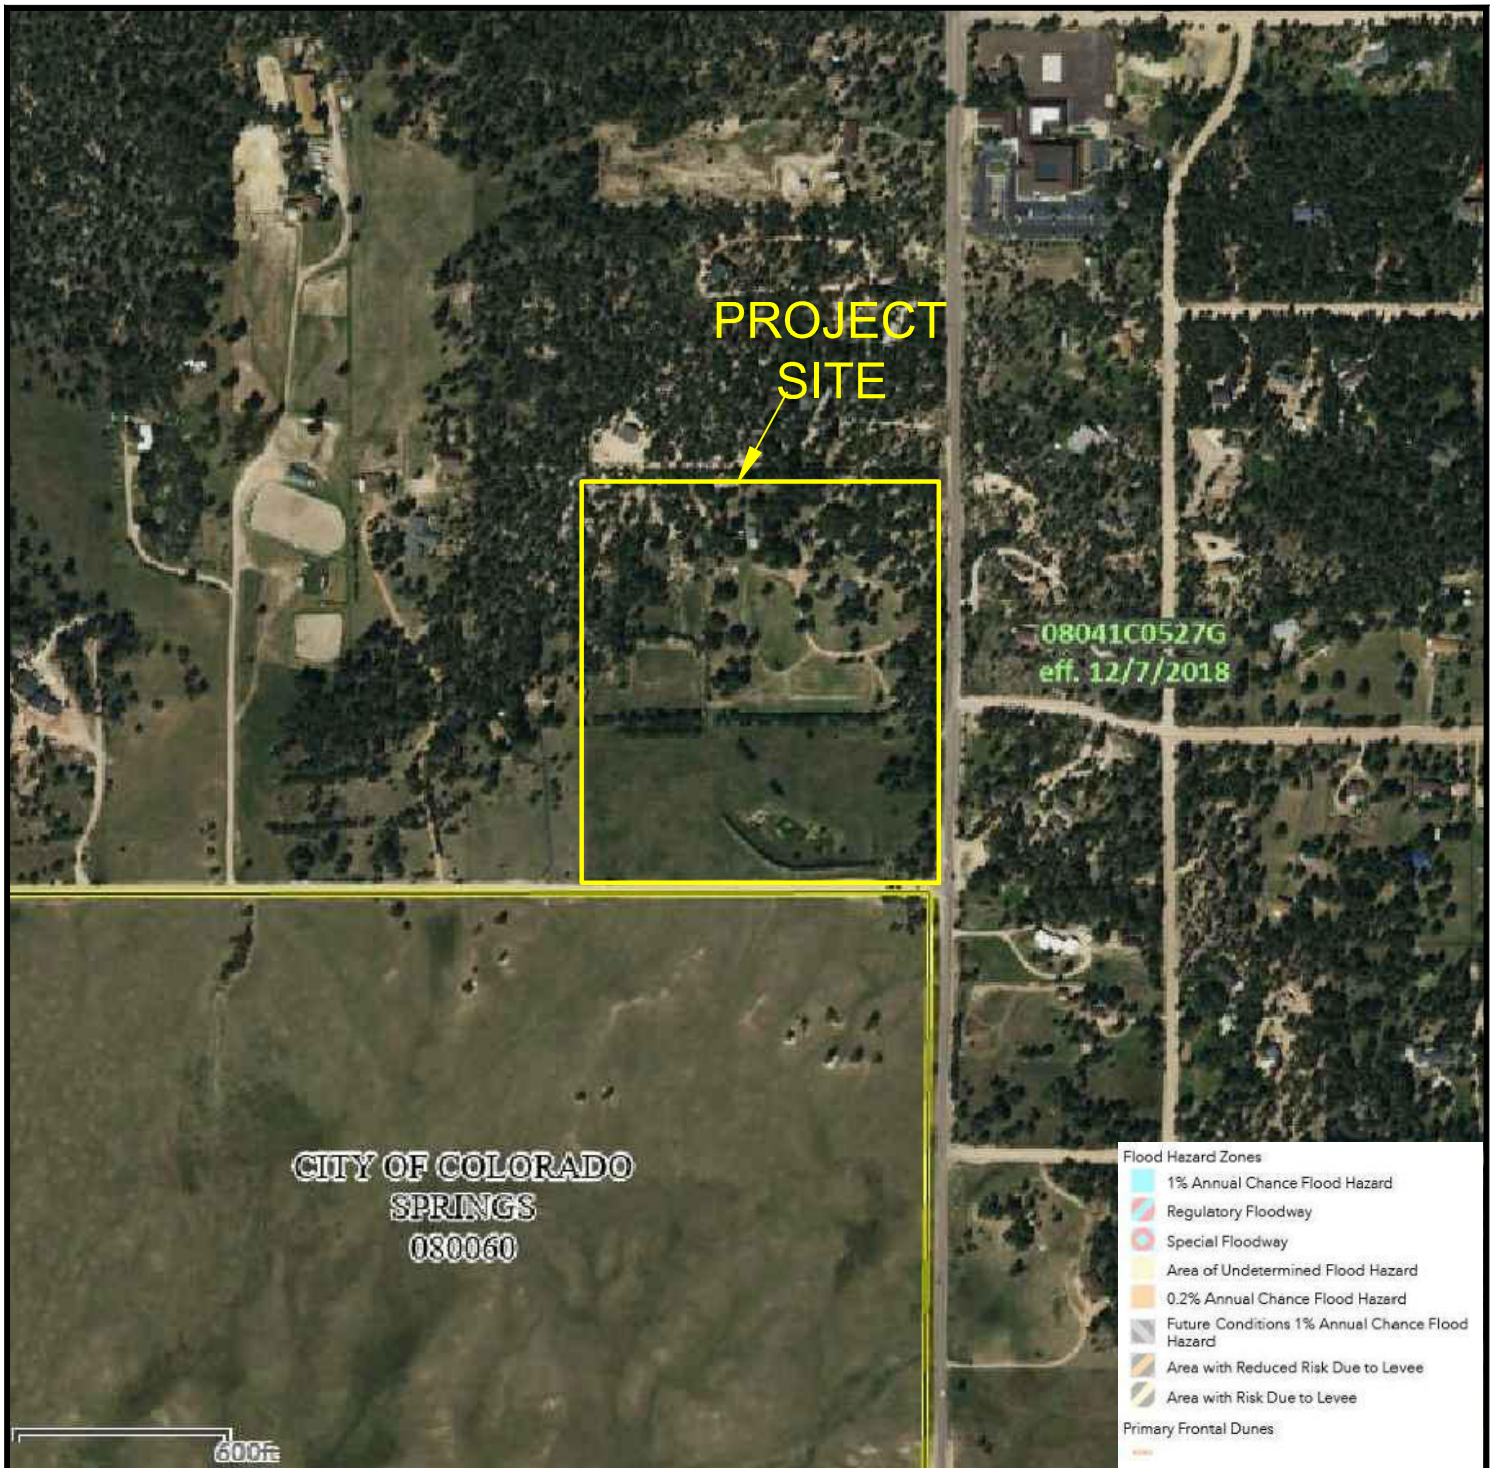
FIG. 7

FEMA FLOODPLAIN MAP

Several minor drainage swales are located across the property with a low-lying potentially seasonally shallow groundwater area in the southwest portion of the site and a pond in the southeastern portion of the site. Water was not observed in the pond or minor drainage swales at the time of this investigation. These areas are indicated in the Geology/Engineering Geology Map (Figure 6) and are discussed below. Due to the size of the proposed lots these areas can be avoided or redirected around proposed structures or proposed soil treatment areas. The site does not lie within any floodplain zones according to the FEMA Map No. 08041CO527G dated December 7, 2018 (Figure 7, Reference 7). Exact locations of floodplain and specific drainage studies are beyond the scope of this report.
