ENTECH
ENGINEERING, INC.

Re: OWTS – Wastewater Study
10650 Black Forest Road
Parcel No. 52190-00-101
El Paso County, Colorado
Entech Job No. 221371

Taher Nabulsi
OWTS – Wastewater Study-Revised
10650 Black Forest Road
Parcel No. 52190-00-101
El Paso County, Colorado
Entech Job No. 221371

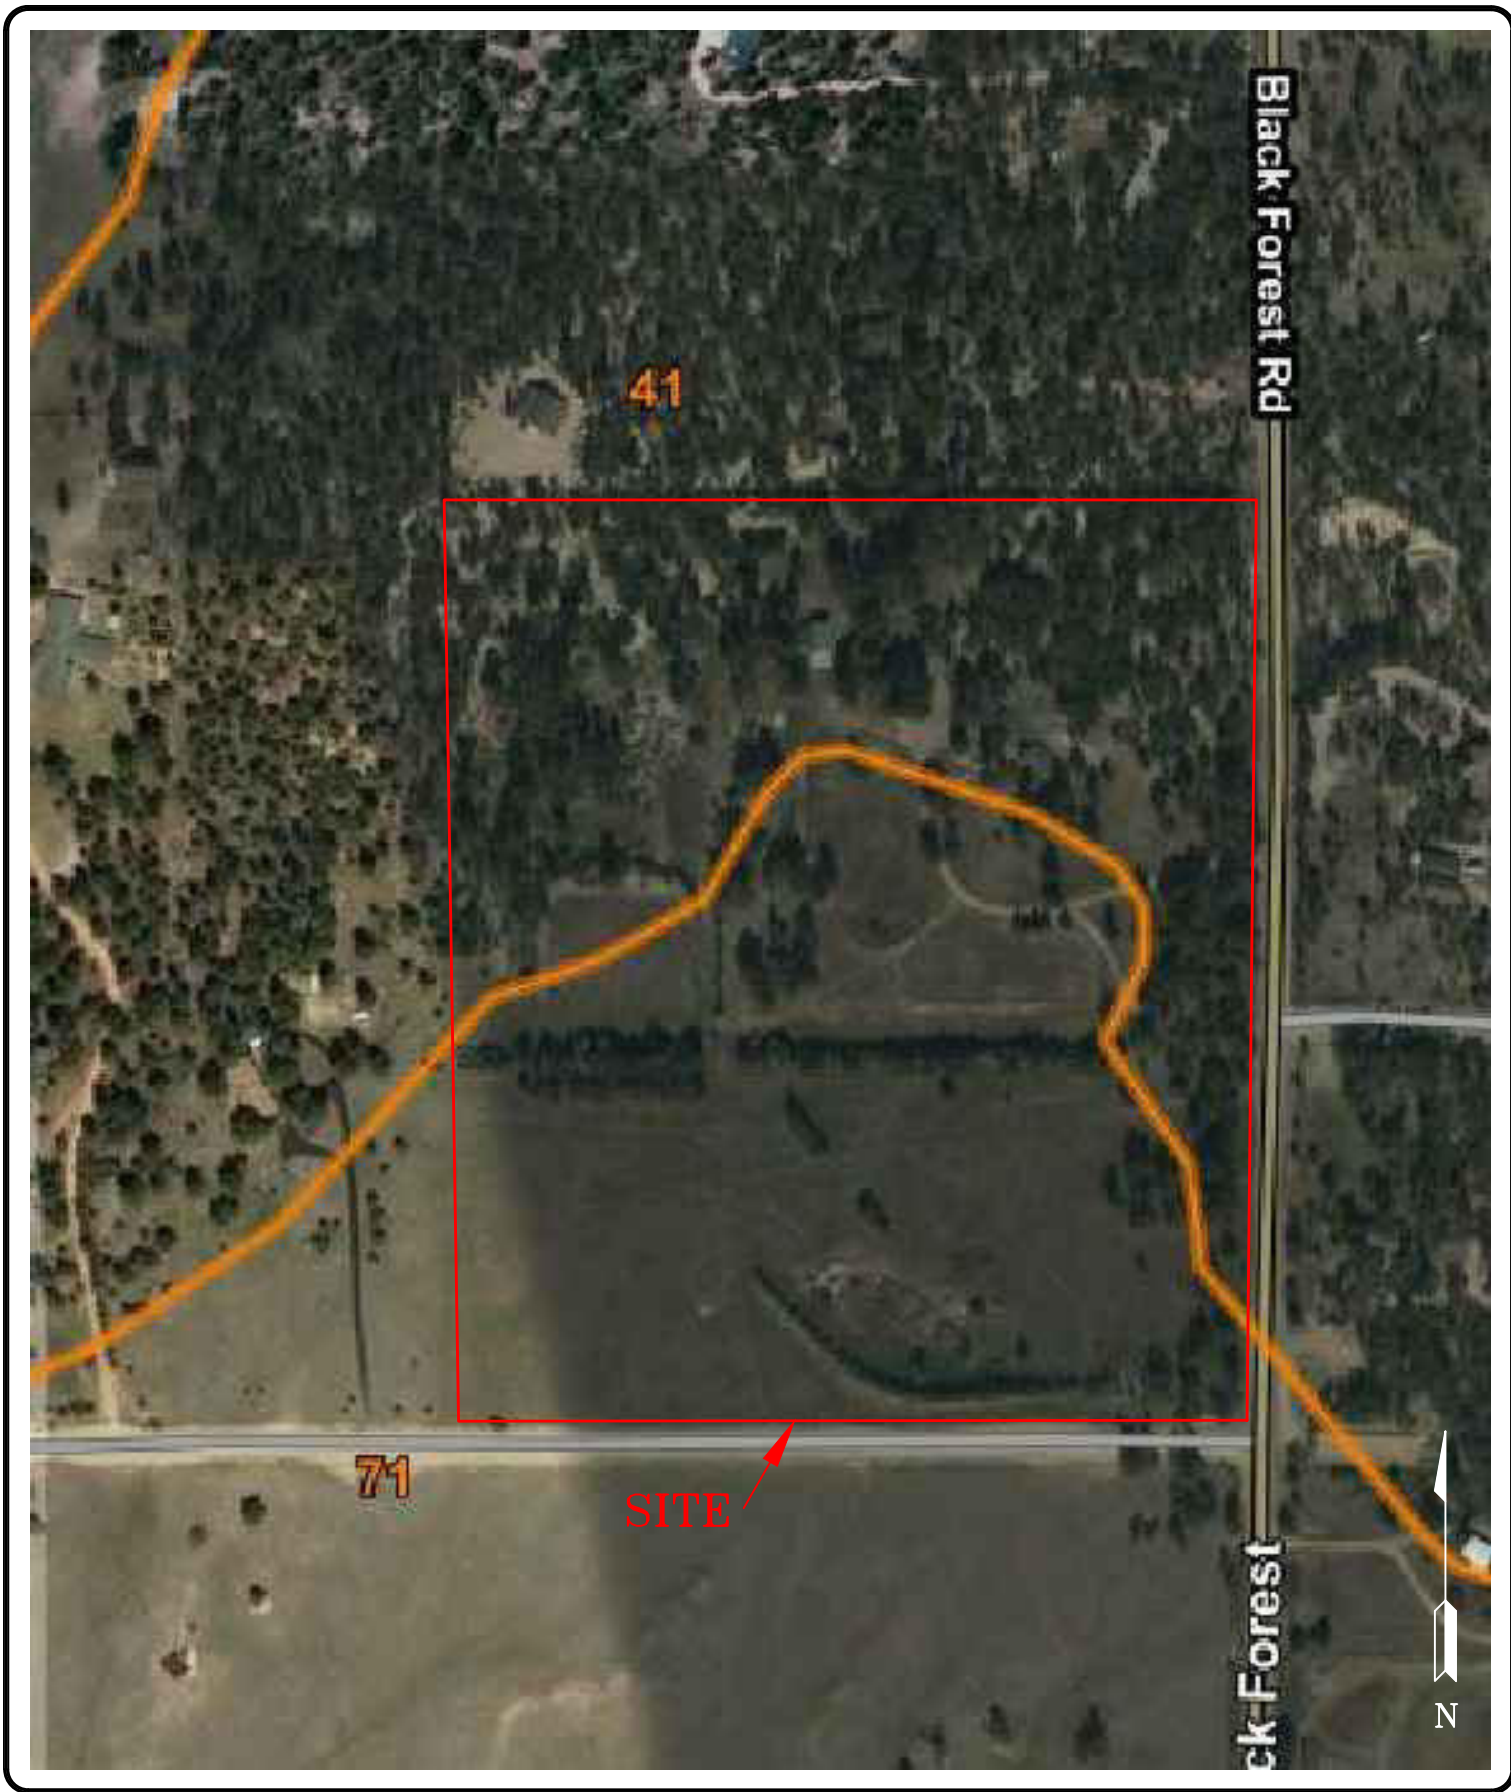
FIG NO.:
4

SOIL SURVEY MAP
 10650 BLACK FOREST ROAD
 EL PASO COUNTY, CO.
 FOR: TAHER NABULSI

The soils have been described to have rapid permeabilities. The soils are described as well suited for use as homesites. Possible hazards with soils erosion are present on the site. The erosion potential can be controlled with vegetation. The soils have been described to have moderate erosion hazards (Reference 2).
