**GEOLOGICAL HAZARDS STUDY  
PROPOSED USAFA EUL DEVELOPMENT  
NORTHGATE BOULEVARD WEST OF INTERSTATE 25  
UNITED STATES AIR FORCE ACADEMY  
EL PASO COUNTY, COLORADO**

**PROJECT NO. 18-2-219**

**AUGUST 31, 2018**

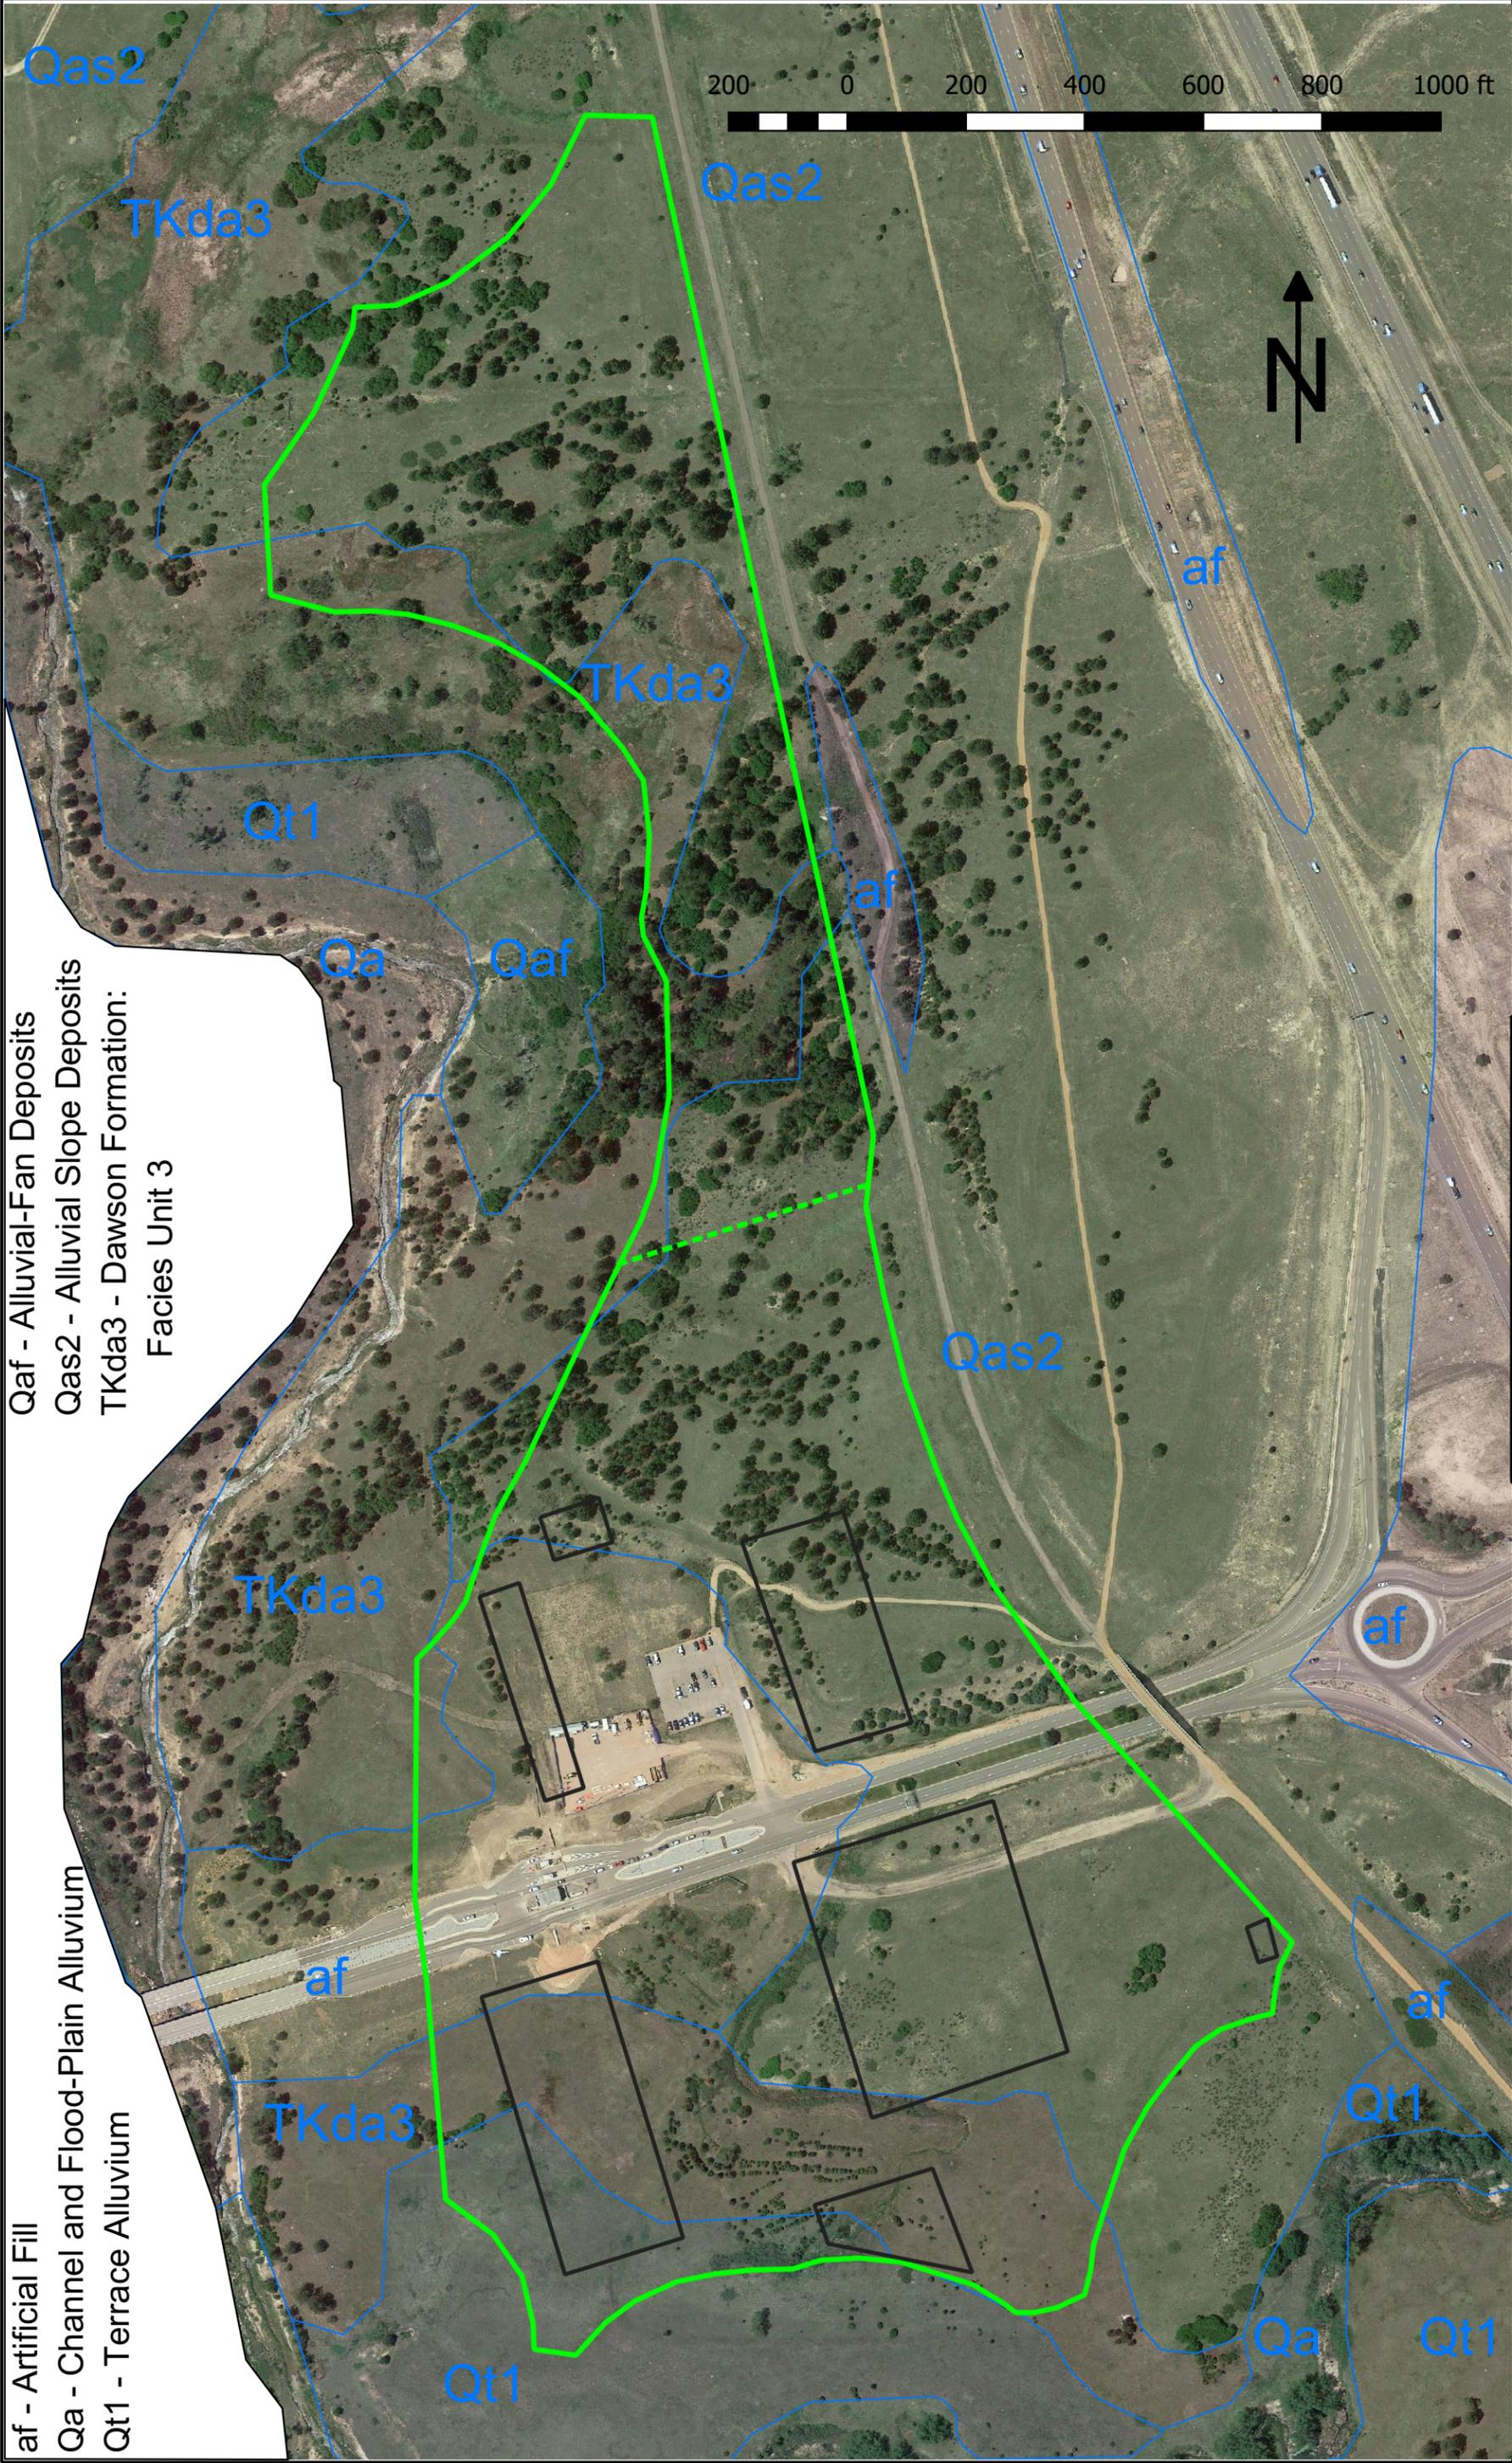
Qaf - Alluvial-Fan Deposits  
 Qas2 - Alluvial Slope Deposits  
 TKda3 - Dawson Formation:  
 Facies Unit 3

af - Artificial Fill  
 Qa - Channel and Flood-Plain Alluvium  
 Qt1 - Terrace Alluvium

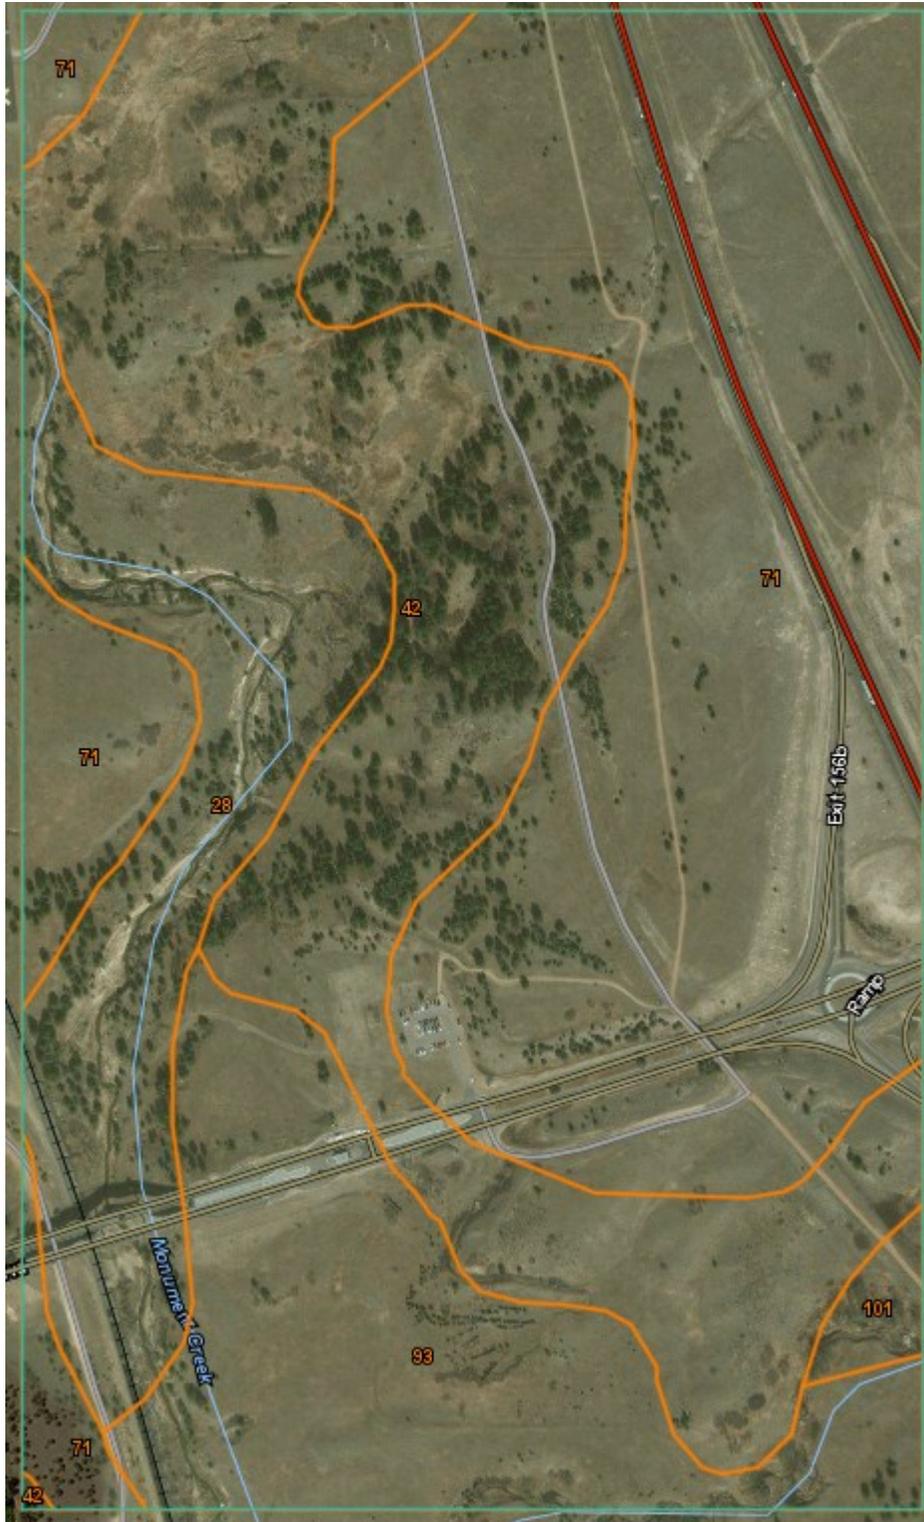
- 28 - Ellicott Loamy Coarse Sand
- 42 - Kettle-Rock Outcrop Complex
- 71 - Pring Coarse Sandy Loam
- 93 - Tomah-Crowfoot Complex
- 101 - Ustic Torrifluvents, Loamy
