SOILS AND GEOLOGY STUDY

**Hillside at Lorson Ranch – “Area I”
El Paso County, Colorado**

JOB NO. 181988

January 3, 2022

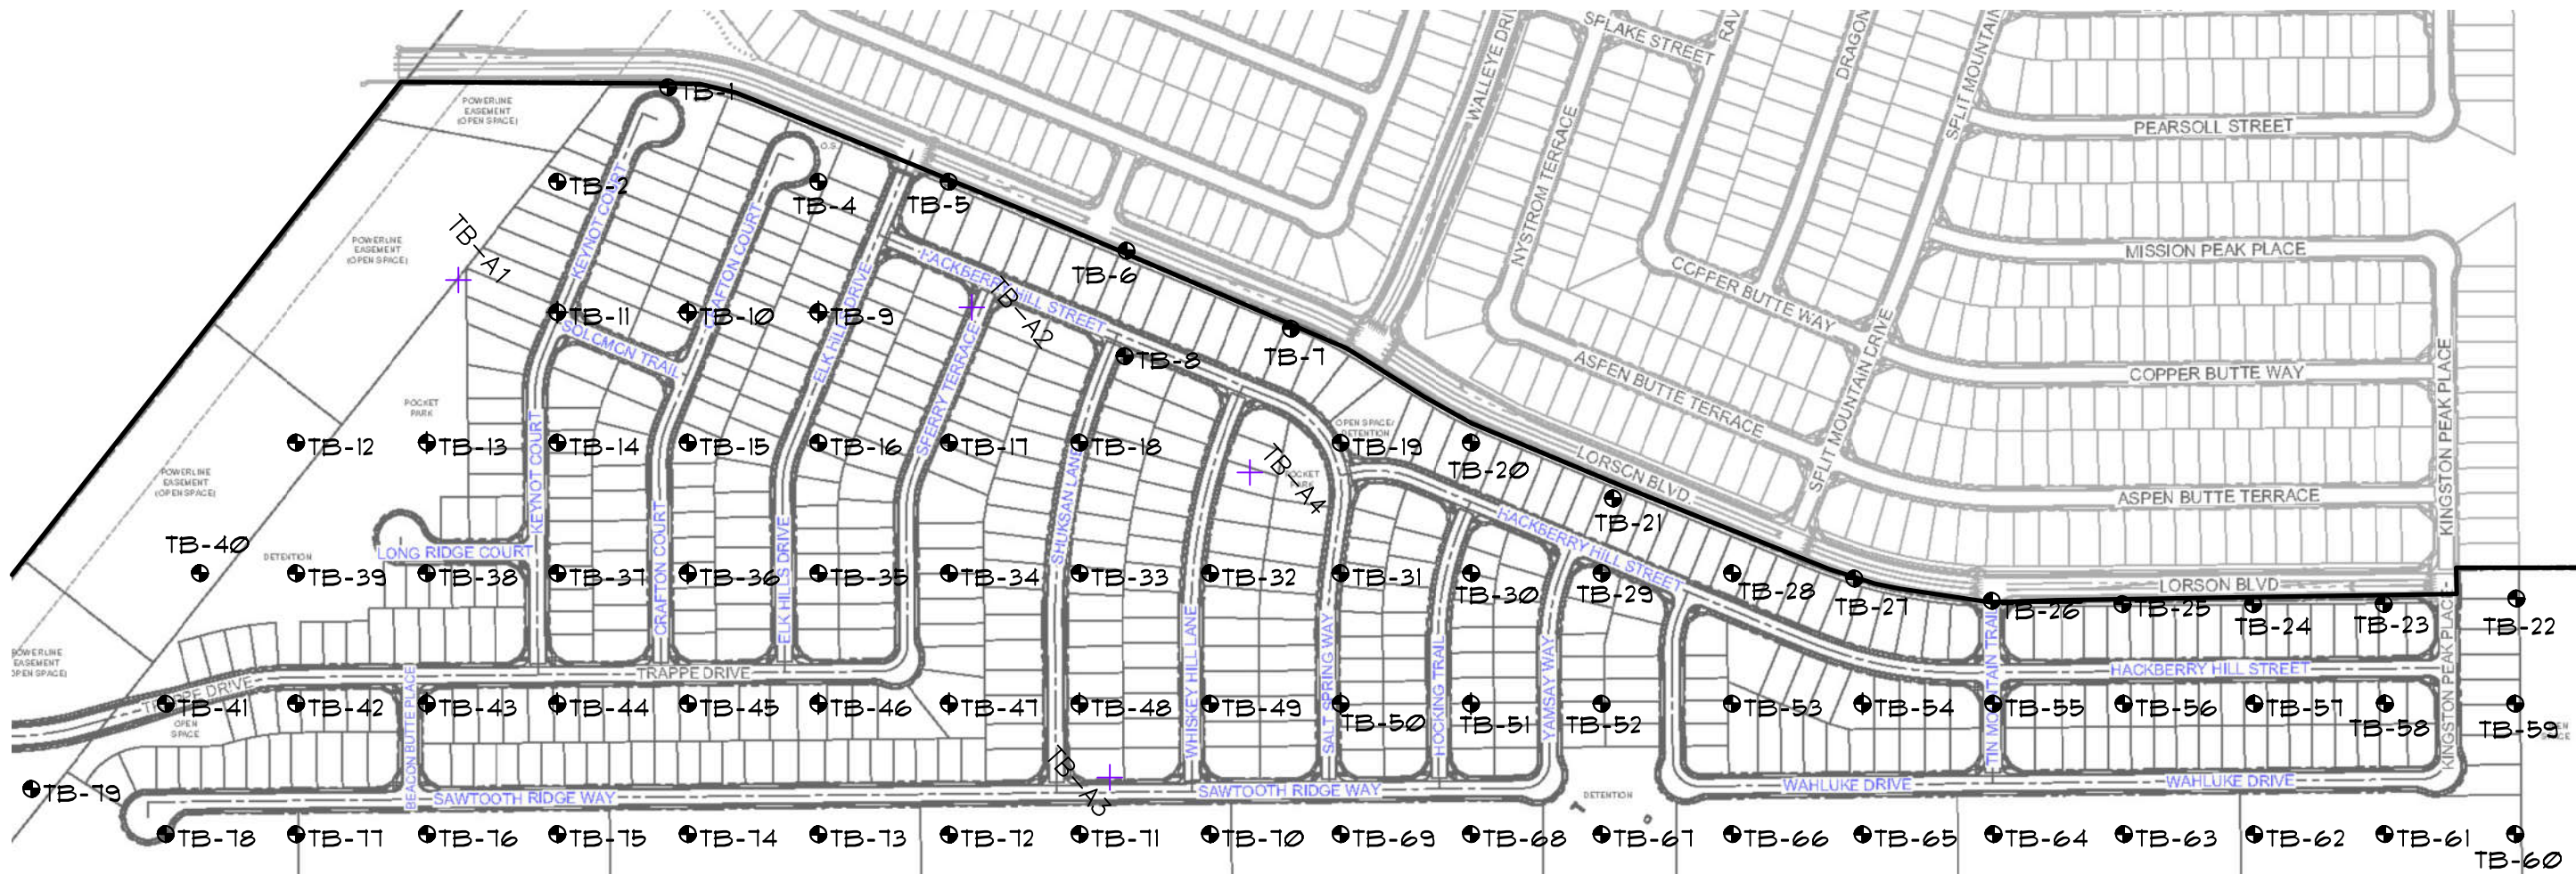
FIG-2

● DENOTES APPROXIMATE
LOCATION OF TEST BORING

The proposed site development is to consist of 494 single-family residential units. The majority of the lots reportedly range from 3,825 to 6,600 square feet. Eight “buffer” lots, approximately 5 acres each along the southern boundary, are to provide transition from the smaller lots within the new Hillside at Lorson Ranch subdivision to the existing Peaceful Valley Lake Estates to the south. Entrance into the subdivision is to be provided from the west by extending the existing Trappe Drive and Lorson Boulevard, from the east by extending Kingston Peak Place, and from the north by two interior roadways (Elk Hills Drive and Tin Mountain Trail) extending south from Lorson Boulevard. Additional proposed land usage includes landscaped easements, parks, open spaces, trail corridors, utility easements, and drainage and detention facilities. The Proposed Lot Layout With Test Boring Locations plan is presented in Figure 2.

The subsurface conditions within the property were explored by drilling 78 exploratory test borings to depths of approximately 12 to 20 feet below the existing ground surface. The test boring locations are presented on the Proposed Lot Layout With Test Boring Locations plan, Figure 2. Additionally, 6 preliminary test borings were performed in March of 2020. The Test Boring Logs for these preliminary borings are included in Appendix B.

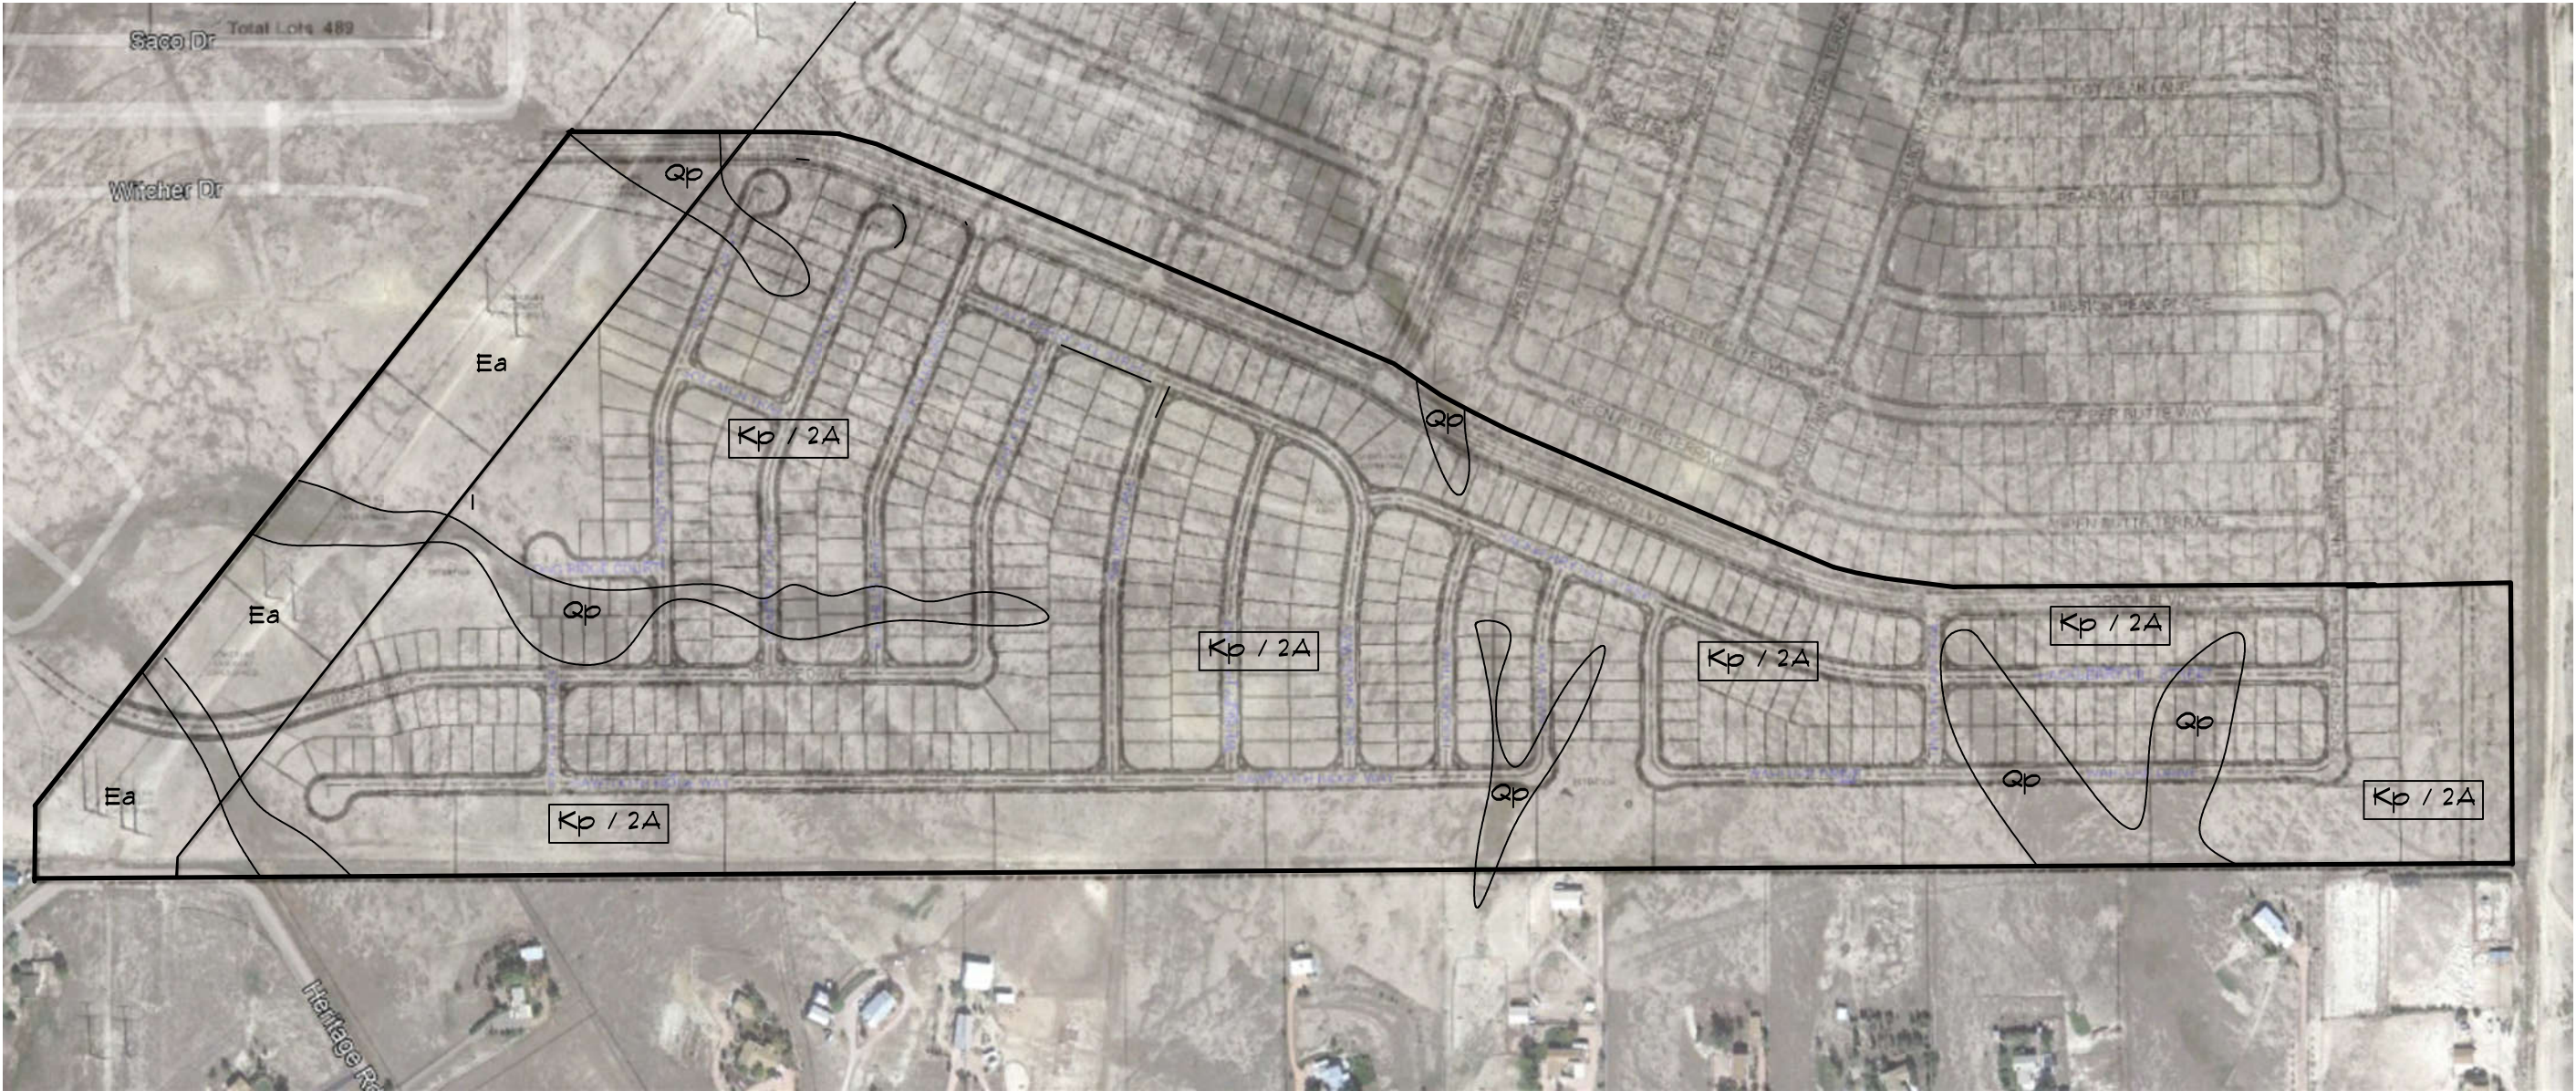
FIGURE No. 84

GEOLOGIC UNITS

- *Qp - Piney Creek Alluvium* - silty to gravelly humus-rich alluvium along/within all valleys. The alluvium was encountered in the borings across the site at various depths and is anticipated in the low-lying areas.
- *Kp - Pierre Shale, cone-in-cone zone of Lavington (1933)* dark-gray to tan-gray to olive-gray, subblocky to finely fissile non-calcareous shale, silty shale with thin bentonite beds and very fine grained-grained sandstone. Thickness of this zone is approximately 2,290 (Scott and Cobban, 1986). Residual clay and claystone were encountered in all the borings across the site up to depths of 20 feet.

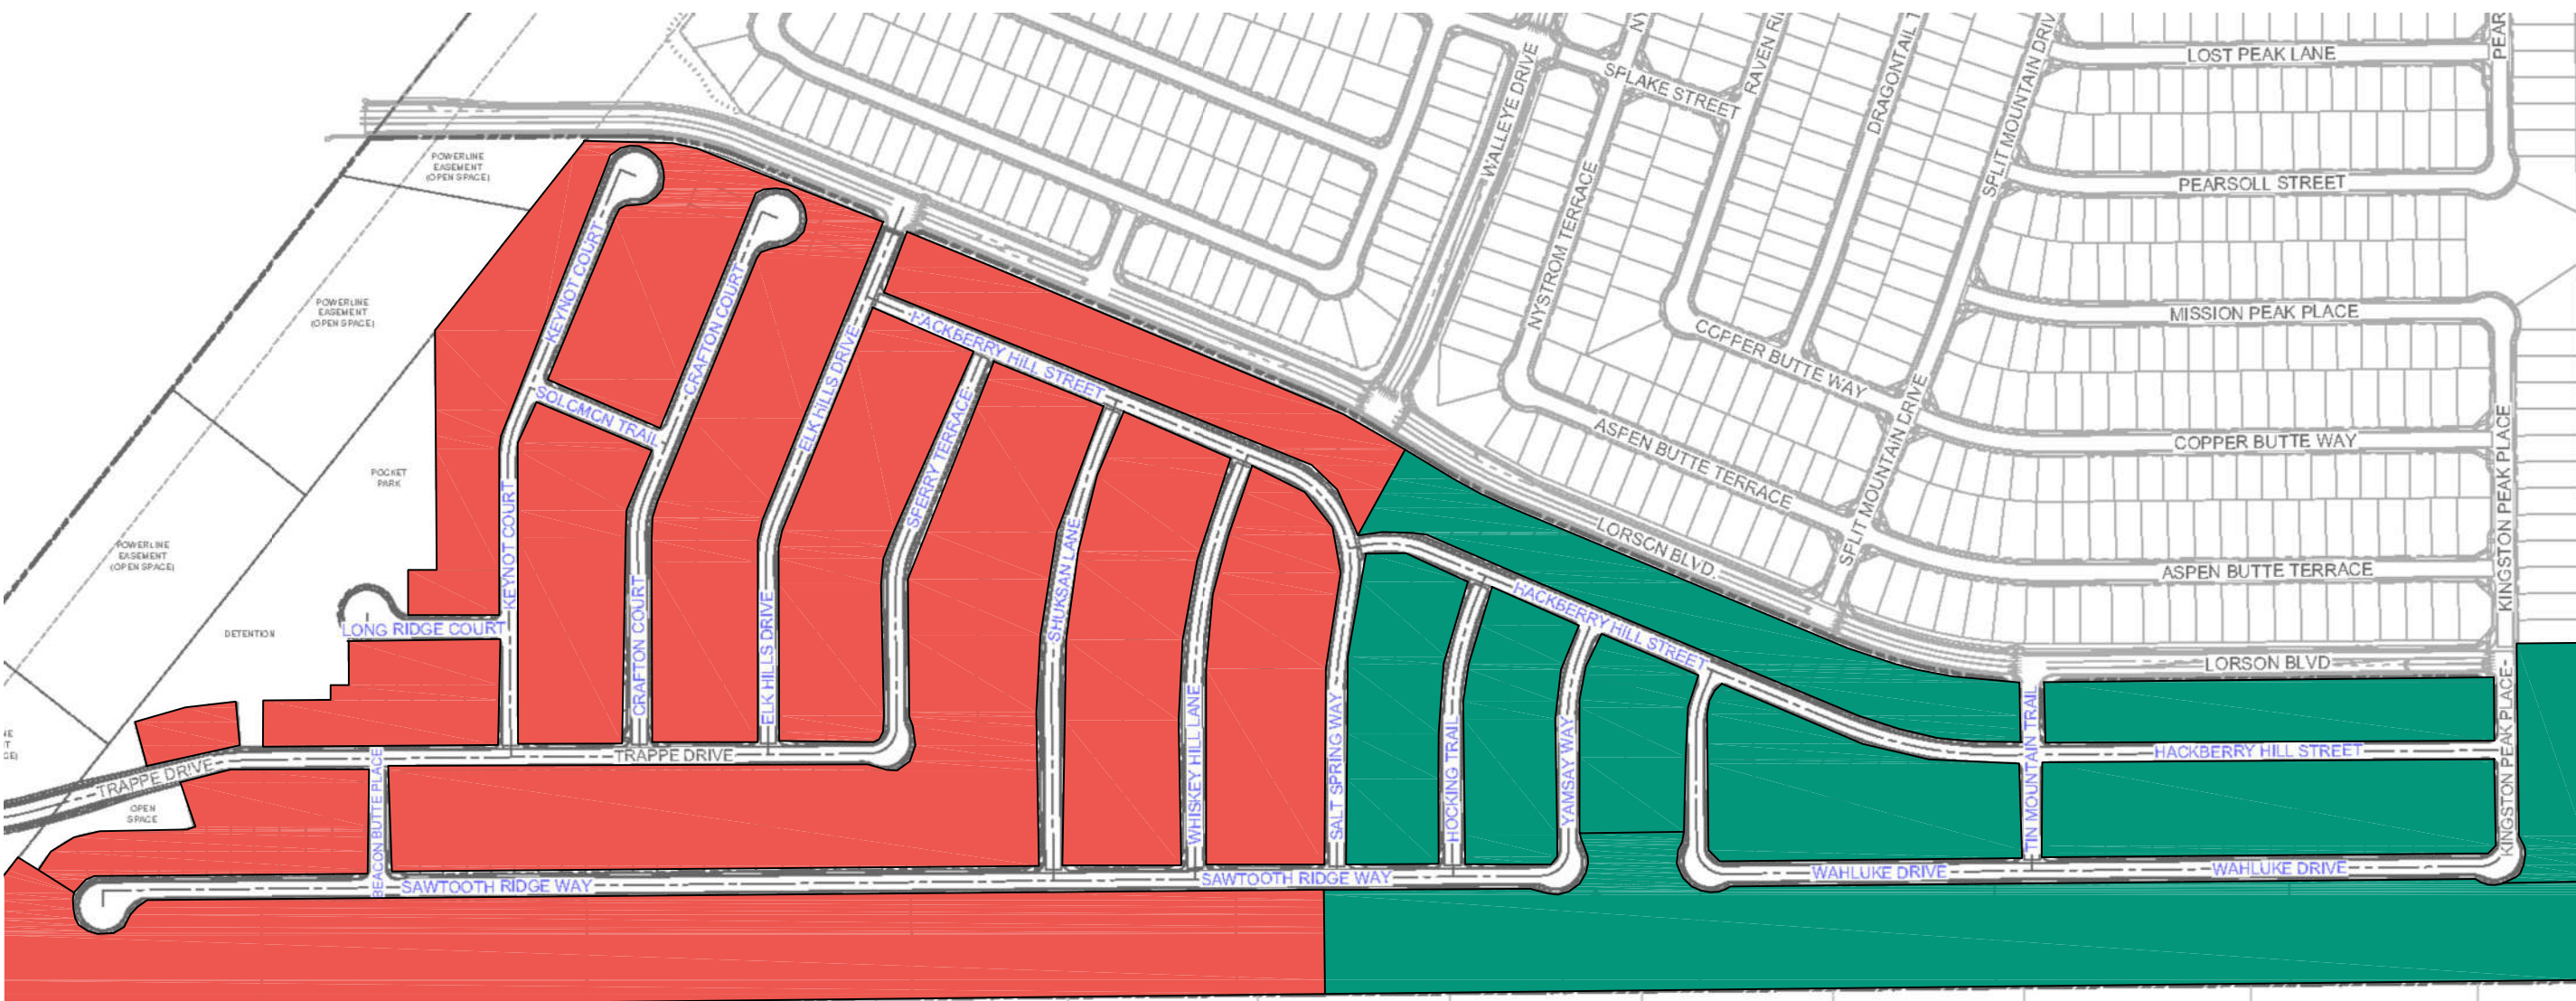
FIG-88

SUBEXCAVATION
RECOMMENDATIONS

SUBEXCAVATION TO:
8 FEET BELOW AND 8 FEET
(LATERALLY) BEYOND SPREAD
FOOTING FOUNDATION COMPONENTS

SUBEXCAVATION TO:
10 FEET BELOW AND 10 FEET
(LATERALLY) BEYOND SPREAD
FOOTING FOUNDATION COMPONENTS

Our subexcavation recommendations are presented in Section **13.0 Subexcavation and Replacement** of this report and the attached Figure 88.

Where sub-excavation is to be performed, vegetation, organic and deleterious material shall be cleared and disposed of in accordance with applicable requirements prior to performing excavation and/or filling operations. The subexcavation should extend to minimum depths up to 10 feet (as indicated on Figure 88, Subexcavation Recommendations) below the bottom of all proposed foundations components, and at least those same distances (laterally) beyond the proposed "buildable" area on each lot. Before the placement of moisture-conditioned fill, the underlying subgrade shall be scarified, moisture conditioned to within 2% of the optimum moisture content and compacted to the degree specified for the overlying fill material.
