**SOIL, GEOLOGY, GEOLOGIC HAZARD,
AND WASTEWATER STUDY
THE RETREAT AT TIMBER RIDGE
VOLLMER ROAD AND ARROYA LANE
EL PASO COUNTY, COLORADO**

Arroya Investments
P.O. Box 50223
Colorado Springs, Colorado 80949

April 12, 2017
Revised: December 1, 2017

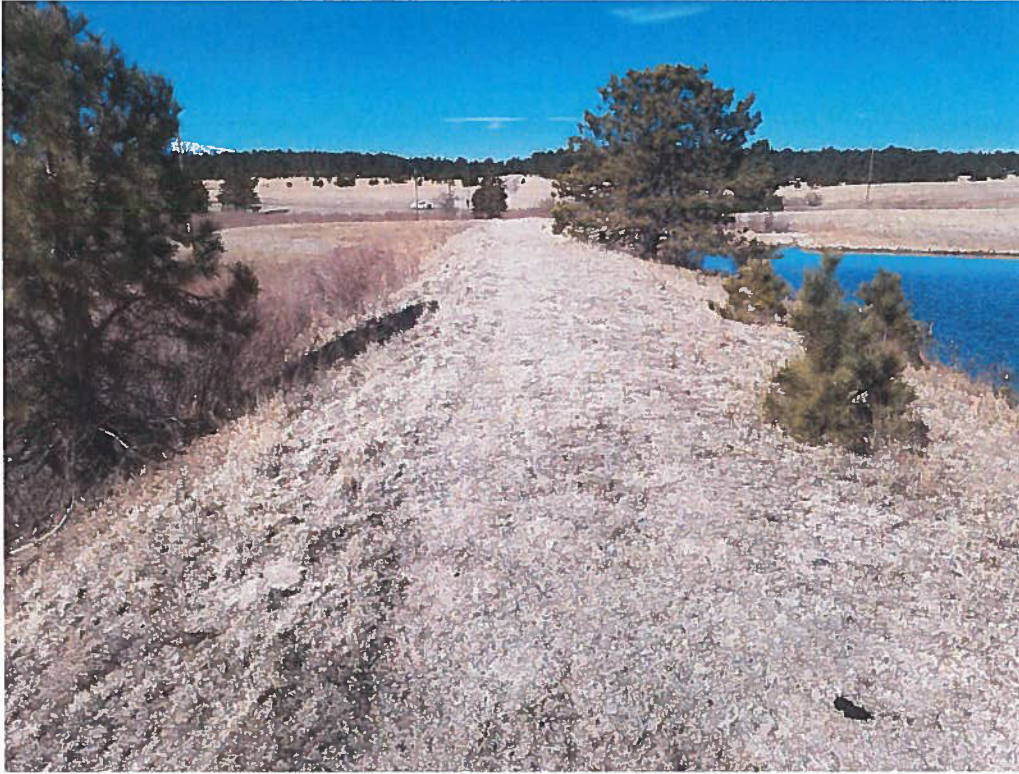
**Looking west along
the crest of the dam in
the northern portion of
the site.**
