**SOIL, GEOLOGY, GEOLOGIC HAZARD,
AND WASTEWATER STUDY
THE RETREAT AT TIMBER RIDGE
VOLLMER ROAD AND ARROYA LANE
EL PASO COUNTY, COLORADO**

April 12, 2017
Revised: December 1, 2017

Entech Job No. 170020
AAprojects/2017/170020 countysoil/geo revised

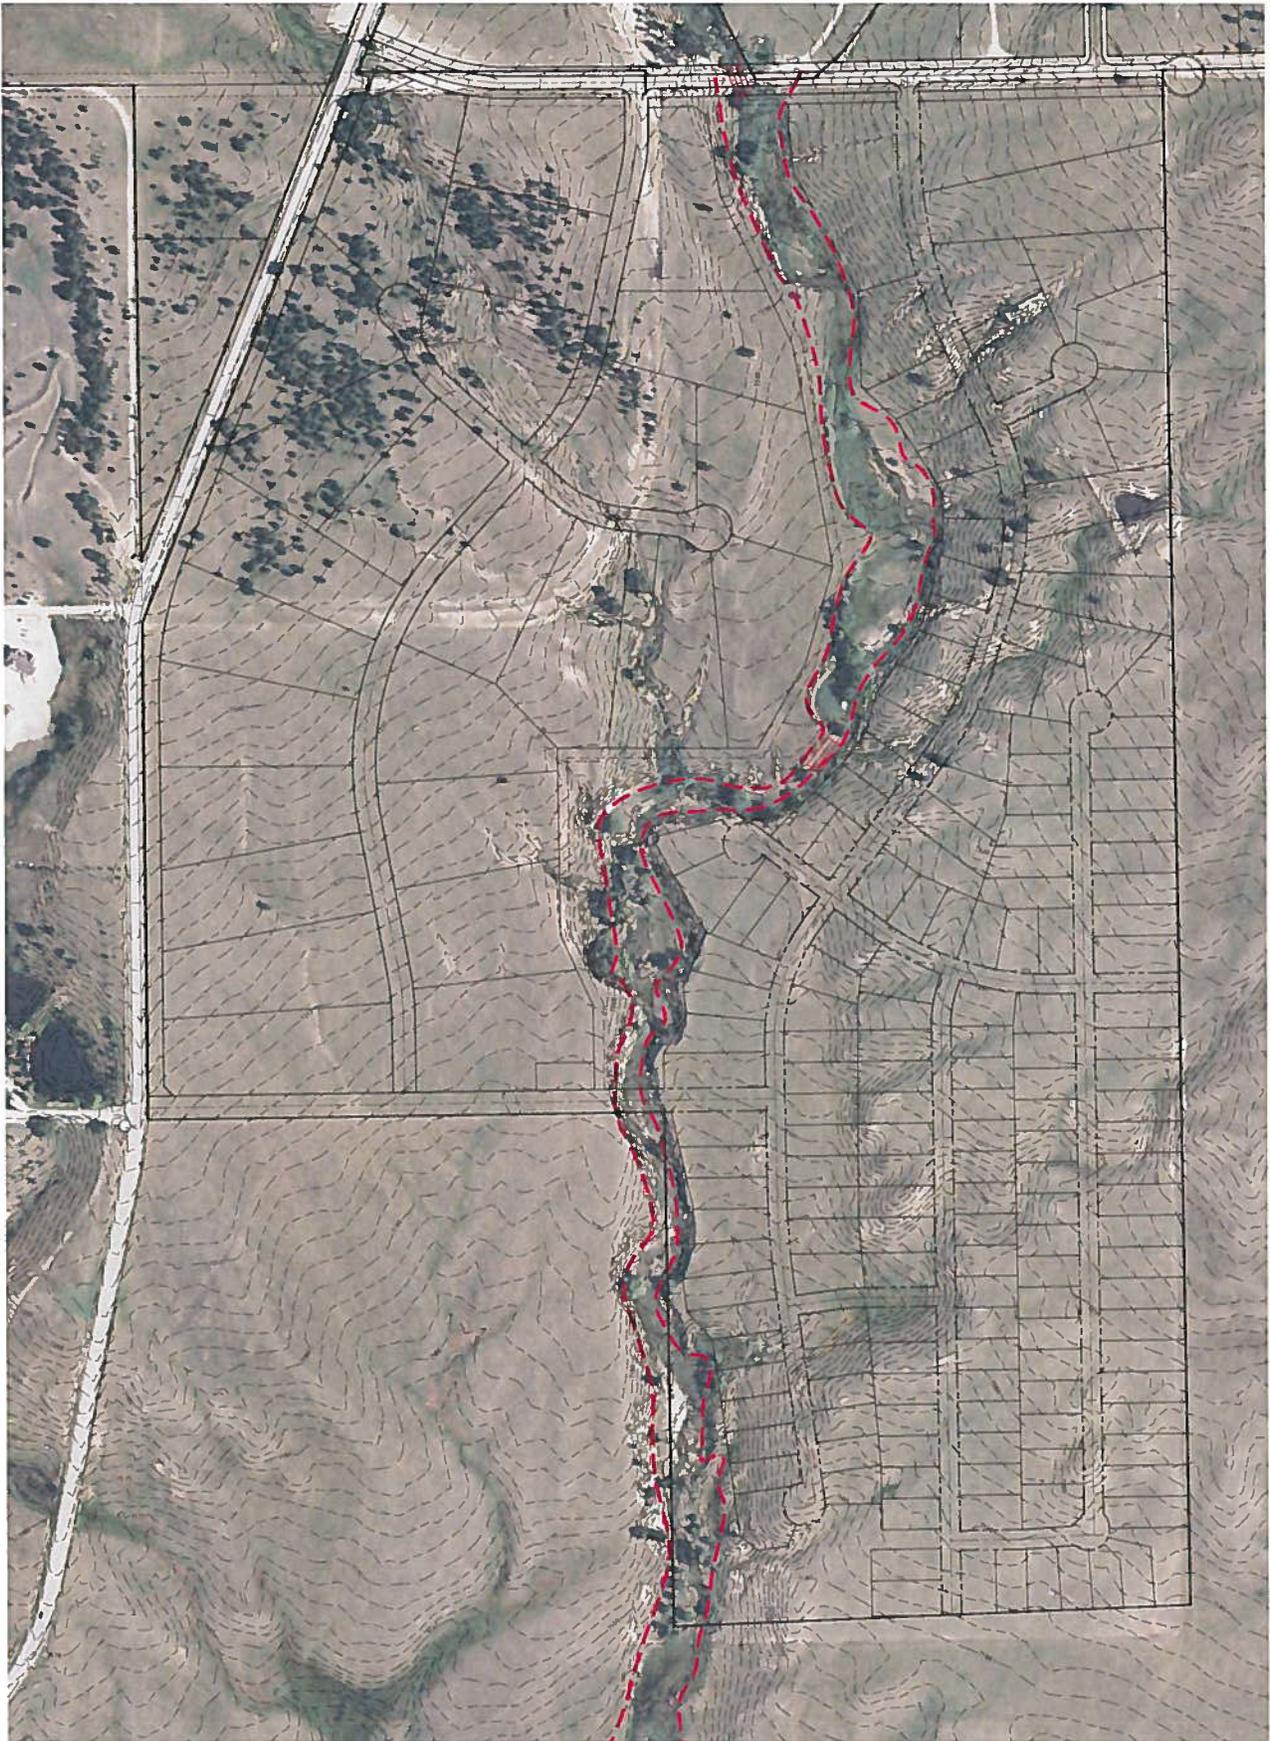
FIG NO.:
3

PRELIMINARY CONCEPT PLAN
THE RETREAT AT TIMBER RIDGE
VOLLMER ROAD AND ARROYA LANE
EL PASO COUNTY, CO.
FOR: ARROYA INVESTMENTS

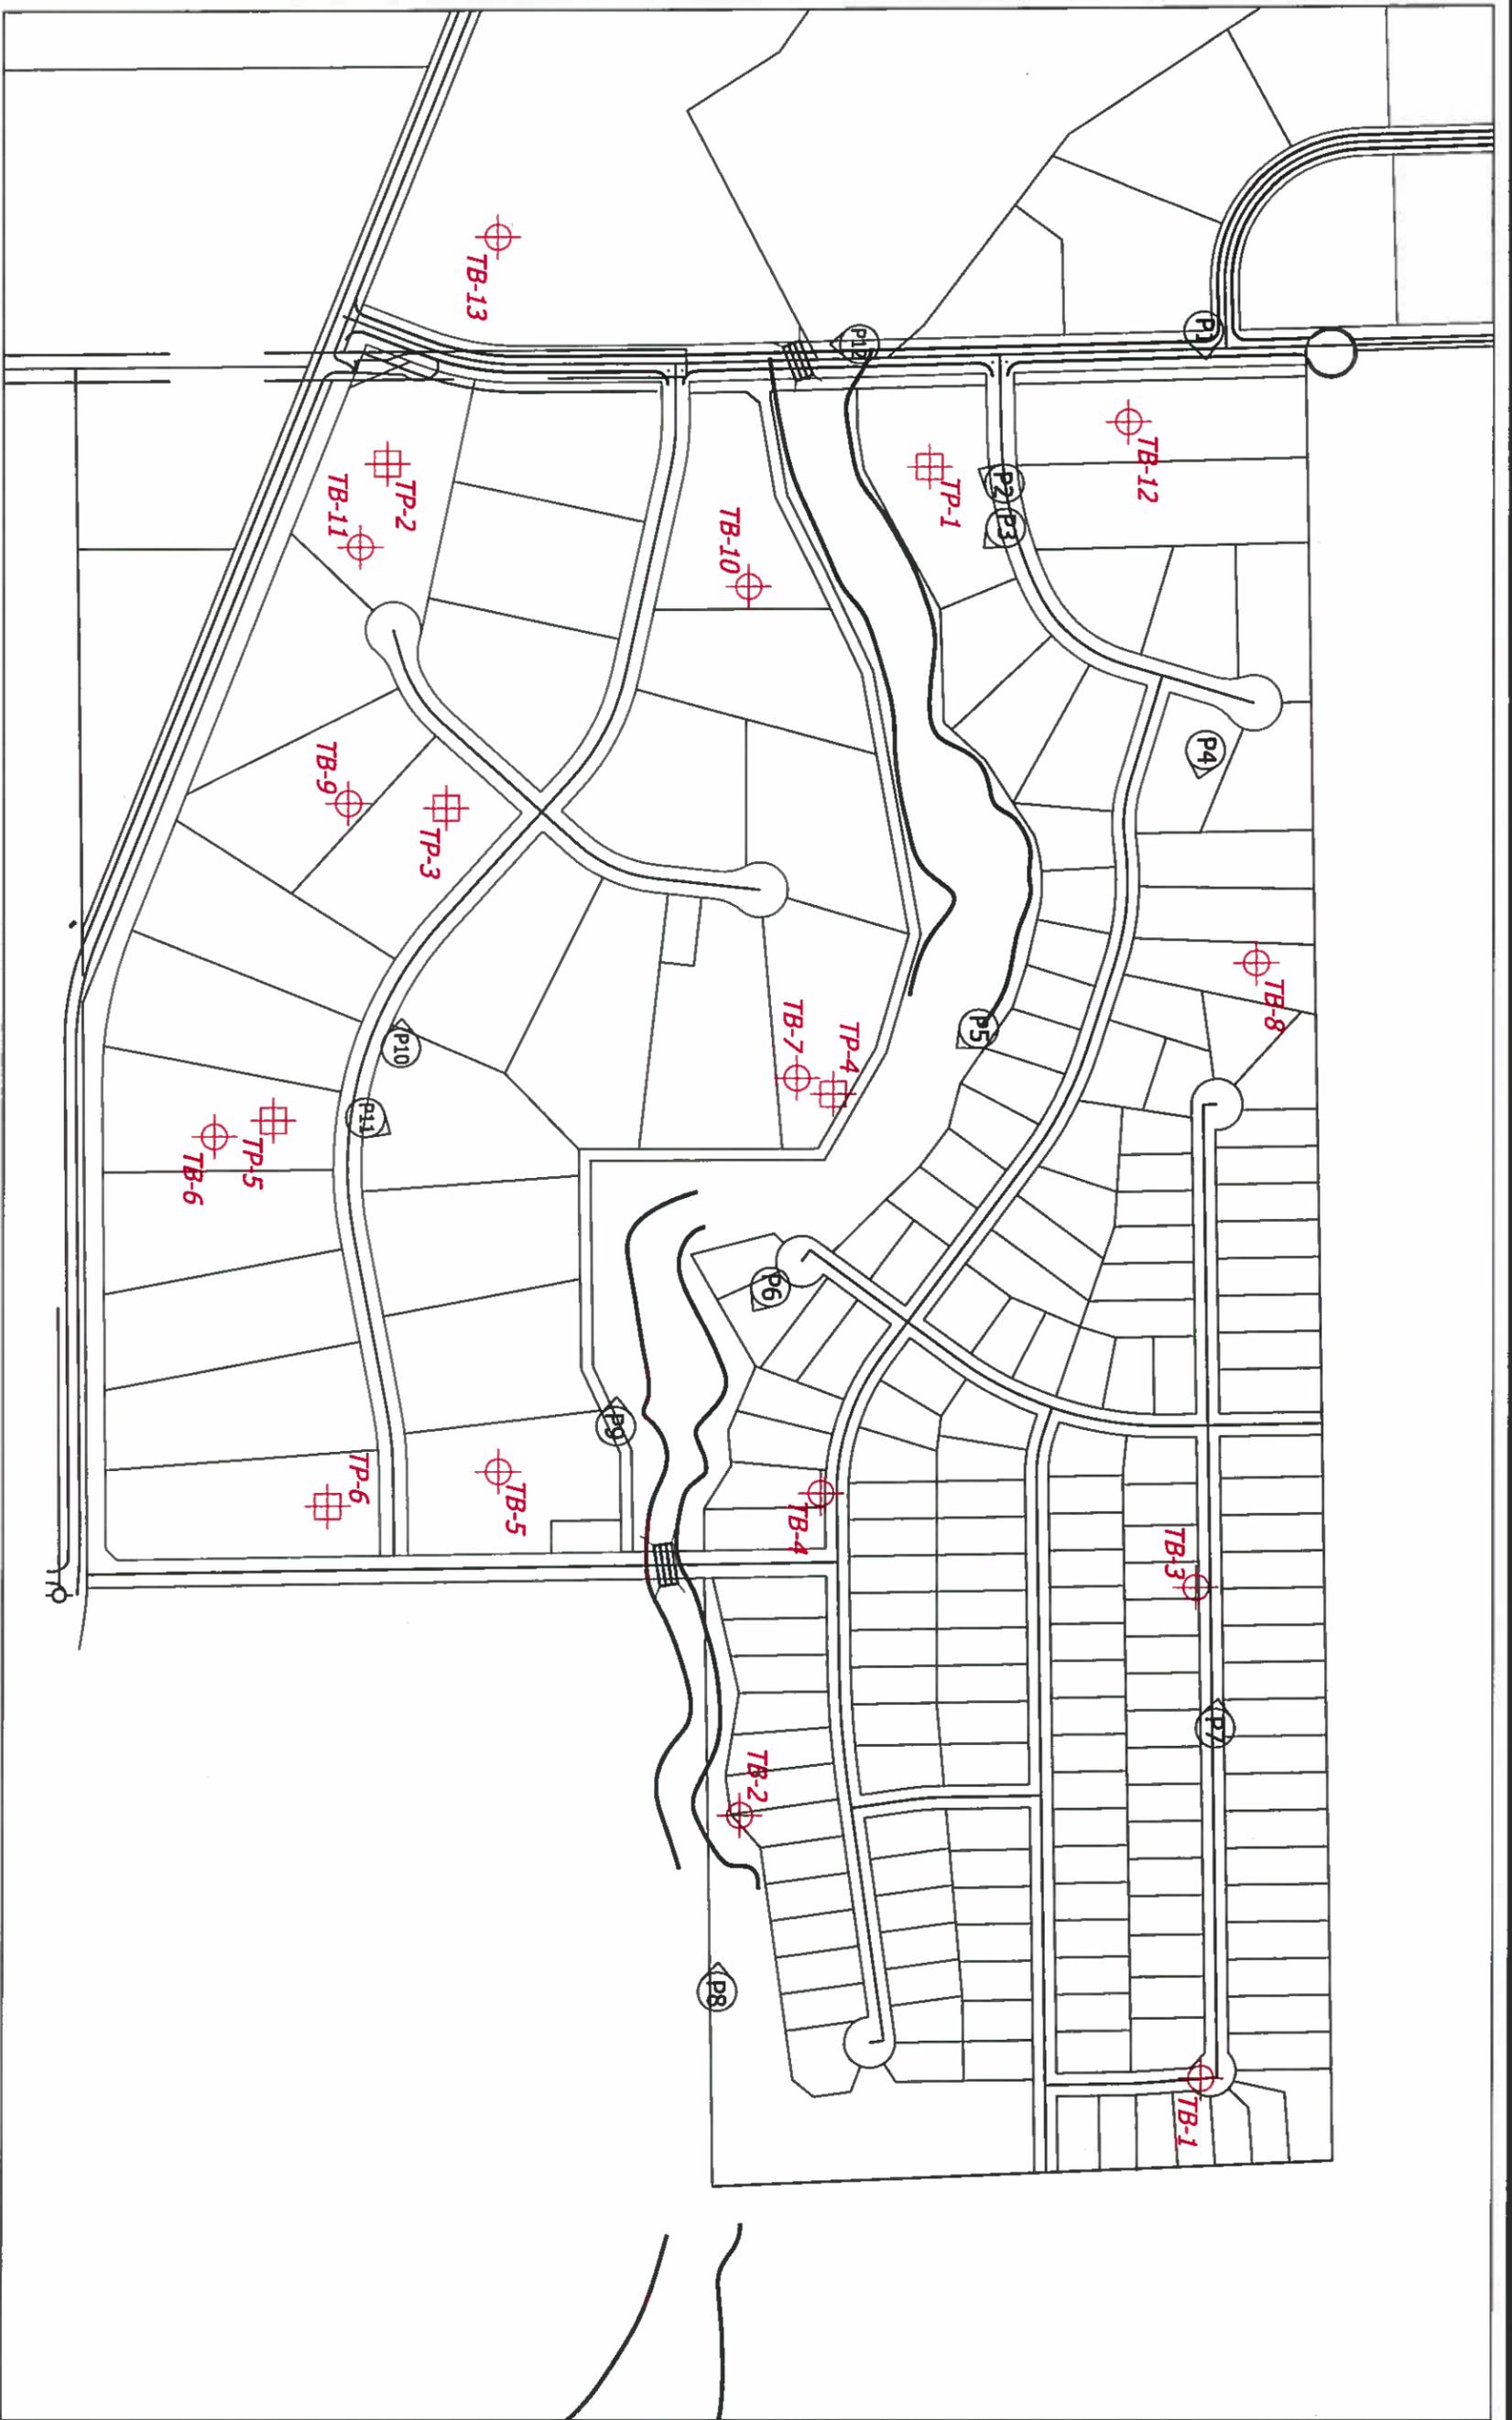
DATE	BY	SCALE	FIGURE NO.
12/17/17	AS SHOWN	1"=20'	4

SITE PLAN/TEST BORING LOCATION MAP
THRE RETREAT AT TIMBER RIDGE
VOLLMER ROAD AND ARROYA LANE
EL PASO COUNTY, CO.
FOR: ARROYA INVESTMENTS

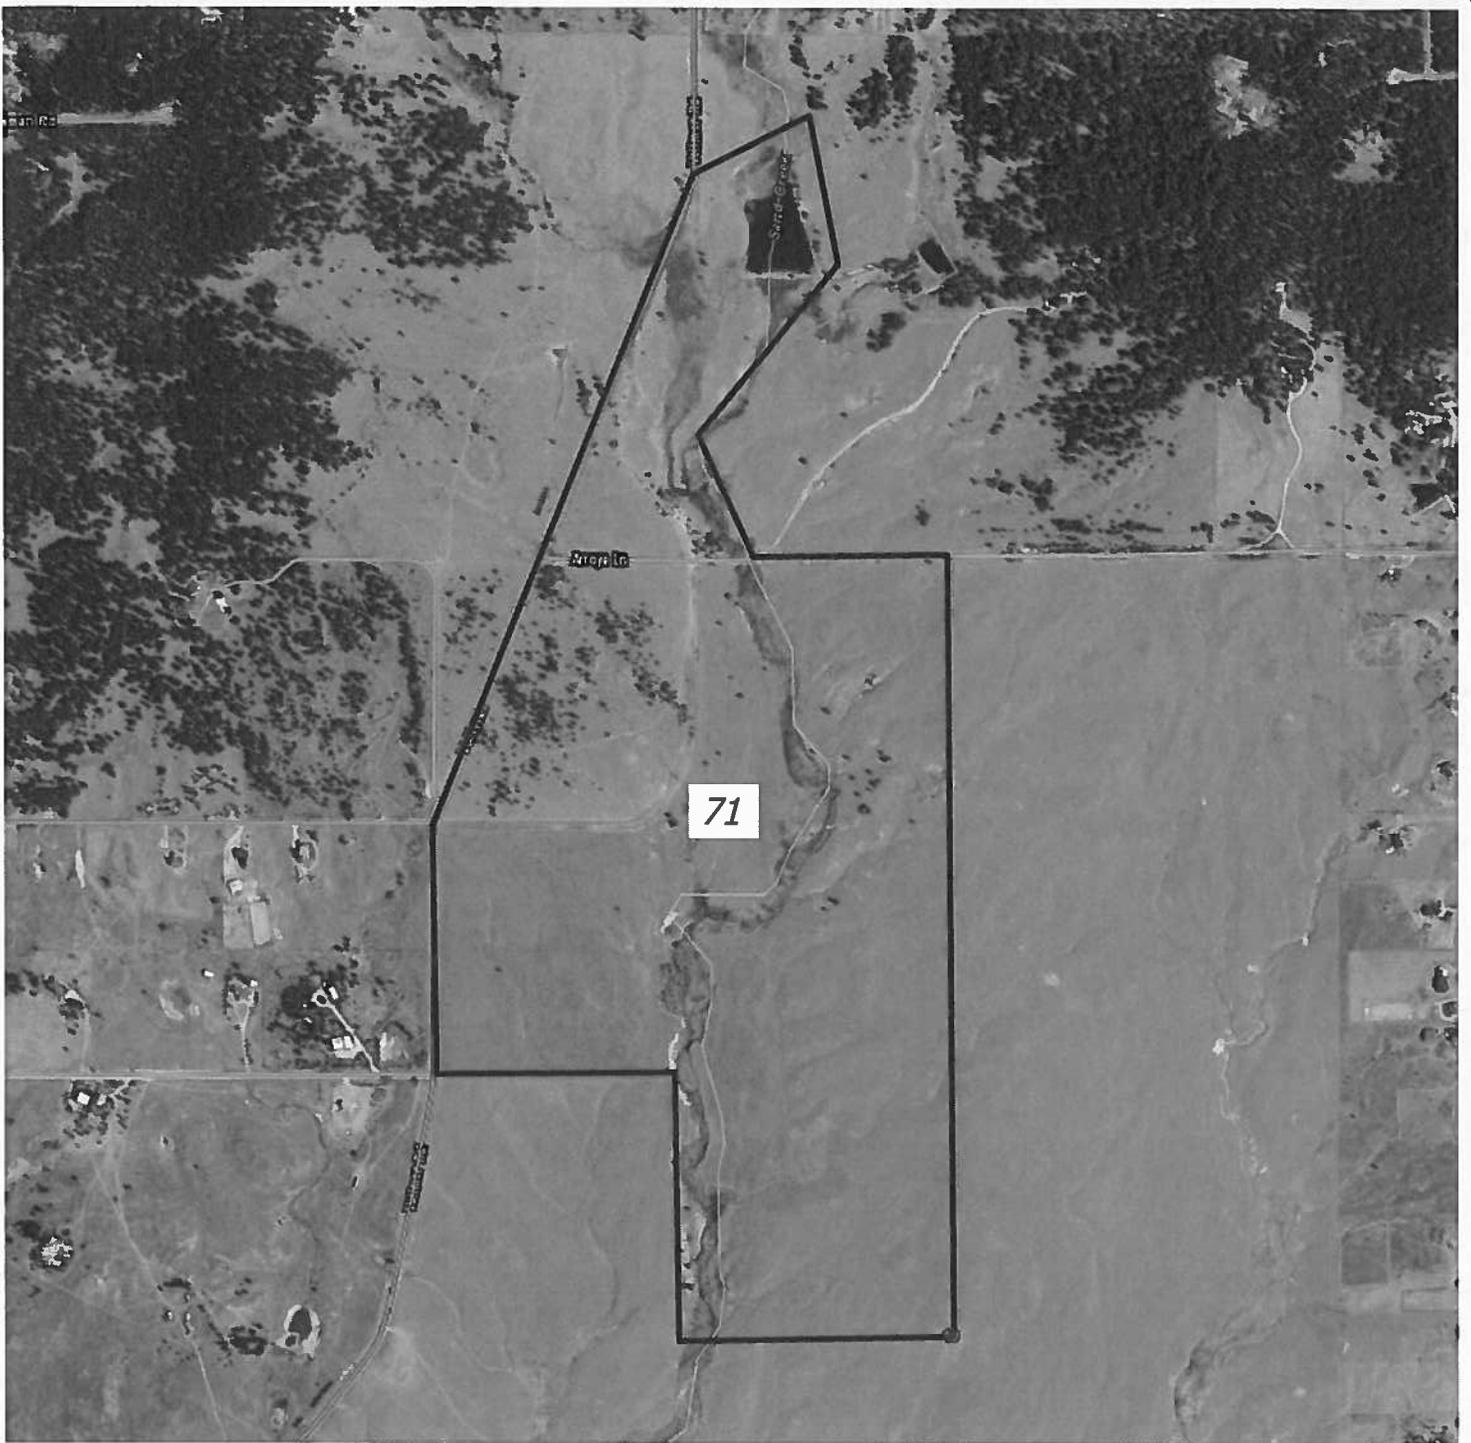
SOIL SURVEY MAP
THE RETREAT AT TIMBER RIDGE
VOLLMER ROAD AND ARROYA LANE
EL PASO COUNTY, CO.
FOR: ARROYA INVESTMENTS

Complete descriptions of each soil type are presented in Appendix D. The soils have generally been described to have moderate to moderately rapid permeabilities. Possible hazards with soil erosion are present on the site. The erosion potential can be controlled with vegetation. The majority of the soils have been described to have slight to moderate erosion hazards.

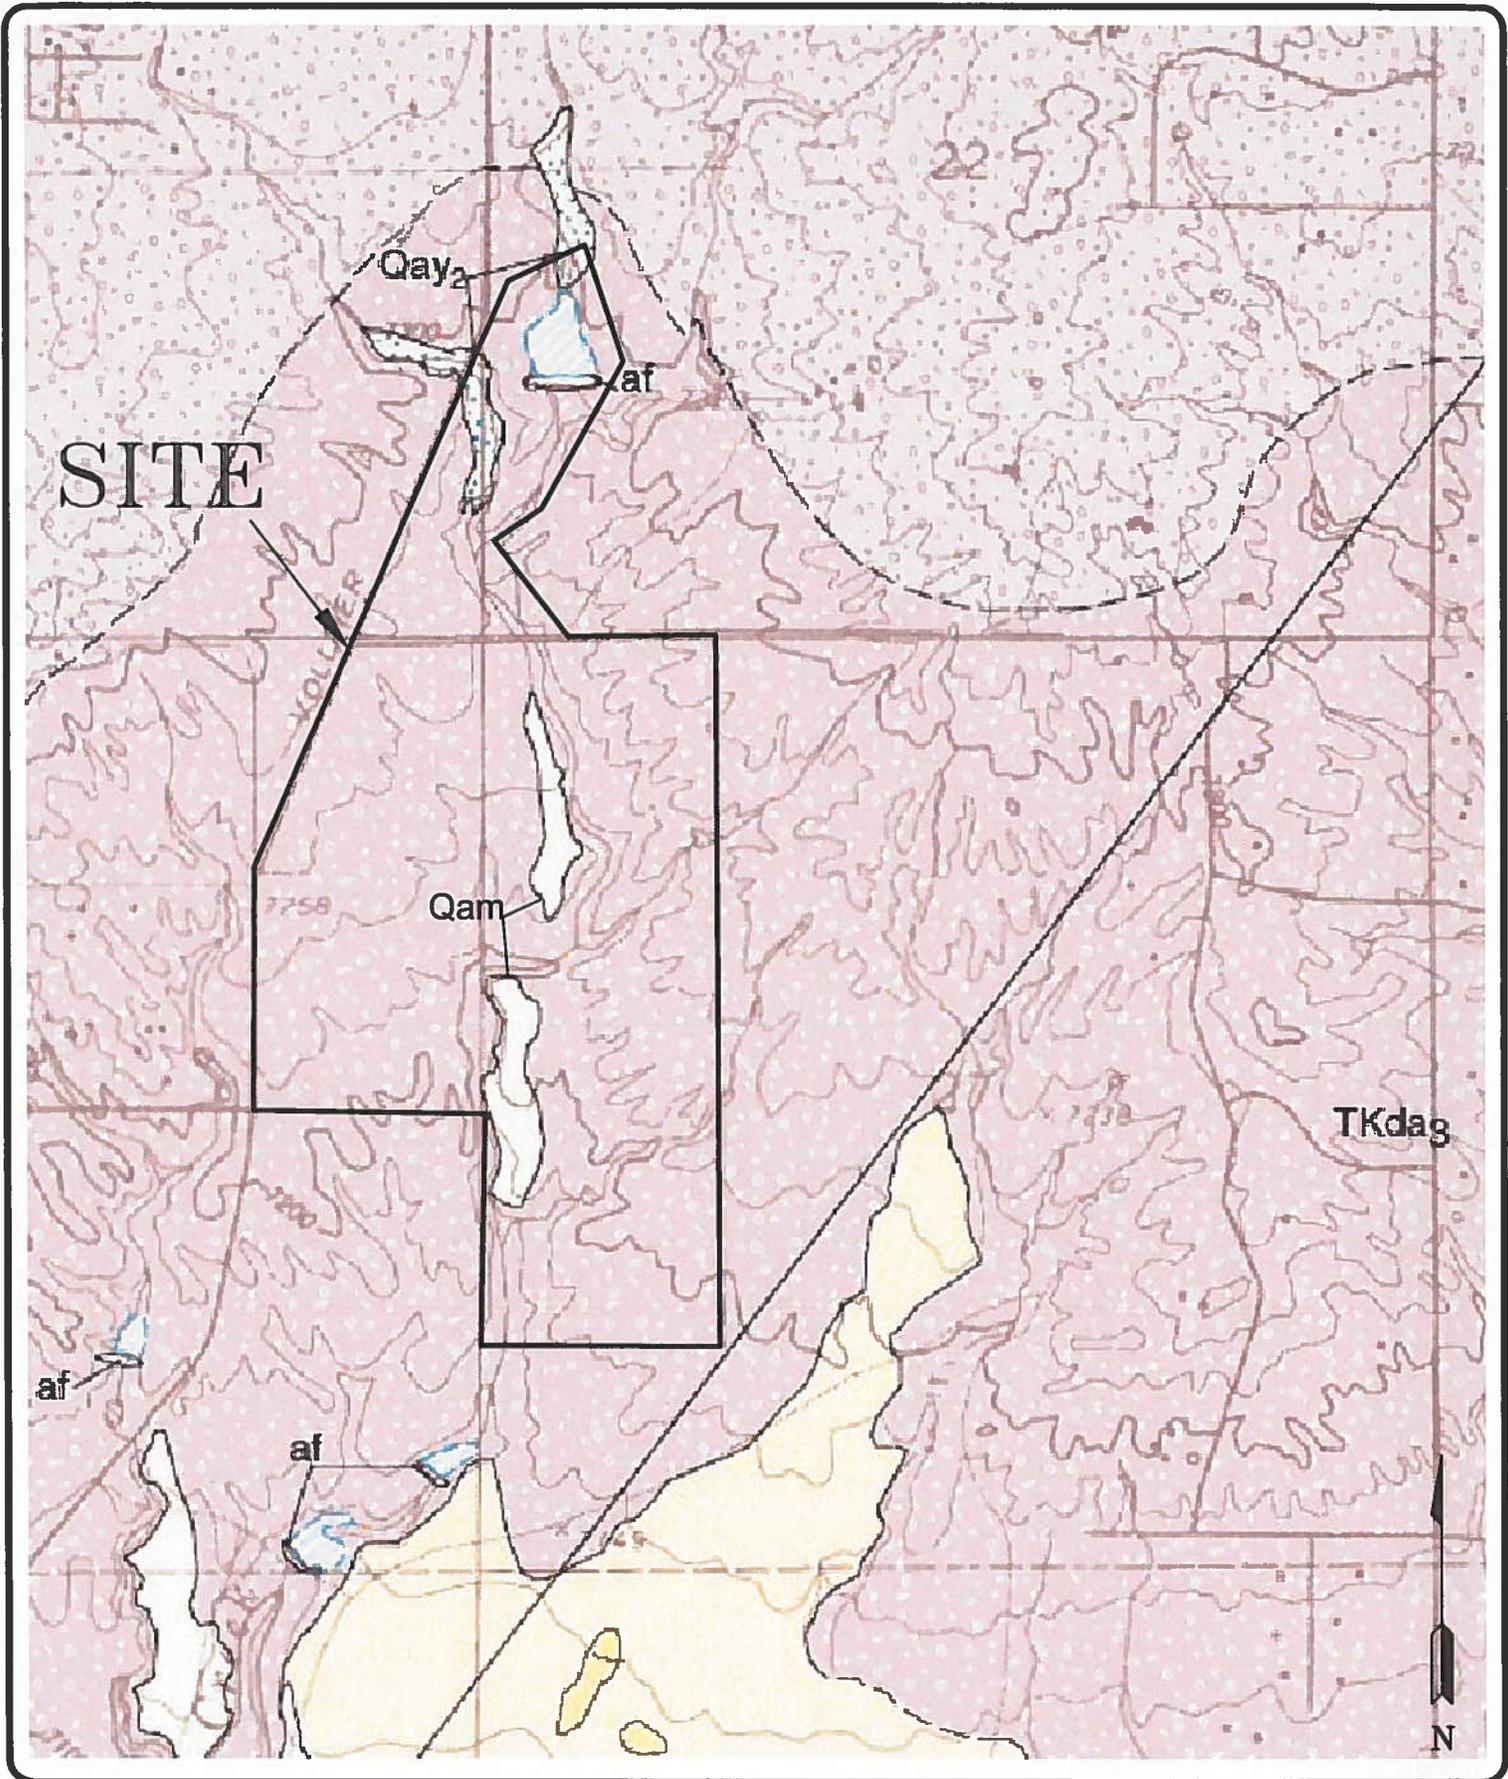
FIG NO.:
6

FALCON NW QUADRANGLE GEOLOGY MAP
THE RETREAT AT TIMBER RIDGE
VOLLMER ROAD AND ARROYA LANE
EL PASO COUNTY, CO.
FOR: ARROYA INVESTMENTS

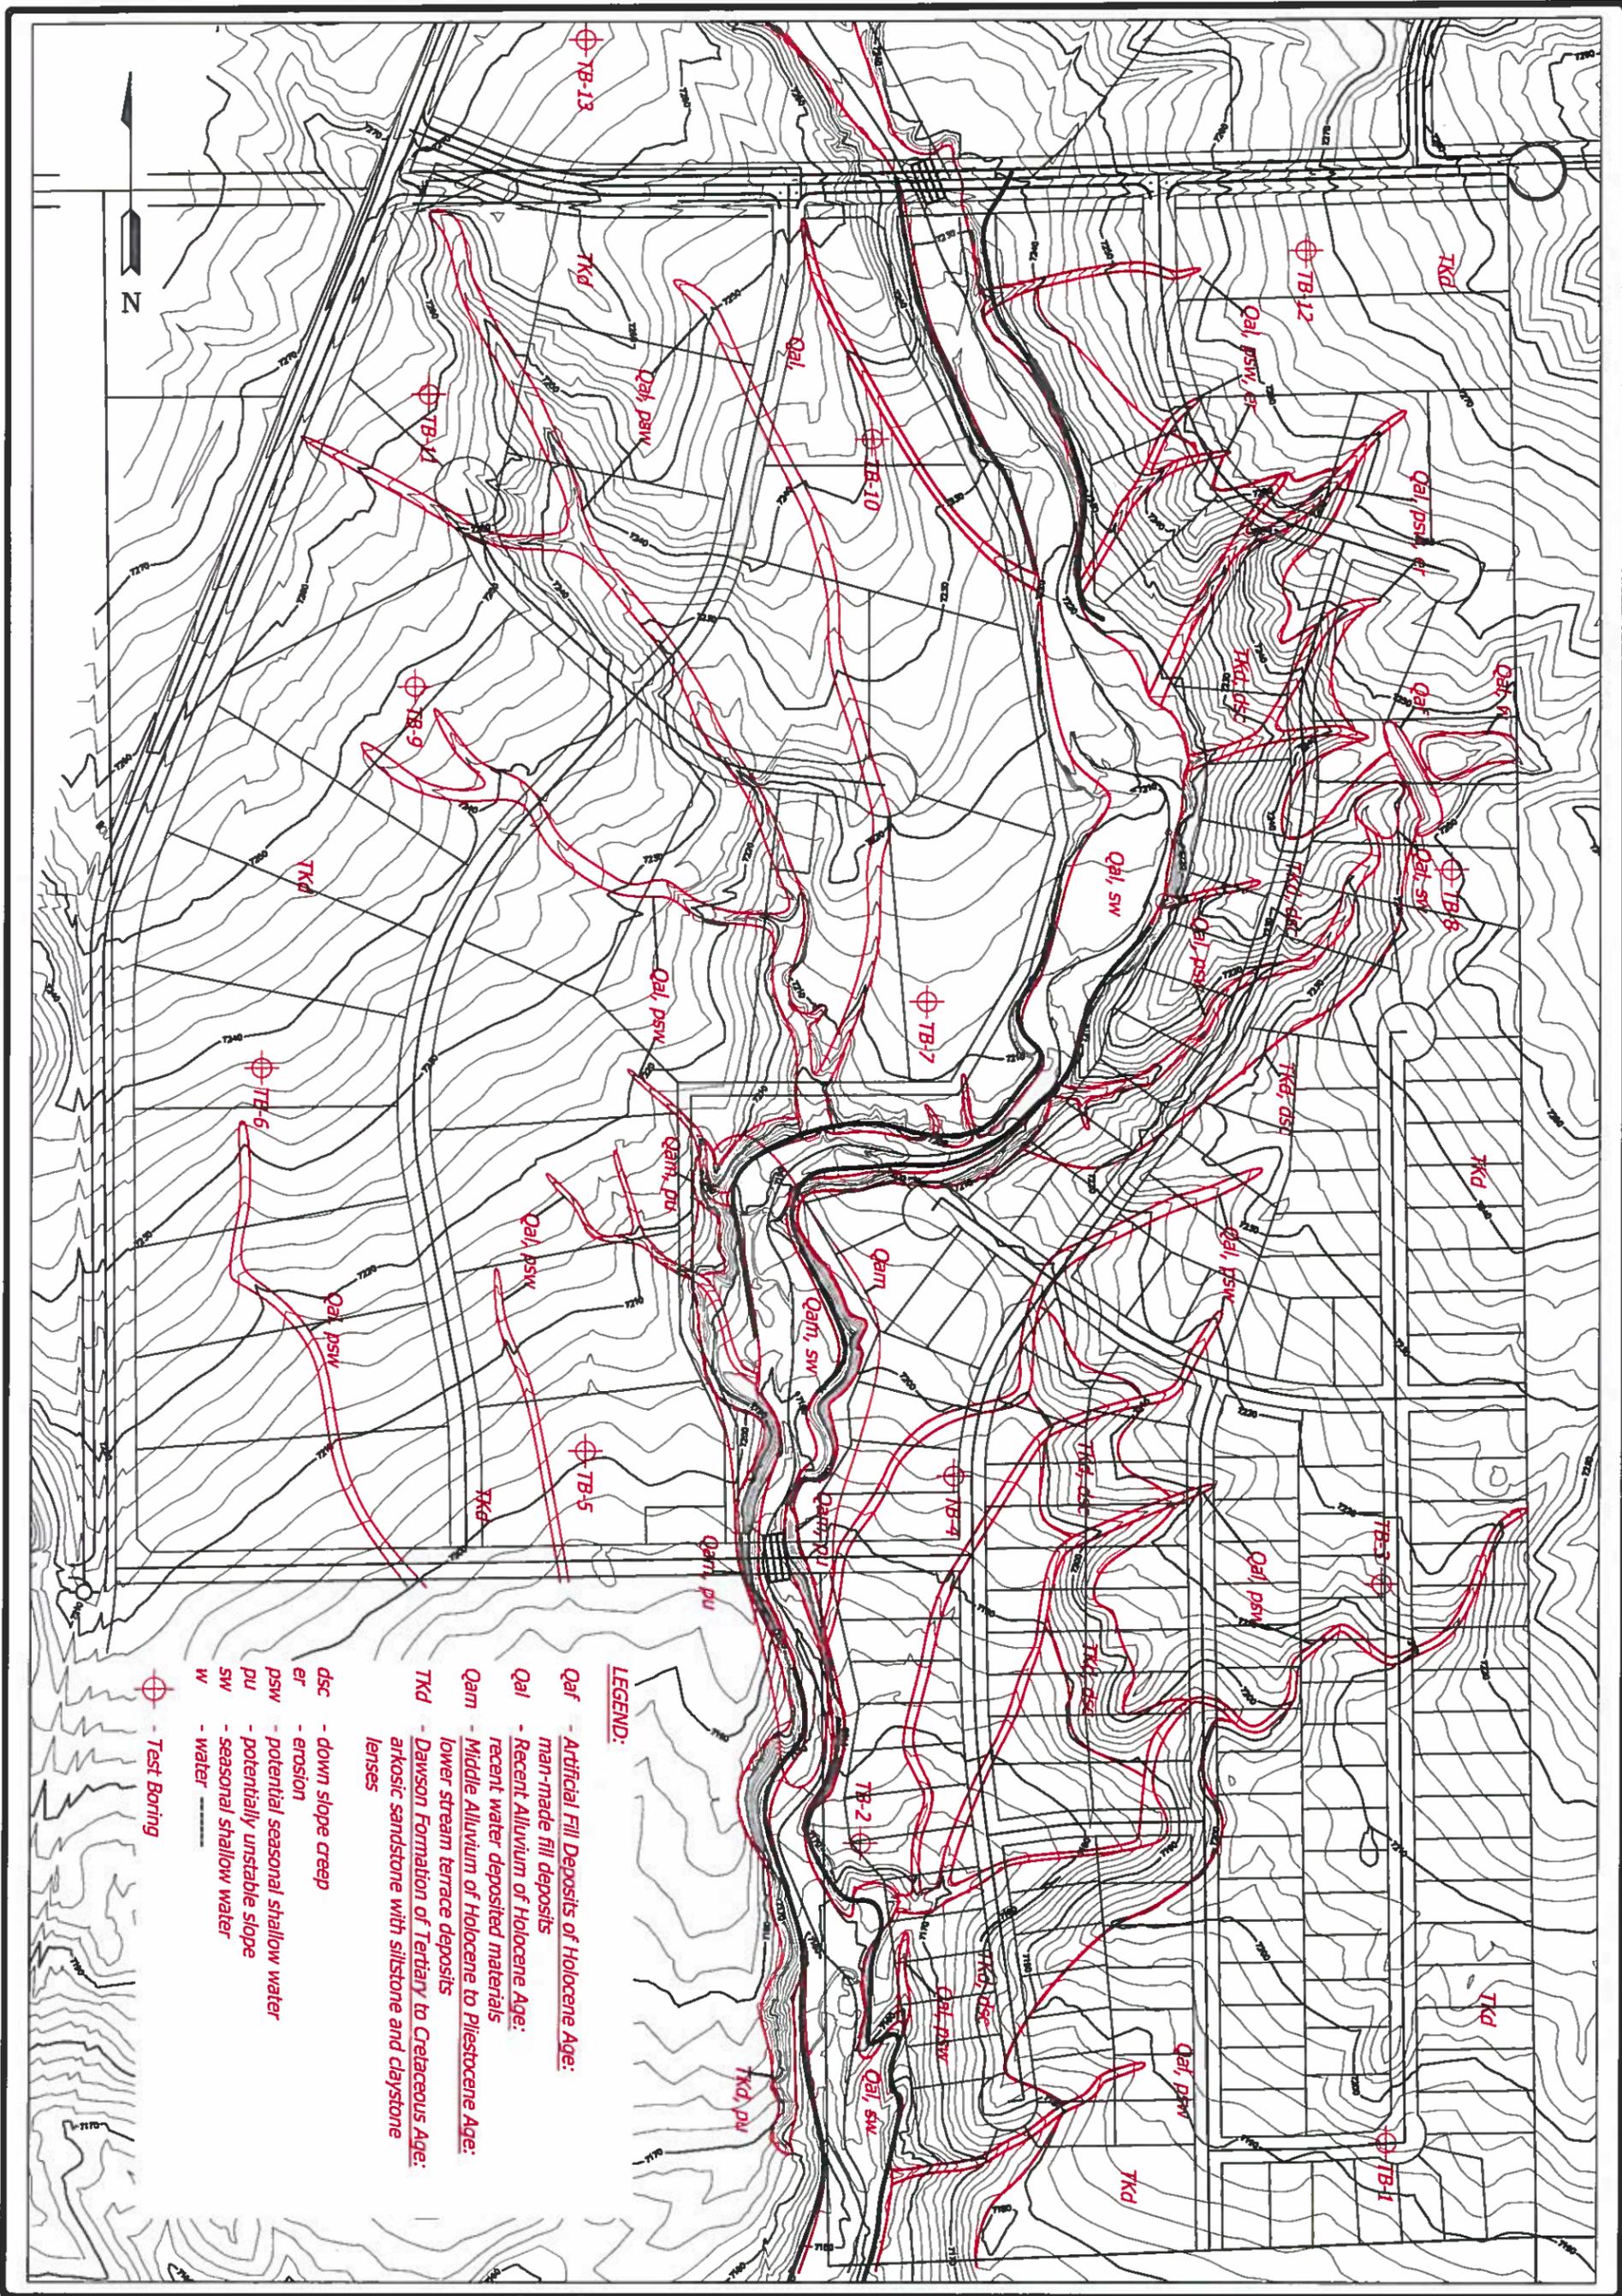
GEOLOGY MAP/ENGINEERING GEOLOGY TRAILS AT TIMBER RIDGE
VOLLMER ROAD AND ARROYA LANE
EL PASO COUNTY, CO.
FOR: ARROYA INVESTMENTS

As mentioned previously, detailed mapping has been performed on this site to produce an Engineering Geology Map Figure 7. This map shows the location of various geologic conditions of which the developers should be cognizant during the planning, design and construction stages of the project. These hazards and the recommended mitigation techniques are as follows:

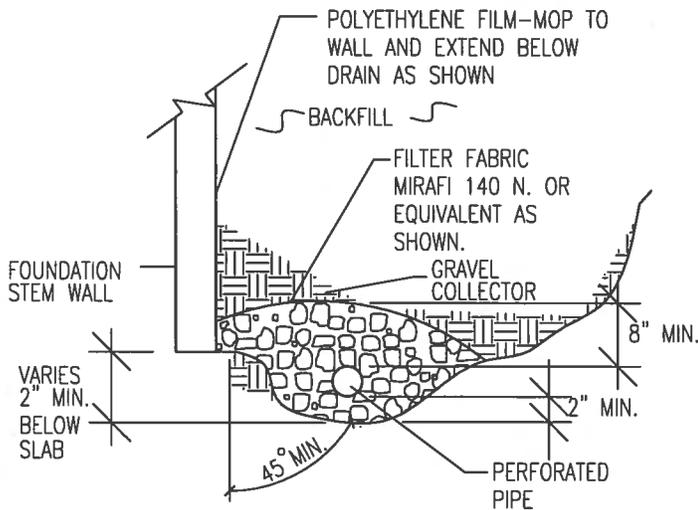
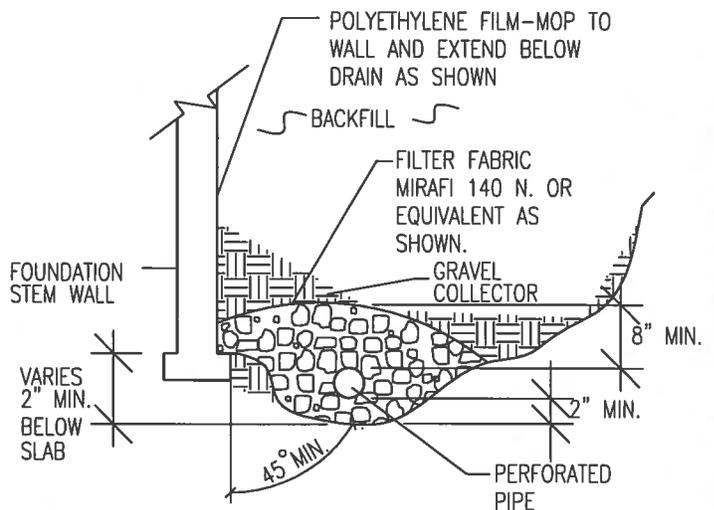
FIG NO.:
9

-GRAVEL SIZE IS RELATED TO DIAMETER OF PIPE PERFORATIONS-85% GRAVEL GREATER THAN 2x PERFORATION DIAMETER.

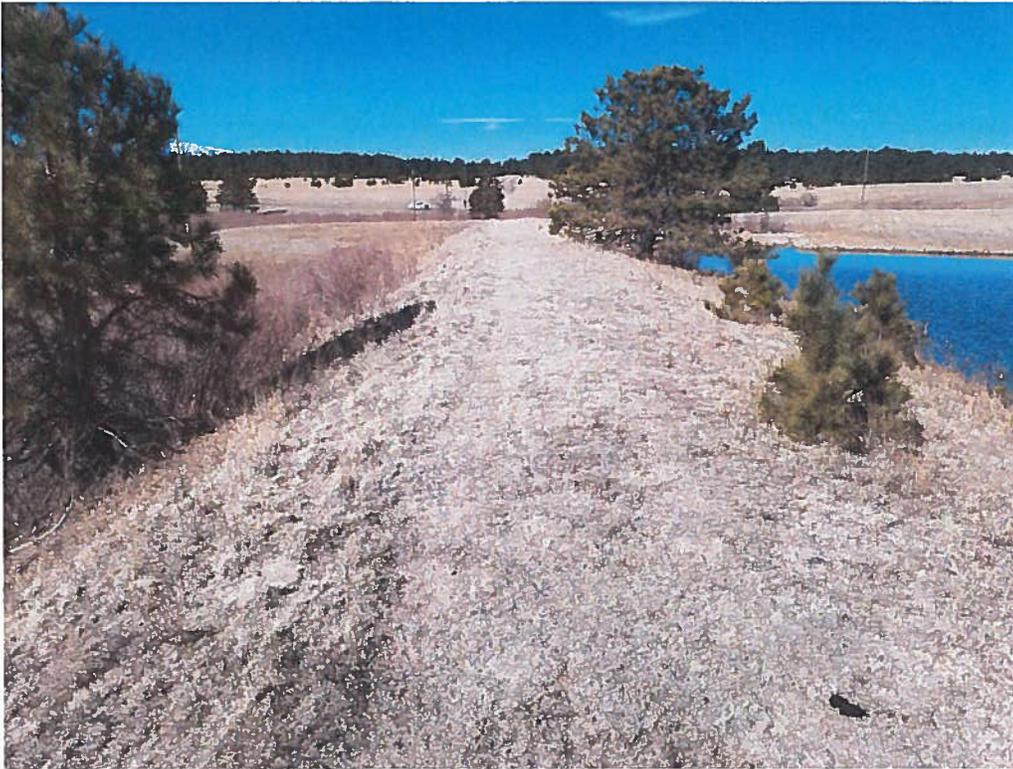
**Looking west along
the crest of the dam in
the northern portion of
the site.**

These are recent man-made fill deposits associated with the two dams located across the site. One of the dam is located north of Arroya Lane and is not within the proposed developed area. One dam is located on the eastern side of Parcel C. It is anticipated that this dam will be removed and filled during the site grading process. At the time of the investigation the condition of the dams was observed, and appeared to be in good condition.

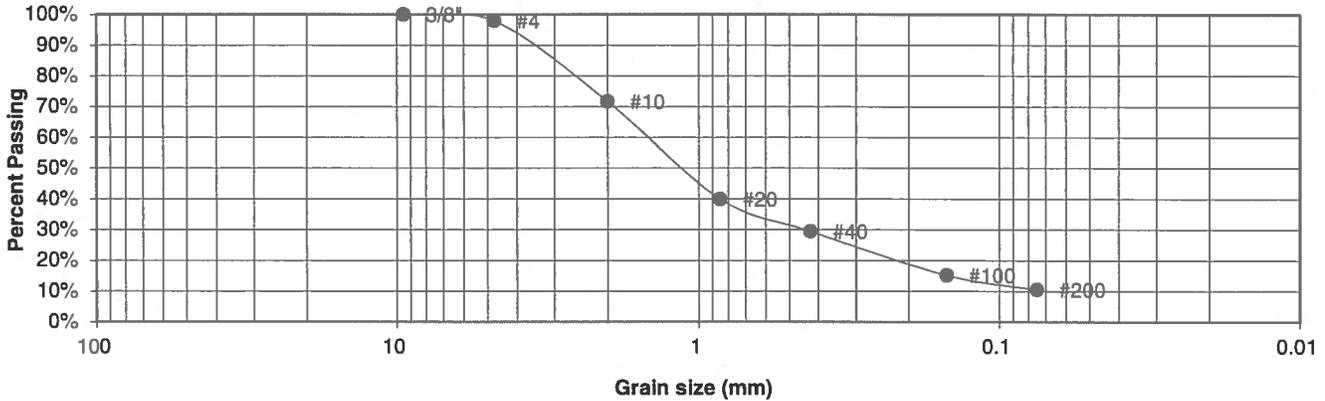
UNIFIED CLASSIFICATION	SM-SW	CLIENT	ARROYA INVESTMENTS
SOIL TYPE #	1	PROJECT	THE RETREAT AT TIMBER RIDGE
TEST BORING #	5	JOB NO.	170020
DEPTH (FT)	2-3	TEST BY	BL

**Sieve Analysis
Grain Size Distribution**

U.S. Sieve #	Percent Finer
3"	
1 1/2"	
3/4"	
1/2"	
3/8"	100.0%
4	97.9%
10	71.7%
20	40.0%
40	29.4%
100	15.2%
200	10.5%

Soil Type 1 silty to slightly silty sand and very clayey sand (SM-SW, SM, SC), encountered in all of Test Borings at the existing ground surface and extending to depths ranging from 1 foot to 17 feet bgs. These soils were encountered at loose to dense states and at moist conditions. The majority of the soils were encountered and medium dense states. Samples tested had 9 to 41 percent passing the No. 200 Sieve. Atterberg Limits Testing resulted in the sand being non-plastic. Sulfate testing resulted in less than 0.01 to 0.01 percent sulfate by weight indicating the sand exhibits negligible potential for below grade concrete degradation.

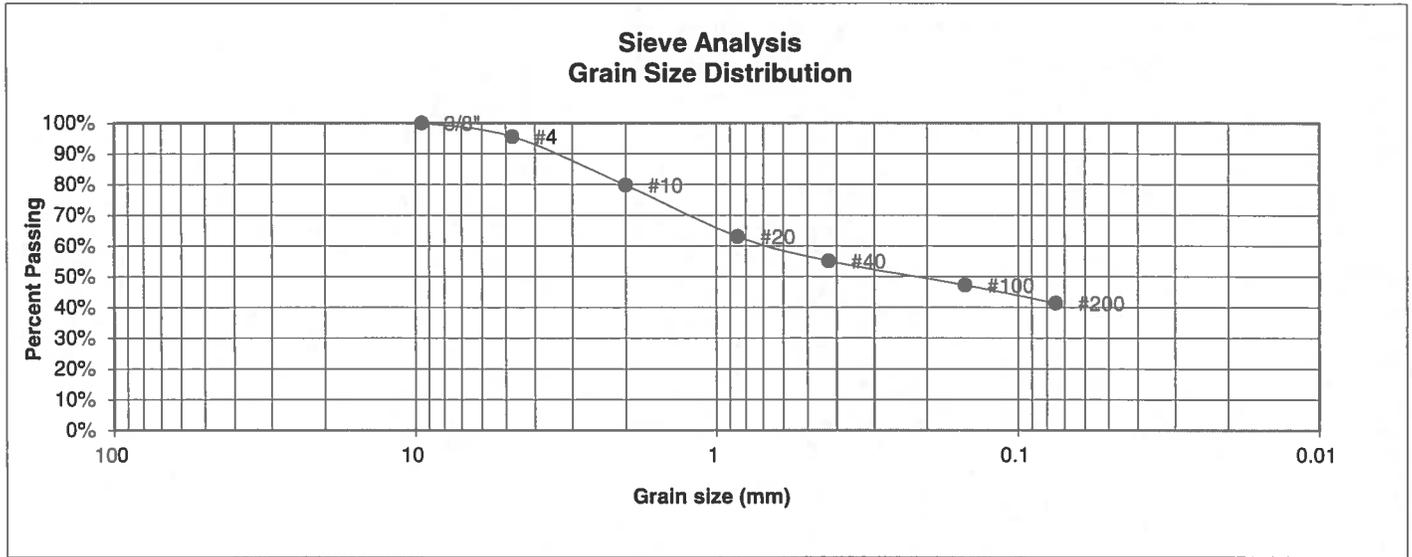
<u>UNIFIED CLASSIFICATION</u>	SC	<u>CLIENT</u>	ARROYA INVESTMENTS
<u>SOIL TYPE #</u>	1	<u>PROJECT</u>	THE RETREAT AT TIMBER RIDGE
<u>TEST BORING #</u>	6	<u>JOB NO.</u>	170020
<u>DEPTH (FT)</u>	5	<u>TEST BY</u>	BL

<u>U.S. Sieve #</u>	<u>Percent Finer</u>
3"	
1 1/2"	
3/4"	
1/2"	
3/8"	100.0%
4	95.6%
10	79.8%
20	63.1%
40	55.1%
100	47.2%
200	41.3%

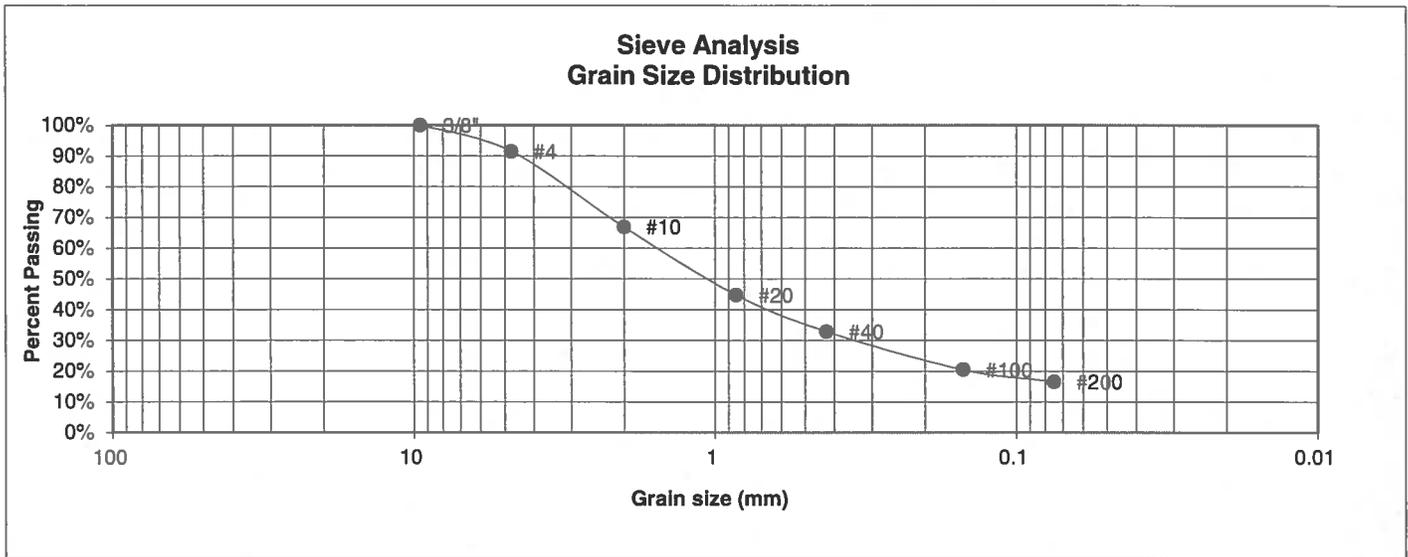
FIG NO.:
C-2

UNIFIED CLASSIFICATION	SM	CLIENT	ARROYA INVESTMENTS
SOIL TYPE #	1	PROJECT	THE RETREAT AT TIMBER RIDGE
TEST BORING #	11	JOB NO.	170020
DEPTH (FT)	5	TEST BY	BL

U.S. Sieve #	Percent Finer
3"	
1 1/2"	
3/4"	
1/2"	
3/8"	100.0%
4	91.5%
10	66.9%
20	44.8%
40	32.9%
100	20.5%
200	16.5%

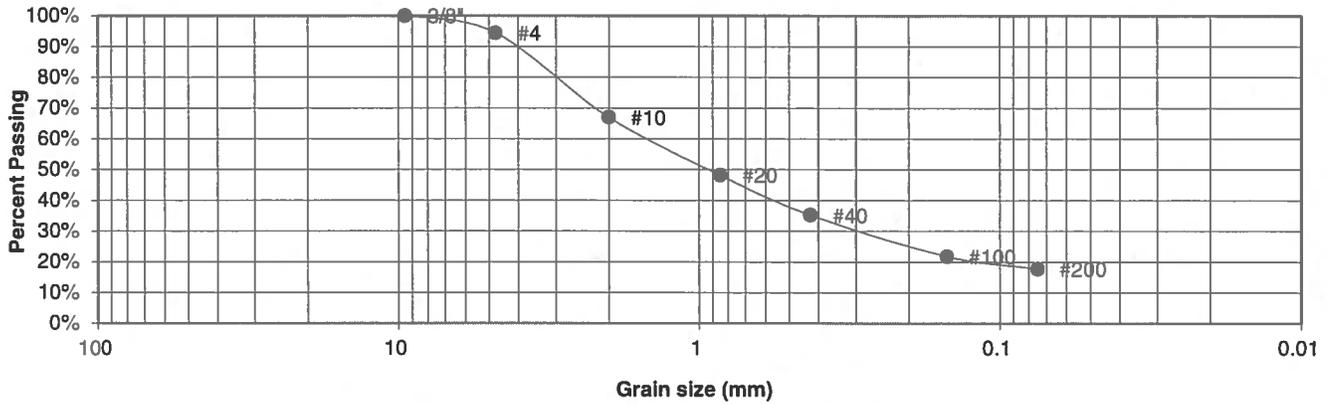
UNIFIED CLASSIFICATION	SM	CLIENT	ARROYA INVESTMENTS
SOIL TYPE #	1	PROJECT	THE RETREAT AT TIMBER RIDGE
TEST BORING #	13	JOB NO.	170020
DEPTH (FT)	2-3	TEST BY	BL

**Sieve Analysis
Grain Size Distribution**

U.S. Sieve #	Percent Finer
3"	
1 1/2"	
3/4"	
1/2"	
3/8"	100.0%
4	94.4%
10	67.0%
20	48.2%
40	35.2%
100	21.8%
200	17.8%

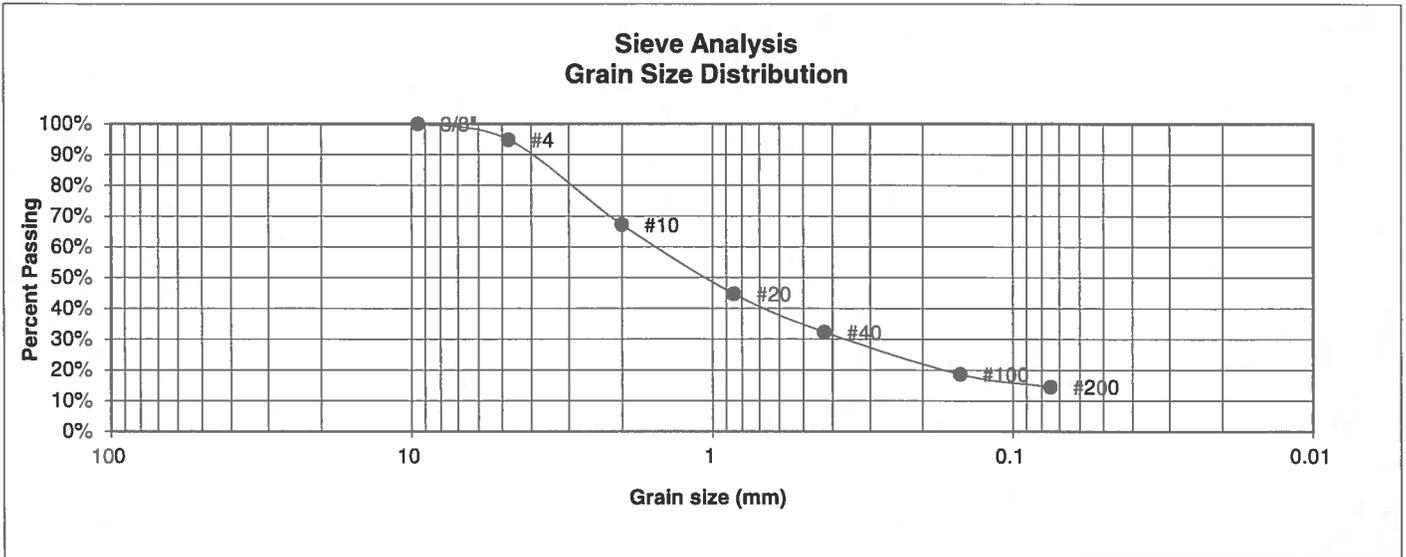
FIG NO.:
C-4

UNIFIED CLASSIFICATION	SM	CLIENT	ARROYA INVESTMENTS
SOIL TYPE #	1	PROJECT	THE RETREAT AT TIMBER RIDGE
TEST BORING #	9	JOB NO.	170020
DEPTH (FT)	2-3	TEST BY	BL

U.S. Sieve #	Percent Finer
3"	
1 1/2"	
3/4"	
1/2"	
3/8"	100.0%
4	94.8%
10	67.2%
20	44.7%
40	32.3%
100	18.6%
200	14.6%

Atterberg Limits	
Plastic Limit	NP
Liquid Limit	NV
Plastic Index	NP

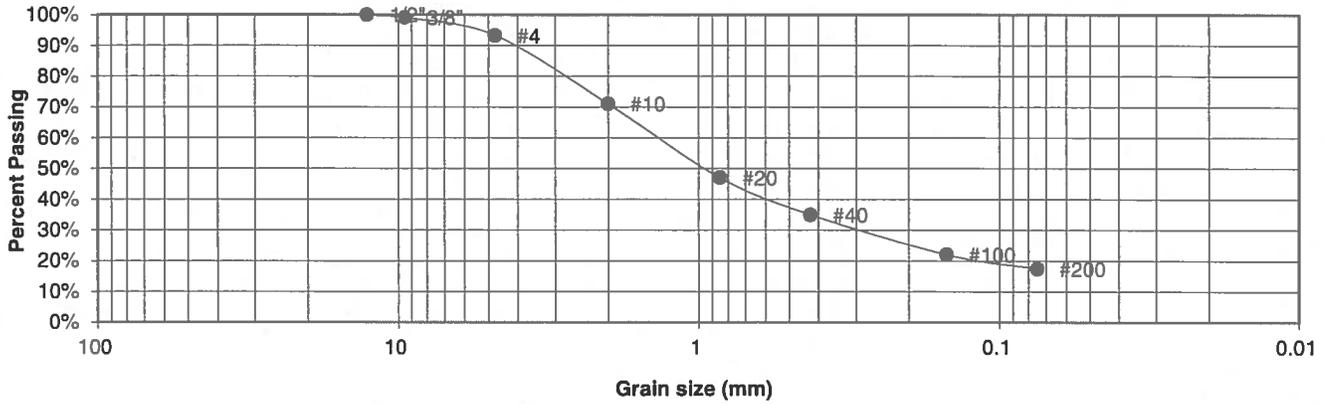
<u>UNIFIED CLASSIFICATION</u>	SM	<u>CLIENT</u>	ARROYA INVESTMENTS
<u>SOIL TYPE #</u>	1	<u>PROJECT</u>	THE RETREAT AT TIMBER RIDGE
<u>TEST BORING #</u>	10	<u>JOB NO.</u>	170020
<u>DEPTH (FT)</u>	5	<u>TEST BY</u>	BL

**Sieve Analysis
Grain Size Distribution**

<u>U.S. Sieve #</u>	<u>Percent Finer</u>
3"	
1 1/2"	
3/4"	
1/2"	100.0%
3/8"	99.1%
4	93.3%
10	71.0%
20	47.0%
40	35.0%
100	22.0%
200	17.4%

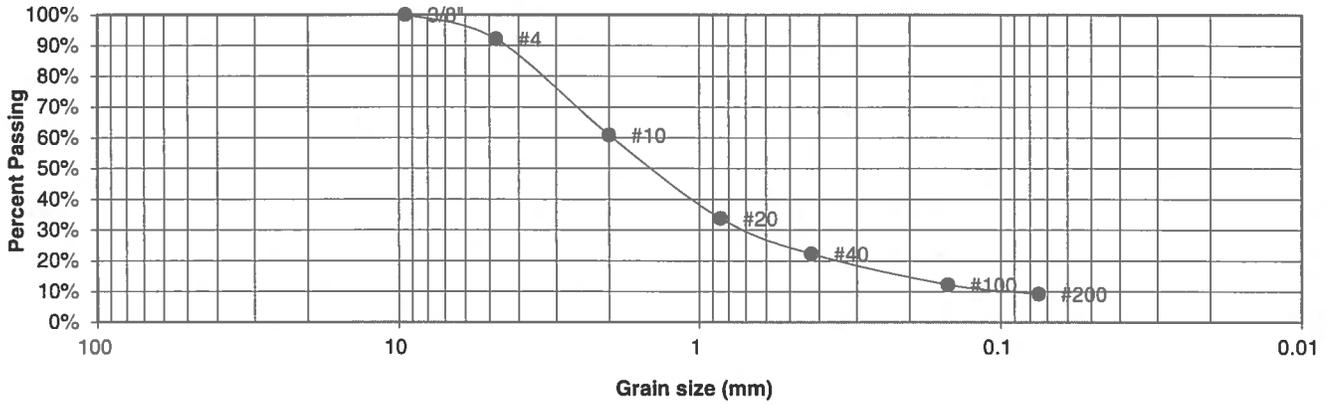
UNIFIED CLASSIFICATION	SM-SW	CLIENT	ARROYA INVESTMENTS
SOIL TYPE #	1	PROJECT	THE RETREAT AT TIMBER RIDGE
TEST BORING #	2	JOB NO.	170020
DEPTH (FT)	10	TEST BY	BL

**Sieve Analysis
Grain Size Distribution**

U.S. Sieve #	Percent Finer
3"	
1 1/2"	
3/4"	
1/2"	
3/8"	100.0%
4	92.1%
10	60.9%
20	33.9%
40	22.3%
100	12.3%
200	9.2%

Atterberg Limits	
Plastic Limit	NP
Liquid Limit	NV
Plastic Index	NP

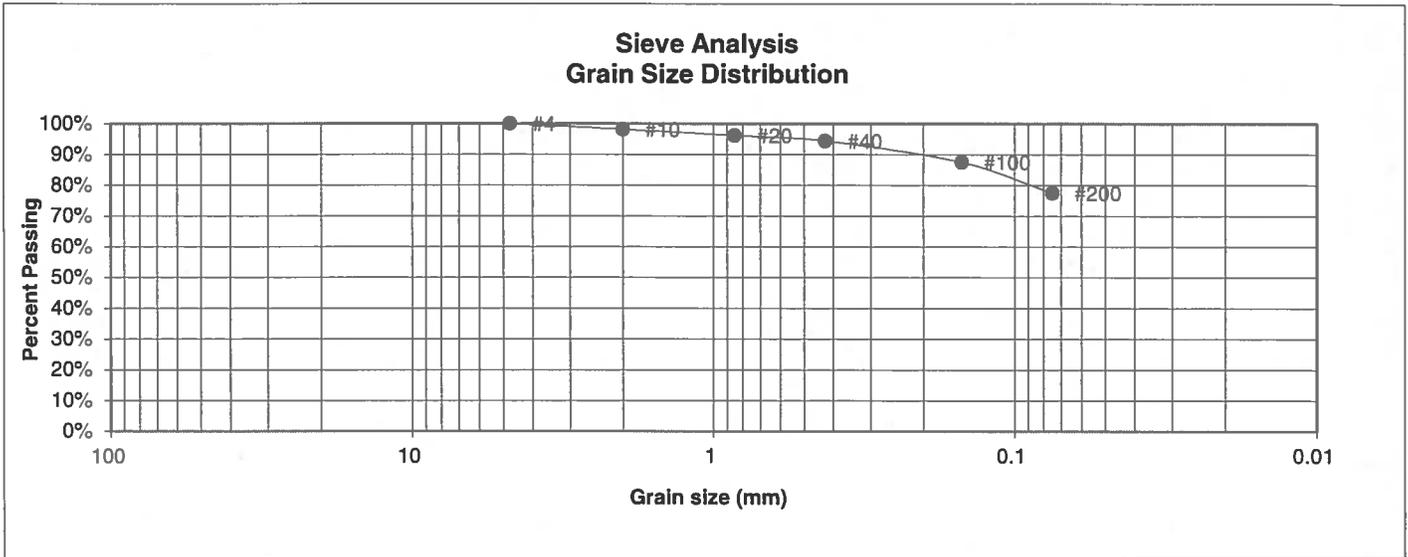
FIG NO.:
L-7

UNIFIED CLASSIFICATION	CL	CLIENT	ARROYA INVESTMENTS
SOIL TYPE #	2	PROJECT	THE RETREAT AT TIMBER RIDGE
TEST BORING #	1	JOB NO.	170020
DEPTH (FT)	2-3	TEST BY	BL

U.S. Sieve #	Percent Finer
3"	
1 1/2"	
3/4"	
1/2"	
3/8"	
4	100.0%
10	98.2%
20	96.2%
40	94.4%
100	87.5%
200	77.5%

Swell	
Moisture at start	10.9%
Moisture at finish	20.4%
Moisture increase	9.5%
Initial dry density (pcf)	131
Swell (psf)	1550
