**SOIL, GEOLOGY, GEOLOGIC HAZARD,
AND WASTEWATER STUDY
THE RETREAT AT TIMBER RIDGE
VOLLMER ROAD AND ARROYA LANE
EL PASO COUNTY, COLORADO**

April 12, 2017
Revised: December 1, 2017

Entech Job No. 170020
AAprojects/2017/170020 countysoil/geo revised

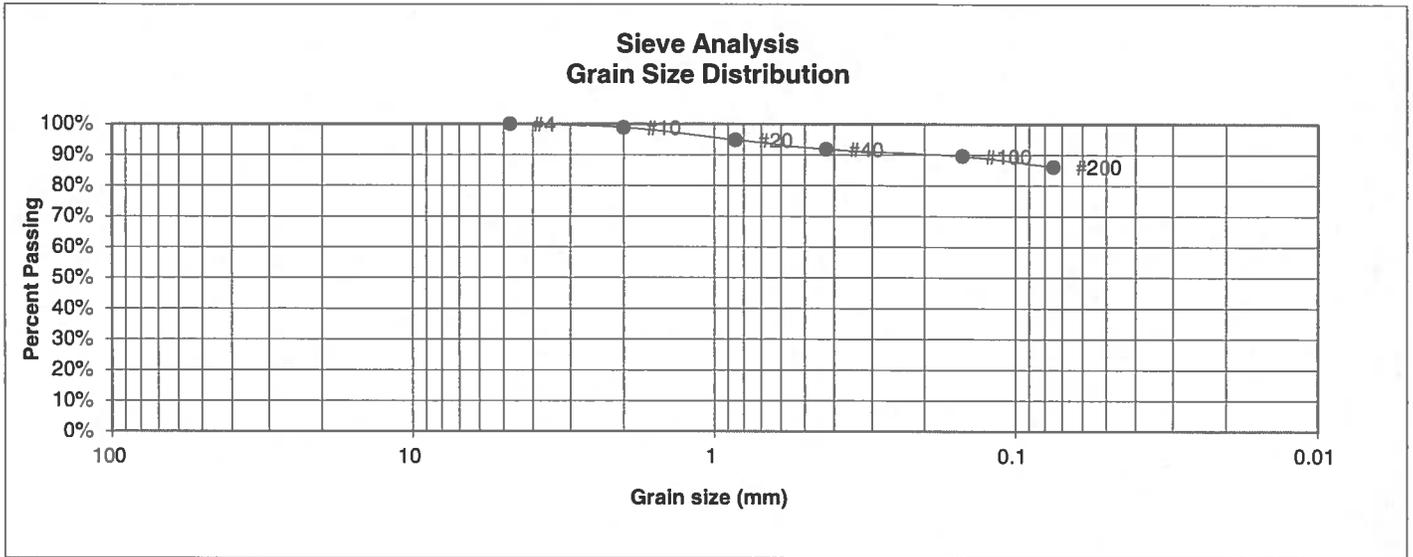
FIG NO.:
C-8

UNIFIED CLASSIFICATION	CL	CLIENT	ARROYA INVESTMENTS
SOIL TYPE #	2	PROJECT	THE RETREAT AT TIMBER RIDGE
TEST BORING #	2	JOB NO.	170020
DEPTH (FT)	4	TEST BY	BL

U.S. Sieve #	Percent Finer
3"	
1 1/2"	
3/4"	
1/2"	
3/8"	
4	100.0%
10	98.9%
20	94.9%
40	91.8%
100	89.6%
200	86.1%

Swell	
Moisture at start	15.9%
Moisture at finish	24.9%
Moisture increase	9.0%
Initial dry density (pcf)	99
Swell (psf)	1520

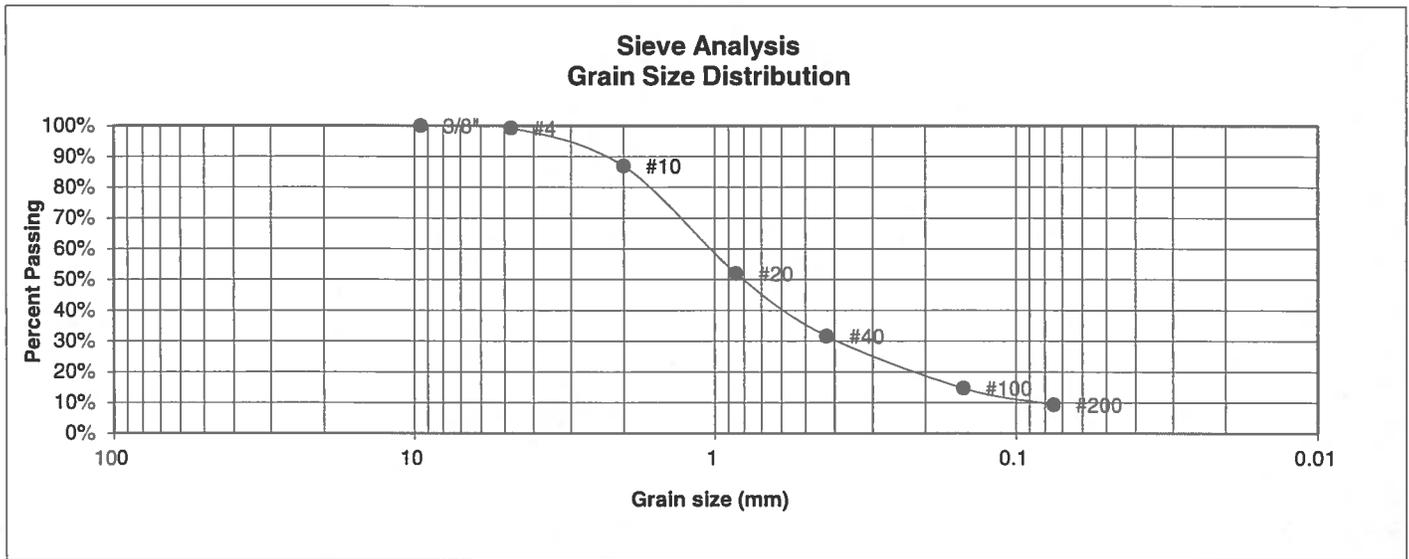
FIG NO.:
C-9

UNIFIED CLASSIFICATION	SM-SW	CLIENT	ARROYA INVESTMENTS
SOIL TYPE #	3	PROJECT	THE RETREAT AT TIMBER RIDGE
TEST BORING #	1	JOB NO.	170020
DEPTH (FT)	10	TEST BY	BL

U.S. Sieve #	Percent Finer
3"	
1 1/2"	
3/4"	
1/2"	
3/8"	100.0%
4	99.3%
10	87.0%
20	52.0%
40	31.6%
100	14.7%
200	9.3%

Atterberg Limits	
Plastic Limit	NP
Liquid Limit	NV
Plastic Index	NP

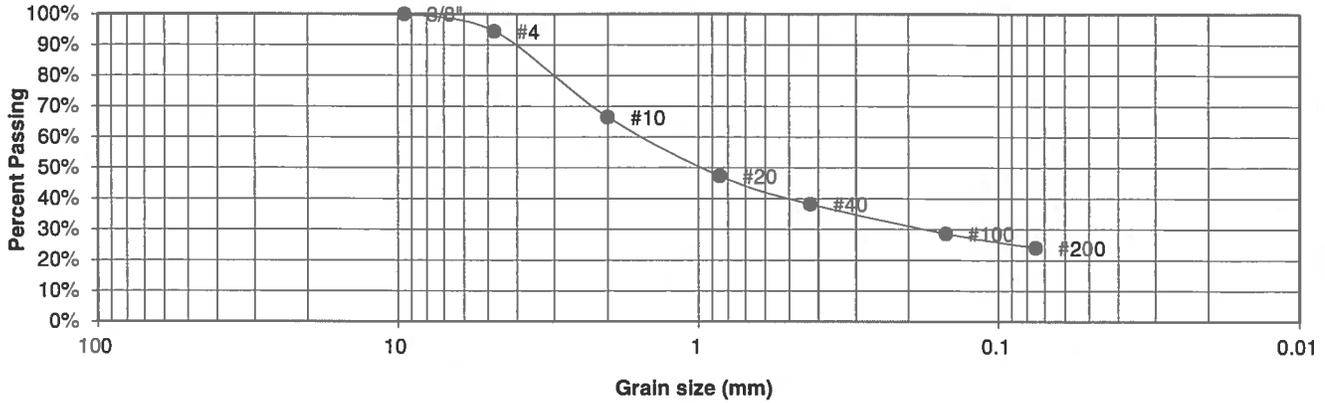
<u>UNIFIED CLASSIFICATION</u>	SM	<u>CLIENT</u>	ARROYA INVESTMENTS
<u>SOIL TYPE #</u>	3	<u>PROJECT</u>	THE RETREAT AT TIMBER RIDGE
<u>TEST BORING #</u>	3	<u>JOB NO.</u>	170020
<u>DEPTH (FT)</u>	5	<u>TEST BY</u>	BL

**Sieve Analysis
Grain Size Distribution**

<u>U.S. Sieve #</u>	<u>Percent Finer</u>
3"	
1 1/2"	
3/4"	
1/2"	
3/8"	100.0%
4	94.4%
10	66.5%
20	47.4%
40	38.2%
100	28.7%
200	24.0%

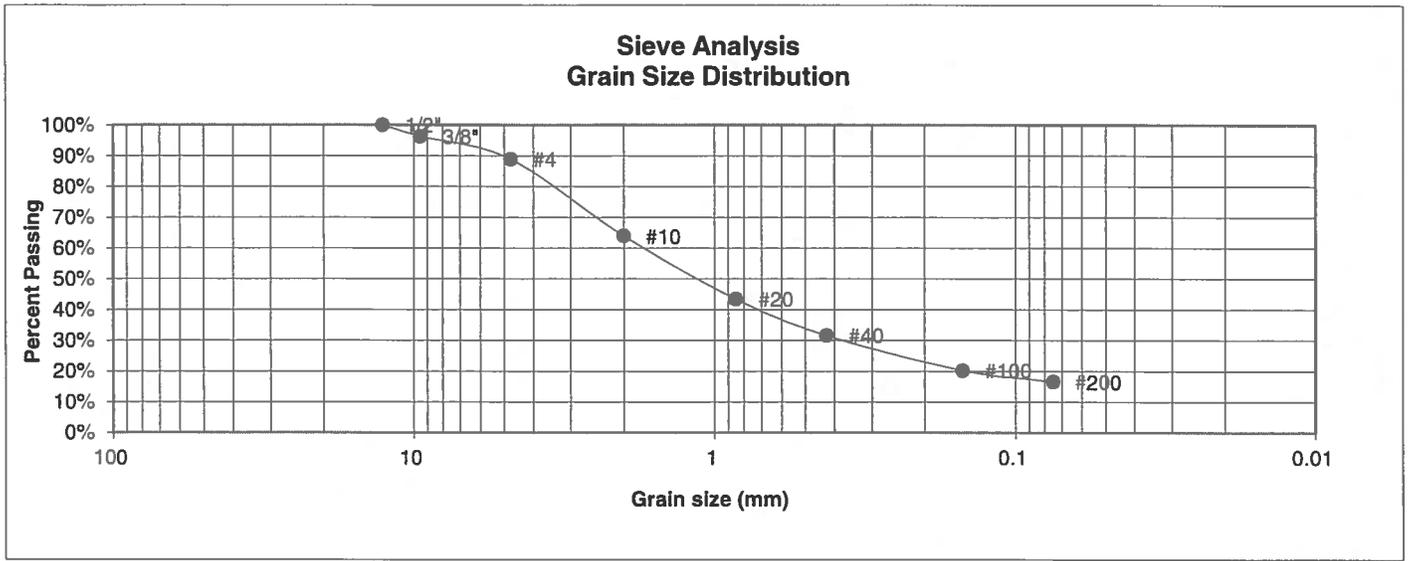
FIG NO.:
C-11

UNIFIED CLASSIFICATION	SM	CLIENT	ARROYA INVESTMENTS
SOIL TYPE #	3	PROJECT	THE RETREAT AT TIMBER RIDGE
TEST BORING #	7	JOB NO.	170020
DEPTH (FT)	20	TEST BY	BL

U.S. Sieve #	Percent Finer
3"	
1 1/2"	
3/4"	
1/2"	100.0%
3/8"	96.3%
4	88.9%
10	64.0%
20	43.5%
40	31.6%
100	20.3%
200	16.6%

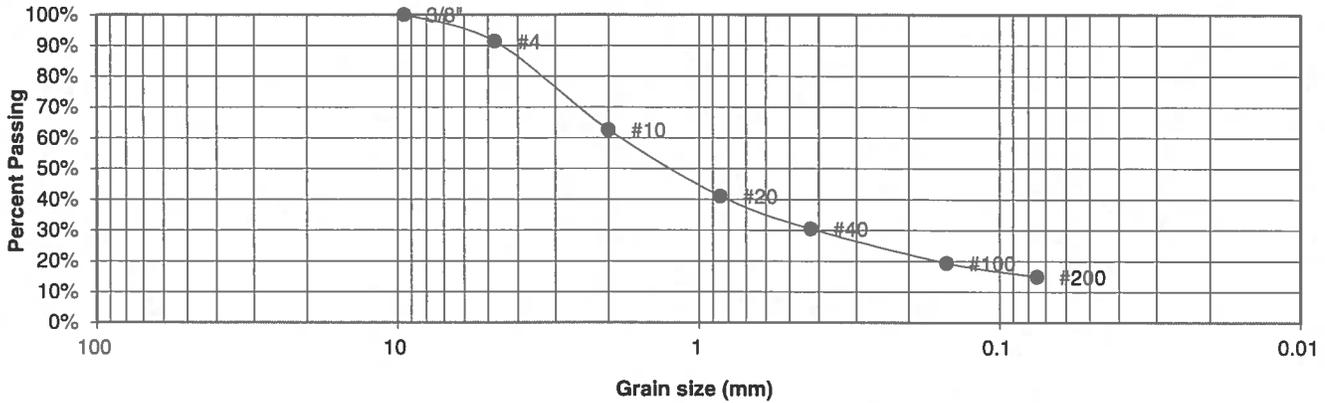
<u>UNIFIED CLASSIFICATION</u>	SM	<u>CLIENT</u>	ARROYA INVESTMENTS
<u>SOIL TYPE #</u>	3	<u>PROJECT</u>	THE RETREAT AT TIMBER RIDGE
<u>TEST BORING #</u>	8	<u>JOB NO.</u>	170020
<u>DEPTH (FT)</u>	5	<u>TEST BY</u>	BL

**Sieve Analysis
Grain Size Distribution**

<u>U.S. Sieve #</u>	<u>Percent Finer</u>
3"	
1 1/2"	
3/4"	
1/2"	
3/8"	100.0%
4	91.3%
10	62.6%
20	41.1%
40	30.5%
100	19.4%
200	14.9%

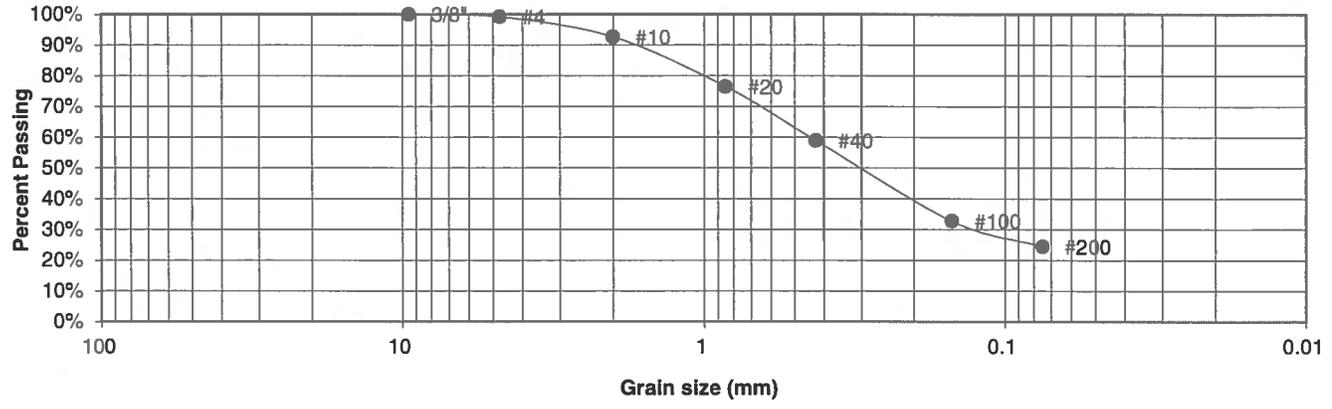
<u>UNIFIED CLASSIFICATION</u>	SC	<u>CLIENT</u>	ARROYA INVESTMENTS
<u>SOIL TYPE #</u>	3	<u>PROJECT</u>	THE RETREAT AT TIMBER RIDGE
<u>TEST BORING #</u>	12	<u>JOB NO.</u>	170020
<u>DEPTH (FT)</u>	10	<u>TEST BY</u>	BL

**Sieve Analysis
Grain Size Distribution**

<u>U.S. Sieve #</u>	<u>Percent Finer</u>
3"	
1 1/2"	
3/4"	
1/2"	
3/8"	100.0%
4	99.1%
10	92.7%
20	76.5%
40	58.9%
100	32.7%
200	24.4%

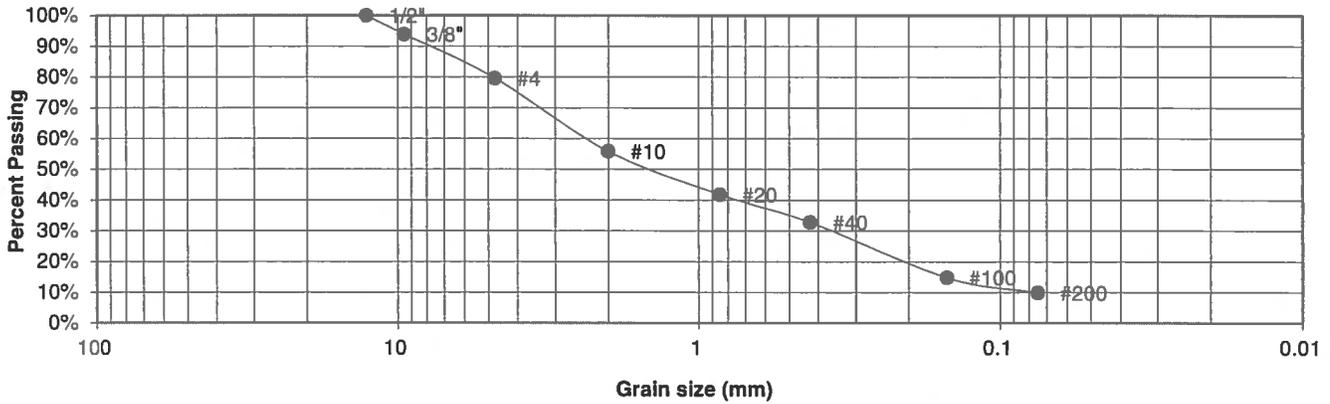
UNIFIED CLASSIFICATION	SM-SW	CLIENT	ARROYA INVESTMENTS
SOIL TYPE #	3	PROJECT	THE RETREAT AT TIMBER RIDGE
TEST BORING #	9	JOB NO.	170020
DEPTH (FT)	15	TEST BY	BL

**Sieve Analysis
Grain Size Distribution**

U.S. Sieve #	Percent Finer
3"	
1 1/2"	
3/4"	
1/2"	100.0%
3/8"	93.9%
4	79.6%
10	55.8%
20	41.8%
40	32.8%
100	14.8%
200	9.9%

Atterberg Limits	
Plastic Limit	NP
Liquid Limit	NV
Plastic Index	NP

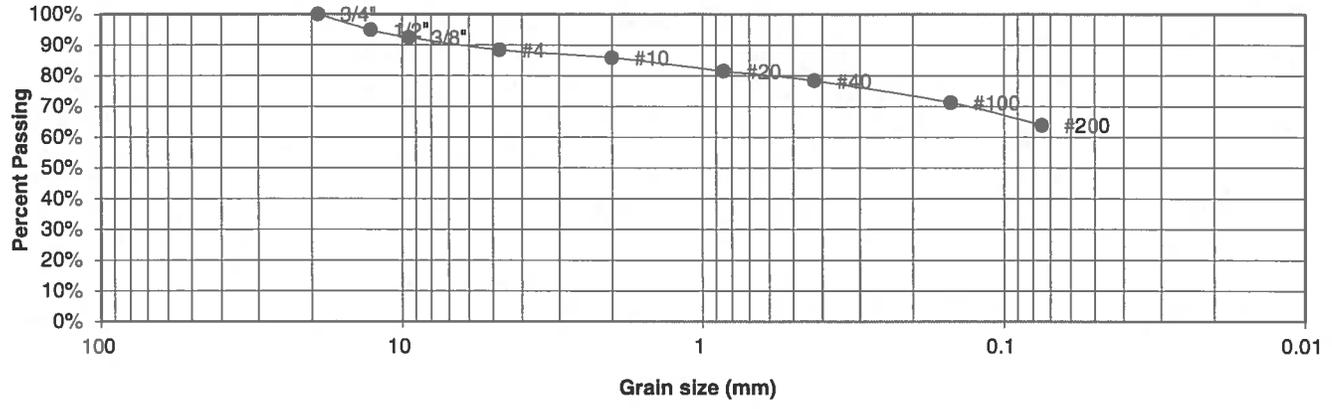
<u>UNIFIED CLASSIFICATION</u>	CL	<u>CLIENT</u>	ARROYA INVESTMENTS
<u>SOIL TYPE #</u>	4	<u>PROJECT</u>	THE RETREAT AT TIMBER RIDGE
<u>TEST BORING #</u>	4	<u>JOB NO.</u>	170020
<u>DEPTH (FT)</u>	15	<u>TEST BY</u>	BL

**Sieve Analysis
Grain Size Distribution**

<u>U.S. Sieve #</u>	<u>Percent Finer</u>
3"	
1 1/2"	
3/4"	100.0%
1/2"	94.9%
3/8"	92.5%
4	88.4%
10	85.9%
20	81.5%
40	78.4%
100	71.3%
200	63.9%

<u>Atterberg Limits</u>	
Plastic Limit	24
Liquid Limit	44
Plastic Index	20

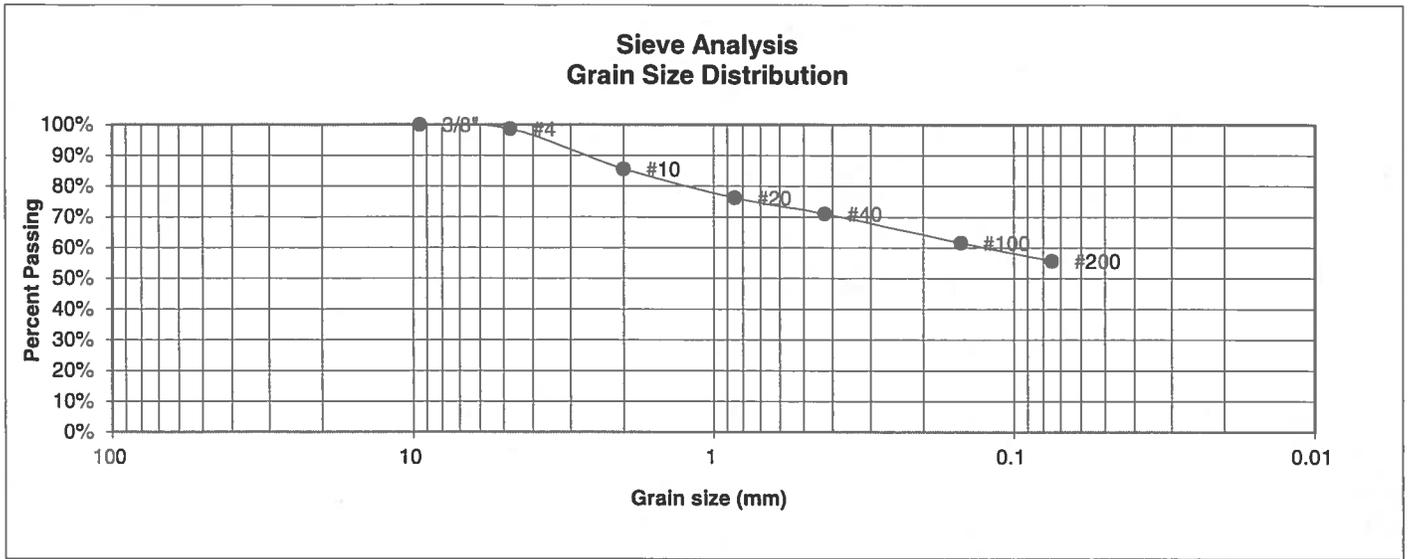
FIG NO.:
C-16

<u>UNIFIED CLASSIFICATION</u>	CL	<u>CLIENT</u>	ARROYA INVESTMENTS
<u>SOIL TYPE #</u>	4	<u>PROJECT</u>	THE RETREAT AT TIMBER RIDGE
<u>TEST BORING #</u>	5	<u>JOB NO.</u>	170020
<u>DEPTH (FT)</u>	10	<u>TEST BY</u>	BL

<u>U.S. Sieve #</u>	<u>Percent Finer</u>
3"	
1 1/2"	
3/4"	
1/2"	
3/8"	100.0%
4	98.6%
10	85.6%
20	76.2%
40	71.0%
100	61.6%
200	55.7%

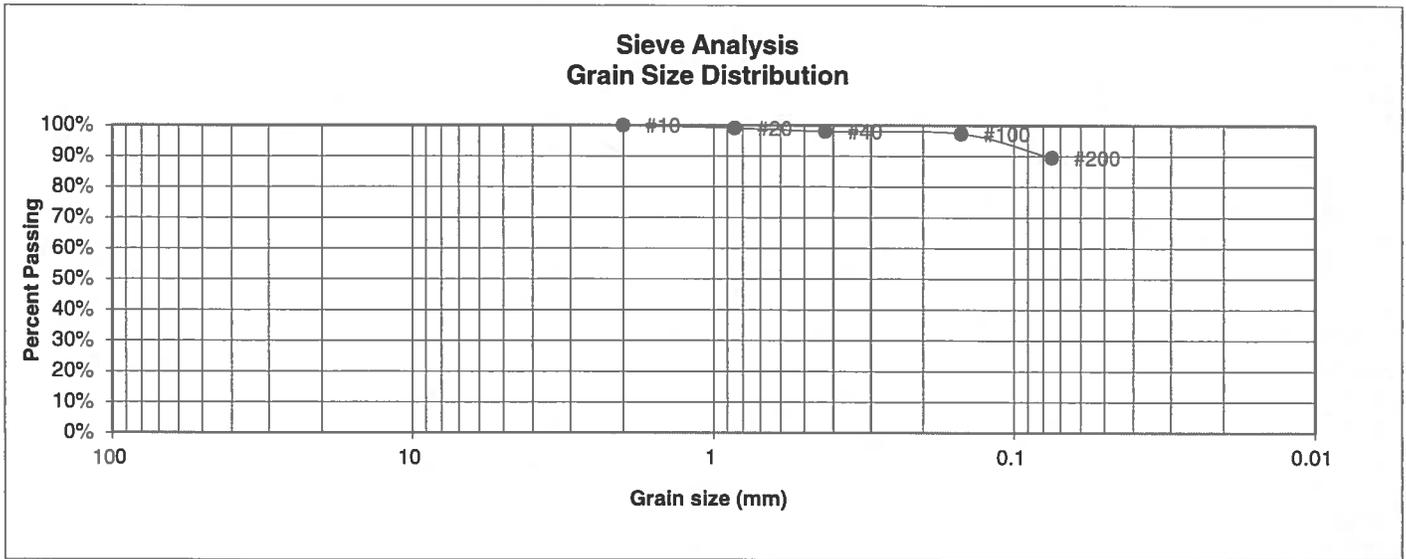
FIG NO.:
C-17

UNIFIED CLASSIFICATION	CL	CLIENT	ARROYA INVESTMENTS
SOIL TYPE #	4	PROJECT	THE RETREAT AT TIMBER RIDGE
TEST BORING #	7	JOB NO.	170020
DEPTH (FT)	15	TEST BY	BL

U.S. Sieve #	Percent Finer
3"	
1 1/2"	
3/4"	
1/2"	
3/8"	
4	
10	100.0%
20	99.1%
40	98.1%
100	97.3%
200	89.5%

Atterberg Limits	
Plastic Limit	26
Liquid Limit	47
Plastic Index	21

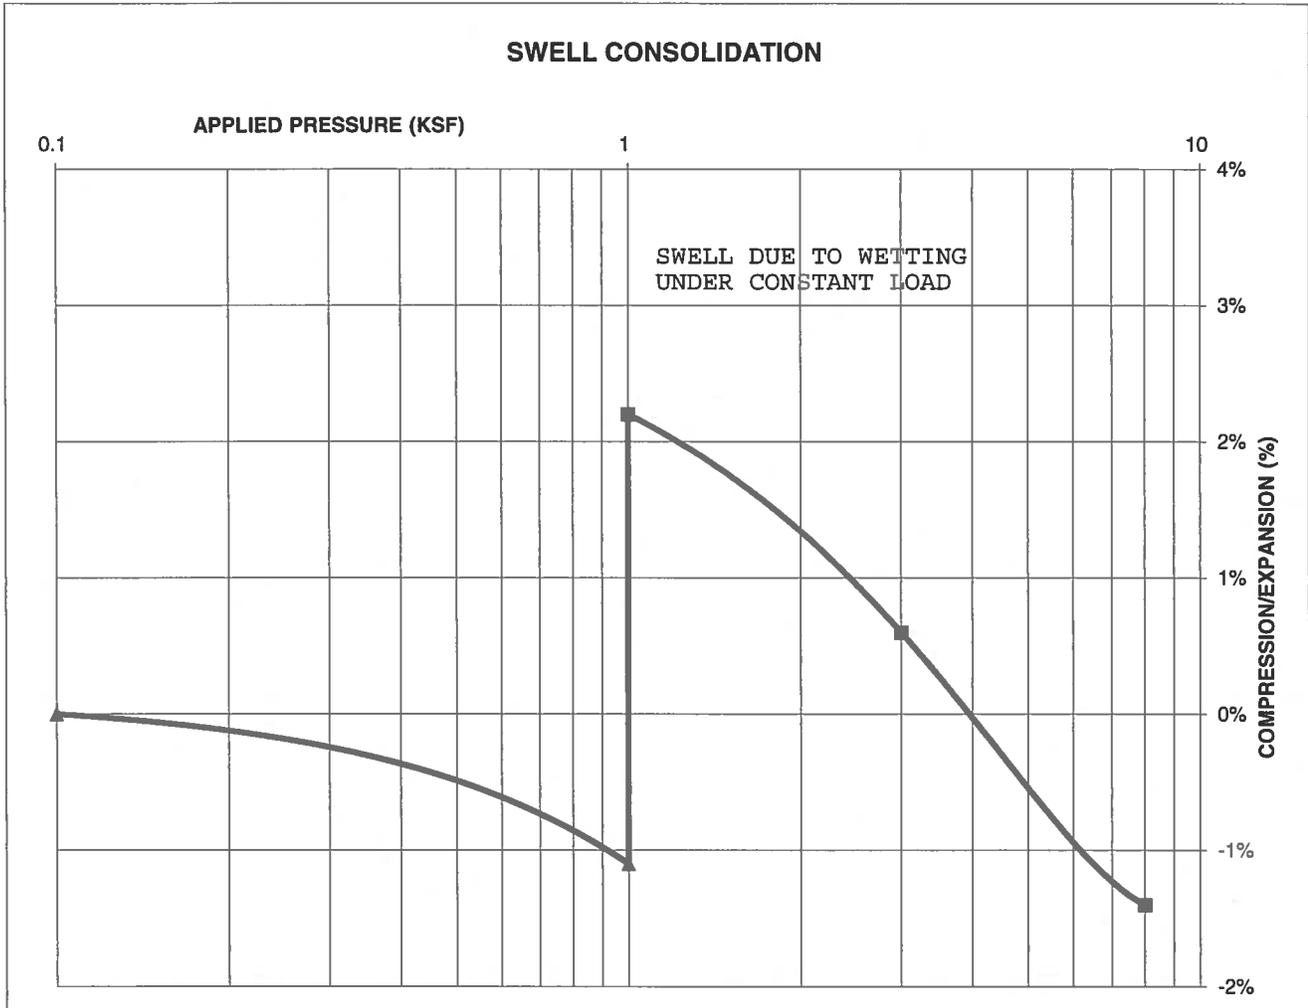
TEST BORING #	4	DEPTH(ft)	15
DESCRIPTION	CL	SOIL TYPE	4
NATURAL UNIT DRY WEIGHT (PCF)			109
NATURAL MOISTURE CONTENT			19.9%
SWELL/CONSOLIDATION (%)			3.3%

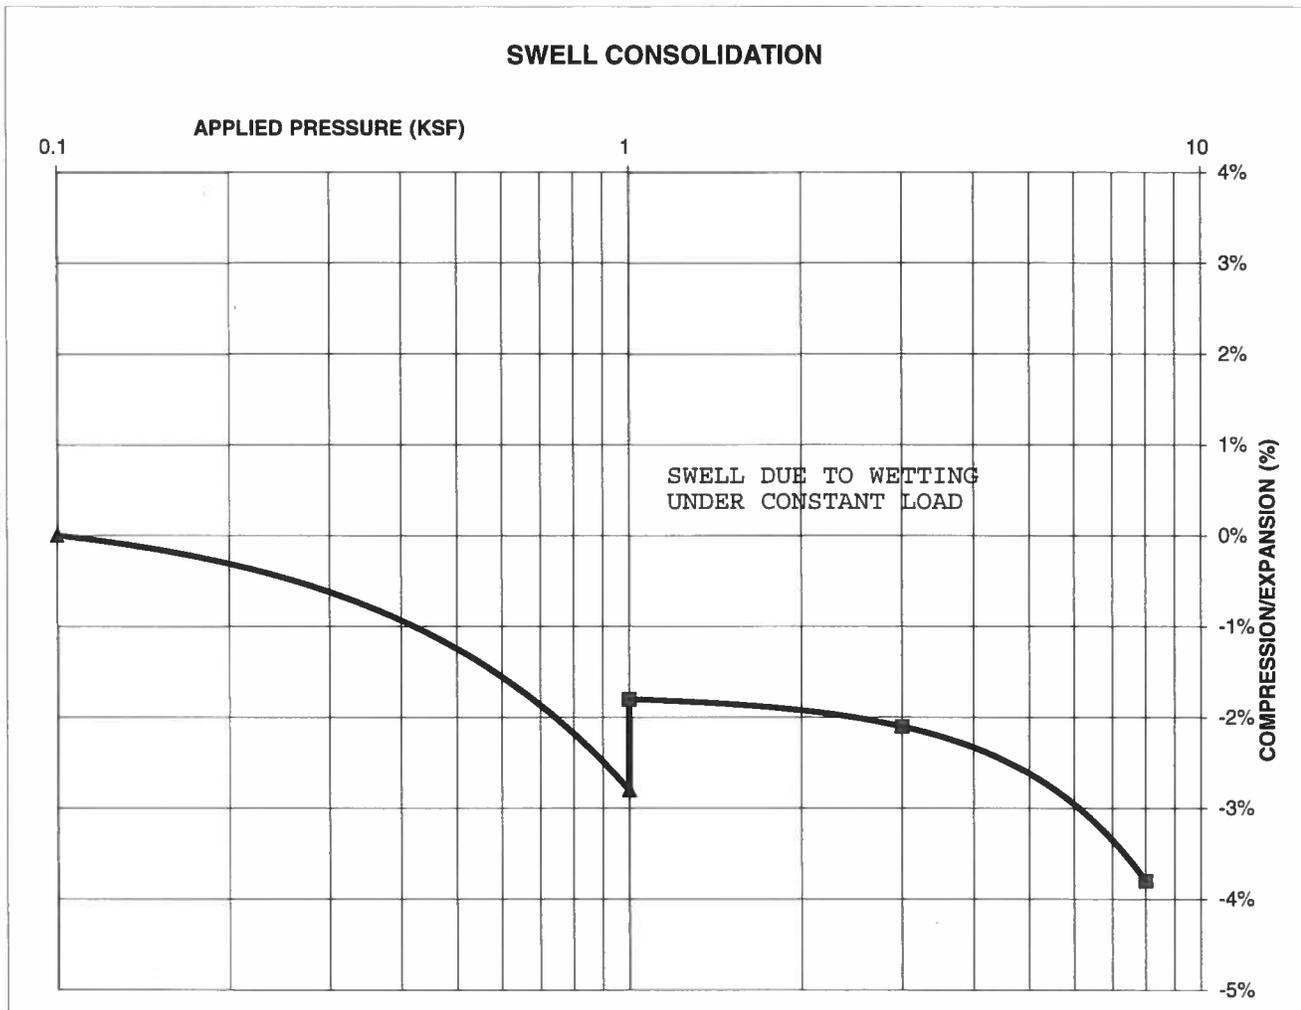
TEST BORING #	5	DEPTH(ft)	10
DESCRIPTION	CL	SOIL TYPE	4
NATURAL UNIT DRY WEIGHT (PCF)			111
NATURAL MOISTURE CONTENT			17.8%
SWELL/CONSOLIDATION (%)			1.0%

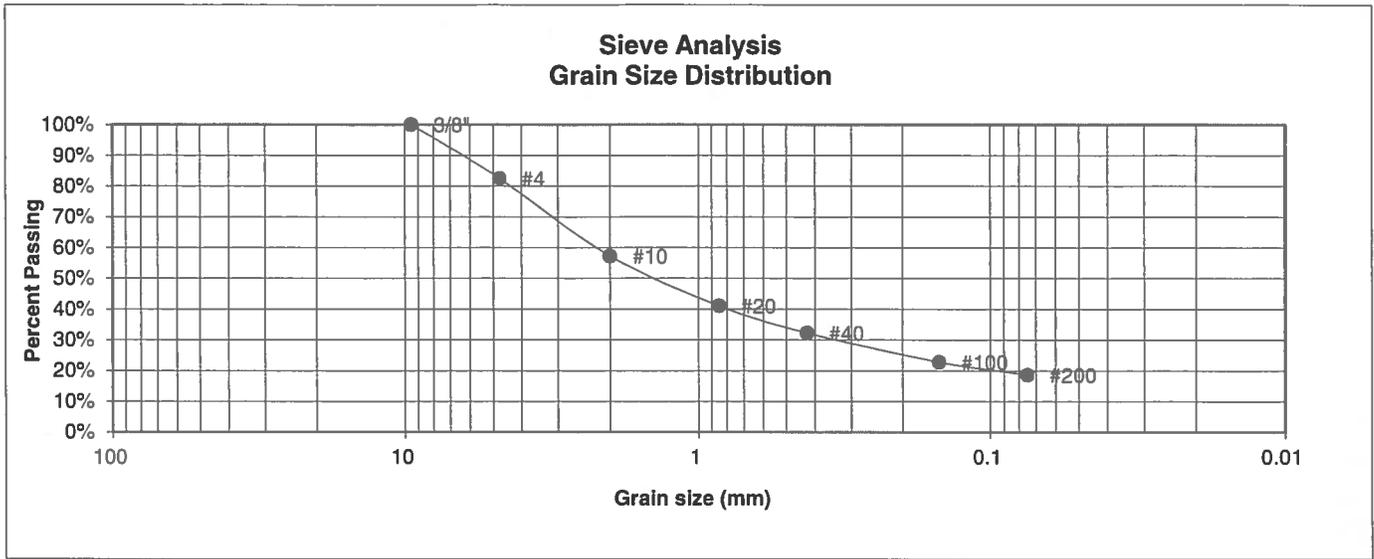
C-20

BORING NO.	TP-2	UNIFIED CLASSIFICATION	SM	TEST BY	BL
DEPTH(ft)	3	AASHTO CLASSIFICATION		JOB NO.	170020
CLIENT	ARROYA INVESTMENTS				
PROJECT	THE RETREAT AT TIMBER RIDGE

U.S. Sieve #	Percent Finer
3"	
1 1/2"	
3/4"	
1/2"	
3/8"	100.0%
4	82.5%
10	57.3%
20	41.0%
40	32.3%
100	22.9%
200	18.7%

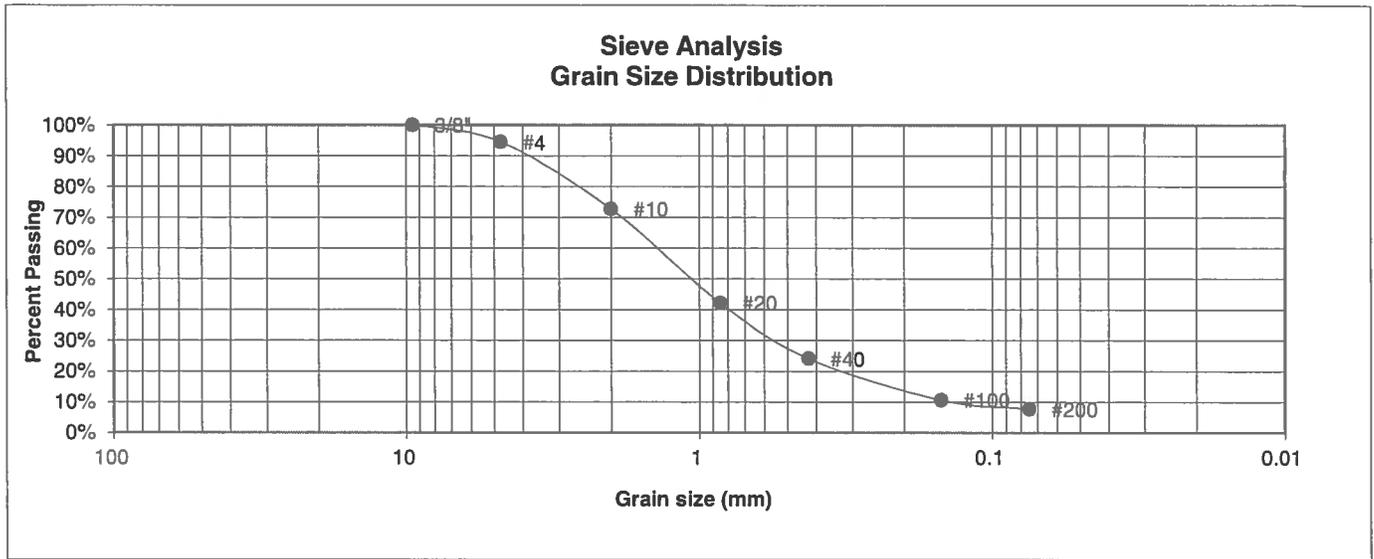
C-22

BORING NO.	TP-4	<u>UNIFIED CLASSIFICATION</u>	SM-SW	<u>TEST BY</u>	BL
DEPTH(ft)	4	<u>AASHTO CLASSIFICATION</u>		<u>JOB NO.</u>	170020
CLIENT	ARROYA INVESTMENTS				
PROJECT	THE RETREAT AT TIMBER RIDGE

U.S. Sieve #	Percent Finer
3"	
1 1/2"	
3/4"	
1/2"	
3/8"	100.0%
4	94.6%
10	72.7%
20	42.2%
40	24.1%
100	10.6%
200	7.7%

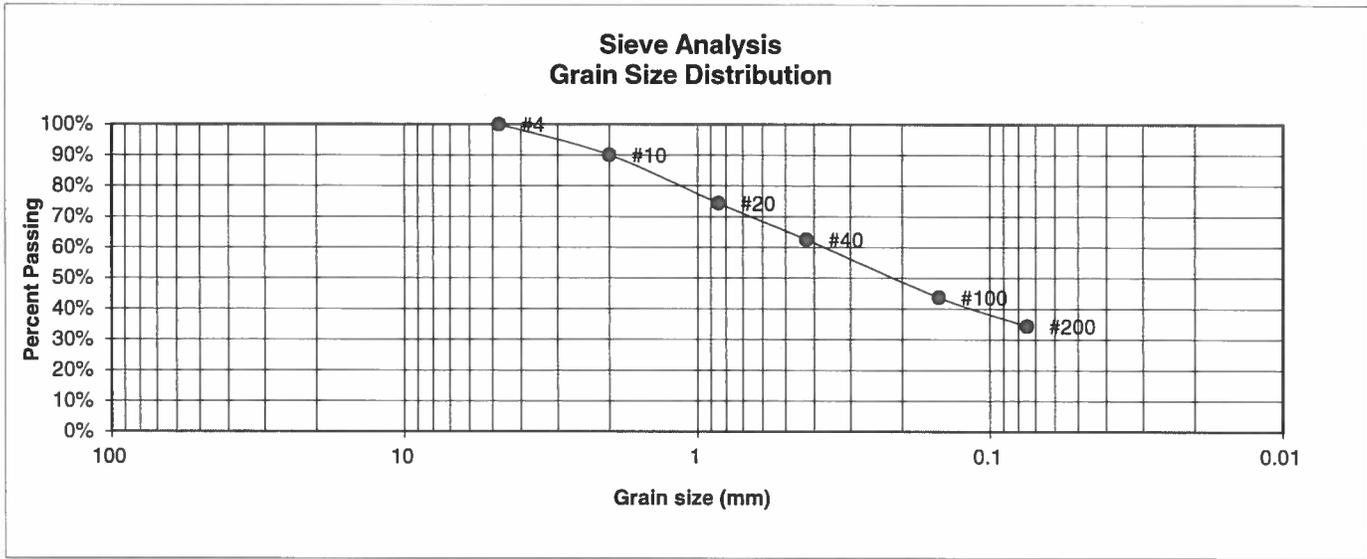
C-23

BORING NO.	TP-5	UNIFIED CLASSIFICATION	SC	TEST BY	BL
DEPTH(ft)	7-8	AASHTO CLASSIFICATION		JOB NO.	170020
CLIENT	ARROYA INVESTMENTS				
PROJECT	THE RETREAT AT TIMBER RIDGE

<u>U.S. Sieve #</u>	<u>Percent Finer</u>	<u>Atterberg Limits</u>
3"		Plastic Limit
1 1/2"		Liquid Limit
3/4"		Plastic Index
1/2"		
3/8"		
4	100.0%	<u>Swell</u>
10	90.1%	Moisture at start
20	74.4%	Moisture at finish
40	62.5%	Moisture increase
100	43.8%	Initial dry density (pcf)
200	34.4%	Swell (psf)

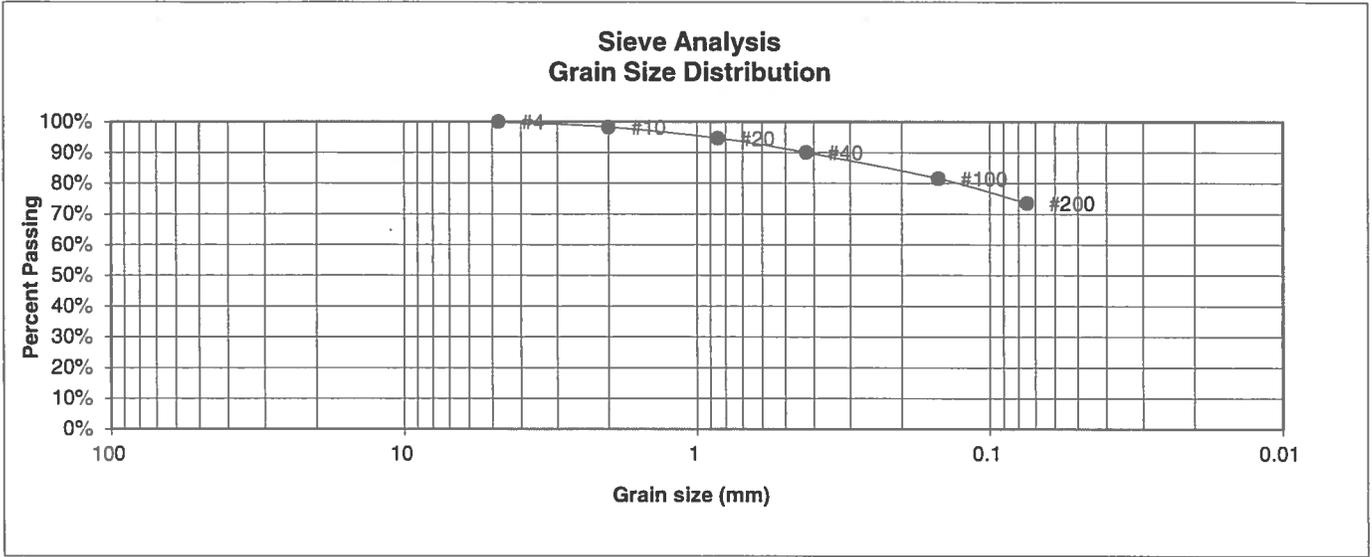
FIG NO.:
C-24

BORING NO.	TP-6	UNIFIED CLASSIFICATION	CL	TEST BY	BL
DEPTH(ft)	2	AASHTO CLASSIFICATION		JOB NO.	170020
CLIENT	ARROYA INVESTMENTS				
PROJECT	THE RETREAT AT TIMBER RIDGE

U.S. Sieve #	Percent Finer
3"	
1 1/2"	
3/4"	
1/2"	
3/8"	
4	100.0%
10	98.3%
20	94.7%
40	90.0%
100	81.6%
200	73.6%
