WASTEWATER DISPOSAL REPORT

***PT Overlook, LLC
Overlook Filing No. 1***

OVERLOOK FILING NO. 1

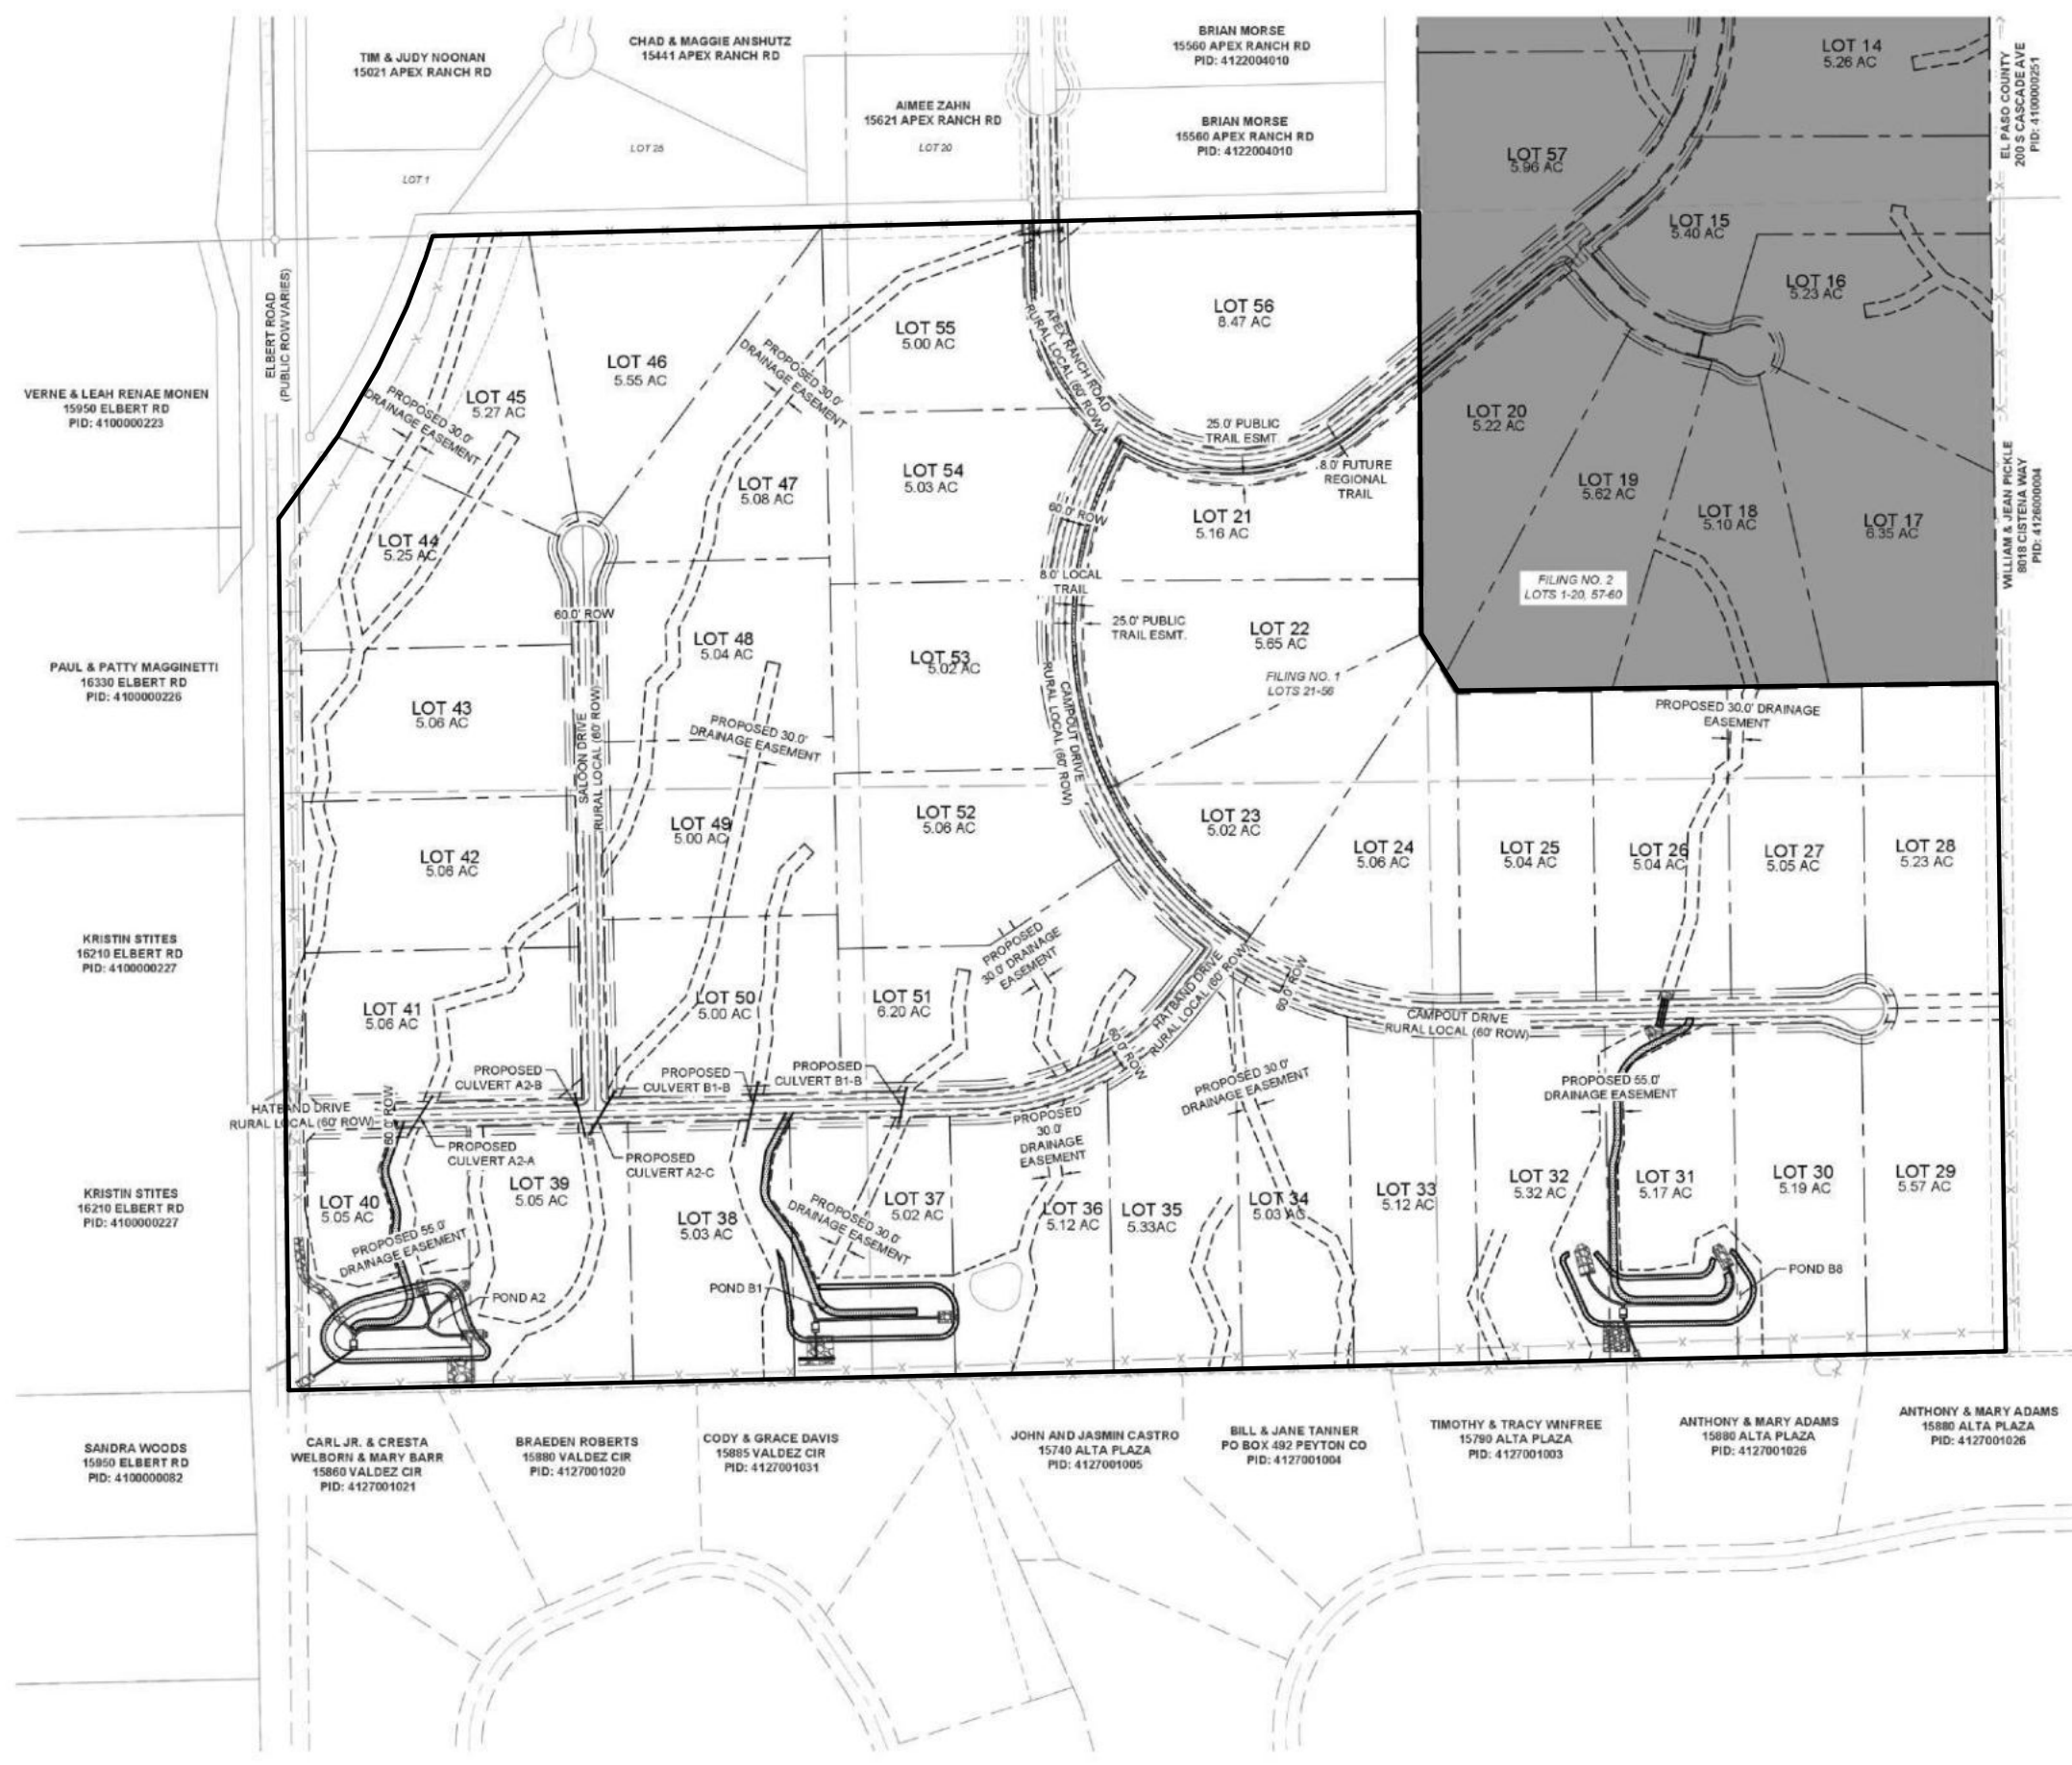
JOB NO.
 230677
FIG. 3

OVERALL SITE PLAN
 OVERLOOK AT HOMESTEAD, FILING NO. 1
 PT OVERLOOK, LLC

Overlook at Homestead Filing No. 1 Subdivision is approximately 202 acres, with thirty-six (36) 5-acre rural residential lots proposed (Lots 21 – 56). Preliminary grading plans indicate three extended detention basins (EDBs) across the southern side of Filing No. 1 to be located on Lots 31-32, 37-38, and 39-40. Grading will primarily be associated with the construction of roads and detention basins. The Development Plan/Test Boring Location Map is presented in Figure 3.

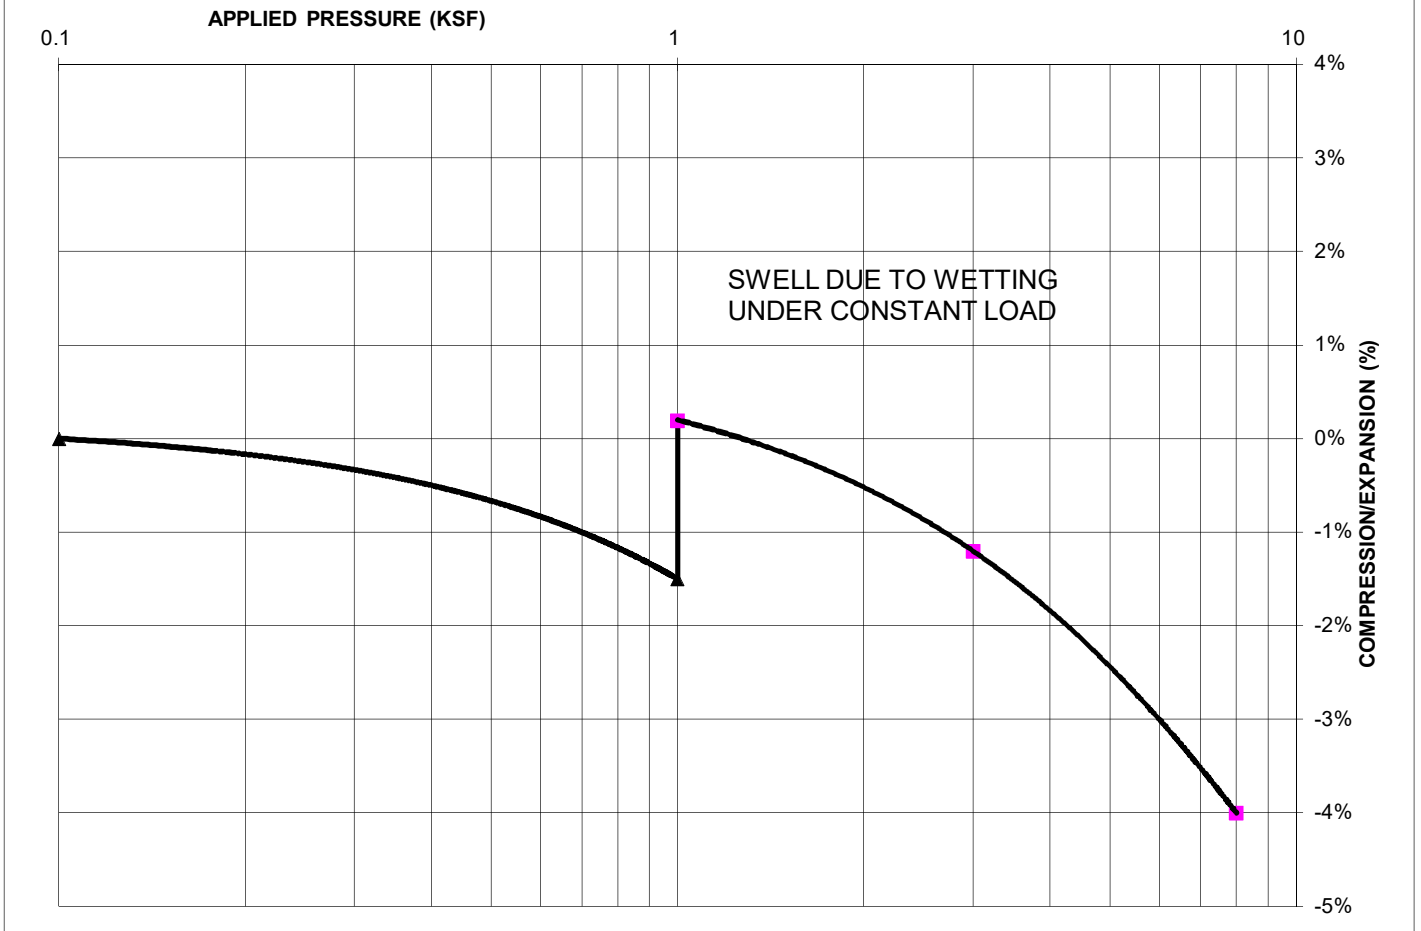
SWELL CONSOLIDATION

SOIL DESCRIPTION CLAY, SANDY
SOIL TYPE 2

SWELL/COLLAPSE TEST RESULTS

NATURAL UNIT DRY WEIGHT (PCF): 109
NATURAL MOISTURE CONTENT: 14.9%
SWELL/COLLAPSE (%): 1.7%

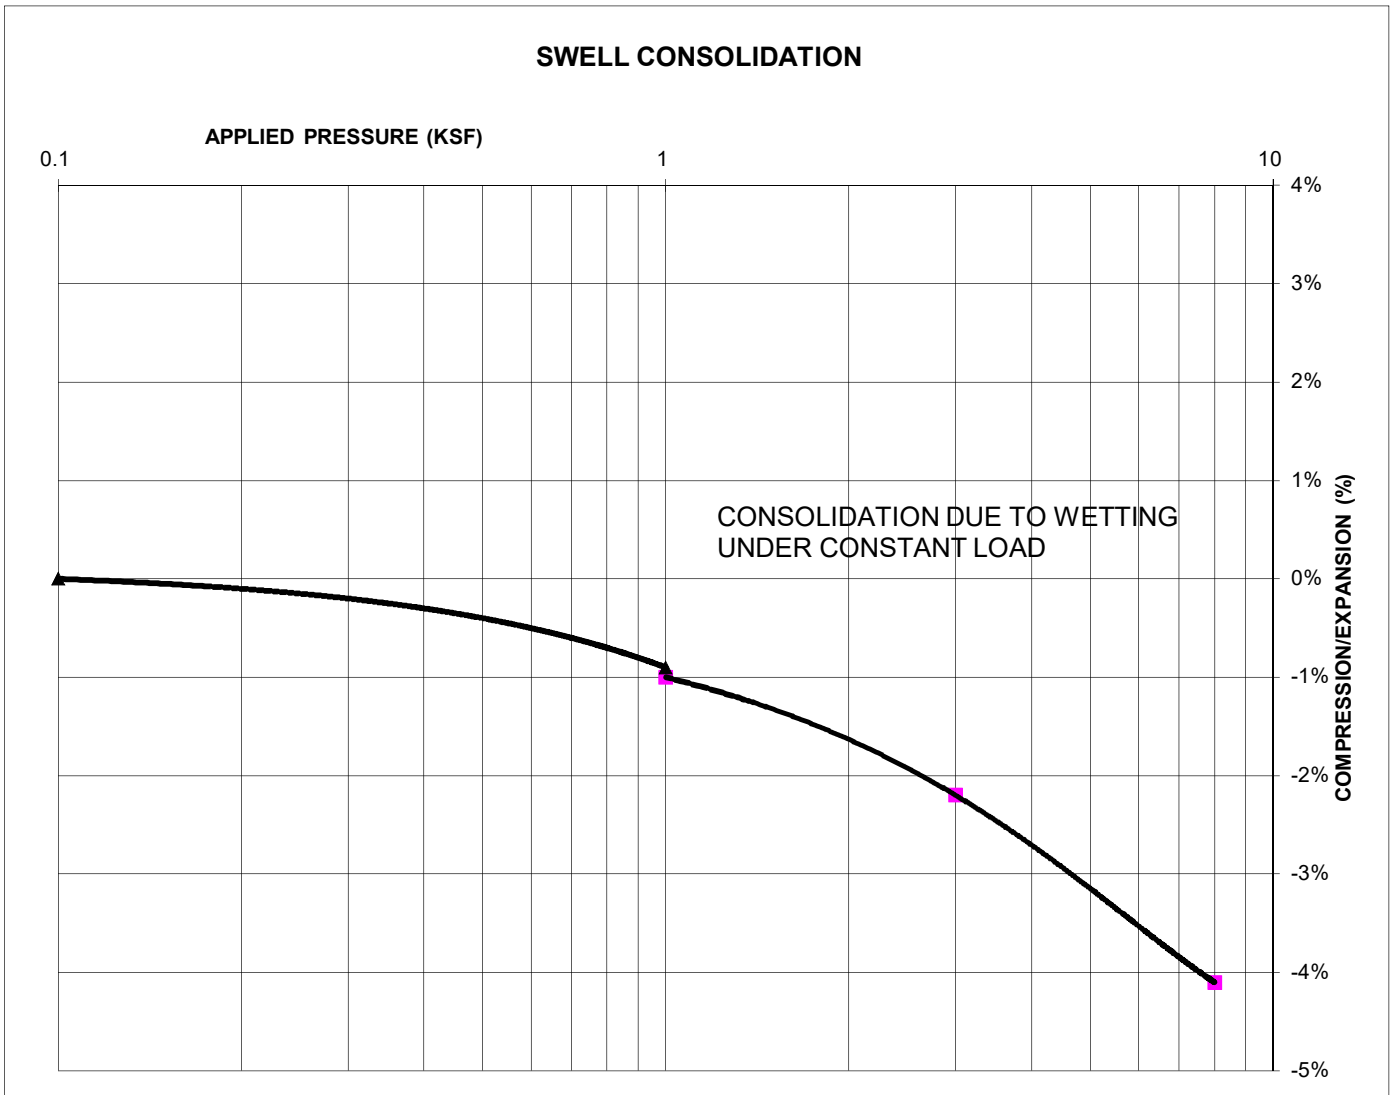
TEST BORING 3
DEPTH (FT) 15

SOIL DESCRIPTION SILTSTONE, SANDY
SOIL TYPE 4

SWELL/CONSOLIDATION TEST RESULTS

NATURAL UNIT DRY WEIGHT (PCF): 108
NATURAL MOISTURE CONTENT: 15.0%
SWELL/CONSOLIDATION (%): -0.1%
