ENTECH
ENGINEERING, INC.

**WASTEWATER STUDY
OVERLOOK AT HOMESTEAD – FILING NO. 1
ELBERT ROAD
EL PASO COUNTY, COLORADO**

June 7, 2024
Revised November 13, 2024

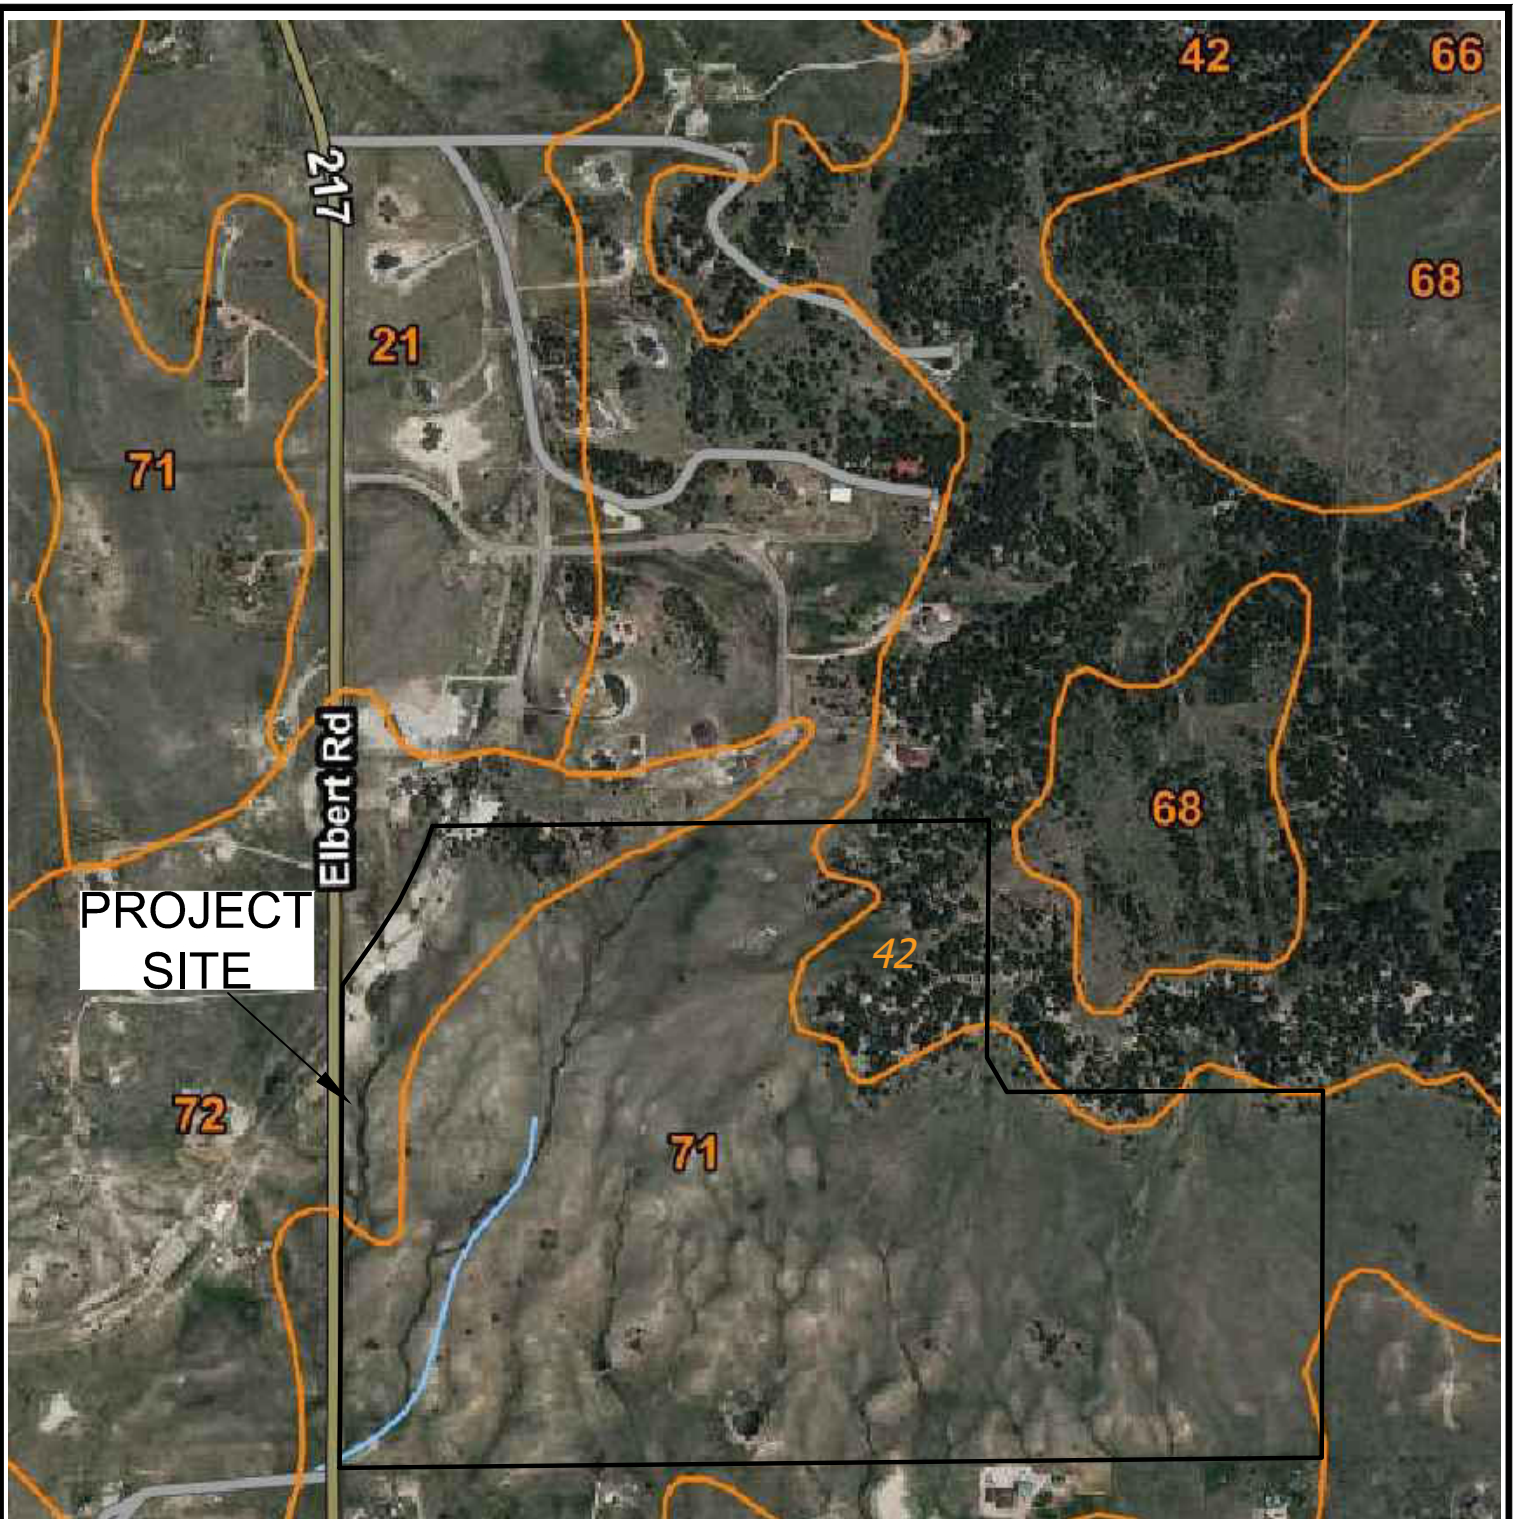
FIG. 5

SOIL SURVEY MAP
OVERLOOK AT HOMESTEAD, FILING NO. 1
PT OVERLOOK, LLC

The Natural Resource Conservation Service (Reference 2), previously the Soil Conservation Service (Reference 3) has mapped four soil types on the site (Figure 5). In general, the soils classify as coarse sandy loam, sandy loam, and rock outcrops. The soils are described as follows:

The Natural Resource Conservation Service (Reference 4), previously the Soil Conservation Service (Reference 5) has been mapped with four soil descriptions. The Soil Survey Map (Reference 4) is presented in Figure 5, and the Soil Survey Descriptions are presented in Appendix D. The soils are described as having slow to rapid percolation rates. The majority of the soils have been described with moderate permeabilities.

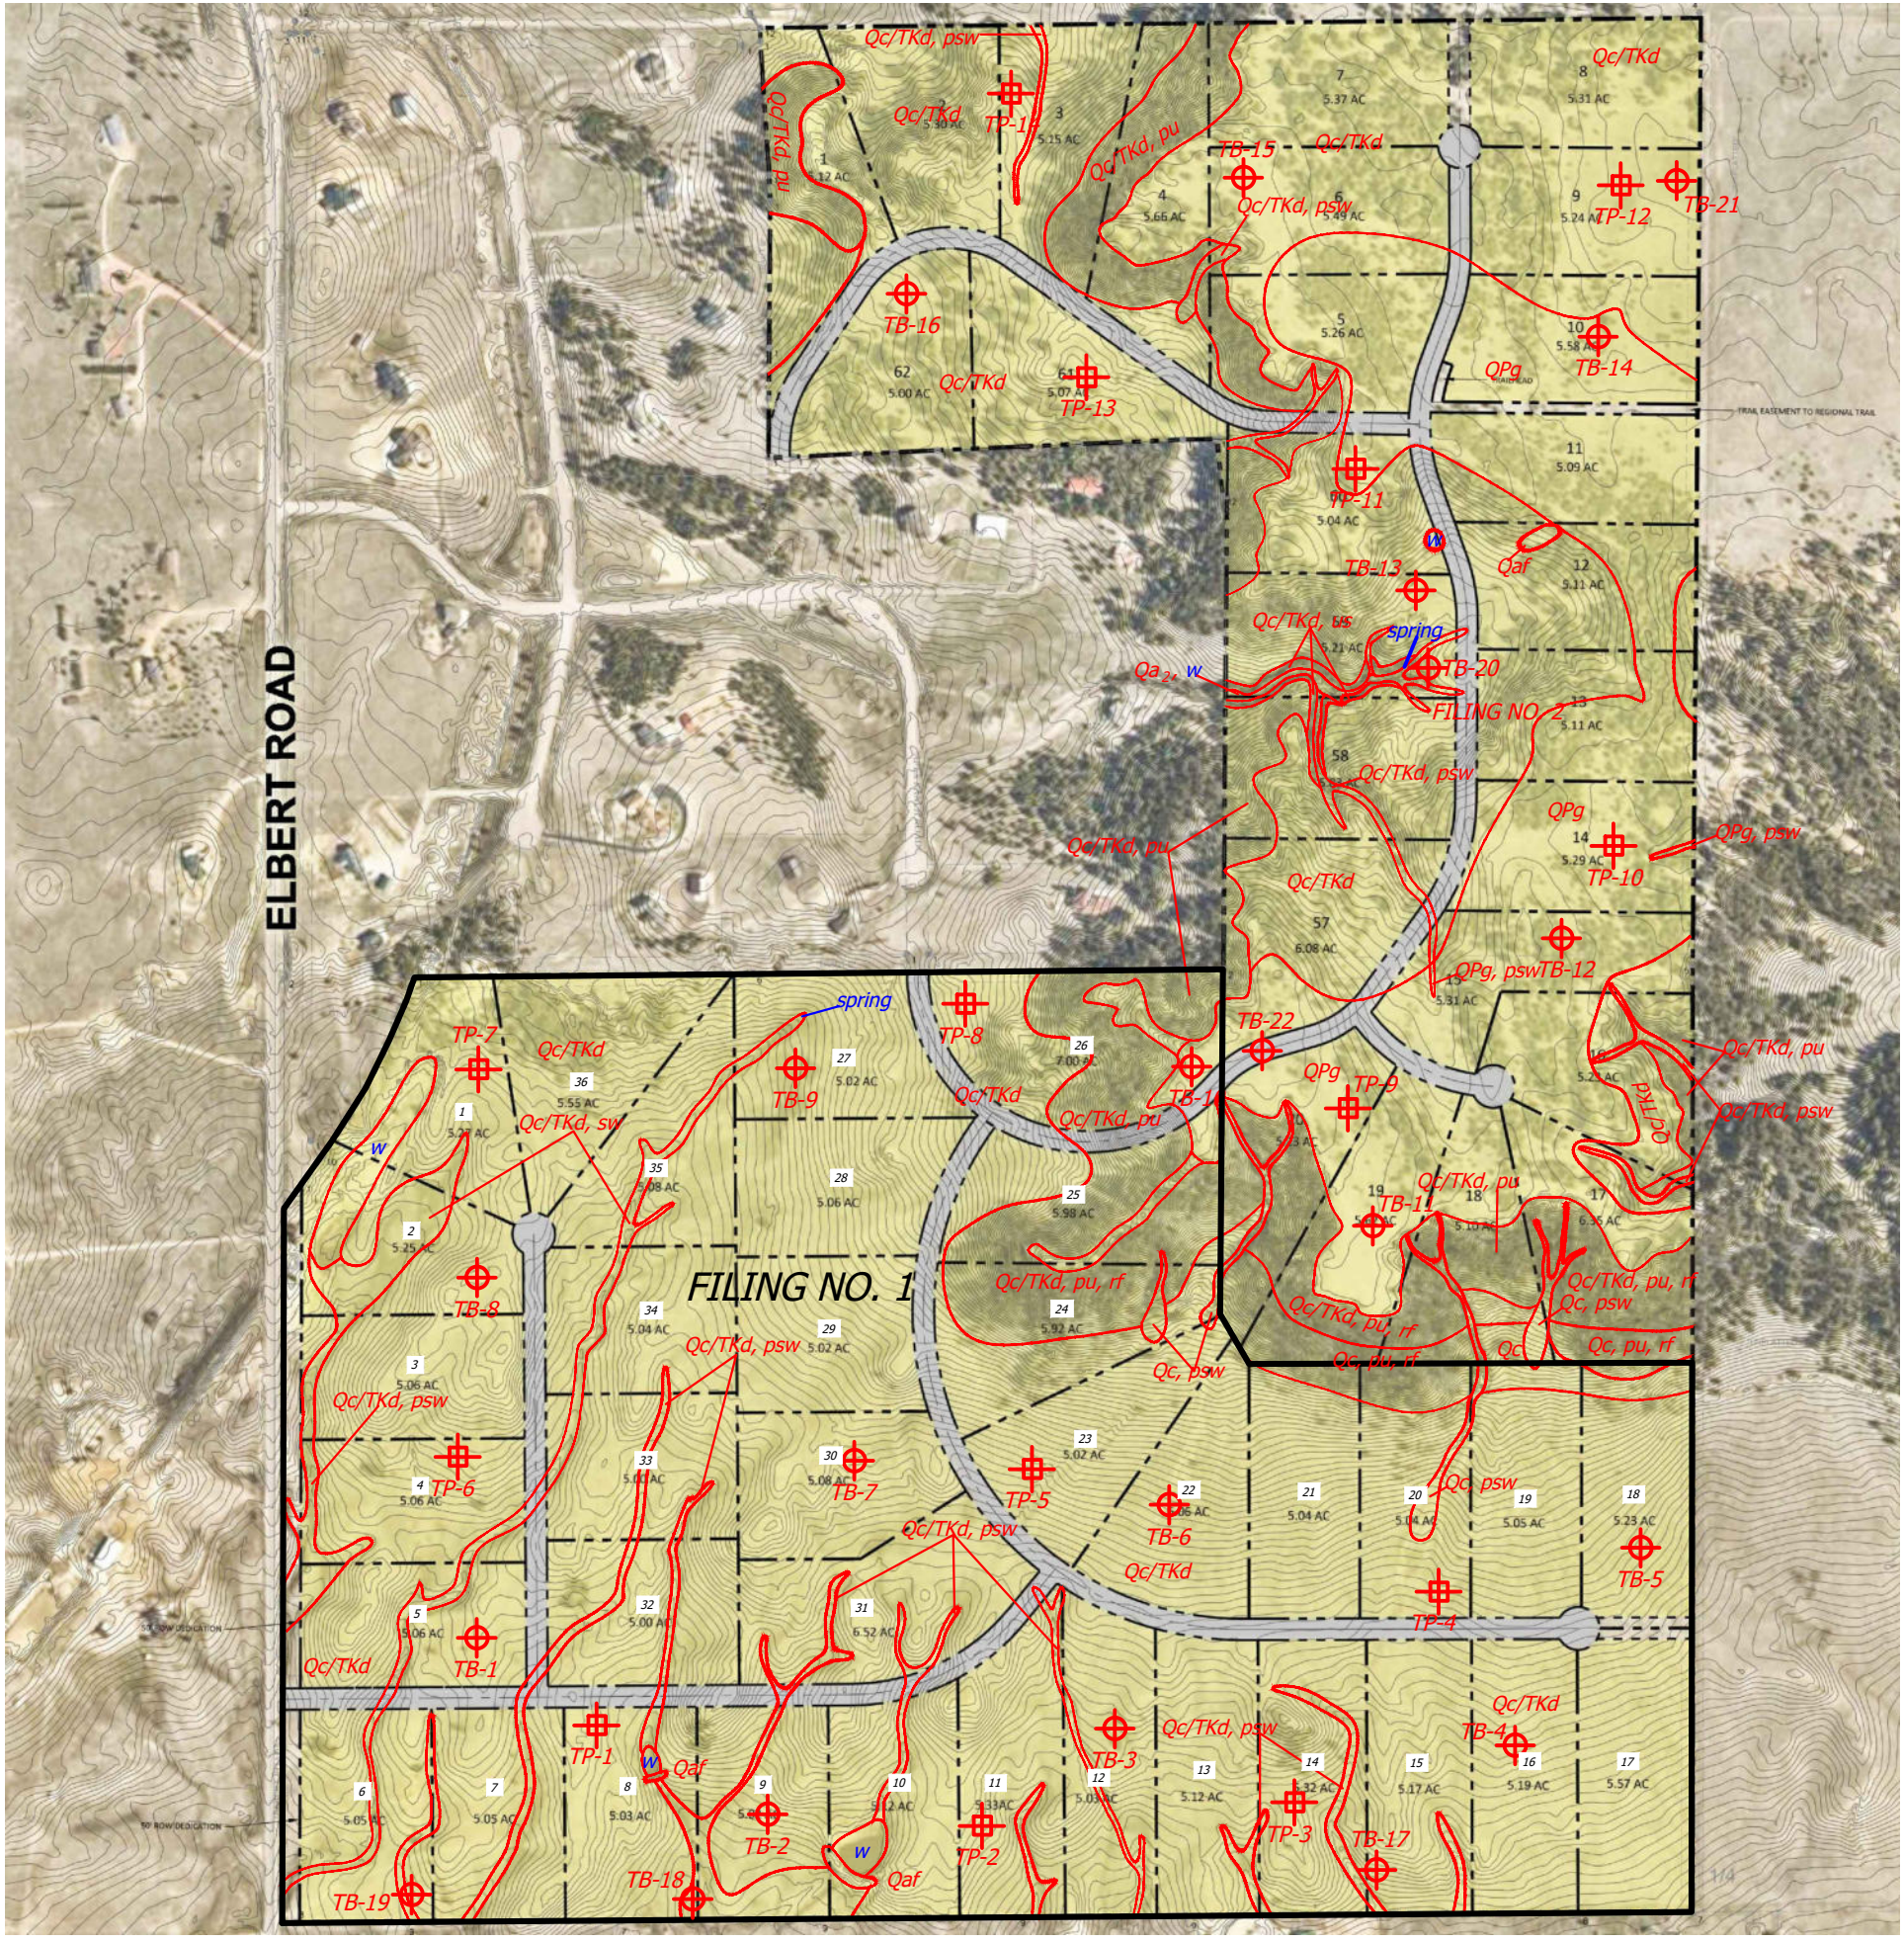
JOB NO.
230677
FIG. 7

GEOLOGY/ENGINEERING MAP
 OVERLOOK AT HOMESTEAD, FILING NO. 1
 PT OVERLOOK, LLC

- Legend:**
- Qaf - Artificial Fill of Holocene Age: man-made fill deposits associated with existing earthen berms and trash pile on lot 12
 - Qa₂ - Alluvium Two of Early Holocene Age: water deposited alluvium within drainage on Lot 59
 - Qc - Colluvial deposits of Holocene to Late Pleistocene Age: rockfall, sheetwash, and minor fan deposits
 - QPg - Gravel of the Palmer Divide of early Pleistocene? or late Pliocene Age: alluvial deposited sands with pebble and cobble gravel
 - pu - potentially unstable slopes
 - psw - potentially seasonal shallow groundwater
 - sw - seasonal shallow groundwater
 - w - ponded or flowing water
 - rf - rockfall

The Eastonville Quadrangle Geology Map showing the site is presented in (Figure 6, Reference 6). The Geology Map prepared for the site is presented in Figure 7. Five mappable units were identified on this site which are described as follows:

The soils listed above were mapped from site-specific mapping, the *Geologic Map of the Eastonville Quadrangle* distributed by the Colorado Geological Survey in 2012 (Reference 6), the *Geologic Map of the Colorado Springs-Castle Rock Area*, distributed by the US Geological Survey in 1978 (Reference 7), and the *Geologic Map of the Denver 1⁰ x 2⁰ Quadrangle*, distributed by the US Geological Survey in 1981 (Reference 8). The Test Borings used in evaluating the site and are included in Appendix B. The Geology Map prepared for the site is presented in Figure 7.

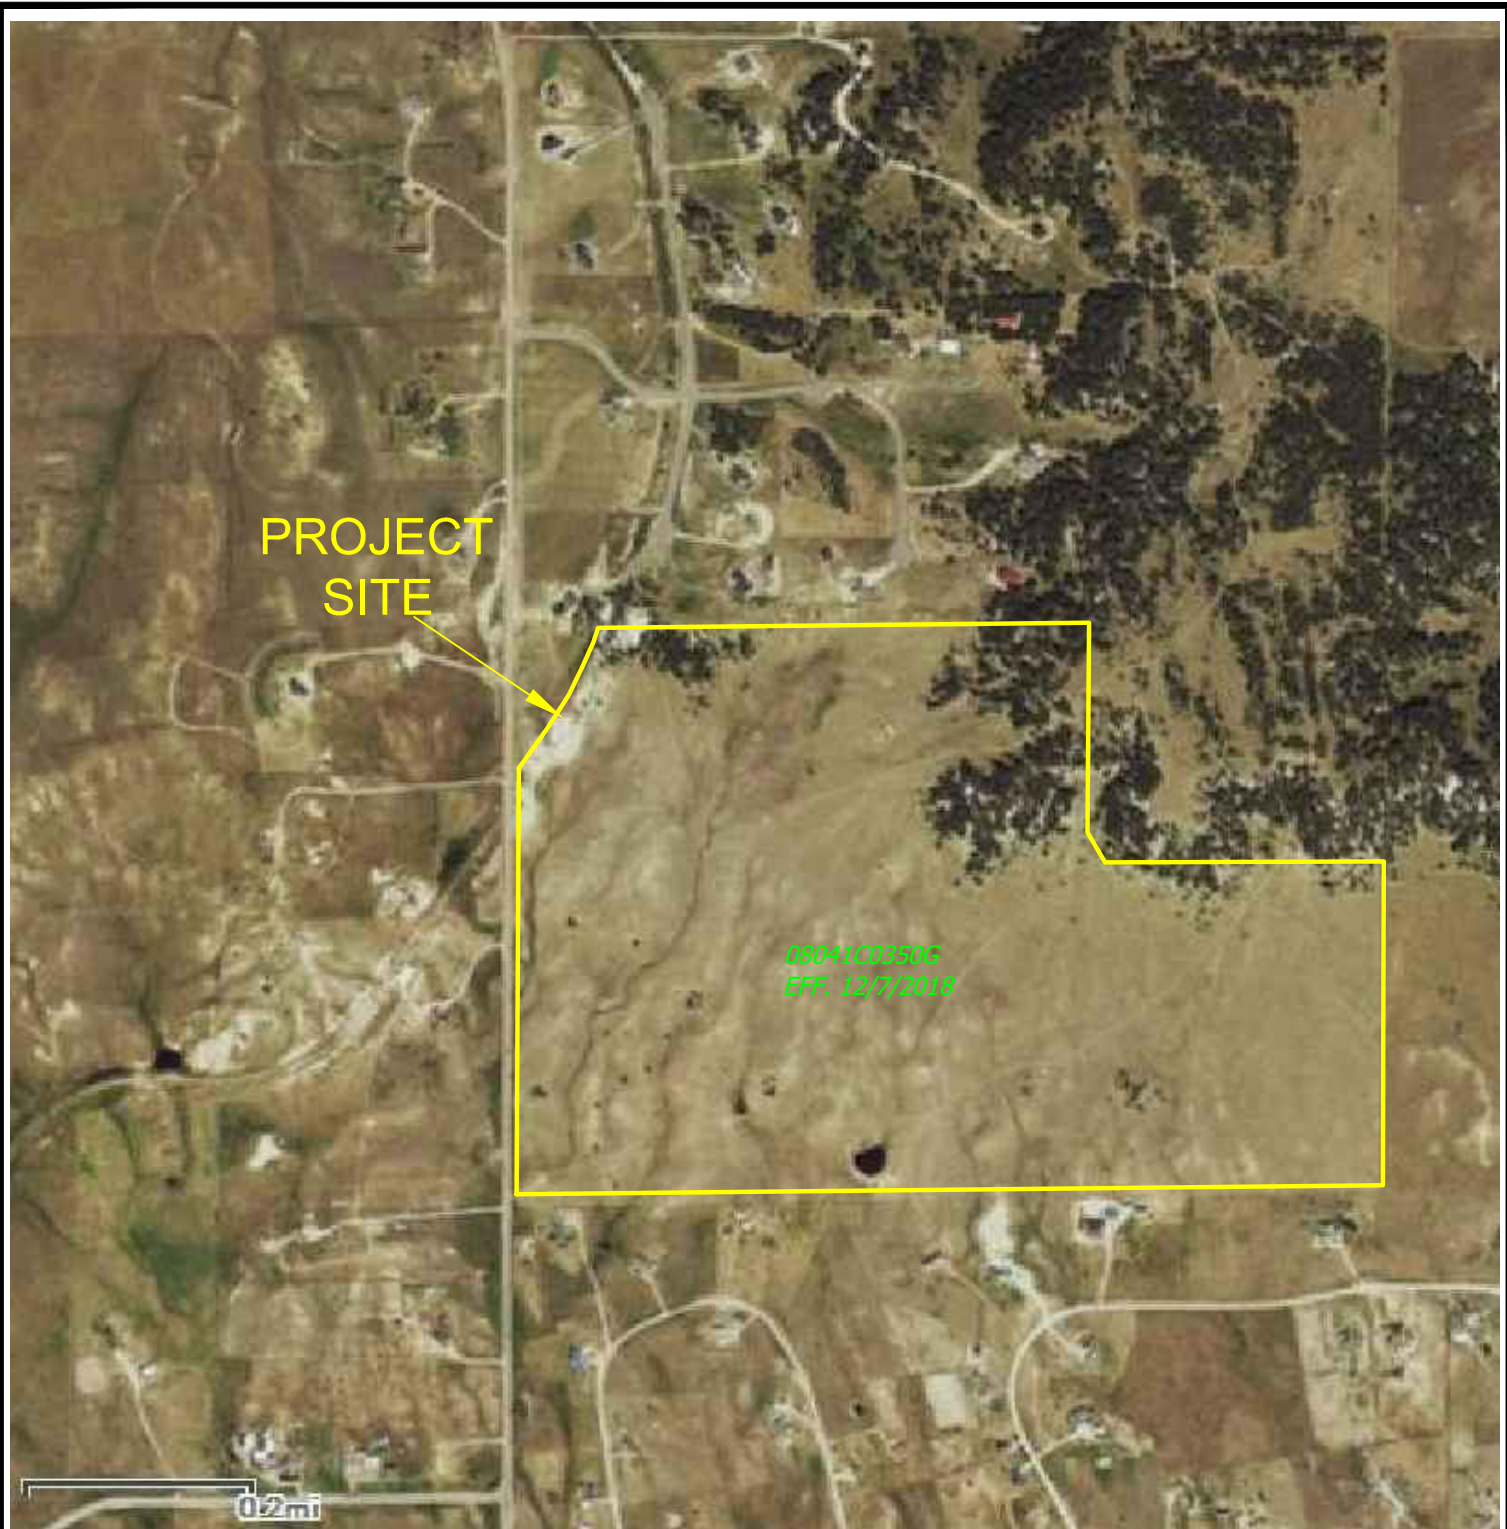
FIG. 8

FEMA FLOODPLAIN MAP
OVERLOOK AT HOMESTEAD, FILING NO. 1
PT OVERLOOK, LLC

A drainage is located in the southwestern portion of the site and several minor drainages are located across the site that generally flow in southerly directions. None of the drainages on the site have been mapped within floodplain zones according to the FEMA Map No. 08041CO350G, (Figure 8, Reference 9). Areas where potentially seasonal shallow, seasonal shallow, ponded water, and springs have been indicated on the site geology/engineering geology map, Figure 7. Lots adjacent to the drainages may experience higher groundwater levels during peak flows. Subsurface perimeter drains are recommended for structures adjacent to the floodplains and drainages to help prevent the intrusion of water into areas below grade. Typical drain details are presented in Figure 9. Finished floor levels must be a minimum of one floor above the floodplain level. **Exact floodplain locations and drainage studies are beyond the scope of this report.**

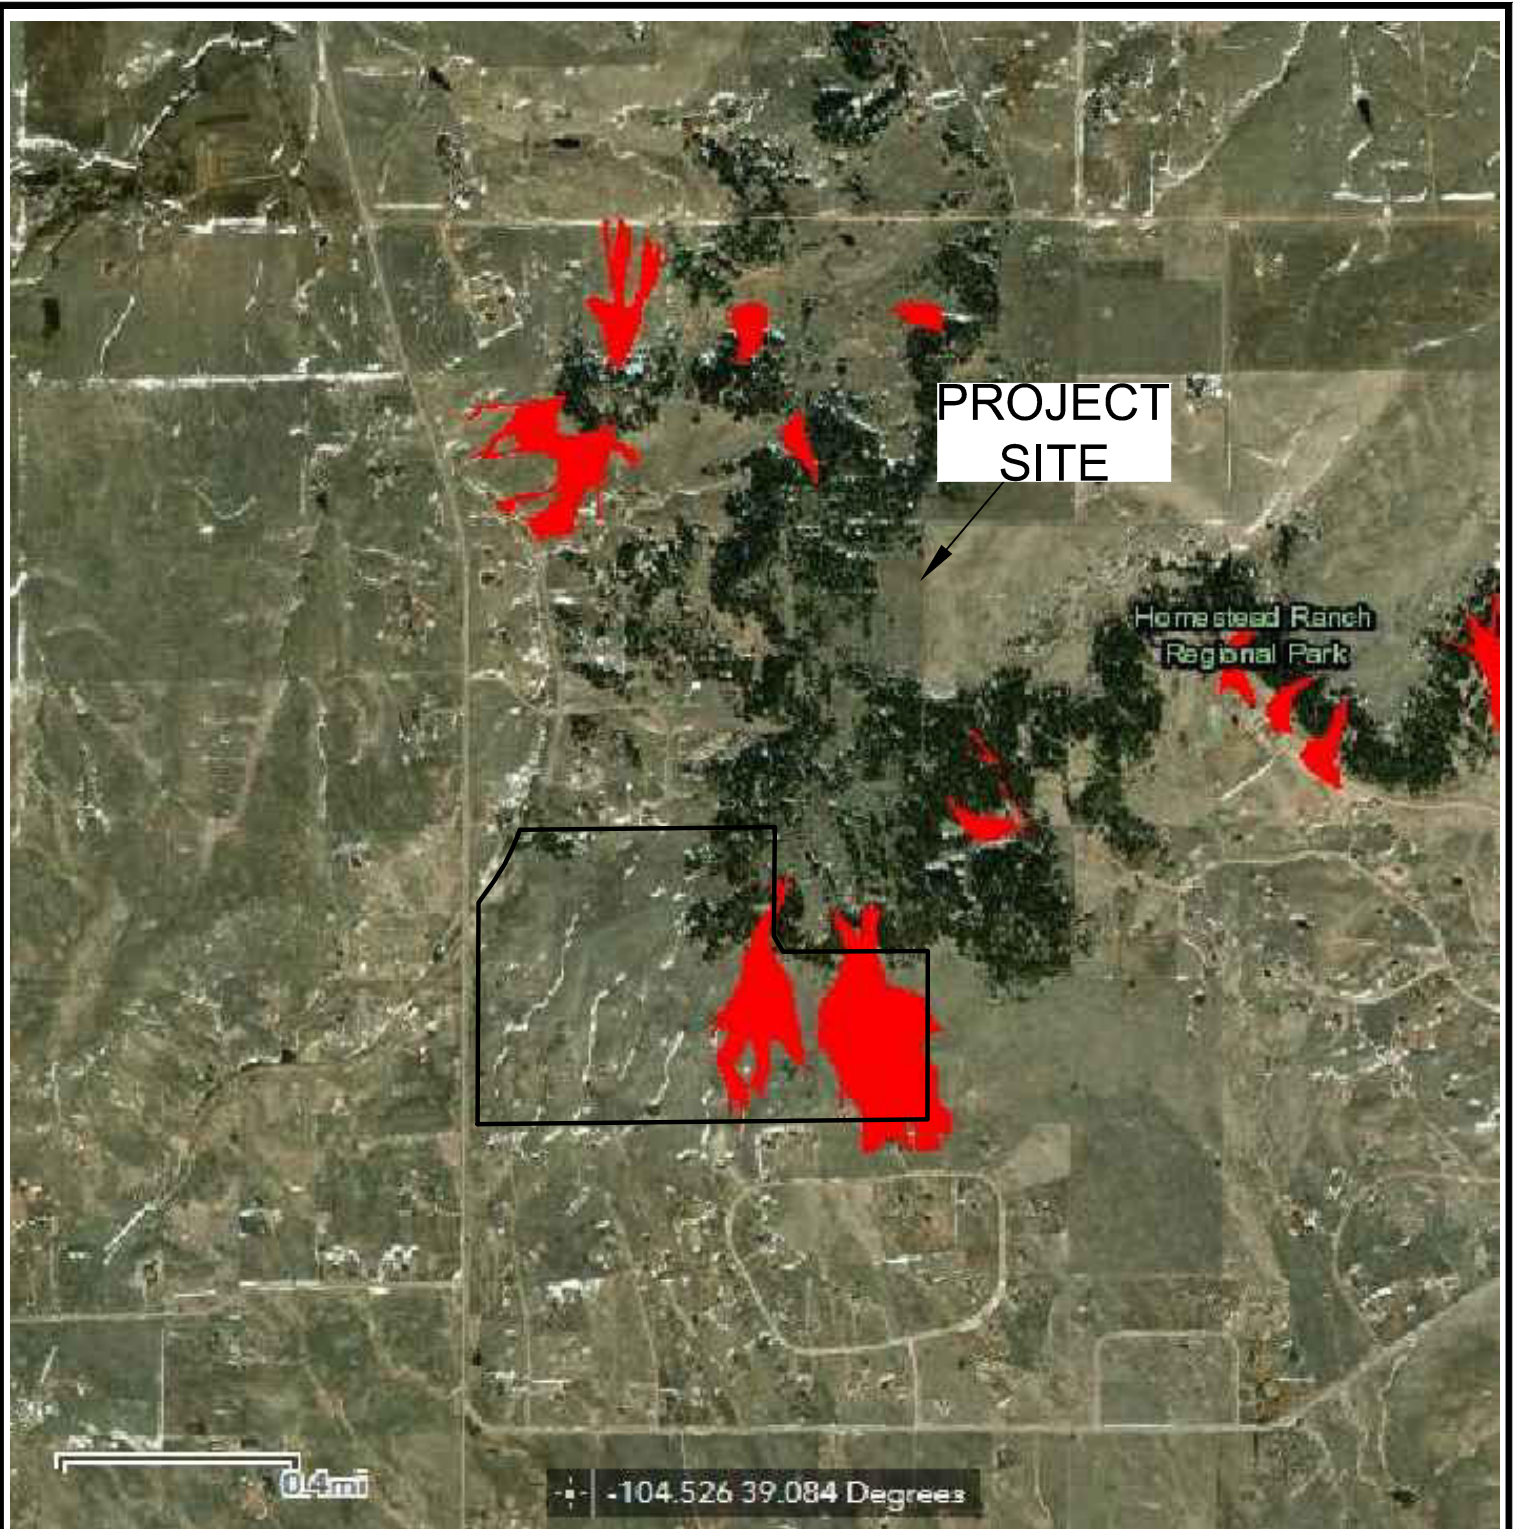
FIG. 9

Debris Flow Susceptibility - (Figure 9) Lots affecting by this potential hazard include Lots 23 - 35

DEBRIS FLOW SUSCEPTIBILITY MAP

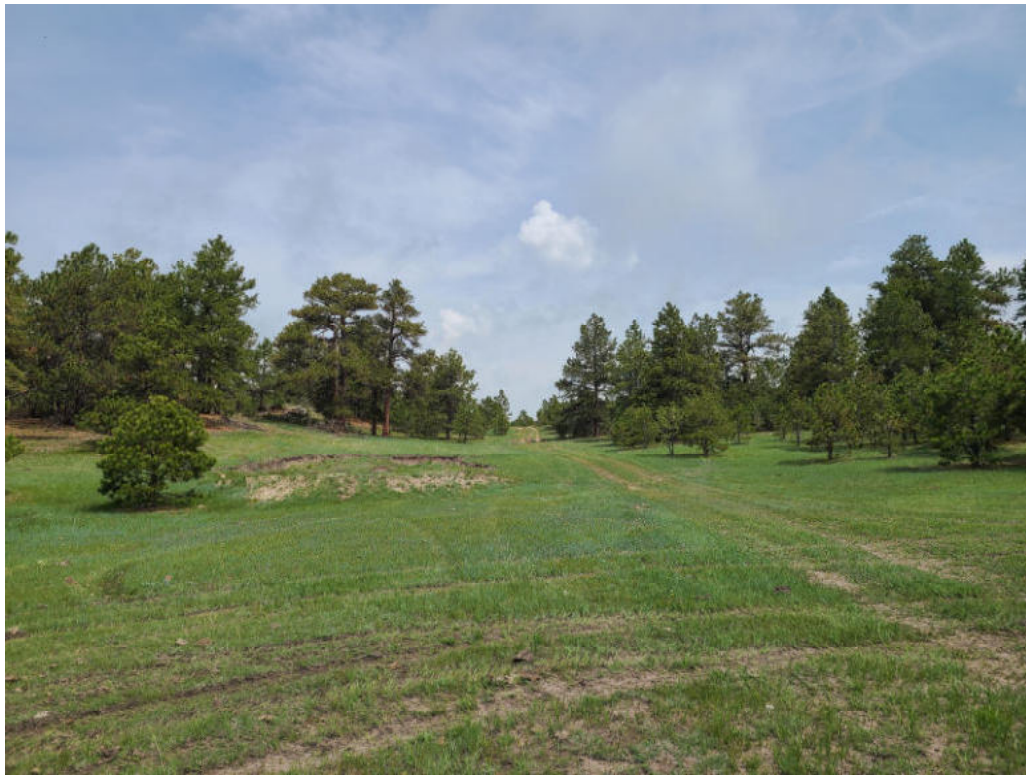
**Looking east along
drainage on Lot 59.**

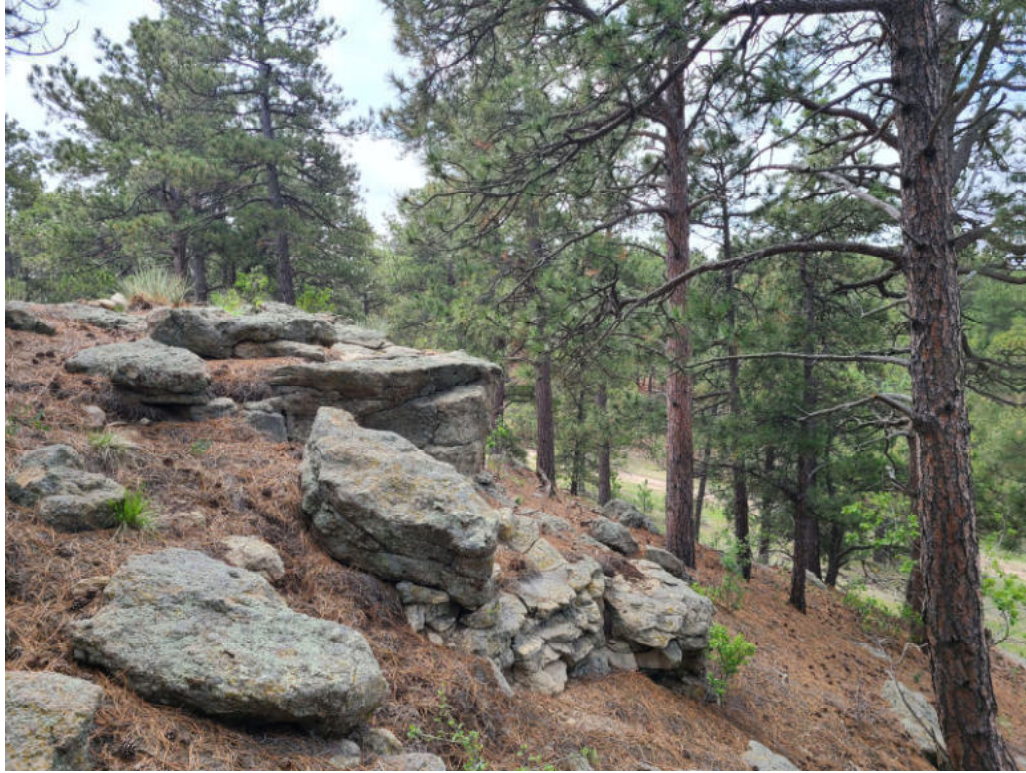
**Looking southwest
along cliff and slope
northern portion of the
site.**

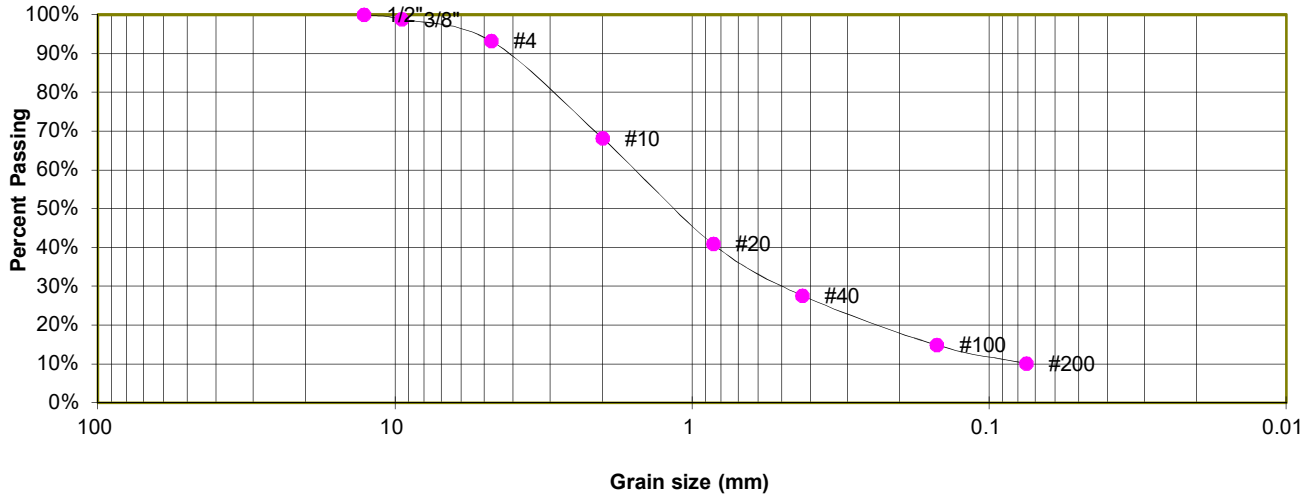
**Sieve Analysis
 Grain Size Distribution**

SOIL DESCRIPTION SAND, WITH SILT
 USCS CLASSIFICATION SM-SW

U.S. Sieve #	Percent Finer
3"	
1 1/2"	
3/4"	
1/2"	100.0%
3/8"	98.9%
4	93.2%
10	68.1%
20	40.9%
40	27.6%
100	14.8%
200	10.1%

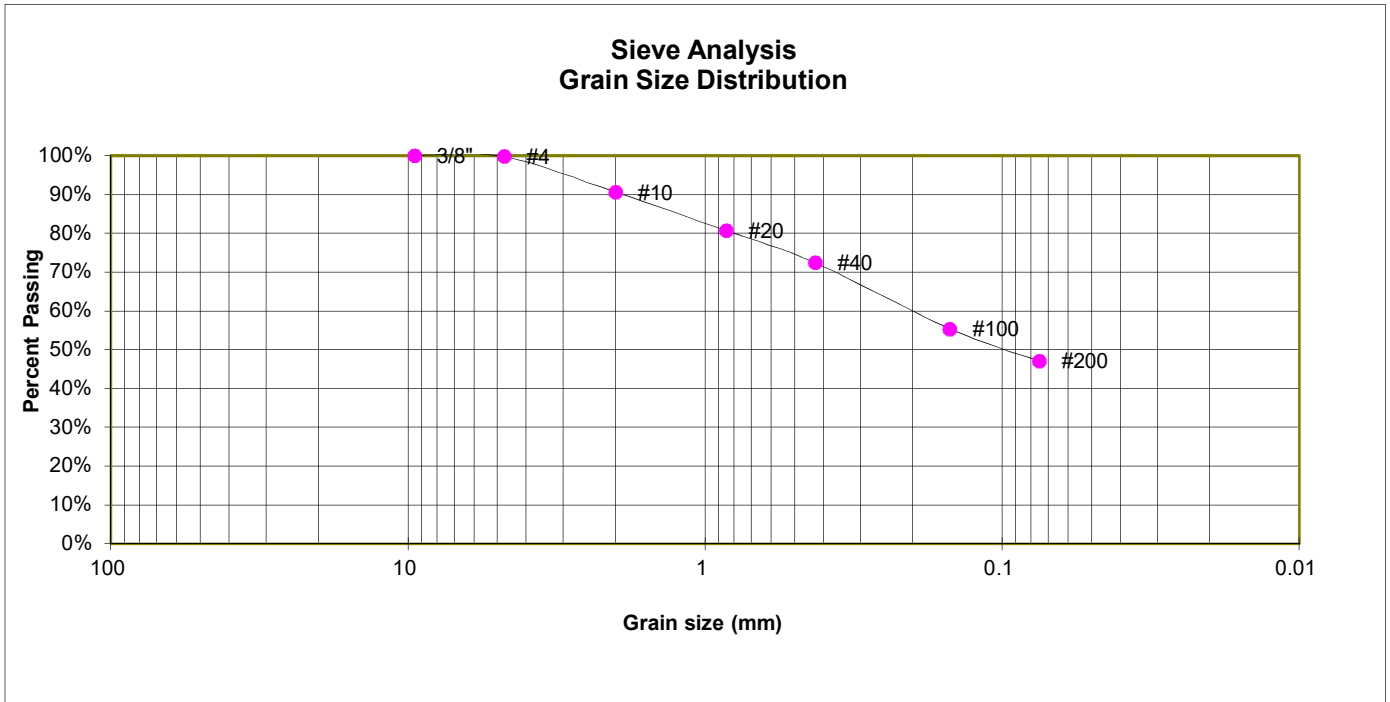
TEST BORING TP-11
DEPTH (FT) 1-2.5
SOIL TYPE 4A

SOIL DESCRIPTION SAND, CLAYEY
USCS CLASSIFICATION SC

<u>U.S. Sieve #</u>	<u>Percent Finer</u>
3"	
1 1/2"	
3/4"	
1/2"	
3/8"	100.0%
4	99.8%
10	90.6%
20	80.7%
40	72.4%
100	55.4%
200	47.0%

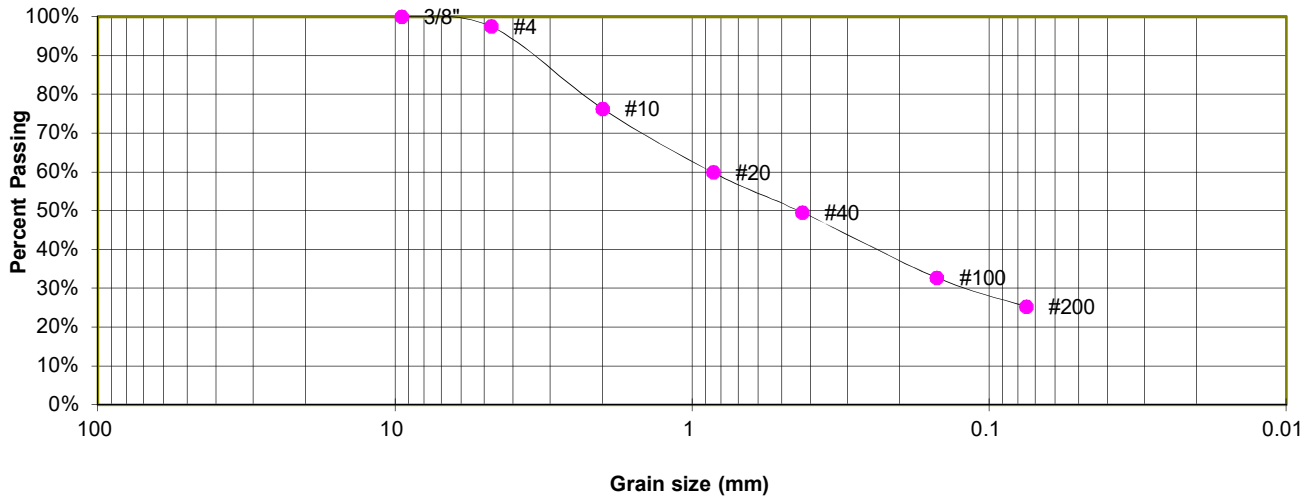
Sieve Analysis Grain Size Distribution

SOIL DESCRIPTION SAND, CLAYEY
USCS CLASSIFICATION SC

U.S. Sieve #	Percent Finer
3"	
1 1/2"	
3/4"	
1/2"	
3/8"	100.0%
4	97.5%
10	76.3%
20	59.8%
40	49.5%
100	32.7%
200	25.2%

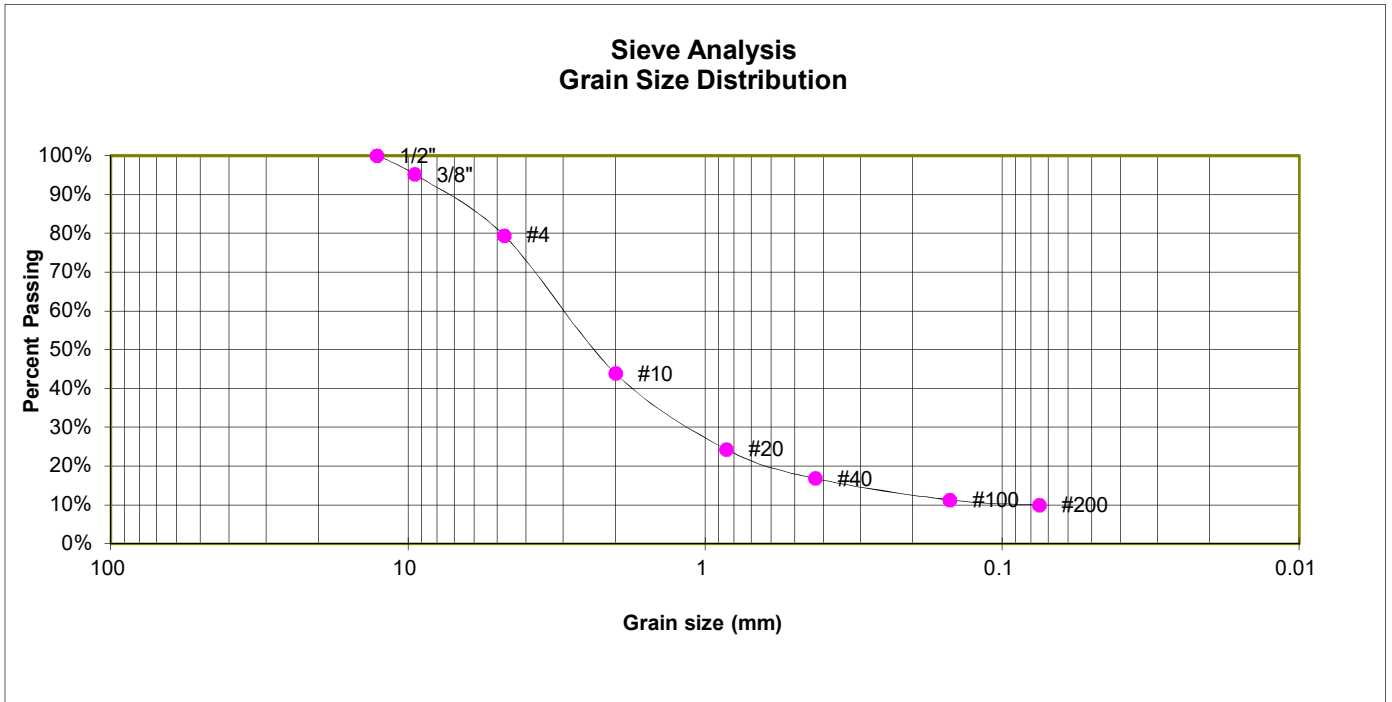
TEST BORING TP-6
DEPTH (FT) 4-8
SOIL TYPE 2A

SOIL DESCRIPTION SAND, WITH SILT
USCS CLASSIFICATION SM-SW

U.S. Sieve #	Percent Finer
3"	
1 1/2"	
3/4"	
1/2"	100.0%
3/8"	95.2%
4	79.5%
10	43.9%
20	24.4%
40	16.8%
100	11.3%
200	9.9%

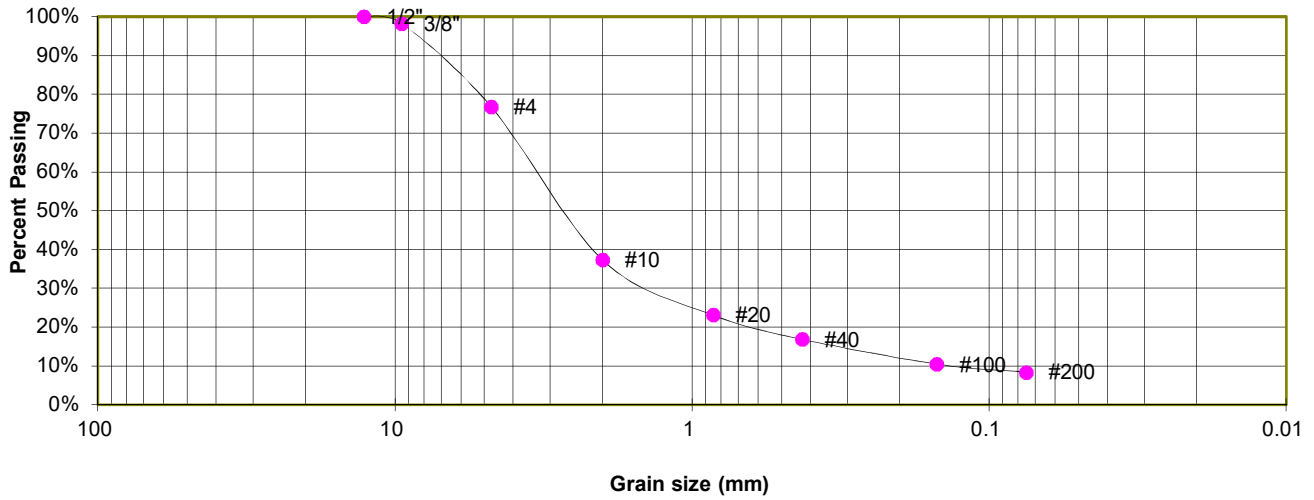
Sieve Analysis Grain Size Distribution

SOIL DESCRIPTION SAND, WITH SILT
USCS CLASSIFICATION SM-SW

U.S. Sieve #	Percent Finer
3"	
1 1/2"	
3/4"	
1/2"	100.0%
3/8"	98.2%
4	76.8%
10	37.3%
20	23.1%
40	16.8%
100	10.4%
200	8.4%

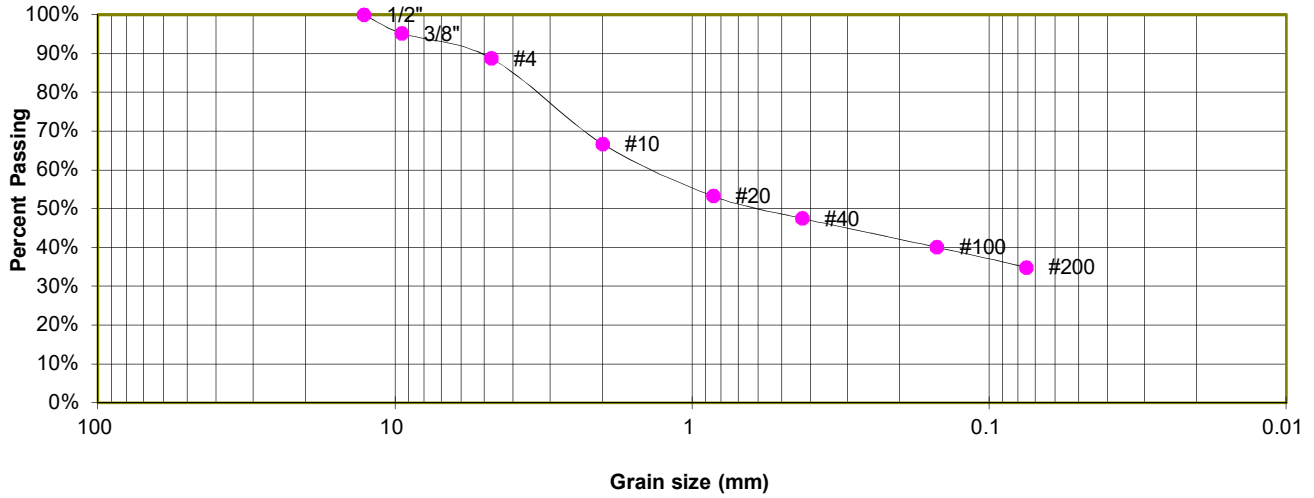
**Sieve Analysis
 Grain Size Distribution**

SOIL DESCRIPTION SAND, CLAYEY
 USCS CLASSIFICATION SC

U.S. Sieve #	Percent Finer
3"	
1 1/2"	
3/4"	
1/2"	100.0%
3/8"	95.2%
4	88.8%
10	66.7%
20	53.3%
40	47.5%
100	40.1%
200	34.9%

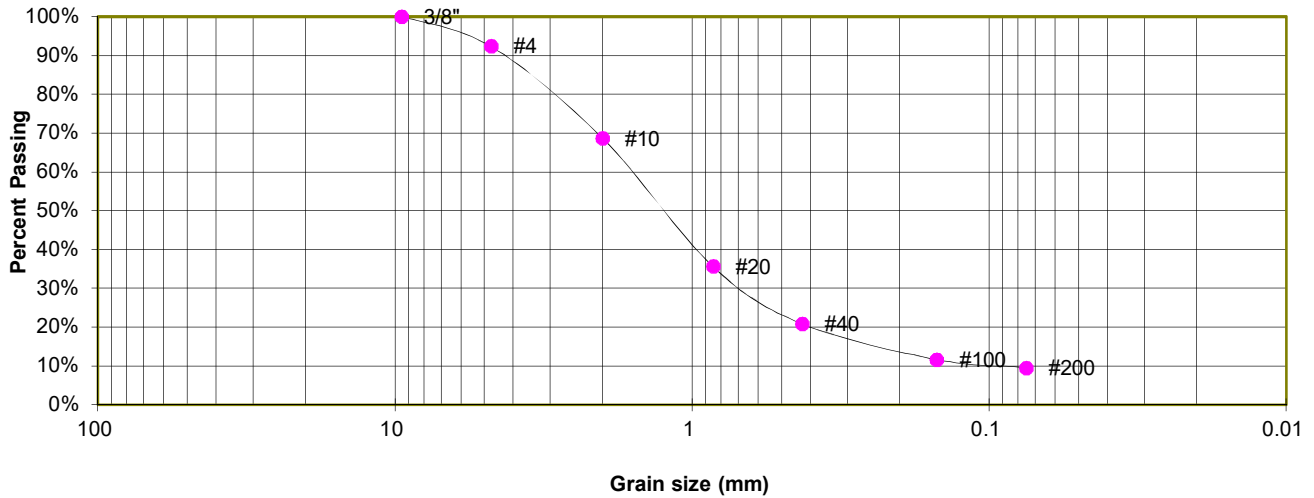
Sieve Analysis Grain Size Distribution

SOIL DESCRIPTION SAND, WITH SILT
USCS CLASSIFICATION SM-SW

U.S. Sieve #	Percent Finer
3"	
1 1/2"	
3/4"	
1/2"	
3/8"	100.0%
4	92.3%
10	68.7%
20	35.6%
40	20.8%
100	11.6%
200	9.5%
