**RE: *Palmer Solar Project, Birdsall Road and Old Pueblo Road  
El Paso County, Colorado  
Access Routes Road Condition Assessment***

The purpose of this letter is to document the results of a road condition assessment completed by Kimley-Horn relative to the proposed Palmer Solar project north of Birdsall Road and east of Old Pueblo Road in El Paso County, Colorado. The solar field project site is approximately 525 acres, separated into two areas, located south of the City of Fountain. A vicinity map illustrating the location of the Palmer Solar project is shown in attached **Figure 1**.

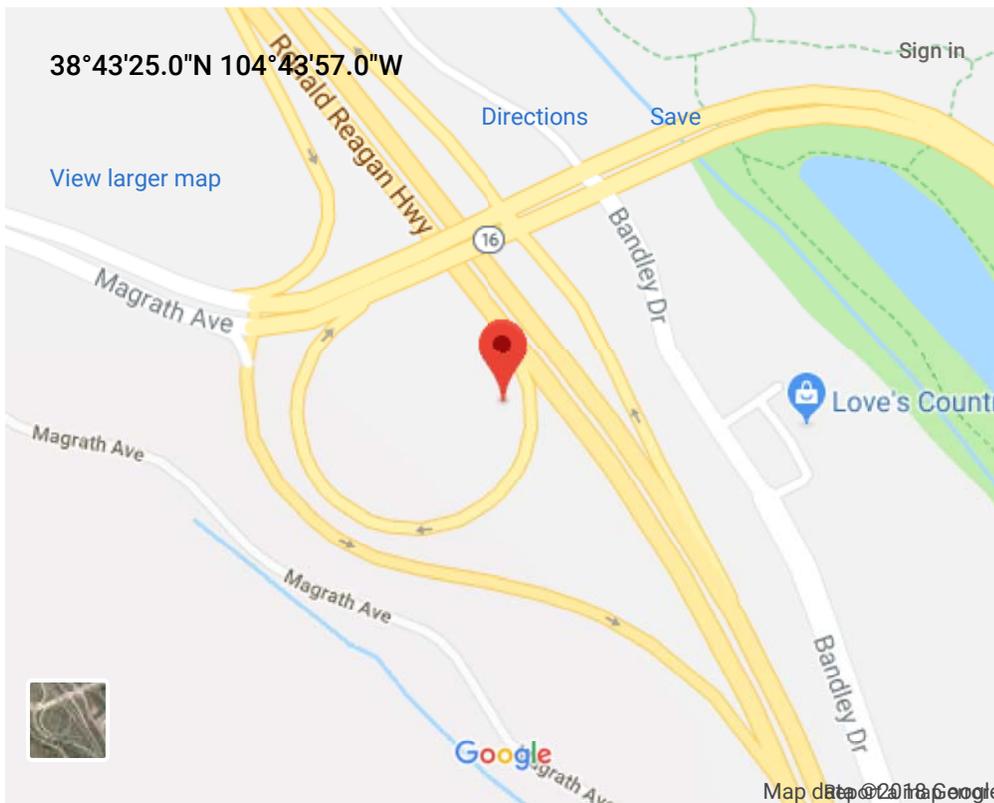
Good/Fair/Poor Condition: Good  
 Status: Open, no restriction [A]  
 Average daily traffic: 27,000 [as of 2011]  
 Truck traffic: 3% of total traffic  
 Deck condition: Good [7 out of 9]  
 Superstructure condition: Very Good [8 out of 9]  
 Substructure condition: Good [7 out of 9]  
 Structural appraisal: Better than present minimum criteria [7]  
 Deck geometry appraisal: Superior to present desirable criteria [9]  
 Underclearances appraisal: Better than present minimum criteria [7]  
 Roadway alignment appraisal: Equal to present desirable criteria [8]  
 Pier/abutment protection: Navigation protection not required [1]  
 Scour condition: Bridge not over waterway. [N]  
 Operating rating: 84.9 tons [77.2 metric tons]  
 Inventory rating: 45.4 tons [41.3 metric tons]  
 Sufficiency rating: 98.7

Date	Suff. Rating	Condition	Deck	Superstructure	Substructure	SD/FO	ADT
December 2016	98.7	Good	Good	Very Good	Good	-	27000
December 2014	98.7	Good	Good	Very Good	Good	-	27000
December 2012	99.0	Good	Very Good	Very Good	Very Good	-	21400
December 2010	99.0	Good	Very Good	Very Good	Very Good	-	21400

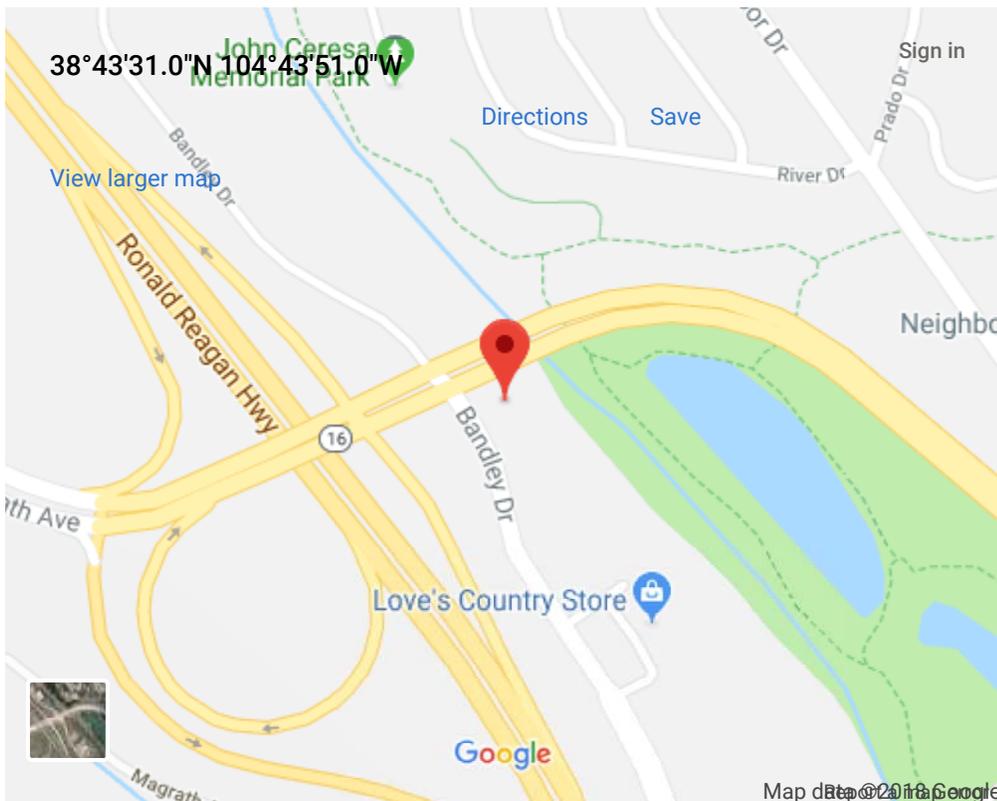
Good/Fair/Poor Condition:	Good
Status:	Open, no restriction [A]
Average daily traffic:	20,000 [as of 2011]
Truck traffic:	3% of total traffic
Deck condition:	Good [7 out of 9]
Superstructure condition:	Very Good [8 out of 9]
Substructure condition:	Good [7 out of 9]
Structural appraisal:	Better than present minimum criteria [7]
Deck geometry appraisal:	Superior to present desirable criteria [9]
Water adequacy appraisal:	Equal to present desirable criteria [8]
Roadway alignment appraisal:	Equal to present desirable criteria [8]
Channel protection:	Banks are protected or well vegetated. River control devices such as spur dikes and embankment protection are not required or are in a stable condition. [8]
Pier/abutment protection:	Navigation protection not required [1]
Scour condition:	Bridge foundations determined to be stable for the assessed or calculated scour condition. [8]
Operating rating:	89.8 tons [81.6 metric tons]

Recommended work: Widening of existing bridge or other major structure without deck rehabilitation or replacement [33]

Date	Suff. Rating	Condition	Deck	Superstructure	Substructure	SD/FO	ADT
December 2016	86.9	Good	Good	Very Good	Good	-	20000
December 2014	86.9	Good	Good	Very Good	Good	-	20000
January 2013	86.4	Good	Very Good	Very Good	Very Good	-	20700
December 2010	86.4	Good	Very Good	Very Good	Very Good	-	20700
May 2009	86.4	Good	Very Good	Very Good	Very Good	-	20700

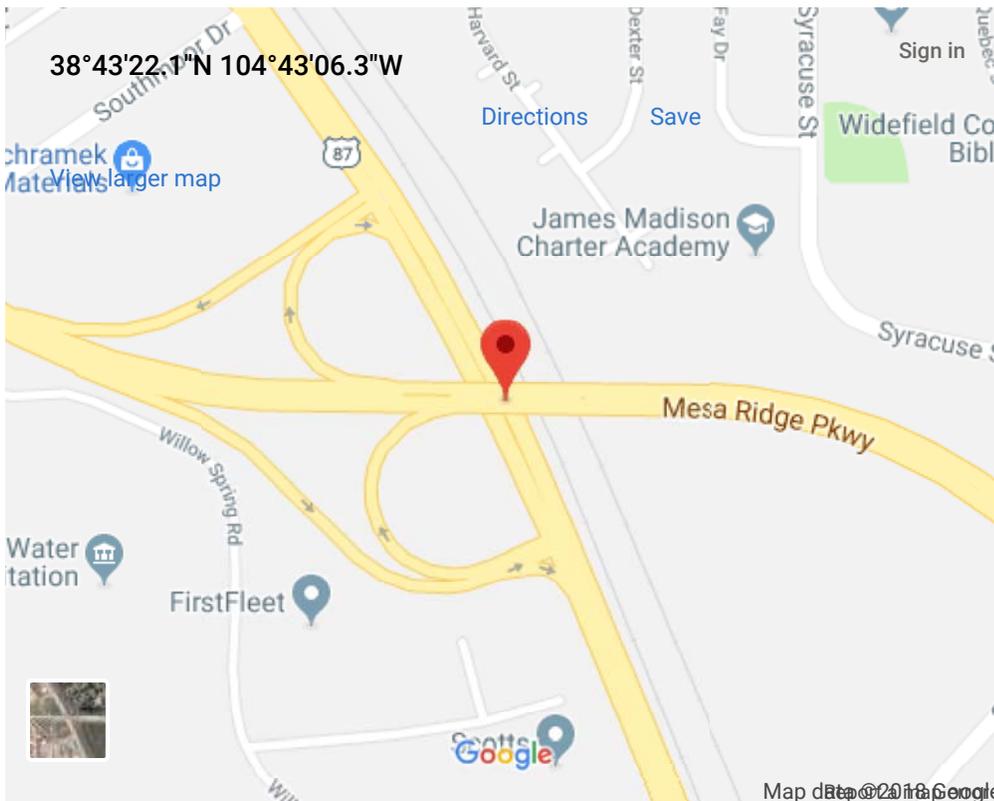
Good/Fair/Poor Condition: Fair  
 Status: Open, no restriction [A]  
 Average daily traffic: 10,000 [as of 2011]  
 Truck traffic: 3% of total traffic  
 Deck condition: Good [7 out of 9]  
 Superstructure condition: Satisfactory [6 out of 9]  
 Substructure condition: Good [7 out of 9]  
 Structural appraisal: Equal to present minimum criteria [6]  
 Deck geometry appraisal: Meets minimum tolerable limits to be left in place as is [4]  
 Underclearances appraisal: Somewhat better than minimum adequacy to tolerate being left in place as is [5]  
 Roadway alignment appraisal: Equal to present desirable criteria [8]  
 Scour condition: Bridge not over waterway. [N]  
 Operating rating: 52.8 tons [48.0 metric tons]  
 Inventory rating: 31.7 tons [28.8 metric tons]  
 Sufficiency rating: 79.2

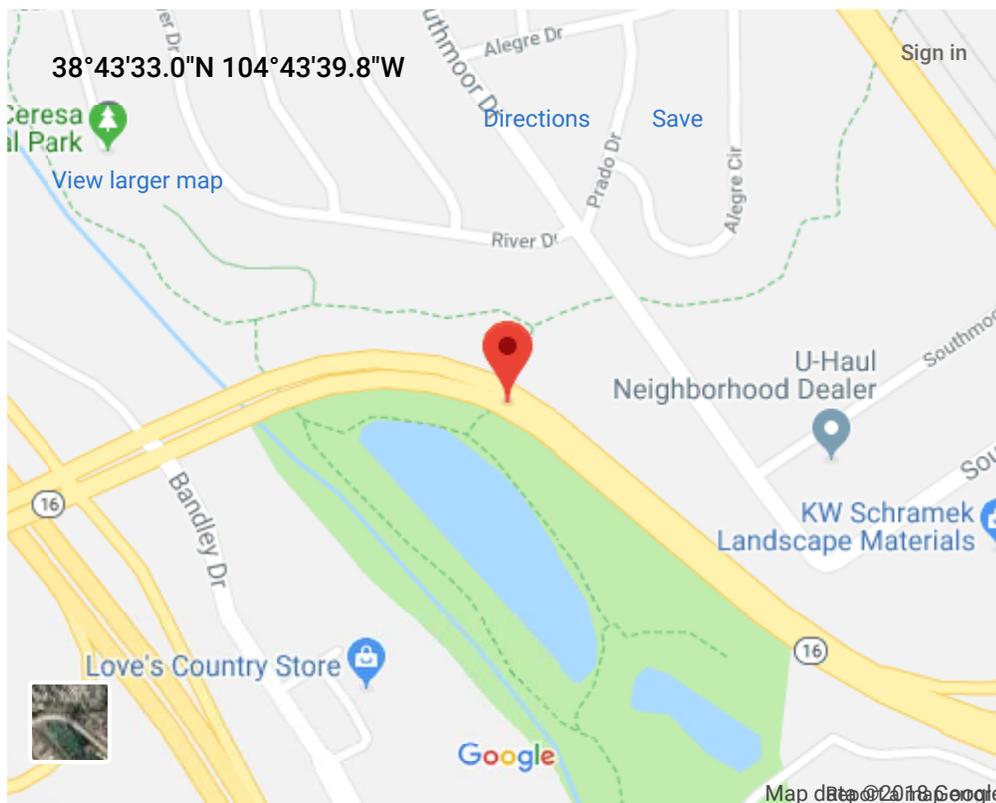
Good/Fair/Poor Condition:	Fair
Status:	Open, no restriction [A]
Average daily traffic:	20,000 [as of 2011]
Truck traffic:	3% of total traffic
Deck condition:	Satisfactory [6 out of 9]
Superstructure condition:	Very Good [8 out of 9]
Substructure condition:	Very Good [8 out of 9]
Structural appraisal:	Equal to present desirable criteria [8]
Deck geometry appraisal:	Equal to present minimum criteria [6]
Water adequacy appraisal:	Equal to present desirable criteria [8]
Roadway alignment appraisal:	Equal to present desirable criteria [8]
Channel protection:	Banks are protected or well vegetated. River control devices such as spur dikes and embankment protection are not required or are in a stable condition. [8]
Pier/abutment protection:	Navigation protection not required [1]
Scour condition:	Bridge foundations determined to be stable for assessed or calculated scour condition. [5]
Operating rating:	72.3 tons [65.7 metric tons]

Date	Suff. Rating	Condition	Deck	Superstructure	Substructure	SD/FO	ADT
December 2016	97.2	Fair	Satisfactory	Very Good	Very Good	-	20000
December 2014	97.2	Fair	Satisfactory	Very Good	Very Good	-	20000
December 2012	96.8	Good	Good	Very Good	Very Good	-	17800
December 2010	96.8	Good	Good	Very Good	Very Good	-	17800
May 2009	96.8	Good	Good	Very Good	Very Good	-	17800
November 2006	71.6	Good	Good	Very Good	Very Good	-	17800
October 2004	88.6	Good	Good	Very Good	Very Good	-	15619
October 2002	89.1	Good	Good	Very Good	Very Good	-	12192
October 2000	88.9	Good	Good	Very Good	Very Good	-	11919
December 1998	88.9	Good	Good	Very Good	Very Good	-	11919
November 1996	94.1	Good	Good	Very Good	Very Good	-	10000
October 1994	76.6	Good	Good	Very Good	Very Good	-	10000
December 1992	78.9	Good	Good	Very Good	Very Good	-	11500
November 1990	80.8	Good	Good	Good	Good	-	12000

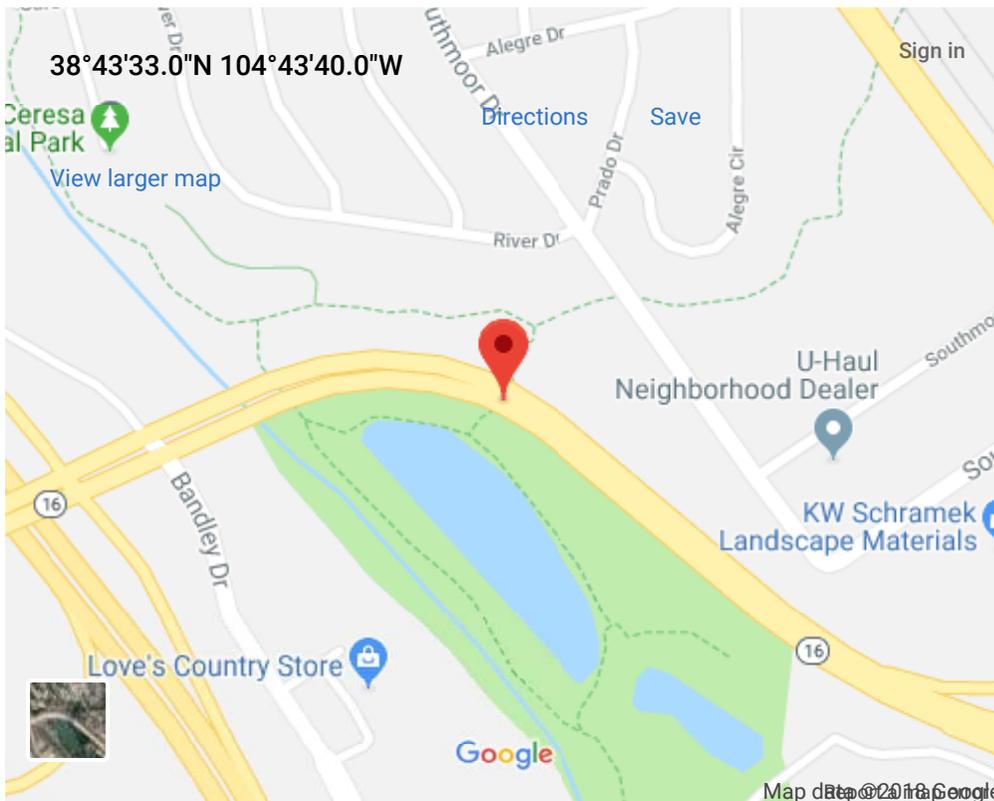
Good/Fair/Poor Condition:	Good
Status:	Open, no restriction [A]
Average daily traffic:	20,000 [as of 2011]
Truck traffic:	3% of total traffic
Deck condition:	Very Good [8 out of 9]
Superstructure condition:	Very Good [8 out of 9]
Substructure condition:	Good [7 out of 9]
Structural appraisal:	Better than present minimum criteria [7]
Deck geometry appraisal:	Somewhat better than minimum adequacy to tolerate being left in place as is [5]
Water adequacy appraisal:	Equal to present desirable criteria [8]
Roadway alignment appraisal:	Equal to present desirable criteria [8]
Channel protection:	Banks are protected or well vegetated. River control devices such as spur dikes and embankment protection are not required or are in a stable condition. [8]
Pier/abutment protection:	Navigation protection not required [1]
Scour condition:	Bridge foundations determined to be stable for the assessed or calculated scour condition. [8]

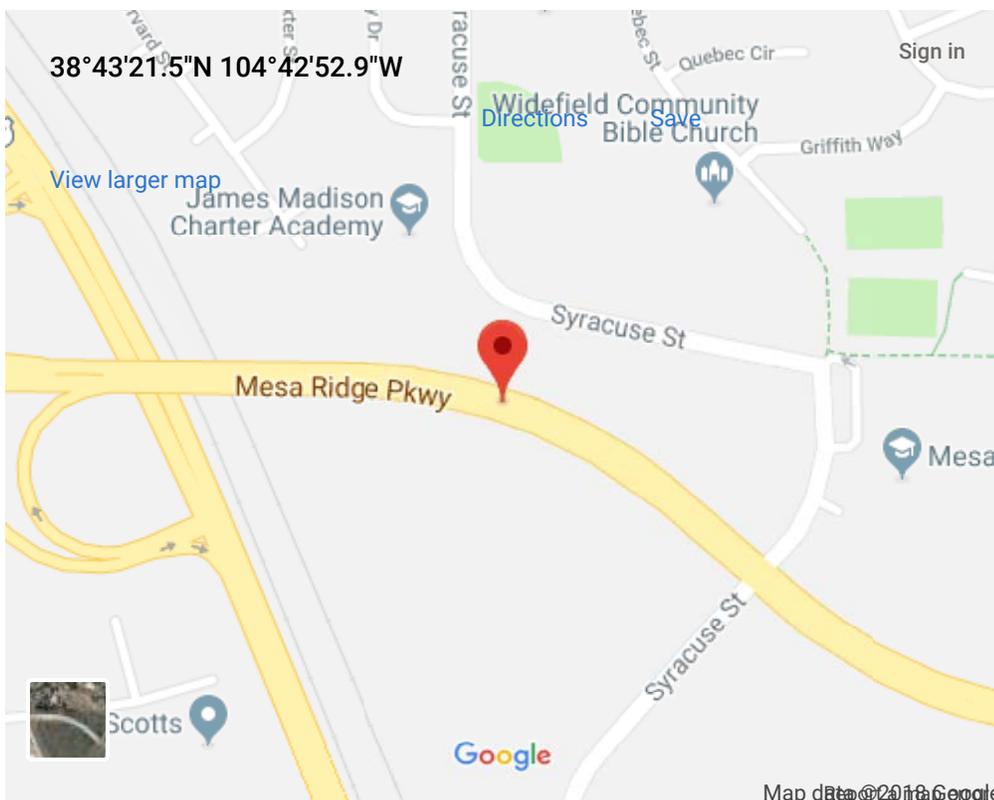
Scour condition: Bridge foundations determined to be stable for the assessed or calculated scour condition. [8]  
Operating rating: 89.8 tons [81.6 metric tons]  
Inventory rating: 89.8 tons [81.6 metric tons]
