GEOLOGY AND SOILS STUDY

**Lots 1-11, Terra Ridge North
Parcel No. 51929-30-002
El Paso County, Colorado**

JOB NO. 169372

**Originally Issued September 3, 2019
Last Revised March 30, 2022**

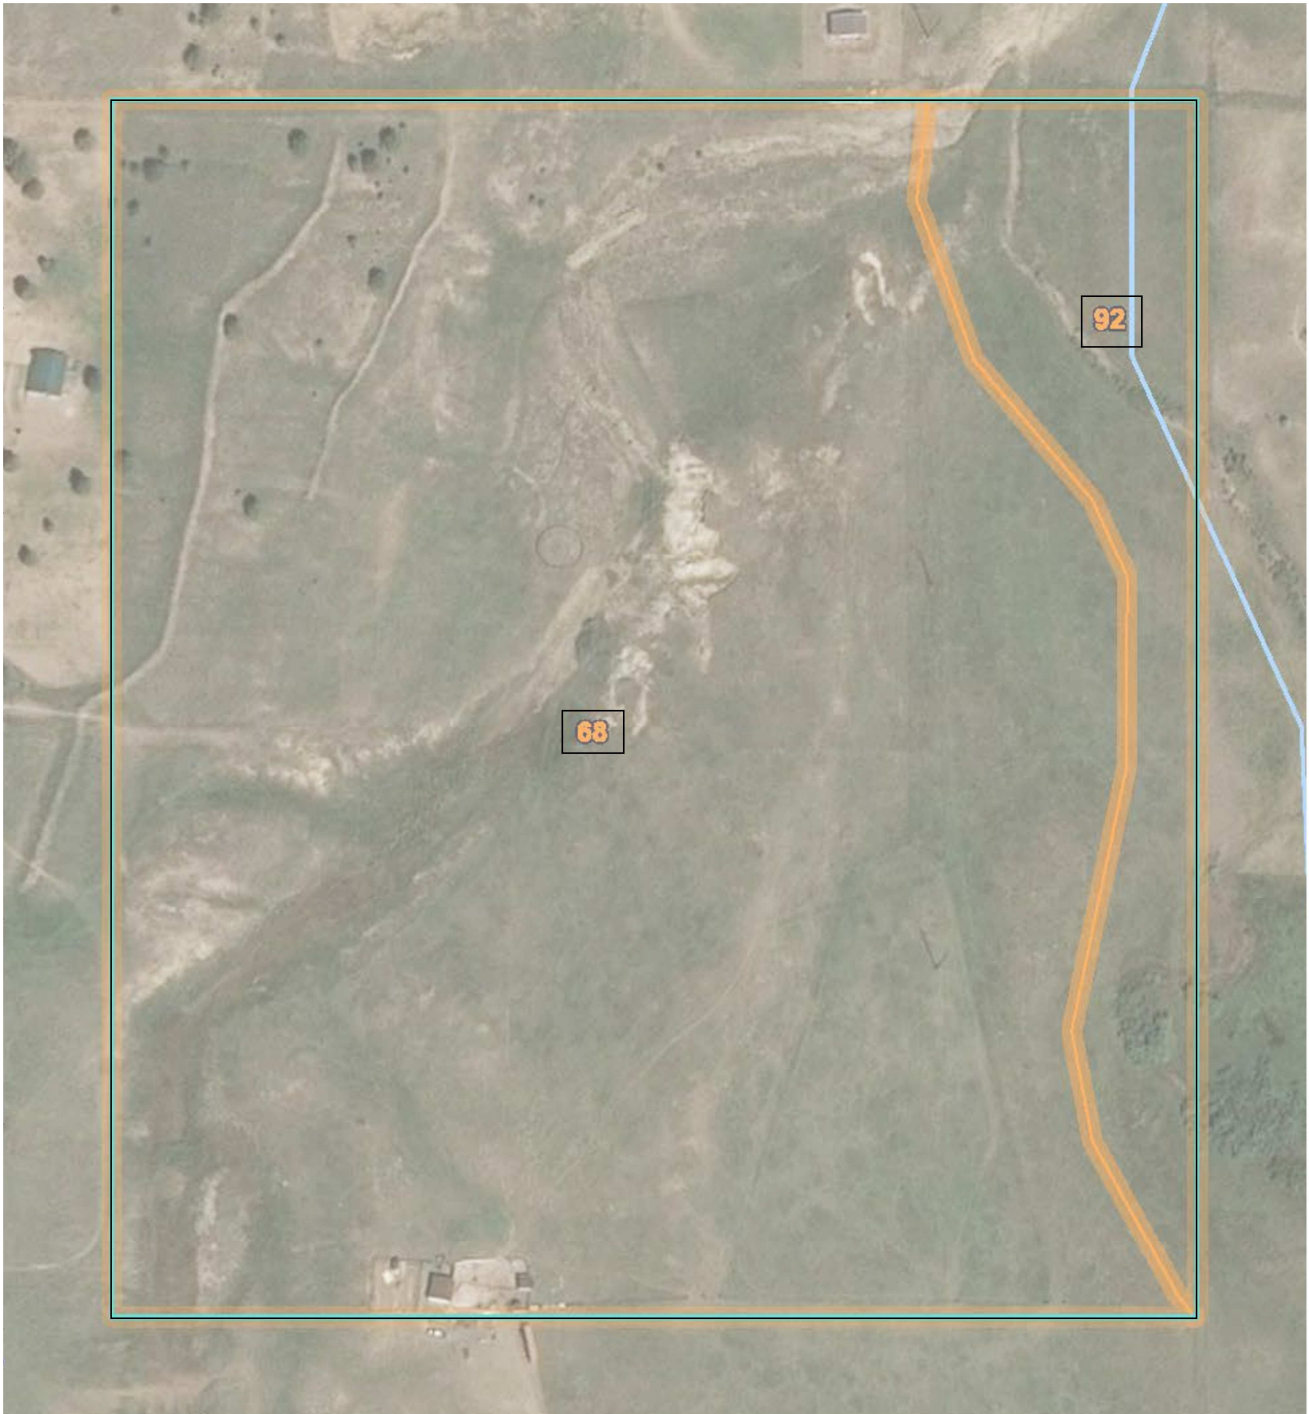
FIG No. 4

68 - Peyton-Pring complex
3 to 8% slopes

92 - Tomah-Crowfoot
3 to 8% slopes

The USDA Soil Survey Map is presented in Figure 4.

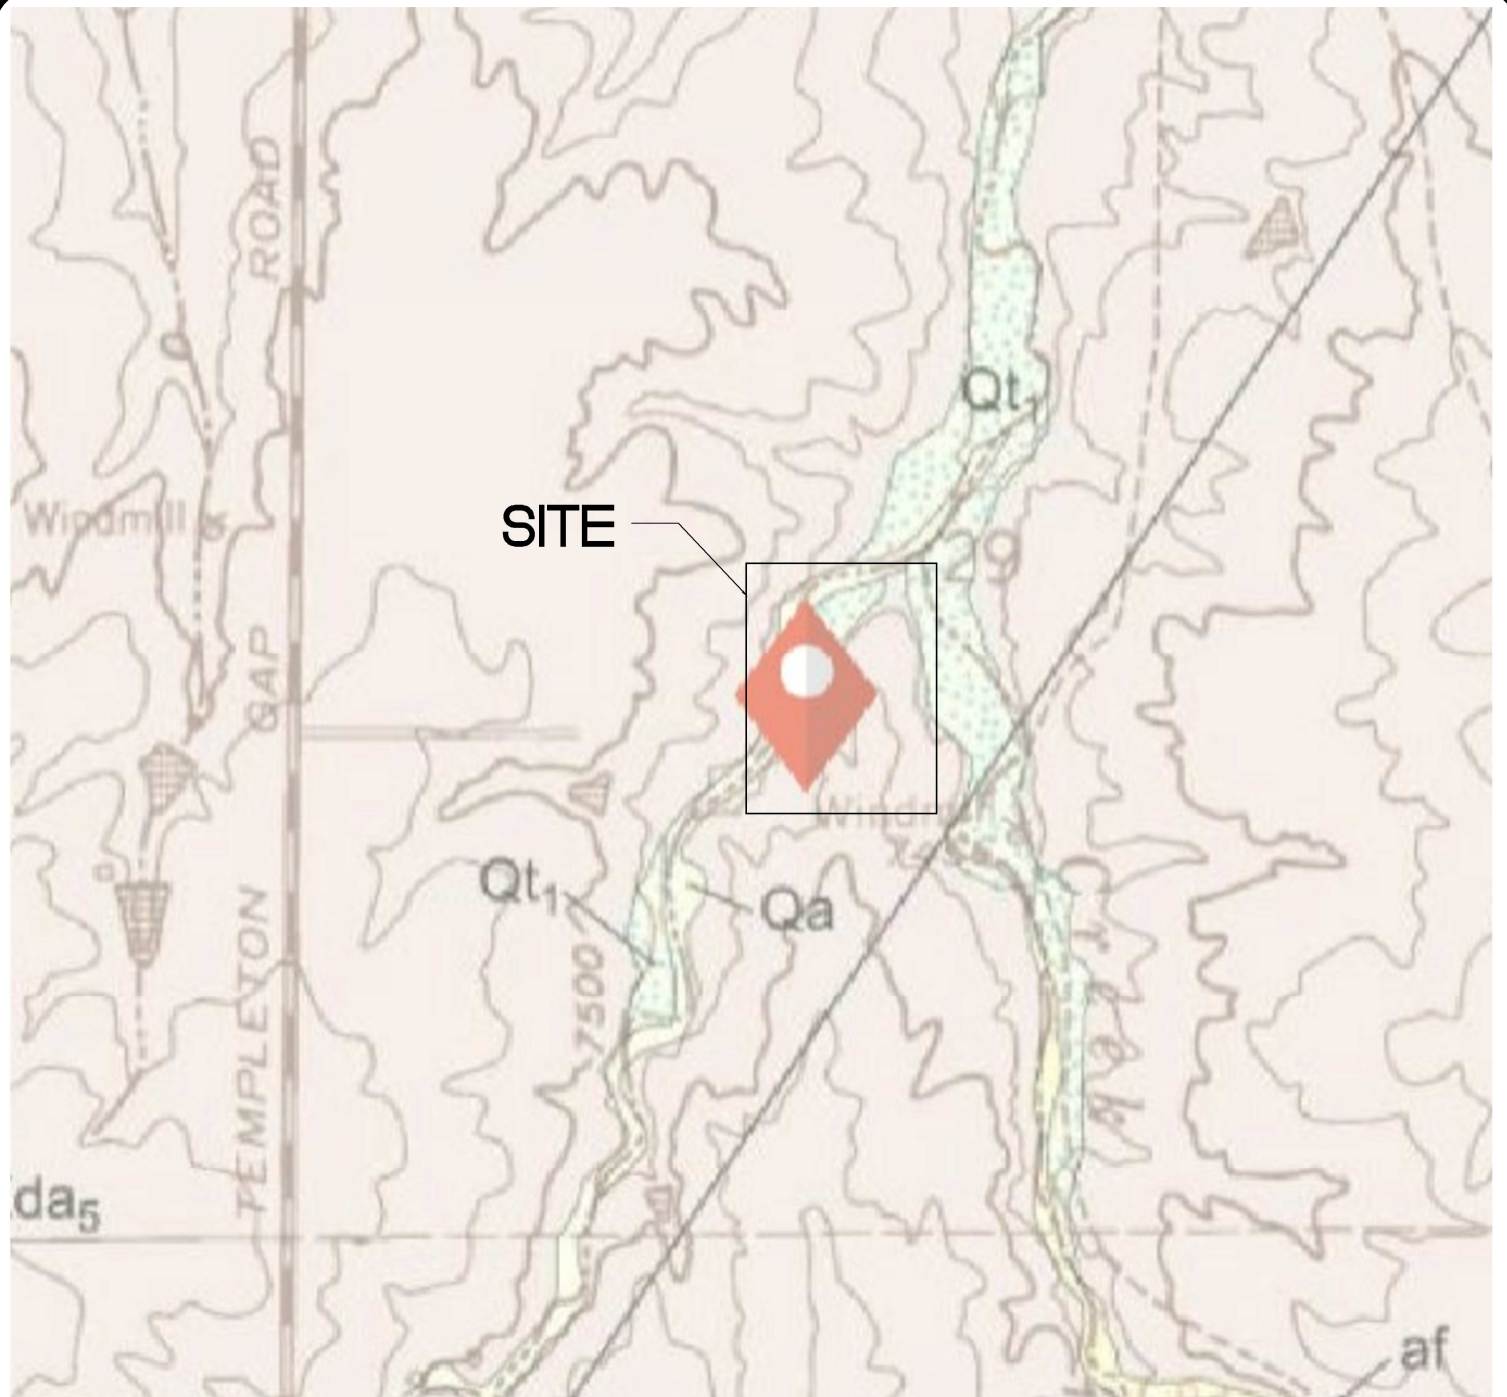
FIG No. 5

Qt₁ - Terrace alluvium one
(Holocene and late Pleistocene)

Qa - Channel and floodplain
alluvium (late Holocene)

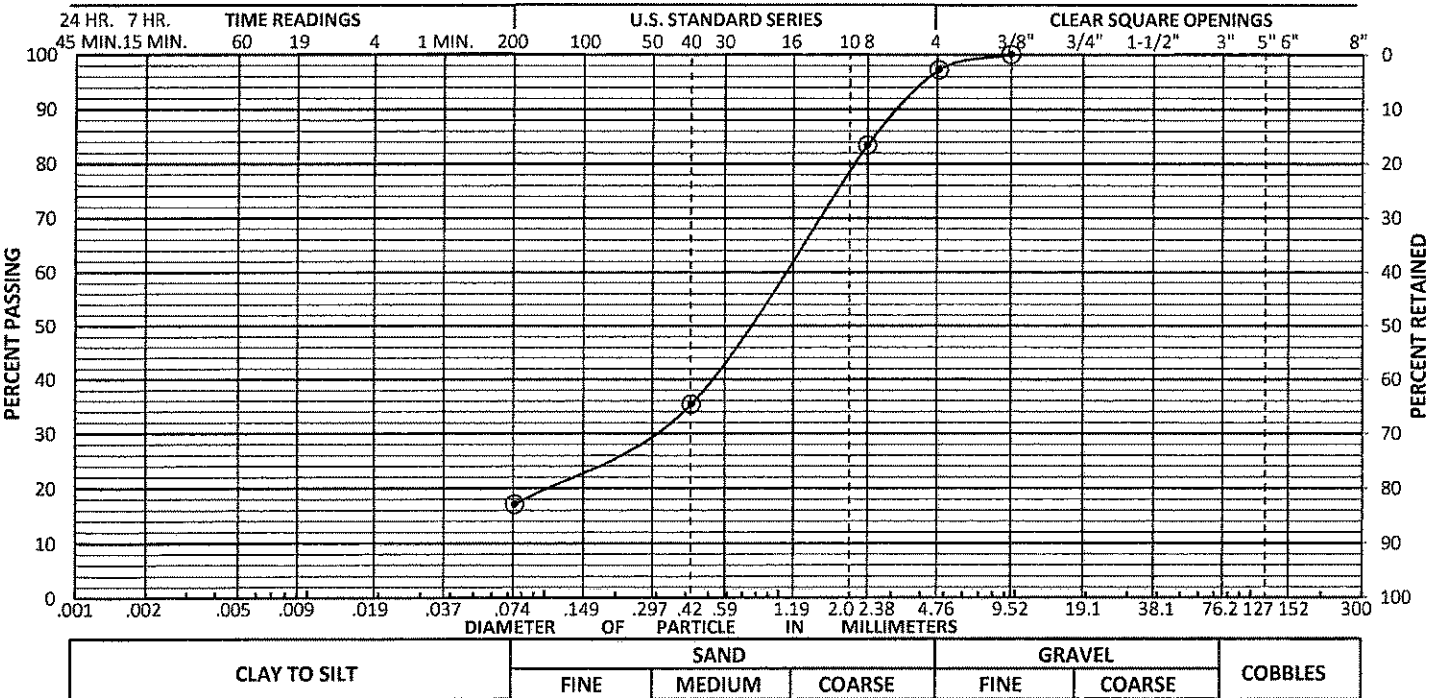
CLASSIFICATION SM
 GRAVEL 2.8 %
 SAND 80.2 %
 FINES 17.0 %
 SAMPLE # 1 HOLE # TH-7 DEPTH 12 FEET
