SOIL, GEOLOGY, AND WASTEWATER STUDY

**15435 East Chaparral Loop
Lot 62, Peyton Ranches
El Paso County, Colorado**

JOB NO. 186430

January 26, 2022

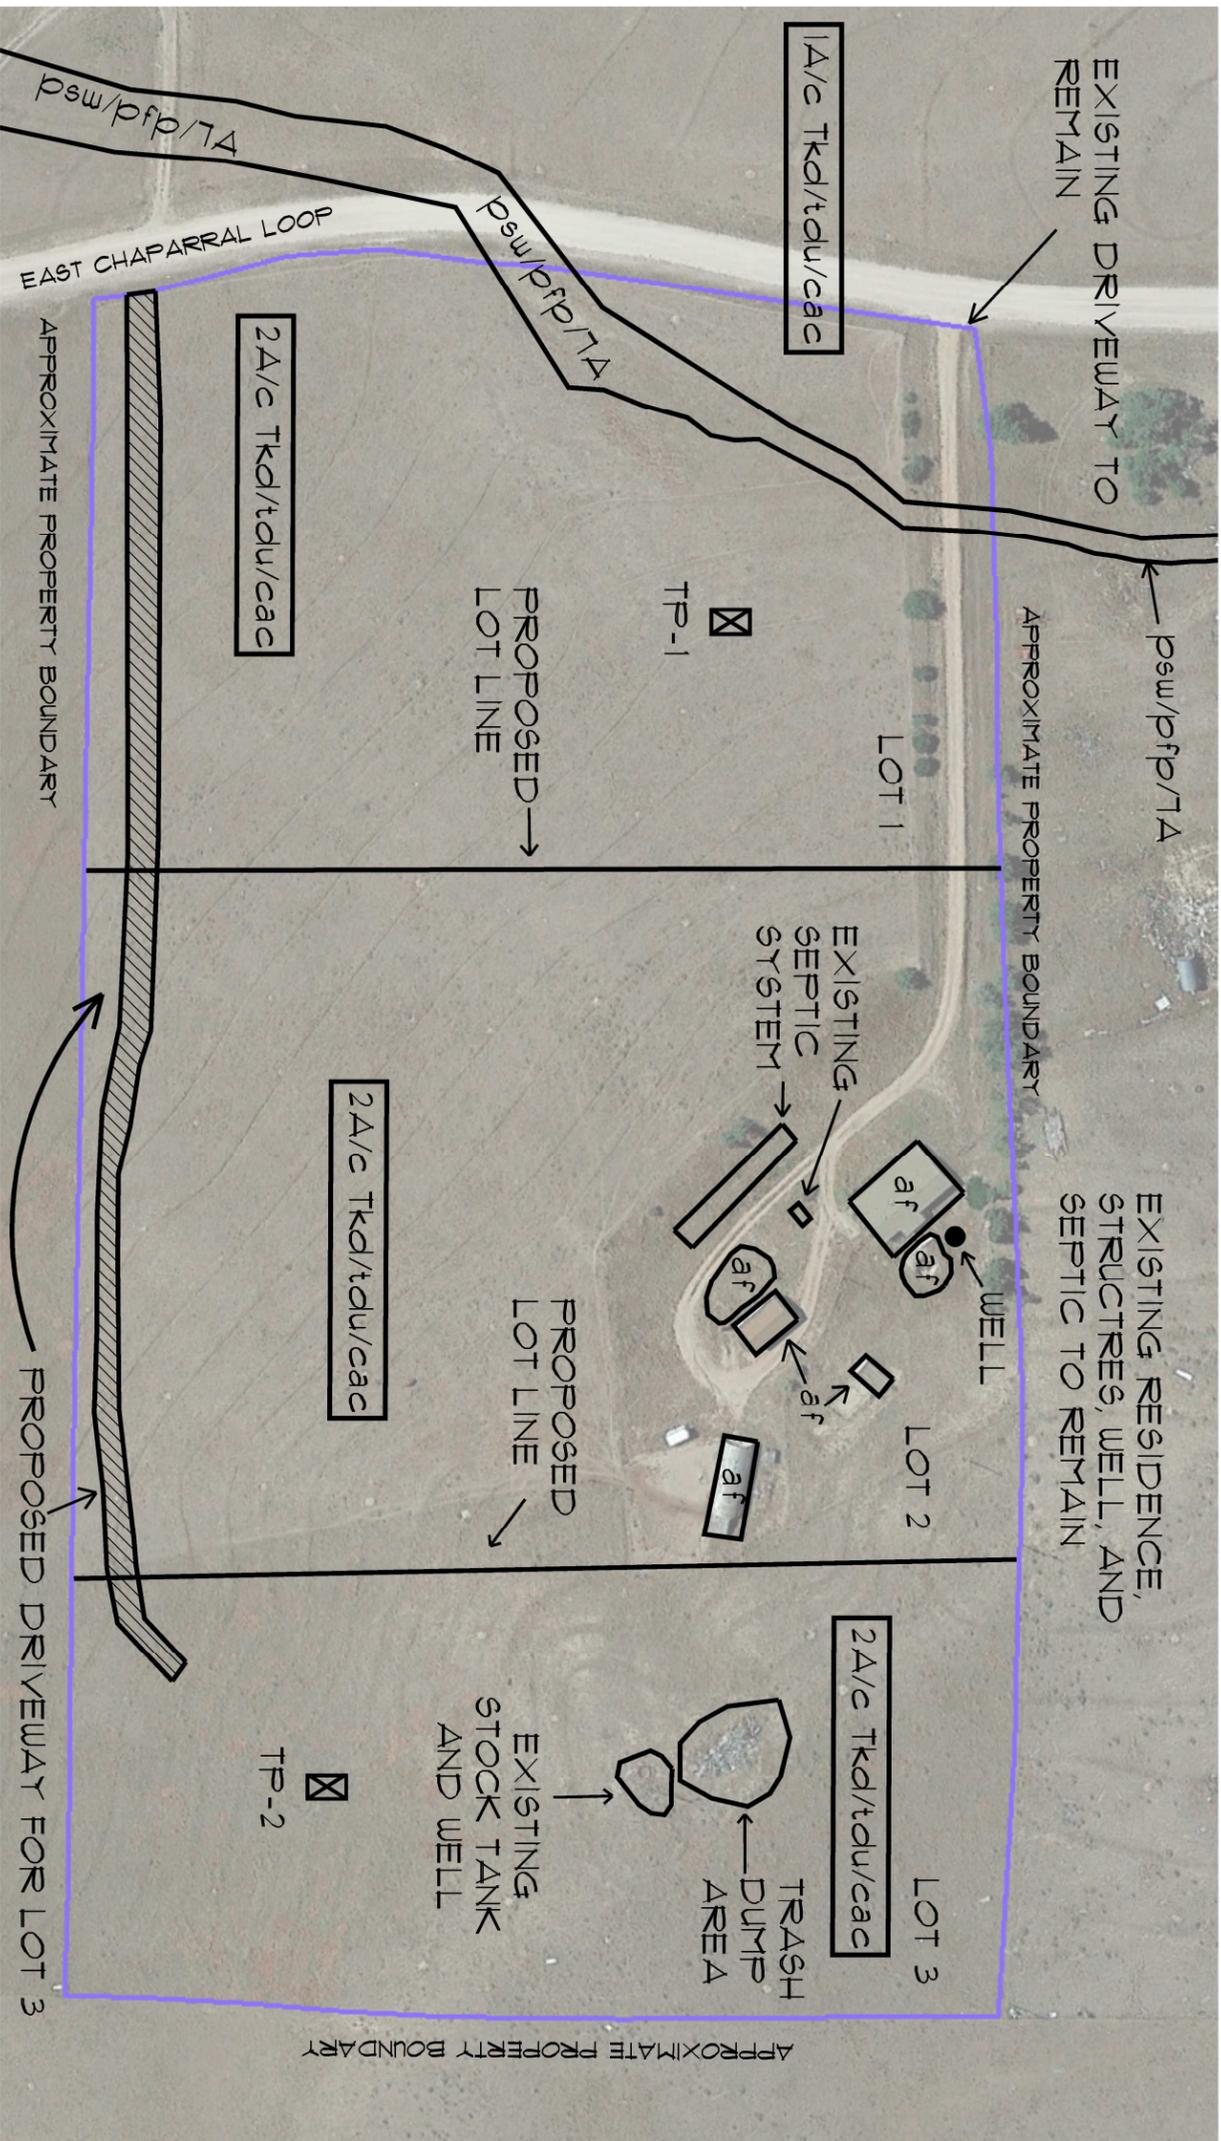
SHEET No.
FIG-6

ENGINEERING
 AND GEOLOGY
 MAP

Geologic

cac - Arkosic loamy colluvium and sheetwash alluvium
 tdu - Upper part of Dawson Arkose - arkosic sandstone, conglomerate, and shale
 psw - Potentially Seasonally Wet Area
 af - Artificial Fill Area

The site is partially developed. An existing stock tank, well, and trash dump area was observed during site reconnaissance on proposed lot 3 near the northeast portion of the property and can be seen in Figure 6, Engineering and Geology Map. The site is generally located northeast of the intersection of Murphy Road and Peyton Highway in El Paso County, Colorado and comprises approximately 17.82 acres. The site is zoned “RR-5” - *Rural Residential*. Adjacent properties to the north, south, and west are zoned “RR-5” - *Rural Residential*, The property to the east is zoned “PUD” – *Planned Unit Development*.

Based on our field observations and review of relevant geologic maps, a geologic map was prepared which identifies the geologic conditions affecting the development. The geologic conditions affecting the development are presented in the Engineering and Geology Map, Figure 6.

- Each lot shall be designed to insure that a minimum of 2 sites are appropriate for a OWTS and do not fall within the restricted areas identified on the Engineering and Geology Map, Figure 6, (e.g. existing ponds, existing septic fields that may remain).

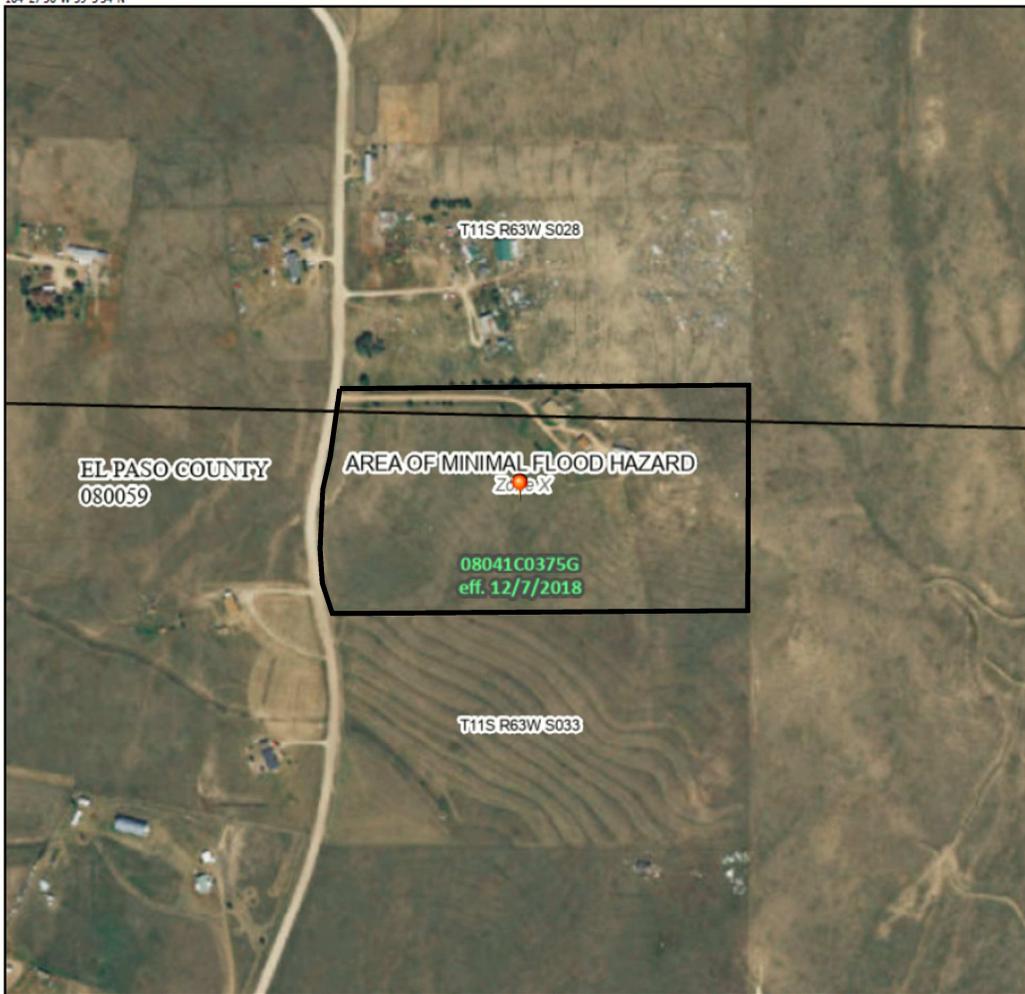
FIG No. 7

Feet 1:6,000
 Basemap: USGS National Map: Orthoimagery: Data refreshed October, 2020

Based on our review of the Federal Emergency Management Agency (FEMA) Community Panel No. 08041C0375G and the online ArcGIS El Paso County Risk Map, the entire site lies outside of identified regulatory floodway and 100 or 500-year floodplains. The site lies in Zone X. Zone X is defined by FEMA as an area of minimal flood hazard that is determined to be outside the Special Flood Hazard Area and higher than the elevation of the 0.2-percent-annual-chance (or 500-year) flood. The FEMA Map is presented in Figure 7.

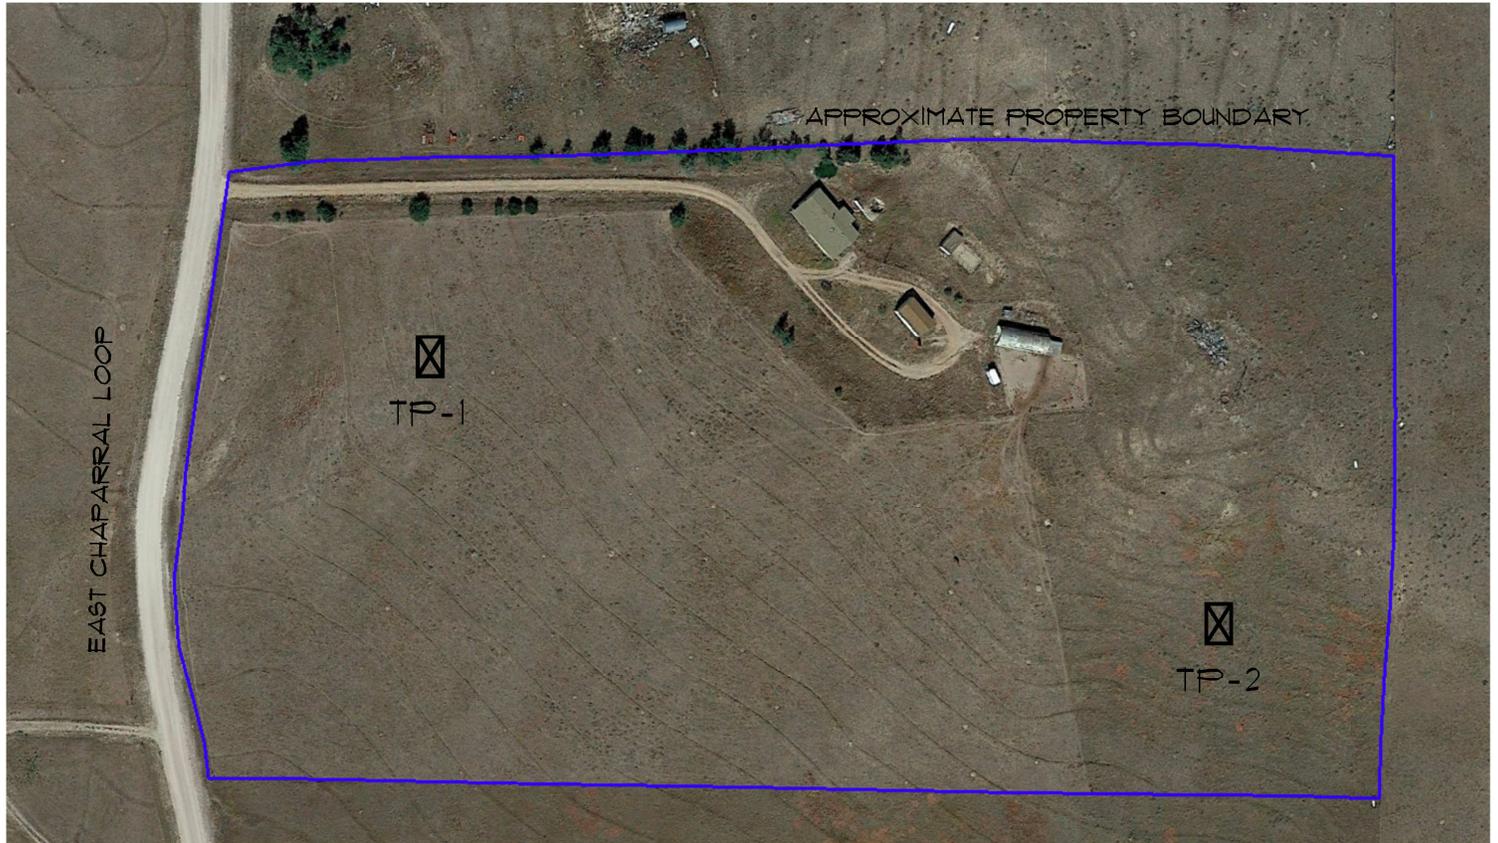
FIG No. 8

DENOTES APPROXIMATE
LOCATION OF TEST PITS

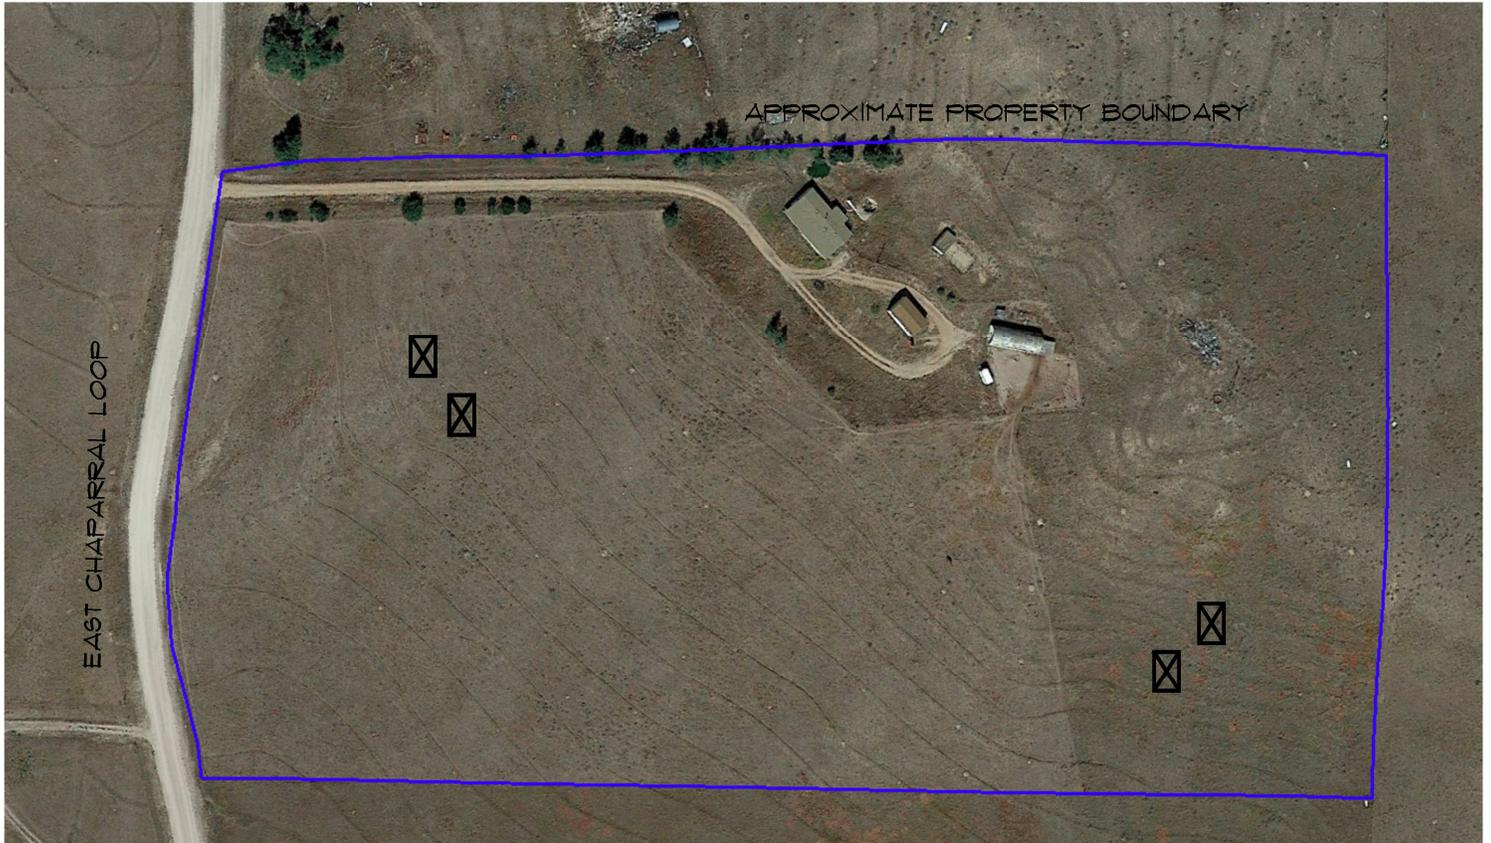
FIG No. 9

DENOTES PRIMARY AND
ALTERNATE SEPTIC
LOCATIONS
