**SOIL, GEOLOGY, & GEOLOGIC HAZARD STUDY
FALCON ACRES
CURTIS ROAD AND DAVIS ROAD
PARCEL NO. 44040-00-014
EL PASO COUNTY, COLORADO**

September 14, 2022

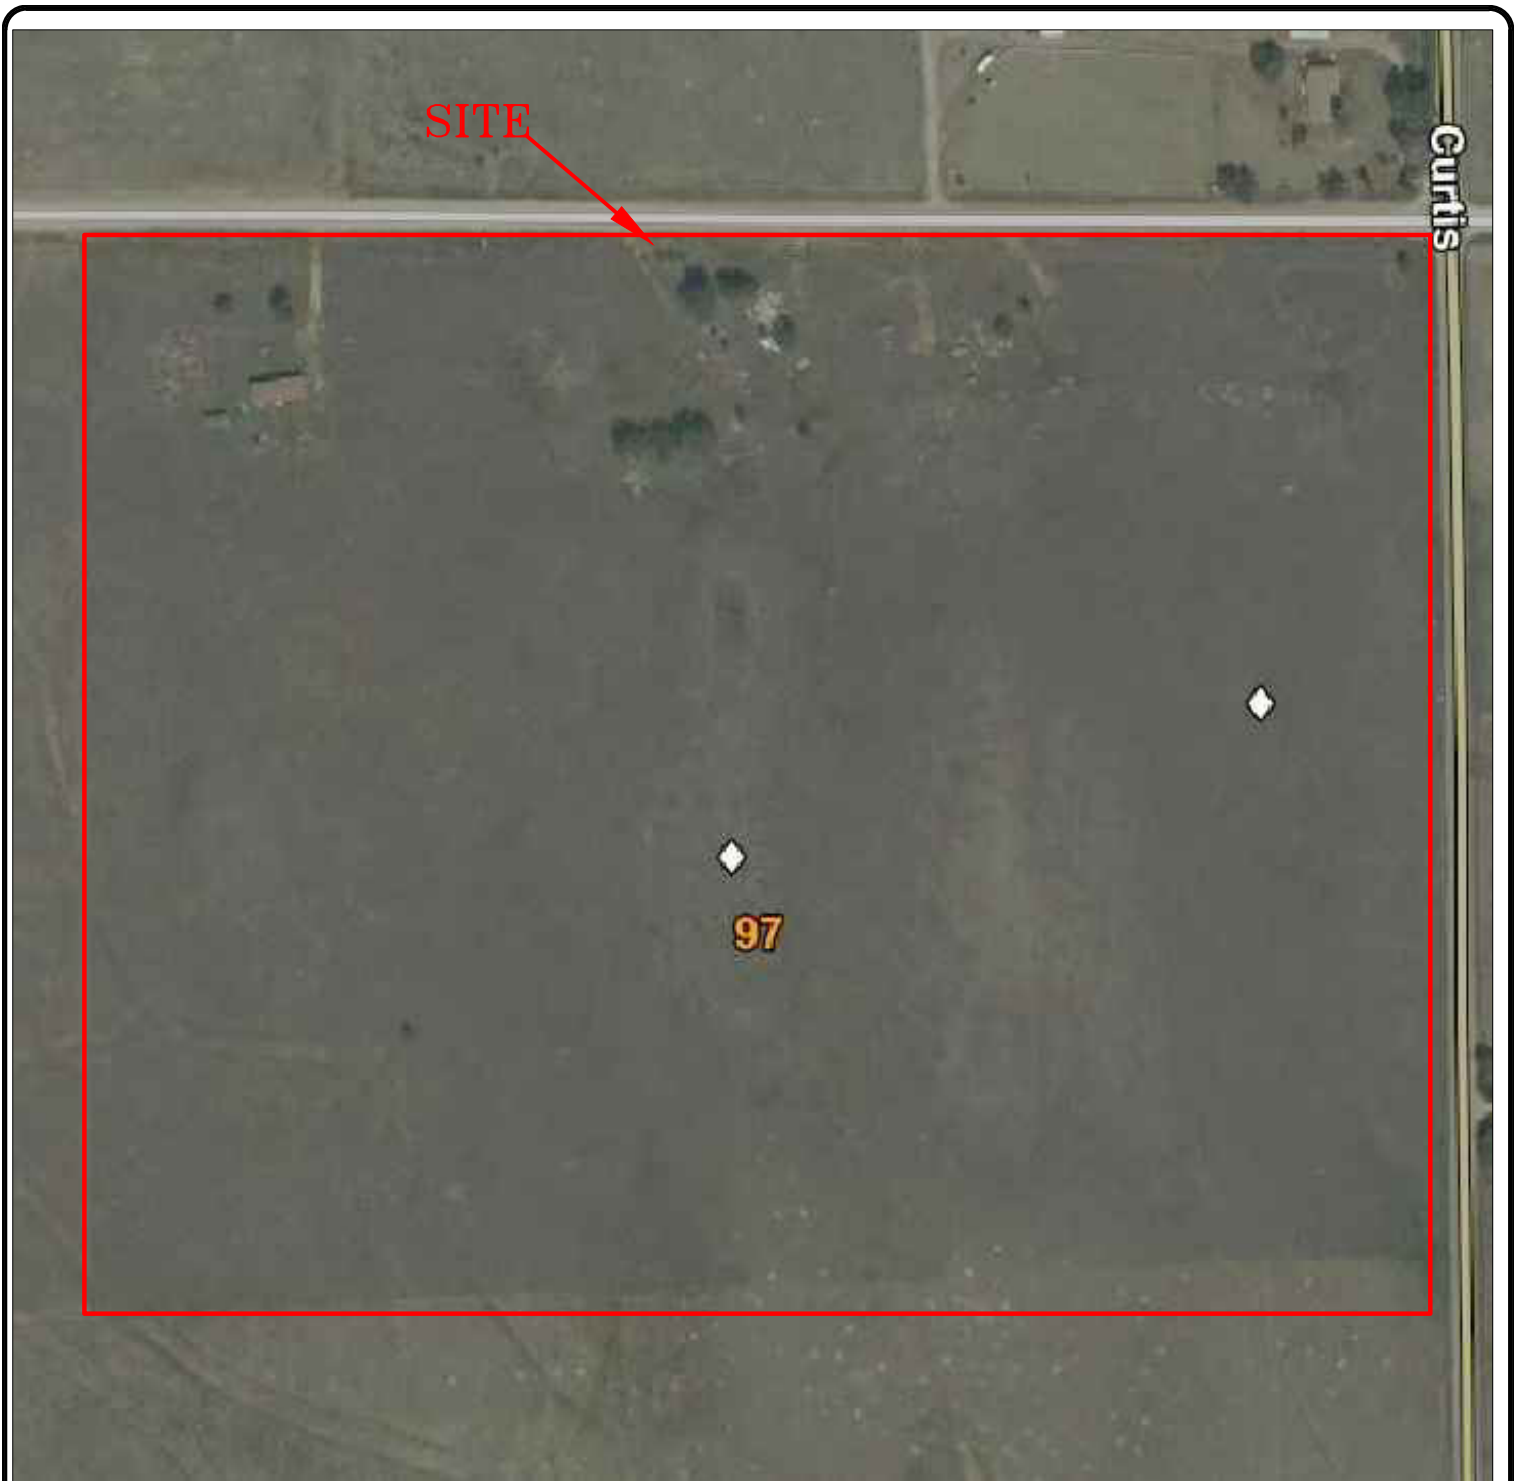
FIG NO.:
4

SOIL SURVEY MAP
FALCON ACRES
CURTIS ROAD AND DAVIS ROAD
EL PASO COUNTY, CO.
FOR: RICHARD ELLIOTT

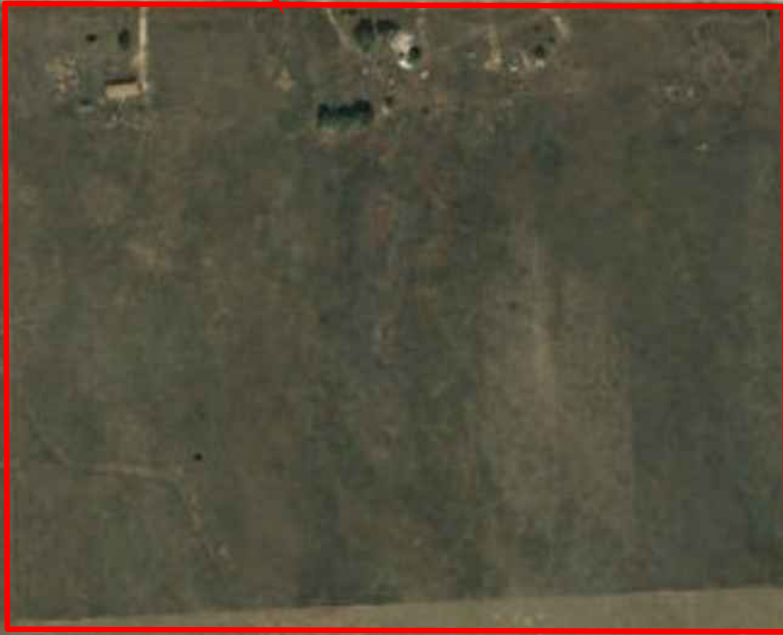
FIG NO.:
7

FEMA FLOODPLAIN MAP
FALCON ACRES
CURTIS ROAD AND DAVIS ROAD
EL PASO COUNTY, CO.
FOR: RICHARD ELLIOTT
